# Ground Test Experience With Large Composite Structures For Commercial Transports

H.L. Bohon, A.J. Chapman, III

MARCH 1983

**NASA**

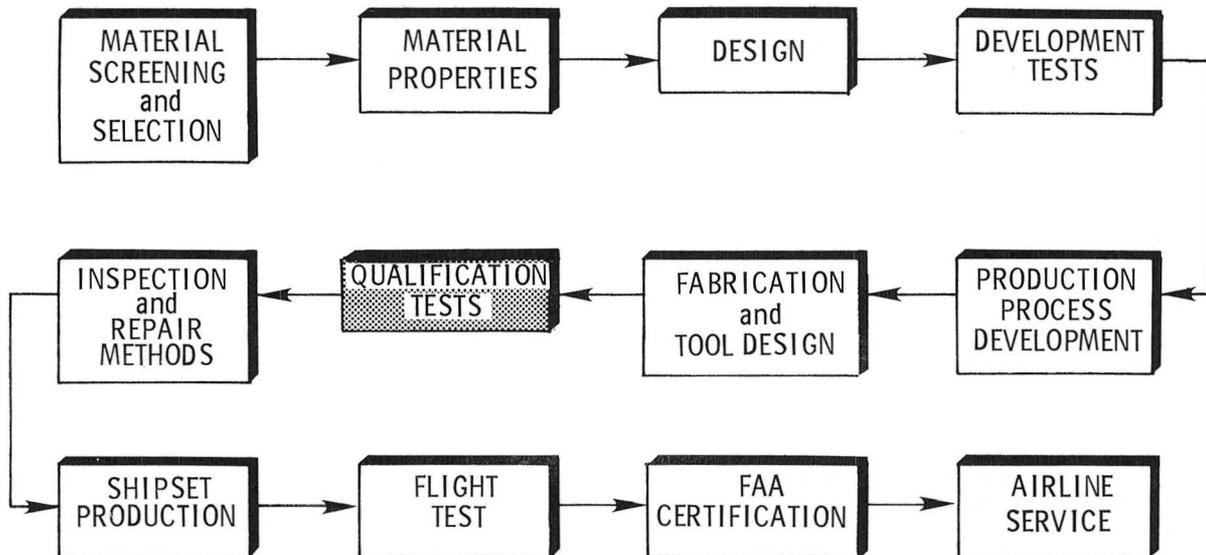
Figure 2 - Medium primary component development program.

The major elements of the technology development program are identified in figure 2. Various material options were evaluated before selecting one and then extensive testing was conducted to develop an adequate data base of material design properties. The material selected by the three manufacturers was the Thorne1 300 fiber with Narmco 5208 resin. Numerous design options for major subcomponents (covers, spars, and ribs) of the empennage structures were evaluated on the basis of weight efficiency, fabricability, maintainability and inspectability, and design options were narrowed through analysis and a varied spectrum of development tests on small and large elements. The program also included the development of a suitable production process including economical laminate preparation and the appropriate combination of temperature and pressure during cure of the structural parts. Tools were designed and fabricated, and full-scale components were then manufactured for ground qualification tests, flight tests, and airline service. Though serial production was limited in this program, fabrication included five shipsets of 737 horizontal stabilizers and three units each of the L-1011 vertical fin and the DC-10 vertical stabilizer. Most of the element, subcomponent and component test data and associated analyses are included in a report submitted to FAA for flight certification, which must precede airline service. Inspection and repair methods to insure adequate maintenance in service were also part of the development program. Principal results from the ground qualification tests on the three empennage structures are the focus of this paper.

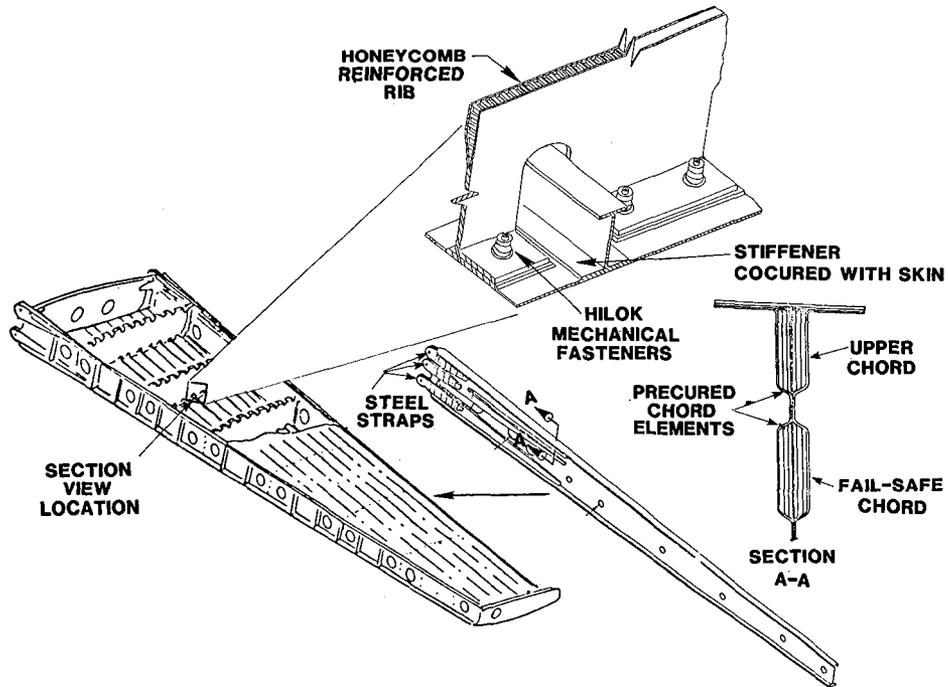
Figure 3 - 737 composite horizontal stabilizer - assembly methods.

737 Composite Horizontal Stabilizer.- The structural configuration of the 737 composite horizontal stabilizer is shown in figure 3. This component is the smallest of the three medium-primary structures and measures 4 feet at the root chord by 17 feet in span. The covers are I-stiffened with the stiffeners and skin integrally cured, whereas the front and rear spars are pre-cured channel sections secondarily bonded back-to-back with web stiffeners mechanically attached. The ribs are also channel sections and have honeycomb stabilized webs. All components are assembled with mechanical fasteners. Load transfer from the stabilizer to the fuselage carry-through structure is by thick graphite lugs with metal face-plates, two on the front spar and three on the rear spar. Concentrated loads from the lugs are dispersed into the spar web by thick pre-cured chord elements indicated by section A-A in figure 3. Component design and manufacturing details are reported in references 7 through 11.

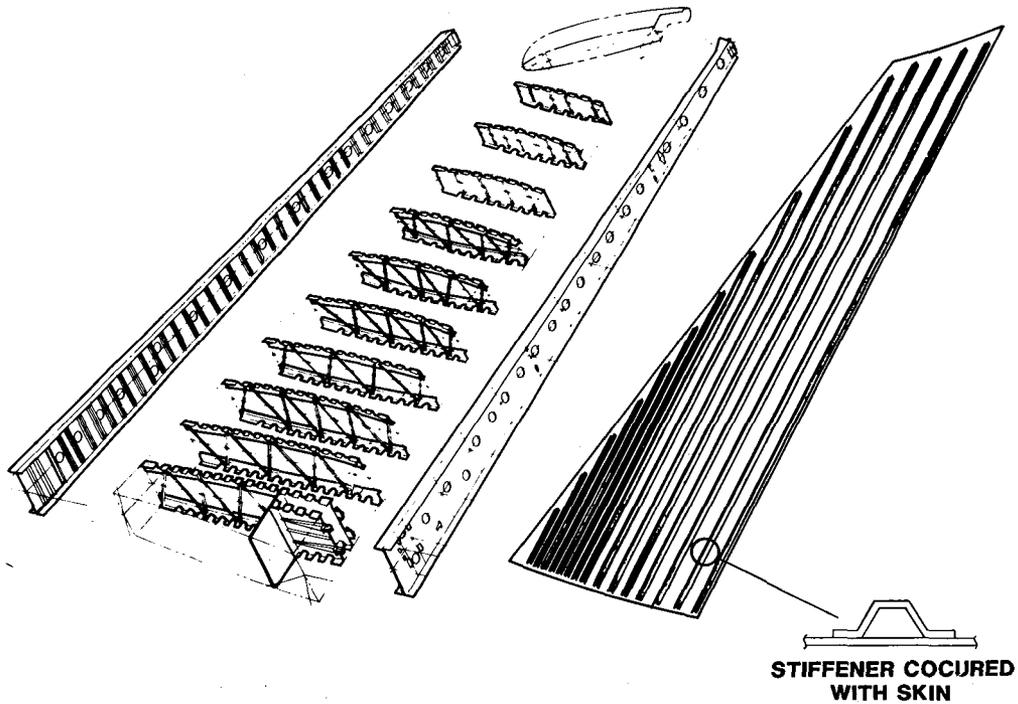
Figure 4 - L-1011 composite vertical fin - structural configuration.

L-1011 Composite Vertical Fin.- The structural arrangement of the fin is shown in figure 4. The vertical fin is the largest in planform of the three empennage structures and measures approximately 9 feet at the root by 25 feet in span. All subcomponent parts of the structural box are fabricated with graphite-epoxy except the aluminum truss members of seven truss ribs.

The design features integrally cured hat-stiffened covers and stiffened web spars. The integrally formed composite I-shaped spars replace 35 metal parts and over 2200 fasteners required in the metal design. The covers, spars, and ribs are mechanically joined during final assembly. Component design and manufacturing details are reported in references 12 through 16.

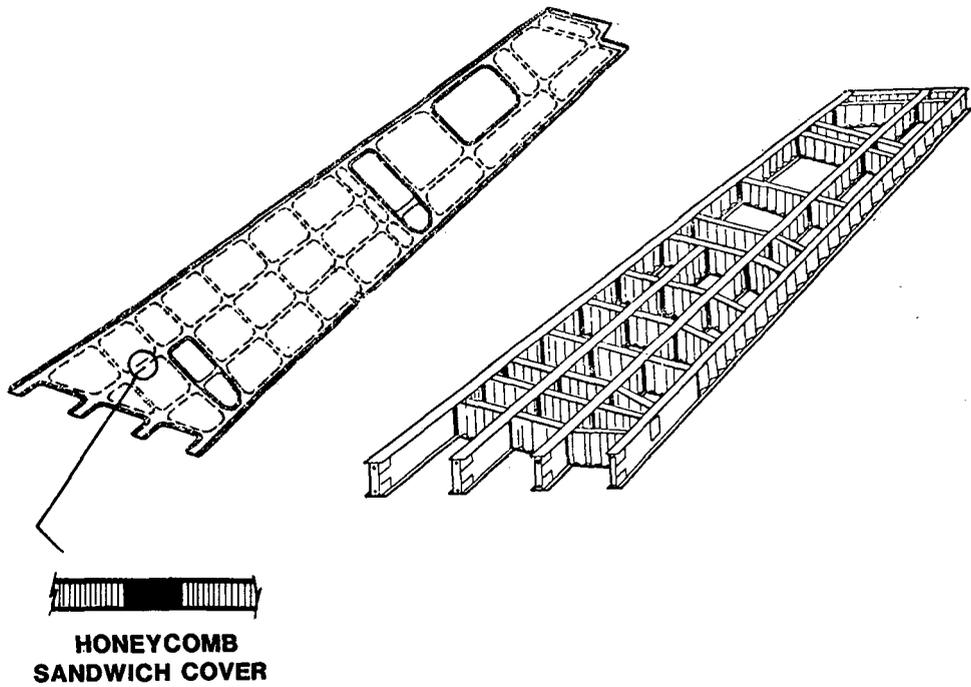
Figure 5 - DC-10 composite vertical stabilizer - structural configuration.

DC-10 Composite Vertical Stabilizer.- The structural configuration of the stabilizer is shown in figure 5. Since aerodynamic loads from the stabilizer are transmitted to the airframe structure at four discrete spar locations in the metal design, retention of the multi-spar concept was necessary. Thus, in order to achieve a significant weight reduction, the composite design incorporated sine wave webs for all spars and ribs, and honeycomb sandwich covers. The covers consist of a grid of thick laminates which mate with and become an extension of the spar and rib caps and Nomex honeycomb core sandwich skins between spar and rib caps. Each of the subcomponents are integrally cured although the three longest spars are cured in two parts and spliced at a spanwise station. The spars and ribs are assembled as shown in the figure by secondary bonding along the webs of the spar/rib interfaces without the use of mechanical fasteners. The covers, when mechanically attached to the spar and rib caps, complete the assembly. Additional details on the DC-10 composite stabilizer are given in reference 17.

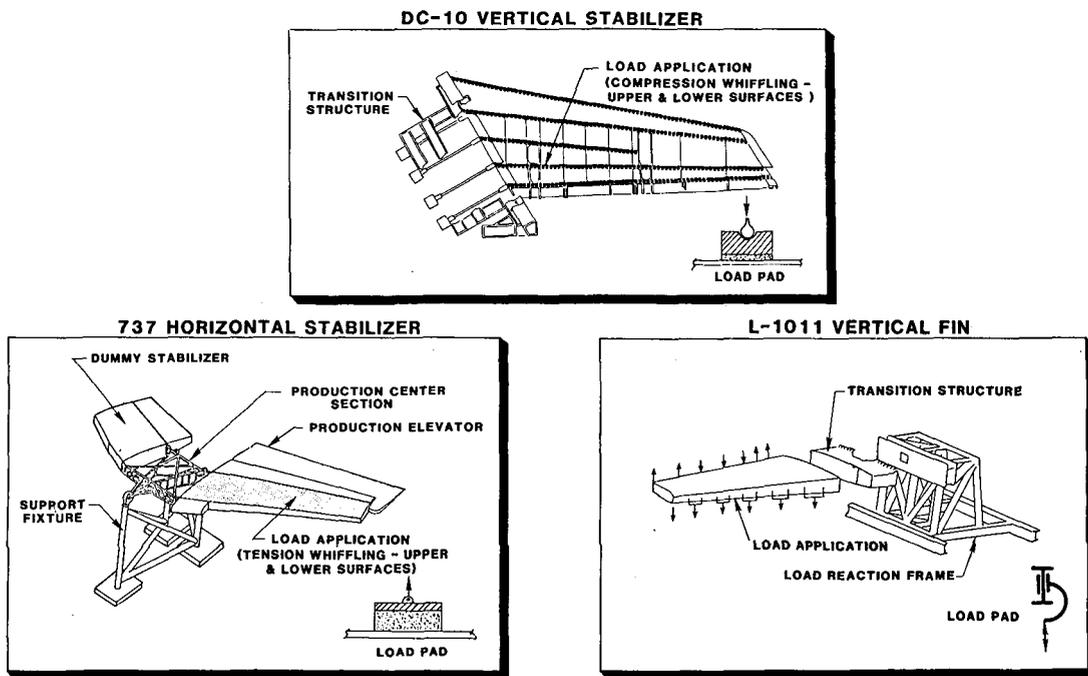
Figure 6 - Full-scale ground test load techniques.

Ground Test Load Introduction.- Methods of applying simulated aerodynamic loads to the full-scale components during ground tests were different for each structure. These methods are shown schematically in figure 6. Static loads to the DC-10 vertical and the 737 horizontal stabilizers were applied to the covers through a whiffletree arrangement. Tension "whiffing" was used with the 737 horizontal stabilizer while compression "whiffing" was used with the DC-10 vertical stabilizer. In each case, loads were transmitted into the covers at pads bonded to the surface. Compression pads on the DC-10 component were restricted to locations over the spars to avoid concentrated loads on the honeycomb areas of the covers, whereas pads on the 737 stabilizer were placed at random to provide the best distribution of internal loads. Primary loads to the L-1011 fin were applied along the front spar web through a yoke device shown by the insert in figure 6. Simulated rudder kick loads on both vertical fin components were imposed by load jacks attached directly to the rudder hinges. The 737 horizontal stabilizer was tested with a production elevator in place which was loaded through a whiffletree in the same fashion as the main structural box.

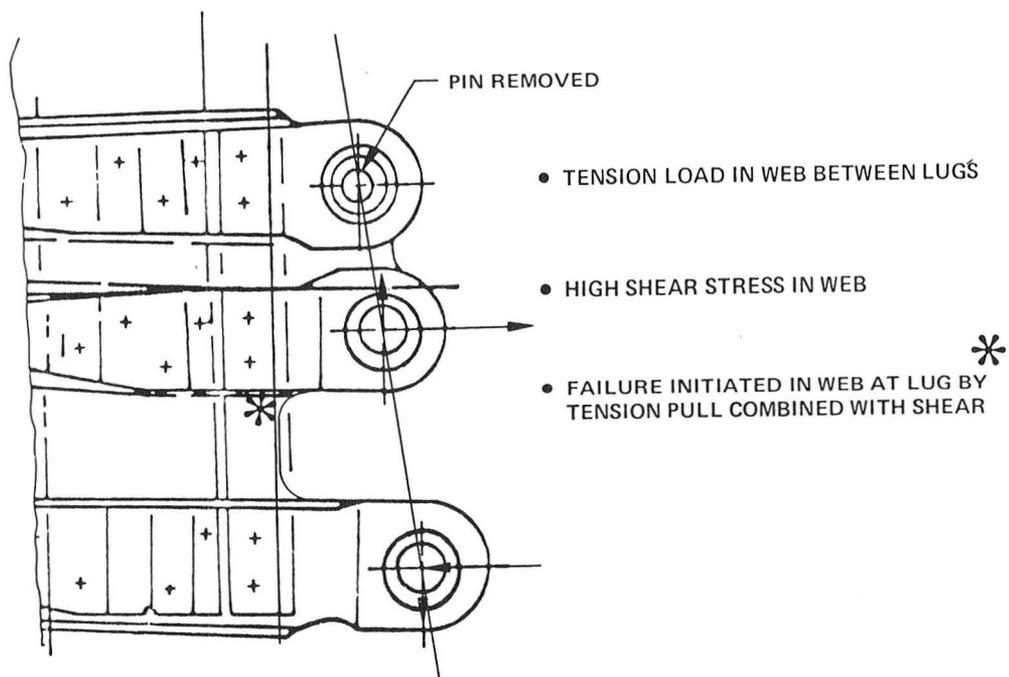
Figure 7 - 737 composite horizontal stabilizer - fail-safe test configuration.

The fail-safe test configuration of the rear spar lug when failure occurred is shown in figure 7. The upper lug pin was removed from the rear spar and the stabilizer was loaded in bending. The arrows depict the direction of reaction loads at the two pinned lugs. Failure was initiated in the web between the lug chords and propagated along the span. However, damage was constrained within the web of the rear spar. A photograph of the damaged spar is shown in figure 8 and the extent of crack propagation on both interior and exterior webs and at the web midplane is shown in figure 9. Two modes of failure are shown by the photographs in figure 10. The tension failure of the web, shown by Section B, is at the region of highest strain. Farther outboard from the lugs, at Section A, the failure was a delamination of the web plies that wrap around the lug chord. Strain measurements at two locations on the rear spar web are shown in figure 11. These data confirm the high diagonal tension strain near the point of failure

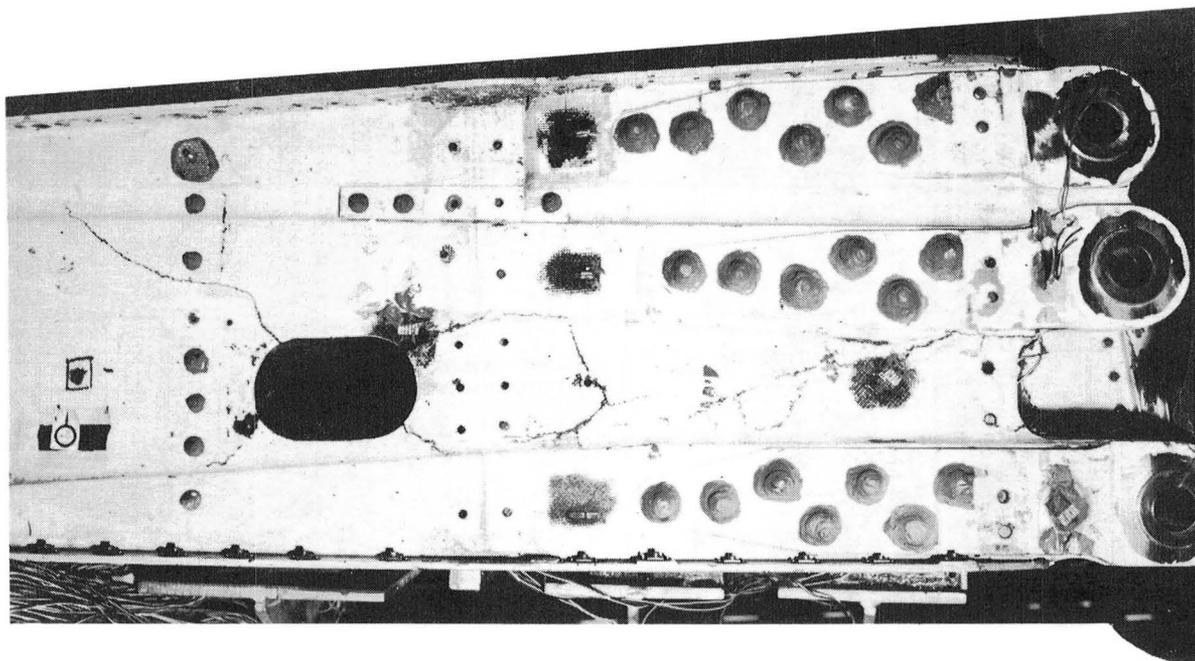
Figure 8 - 737 composite horizontal stabilizer - rear spar failure of ground test article.

737 Composite Horizontal Stabilizer.- The ground test article was subjected to a series of static and fatigue tests at ambient conditions to assess performance of the all-composite stabilizer under several flight conditions for direct comparison with calculated results. Initially, design limit load was applied representing three different critical flight conditions (i.e., shear, torsion, and bending) followed by one-half lifetime of spectrum fatigue loads. The article was then subjected to damage tolerance tests following visible surface damage inflicted on the covers and spars. These tests included one lifetime of spectrum fatigue followed by tests in bending to design ultimate load (150 percent of limit load). After damage tolerance testing, several fail-safe tests were conducted where the stabilizer was loaded to limit load with lug pin removed at the spar attachment to the carry-through structure. The stabilizer failed on the fourth and last of these tests at 91 percent of limit load.

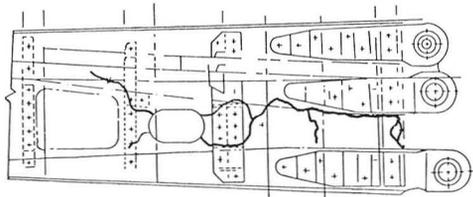
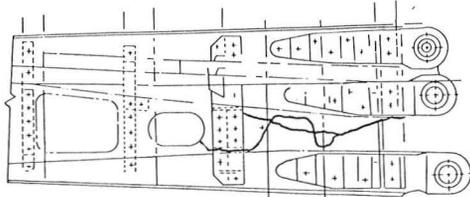
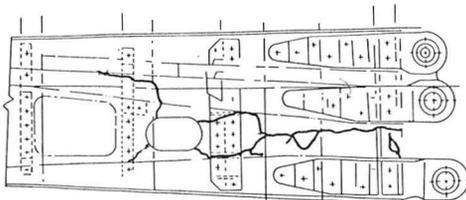
Figure 9 - 737 composite horizontal stabilizer - crack propagation in ground test article.

● WEB CRACKS, INTERIOR FACE

● WEB CRACKS, MID-PLANE

● WEB CRACKS, EXTERIOR FACE

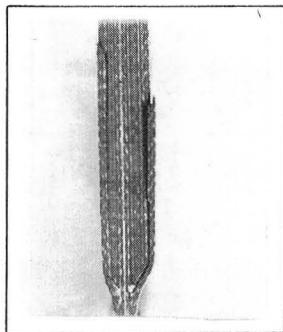
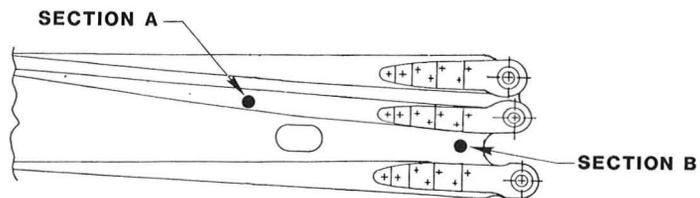
Figure 10 - 737 composite horizontal stabilizer - rear spar web failure.

**SECTION A**  
DELAMINATION OF  
FACE PLYS

**SECTION B**  
TENSILE FAILURE OF  
INBOARD WEB

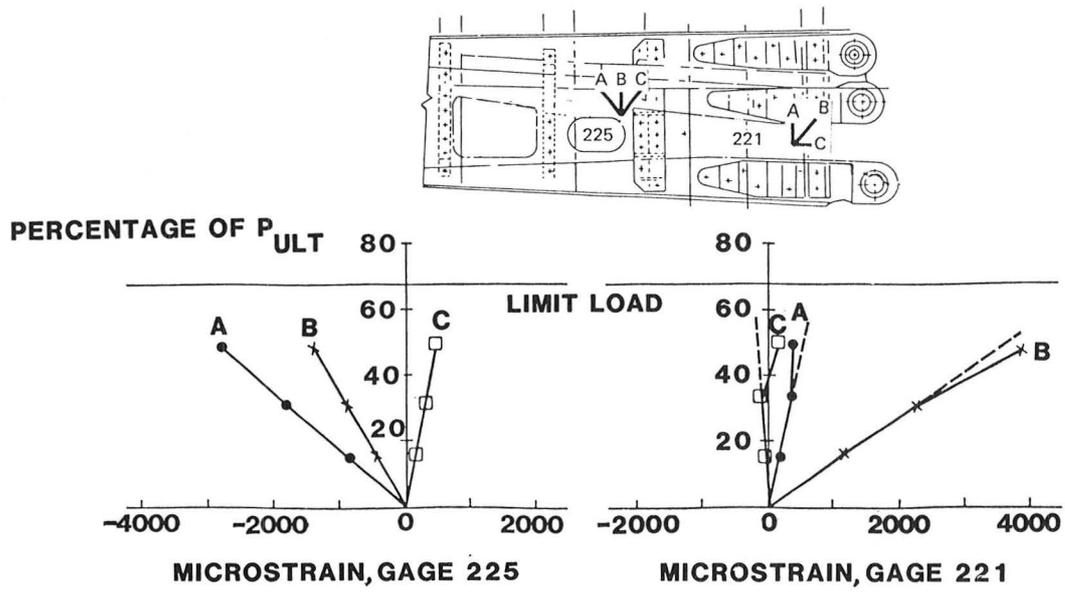
Figure 11 - 737 composite horizontal stabilizer - rear spar strain data.

initiation and indicate nonlinear behavior at this location after about 50 percent of limit load.

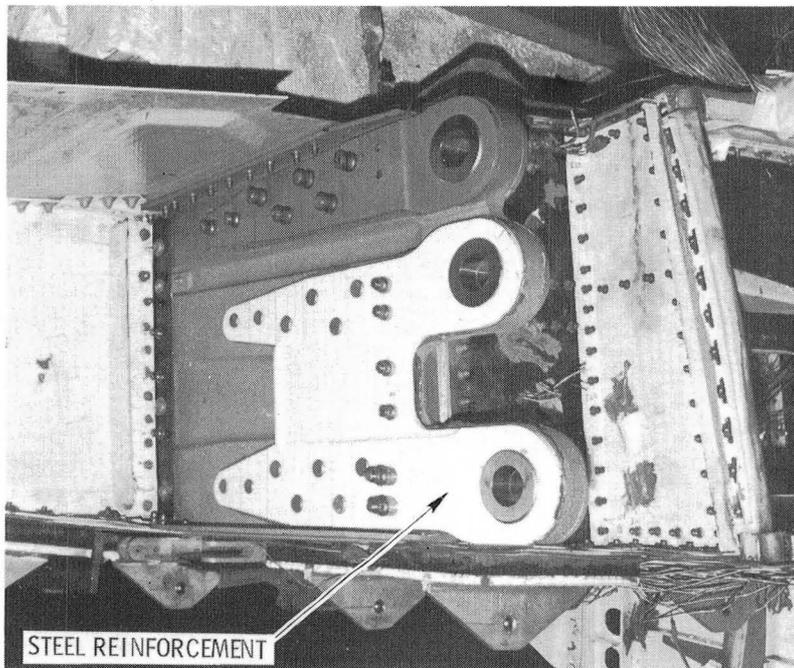
Figure 12 - 737 composite horizontal stabilizer - steel reinforcement of rear spar.

Post-test analysis with a fine grid finite element model confirmed the high strain concentration region and led to the incorporation of a steel plate as shown in figure 12 to provide the additional margin on strength. Based on the analysis and margin predicted with this design change, the FAA proceeded to address certification without requiring further ground tests and certification was granted in August 1982.

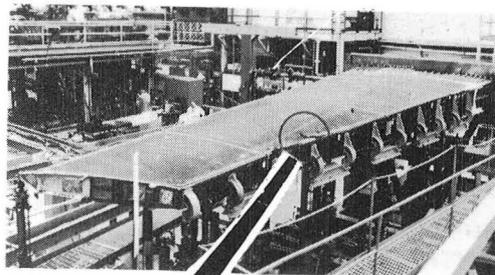
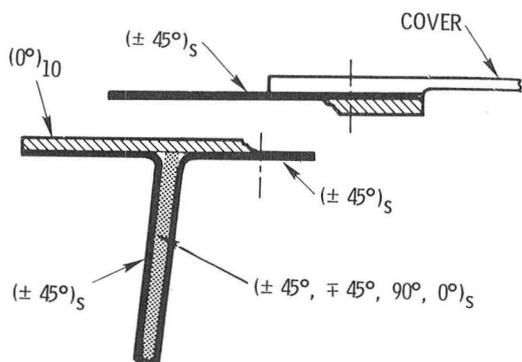
Figure 13 - L-1011 composite vertical fin static test failure at 98% design ultimate load.

The L-1011 fin failed at 98 percent of design ultimate load during the planned test to 106 percent of design ultimate in bending. Failure caused separation of the cover and front spar along the entire length of the spar (see figure 13) as well as considerable internal damage to rib structure. After an investigation, the cause of failure was determined to be due to secondary loads, of which the principal contributor probably was local buckling of the cover near the front spar interface. While local buckling beyond limit load was allowed in the design, the influence of loads caused by buckling on the integrity of the structure was unexpected. Interlaminar tension forces caused delamination of the spar cap as shown by the insert in figure 13 and ultimate separation along the line of fasteners.

A post-failure study was conducted to assess the strength of the cover/spar design when subjected to stresses imposed by secondary loads causing interlaminar tension and transverse tension. Segments of the cover/spar design were tested as shown by figure 14. Secondary loads causing transverse tension could be induced by Poisson's effect and those causing interlaminar tension may be generated by local buckling of the cover or by rotation of the spar web caused by the method of load introduction. The first tests were on virgin material that had no prior loading and measured loads at failure indicated adequate margin. The estimated maximum interlaminar tension load expected in flight was 68 pounds per fastener. The second series of tests on undamaged segments of the failed spar, which had undergone several cycles of load, showed large reductions in strength. This apparent influence of load cycling was verified by a third test on specimens subjected to load cycles similar to those of the ground test article prior to failure. This degradation in strength is an apparent result of a design weakness in the spar cap. In retrospect the 10 plies of zero degree oriented fibers (see figure 13) do not contribute to interlaminar

strength and, in fact, provide the actual delamination plane. Interlaminar strength may have been enhanced if 45 degree plies or even 90 degree plies had been interspersed in the zero degree ply stack.

**TYPICAL SPAR CAP  
DAMAGE IN PRIMARY  
FAILURE ZONE**

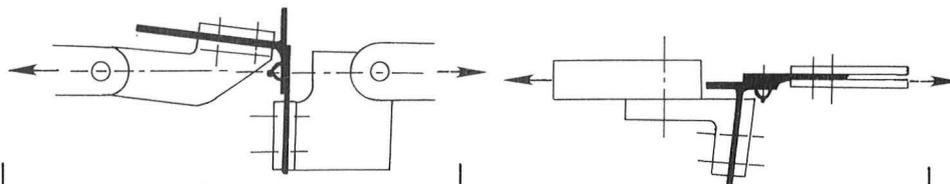
Figure 14 - L-1011 composite vertical fin - influence of load cycling on interlaminar strength.

SPECIMEN CONDITIONING	INTERLAMINAR TENSION (LB./FASTENER)	TRANSVERSE TENSION (LB./IN.)
NO PRIOR LOADING	88	445
SEGMENT OF SPAR OF FAILED GROUND TEST UNIT	34	256
PRIOR LOADING EQUAL TO GROUND TEST UNIT	56	225

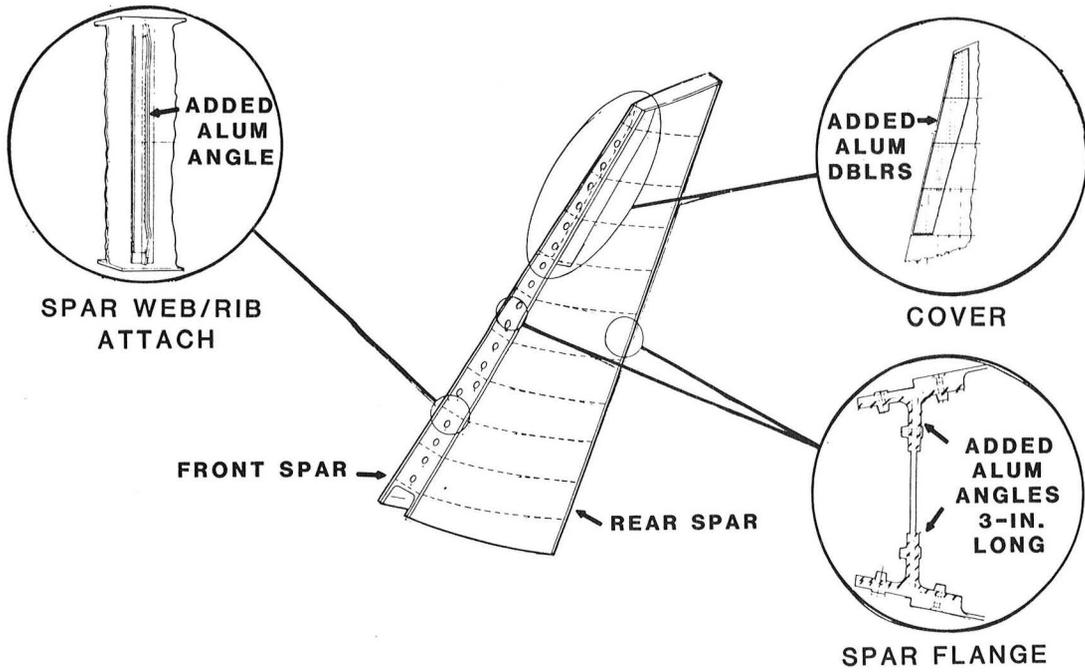
Figure 15 - L-1011 composite vertical fin - ground test article modifications.

After the cause of failure was properly identified the ground test program was continued with a second fin. The composite fin was not to be certificated by FAA nor placed in flight service and redesign of the front spar and subsequent fabrication would have imposed unnecessary delays and cost to the program. Consequently, the second fin was reinforced to suppress the mode of failure of the first ground test article. The reinforcements, shown in figure 15, include aluminum doublers on the external surface of the cover, along the front and rear spar flanges, and at the rib attachment flange on the spar web. The primary purpose of the cover plate doubler was to provide extra material thickness so that run-out flanges of the hat-stiffened cover (see figure 4) could be mechanically fastened in the area where the cover is only 10 plies thick.

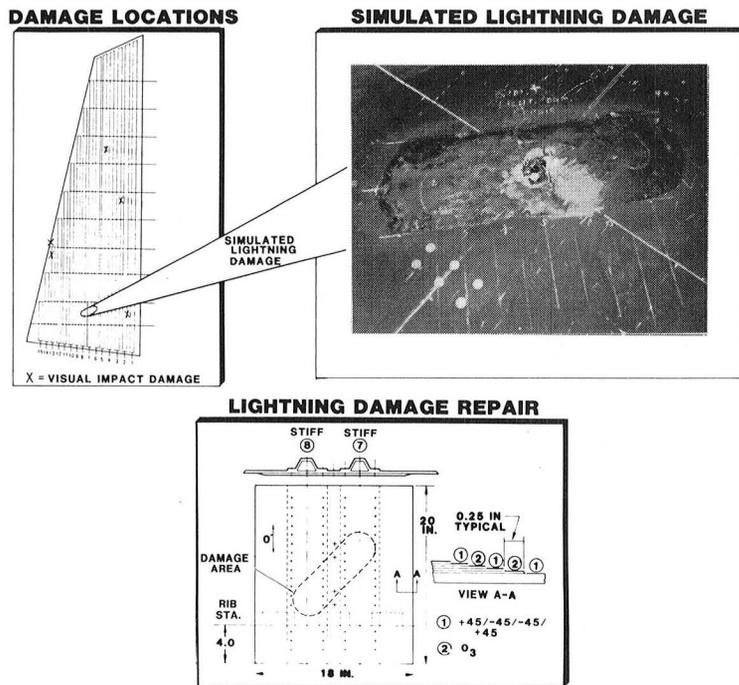
Figure 16 - L-1011 composite vertical fin - damage and repair.

The second fin was subjected to a series of damage tolerance tests which included lightning damage and field repair prior to final test for residual strength. Details of the damage tolerance program are shown in figure 16. The model was impacted at five locations on the surface to cause visible damage and then tested for one lifetime of spectrum fatigue loading. This was followed by simulated lightning damage consisting of vaporizing resin in the first four plies and a punch through as shown in figure 16. The component was then loaded in bending to limit load, repaired with an external patch as shown in the figure, subjected to a second lifetime of fatigue loads and then tested to failure.

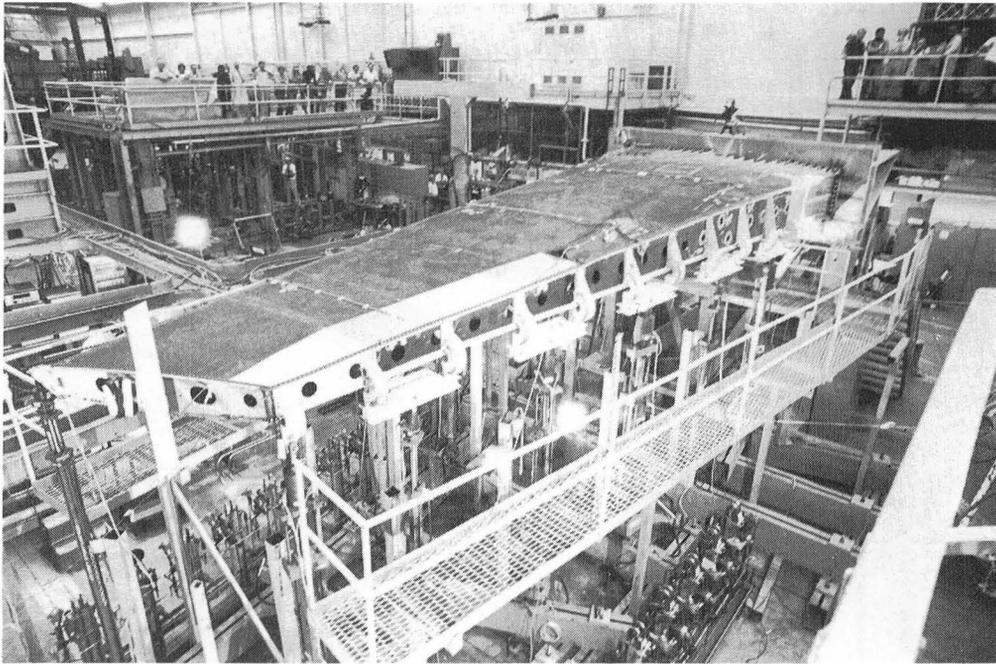
Figure 17 - L-1011 composite vertical fin -  
static test failure at 119.7% design ultimate load.

The failed component, shown in figure 17, carried 119.7 percent of design ultimate load which was only slightly less than the predicted failure load of 121 percent. The mode of failure of the first unit was totally suppressed in this test and the failure did not propagate to other parts of the component. However, the failure mode included buckling of the cover as well as disbonding of some of the hat stiffeners. The stiffener disbond shown by NDI markings in figure 18 included flanges of two hat stiffeners and the disbond extended from the point of initiation at the front spar over most of the stiffener length to the root end. Again, secondary interlaminar tension loads at the stiffener/cover interface were of sufficient magnitude to cause failure. The influence of these loads may be a major design driver in future application of composites to primary structures.

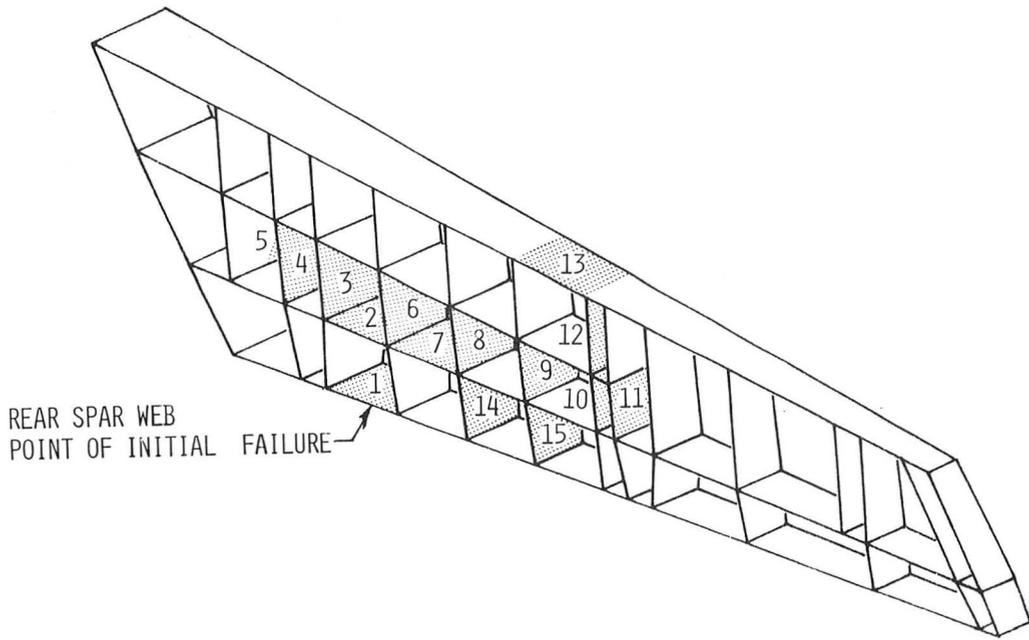
Figure 19 - DC-10 composite vertical stabilizer - ground test failure sequence.

lifetime spectra, and a fail-safe limit load test. For the static test, which began in December 1981, the full-size stabilizer was loaded in three flight critical design limit load conditions. Two limit load tests, inducing critical shear and critical torsion loading in the structure were successfully completed. The third limit load test, inducing critical bending in the structure, was applied to design limit load. While recording data at this load level, the structure failed. External damage included fractures of the compression cover and failure of the rear spar web. After removal of the cover, a detailed inspection revealed the failed spar and rib areas shown shaded in figure 19.

The stabilizer was analyzed using a global finite element model to establish a failure scenario which would be consistent with all the failed elements on the structure. The failure sequence was established by deleting each structural member in the finite element model found to have a negative margin of safety as a result of a previous failure. When the rear spar was selected as the first failure the analysis indicated a progression of failures as shown by the numbered elements in figure 19. Each distinct failure observed in the structure was predicted in this manner and no other failure scenario produced the actual areas of failure.

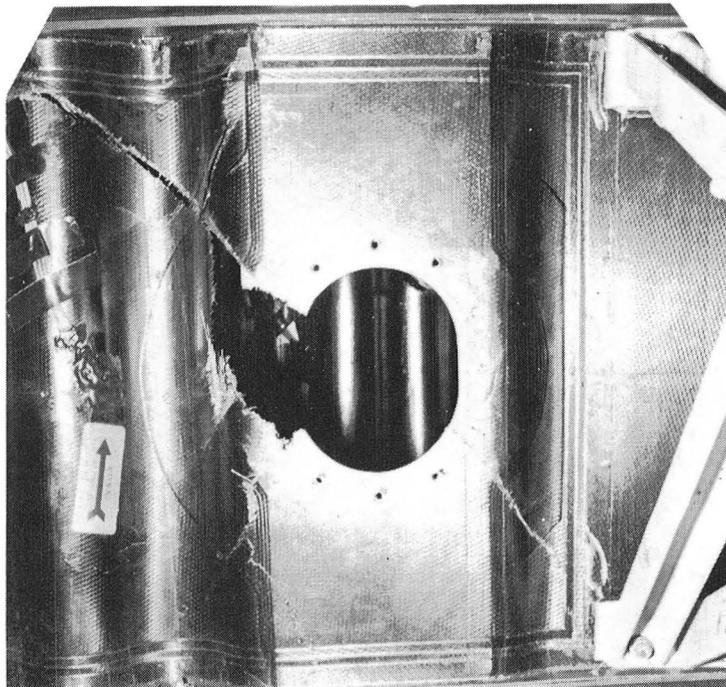
Figure 20 - DC-10 composite vertical stabilizer - rear spar static test failure at limit load.

The failure investigation initially considered possible discrepancies in the following areas: design and analysis, test loads, material quality, and manufacturing. A preliminary analysis showed margins of safety in the structure to be adequate at design limit load. Loads data showed loading throughout the structure to agree with the planned test load distribution. Measured strains and deflections were found to be within design limits for the structure. Quality control records and inspection of failed parts revealed no correlation between part quality and observed failure modes. The investigation next focused on close examination of the failed areas identified in figure 19. The only failure found in the rear spar was a diagonal shear failure in the rear spar web in the bay immediately above the lower rudder actuator and a splice in the rear spar. A photograph of the spar web at this bay (figure 20) shows the failure extending diagonally across the web and through an access cutout.

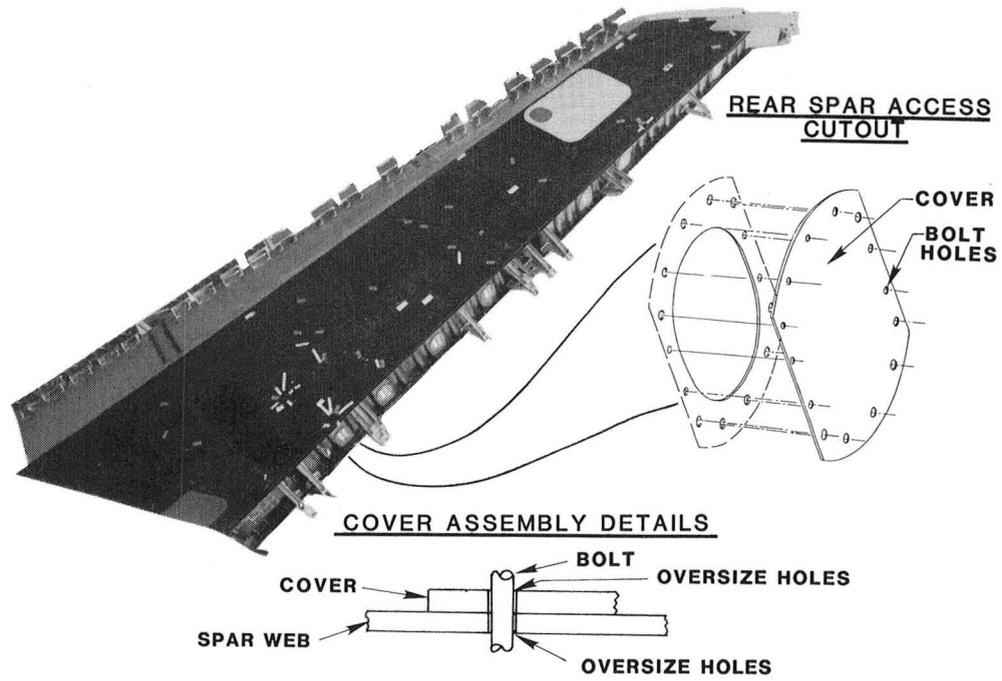
Figure 21 - DC-10 composite vertical stabilizer - failure initiation at rear spar access cutout.

The rear spar web is a thin sine-wave laminate, and contains access cutouts required to complete assembly of the structure and subsequent inspection and maintenance. There are seven such cutouts on the rear spar. Locations and details of the cutouts are shown in figure 21. These cutouts, about 4 by 5 inches in dimensions, are located in flat, reinforced areas in the spar web. Each cutout is fitted with a flat laminate cover which is attached to the web by bolts as shown in the diagram. This cover is designed to carry loads in the spar web as an integral part of the structure. Post-test examination of the spar web failure revealed a discrepancy in the bolt hole size both in the cover and in the spar

web. These holes were 0.057 to 0.072 inches larger in diameter than the bolt.

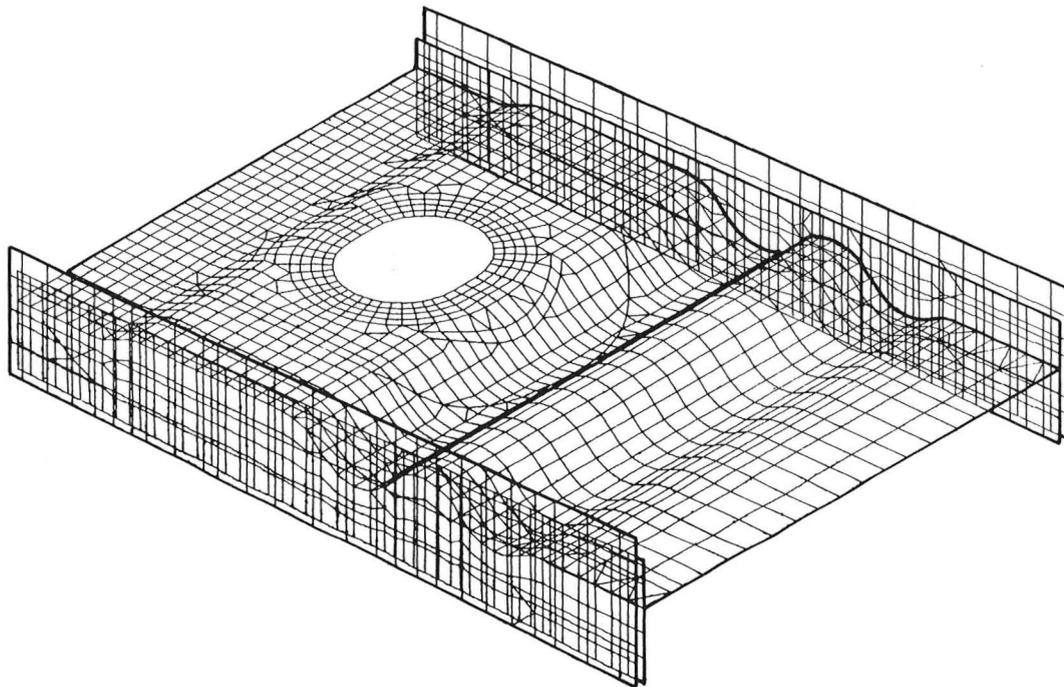
Figure 22 - DC-10 composite vertical stabilizer - rear spar finite element model.

To adequately analyze the sine-wave web rear spar area and the loose fit cover, a detailed finite element model was developed (figure 22). This model included fine grid detail of the spar cap, sine-wave web, flat web area, and cutout. The web cutout cover, not shown, was also modeled in detail. Loads were applied to this model while the web-to-cover interface was analytically varied to simulate various bolt fits. A reference case with no door installed was also run. Results of the analysis are shown in figure 23 where web shear failure loads and cutout perimeter strains are shown for three cases: (1) cover attached with tight holes; (2) cover attached with loose holes; and (3) cover off. The test failure shear load in the web, which was calculated from measured strain gage data, is also shown for comparison with calculated values. The spar web actually failed at a shear load somewhat higher than the calculated value for loose holes. The calculated load and strain values show that the cover with loose holes and the cutout without cover were almost equally ineffective in carrying required design load in the web. The cover attached with tight holes was predicted to provide adequate margin for failure load and to reduce strains at the hole perimeter to an acceptable level.

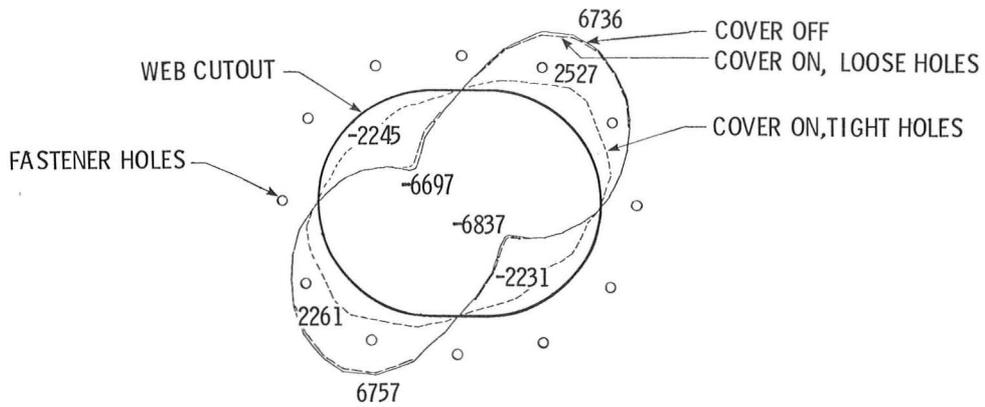
Figure 23 - DC-10 composite vertical stabilizer - rear spar web strains and shear loads.

TEST FAILURE LOAD	ANALYSIS FAILURE LOADS FINITE ELEMENT MODEL
832 LB/IN	COVER ON, TIGHT HOLES - 1140 LB/IN
	COVER ON, LOOSE HOLES - 620 LB/IN
	COVER OFF - 570 LB/IN

**CALCULATED STRAINS AT EDGE OF CUTOUT,  $\mu$ IN/IN**

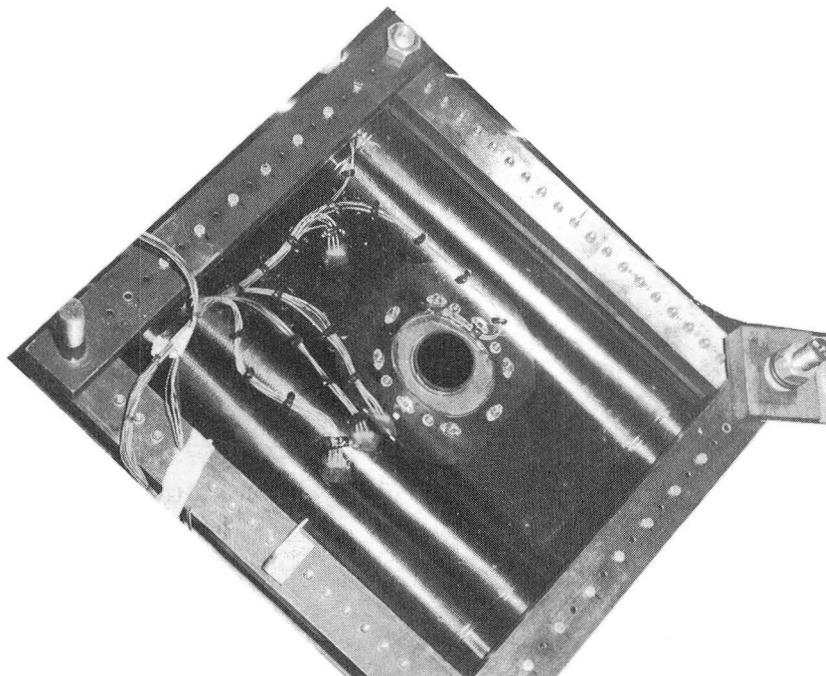
Figure 24 - DC-10 composite vertical stabilizer - shear web test article.

A test program was developed to verify the effect of cover fastener fit on the initial rear spar failure, and to evaluate the structural stability of the sine-wave web. These tests were also used to validate the detailed finite element model of the rear spar. A rib component having a sine-wave web and access cutout similar to the rear spar was used for the tests. The rib was mounted in the picture frame fixture shown in figure 24 and tested first without the cover, and then with the cover installed with oversize holes to match the rear spar configuration, and finally with a redesigned cover installed. The redesign cover, shown in figure 25, is flanged to provide added out-of-plane stiffness, and is permanently installed over the spar web cutout using an adhesive bond together with mechanical fasteners. The small hole in the redesigned cover will provide necessary access for inspection.

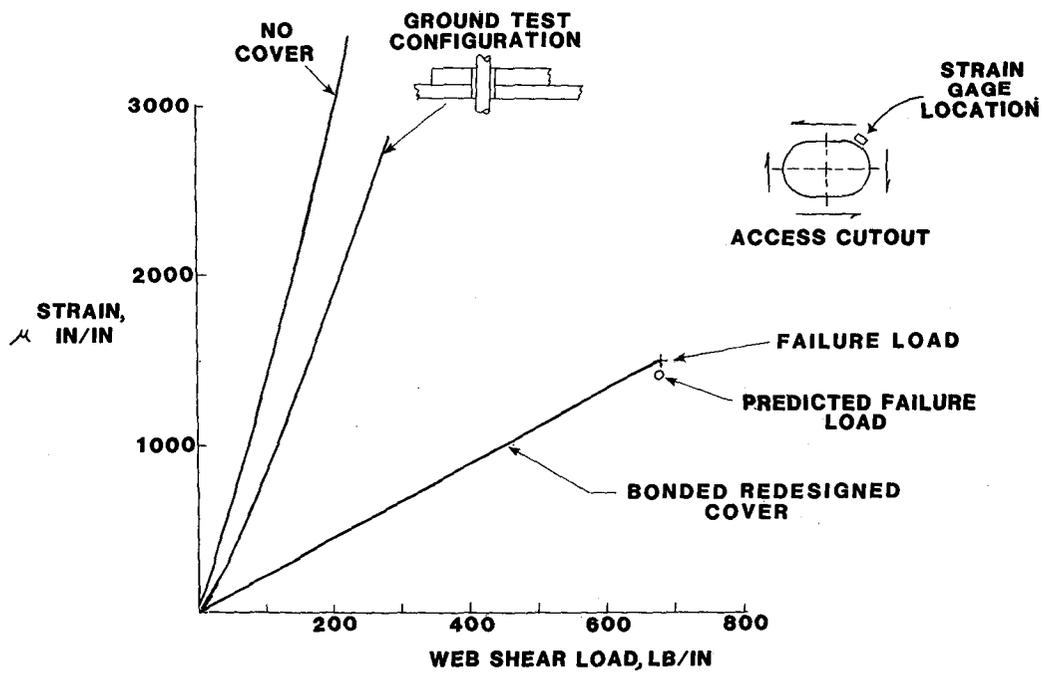
Figure 26 - DC-10 composite vertical stabilizer - access cutout strain data.

Results of the rib web shear test are shown in figure 26 where strains measured at the edge of the cutout (as shown in the inset diagram) are plotted as a function of web shear load. With the cover not installed, strains were extremely high and the test was stopped at a low load to avoid failing the specimen. With both the cover and web fastener holes drilled oversize to represent the ground test configuration, strain was somewhat reduced but still quite high. These results clearly show the importance of the fastener fit in transferring load across the shear web and reducing strains.

With the redesigned cover attached over the rib web cutout and adhesively bonded as well as mechanically fastened, the rib element was tested

to failure. The strains for this test were much lower than for the other configurations and the web failed in the thin sine-wave section, well away from the reinforced cutout area. A detailed finite element analysis of the modified cover configuration agrees closely with the test data, confirming the adequacy of the finite element grid to represent the complex sine-wave web configuration and cutout cover. The results of the rib tests together with the analysis of the stabilizer and the rear spar web confirm the failure theory that the oversize holes in the cover reduced the ability of the cover to carry loads across the rear spar web, resulting in high stress concentration at the edge of the cutout.
