**NASA  
Technical  
Paper  
2236**

Galvanic Coupling Between  
D6AC Steel, 6061-T6 Aluminum,  
Inconel 718, and Graphite-  
Epoxy Composite Material:  
Corrosion Occurrence  
and Prevention

Merlin D. Danford  
and Ralph H. Higgins

*George C. Marshall Space Flight Center  
Marshall Space Flight Center, Alabama*

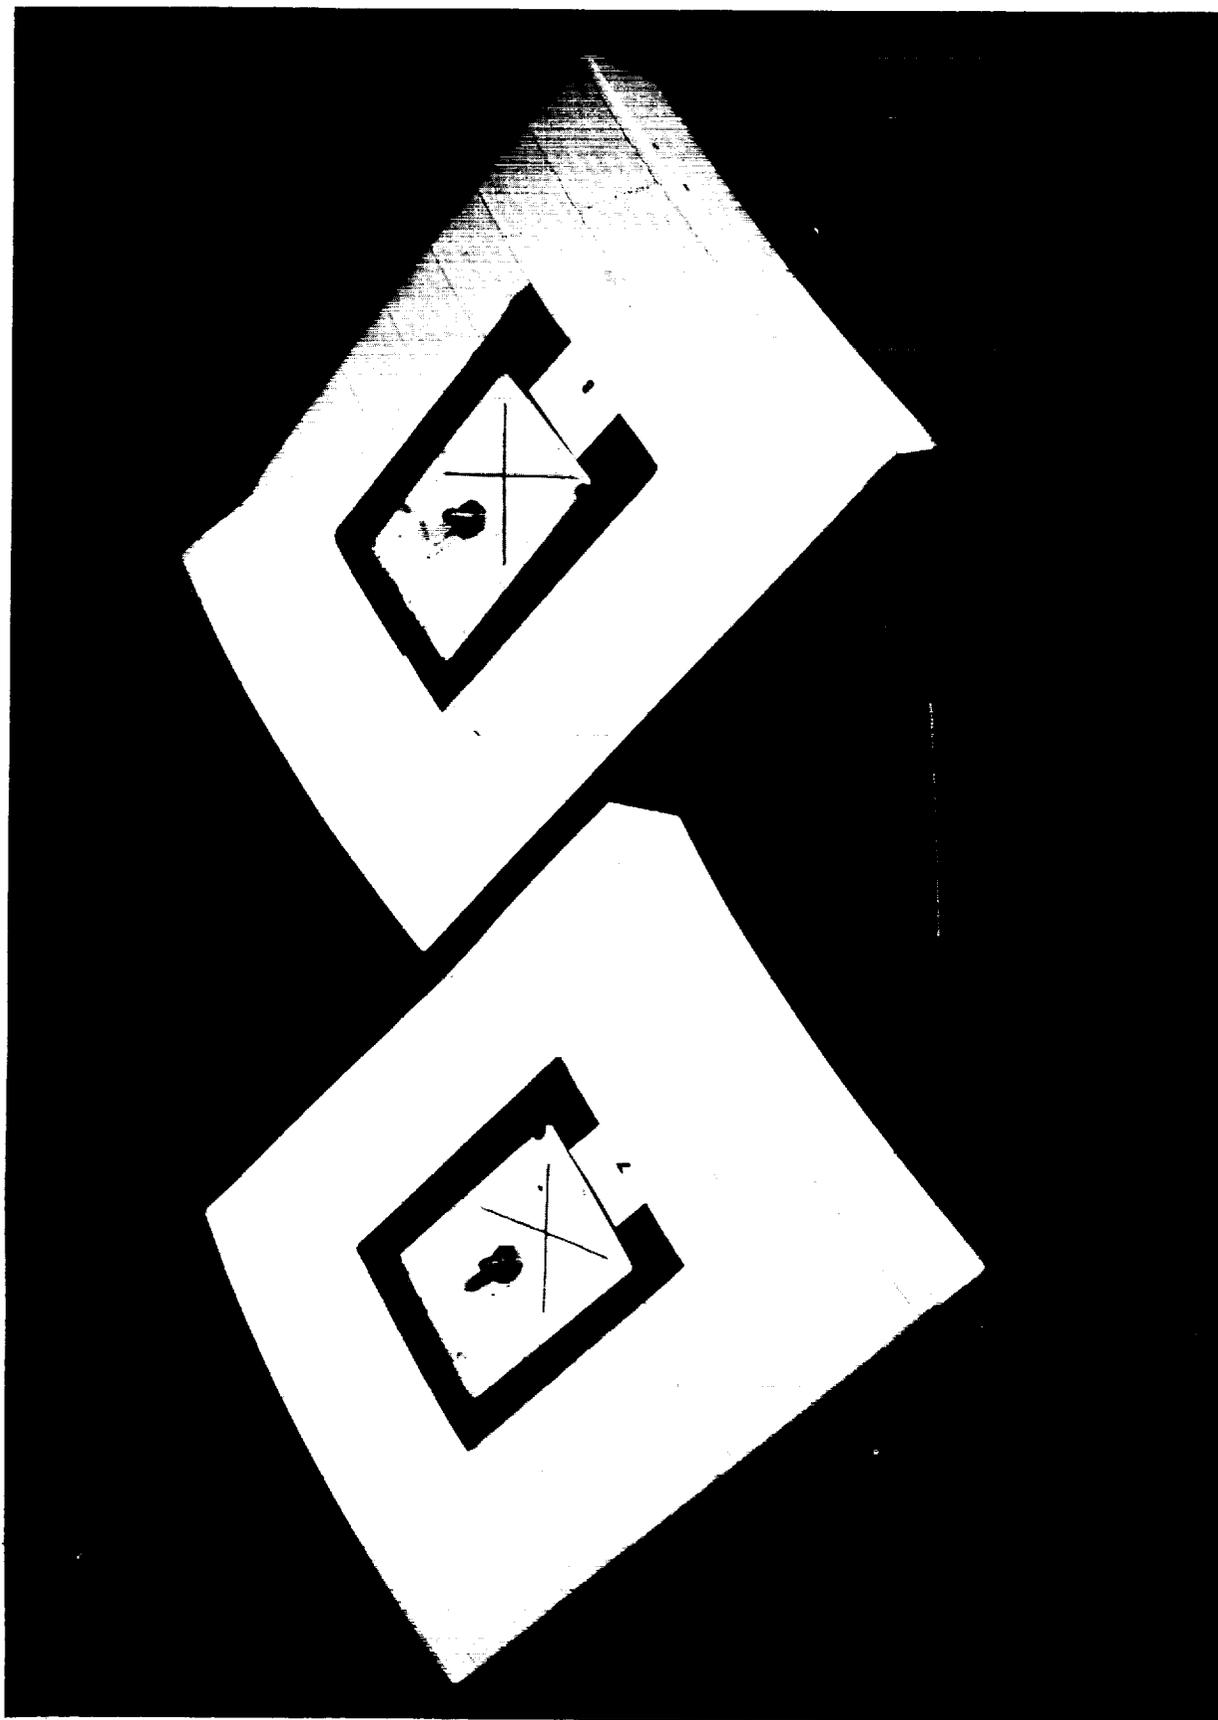
Figure 1. Complete assembly for test No. 4 after removal from 3.5% NaCl solution.

Scribe marks in the form of an X were made on both sides of all painted metal surfaces, after which a coating of Conoco HD Calcium Grease No. 2 was applied for all tests. The metal samples were bolted to the G/E specimens using 4.8 mm diameter stainless steel bolts, with electrical contact of the metal and G/E being verified with a resistance meter. Pieces of "Viton" rubber 1.4 mm thick separated the aluminum samples from the G/E in test number 6 with electrical contact being made through the stainless steel bolts. Figures 1 and 2 show the assembled test specimens.

Photographs of the complete assemblies after removal from the 3.5% NaCl solution are shown in Figures 1 and 2 for tests 4 and 5 respectively. For test number 1, both the G/E and D6AC steel plate were in good condition, with no visible sign of rusting on the metal and no rust streaks on the G/E. Specimens 3 and 4, for test number 2, showed heavy rusting at the center of the scribe marks, with other rust spots being evident on the D6AC steel plates. Heavy rust streaks appeared on the G/E surface. For test number 3, small rust spots were evident at one corner of the D6AC steel plates on both specimens 5 and 6, with small rust streaks being evident on the G/E surfaces. In test number 4, a photograph of which is shown in Figure 1, all surfaces appeared in good condition with no rusting evident on the steel plates, numbers 7 and 8. For test number 5, shown in Figure 2, heavy rusting was evident along one scribe mark for steel specimen 9 and in the center of the scribe marks for steel specimen number 10. Heavy rust streaks appeared on the G/E surfaces in both cases. For test number 6, which comprised the test for aluminum samples, all surfaces appeared in good condition, although a small amount of white  $Al_2O_3$  formed in the scribe marks on the aluminum plates. This condition was difficult to determine visually.

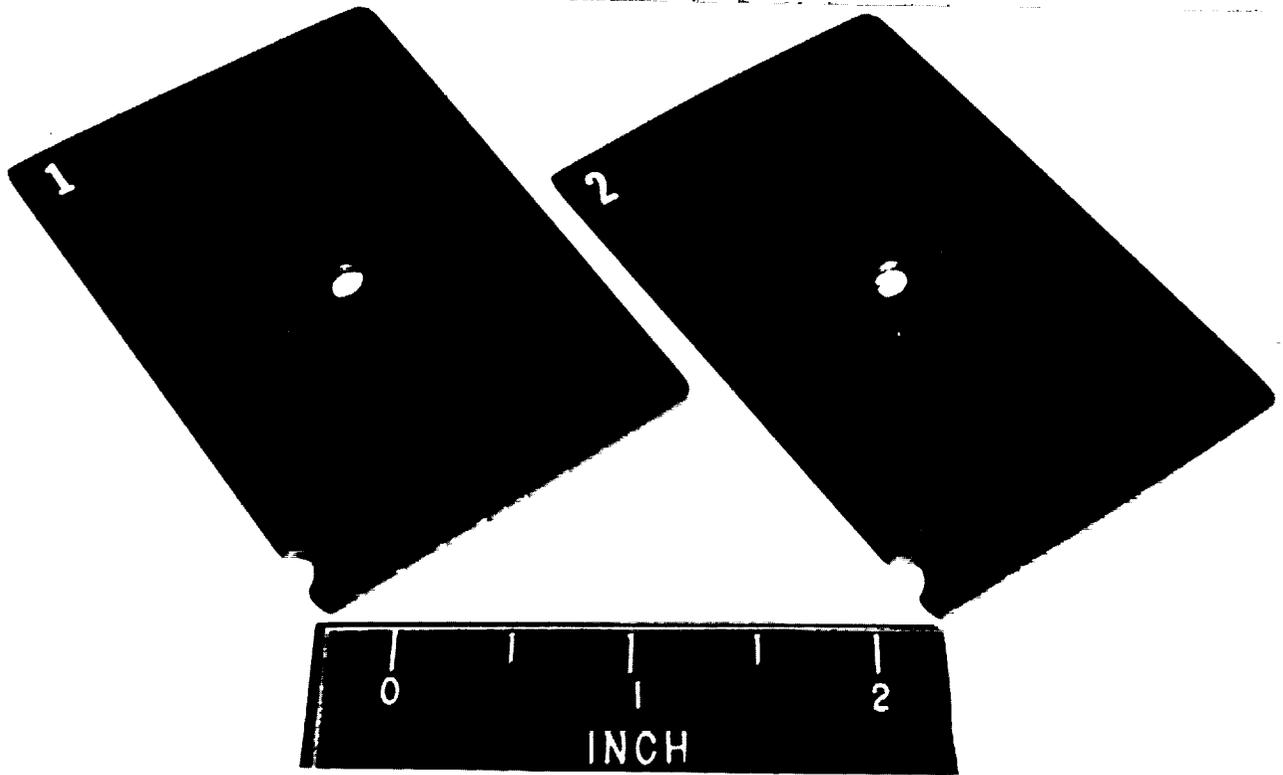
Figure 3. Metal specimens for test No. 1 after exposure and cleaning.

Paint was stripped from all metal samples after disassembly with Cee-Bee A-202 epoxy and polyurethane stripper, after which they were cleaned according to procedures described in ASTM G1-72 and weighed to determine weight loss. Photographs are shown in Figures 3 through 8 for the metal specimens in tests 1 through 6. Weight losses for each specimen are listed in Table 5, along with the average weight loss obtained in each test. For test number 1, the average weight loss was 32.1 mg, a rather small value, with the cleaned surfaces being in good condition. For test number 2, specimen number 3 exhibited a circular pit approximately 6 mm in diameter with corrosion all the way through the metal. The weight loss in this case was 246.7 mg. Specimen number 4 displayed a large oblong pit approximately 5 by 10 mm at the surface corroded to a depth of 1 mm. Weight loss for this case was 459.2 mg. The average weight loss for test number 2 was 353.0 mg. Specimens 5 and 6 for test number 3 had exhibited small rust spots at the corners, but the metal appeared in good condition after stripping and cleaning. This test showed an average weight loss of only 17.0 mg. For test number 4, where a topcoat had been applied over the zinc-rich primer, specimens 7 and 8 displayed an average weight loss of only 12.9 mg and appeared in very good condition. For test number 5, where the G/E surfaces had been left completely bare heavy corrosion occurred on both specimens. Specimen 9 displayed two large pits along one scribe mark. One of the pits was approximately 3 by 5 mm at the surface and had corroded to a depth of 1.5 mm. The other pit measured 5 by 7 mm at the surface and had corroded to a depth of 0.5 mm. Specimen number 10 exhibited a circular pit approximately 8 mm in diameter which had corroded all the way through the metal. Weight loss for these specimens averaged 389.4 mg. For test number 6, which involved the aluminum specimens and G/E completely covered with topcoat, the aluminum samples appeared in very good condition after cleaning, and exhibited an average weight loss of only 12.3 mg.

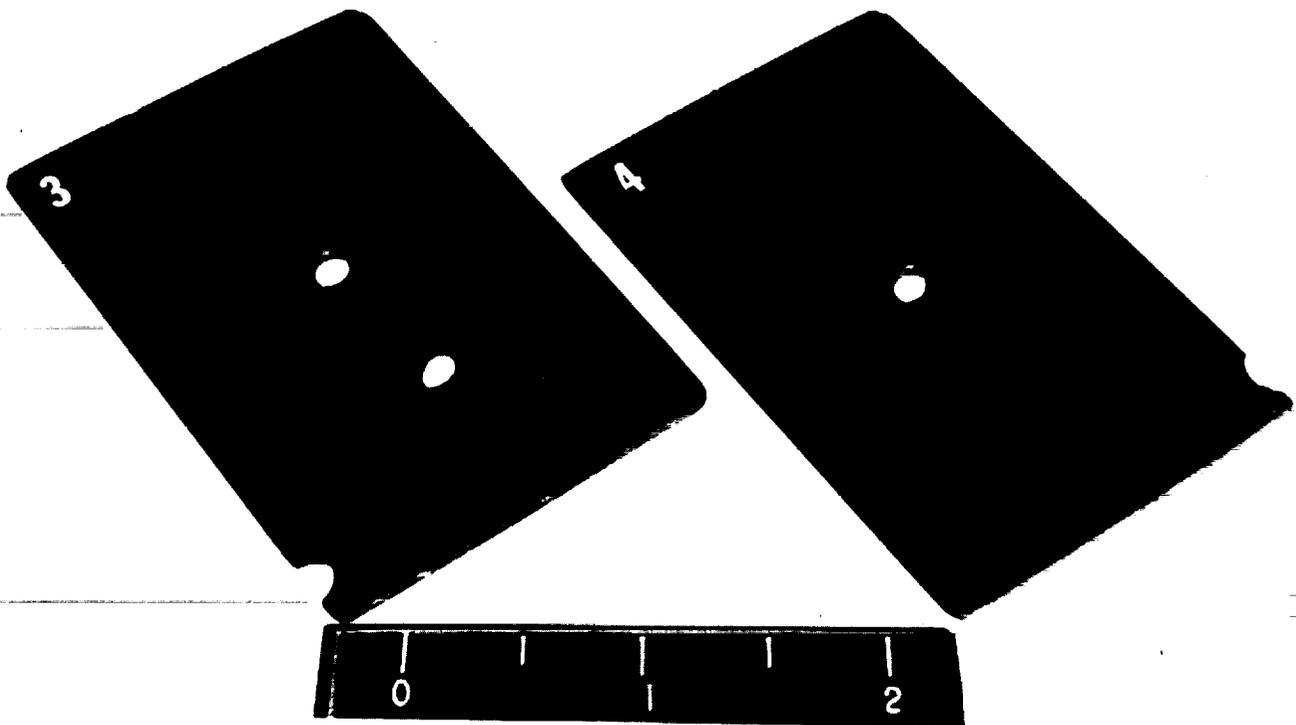
Figure 4. Metal specimens for test No. 2 after exposure and cleaning.

From the experimental results obtained, it is evident that the surfaces of the G/E must be completely coated, either with topcoat or a combination of polyurethane resin and topcoat. In test number 2, where only a polyurethane joint was employed with the remainder of the G/E surface left bare, heavy corrosion

occurred at the scribe marks in the metal surfaces, where only Conoco grease served to protect the bare metal. The remainder of the metal surfaces, which were coated with zinc-rich primer and Conoco grease, appeared to be in relatively good condition. The same situation was present in test number 5, where the total G/E surfaces were left bare.

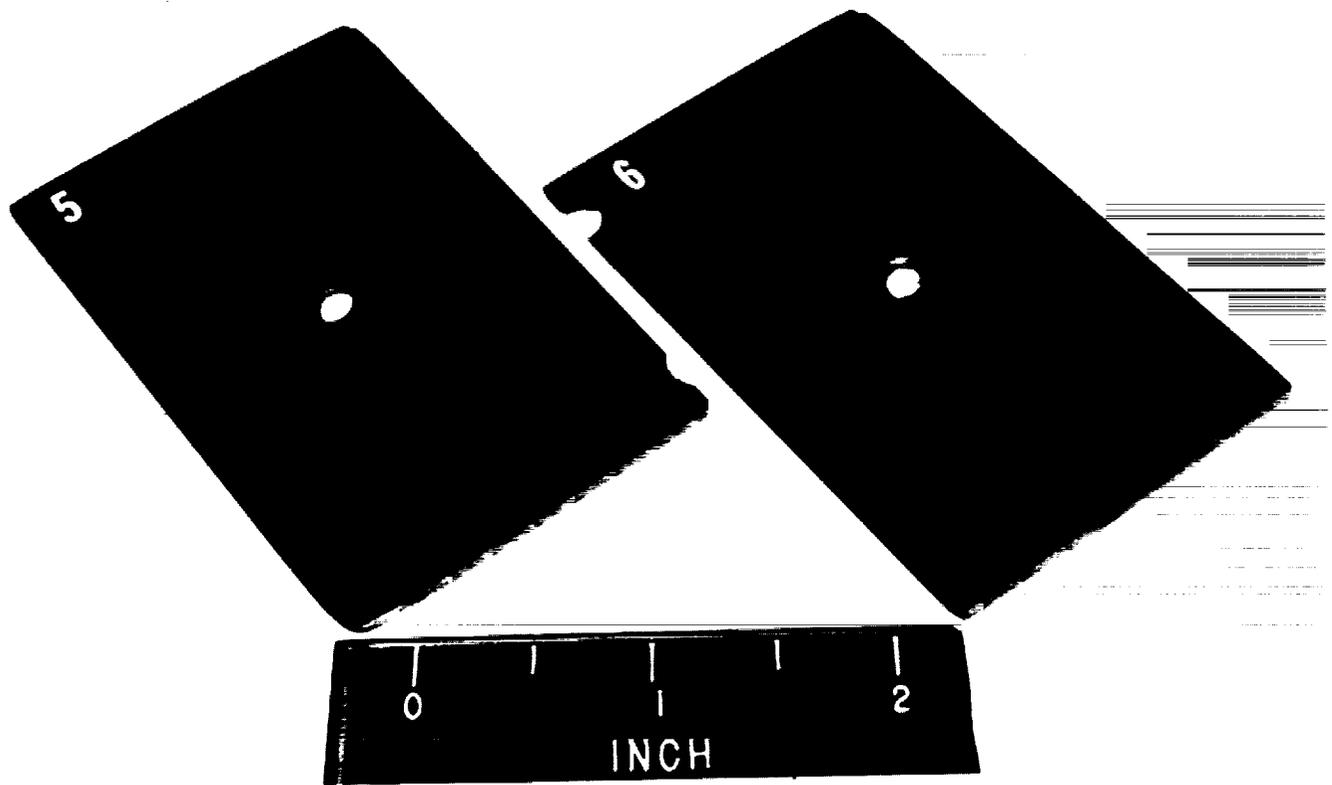
Figure 5. Metal specimens for test No. 3 after exposure and cleaning.

The results also indicate that, when the G/E is completely coated, satisfactory protection of the D6AC steel is achieved with either the zinc-rich primer or the primer/topcoat combination, as shown by comparing tests 3 and 4, which had very similar weight losses. This is true despite the small rust spots observed at the corners of the metal plates in test number 3. These may have been caused by sharp corners on the metal plates.

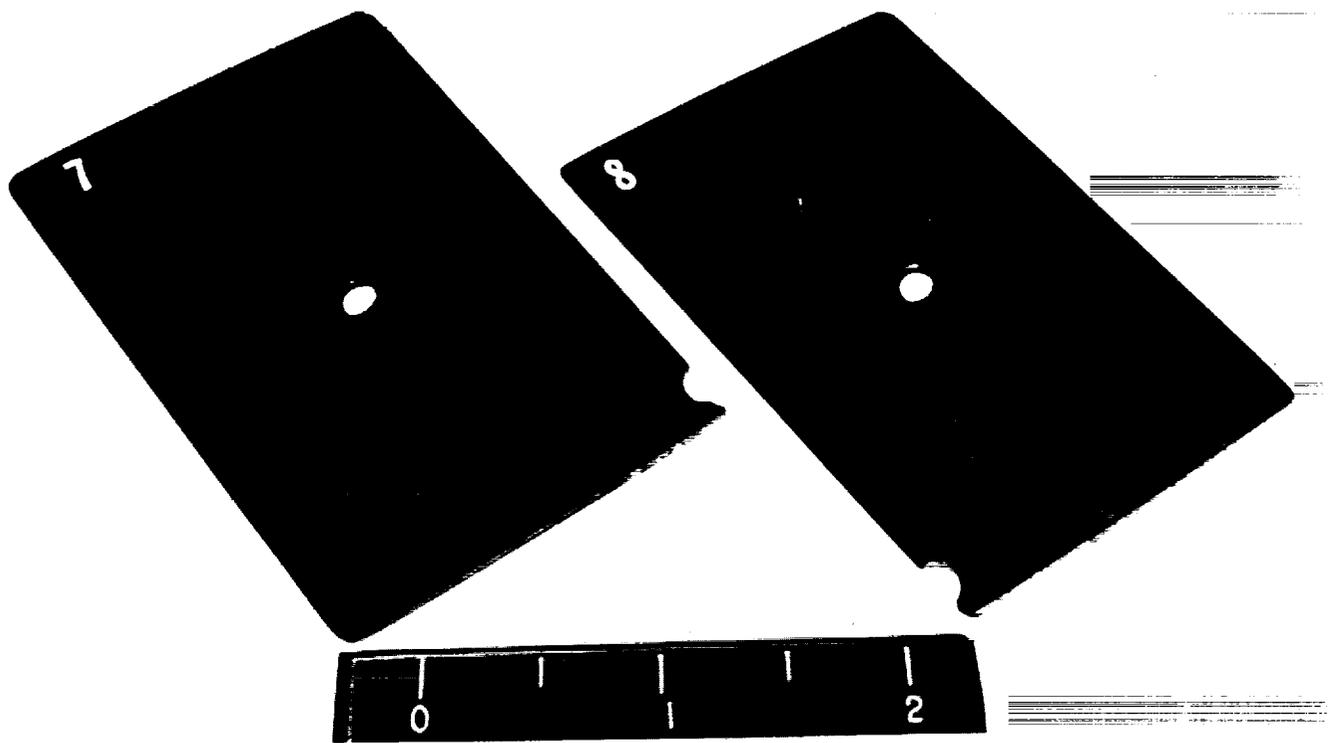
Figure 6. Metal specimens for test No. 4 after exposure and cleaning.

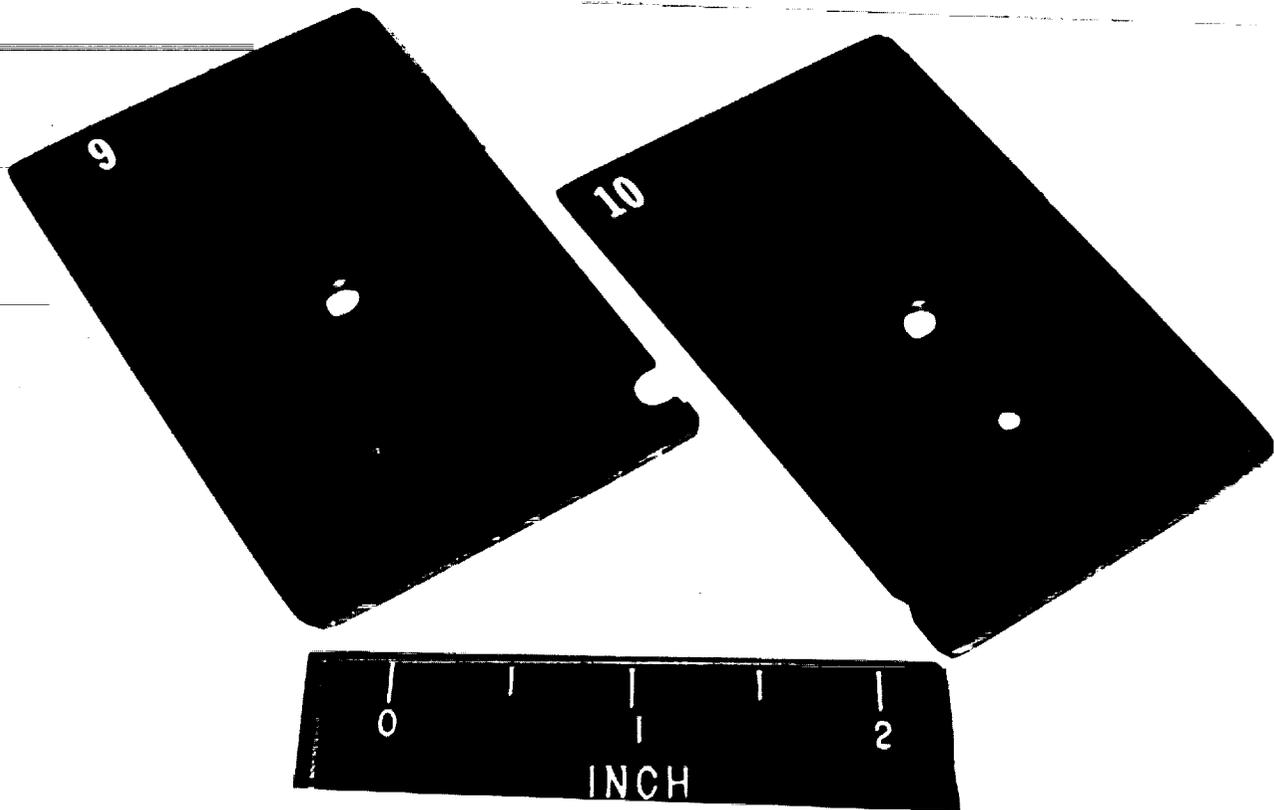
Figure 7. Metal specimens for test No. 5 after exposure and cleaning.

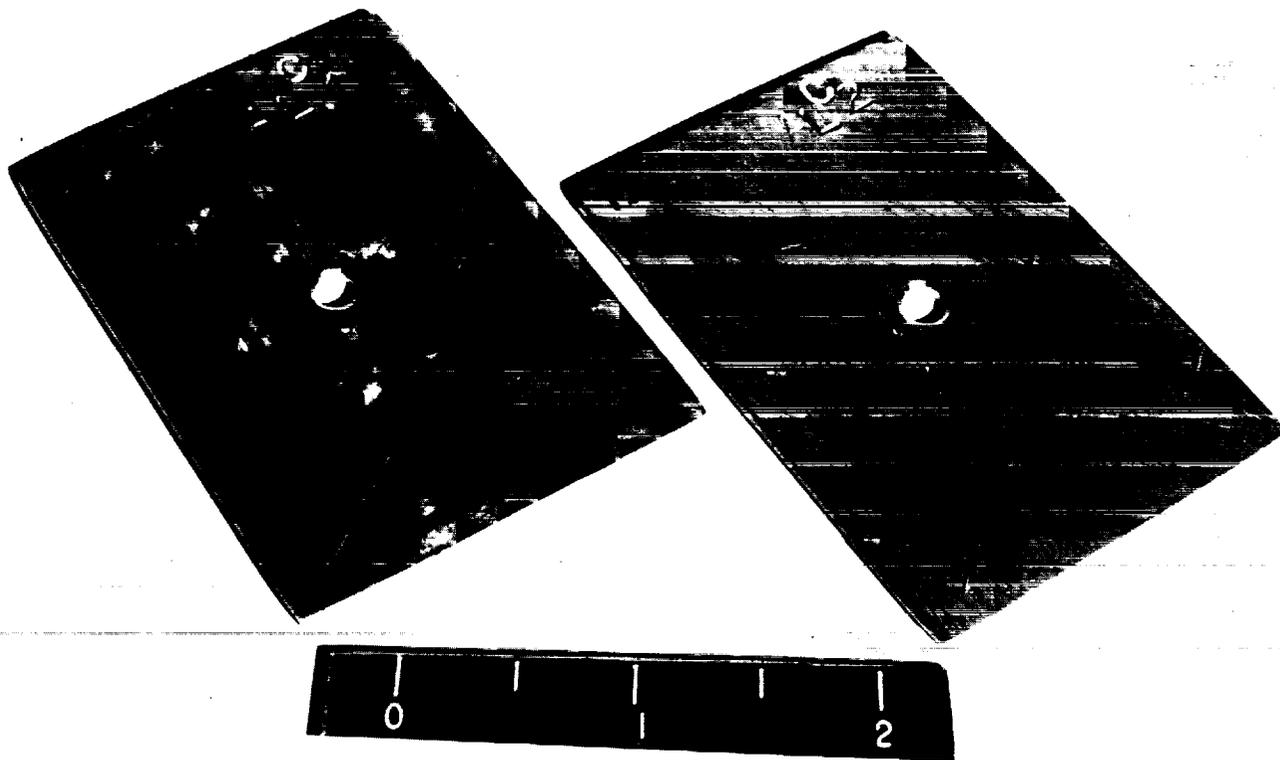
Figure 8. Metal specimens for test No. 6 after exposure and cleaning.

For the case of aluminum in test number 6, the condition of the aluminum was very good and the weight loss was rather small. Although Conoco grease was used as a final coat for the aluminum plates, it is likely that equally good results would have been obtained without Conoco grease.
