NASA Contractor Report 168332

DOCUMENTATION OF ICE SHAPES ON THE MAIN ROTOR OF A UH-1H HELICOPTER IN HOVER

January 1984

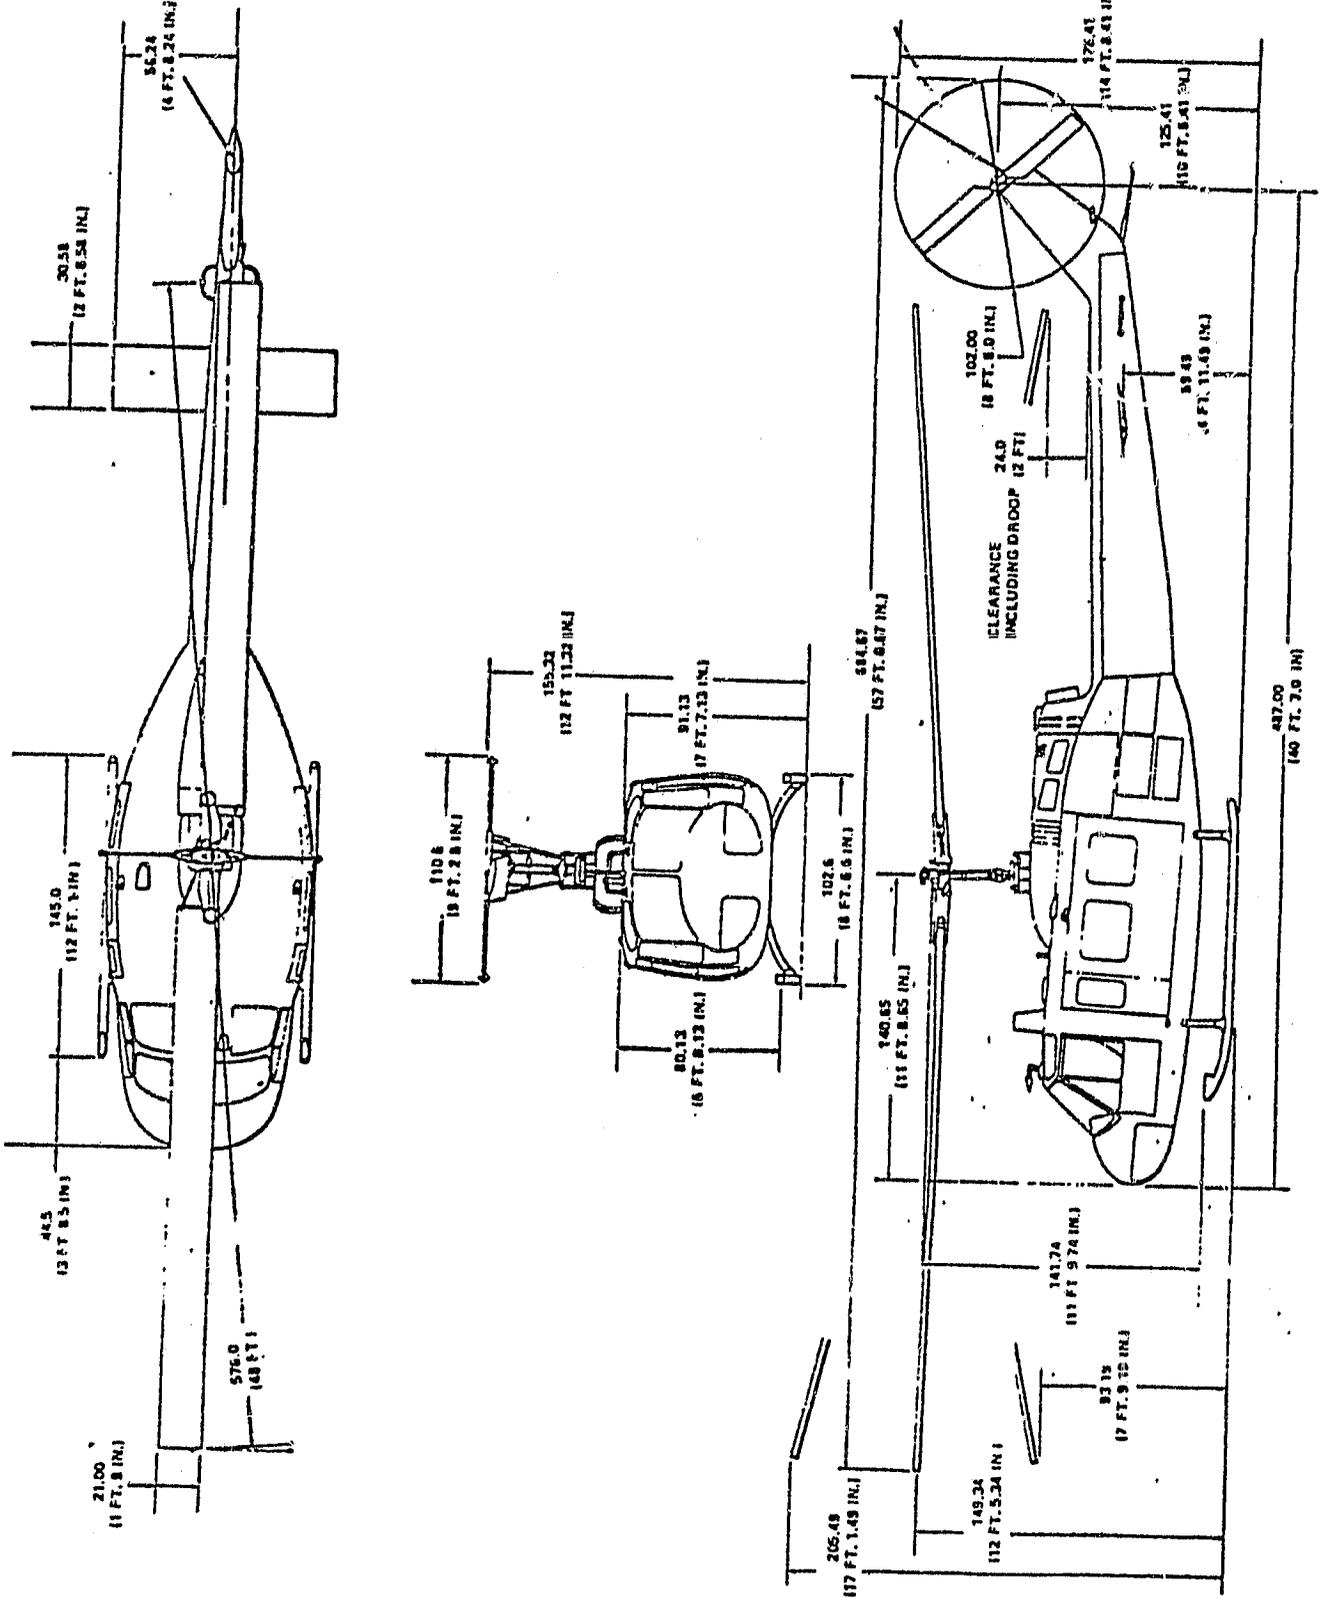
FIGURE 1. Outline of Army UH-1H Helicopter Used in Icing Program.

The UH-1H Helicopter used in the program is shown diagrammatically in Figure 1; Figure 2 is a photo of it hovering in the cloud. Immediately after landing, one of the blades was enclosed in a van (Figure 3) where the temperature and lighting could be controlled for the documentation.

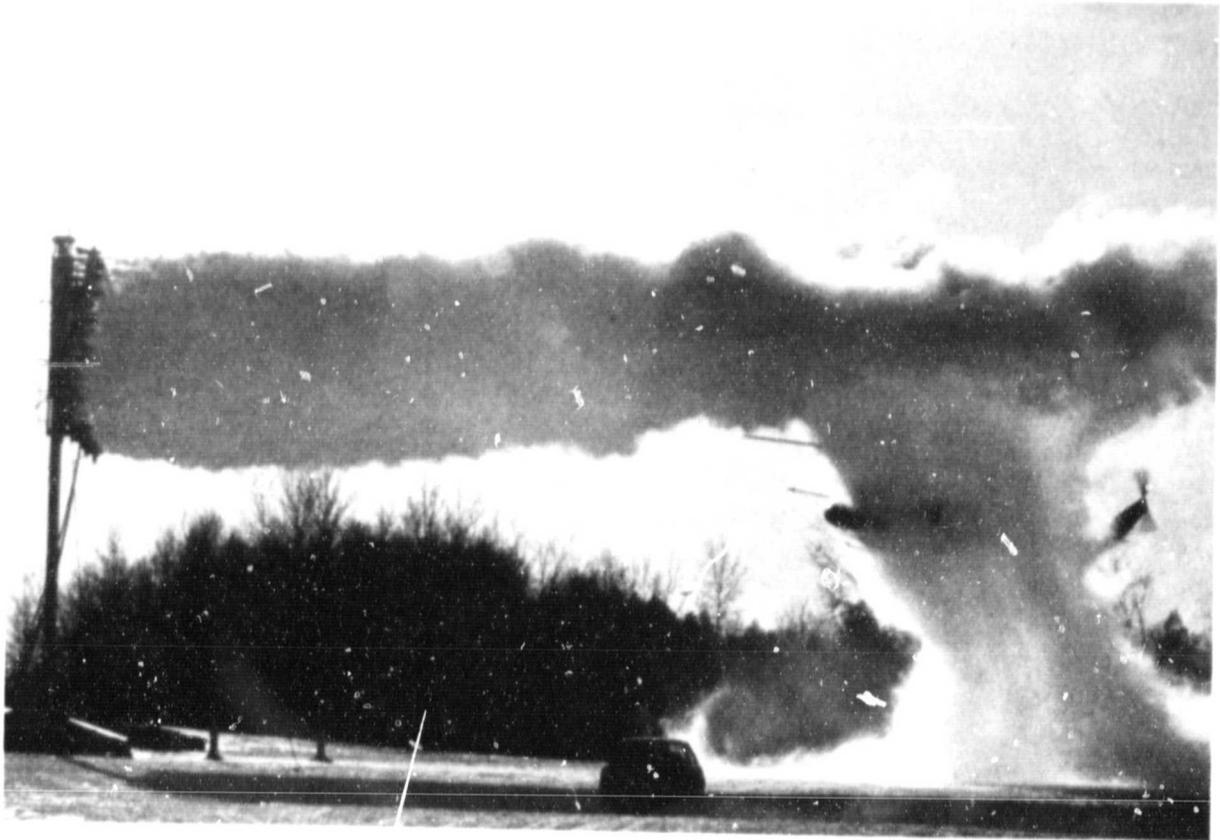
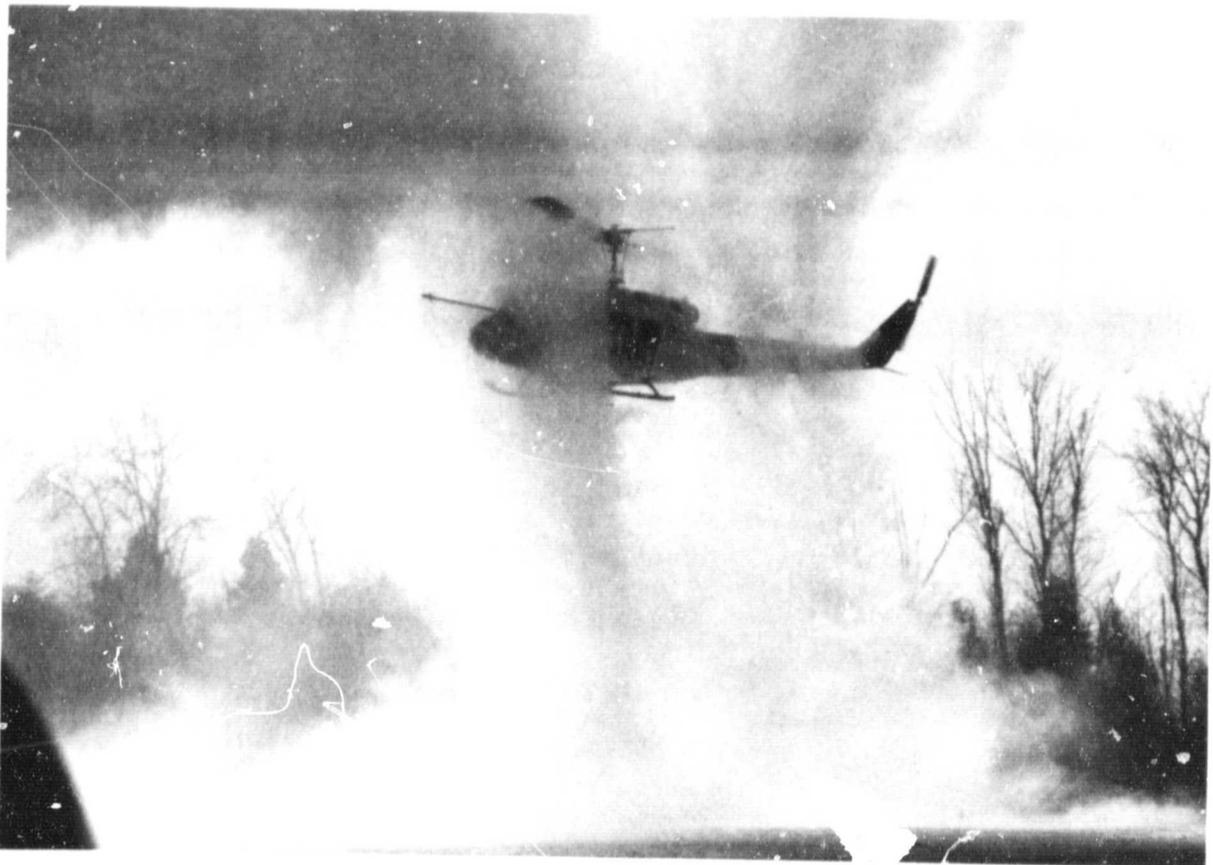
FIGURE 2. Photos of the Army UH1H Hovering in the NRC Icing Cloud.

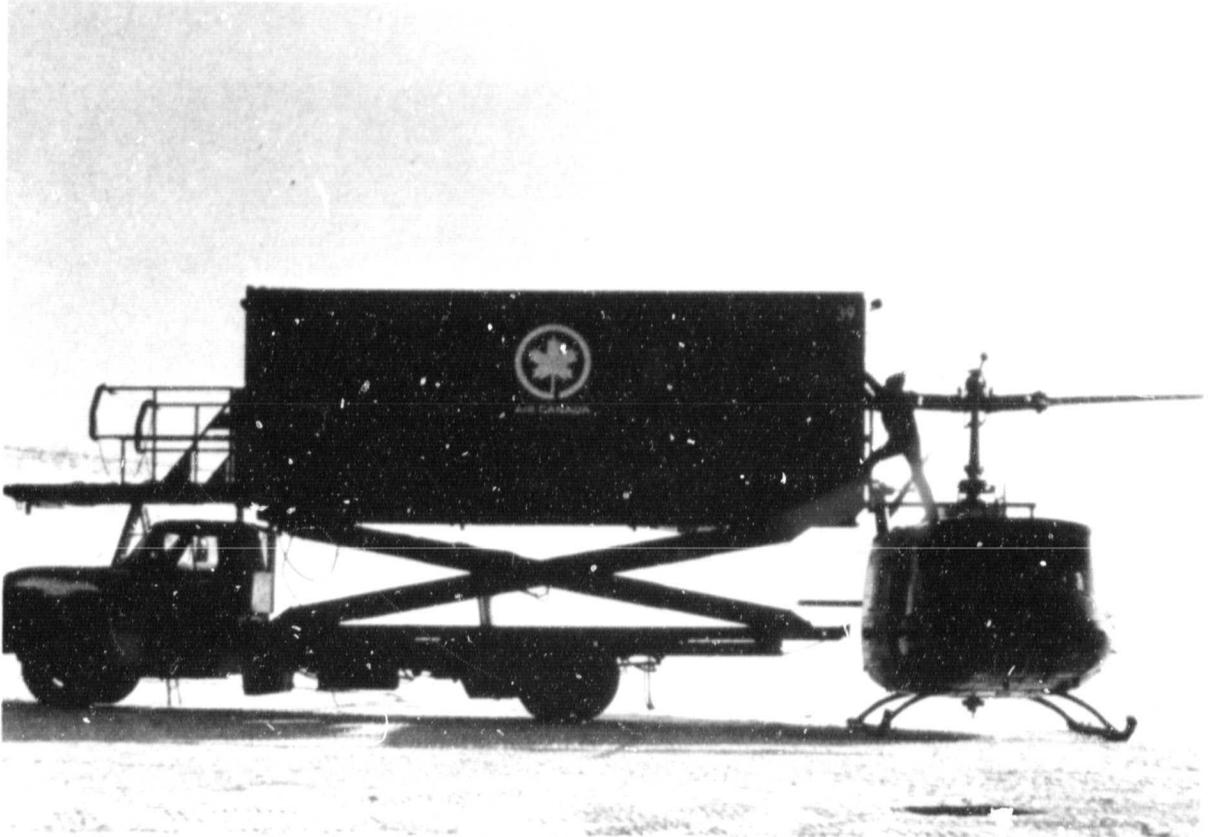
FIGURE 3. Helicopter with the Van Used as the Documentation Station.

Hovey and Associates of Ottawa, Canada, performed the on-site documentation using the equipment described above. An enclosed shelter was assumed necessary in order to control the temperature for the molding process and the lighting for the photography. A "scissors-lift van" was rented from Air Canada and the interior was modified for the test program (see Figures 3, 4, 5).

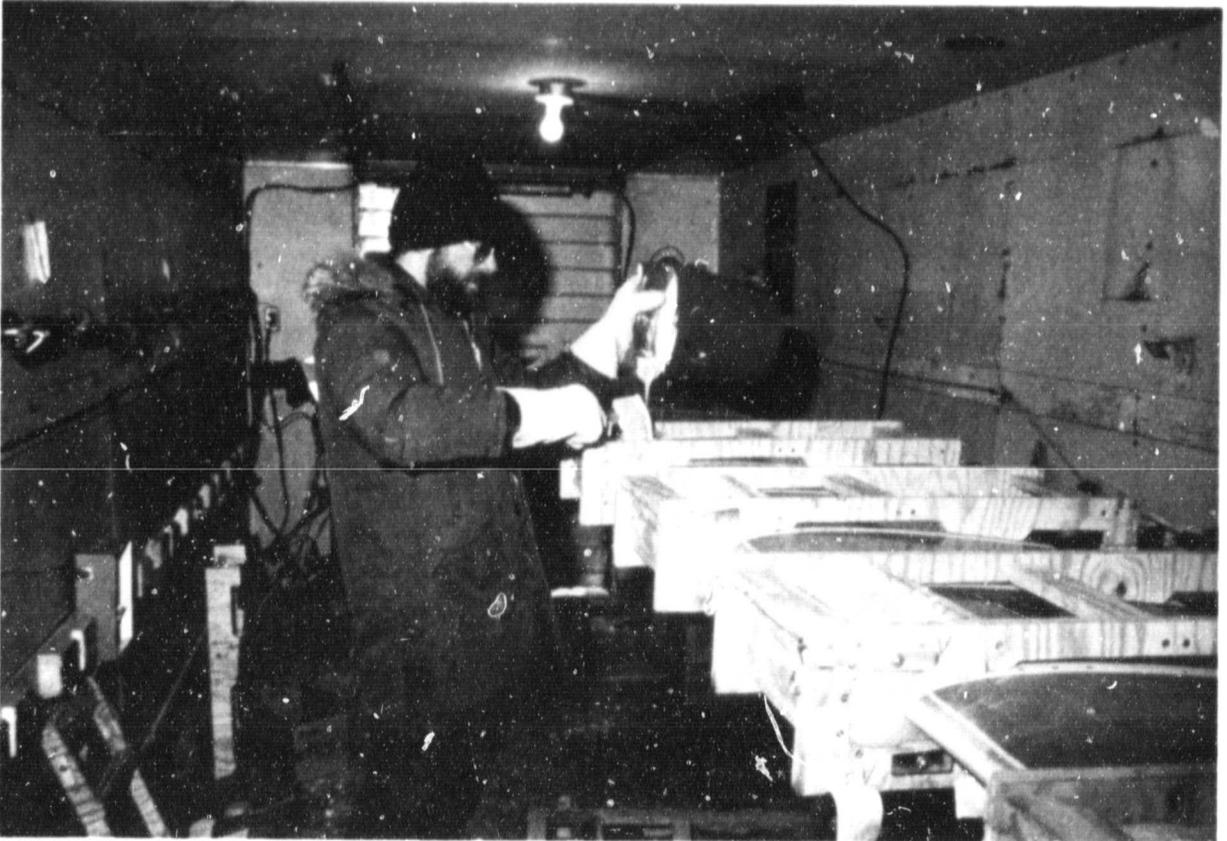
FIGURE 4. Interior of Van Showing Rubber-Mold
Boxes Attached to the Rotor Blade.

Ten plywood mold-containers were fabricated (see Figure 4) in two parts for attachment around the rotor blade. Each "box" isolated a segment of the blade about ten inches wide (spanwise) and permitted molding of ice form two inches ahead of the leading edge to six inches aft.

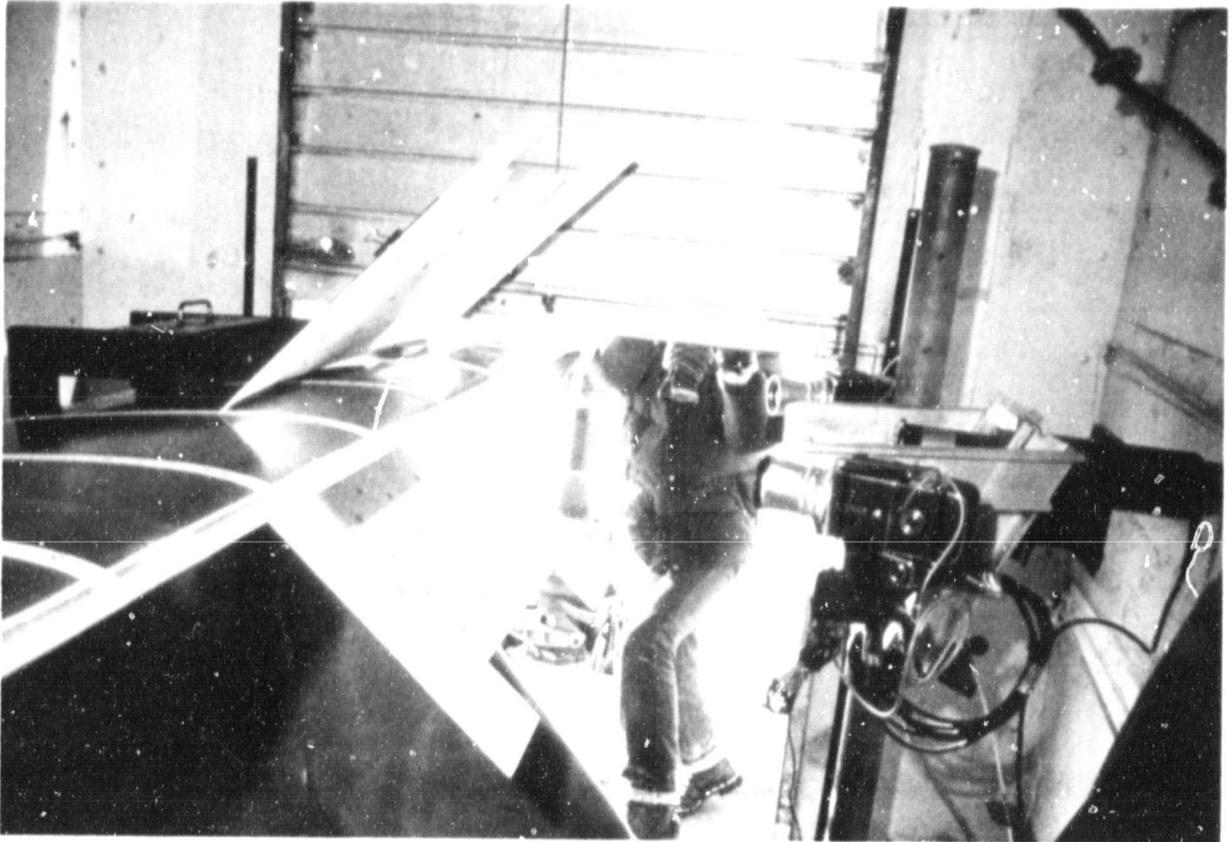
FIGURE 5. Interior of Van Showing Stereo Photography Set Up.

The stereo photography technique was an application of that developed at AEDC (ref. 4) whose personnel provided the design layout of the cameras and reference system. Two Hasselblad cameras were provided by NASA-Lewis. These were assembled onto a rigid support frame together with a grid projector and a set of flash guns. The support frame was adjustable vertically at any station along the blade so that 2 or 3 stereo pairs could be taken from different elevations in order to view all of the ice accretion at that station. The analysis of a given stereo pair of photographs requires the reference to several control points within the field of view, preferably surrounding the region being measured. To supply a set of such points, a rig was fabricated consisting of two plane surface at (about) $\pm 45^\circ$ to the blade chord and designed to be readily mountable to the blade from the rear (trailing edge). Control points were also available from markers on the surface of the rotor blade. Figure 5 shows the rig and the camera system as used; the layout, as specified by AEDC personnel, is given in Figure 6.

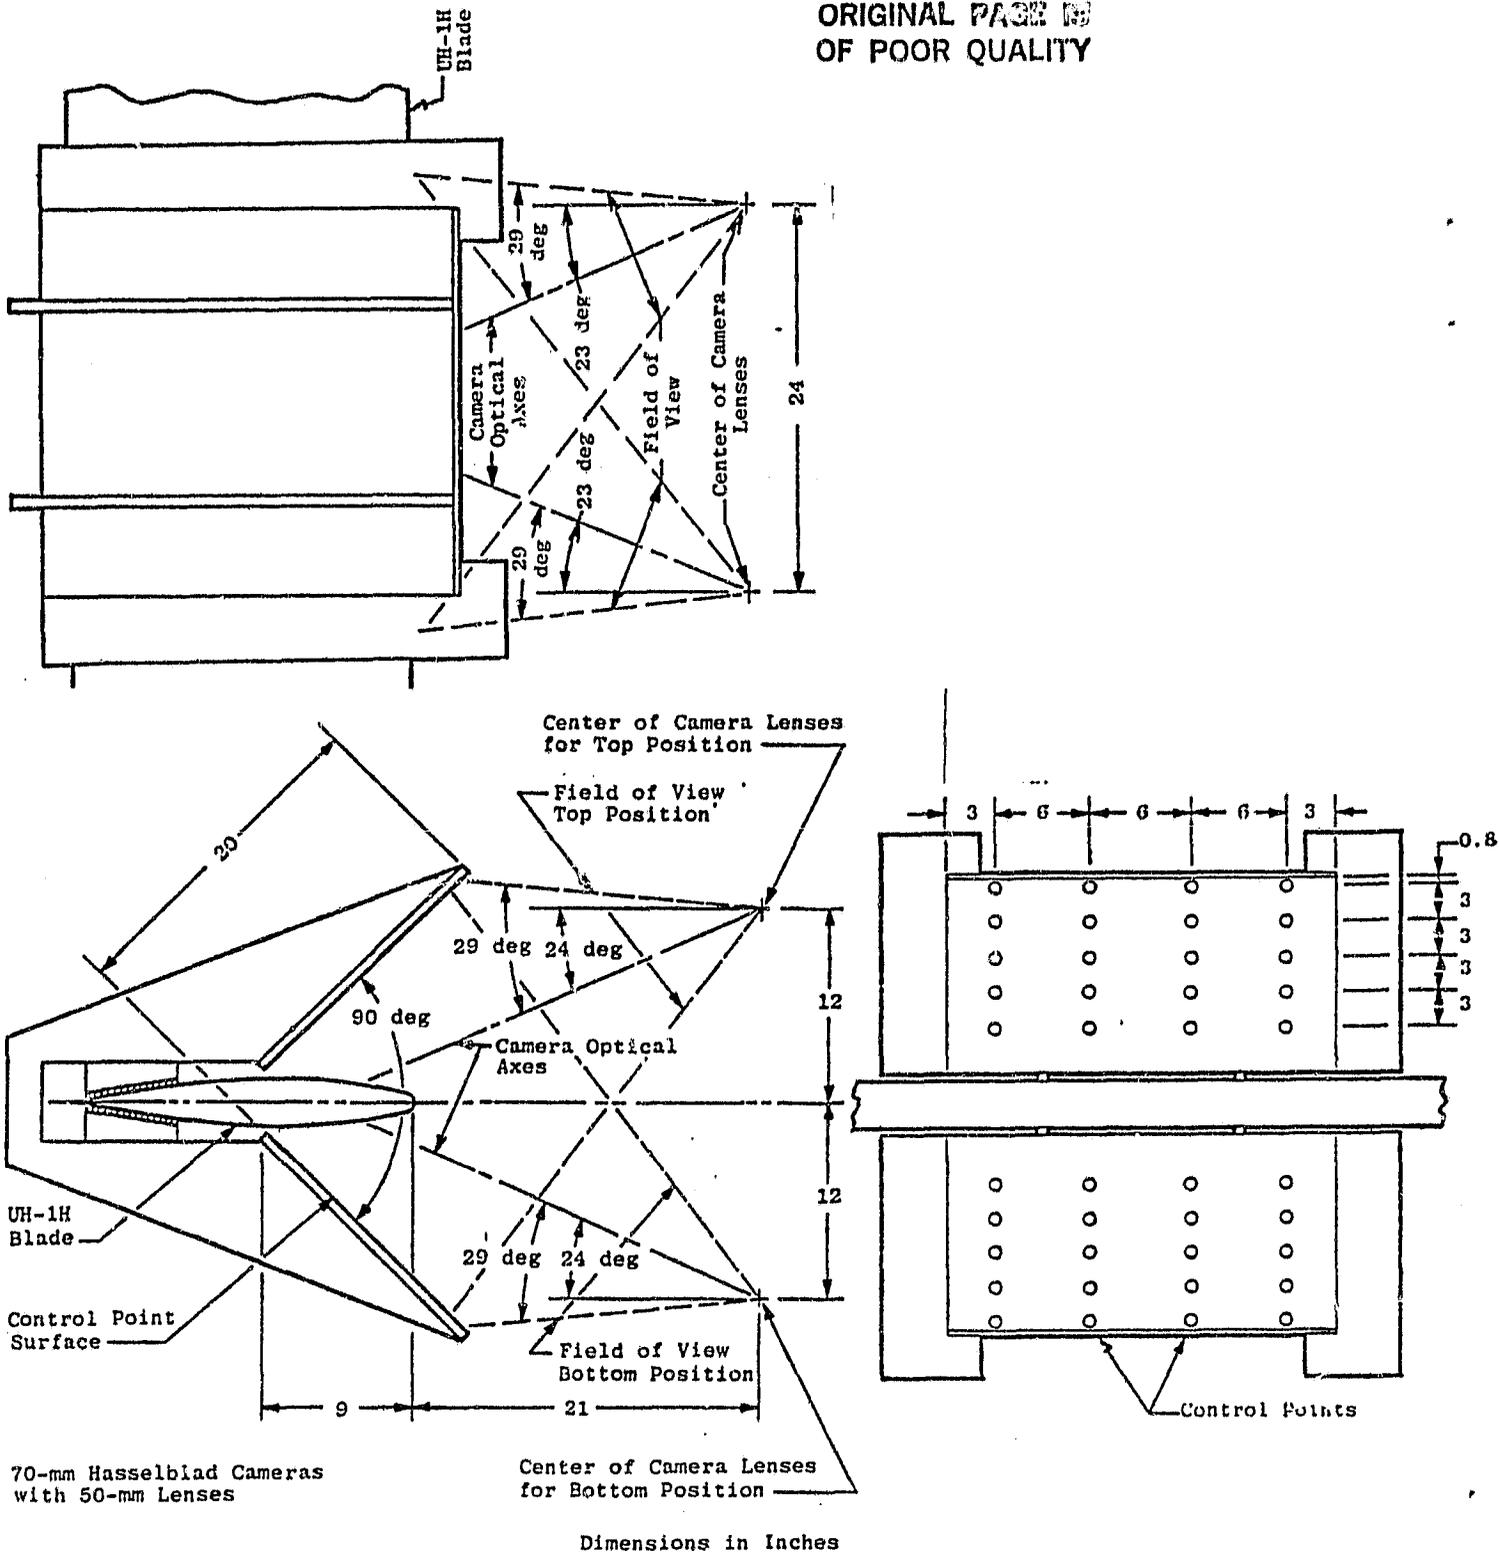
FIGURE 6. Layout of Stereo Photography Cameras and Control-Point Target.

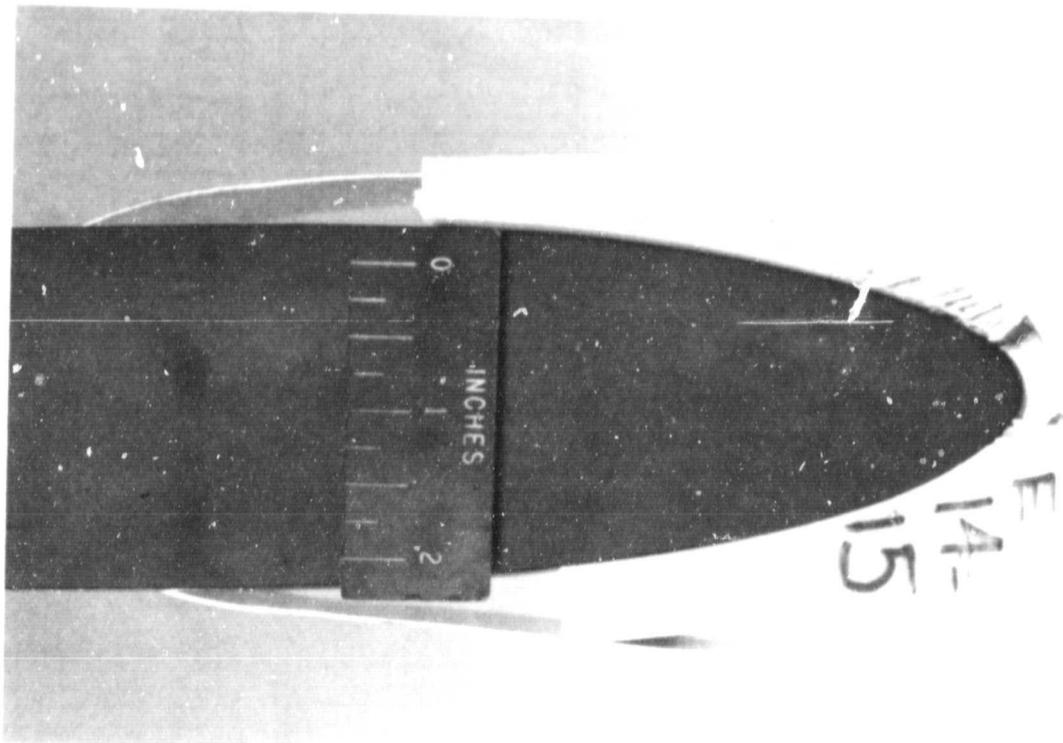
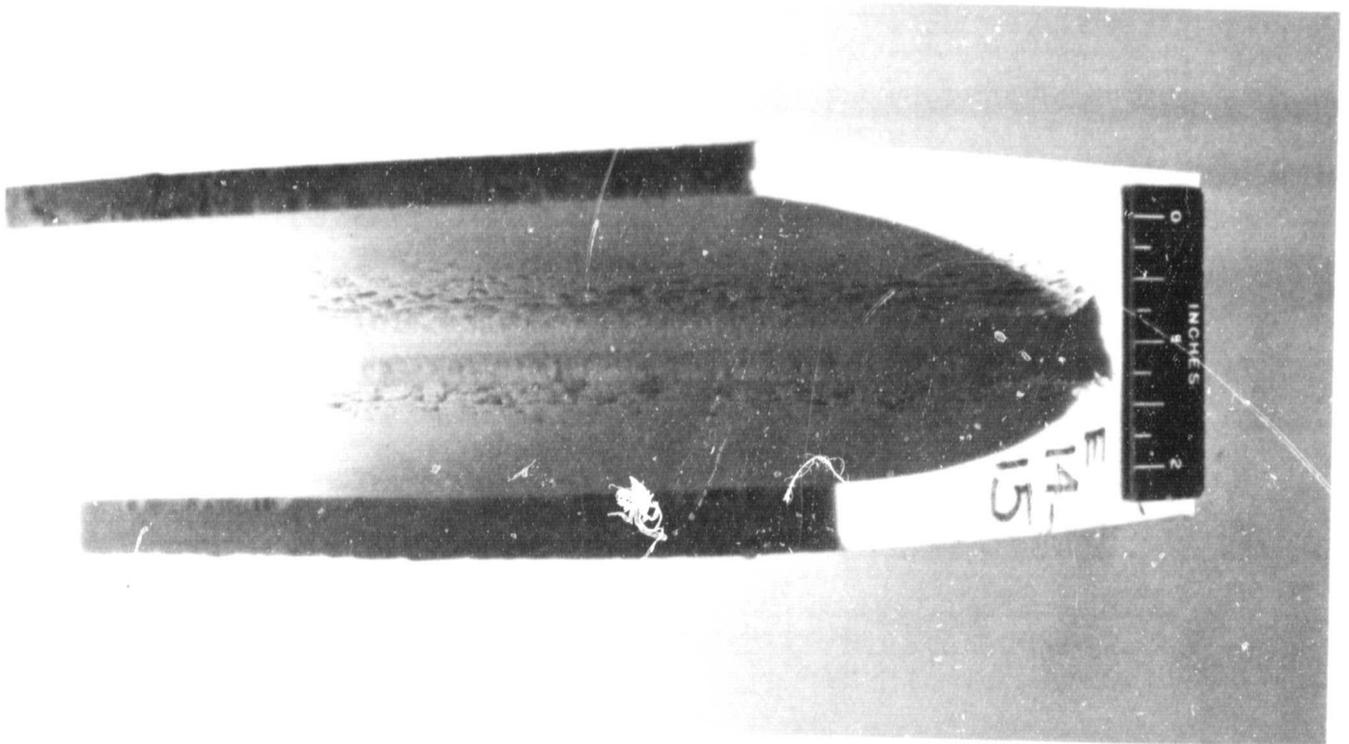
FIGURE 7. Typical Molds Obtained of Ice Formations.

Views of typical molds are shown in Figure 7; except for visual inspection of the ice formations and the resulting molds, it is difficult to appreciate the reproduction of detail which is attainable in a controlled situation such as this. Figure 8 shows a set of photo-reproductions (in full-scale) of the ends of the molds from Flight E, superimposed on a grid with a profile of the rotor airfoil. In constructing these projections, it was noted that there was enough of the bare blade (uniced) molded that the ice formation could be oriented with the grid and profile with an error of less than one degree. Such a set of results as Figure 8, is only from one "slice" out of each mold; a more representative average could be obtained by taking several slices.

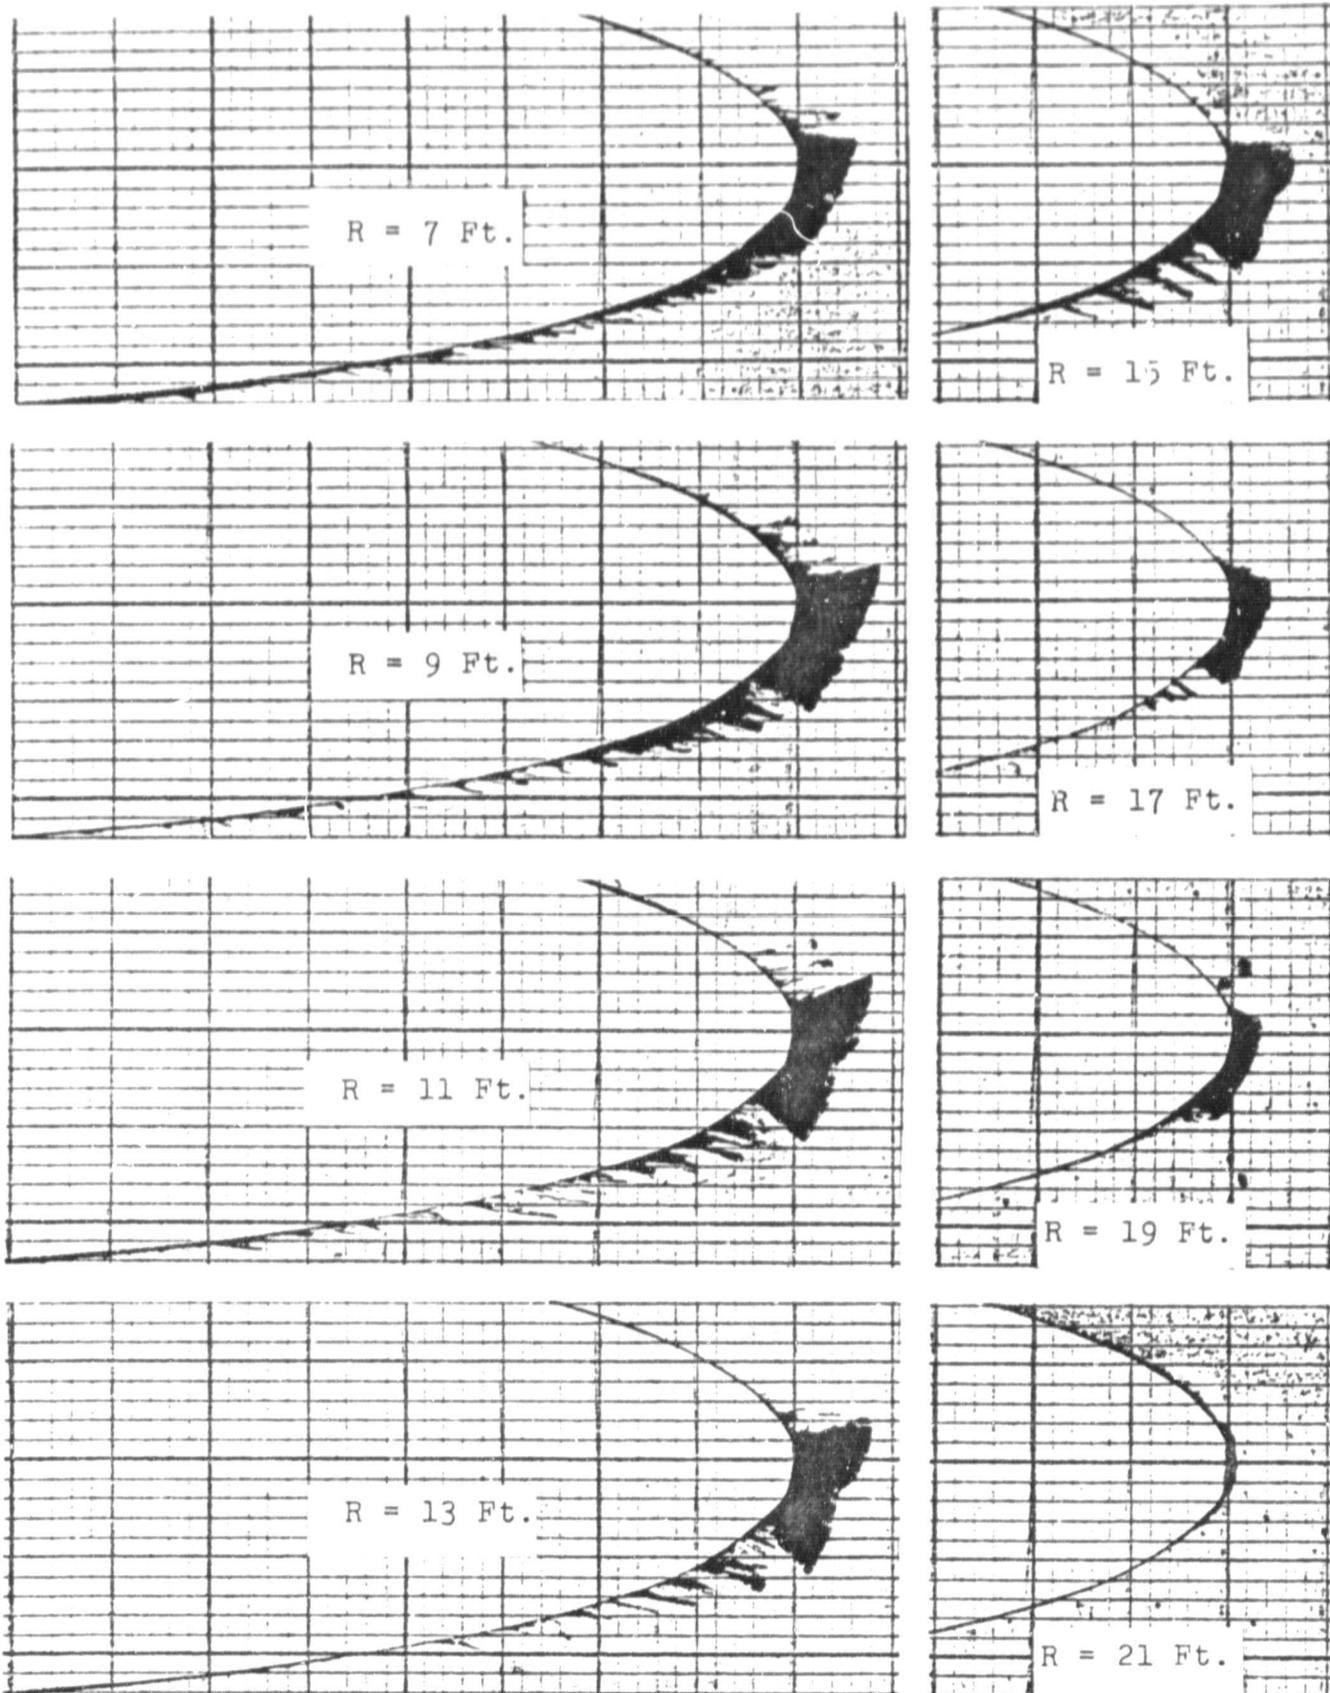
FIGURE 8. Projections of the Molds Obtained From Flight E.

Ice shapes as documented by the three methods may be compared by superimposing the results of Figures 8, 11 and 12. The formation varies slowly enough that the stated stations are sufficiently close for such a comparison. The deviations appear to be no more than those which appear from comparing successive "slices" by any one method, since the ice formation contains considerable three-dimensional detail, as illustrated by Figure 13. The depth of the ice, as measured from the results of the three methods is plotted in Figure 14. The section sketches appear to lack the definition of the contour, which is probably an important feature in determining the aerodynamics.

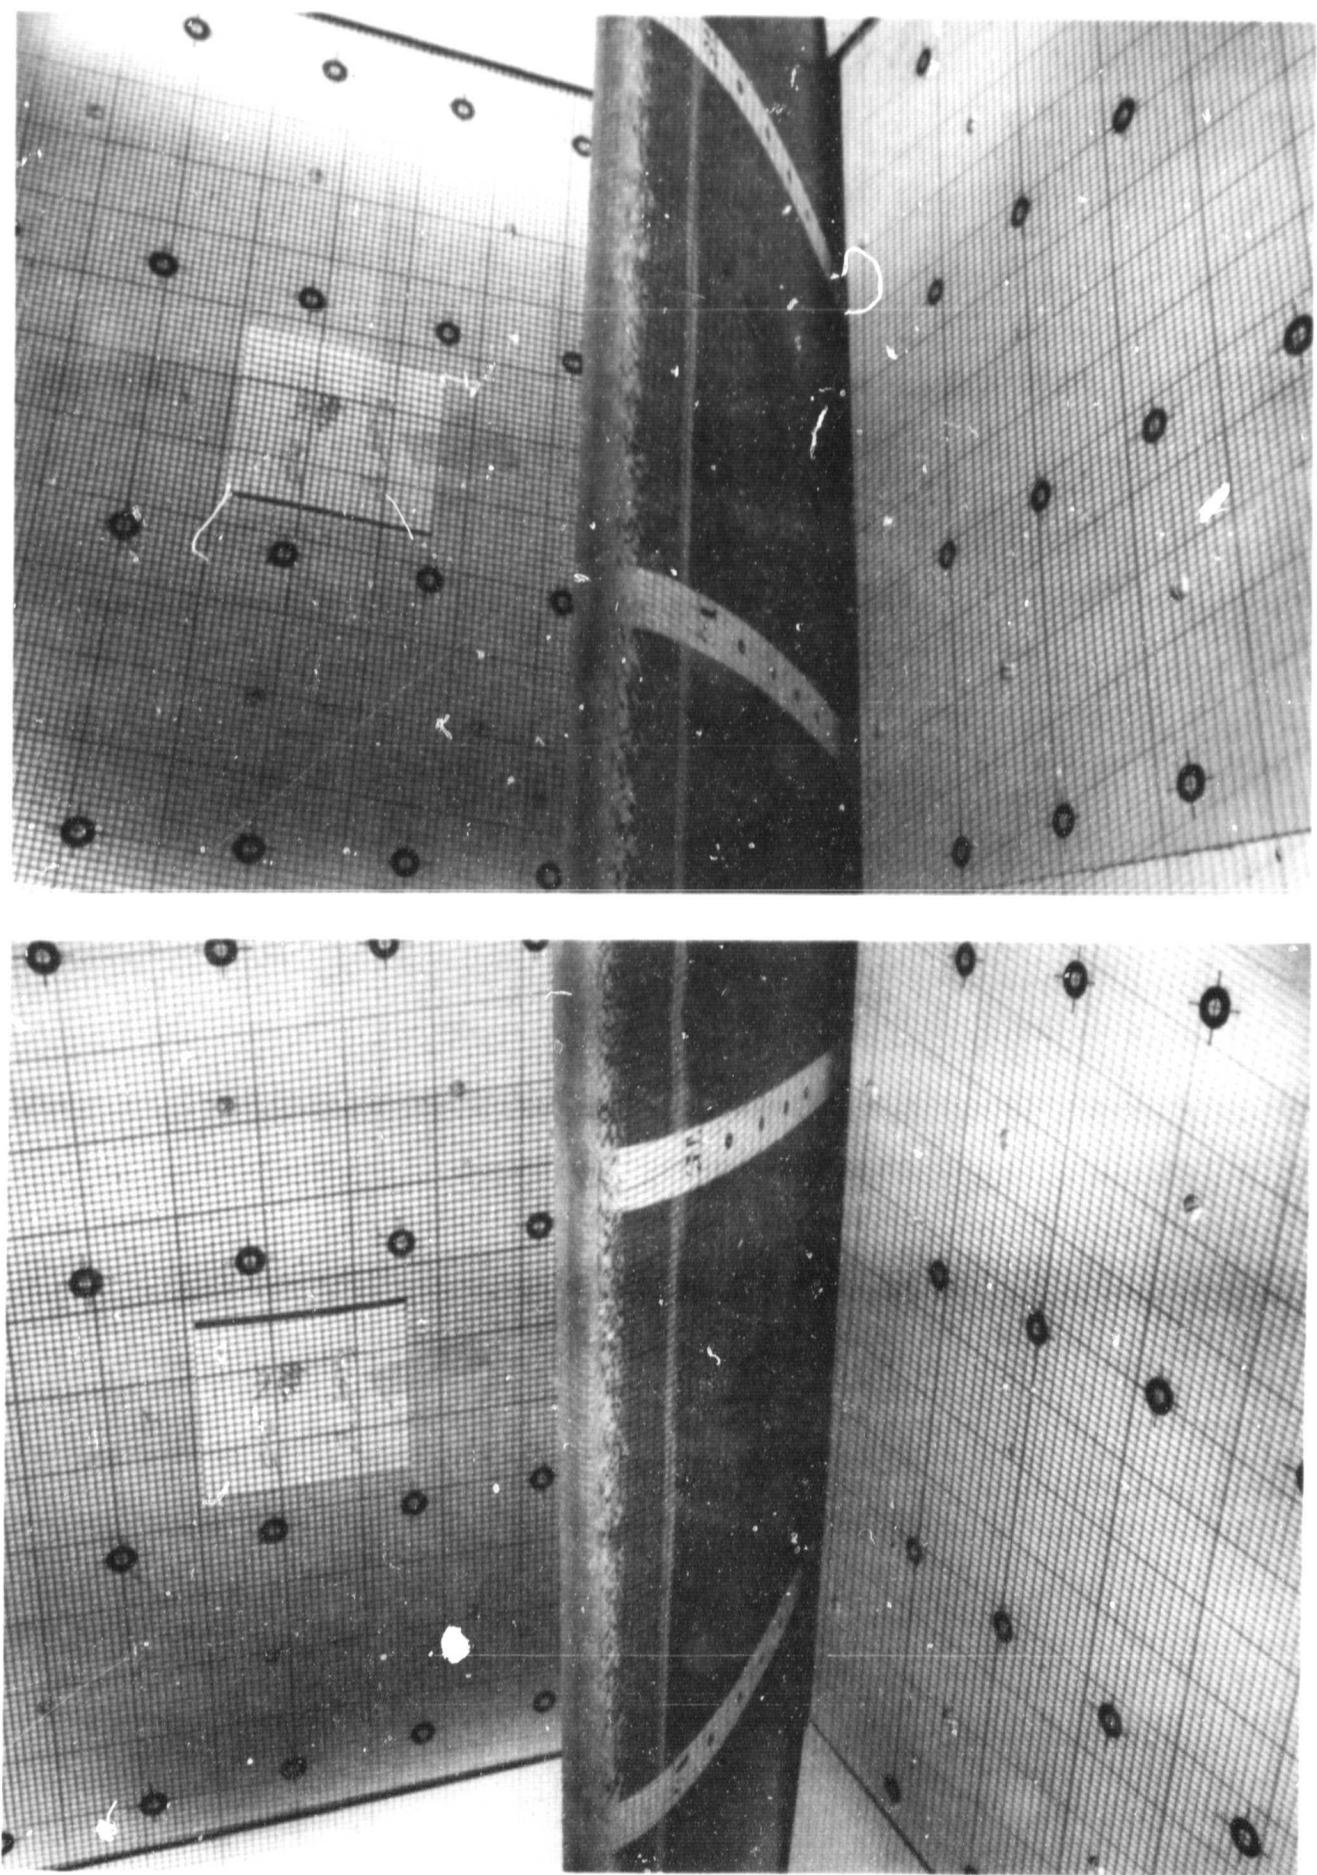
FIGURE 9. Typical Stereo Camera Photo; One of Set of 4 Used in Photogrammetric Analysis: Flight E, R = 8 Ft.

A detailed description of the stereo photogrammetry procedures and results is in publication by AEDC (ref. 5). Typically, a photo set is shown in Figure 9 and the results from the data analysis are plotted in Figure 10.

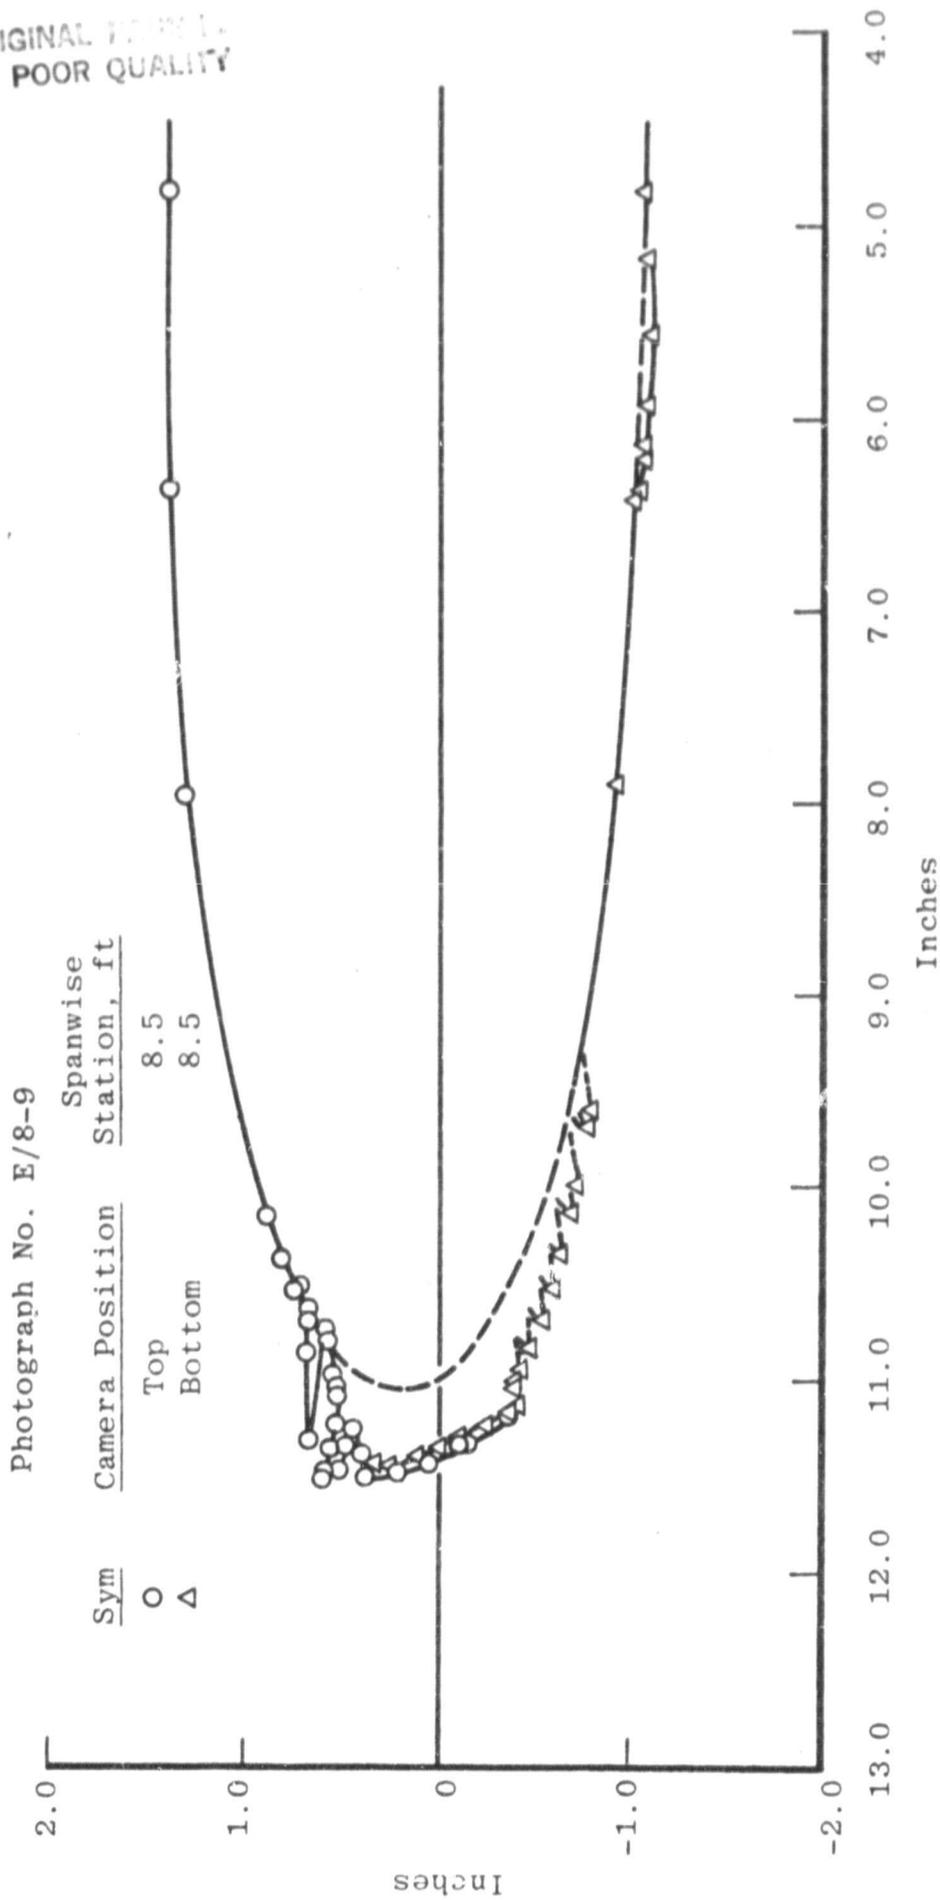
FIGURE 10. Typical Results From the Photogrammetric Analysis of Reference 5.

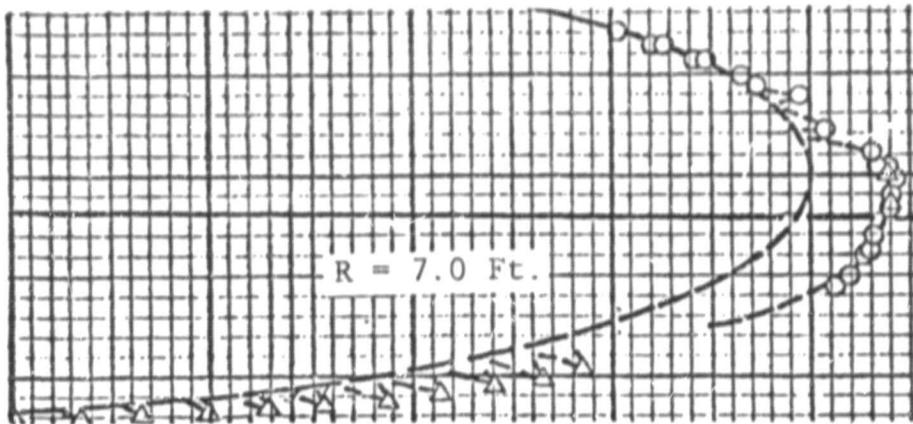
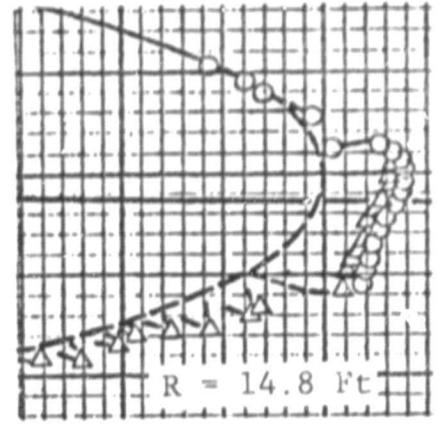
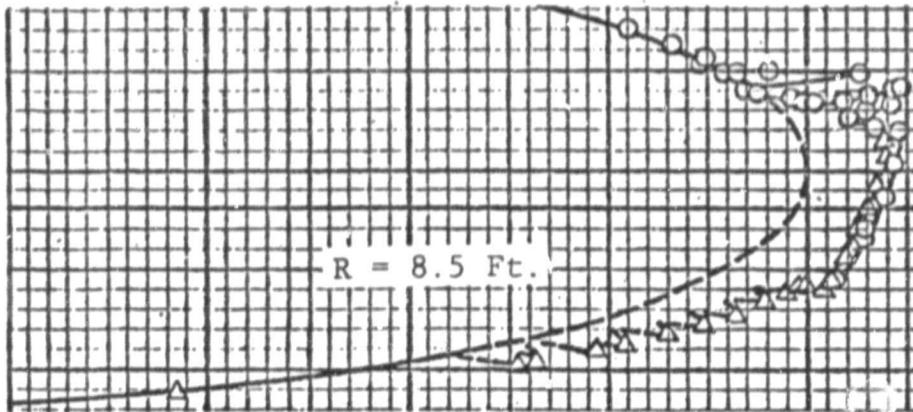
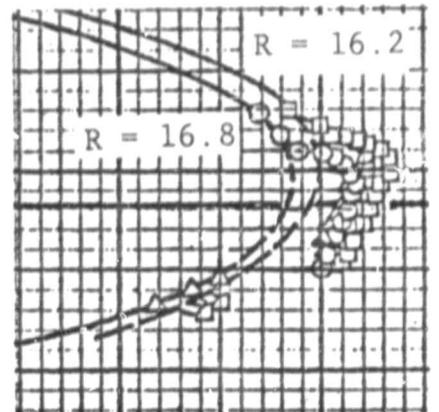
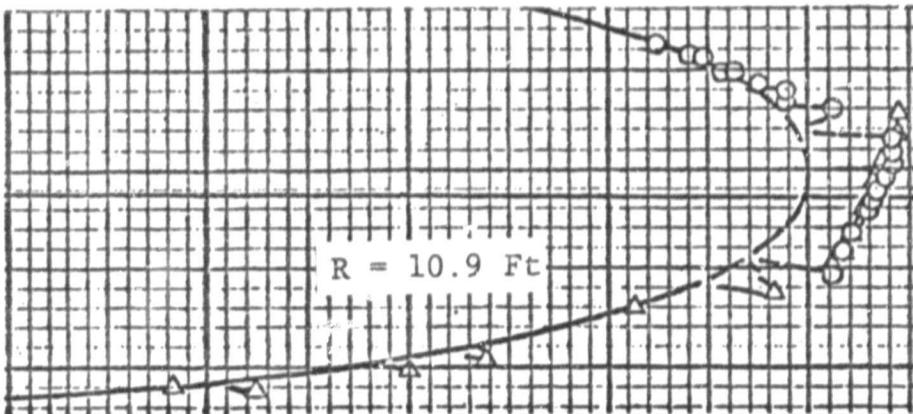
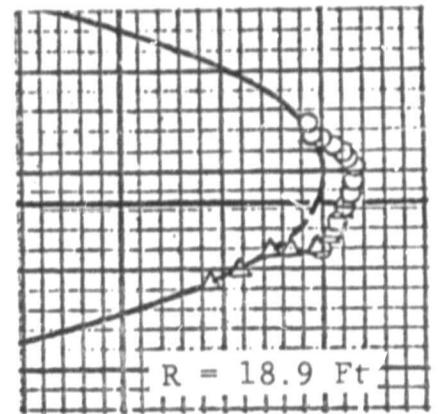
FIGURE 11. Results From Photogrammetric Analysis for Flight E.

The other data for Flight E from the photogrammetric analysis were rearranged to obtain Figure 11 (in the same format as Figure 8). In doing this, the upper and lower contours were shifted from their plotted orientation to match the blade profile.

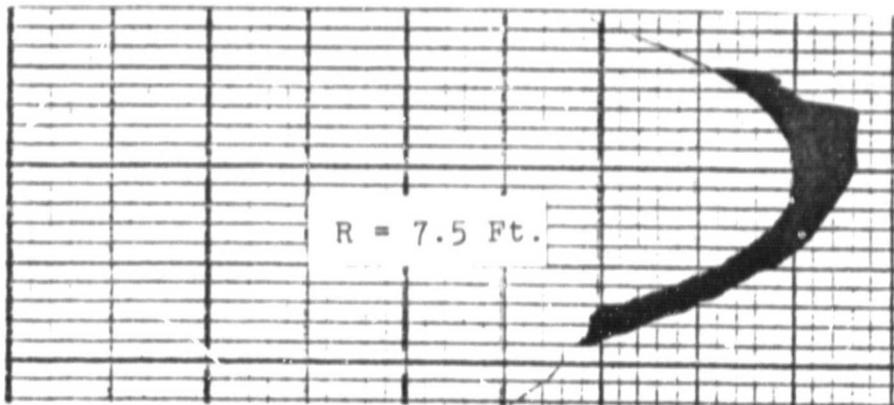
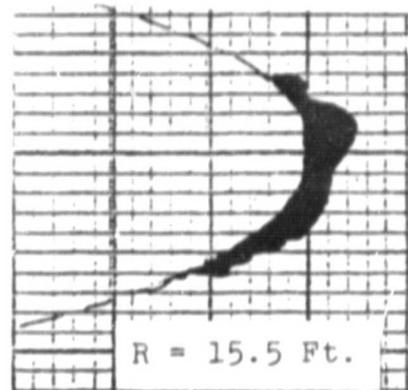
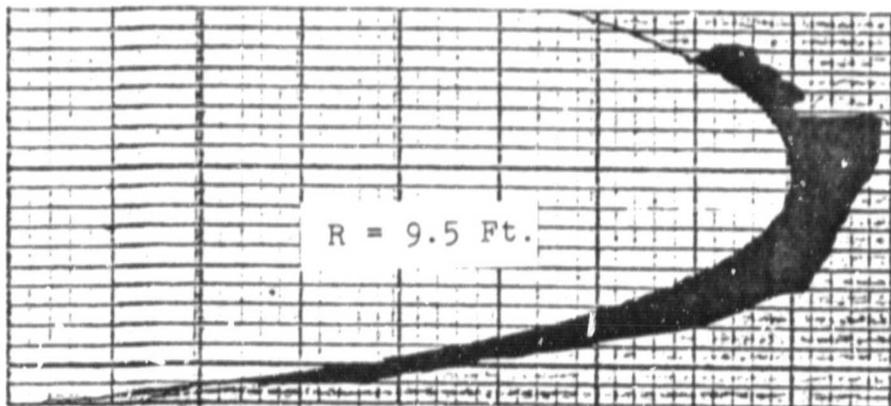
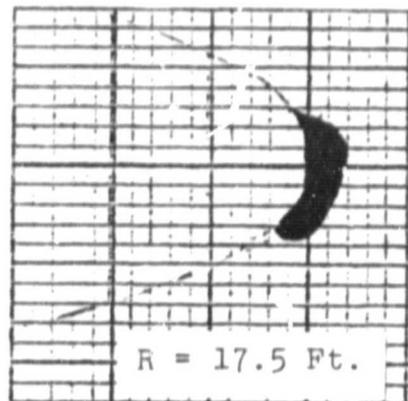
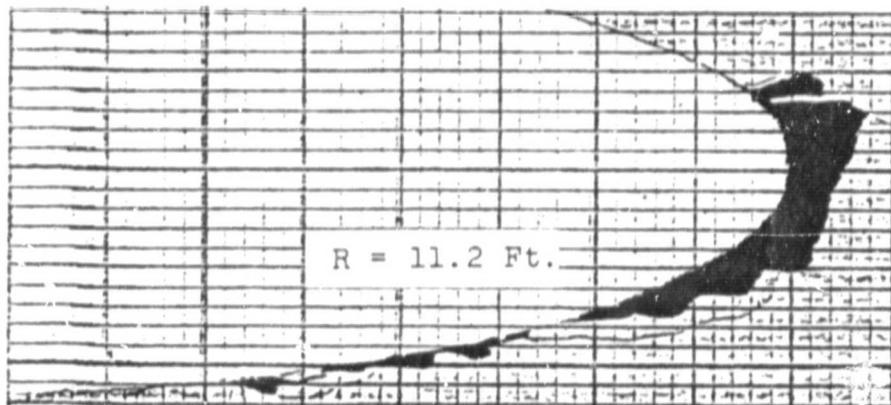
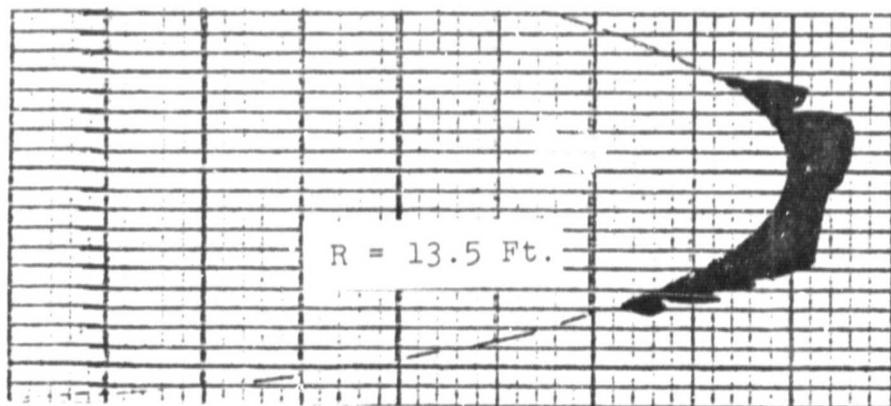
FIGURE 12. Results From Section Cuts on Ice, Flight E.

Projections of the hand-sketched contours on the paper templates as oriented onto a reference grid are reproduced in Figure 12.
