NASA Contractor Report 168332

DOCUMENTATION OF ICE SHAPES ON THE MAIN ROTOR OF A UH-1H HELICOPTER IN HOVER

January 1984

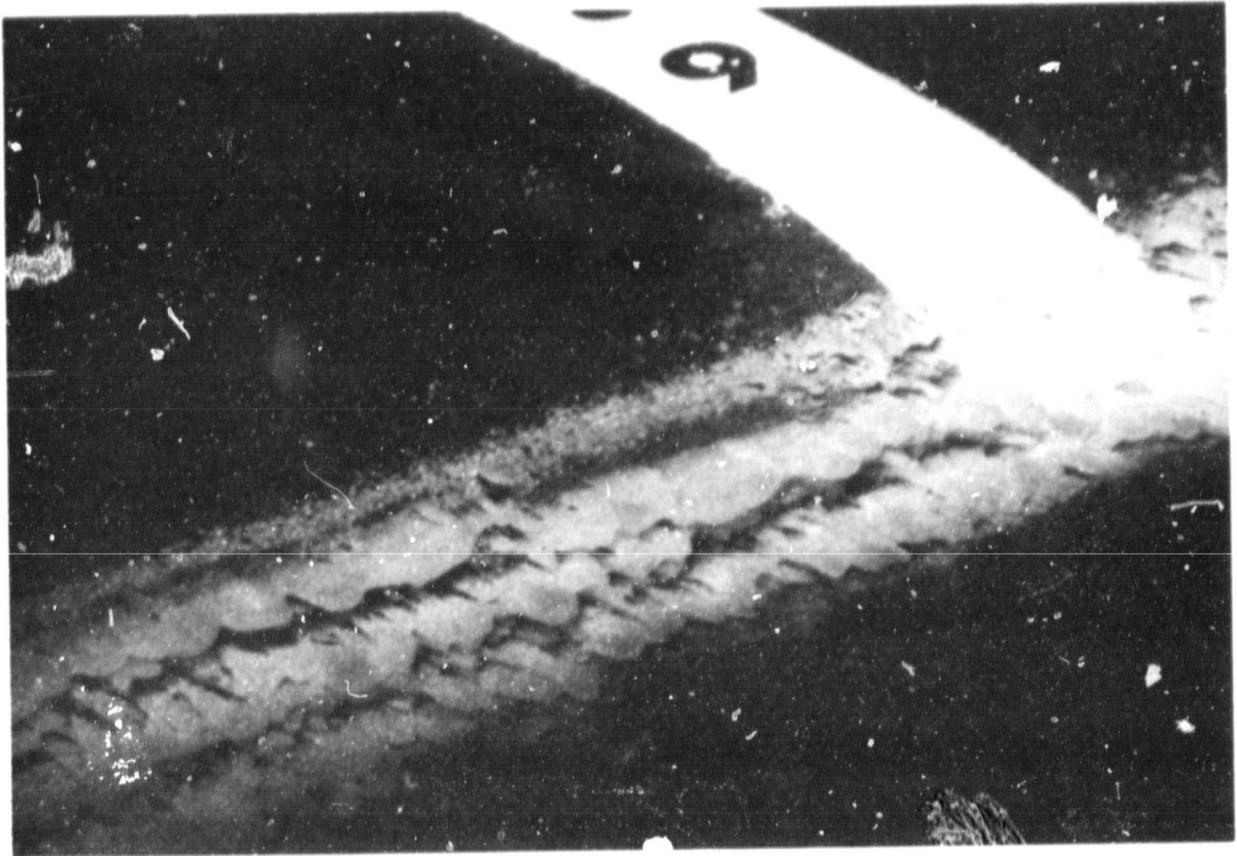
FIGURE: 13. Photo of Typical Ice Formation on Rotor Blade.
(The White Stripe is 1 in. Wide)

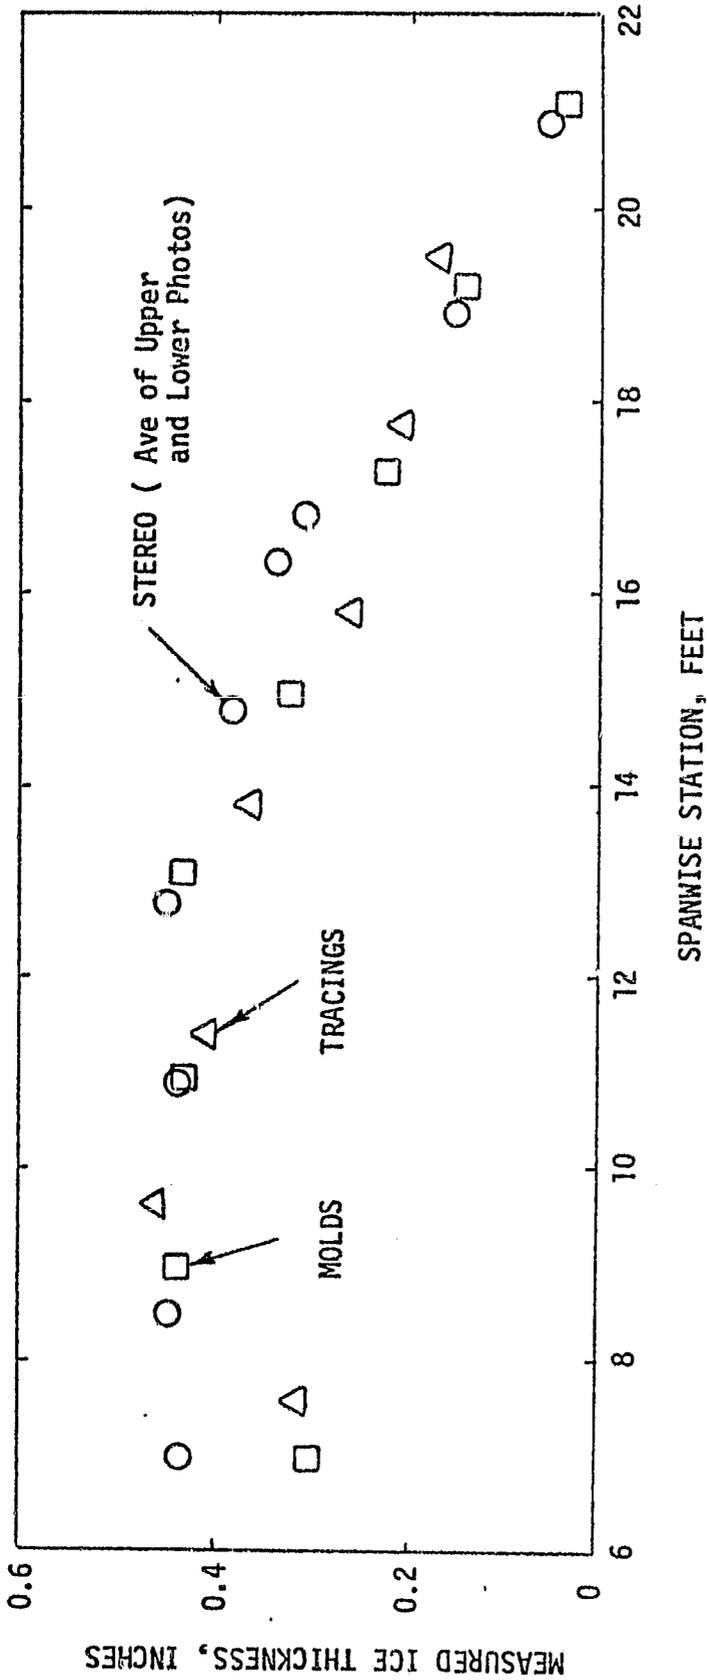
FIGURE 14. Extent of Ice Accretion on Rotor for Flight at
Comparison of Different Methods of Documentation.
