NASA CR-174657

**ANALYTICAL AND EXPERIMENTAL INVESTIGATION OF
RUBBING INTERACTION IN LABYRINTH SEALS FOR A
LIQUID HYDROGEN FUEL PUMP**

Francis X. Dolan
Francis E. Kennedy
Erland M. Schulson

CREARE R&D INCORPORATED
prepared for

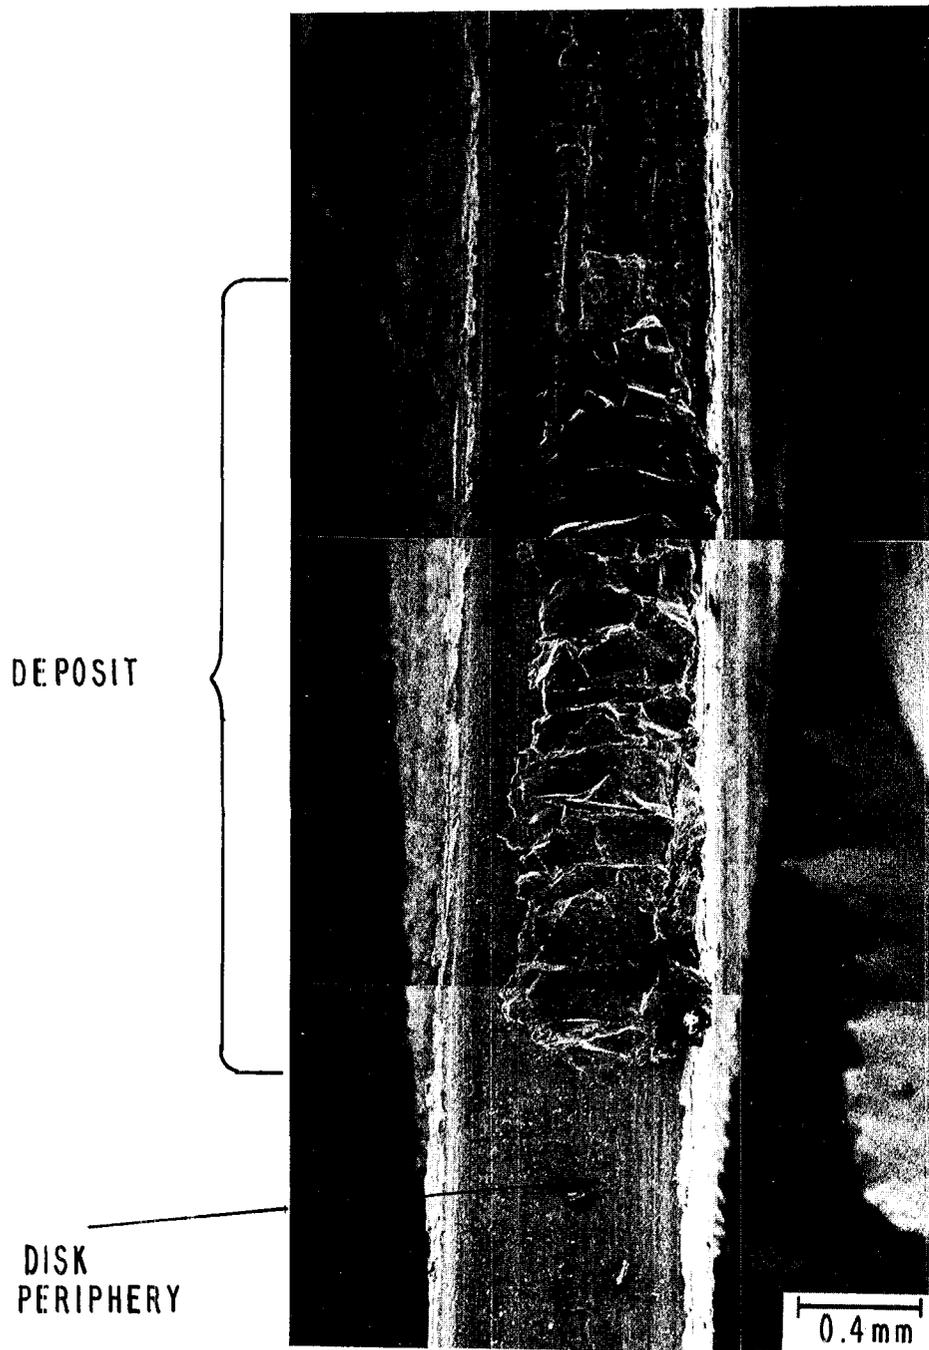
FIGURE 4-9. PHOTOGRAPH OF PERIPHERY OF DISK
SHOWING DEPOSIT OF YSZ (TEST TIYZ03)

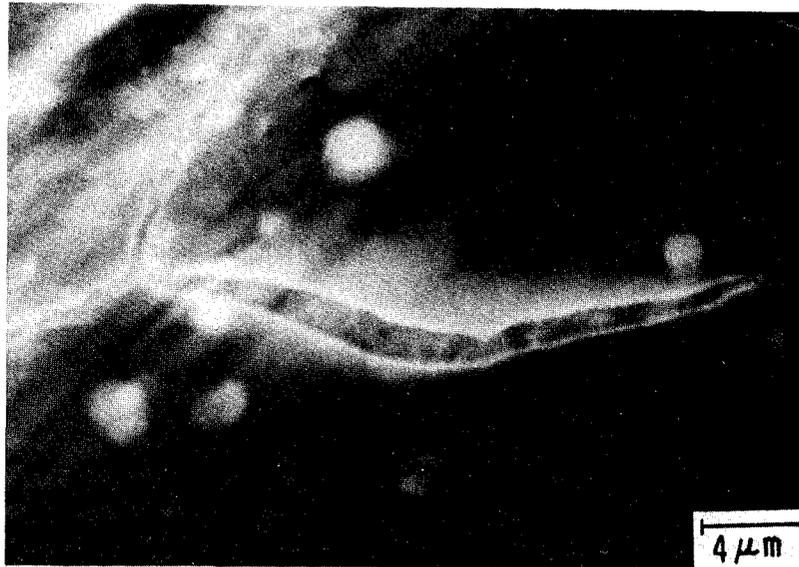
Figure E.5 SEM Micrograph Showing Incision-Like Crack
Within a Thin Film on the Side of the Disk
(Note the transparency of the film)
