LMSC-HREC TM D784773

**Lockheed**
Missiles & Space Company, Inc
Huntsville Research & Engineering Center

RESULTS OF VARIABLE
ENTHALPY TESTS OF CPR-488
'TIP' PANELS IN MSFC HOT
GAS FACILITY

22 February 1982

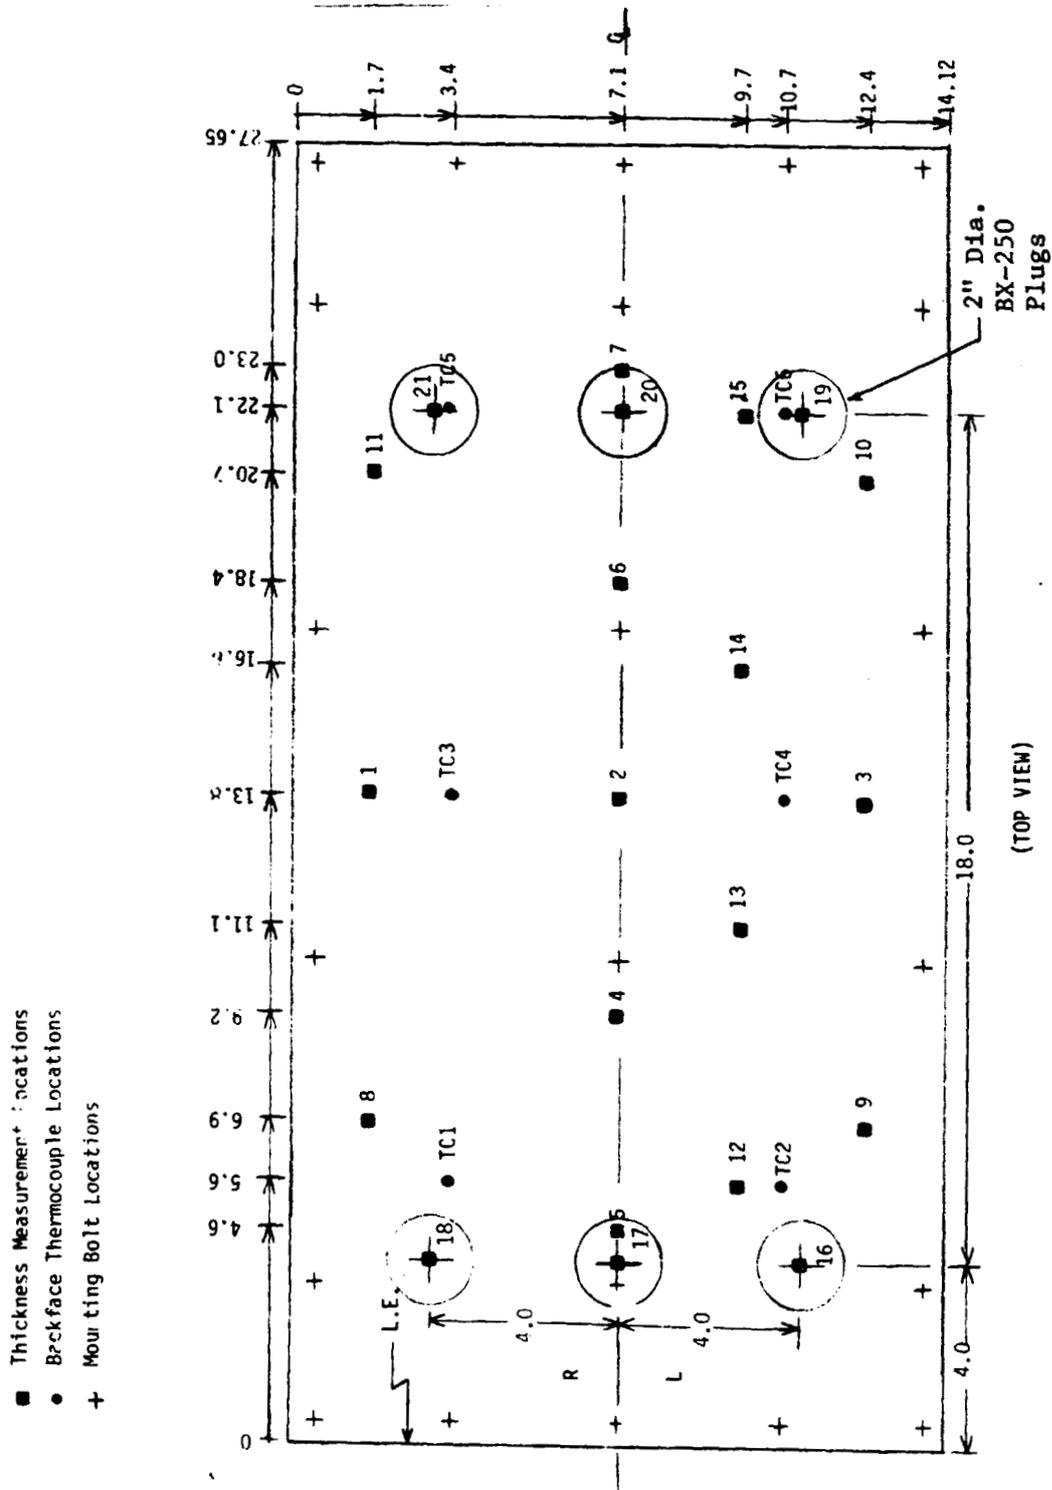
Fig. 1 - Sketch Showing Layout of CPR-488 TIP Panels

Six CPR-488 panels were built and tested in this series of tests. These were designated TIP-1 through TIP-4, and TIP-7 and TIP-8. Figure 1 shows a sketch of these panels with locations of thermocouples, BX-250 plugs, and thickness measurements. Figures 2 through 7 show the pretest photographs of the six panels. The BX-250 plugs were all 2 in. in diameter and of various thicknesses. Figure 8 shows the TIP plug thickness values. TIP-7 and TIP-8 plugs had TiO_2 to make them whiter. Figure 9 shows the heating rate cal model used to calibrate the HGF for these particular tests. It consisted of an array of thin skin/thermocouple locations running horizontally and longitudinally along the HGF duct test section in Position 1.

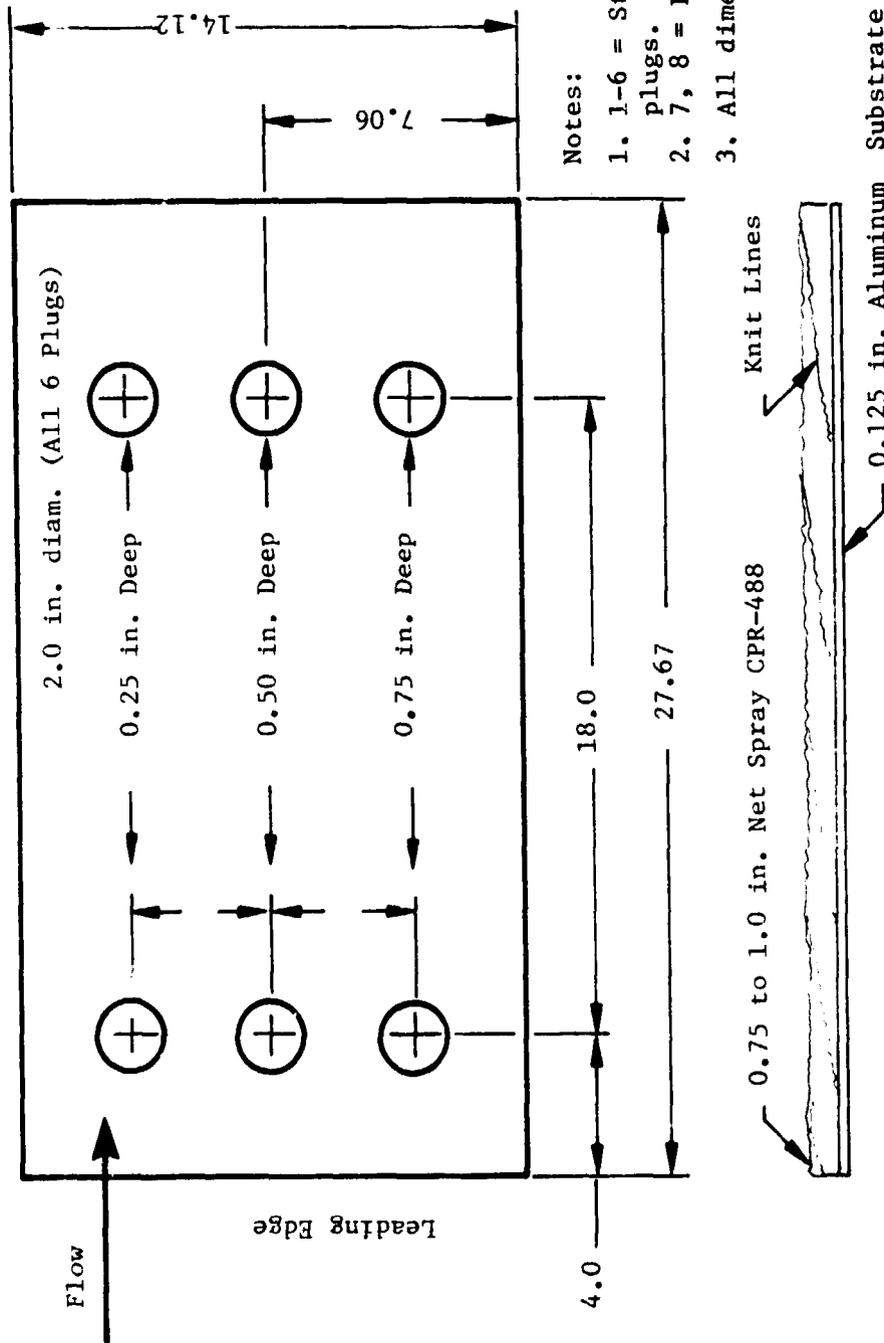
Fig. 8 - TIP Plug Thicknesses

1. 1-6 = Standard BX-250 plugs.
2. 7, 8 = BX + TiO₂ plugs.
3. All dimensions in inches.

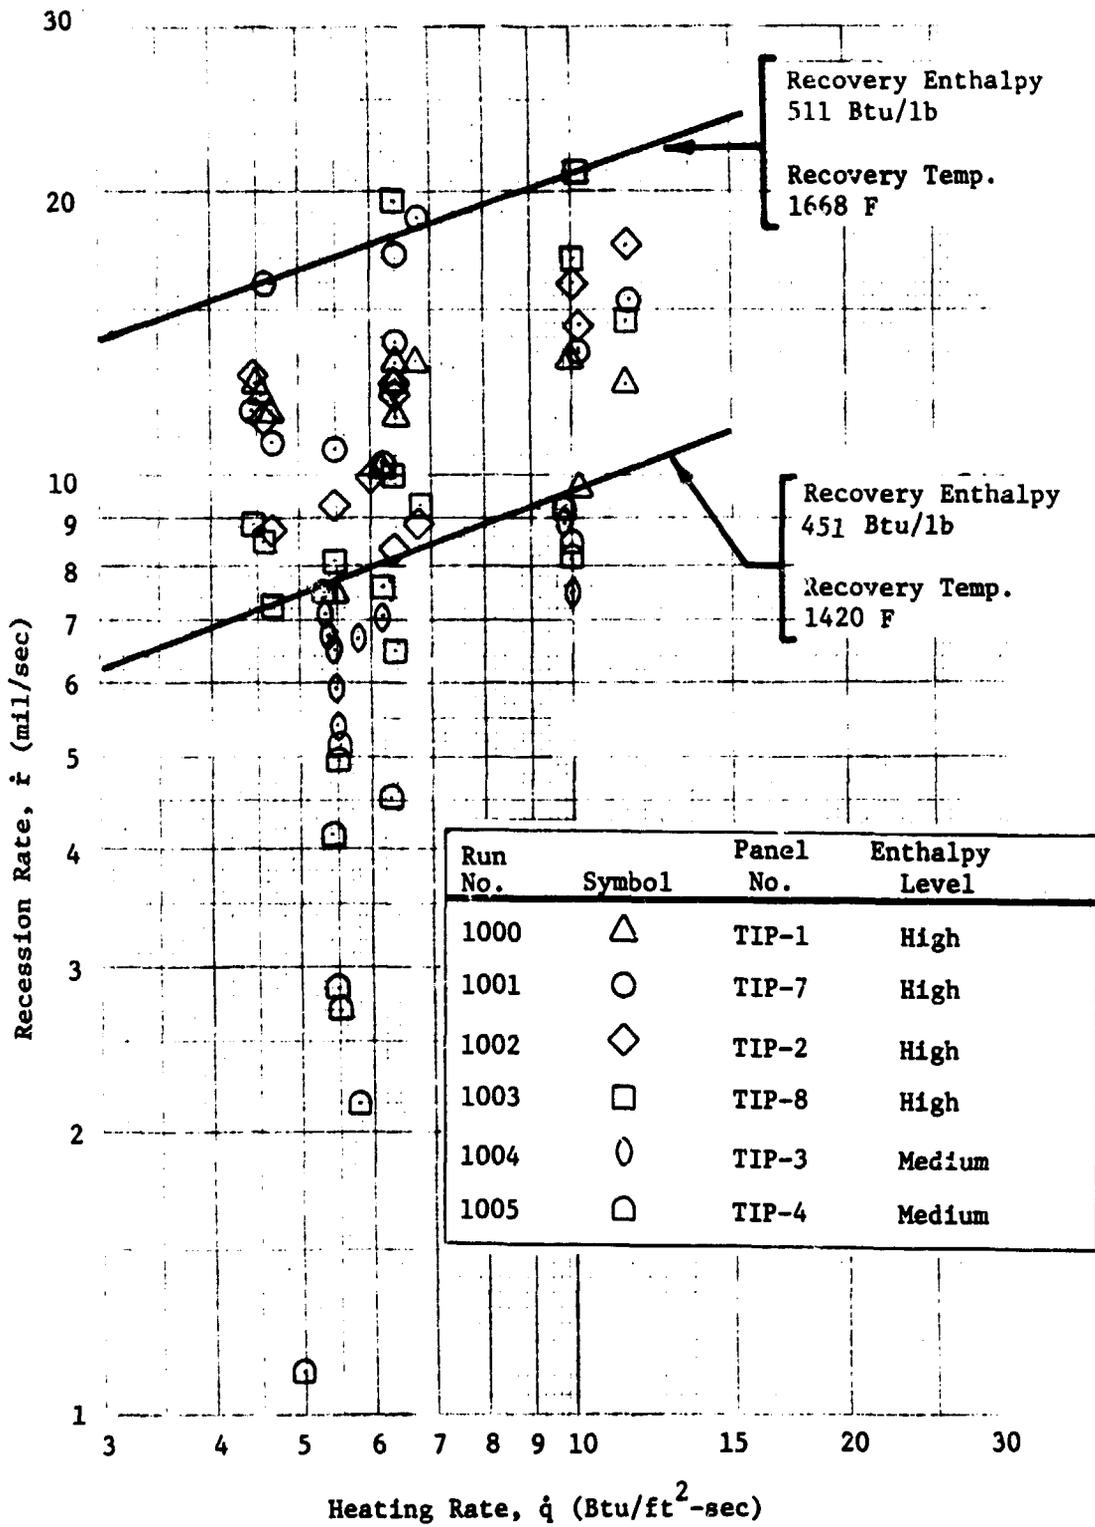
Fig. 10 - Recession Rate vs Heating Rate for CPR-488 Foam at Two Enthalpy Levels

Figure 10 shows a plot of recession rate versus heating rate for CPR-488. The high enthalpy data are in general higher in recession than the low enthalpy data.

A third method was also tried in an effort to show the enthalpy effect. In this method a comparison was made between the peak values of recession at the two enthalpy levels. Straight lines were drawn through the approximate peak points for each enthalpy level on Fig. 10. Using values read from these peak lines, the cross plots of Figs. 11 through 14 were made. These plots show recession rate versus recovery temperature (i.e., enthalpy). Figure 11 is for a constant heating rate of 4 Btu/ft²-sec. Figures 12, 13 and 14 are for constant heating rates of 6, 10 and 15 Btu/ft²-sec, respectively. This form of the data shows a definite trend of the recession with enthalpy. Also shown on these figures for comparison are data from some AEDC tests. These data were taken at approximately 1420 F recovery temperature. Also one data point is available at a recovery temperature of 1100 F. As seen on these figures, the agreement with the HGF data is reasonably good.

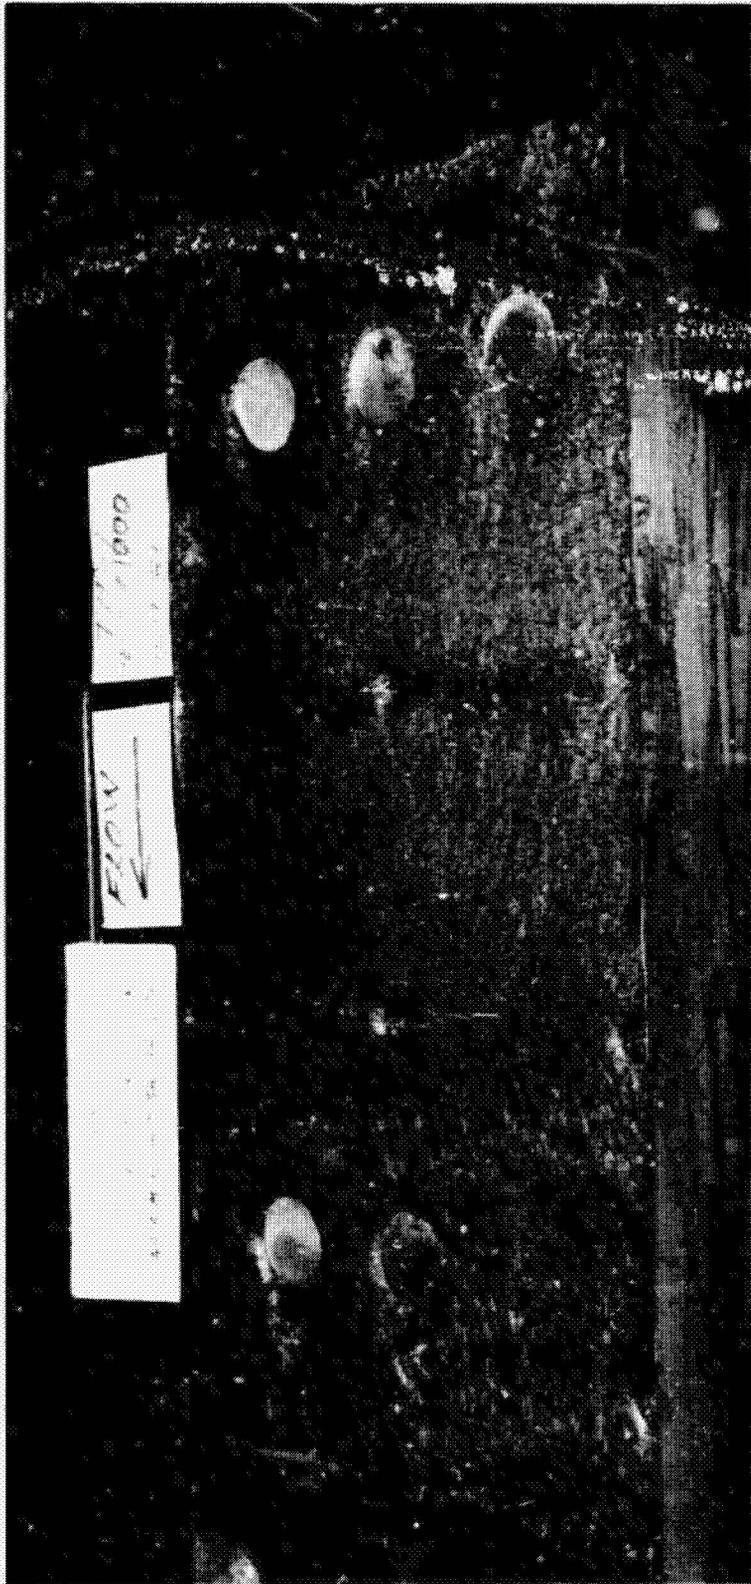
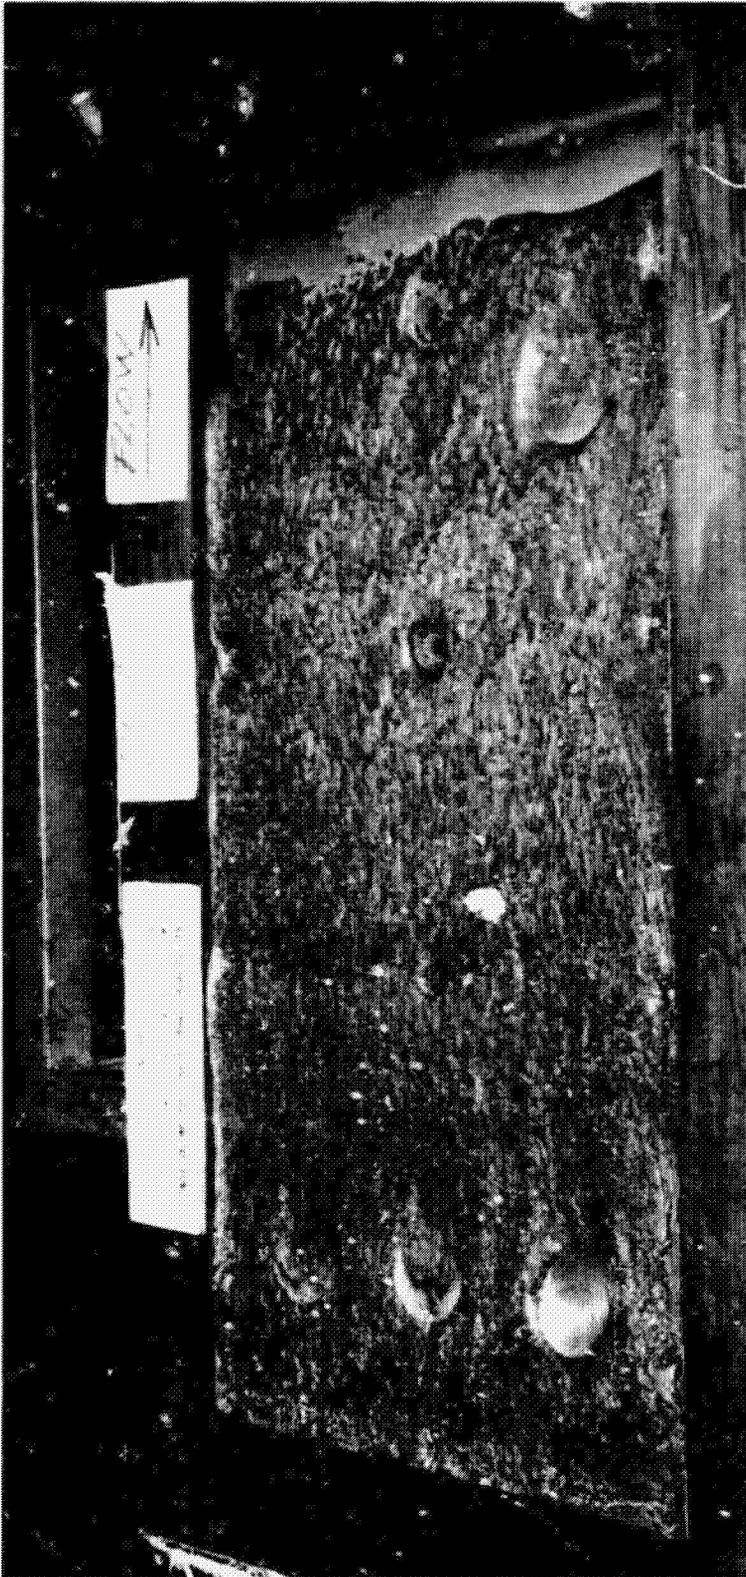
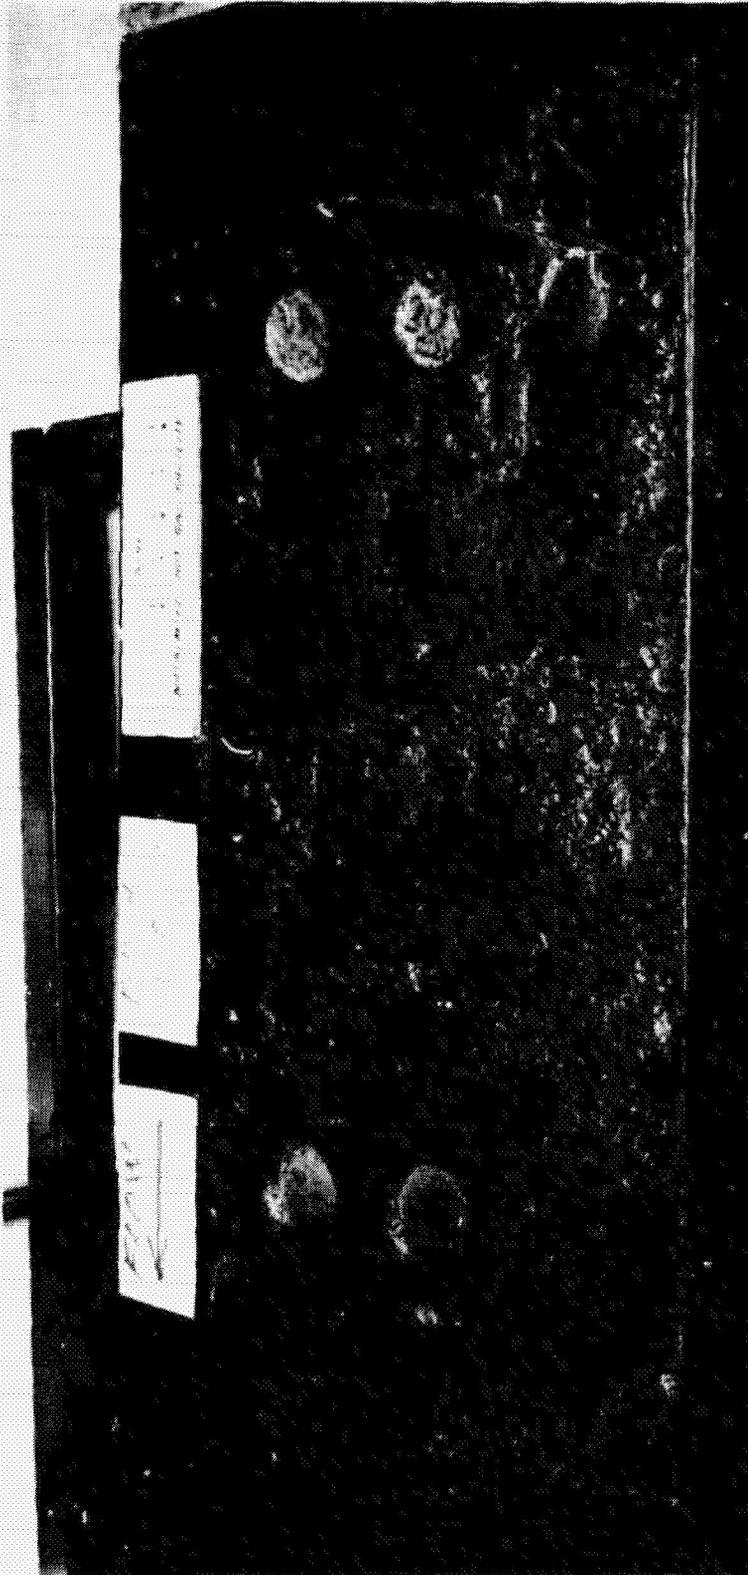
Figures 15 through 20 show the post-test photos of all TIP panels. Inspection of these photos and post-test inspection of the panels showed that the BX-250 TIP plugs receded to about the same depth as the CPR-488. The BX-250 plugs without TiO_2 charred and changed to about the same color as the CPR-488 in most cases. However, it was still obvious when a plug was completely gone. The BX-250 plugs which had TiO_2 gave a more distinct appearance of the plugs and is a better design (see Figs. 17 and 19 of TIP-7 and TIP-8). Figure 20 (Test 1004, TIP-3) has a different appearance from the rest of the panels. The panel is a much lighter color due to removal of most of the char. A review of the movies indicated that this occurred during a rough shutdown of the HGF.

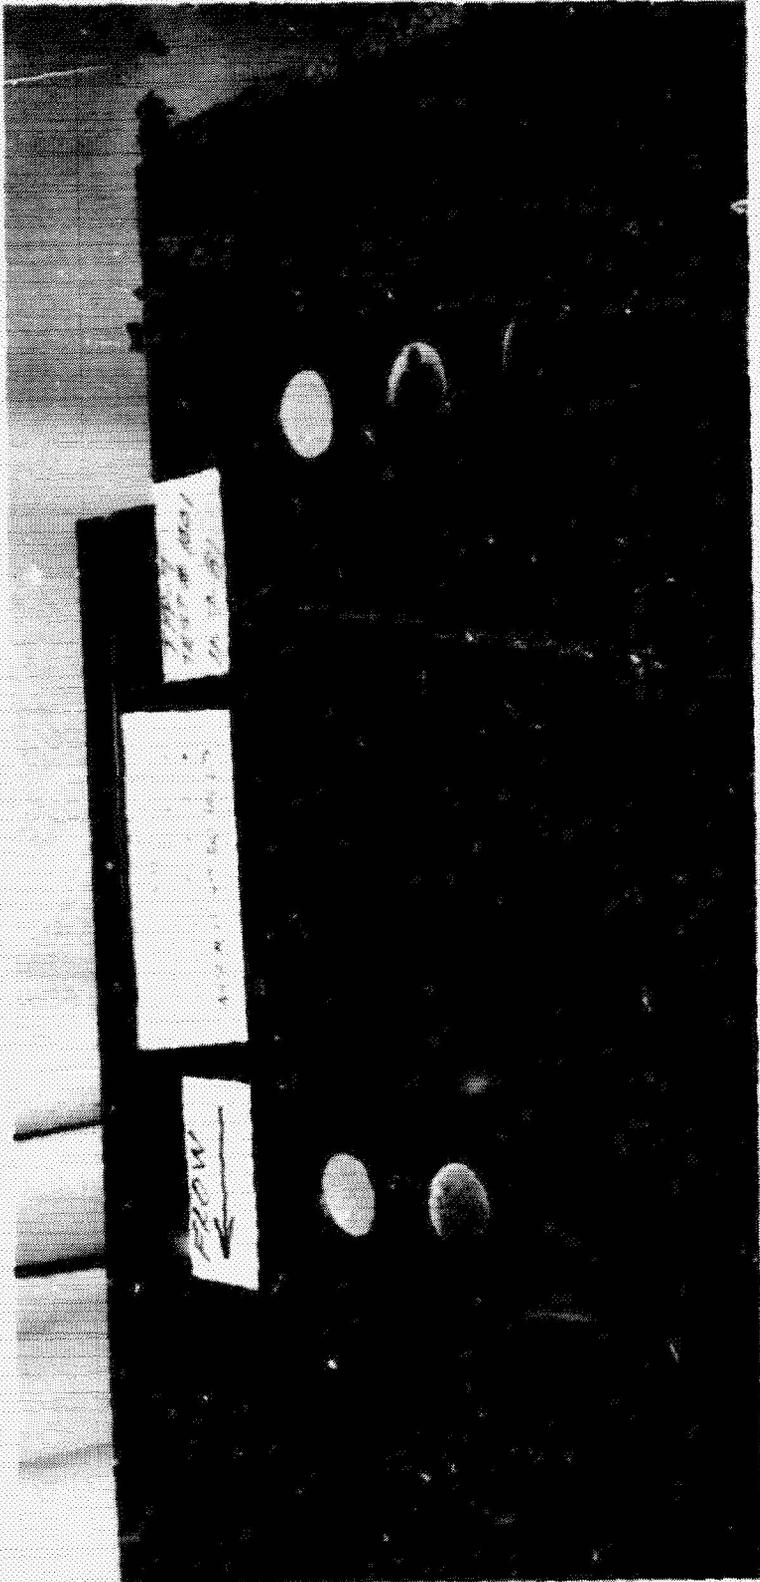
Fig. 16 - Post-Test Photo of Panel TIP-7 (BX-250 Plugs Had TiO_2 Added, Therefore are Lighter in Color)

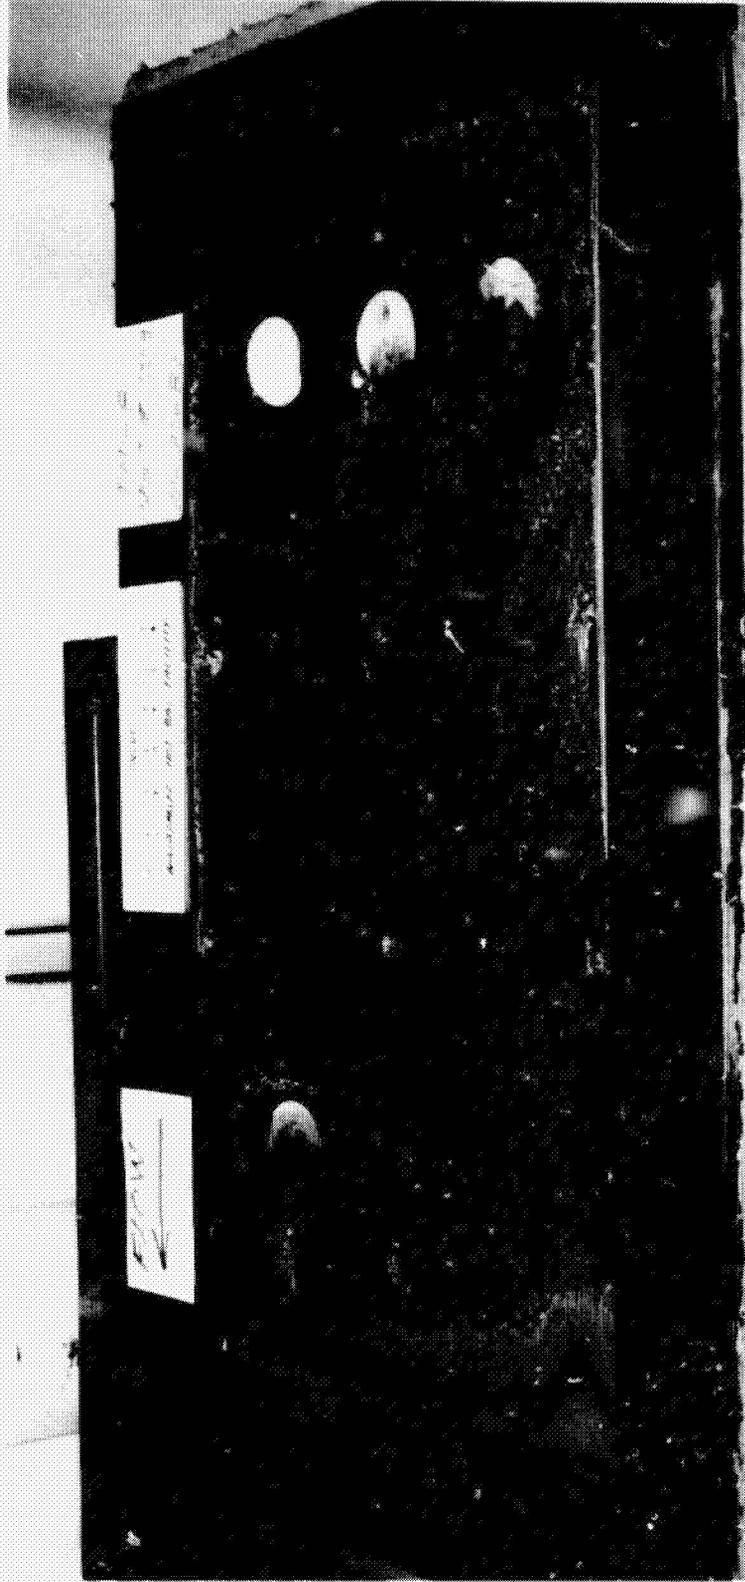
Fig. 18 - Post-Test Photo of Panel TIP-8, (BX-250 Plugs Had TiO_2 Added, Therefore are Lighter in Color)

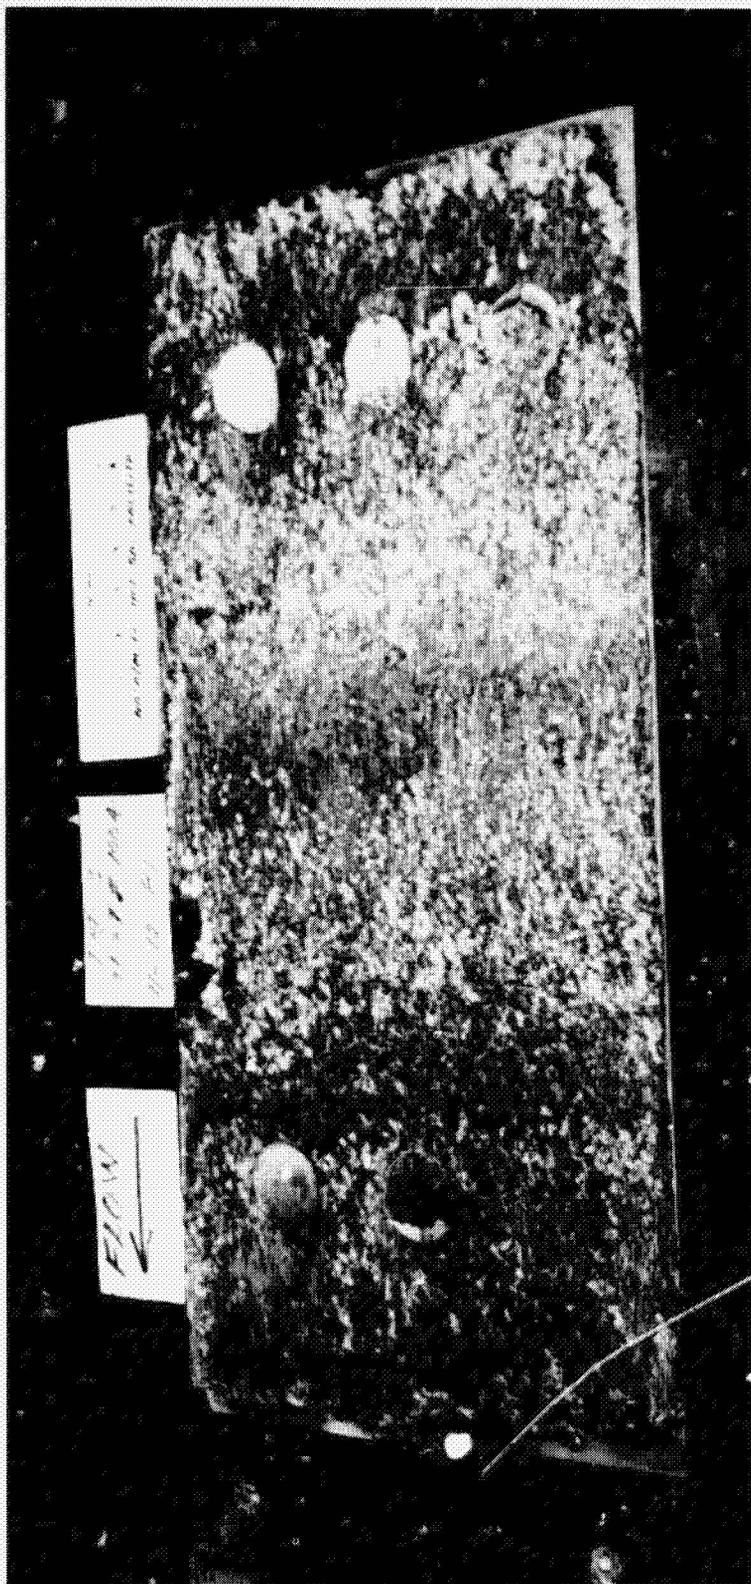
Fig. 19 - Post-Test Photo of Panel TIP-3 (Most of Char Blew Away During Rough Shutdown of HCF)
