Improved Piston Ring Materials for 650°C Service

William D. Bjorndahl
TRW Space & Technology Group
Energy Division

March 1986

Prepared for
NATIONAL AERONAUTICS AND SPACE ADMINISTRATION
Lewis Research Center
Under Contract DEN3-307

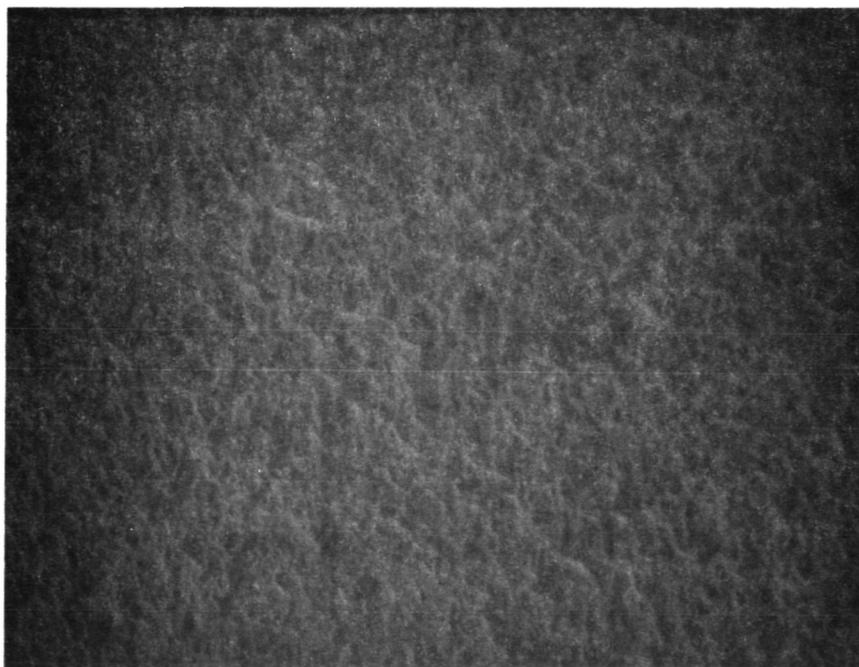
Figure 7.4. Photomicrograph of One of the Poorer Graded Alumina Coatings as Wear Tested Against a Tungsten Carbide Cylinder Sleeve.

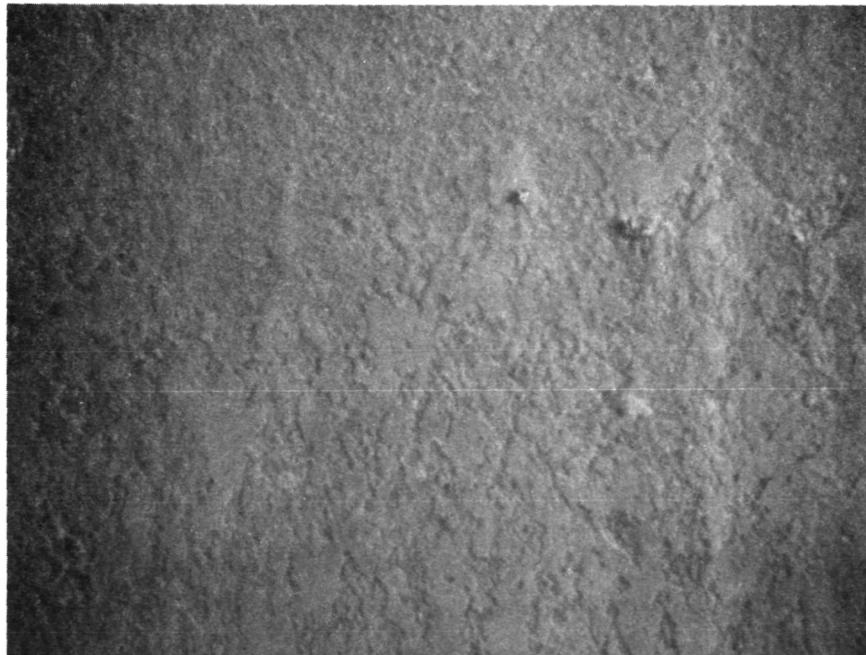
Figure 7.6. Photomicrograph of One of the Poorer Non Graded $ZrO_2/28.5-35TiO_2/2-4 Y_2O_3$ Coatings After Wear Testing Against a Tungsten Carbide Cylinder Sleeve. This Coating Performed Poorly in Thermal Shock Testing.

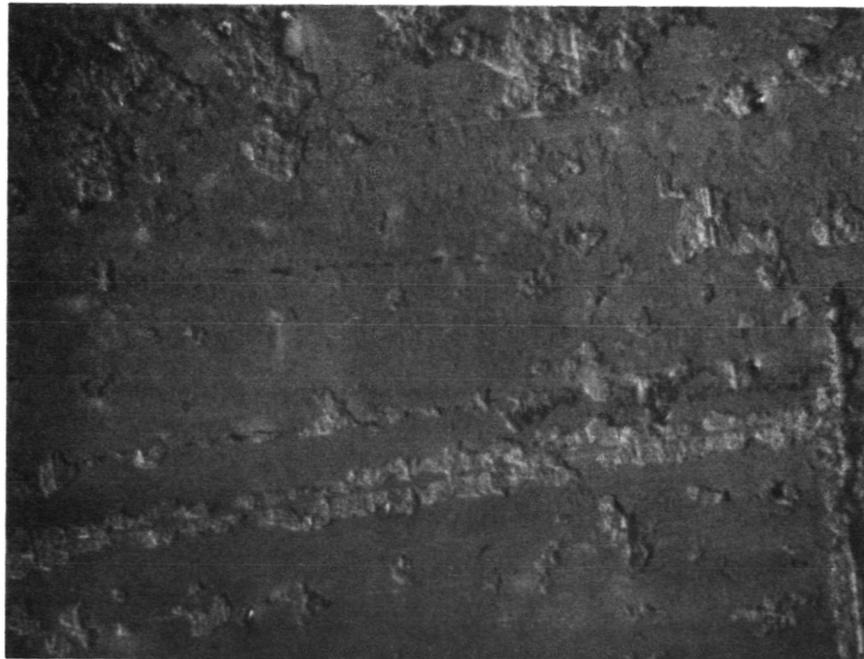
Figure 7.12. Photomicrographs of Tungsten Carbide Based Coating as Wear Tested Against a Tungsten Carbide Cylinder Sleeve.

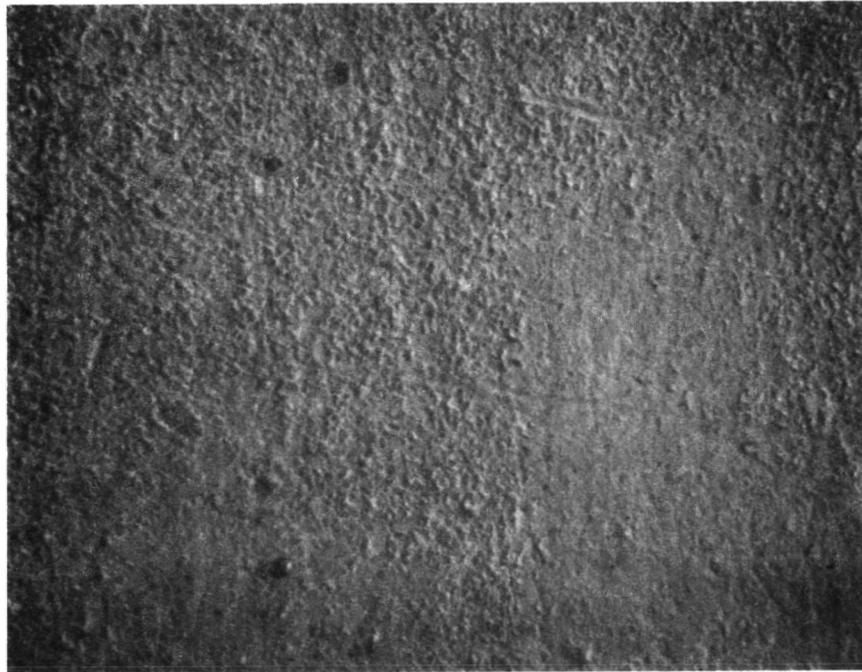
Figure 7.13. Photomicrograph of Molybdenum Based Plasma Transfer Arc Coating After Wear Testing Against a Si_3N_4 Cylinder Sleeve.

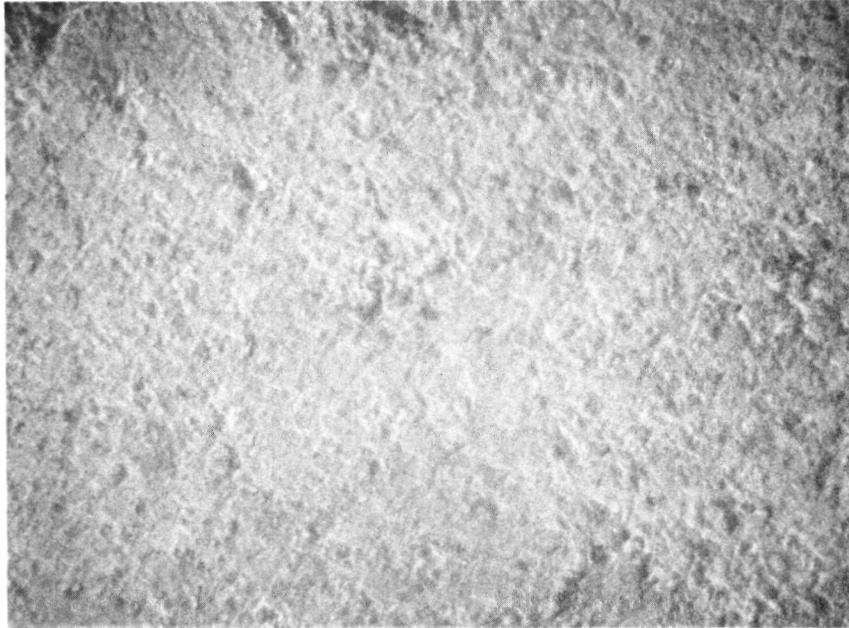
Figure 7.14. Photomicrograph of One of the Better Graded $ZrO_2/TiO_2/Y_2O_3$ Coatings as Wear Tested Against a Tungsten Carbide Cylinder Sleeve. This Coating performed poorly in Thermal Shock Testing.
