NASA Technical Memorandum 87318

The Low Cycle Fatigue Behavior of a Plasma-Sprayed Coating Material

John Gayda, Timothy P. Gabb,
and Robert V. Miner, Jr.
Lewis Research Center
Cleveland, Ohio

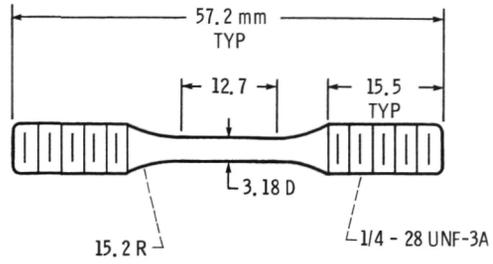
Figure 1. - Miniature low cycle fatigue specimen.

Miniature low cycle fatigue specimens shown in figure 1 were machined from the plates by stress-free grinding to minimize surface damage. The gauge section and radius were given an 8 RMS finish by lapping parallel to the stress axis.

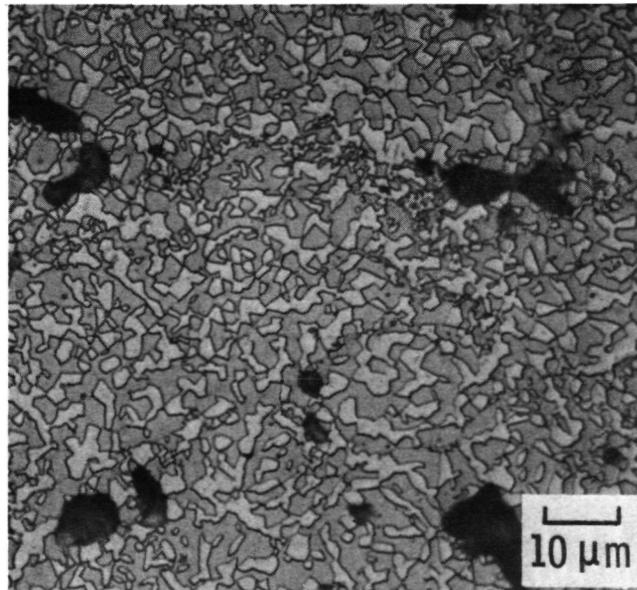
Figure 2. - Microstructure of the NiCoCrAlY alloy.

Etching of the as-received material revealed spherical powder particles of the NiCoCrAlY powder which were not melted in the plasma spraying operation. After heat treatment the microstructure of the plates was very uniform, figure 2,

with a fine grained two-phase microstructures consisting of the dark β phase (NiAl) and the γ phase (Ni-rich solid solution). The grain size of the NiCoCrAlY alloy was less than 3 μm , which is comparable to that found in thin coatings applied to superalloy components.

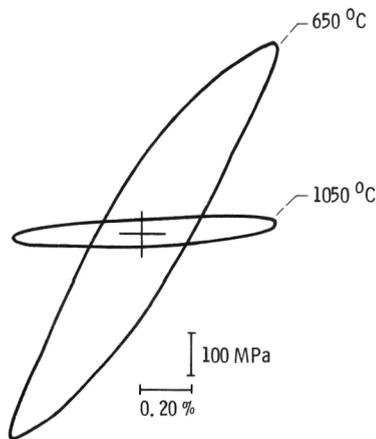
Figure 3. - Typical hysteresis loops.

The vast difference in strength and ductility at the two test temperatures is also reflected in the stress-strain response observed during fatigue testing. Figure 3 shows the 650 and 1050 °C hysteresis loops of the NiCoCrAlY at half life for $\Delta\epsilon = 0.01$. Note that only a small fraction of the total strain range is elastic at 1050 °C. This was case for all tests run at 1050 °C.

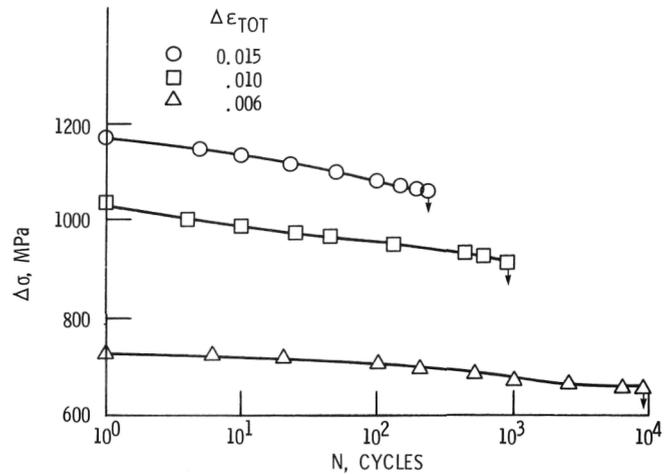
Figure 4. - Cyclic softening observed at 650 °C.

At 650 °C extensive softening of the NiCoCrAlY was observed in all fatigue tests. The actual softening response is shown in figure 4 for three strain ranges. In each instance the softening started from the onset of the test and continued at a measurable rate until failure. The NiCoCrAlY also exhibited a persistent compressive mean stress, varying from a high of 8 percent to a low of 1 percent of the total stress range for the highest and lowest strain ranges, respectively. The cyclic stress-strain response of the NiCoCrAlY at half life is presented in figure 5, and gives a cyclic strain hardening exponent of $m = 0.19$.

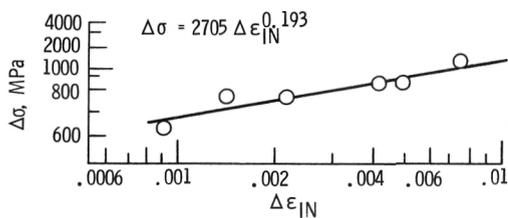
Figure 5. - Cyclic stress-strain response at 650 °C.

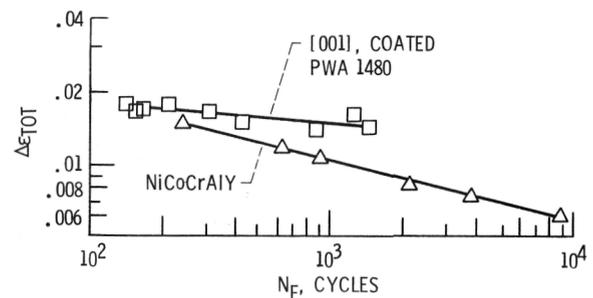
Figure 6. - Fatigue life of the NiCoCrAlY compared to that of coated PWA 1480 at 650 °C.

Fatigue life of the NiCoCrAlY and the NiCoCrAlY-coated PWA 1480 (ref. 4) at 650 °C is plotted in figure 6. Over the test range, the life of the NiCoCrAlY is less than that of the coated PWA 1480, on a total strain basis, and this difference increases at lower strain ranges. The elastic and inelastic life lines of the NiCoCrAlY are presented in figure 7. Also shown are the regression equations for the two life lines.

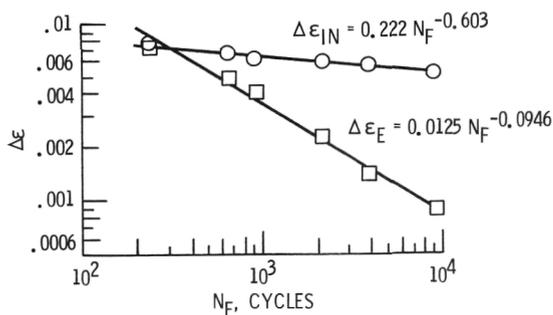
Figure 7. - Elastic and inelastic life lines at 650 °C.

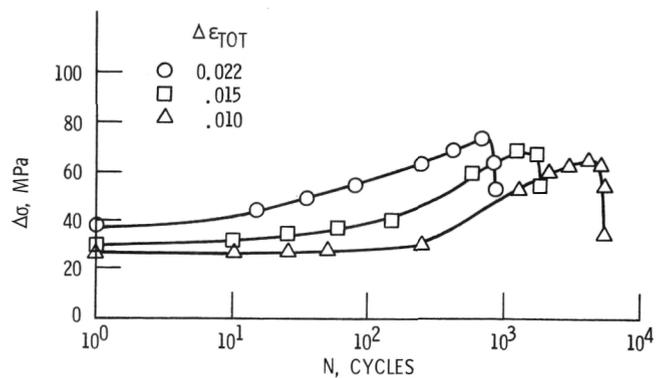
Figure 8. - Cyclic hardening observed at 1050 °C.

Unlike the softening observed at 650 °C, the NiCoCrAlY hardens profusely at 1050 °C, as seen in figure 8. Hardening was observed at all strain ranges and reaches a maximum near the end of the test. Failure is not abrupt at this temperature, as illustrated by the terminal "softening" in figure 8, which is related to stable crack growth produced by strain control. Within the accuracy of the stress measurements at 1050 °C, no consistent mean stresses were observed.

polycrystalline materials generally increase with increasing grain size. A further correlation between these two factors is illustrated by a detailed comparison of figures 8 and 12. In the lower strain range test little hardening is observed in the first hour of testing ($N = 360$ cycles) and very little grain growth is evident. From this point on the hardening rate and the rate of grain growth accelerate reaching a maximum near the end of the test. As previously stated the terminal "softening" is a result of significant cracking.

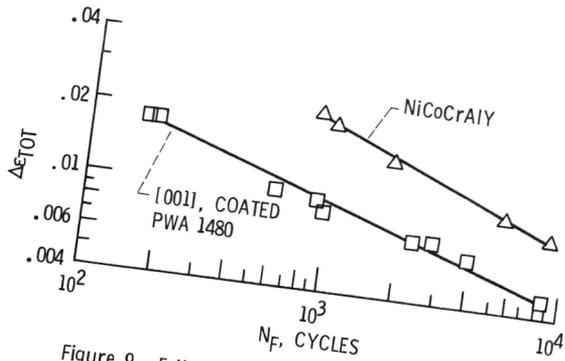
Figure 9. - Fatigue life of the NiCoCrAlY compared to that of coated PWA 1480 at 1050 °C.

The 1050 °C fatigue life response of the NiCoCrAlY and NiCoCrAlY-coated PWA 1480 (ref. 4) are presented in figure 9 on a total strain basis. Over the range of tests performed, the NiCoCrAlY had a fatigue life about five times greater than that of the coated single crystal. The cyclic stress-strain response of the NiCoCrAlY is plotted in figure 10 and illustrates the immense

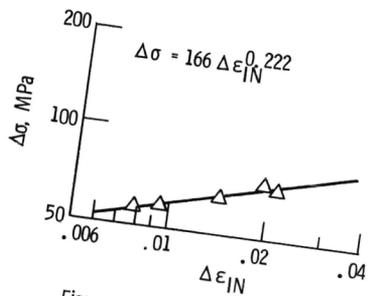
Figure 10. - Cyclic stress-strain response at 1050 °C.

decrease in strength at this temperature, compare the coefficients of the regression equations, 166 MPa at 1050 °C versus 2705 MPa at 650 °C. Further, the cyclic hardening exponent, $m = 0.22$, is slightly higher than that observed at 650 °C, $m = 0.19$.

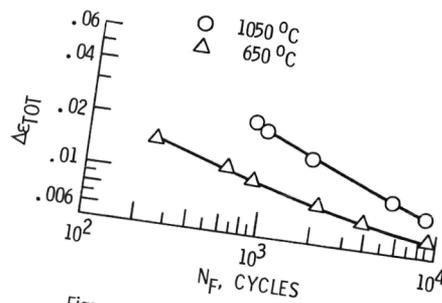
Figure 11. - Fatigue life of the NiCoCrAlY at 650 and 1050 °C.

A comparison of the fatigue lives of the NiCoCrAlY, figure 11, shows the 1050 °C life to be significantly greater than that at 650 °C on a total strain basis. This difference becomes even greater when the comparison is made on an inelastic strain basis, as might be expected from ductility considerations.

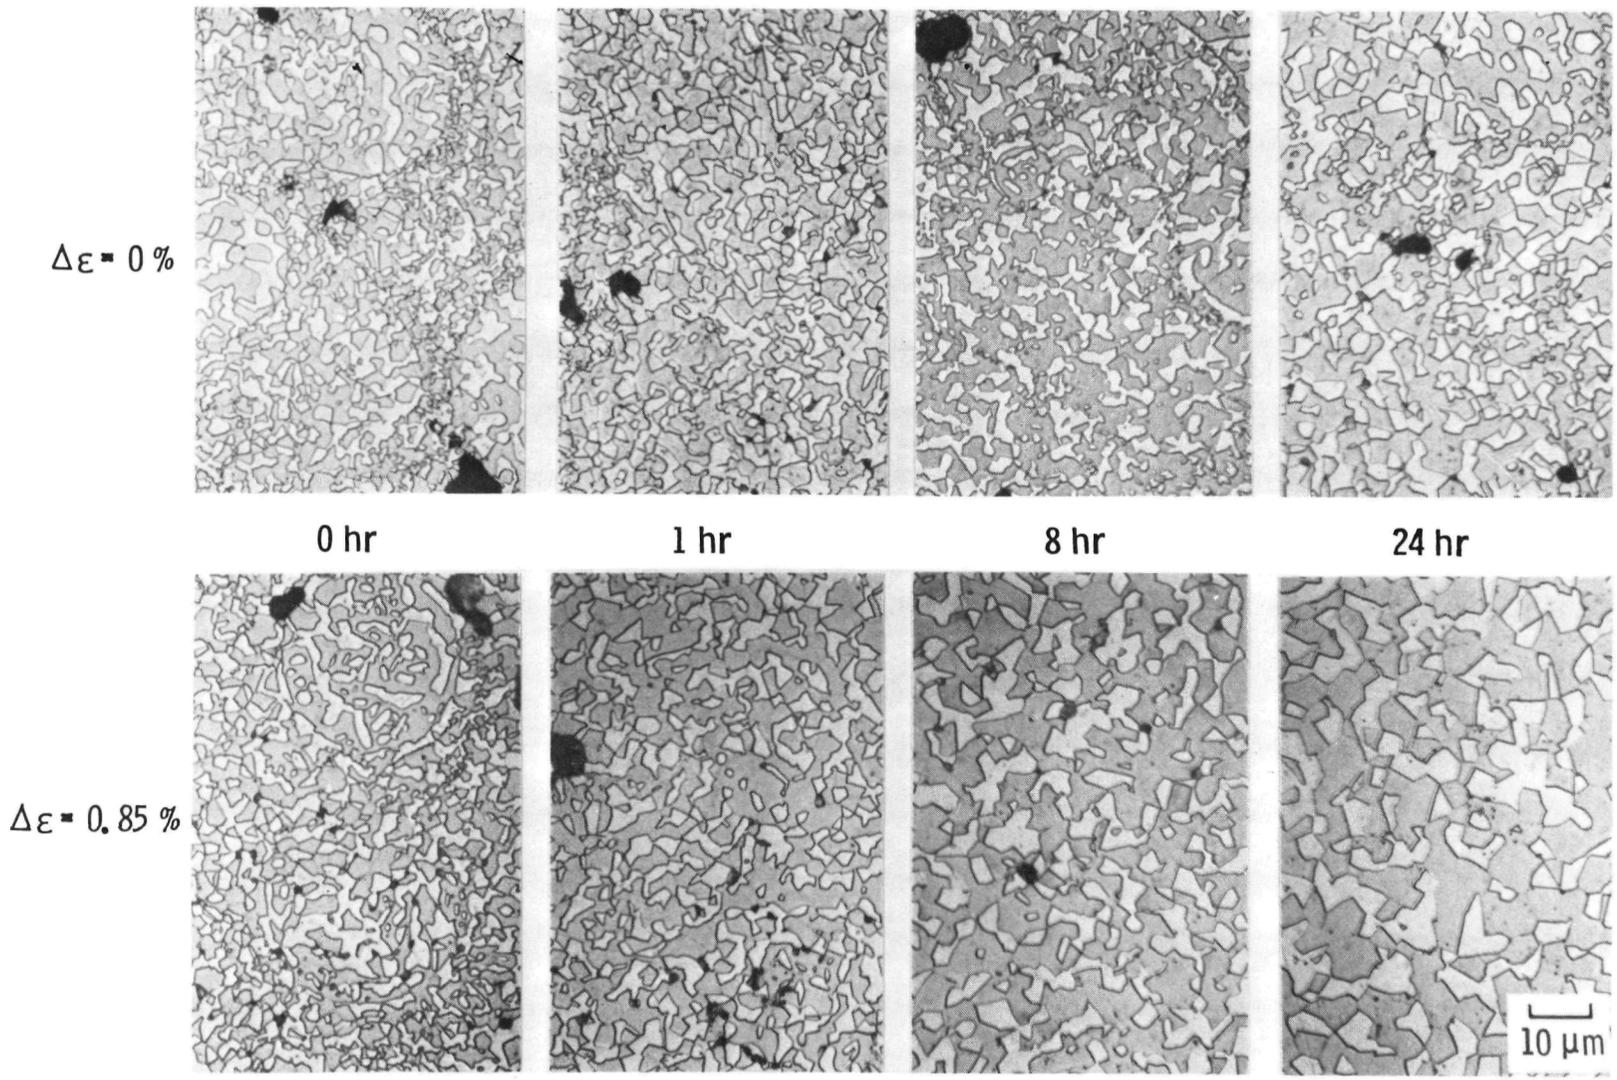
Figure 12. - Grain growth at 1050 °C as a function of time and applied strain.

Accompanying the large variation in life are significant differences in microstructural stability at the two test temperatures. Significant grain growth and redistribution of the γ and β phases were observed at 1050 °C as seen in figure 12, however, at 650 °C the microstructure was stable even at the higher strain ranges. Porosity level was affected in a similar manner. A net reduction of porosity was observed in fatigue tests at 1050 °C, although large pores were present throughout the test. At 650 °C porosity content and distribution were virtually unaffected. Returning to figure 12, it is apparent that the applied strain has accelerated the grain growth process. Simple heating at 1050 °C has altered grain size and phase distribution, but not to the extent seen in interrupted fatigue tests of equivalent time. Further, porosity content and "remnant powder" structure are virtually unaffected by simple thermal treatment for times up to 24 hr.

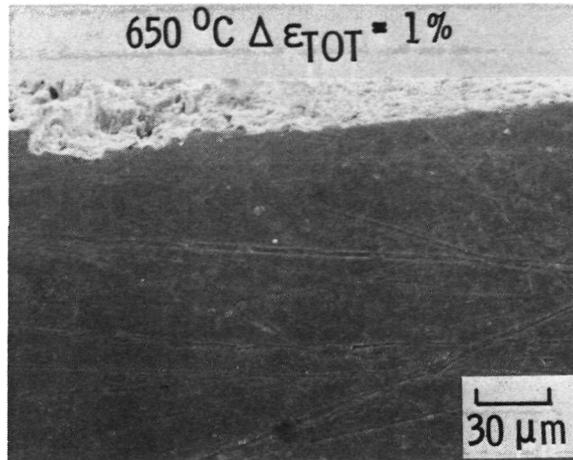
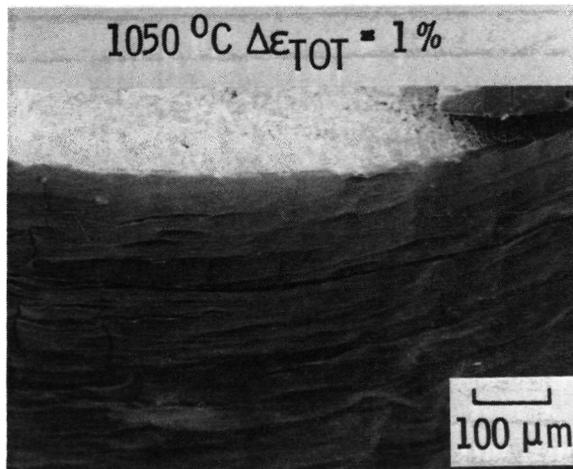
Figure 13. - Surface damage was extensive at 1050 °C and minimal at 650 °C.

Accompanying the microstructural instabilities at 1050 °C, surface "rumpling" and cracking were observed in the NiCoCrAlY, as seen in figure 13, while little if any surface damage is seen at 650 °C. Surface cracking at 1050 °C was readily observable at or shortly after half life.

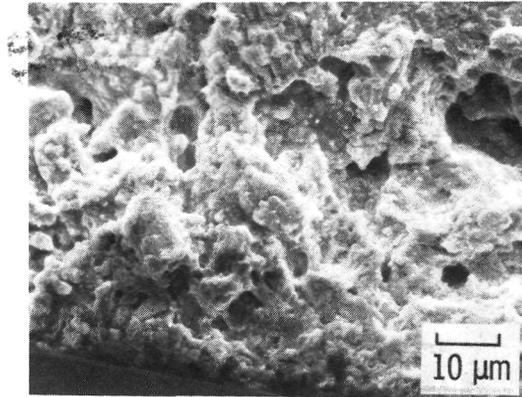
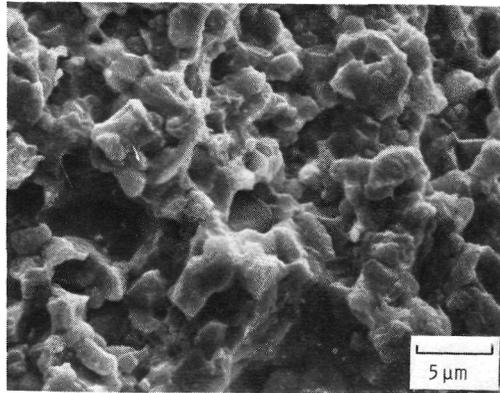
Figure 14. - Fracture initiation (top) and propagation (bottom) at 650 °C.

Fracture initiation and propagation at 650 °C is characterized by the photomicrographs in figure 14. A singular, mixed mode initiation event was identified in most specimens, generally associated with a cluster of pores at or near the surface. The mode of crack propagation quickly became intergranular as was the final fracture event.

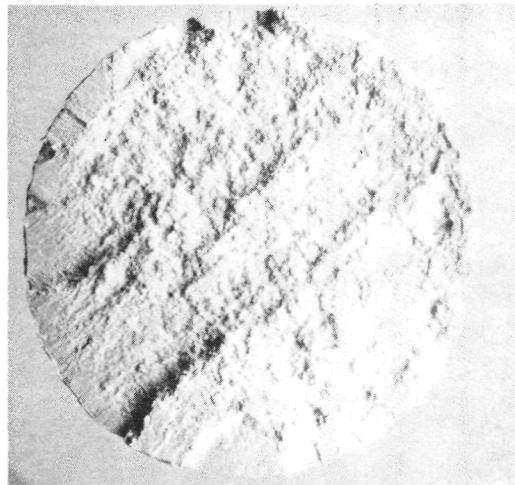
Figure 15. - Multiple surface initiation sites were observed at 1050 °C.

At 1050 °C the fracture process was quite different, multiple surface initiation sites were identified on all specimens, as seen in figure 15. Surprisingly, the mode of initiation and early propagation was transgranular. As shown in figure 16, the transgranular fracture mode extended to depths of 50 μm or more after which failure became intergranular. Close examination also discloses depletion of the β phase due to oxidation of aluminum, along the specimen surface and the crack faces. Also note the lack of large pores or cracks ahead of the main crack tip in figure 16.

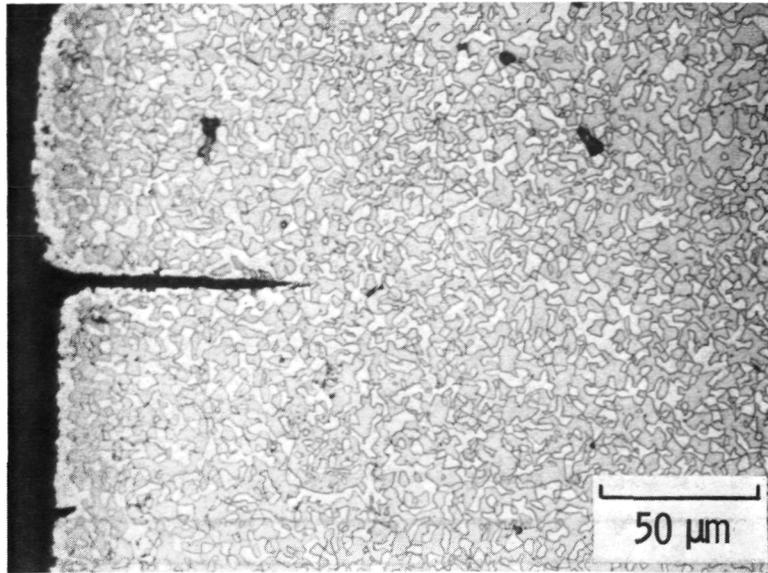
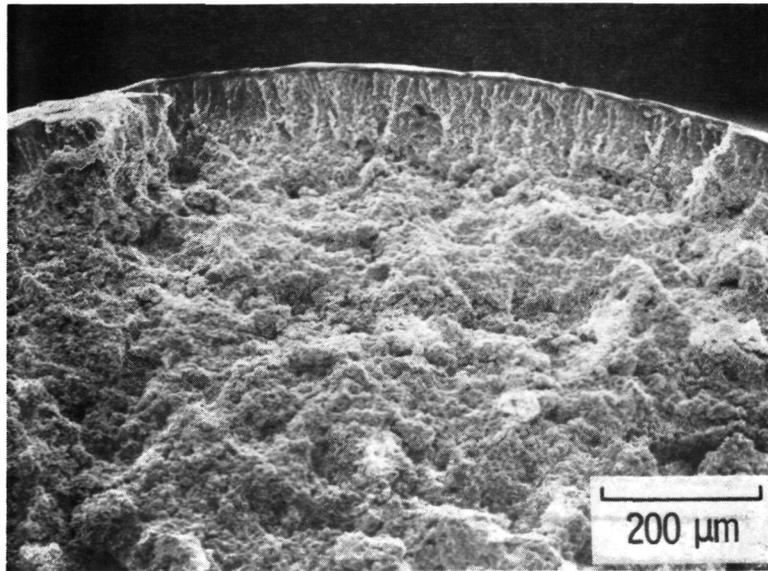
Figure 16. - Fracture initiation and propagation at 1050 °C.

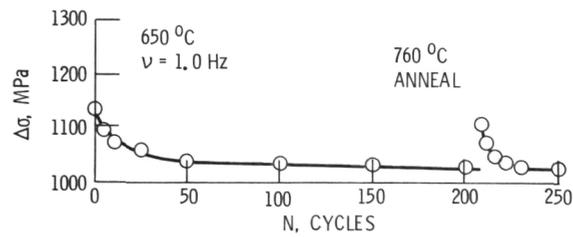
Figure 17. - NiCoCrAlY strength was partially recovered by short time anneals at 760 °C.

As previously stated, cyclic softening of the NiCoCrAlY was observed at 650 °C. Possible causes of this softening include relaxation of an initial dislocation substructure, accelerated creep processes associated with enhanced vacancy generation, and disordering of the β phase and/or fine γ' in the γ phase. The existence of an initial dislocation substructure in cold worked material often leads to softening (ref. 5). Although the NiCoCrAlY was not cold worked, it was thought that the plasma spray process may have produced a significant dislocation substructure. However subsequent TEM examination of the NiCoCrAlY showed very little dislocation substructure before testing. Also any explanation based on accelerated creep rates appears to be incorrect as testing at 1.0 Hz, ten times faster than the base frequency, showed little if any changes in the rate or amount of softening. Disordering has been shown to produce cyclic softening in a number of materials including superalloys such as Waspaloy (ref. 6) and Inconel 718 (ref. 7). In these materials the disordering, caused by continual movement of dislocations in slip bands results in atomic rearrangement over very small distances. Local order and alloy strength can be restored by short time anneals since little long range movement of atomic species is required. Annealing the NiCoCrAlY at 760 °C for 10 min was found to restore the strength after softening had occurred, figure 17. Continued cycling of the NiCoCrAlY at 650 °C subsequently resoftened the material. Based on these observations it would appear that the softening of the NiCoCrAlY at 650 °C is caused by disordering of the β phase and/or fine γ' in the γ phase.
