Environmental Projects: Volume 2

Underground Storage Tanks Compliance Program

Goldstone Deep Space Communications Complex

JPL
Jet Propulsion Laboratory
California Institute of Technology
Pasadena, California

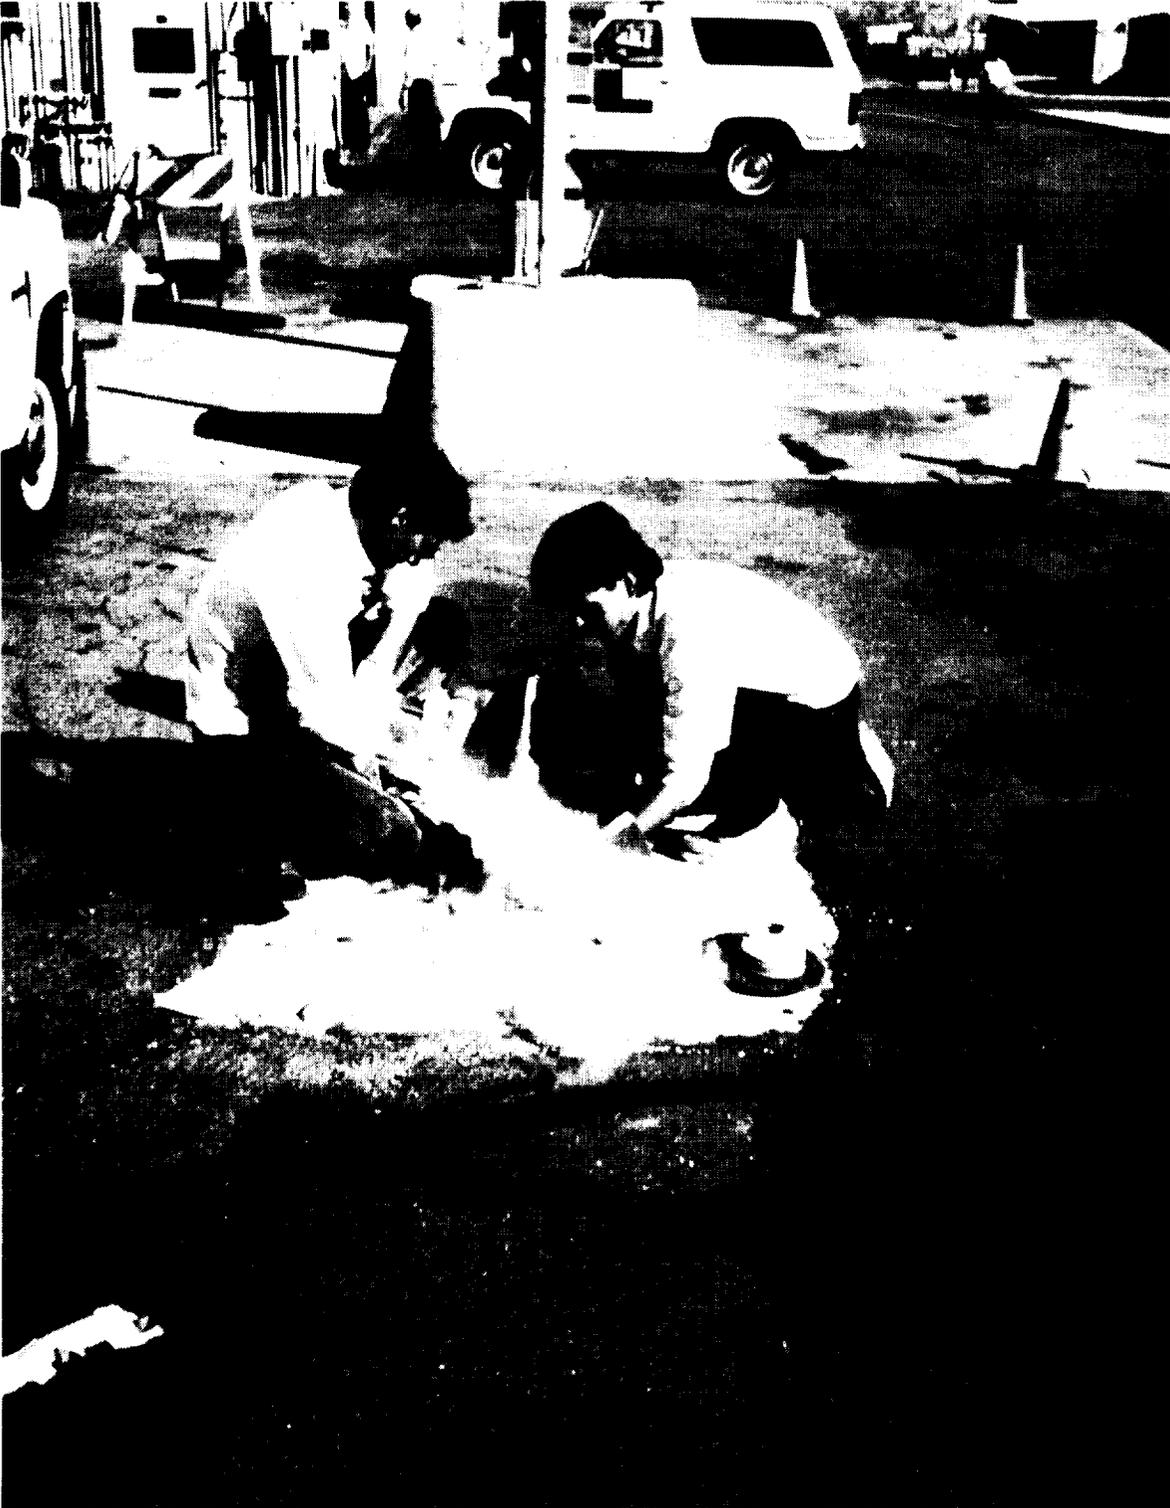
Figure A-5. Echo Site: Use of Dry Ice to Inert Tanks G25-1G and G25-2G Before Their Closures

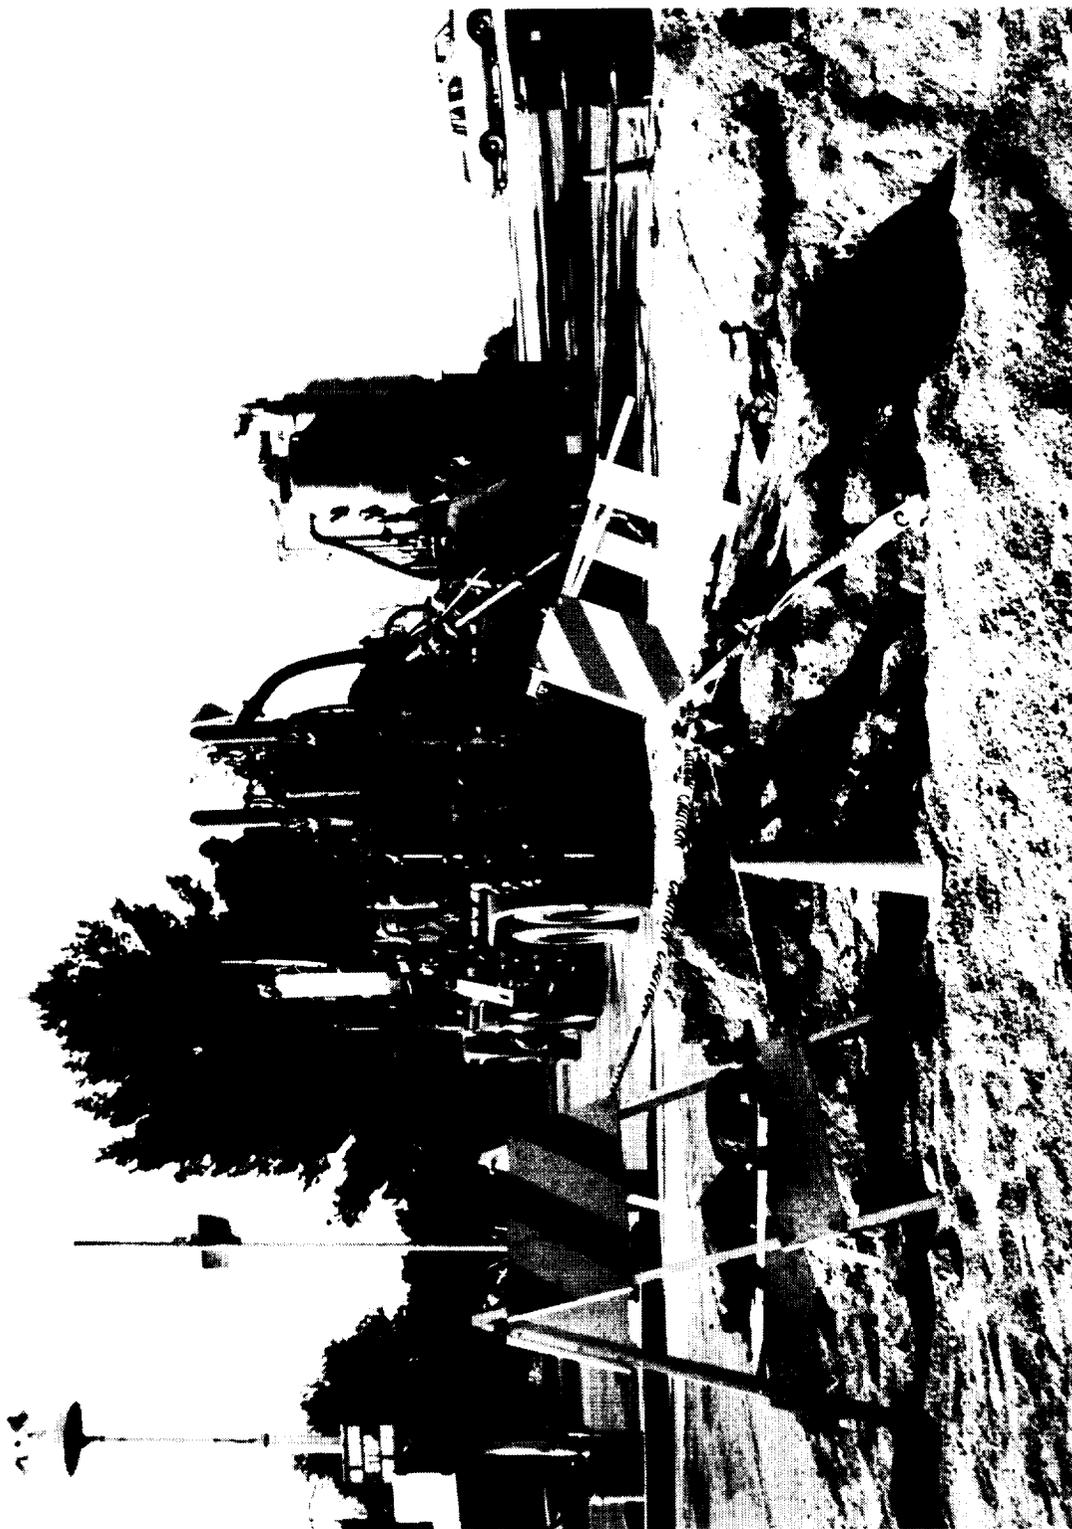
Figure A-7a. Echo Site: Preparation for Filling Gasoline Tank G25-2G
with Concrete Prior to Abandonment of Tank in Place

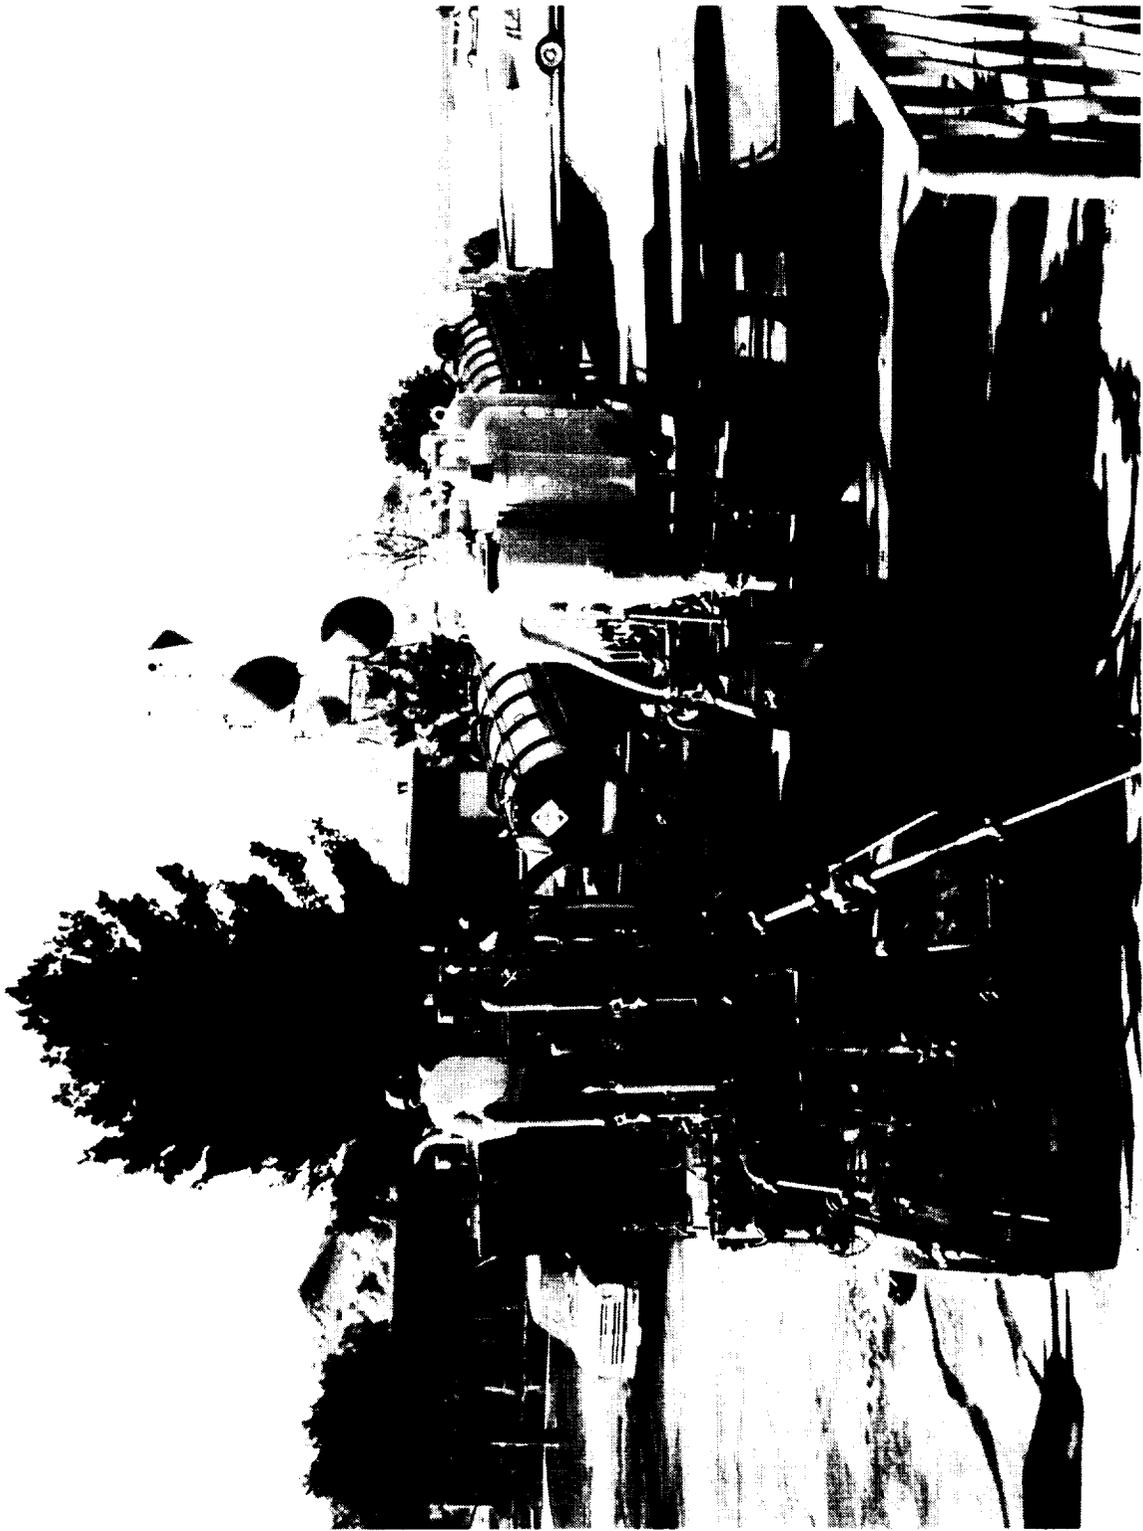
Figure A-7b. Echo Site: Preparation for Filling Gasoline Tank C25-2G with Concrete Prior to Abandonment of Tank in Place

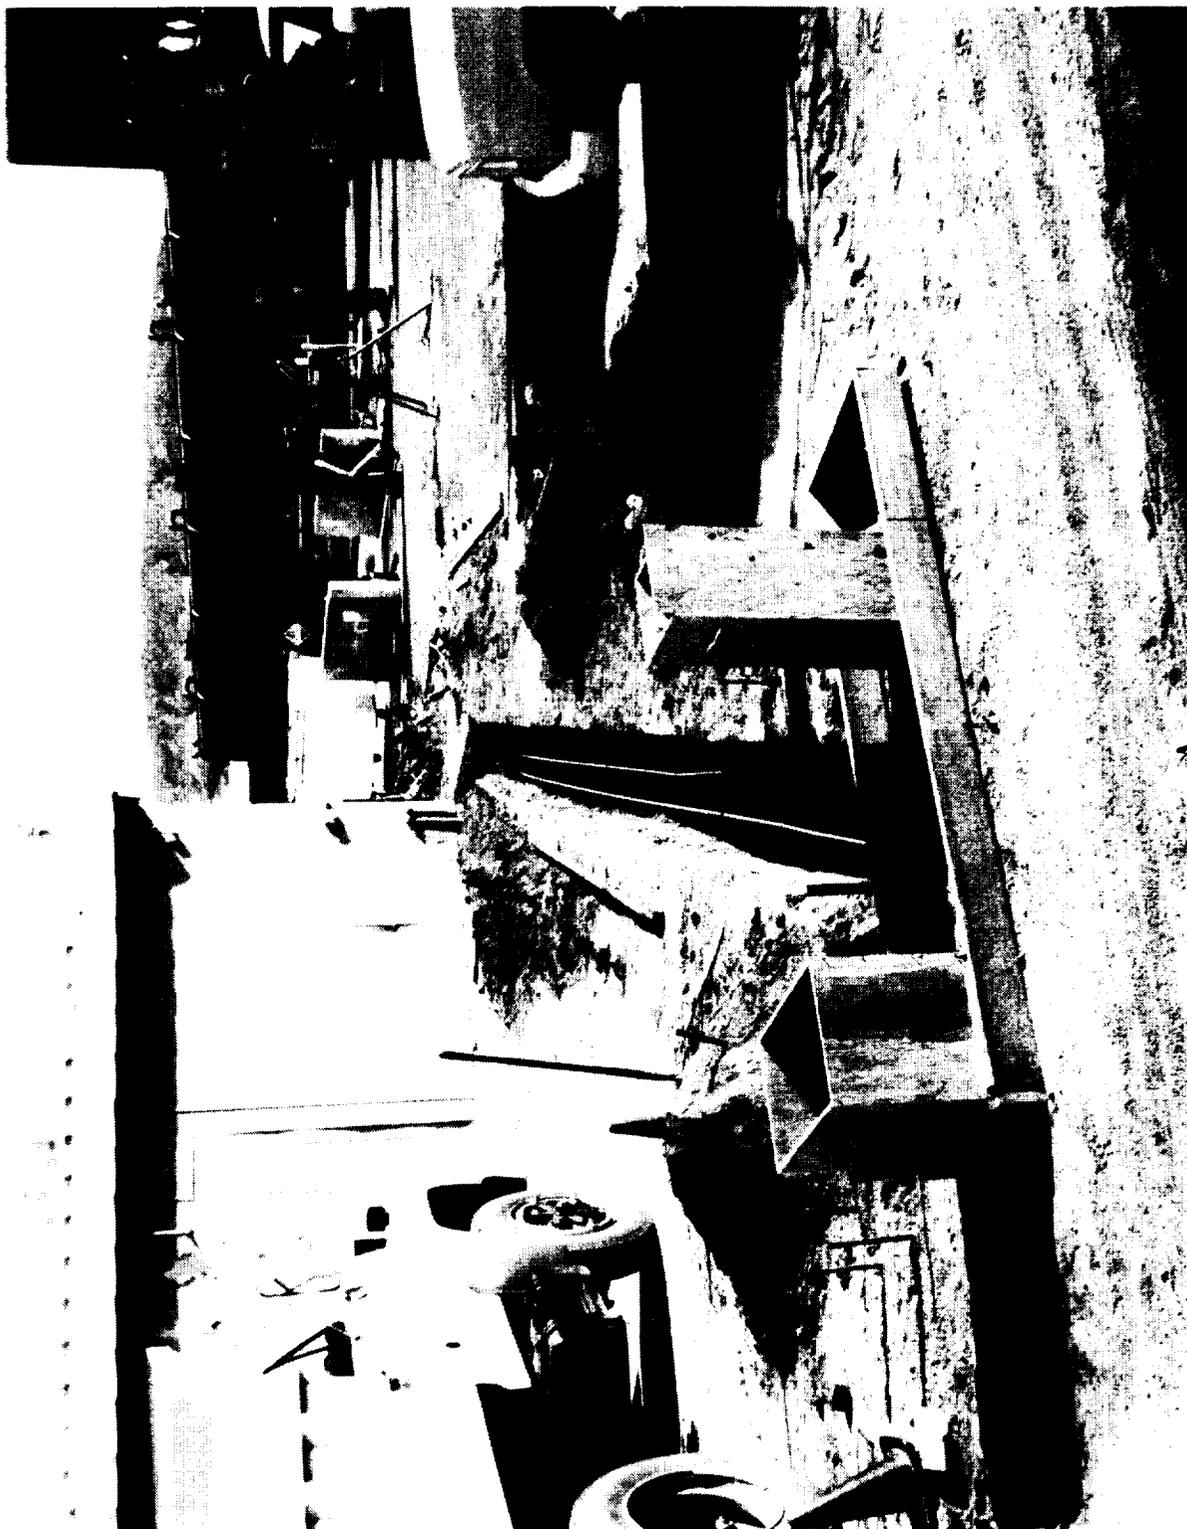
Figure A-9a. Echo Site: Construction of New Gasoline Dispensing
Station near Building G-27

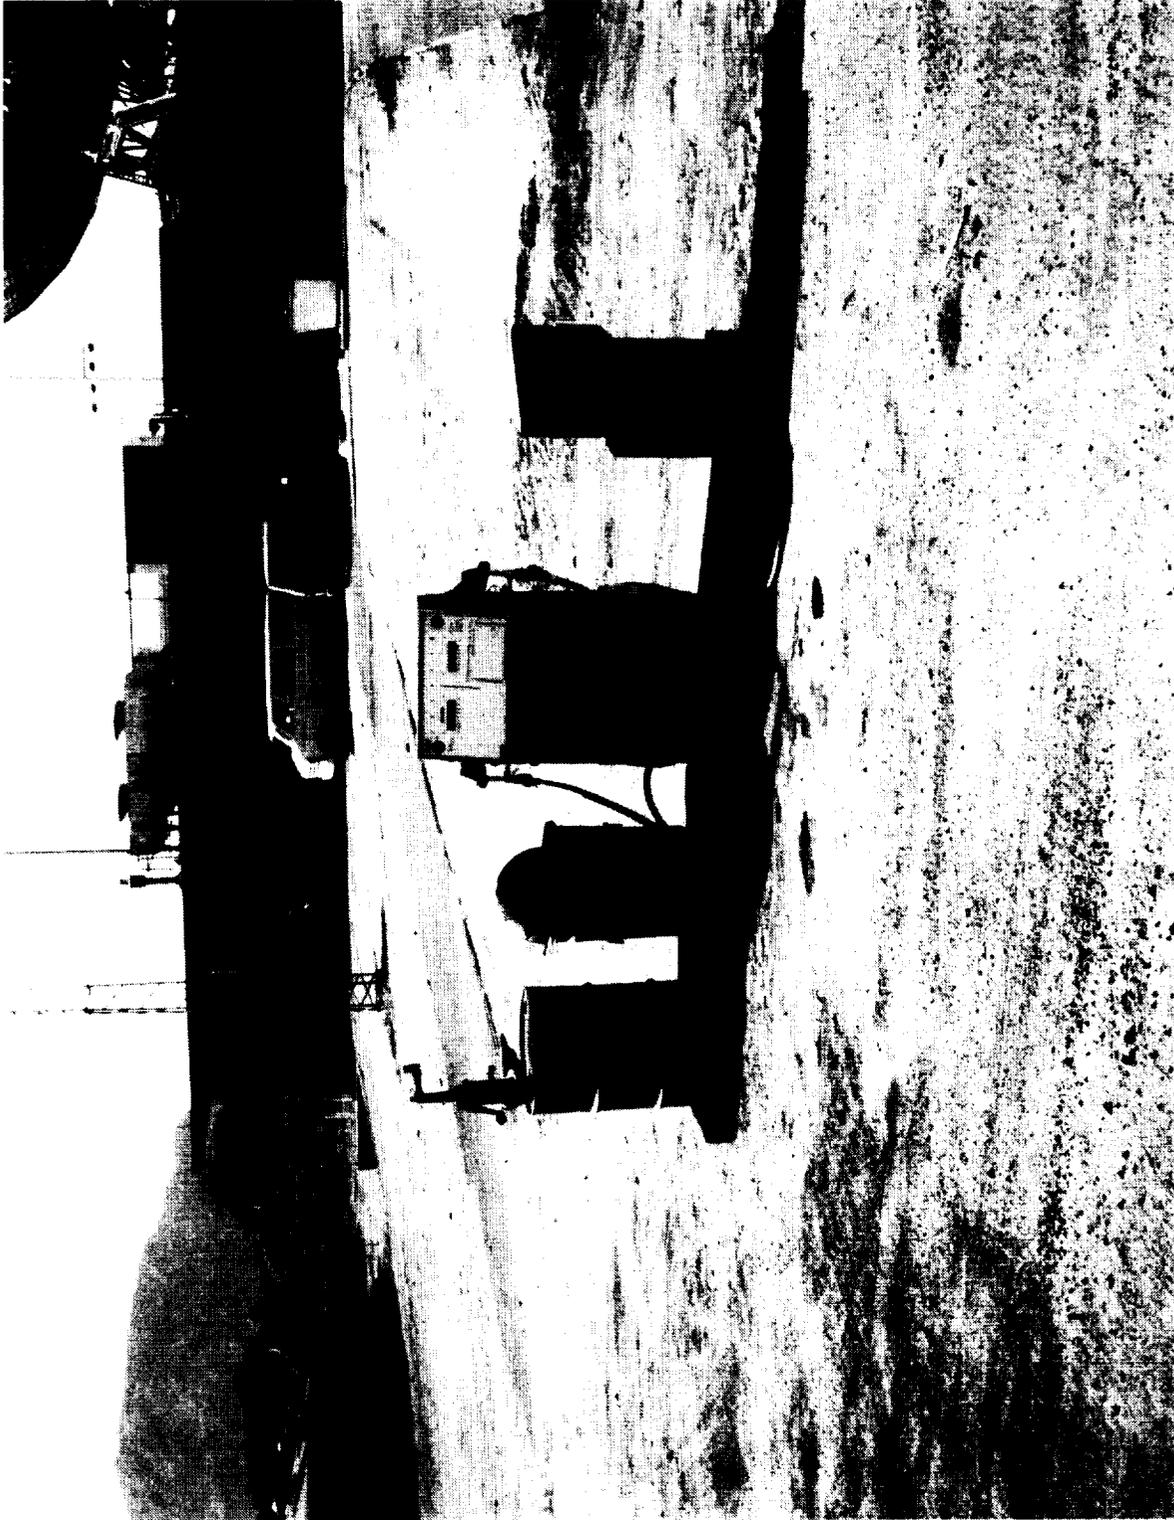
Figure A-9c. Echo Site: Completed New Gasoline Dispensing Station near Building G-27

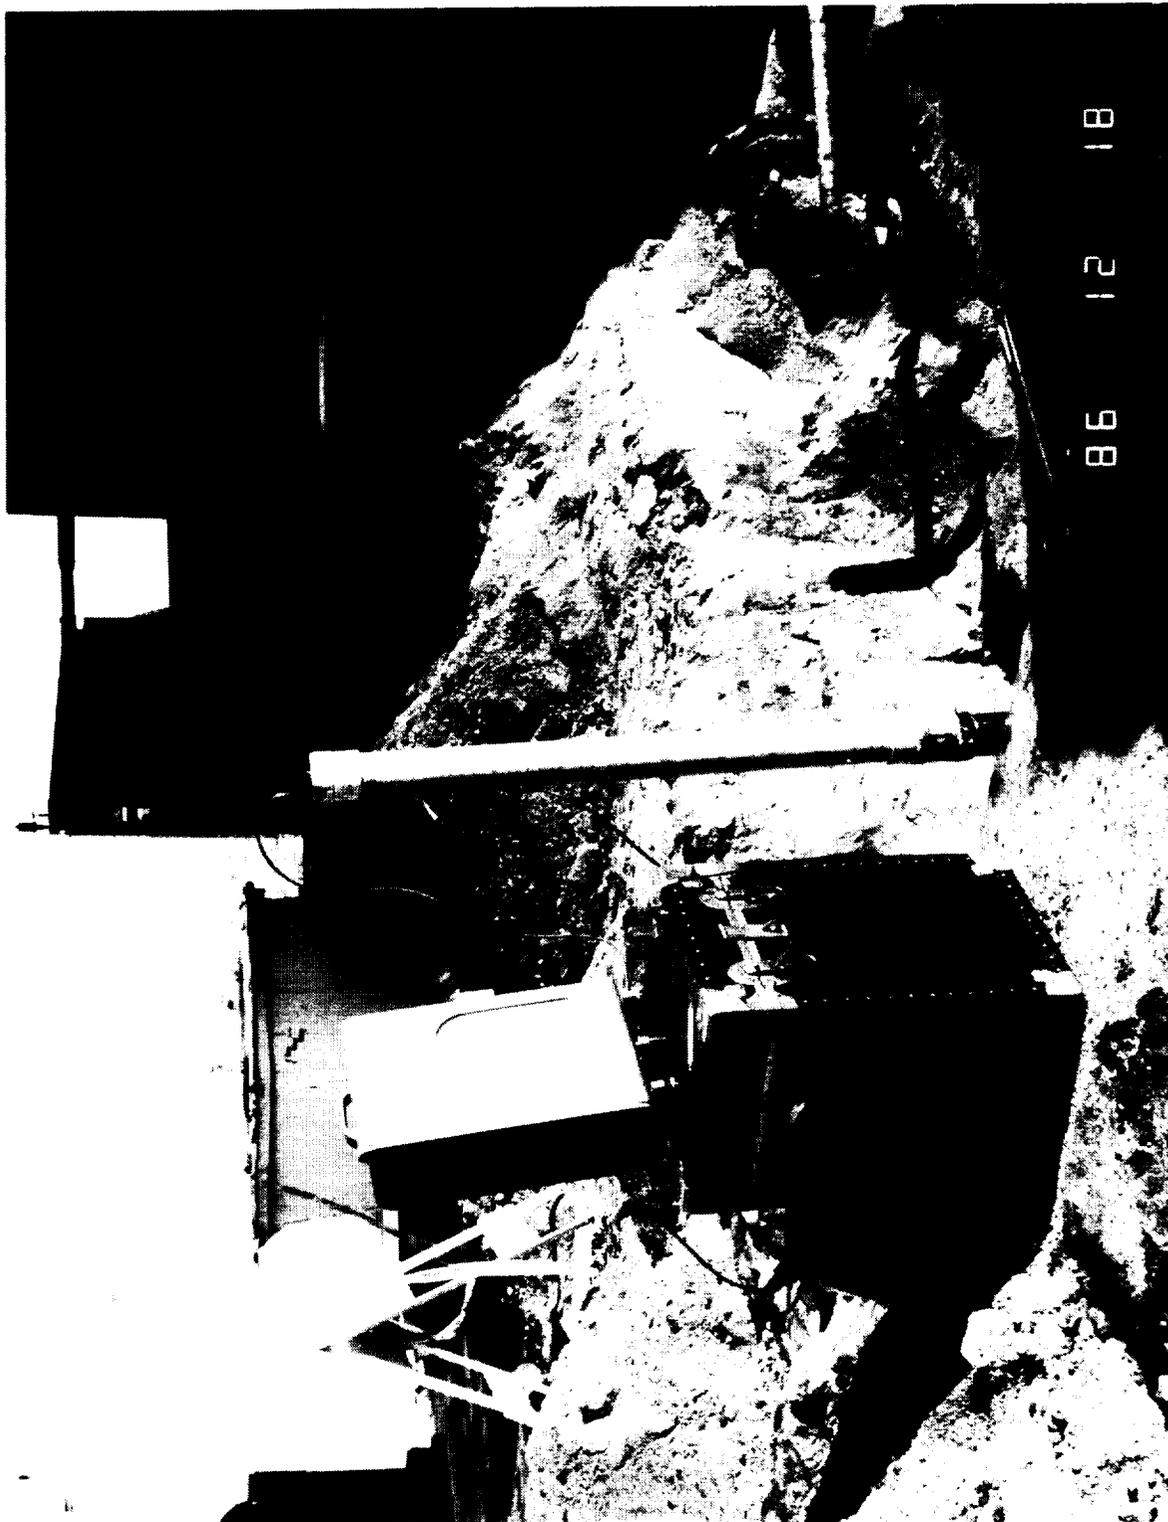
Figure A-10. Echo Site: Typical Precision Leak-Test Set-up at Diesel Oil Storage Tanks G24-1D and G24-2D Near Building G-24

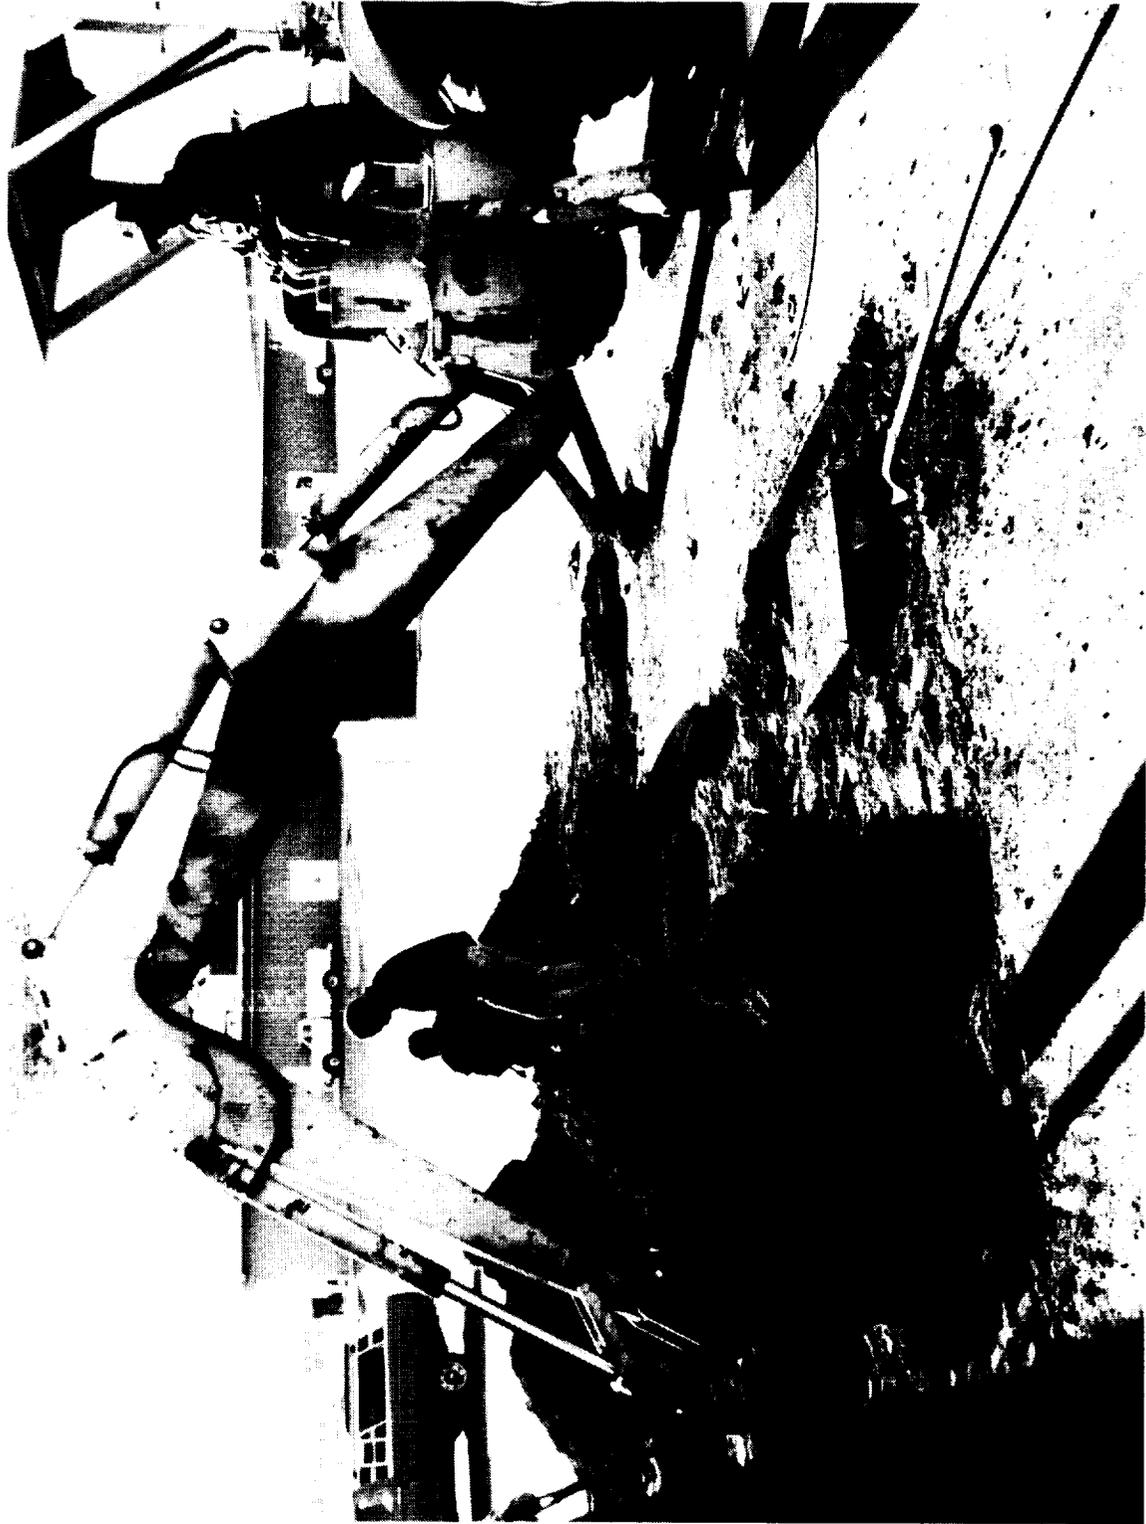
Figure A-11a. Echo Site: Excavation to Locate Piping Leaks at Diesel Oil Storage Tanks G24-1D and G24-2D Near Building C-24

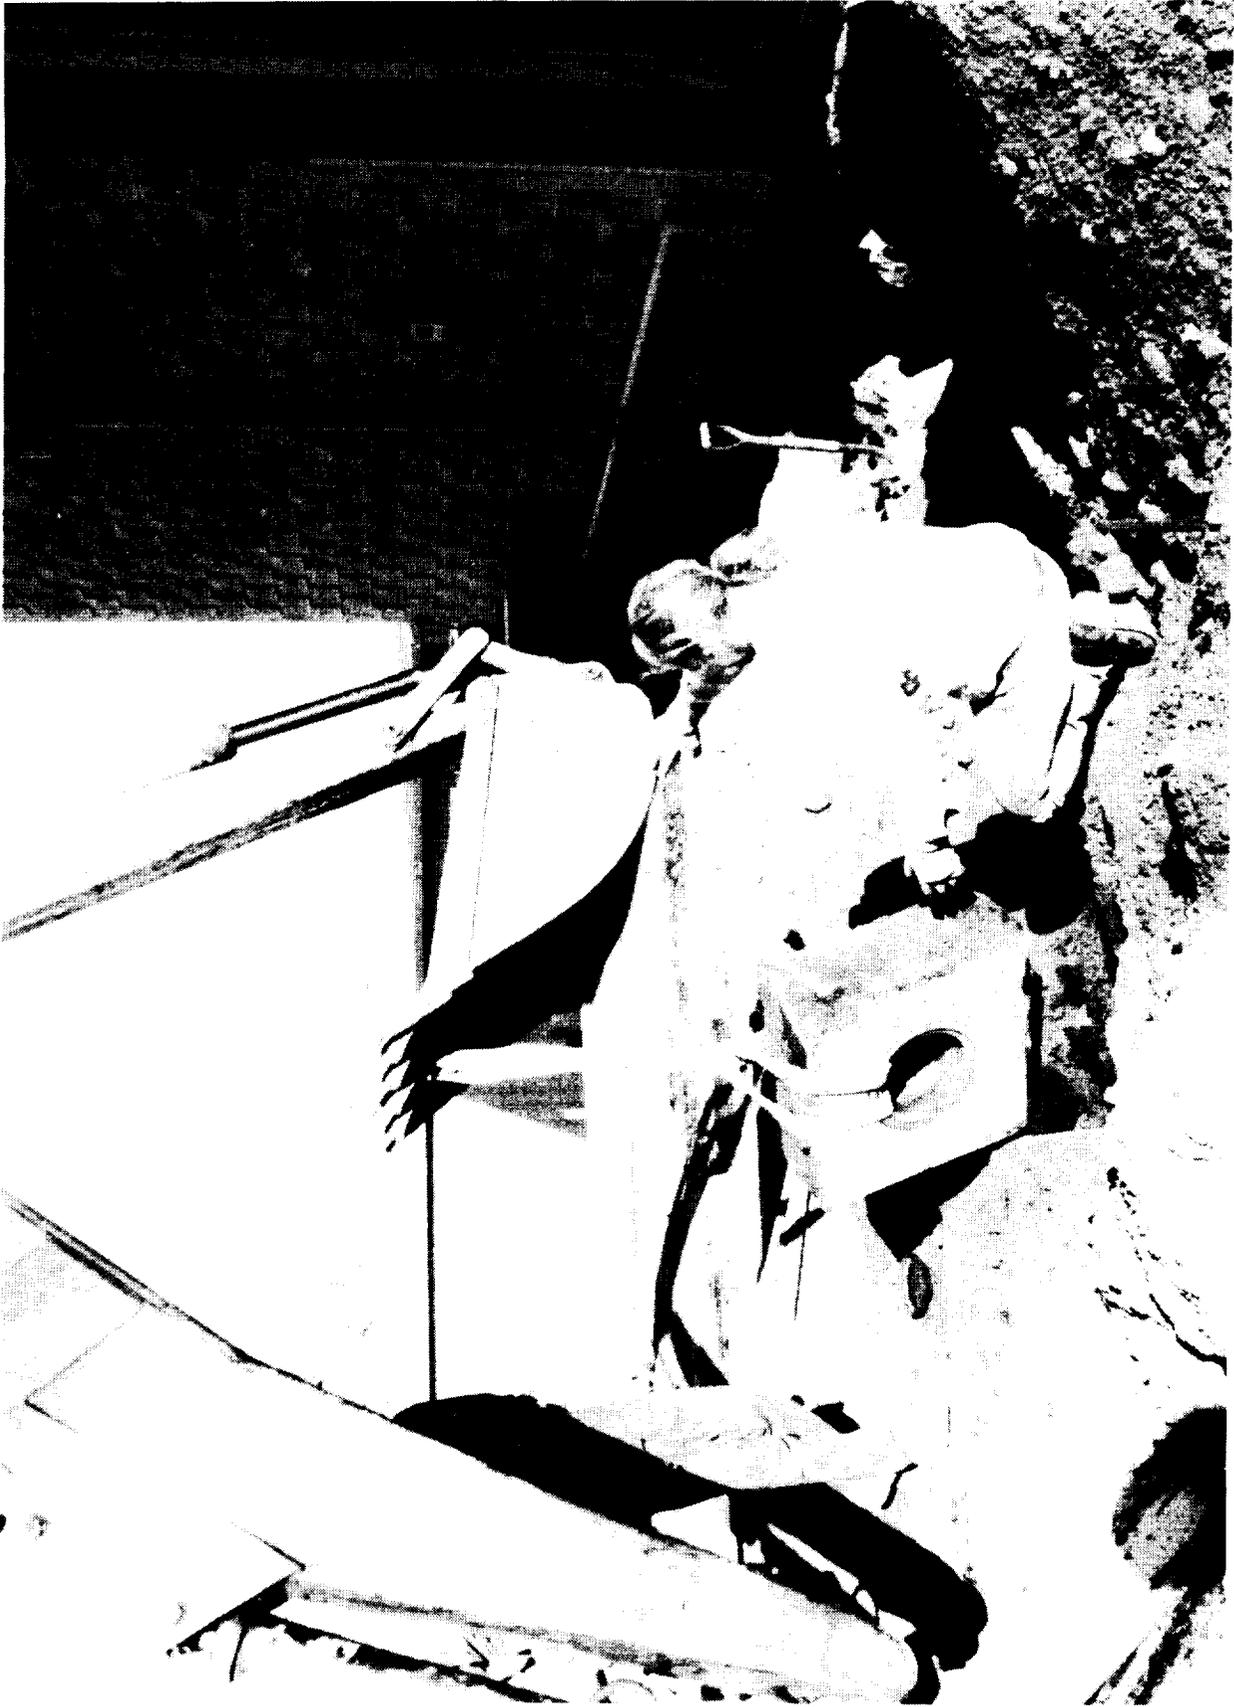
Figure A-11b. Echo Site: Excavation to Locate Piping Leaks at Diesel Oil Storage Tanks G24-1D and G24-2D Near Building G-24

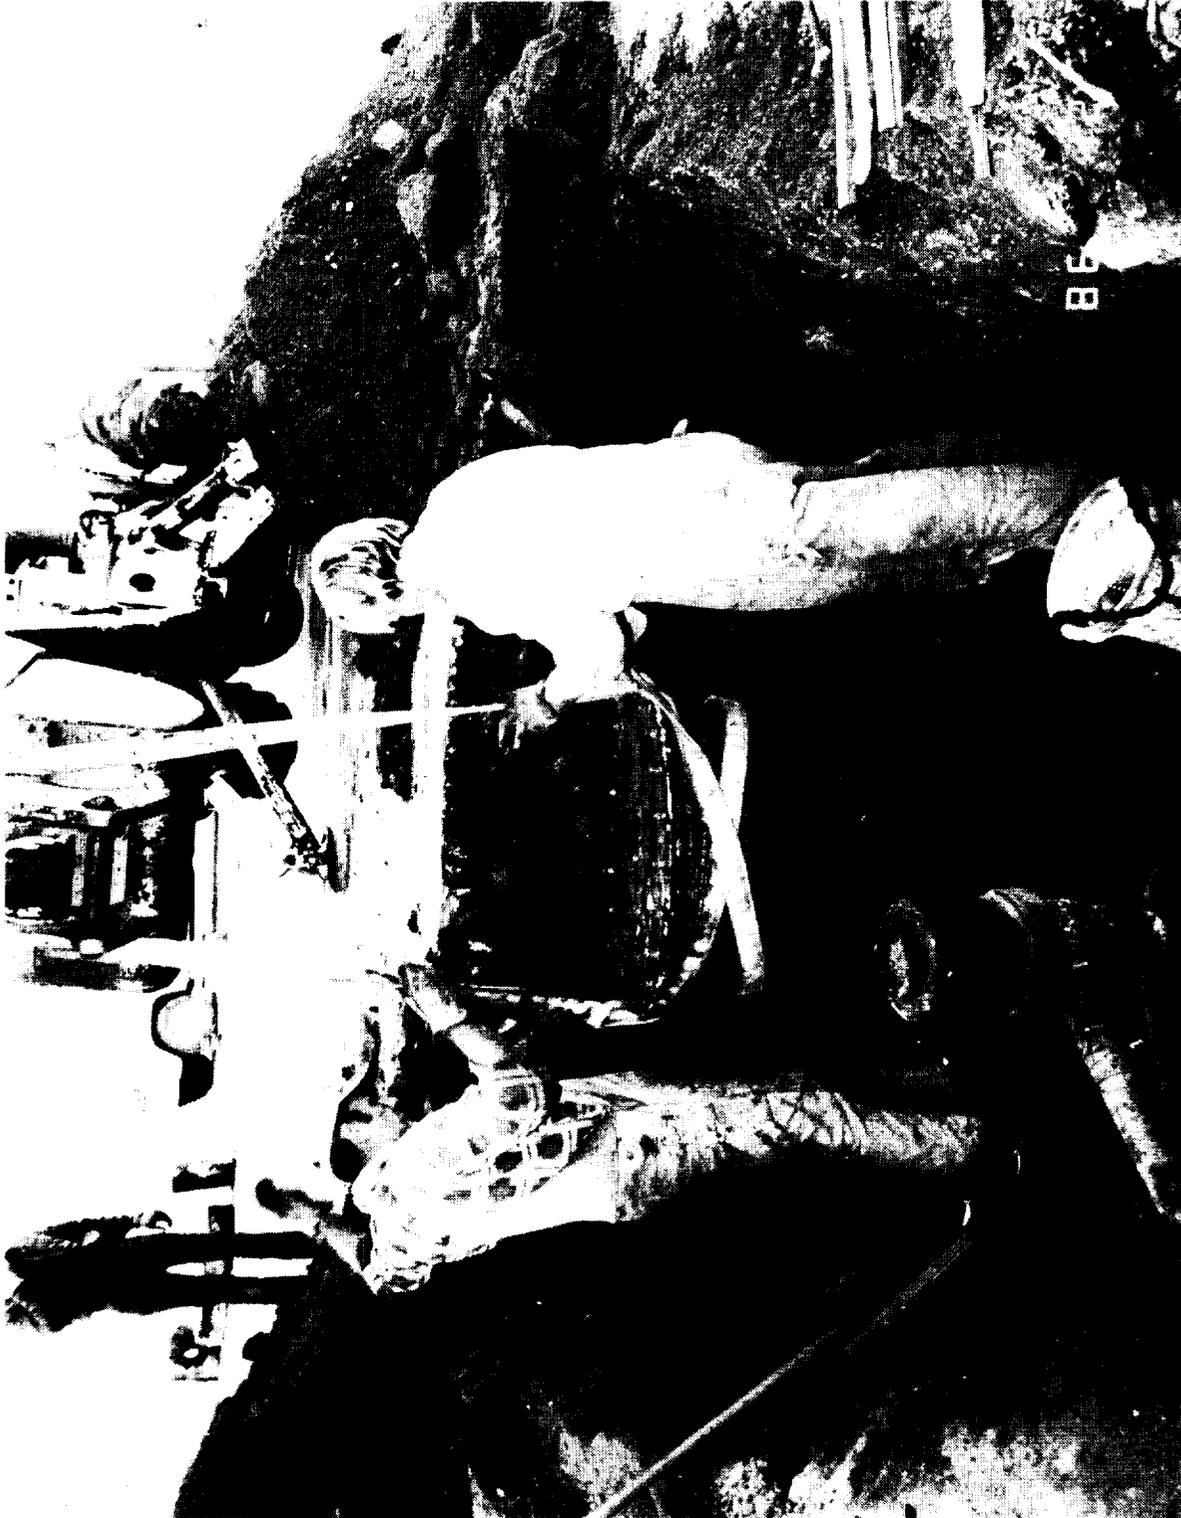
Figure A-11d. Echo Site: Excavation to Locate Piping Leaks at Diesel Oil Storage Tanks G24-1D and G24-2D Near Building G-24

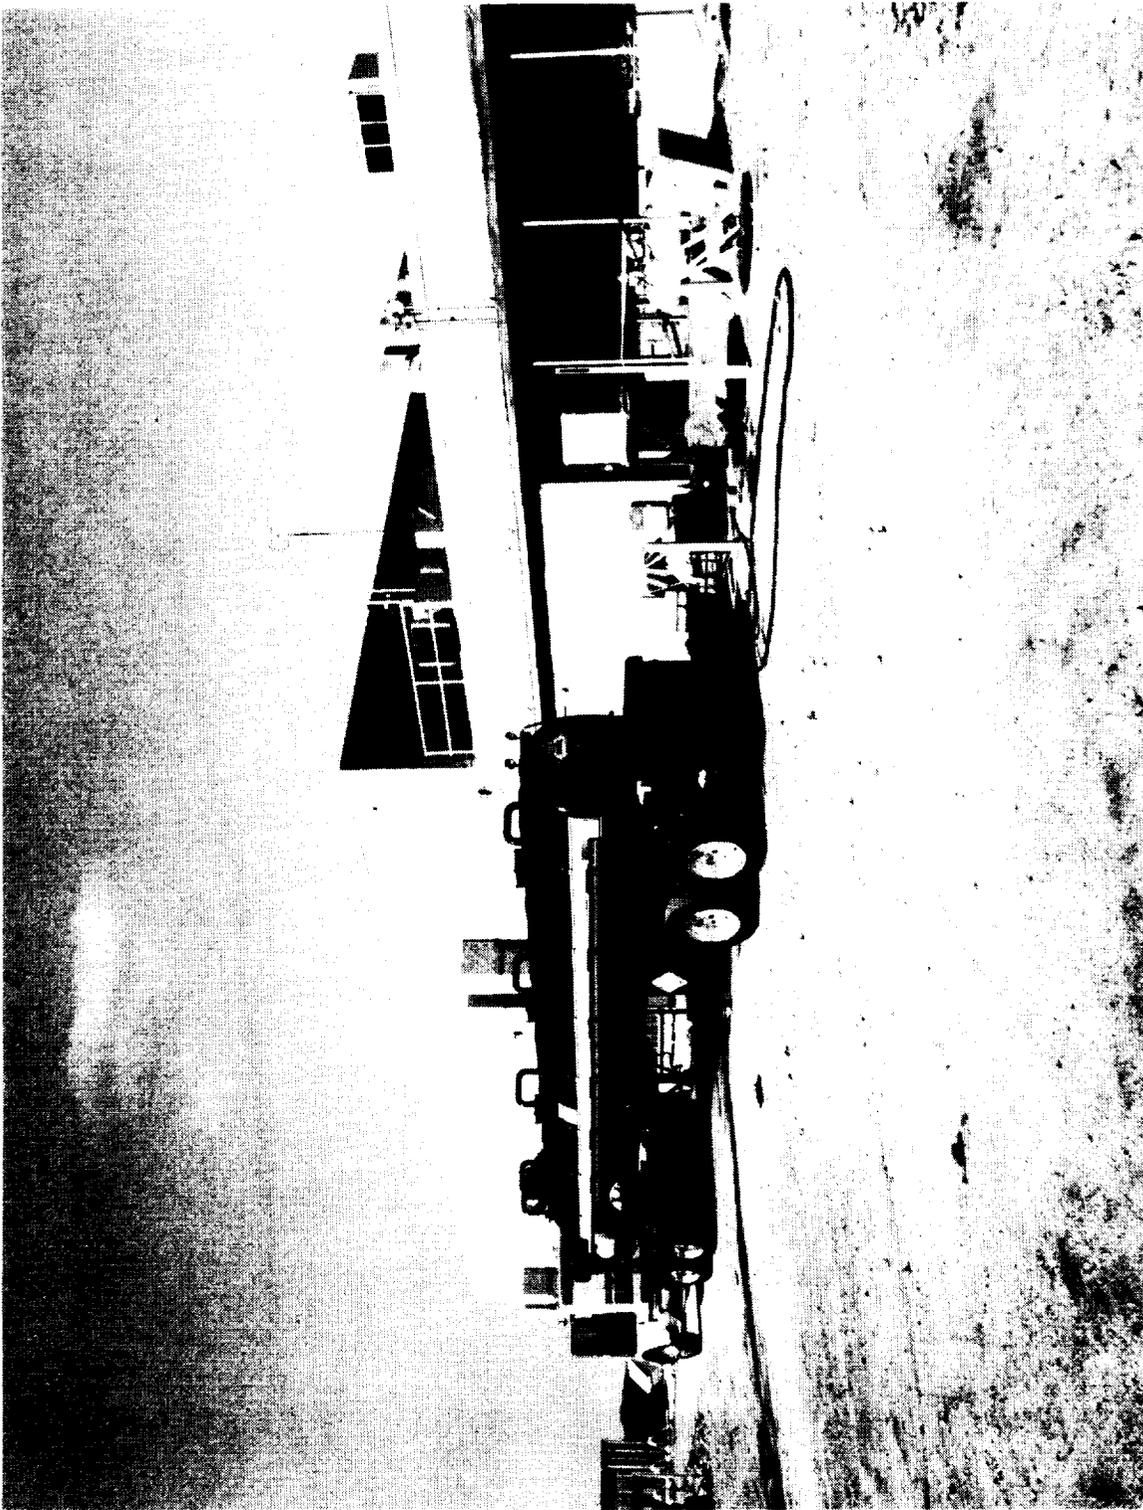
Figure A-17. Mars Site: Diesel Oil Transfer in Preparation for Precision Leak-Testing
of Diesel Oil Storage Tanks G81-LDA and G81-LDB near Building G-81

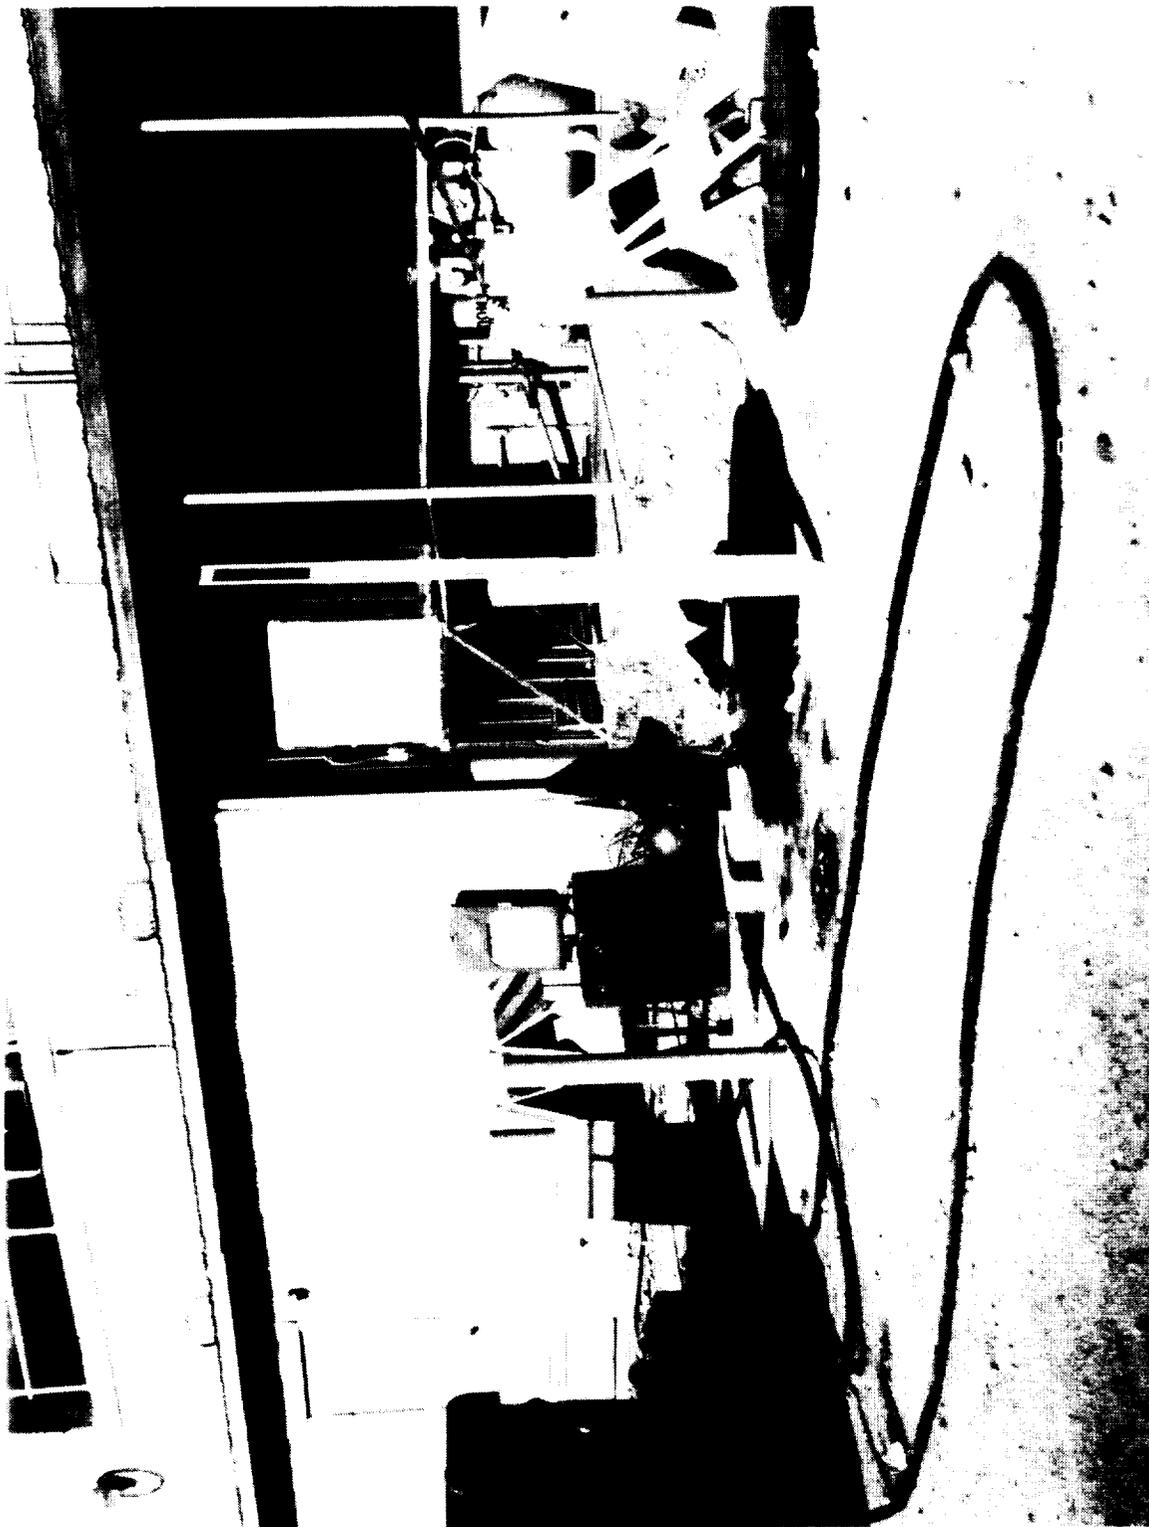
Figure A-18a. Mars Site: Precision Leak-Testing at Diesel Oil Storage Tanks
G81-1DA and G81-1DB near Building G-81

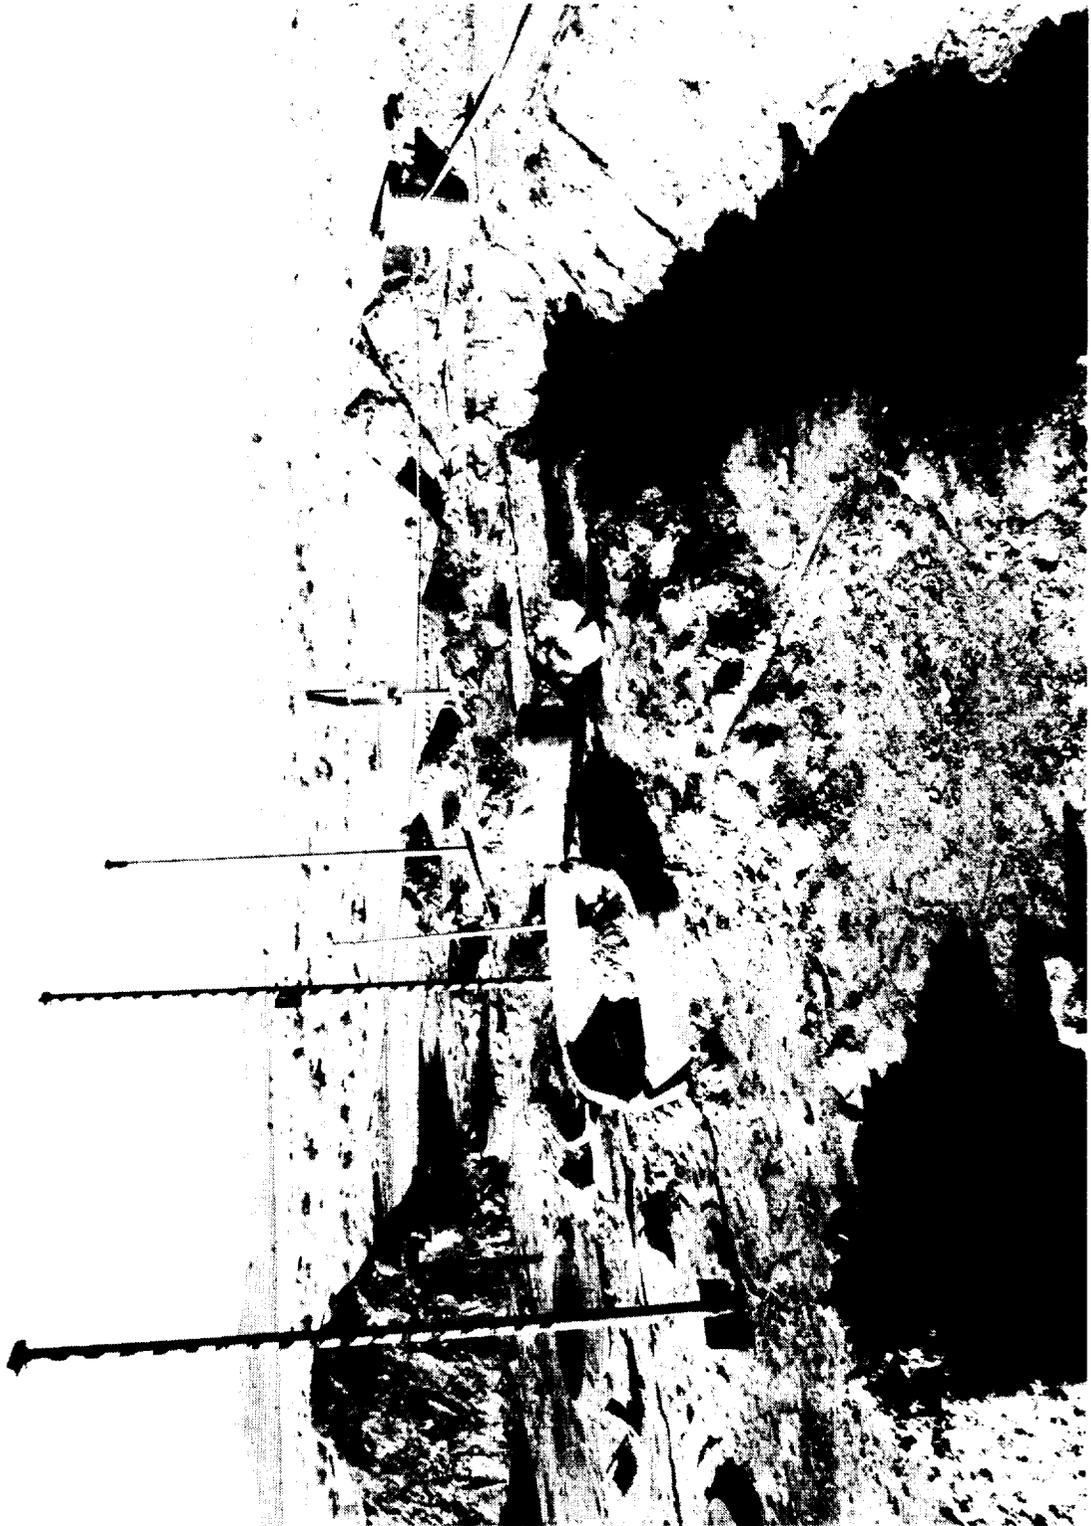
Figure A-28a. Mojave Base Site: Excavation to Locate Piping Leaks at Diesel Oil Storage Tanks M9-1D, M9-2D and M9-3D near Building M-9
