Environmental Projects: Volume 2

Underground Storage Tanks Compliance Program

Goldstone Deep Space Communications Complex

JPL
Jet Propulsion Laboratory
California Institute of Technology
Pasadena, California

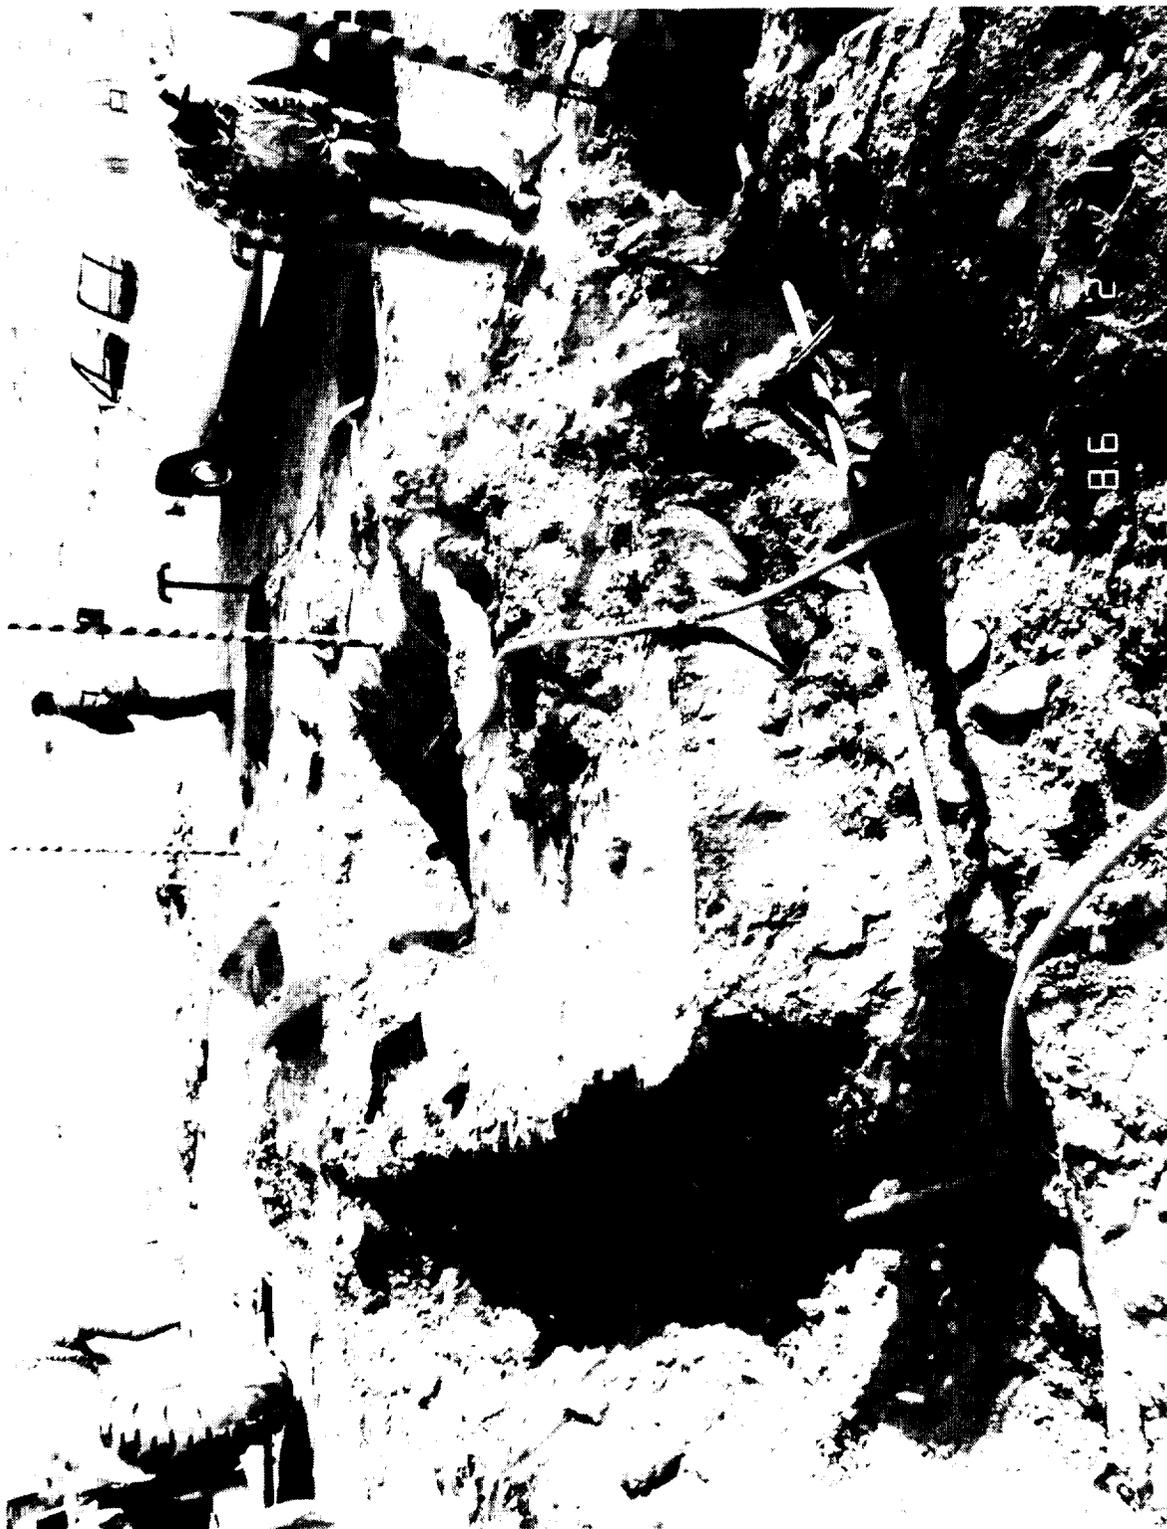
Figure A-28b. Mojave Base Site: Excavation to Locate Piping Leaks at Diesel Oil Storage Tanks M9-1D, M9-2D and M9-3D near Building M-9

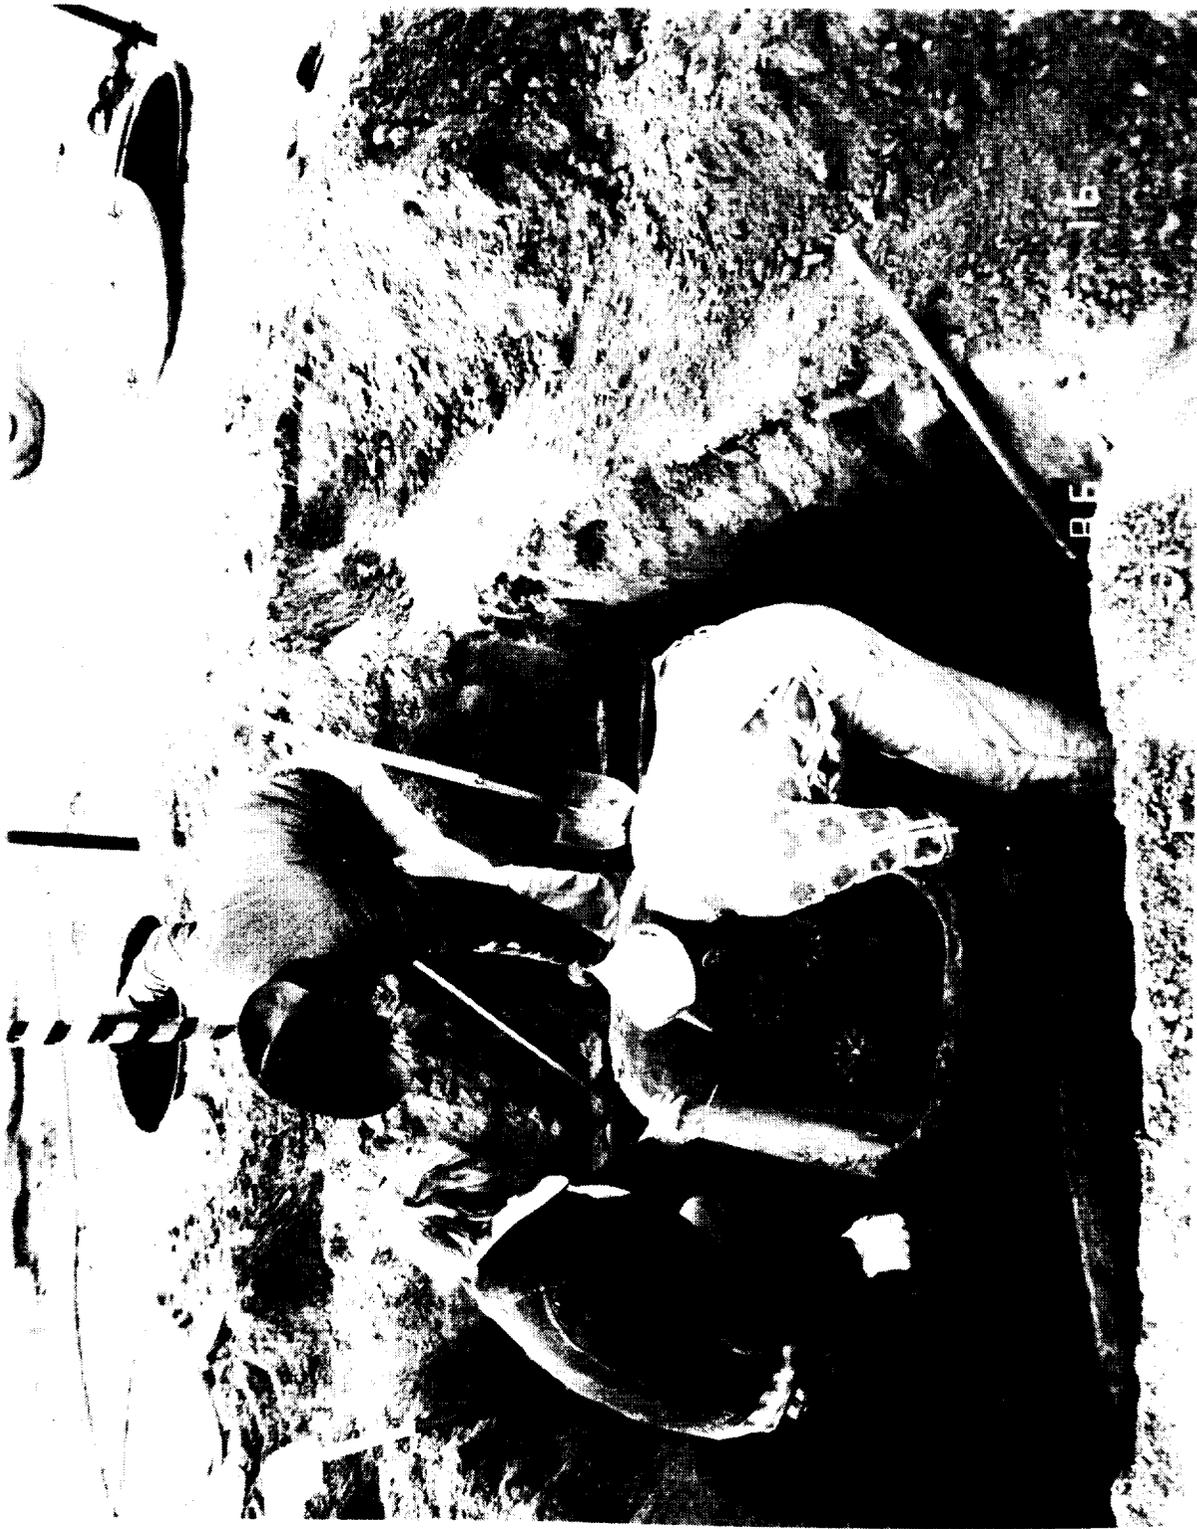
Figure A-28d. Mojave Base Site: Excavation to Locate Piping Leaks at Diesel Oil Storage Tanks M9-1D, M9-2D and M9-3D near Building M-9

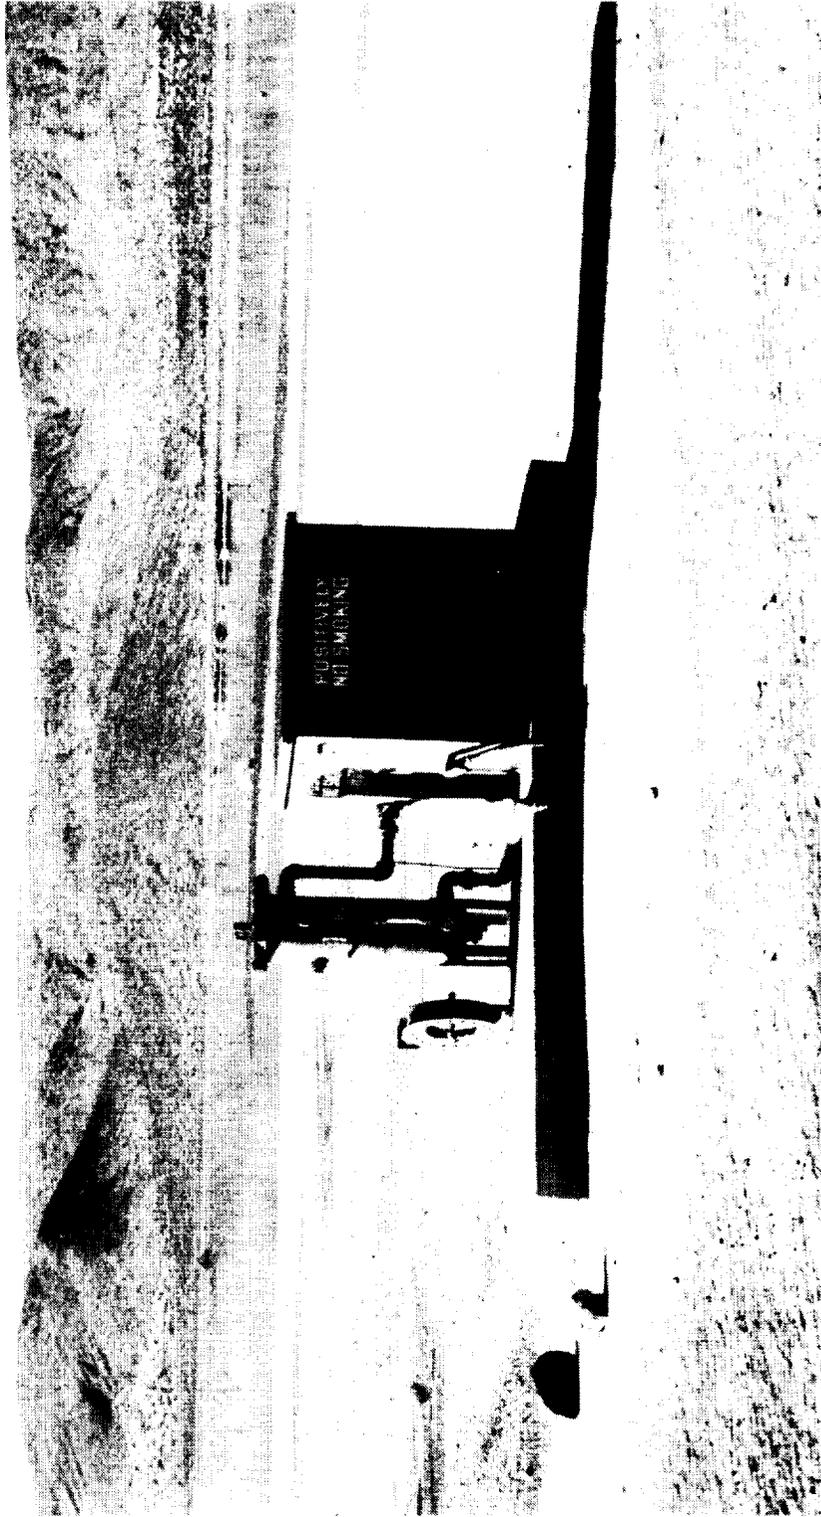
Figure A-32. Goldstone Dry Lake Airport: Aviation Gas Dispensing Station that had not been used for several years
