FULL SCALE TECHNOLOGY DEMONSTRATION OF A MODERN COUNTERROTATING UNDUCTED FAN ENGINE CONCEPT

COMPONENT TEST

December 1987

by
GE Aircraft Engines
GE36 Project Department
Cincinnati, Ohio 45215

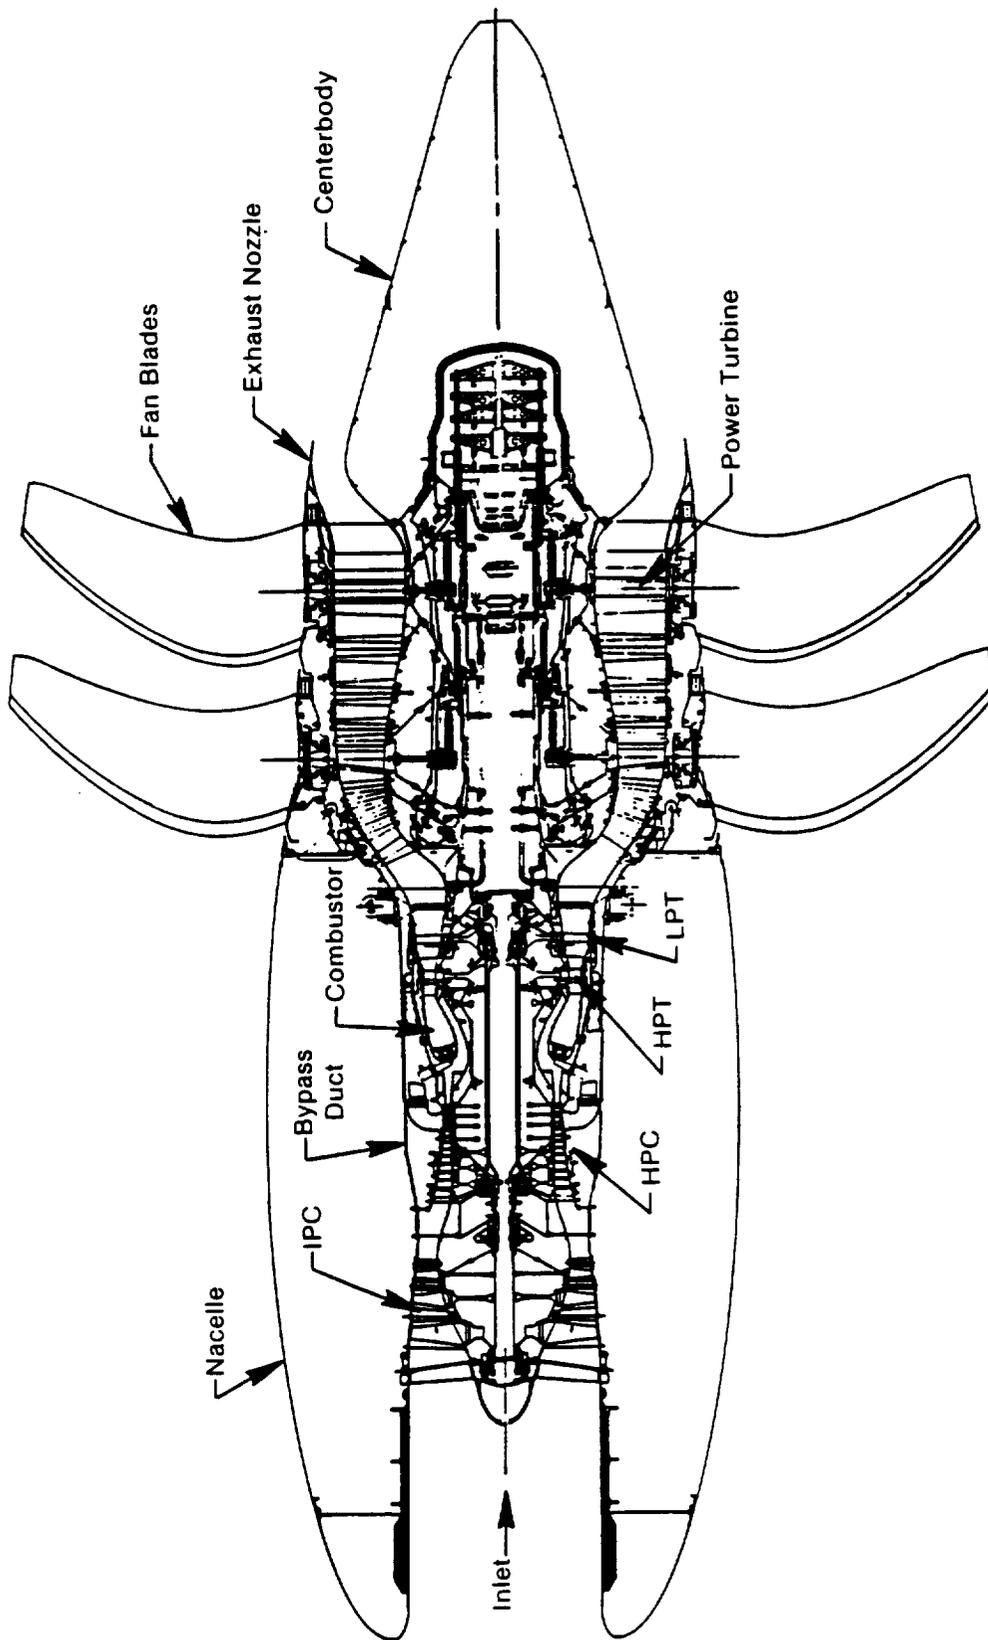
Figure 1. Cross Section of Unducted Fan Engine.

The counterrotating turbine rotors, power turbine frames, fan blades, and static structures are components which comprise the "propulsor" for the UDF™ engine. Mounted in front of the propulsor is a gas generator engine which provides the required gas horsepower. The gas generator is a modified production F404 turbofan engine. A cross-sectional view of the UDF™ engine is shown in Figure 1. An enlarged cross section of the propulsor is shown in Figure 2.

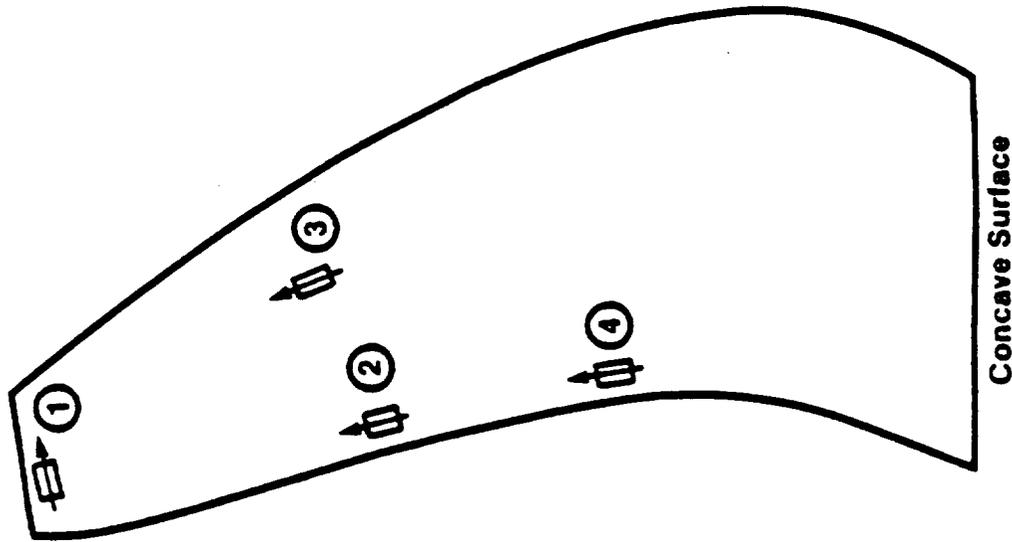
Figure 4. Engine Strain Gage Locations.

Based on the strain survey test and analytical results, four strain gage locations (Figure 4) were selected for the fan blade static HCF and engine

- **Total Of 16 Gages Per Stage
4 Gages/Blade And 4 Blades/Stage**
- ① - **Gage - Sensitive To 1 Torsion And High Order Modes**
- ② - **Gage - Sensitive To 2 Flex And I/P Forced Response**
- ③ - **Gage - Sensitive To Axial Mode And High Order Flex Modes**
- ④ - **Gage - Location of Highest SS Stress And 1 Flex Vibratory Stress**

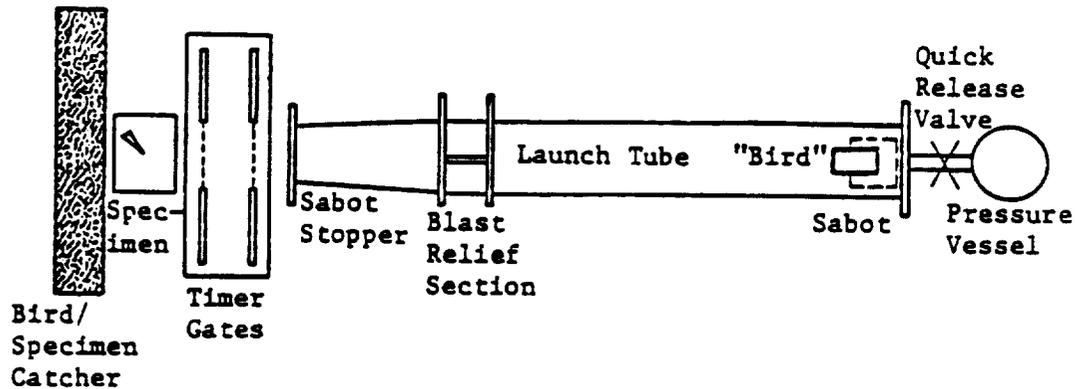
Figure 7. Schematic of Ballistic Impact Testing Facility.

The ballistic impact testing facility is depicted schematically in Figure 7. The blade was set up horizontally on a stand, in the cantilevered mode and positioned to achieve impact at the desired incidence angle to the path of the incoming simulated bird.

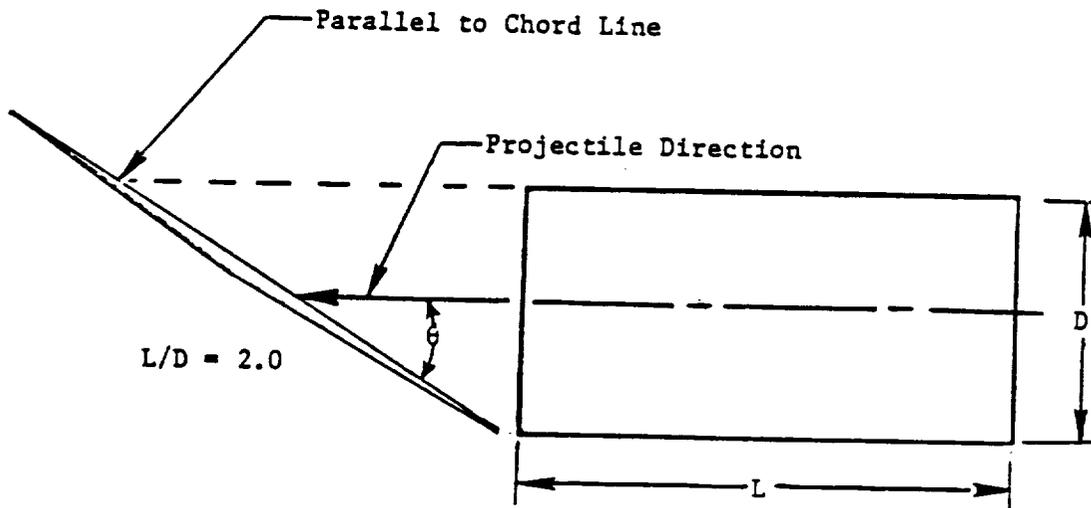
Figure 8. Projectile Direction.

The aiming point was set at the desired span location so that the edge of the projectile extends slightly beyond the leading edge in the chord direction, as illustrated in Figure 8.

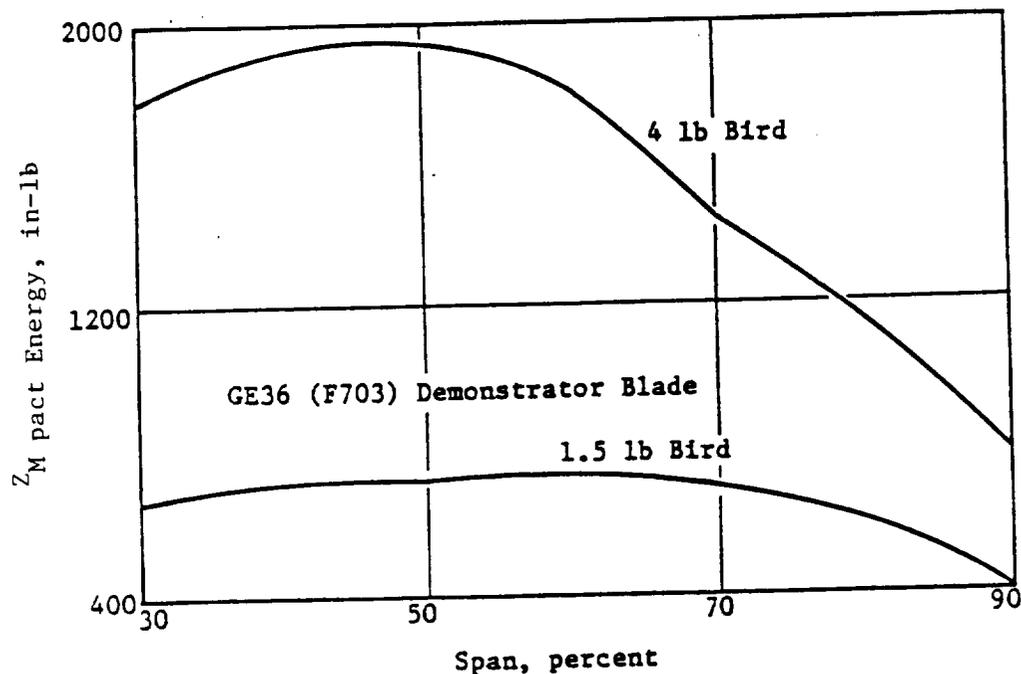
Figure 9. Impact Energy at Takeoff Versus Percent Span.

These impact tests were designed to simulate a leading edge impact. Bird impact energy on a blade depends on the bird size, incidence angle, and relative velocity to the blade. Figure 9 demonstrates the impact energy spanwise distributions for the Stage 1 blade corresponding to the aircraft velocity during rotation for the GE36 engine. For the 4-pound bird impact, the impact energy peaks at 45% span, although there is not a great deal of difference in the energy levels for span positions less than or equal to 60%. The 60% span location was selected as the impact location, in addition to the 90% location.

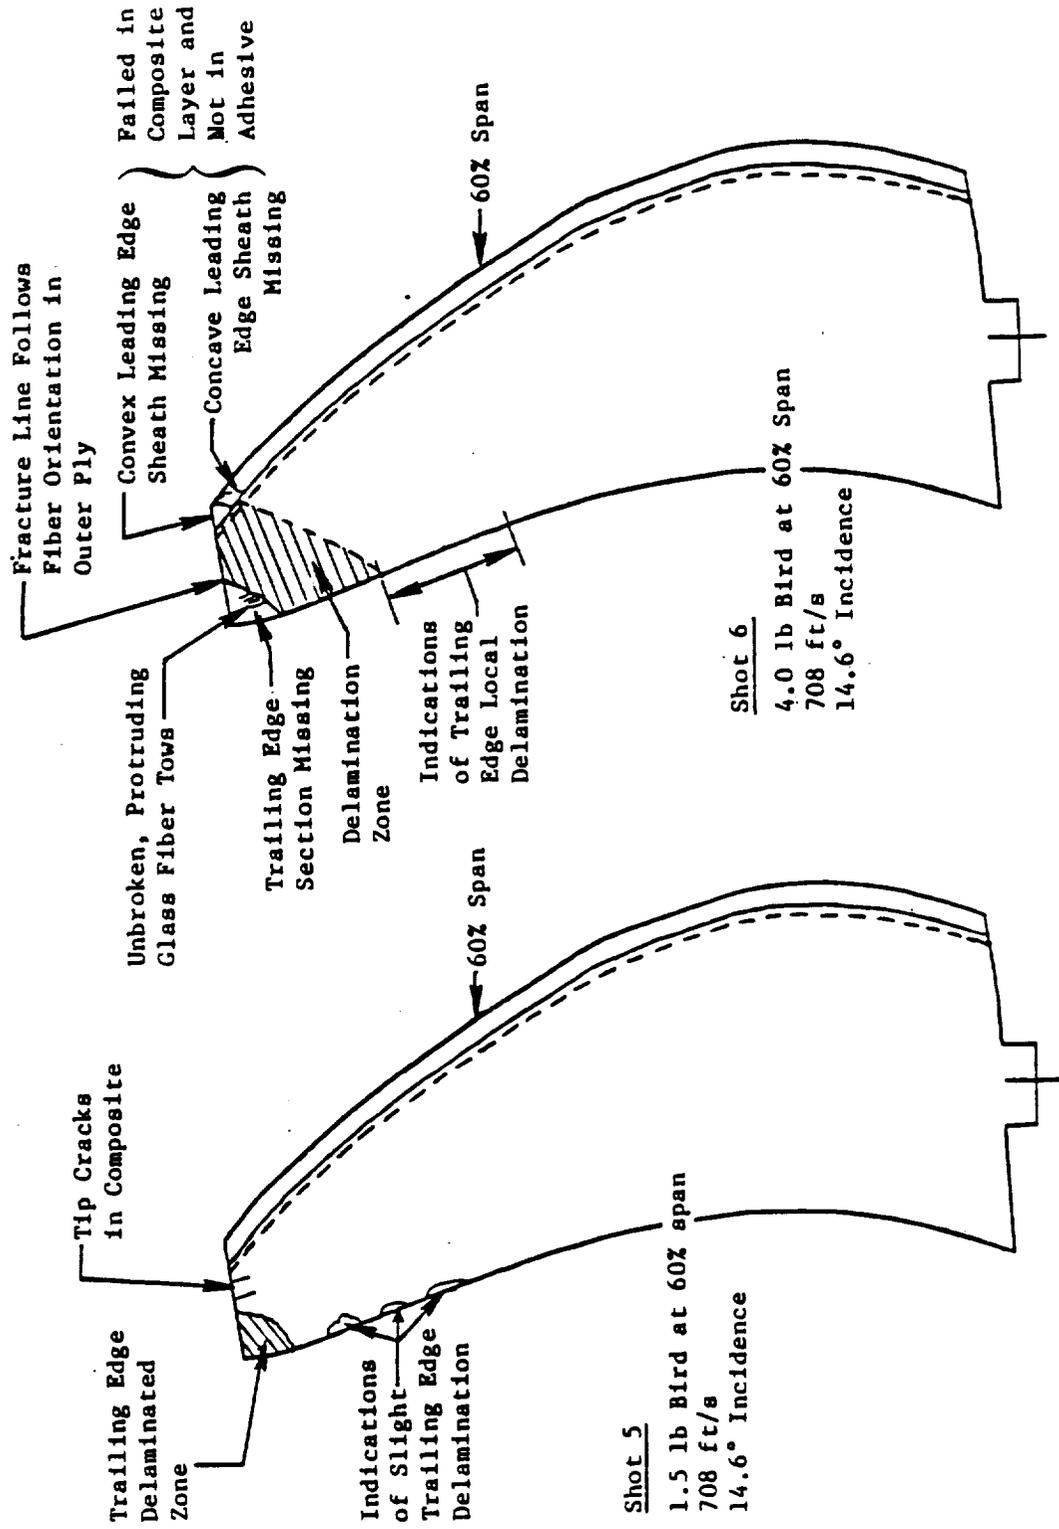
- Shot 4 - Local polyurethane protection layer separation from the composite near the trailing edge at 70% span.
- Shot 5 - Delamination at the tip trailing edge about 2 inches in and 2 inches down along the trailing edge (Figure 10); repair was made in the delaminated areas.

- Shot 6 - Delamination occurred across the blade tip and down the trailing edge approximately 12 inches from the tip; a small area of the tip trailing edge and the tip leading edge protection was missing. Total mass loss less the one ounce (Figure 11); the blade was repaired.

Figure 10. Damage Assessment for Shot No. 5.

Figure 11. Damage Assessment for Shot No. 6.

Less damage may have been sustained in Shot 6 if the test had been conducted on a new blade. Delamination had already initiated in the tip-trailing area from Shots 3 and 5, which propagated during Shot 6.

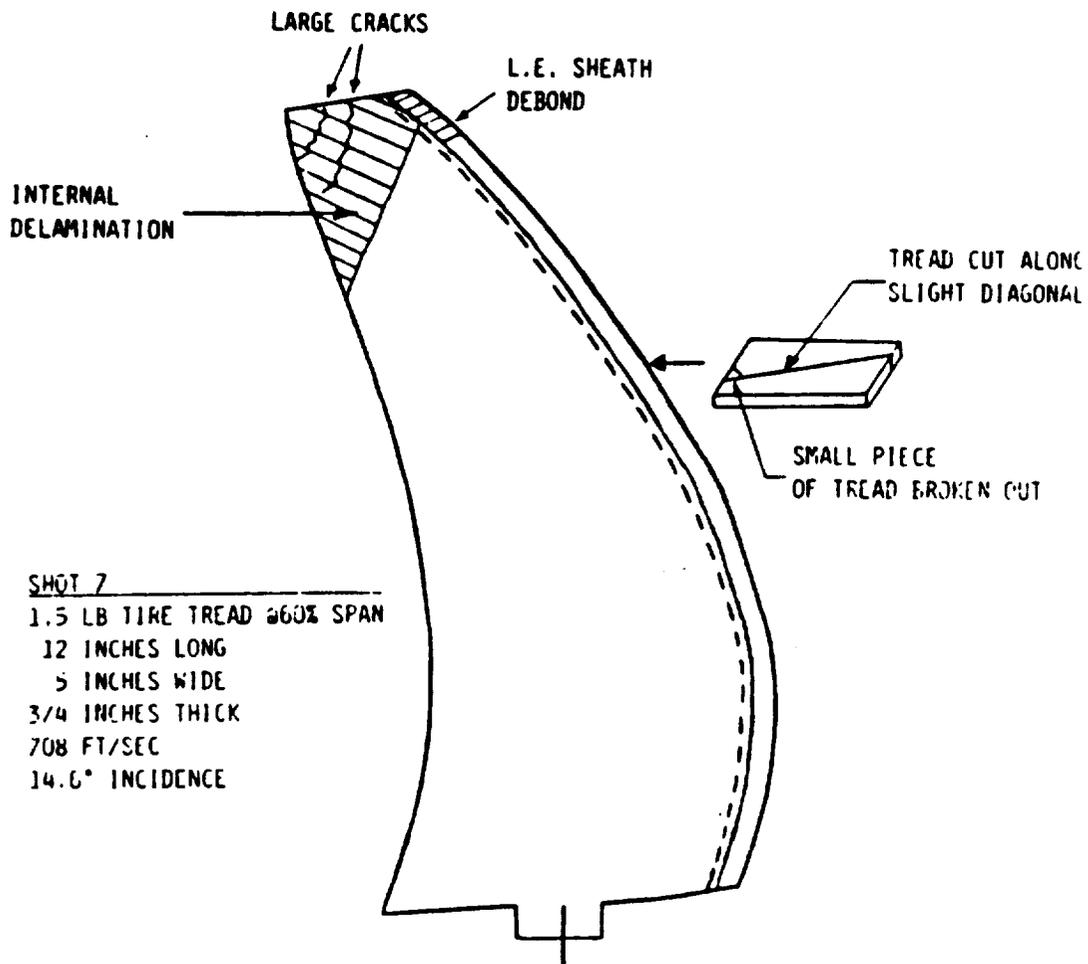
Figure 12. Damage Assessment for Shot 7.

- Shot 7 - No blade damage was sustained at the impact location; however, the blade tip trailing edge had several large cracks through the thickness. No pieces were completely severed, but the internal delamination appears to have propagated beyond the previously damaged area. The leading edge strip also debonded approximately 6 inches down from the tip (Figure 12).

Impact testing was concluded with Shot 7. For this shot, a hard-bodied impactor, consisting of a section of tire tread 5-inches wide by 12-inches long by 3/4-inch thick and weighing approximately 1.5 pounds, was used with impact conditions of a 14.6° incidence angle and a relative velocity of 708 feet per second. Upon impact, the tread was sliced its entire length.

In its final condition, the blade retention capability remained intact, and it is assumed that the engine would still be able to produce at least 90% of its original thrust.

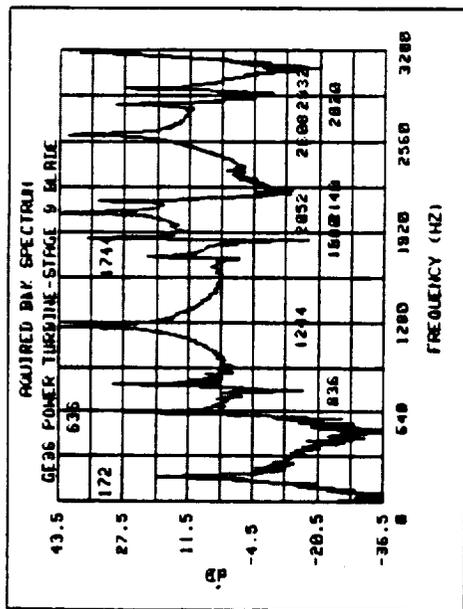
Figure 17. Turbine Blade Frequency Test, Status.

- System Checked Out — Stages 9 and 11 Pilot Parts
- Correlation Obtained for Stage 9

Test	Analysis	% Error
172	187	+8.7
636	651	+2.4
836	889	+6.3
1244	1280	+2.9
1744	1907	+9.3
1880	1917	+2.0
2052	2122	+3.4
2140	2279	+6.5
2608	2714	+4.1
2820	2968	+5.2

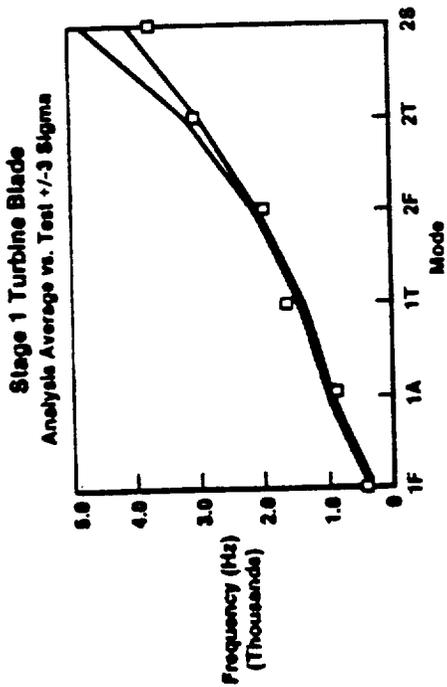
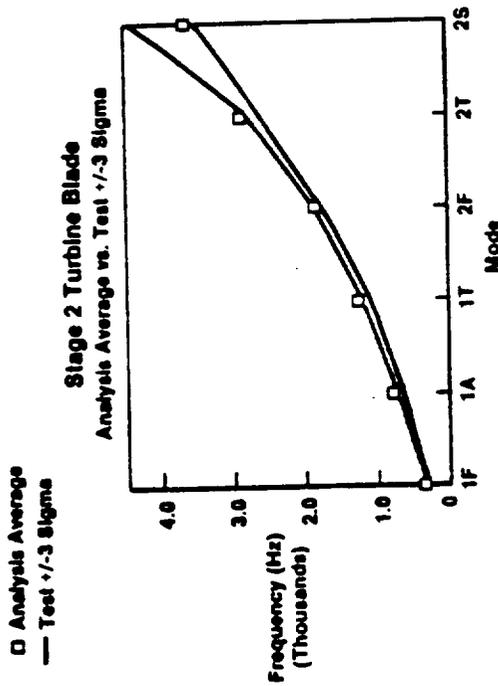
Figure 18. Turbine Blade Frequency Results Summary.

- Results Shown at Take-Off Speed and Temperature
- Excellent Correlation Except 2S Mode
 - Test Higher Than Analysis
 - Stages 1 and 3 Resonant with Downstream Excitation
 - CF6 LPT and Booster Data Indicates Low Response Amplitude
- All Stages Instrumented

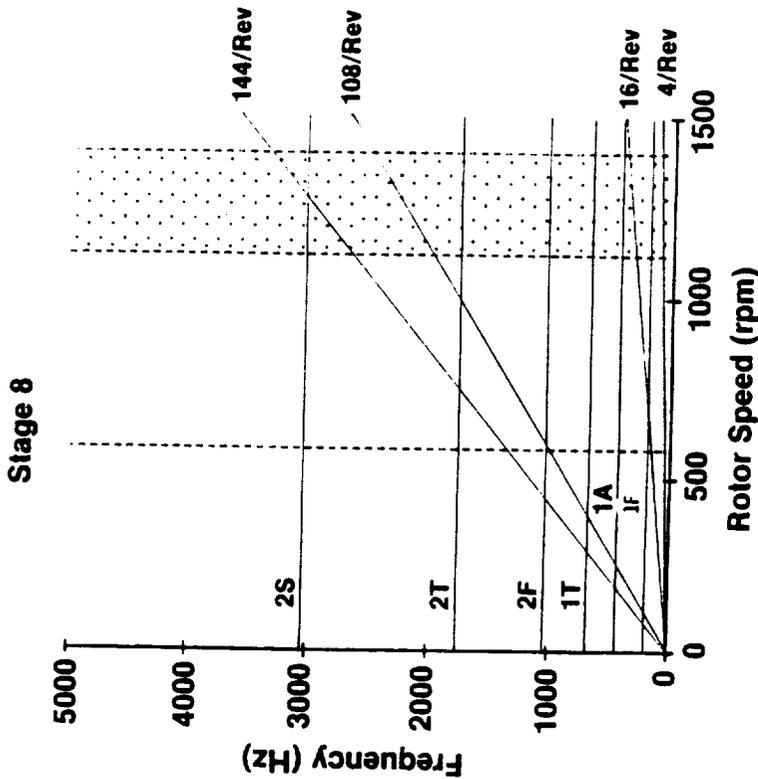
Figure 21. Stage 8 Design Modification.

- **Problem**
 - **2-Stripe Resonance in Operating Band**
 - **Unable to Increase Frequency to Avoid**
 - **Hardware Ready to Manufacture**
- **Approach**
 - **Bench Test 3 Specimens**
 - **Original Design**
 - **Delete Transverse Ribs**
 - **Delete Transverse Ribs and Stiffener (Hollow)**
 - **Correlate Analysis**
 - **Revise Design and Confirm by Test**

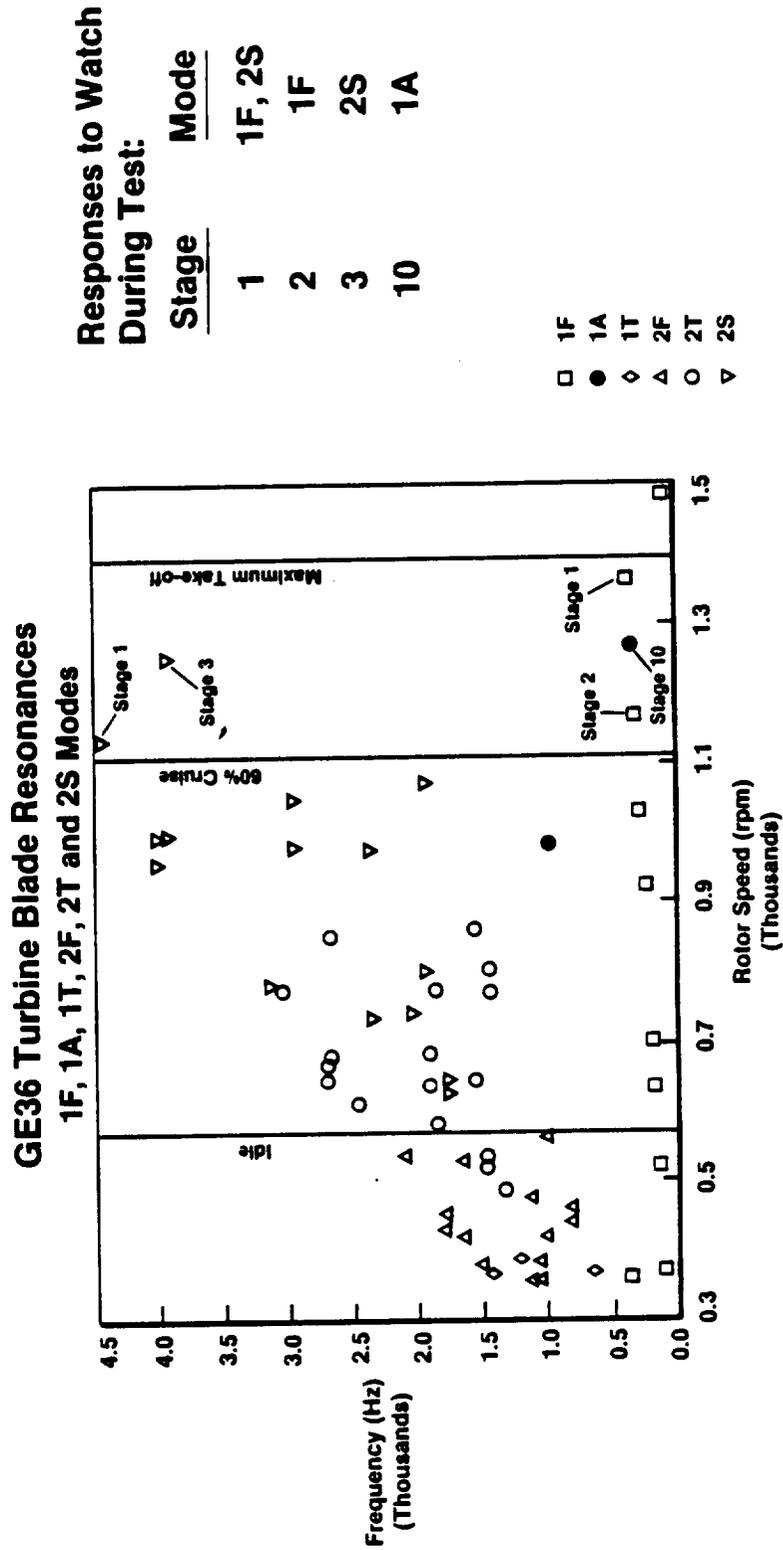
Figure 24. Turbine Blade, Frequency Results.

- All 10 Stages Shown
- Average Bench Test Corrected for Speed and Temperature
- 4/Rev, 16/Rev, 60/Rev, Upstream and Downstream Crossing

Test results for the six modes of interest were corrected to engine conditions to determine potential resonances. Five potential resonances were identified in the operating range affecting Stages 1, 2, 3, and 10. These modes were believed to have either relatively weak excitations or high damping but were identified as the primary responses to monitor during engine test, as seen in Figure 24.

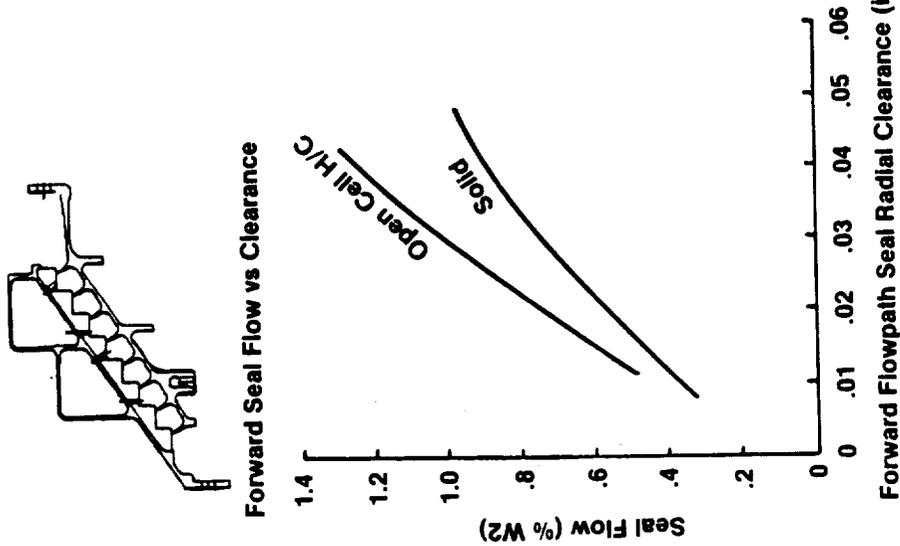
Figure 29. Forward Seal Rub Material Test.

Detail design development continued with the intention of utilizing Teflon, as seen in Figure 29. A dynamics evaluation of the rotating and stationary seal members revealed an unacceptable resonant interaction margin for the three-nodal diameter mode. Studies indicated little help for changing the rotating seal frequency, because there were already two distinct modes: seal only and seal-spool combined modes. Lowering the static seal frequency moved the three-nodal diameter interaction outside the operating range but caused other nodal diameter interactions. Because of the seal configuration, adding stiffness was not practical. However, Teflon material weight was 9 pounds

- **Background**
 - **Solid Seal Provides Performance Advantage**
 - **Less Leakage Than Open Cell Honeycomb**
 - **Performance Derivative (1% W2 = 0.5% SFC)**
 - **Solid Rubber Selected**
 - **Within Experience Except Fuel Soak, Low Rub Speed**
 - **Less Heat Input During Rub**
- **Test Results**
 - **Unacceptable Swelling of Rubber During Fuel Soak**
 - **Test Restructured Around Teflon**
 - **Teflon Bond Strength at Temperature Validated**
- **Conclusions**
 - **Rubber Unacceptable**
 - **Teflon Technically Acceptable, Requires Manufacturing Process Development**
 - **Pursue Teflon, Keep Honeycomb Back-up**

greater than conventional open-cell honeycomb, and the substitution of honeycomb material significantly improved the dynamic margin of the seal, as seen in Table 4. Honeycomb rub material was selected for the final design because it offered the best compromise between dynamics, weight, and leakage. An additional penalty of +0.13 lb/sec leakage flow at takeoff (+0.65% sfc) was the predicted result relative to the use of a solid rub material.

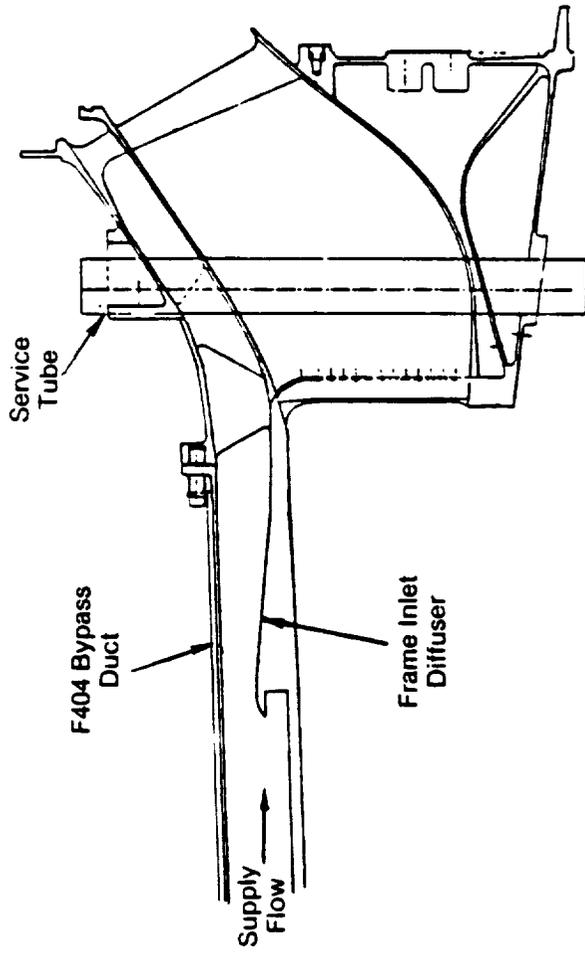
Figure 30. Internal Flow Test.

- 3 Strut Frame Model
 - Center Strut Has Adjusted Hole Pattern
- Bypass Duct and Diffuser Model of Internal Passages
- Service Tube Blockage
- Engine Conditions Simulated by Matching Flow Functions
- Full Range of Flow Conditions Tested

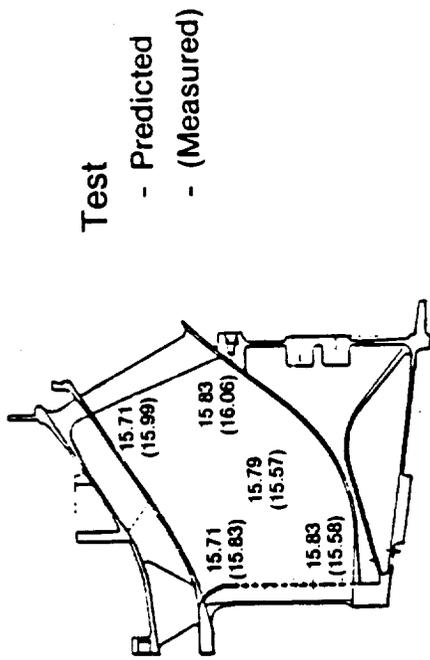
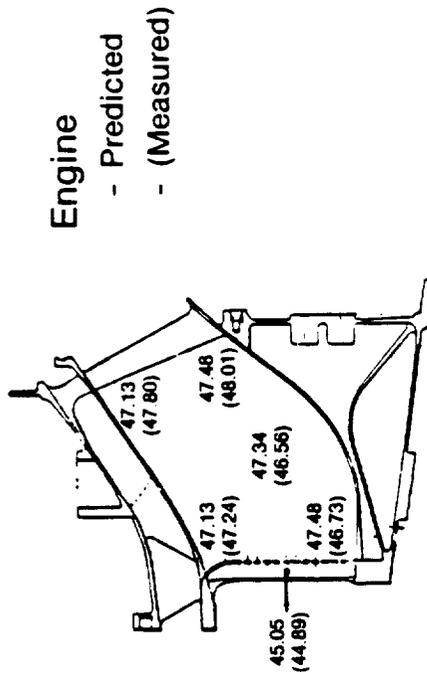
Figure 32. Flow Test Results, No Service Tube Blockage.

- Measured Test Pressures Converted to Engine Operating Conditions
- Low Pressures Measured at Center of Recirculation

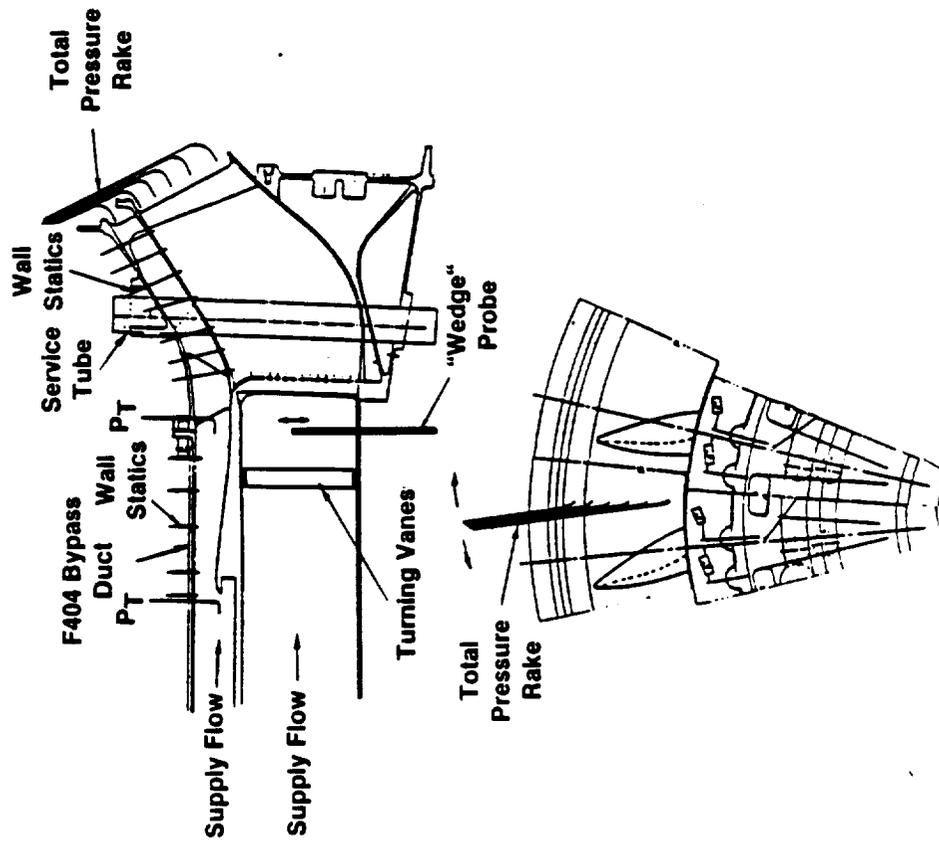
Figure 34. External Flow Test, Instrumentation.

This flow test was performed to determine if flow separation will occur along with mixer frame outer flowpath. The test setup is shown in Figure 34. The model consists of two struts, a segment of the bypass duct, and a segment of the gas flowpath annulus. There are two separate supply flows to simulate both the fan bypass flow and the core flow. Turning vanes upstream of the frame simulate F404 exit swirl. The frame flow exits to ambient pressure. The bypass and core supply pressures are varied to cover the full range of flow conditions.

- **Bypass Duct**
 - **Total Pressure**
 - **Wall Statics**
- **Frame**
 - **Strut Cooling Air Total Pressure**
 - **Outer Flowpath Wall Statics**
 - **Exit Total Pressure Rake**
 - **6 Elements**
 - **Can Be Rotated Circumferentially**
 - **"Wedge" Probe**
 - **To Measure Swirl**
 - **Tuft**

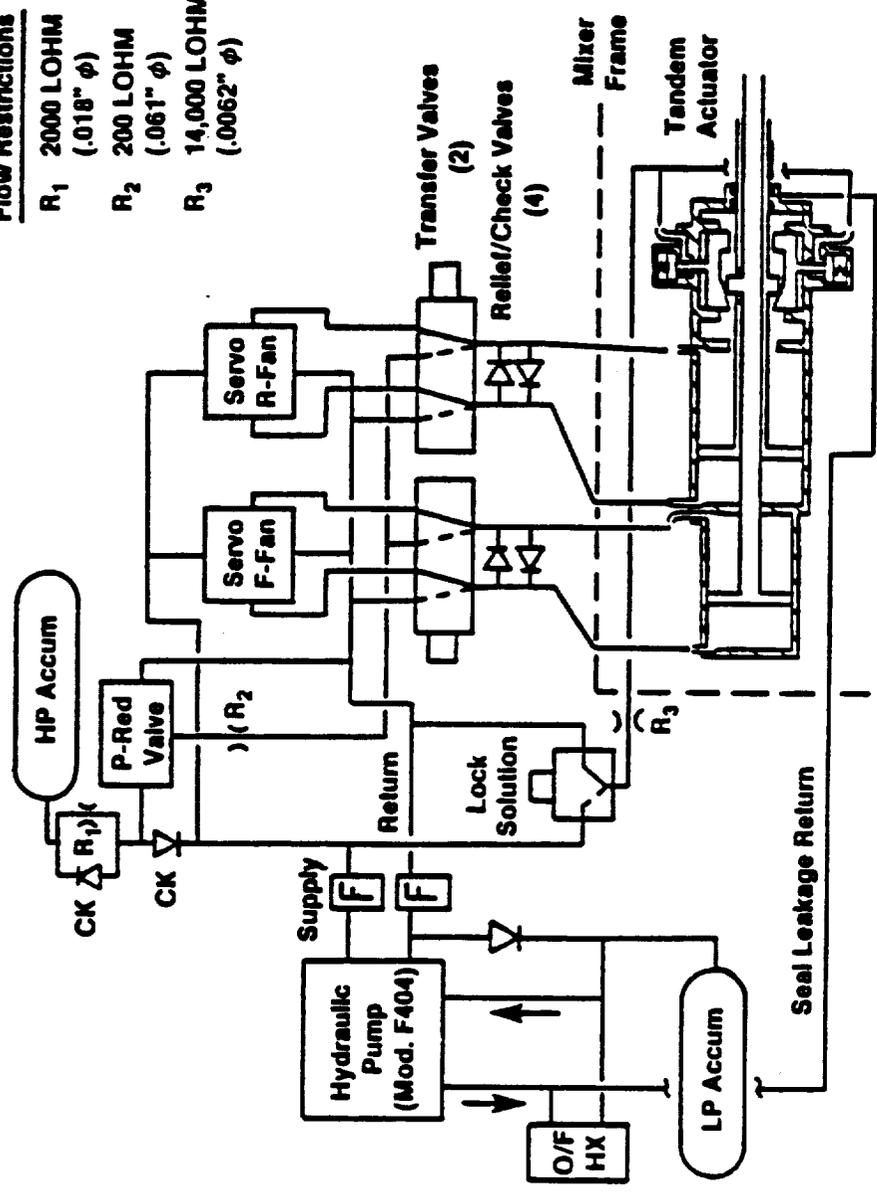
Figure 39. Schematic of Fan Pitch Actuation System - Engine Ground Test Configuration (Concluded).

Flow Restrictions
 R₁ 2000 LOHM
 (.018" φ)
 R₂ 200 LOHM
 (.061" φ)
 R₃ 14,000 LOHM
 (.0062" φ)

During vendor component DAT (Design Assurance Testing) on the fan pitch actuator, it was determined that an uncontrolled pitch lock signal rate caused high impact loads on the pitch lock piston pin. A flow rate control (R_3) was added in the pitch lock signal line and the lock piston pin diameter was increased. The pitch lock piston was then tested to 10,000 cycles by the vendor with an uncontrolled flow rate (that is, worst case).

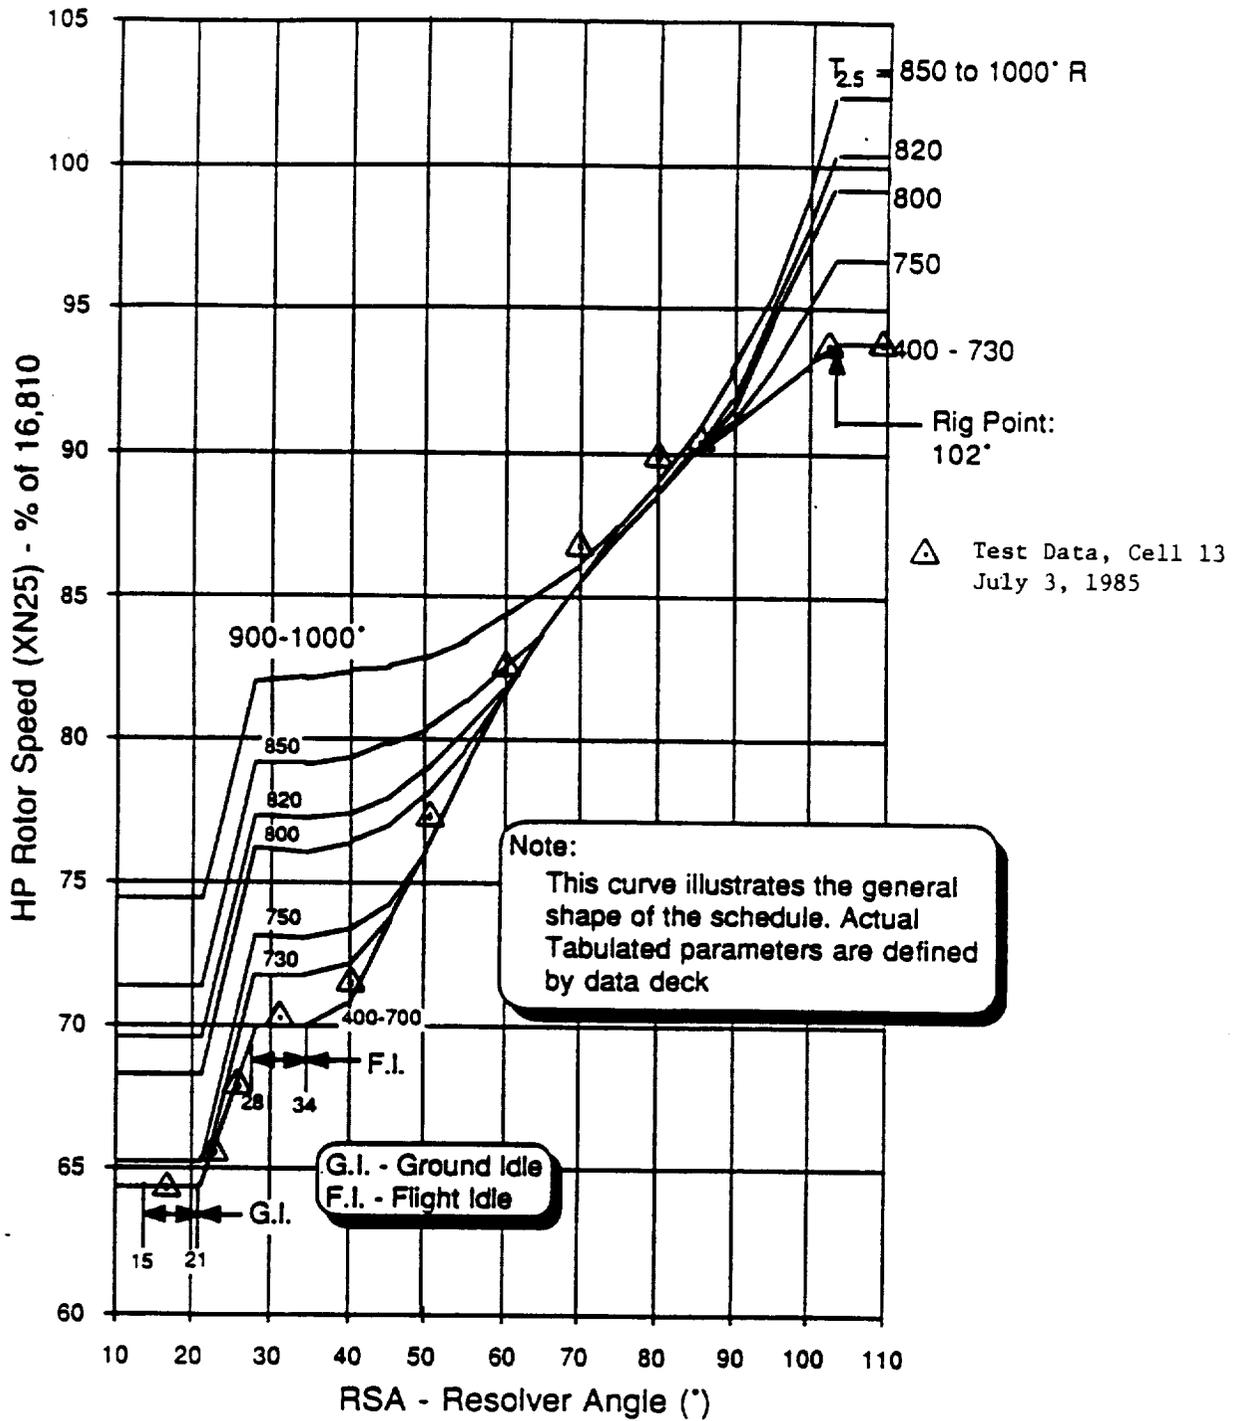
Figure 40. HP Rotor Speed Governing Schedule.

The hydromechanical control is configured such that low power operation modulates fuel flow as a function of corrected HP rotor speed (XN25R) and at high power, the resultant fuel flow of the basic HP rotor speed control is downtrimmed through a torque motor input as a function of intermediate turbine speed (XN2), core engine exhaust temperature (T46), or engine pressure ratio (P46/P2), whichever provides maximum fuel downtrim. The features of the fuel flow cutback characteristics were tested. In each case, a reference value (RXN2, RT46, or RP46/P2) was set and the sensor value was increased until maximum fuel flow cutback (decel schedule) was achieved, then sensor value was decreased until fuel flow returned to the zero cutback condition (accel schedule).

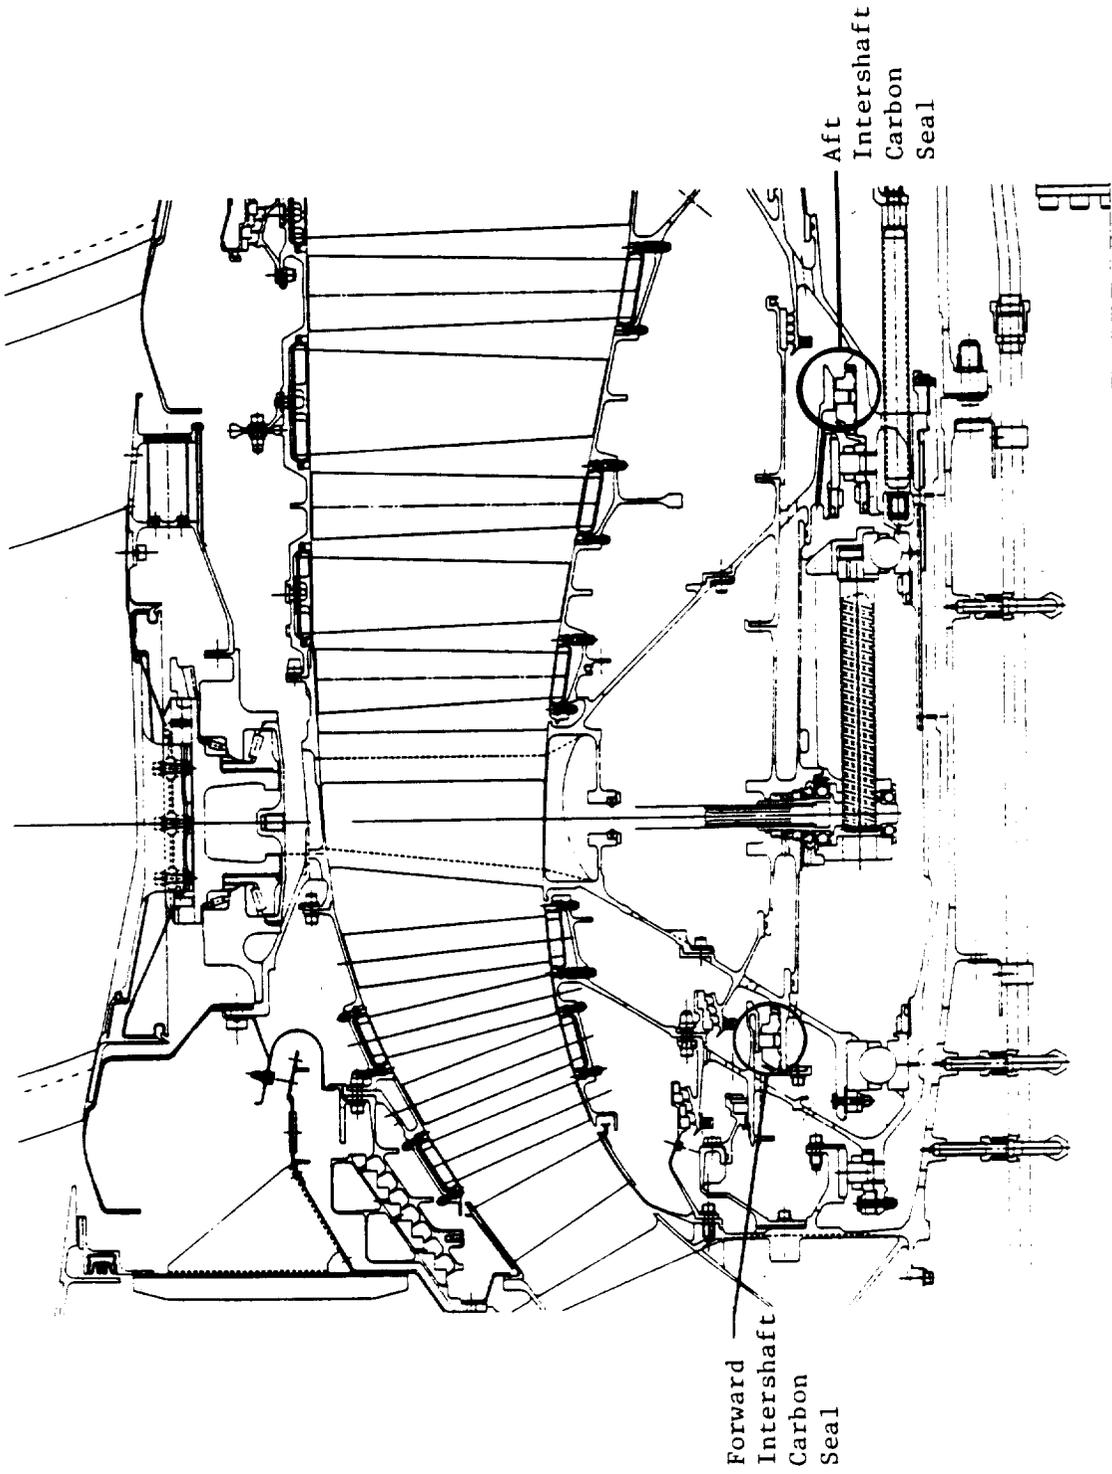
Figure 42. Forward and Aft Intershaft Carbon Seal.

The intershaft seal (Figure 42) tests were conducted with tooling that simulate the OD land and inner mount of the shafts. A test of the intershaft seal assembly consisted of the carbon element, both races, the preload spring, and a mount element. Results for the forward intershaft seal test are shown

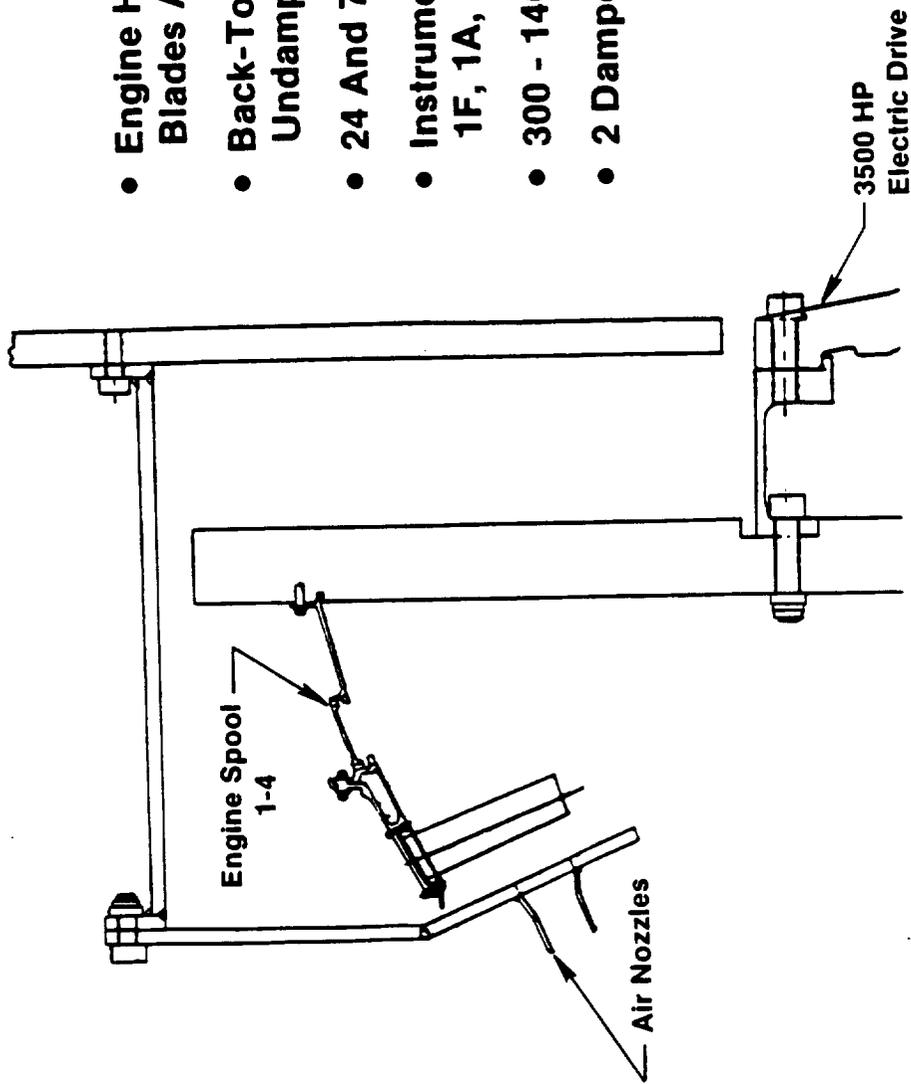
Figure 49. Whirligig Damper Test.

- Engine Hardware - Blades And Spools
- Back-To-Back Damped And Undamped (12 Each)
- 24 And 74 Nozzle Excitation
- Instrumentation Sensitive To 1F, 1A, 1T, 2F, 2T, And 2S
- 300 - 1400 rpm Test Range
- 2 Damper Sizes

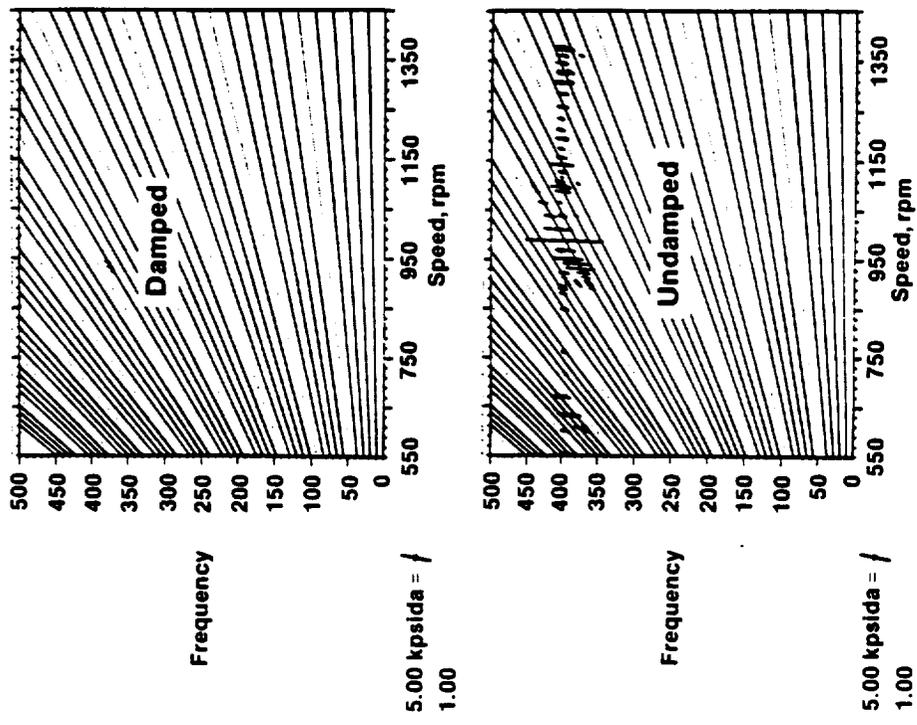
Figure 50. Whirligig Test Results Summary.

- Undamped Blades Highly Responsive
 - Unable To Control Excitation With 24 Nozzles
 - Testing Conducted With 12 And 6 Nozzles (2 x 12/Rev And 3 x 6/Rev)
- No Discernable Difference Between Two Damper Weights
- Significant Reduction In 1F Stress Level And Scatter With Dampers
- Unable To Drive Higher Order Modes
- Ability To Vary Excitation Energy Limited By Undamped Blades

The damped blade response was significantly less on an average basis and showed significantly less blade-to-blade scatter. There was no discernible difference between the two damper sizes, as seen in Figures 50 and 51. Based
