FINAL REPORT

HYDROGEN INDUCED FRACTURE
CHARACTERISTICS OF SINGLE CRYSTAL
NICKEL-BASED SUPERALLOYS

Po-Shou Chen and Roy C. Wilcox

Prepared for
George C. Marshall Space Flight Center
Marshall Space Flight Center, Alabama 35812

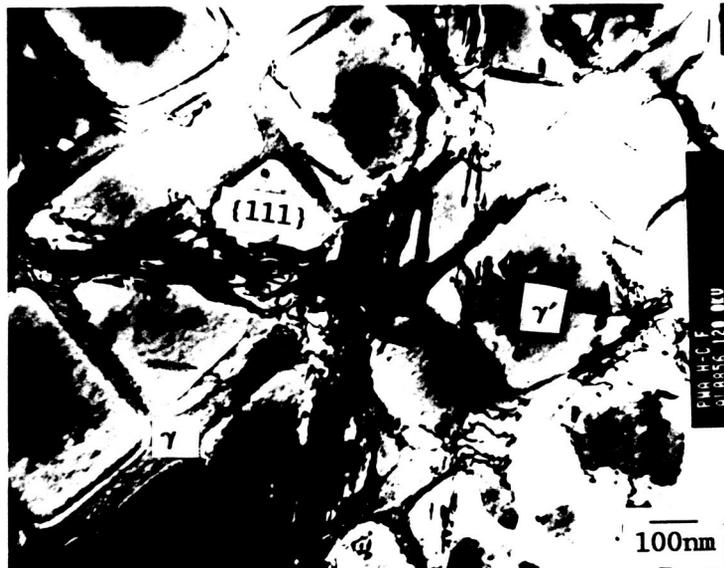
Figure 2. Bright field TEM micrograph with the foil normal parallel to the [100] stress axis showing intense bands lying on {111} planes

the fracture surface with the foil normal perpendicular to the tensile axis. In most cases, the deformation was found to occur inhomogeneously in intense slip bands lying on $\{111\}$ planes and aligned parallel to the different slip directions as shown in Figure 2. Dislocation accumulations within narrow γ regions and near the γ/γ' interface were detected (Figure 3). Furthermore, alternate cracks on $\{111\}$ type planes along $[011]$ and $[01\bar{1}]$ directions were also observed (Figure 4). The TEM studies indicated that $\{111\}$ type slip was the controlling factor during cleavage fracture of single crystals of the PWA 1480 nickel-base superalloy.

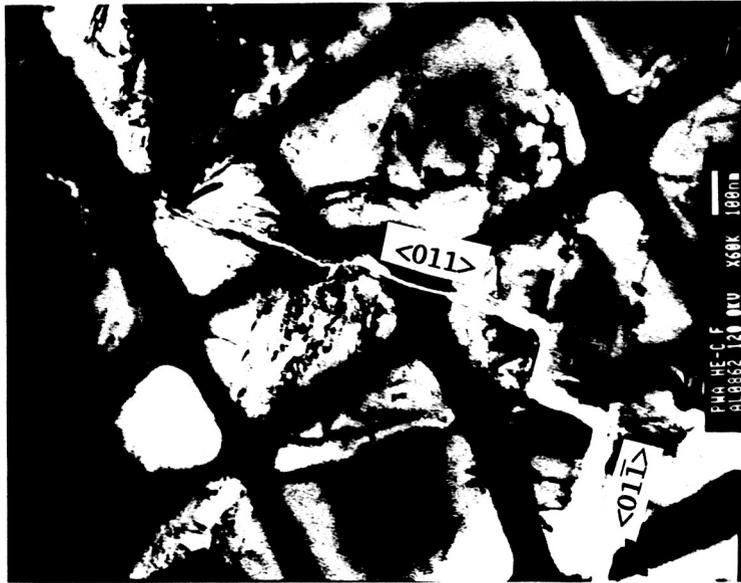
Figure 4. Cracking along $\langle 011 \rangle$ and $\langle 0\bar{1}\bar{1} \rangle$ directions on a $\{111\}$ slip plane.

The TEM observation of cracks formed on the $\{111\}$ type planes

further supported the present SEM results that cleavage planes were either a single large {111} plane or a combination of smaller {111} planes. Therefore, what appeared to be brittle cleavage along crystallographic planes at the notch root did in fact involve plastic deformation because most of the cleavage occurred on the {111} planes. During the deformation process, both γ and γ' slipped on {111} planes. Thus, both SEM and TEM observations indicate that {111} type slip was the controlling factor of fracture in the PWA 1480E single crystals.

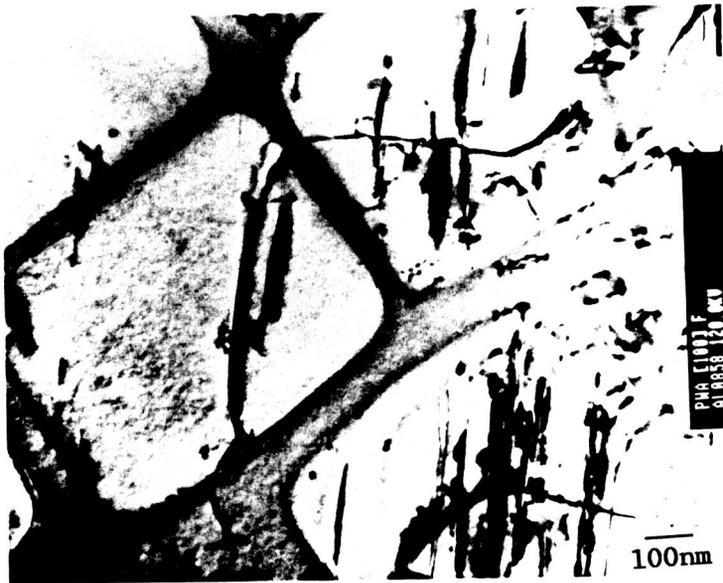
Figure 7. "V" shaped superdislocation.

Superdislocations with "V" shaped configuration were found in the γ' particles (Figure 7). This is a typical morphology of $\{100\}$ type superdislocations [29]. In addition to $[110]$ and $[011]$ cracking on the $\{111\}$ planes, microcracking along $\{111\}$ slip planes within the γ matrix (Figure 8a) or along $\{100\}$ γ/γ' interfaces was detected (Figure 8b). This revealed that, in addition to the cracking cutting across both γ and γ' particles, cracking could occur in the narrow γ region on $\{111\}$ planes or be deflected by γ' particles leading to interfacial cracking on $\{100\}$ planes. In a previous study [4], the dislocation structure in helium charged specimens was similar to that found in the hydrogen charged specimens in this work. The primary differences were the formation of $\{100\}$ type slip and cracking along the γ/γ' interface in an hydrogen atmosphere.

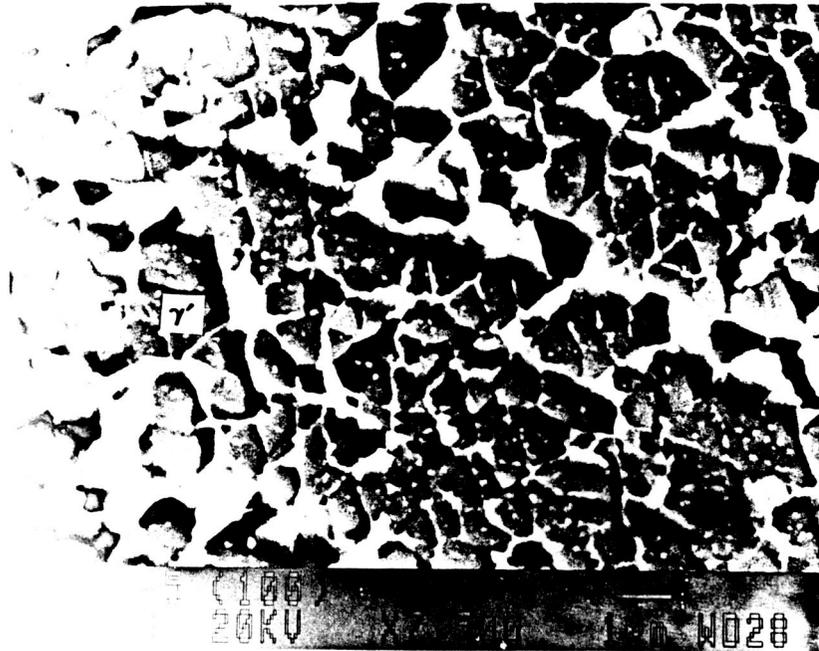
Figure 14. (a) (111) type of cleavage planes found in the [100] specimen showing the notch area. (b) Fractograph taken at high magnification showing the triangular network.

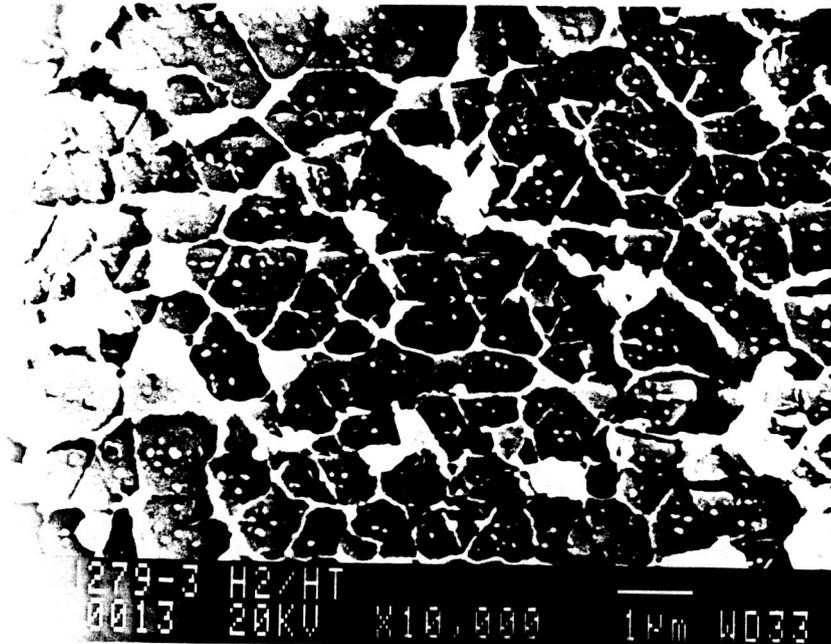
Figure 20. (a) $\{111\}$ type of cleavage planes found in the $[100]$ specimen near the notch area. (b) Fractograph taken at high magnification showing a triangular γ' network.
