NASA Technical Memorandum 4219

In-Flight Investigation of Shuttle Tile Pressure Orifice Installations

Timothy R. Moes and Robert R. Meyer, Jr.
Ames Research Center
Dryden Flight Research Facility
Edwards, California

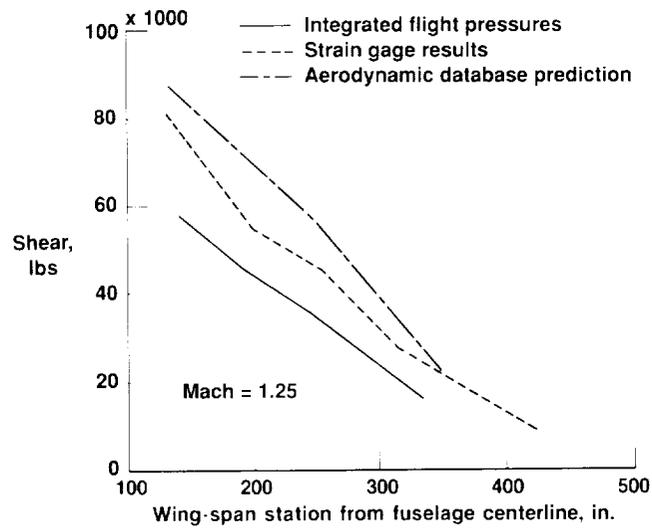
Figure 1. Wing-root shear loads from STS 61-C strain gage, pressure measurements, and the aerodynamic database prediction.

To verify predictions of wing load during ascent, the shuttle orbiter Columbia (OV-102) was instrumented with multiple strain gages and pressure orifices on the wing. Initial wing pressure measurements were obtained during the orbiter flight test program (STS 1-5). There were not enough orifices, however, to adequately determine the wing pressure distributions for an accurate determination of wing loads. Consequently, additional orifices were added to OV-102. The STS 61-C mission in January 1986 was the first shuttle flight to obtain extensive wing pressure measurements. The unpublished loads data from flight 61-C wing pressure measurements did not agree with the loads predicted from the aerodynamic database or with the loads determined from strain gage measurements (fig. 1). Also, the pressures measured during flight 61-C did not agree with those measured in the earlier STS 1-5 flights. The installation technique of the pressure orifices in the thermal protection system (TPS) tiles was believed to be one cause of the discrepancy. The installation technique used for STS 61-C was different from that for STS 1-5.

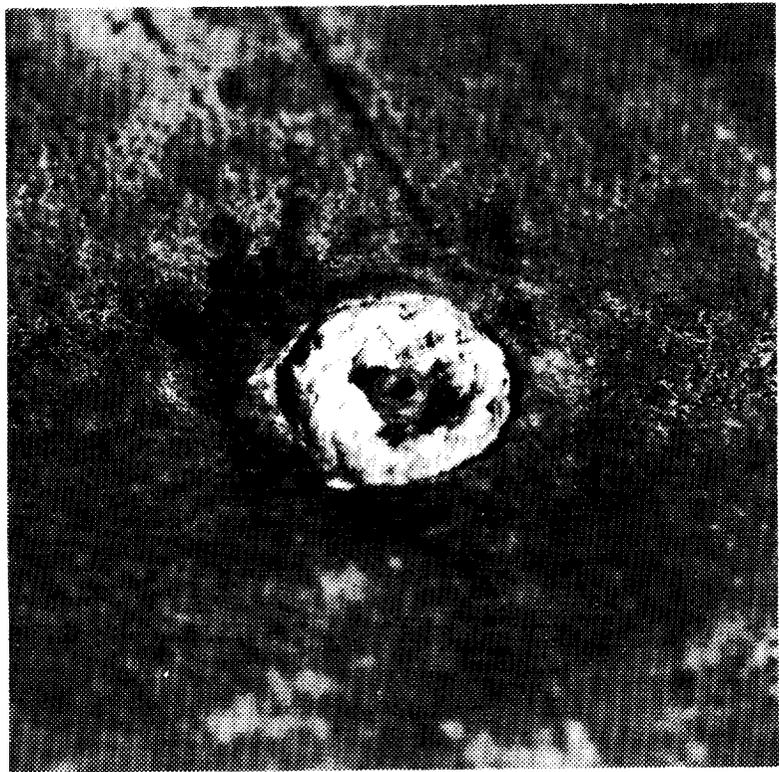
Figure 2. Postflight condition of typical STS 61-C TPS tile orifice.

Figure 2 shows a typical TPS tile orifice after STS 61-C. The gap filler material was usually recessed into the hole surrounding the pressure tube, although in some cases it protruded from it. The deformation of the orifice installations was attributed to reentry heating, improper installation, or air loads. For this experiment, test panels contained recessed, protruding, and nearly flush gap filler installations. These panels were flight-tested on an F-104 aircraft with a flight test fixture (FTF) mounted on its undersurface. Stabilized test points were flown at dynamic pressures similar to shuttle launch conditions for Mach numbers between 0.6 and 1.4. This report describes the flight test techniques used to analyze the orifice installations. It also describes the orifice installations and presents the results from the flight tests.

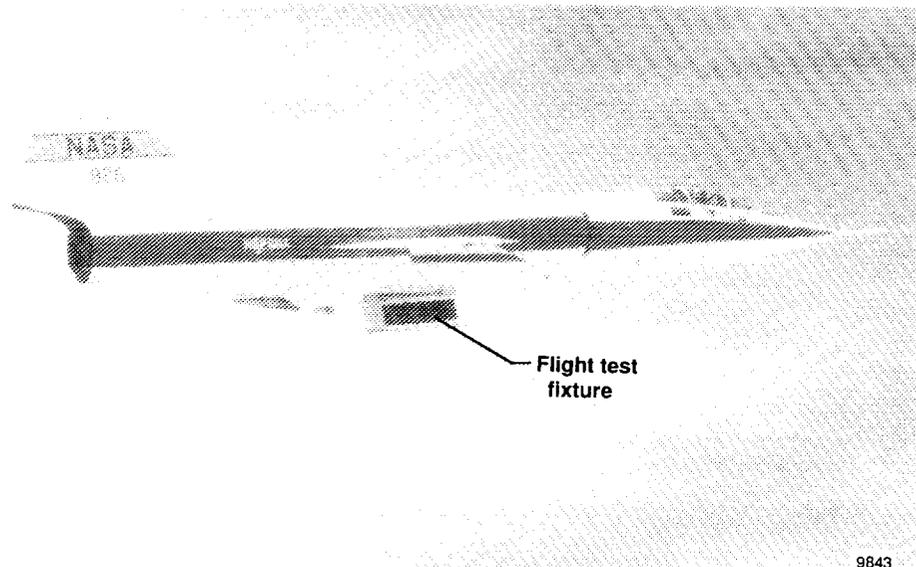
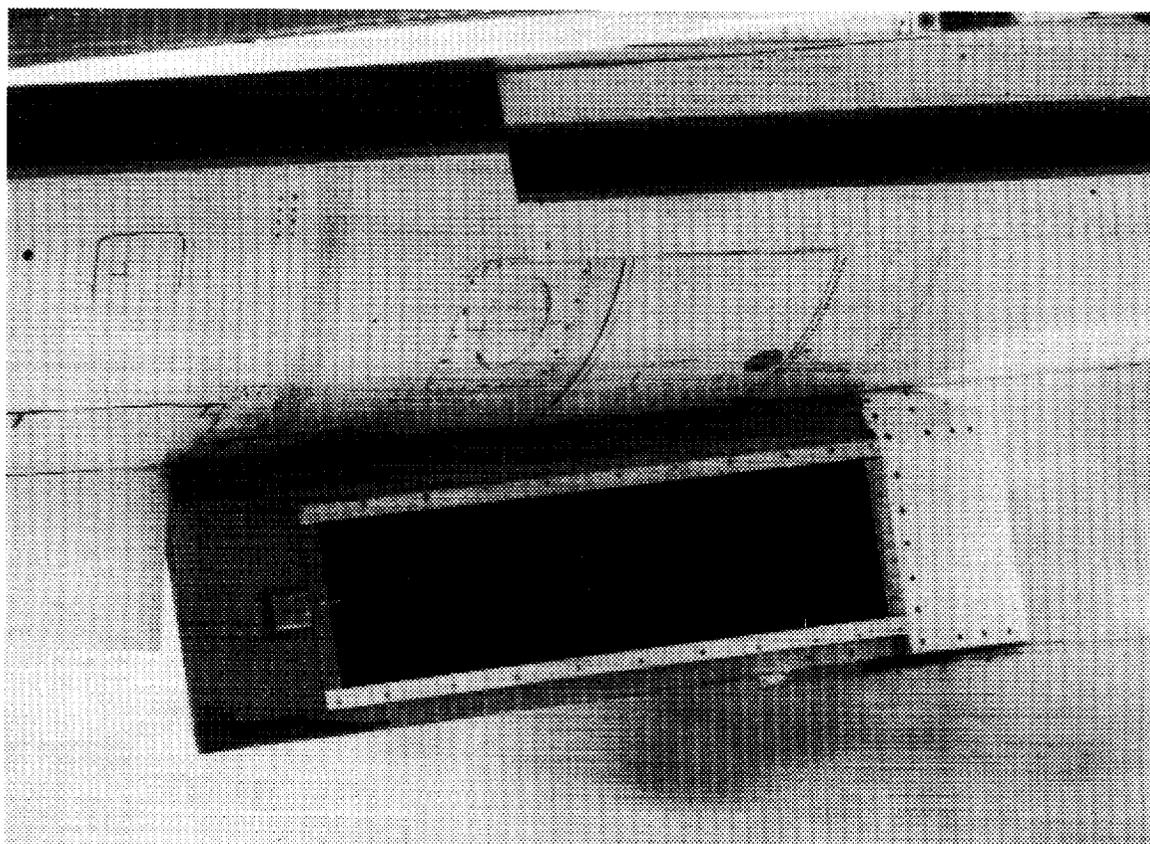
Figure 3. The F-104 aircraft in flight.

(a). Aircraft with the FTF mounted beneath the fuselage.

(b) The FTF with test panel installed.

A specially equipped F-104 aircraft was used as a carrier vehicle for these experiments because it is capable of obtaining the shuttle Mach number and dynamic pressure profile of interest. It was modified to carry a lower fuselage fin, the FTF, on which the test articles were installed. An airdata probe mounted on the noseboom was used to obtain free-stream airdata parameters such as Mach, altitude, and dynamic pressure. Figure 3 shows the F-104 airplane with the FTF. The aircraft was also instrumented with special cockpit displays (Meyer and Schneider, 1983) that allowed for precise Mach and dynamic pressure flight profiles, which generally matched orbiter launch conditions.

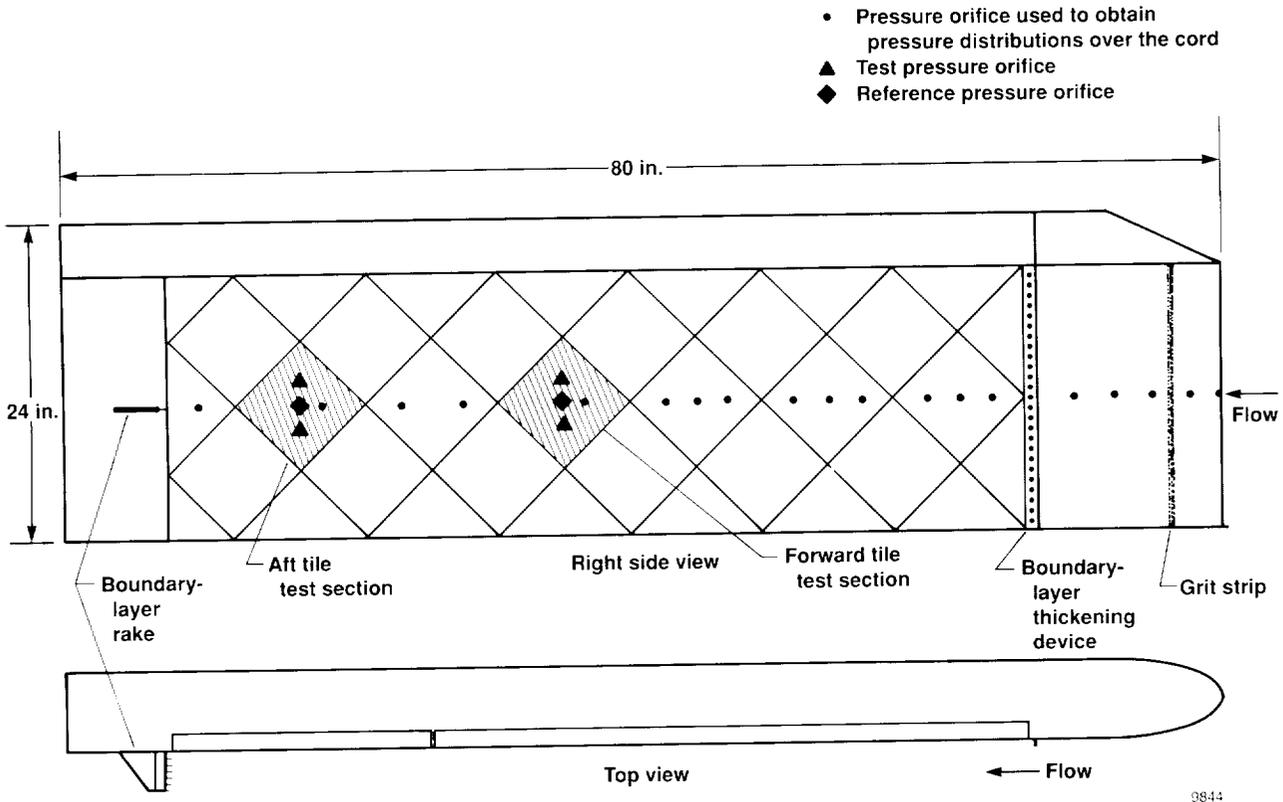
Figure 4. The FTF with tile test articles locations.

within this foam panel to allow for realistic gaps and steps between the test article and the foam panel. The tiles were also oriented to surface streamlines as on the orbiter. Both a forward and an aft position were provided for the test articles (fig. 4). This allowed simultaneous flight test of two identical tiles to determine if the results would be similar at different FTF chord locations. In addition to the test articles, flush pressure orifices were installed along the length of the FTF to obtain a pressure distribution along the chord. For consistency in the flight data, a grit strip at the 5-percent chord location was used to insure boundary-layer transition from laminar to turbulent flow. A boundary-layer rake was used to measure the thickness of the boundary layer aft of the test articles. On some flights a boundary-layer thickening device (BLTD) was located at the 20-percent chord location to increase the thickness of the turbulent boundary layer. The BLTD consisted of forty-five 0.138-in. diameter machine screws on a metal strip that spanned the fin. The screws were spaced every 0.31 in. and the shaft end extended 0.25 in. above the surface. Figure 5 shows the BLTD. Figure 4 also shows the locations of the grit strip and BLTD.

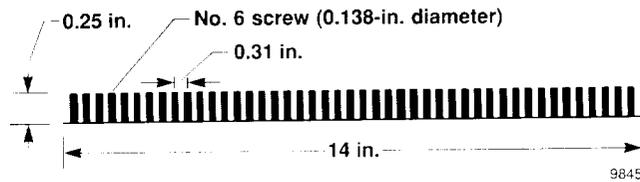
Figure 5. Boundary-layer thickening device.

Increasing the obtainable boundary-layer thickness on the FTF was also considered for this experiment. Although it was impossible to generate the large turbulent boundary layers obtained on the orbiter wing, two approaches were used to thicken the FTF boundary layer. The first approach involved flying each design Mach number at a higher altitude, determined by reducing the Reynolds number by half. A thicker boundary layer would then be obtained since boundary-layer thickness increases as Reynolds number decreases. However, with this method the dynamic pressure was less for each Mach number. The second method of increasing the boundary-layer thickness used the BLTD at the 20-percent chord location of the FTF.

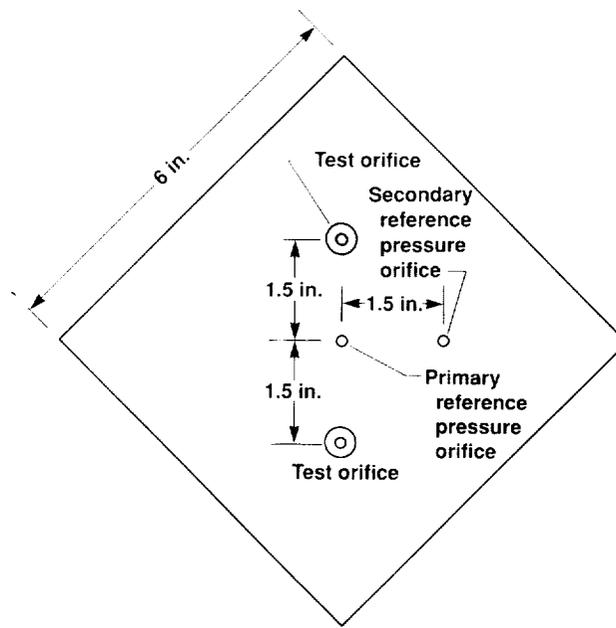
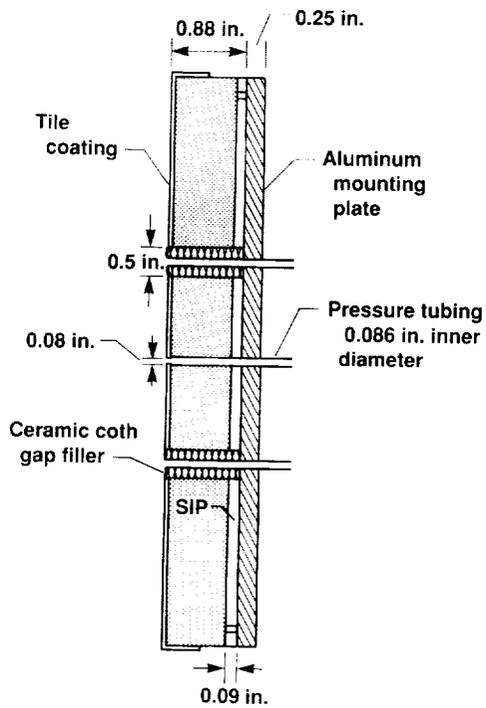
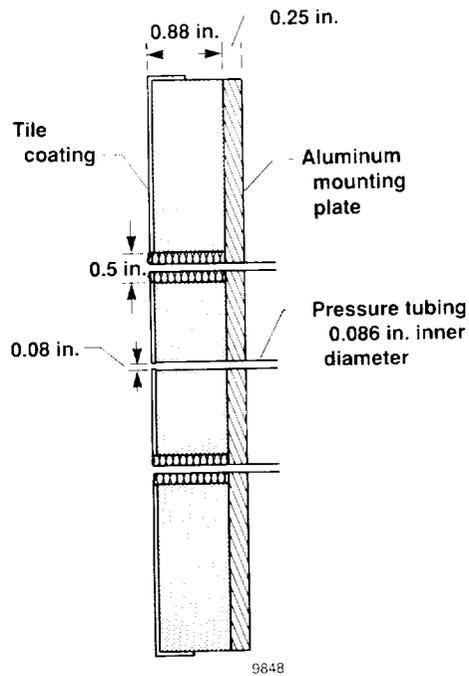
Figure 6. Test article configuration.

(a) Planform.

(b) Tile cross section with SIP.

(c) Tile cross section without SIP.

For this experiment, eight silicon fibrous refractory composite insulation 12 (FRCI 12) tiles were constructed. This is the type of TPS tile used for the high-temperature reusable surface insulation (HRSI) which covers much of the orbiter wing's lower surface and the outboard portions of the wing's upper surface. Figure 6 shows the dimensions of the tiles. Each tile was a square, 6 in. on a side, and contained four orifices. On most tiles, two were test orifices, one a primary reference orifice, and the fourth a secondary reference orifice, which was used as a backup for the primary reference orifice (fig. 6(a)). Two of the tiles contained four reference orifices which verified the uniformity of the pressure distribution across the tile when flown on the FTF. The tiles were bonded to a 0.25-in. aluminum plate for mounting to the FTF. Two of the eight tiles were fabricated with a strain isolation pad (SIP) between the aluminum plate and the tile (fig. 6(b)). The tiles with the SIP installation are more representative of the actual shuttle tile installation than the six remaining tiles which did not contain an SIP (fig. 6(c)).

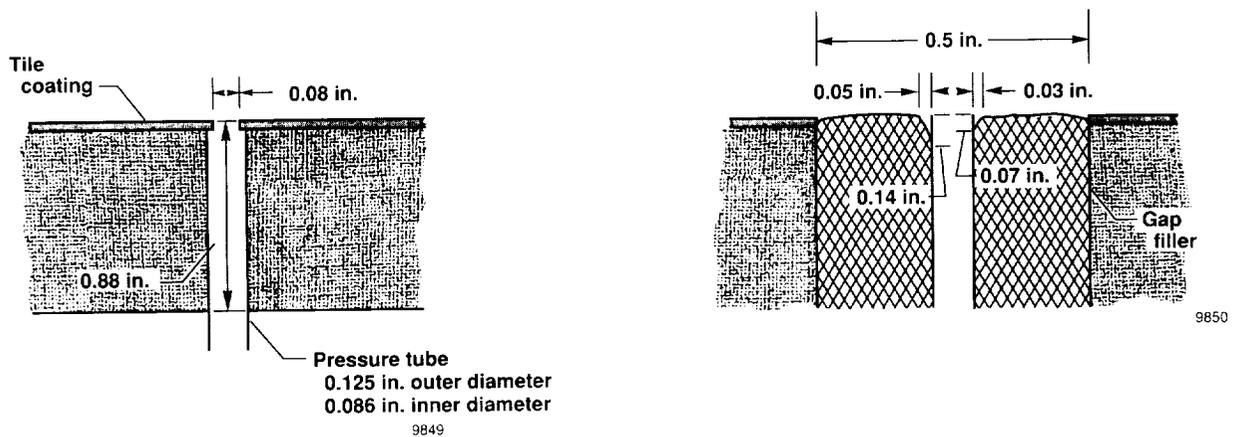
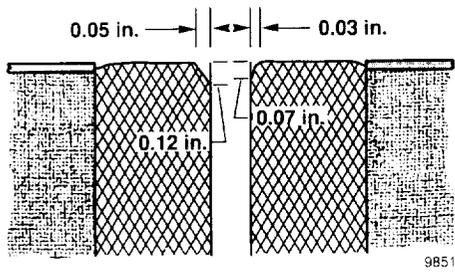
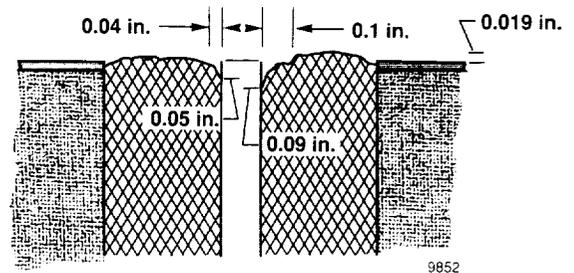
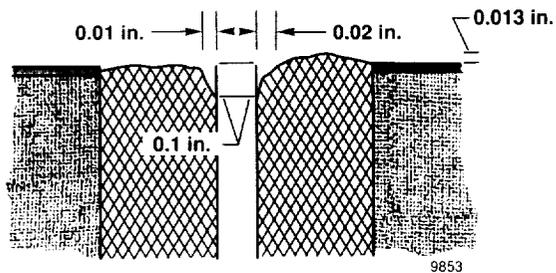
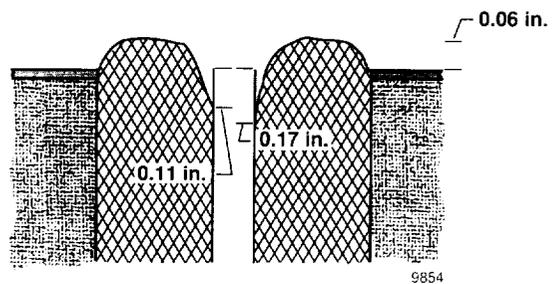
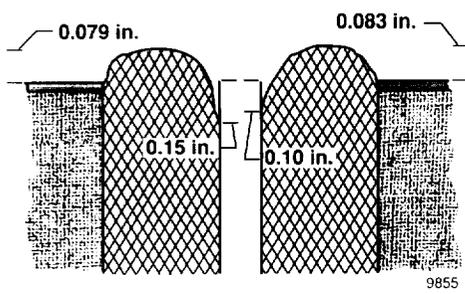
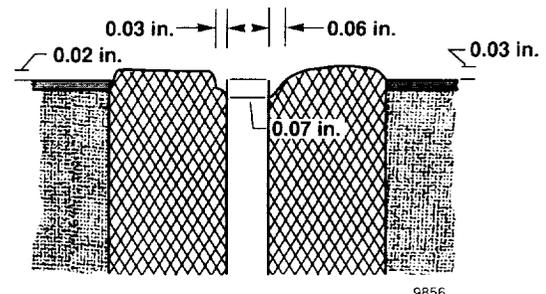
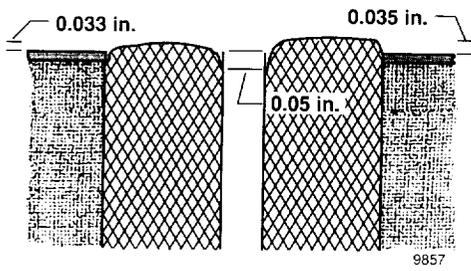
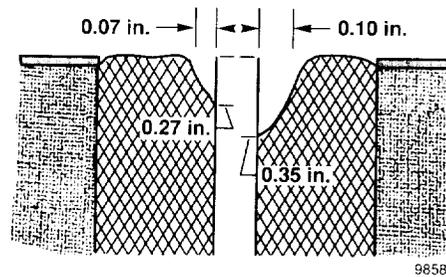
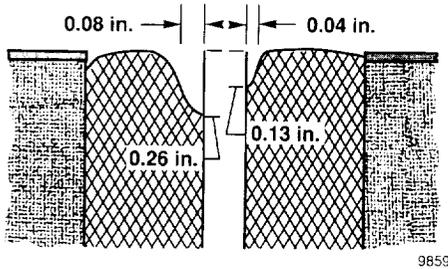
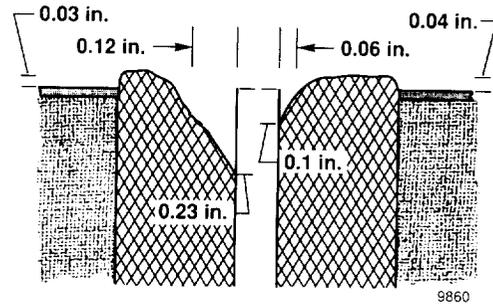
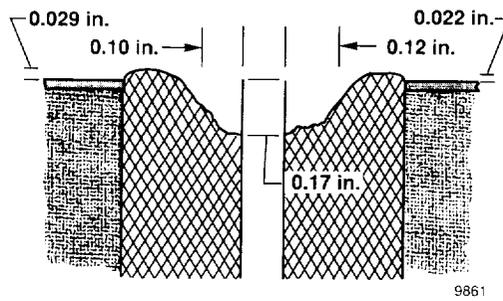
Figure 7. Orifice installations.

(a) Reference orifices R1 to R4.

(b) Orifice 1.

(c) Orifice 2.

(d) Orifice 3.

(e) Orifice 4.

(f) Orifice 5.

(g) Orifice 6.

(h) Orifice 7.

(i) Orifice 8.

(j) Orifice 9.

(k) Orifice 10.

(l) Orifice 11.

(m) Orifice 12.

The reference orifices were 0.08 in. in diameter and flush with the tile surface, as shown in figure 7(a). The test orifices were installed within a 0.5-in. diameter hole in the tile. The aluminum pressure tube had a 0.086 in. inner diameter and 0.125 in. outer diameter. Figures 7(b) through 7(m) show the orifices tested in this experiment. The exposed surface of the gap filler was shaped to simulate orifice region anomalies on the orbiter after flight 61-C. The test orifices varied from nearly flush (test orifices 1 through 4) to excessively distorted (test orifices 5 and 6). The excessively protruding gap filler installations of test orifices 5 and 6 were not typical of those found on the orbiter after flight 61-C but were tested to extend the database.

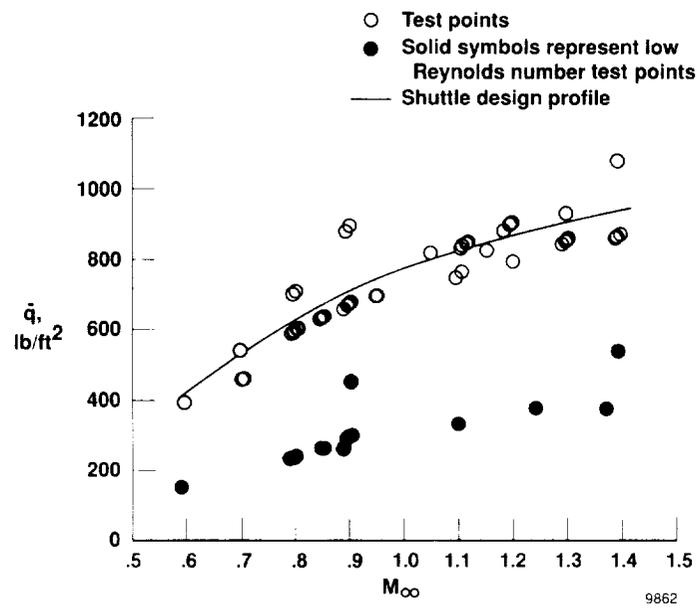
Figure 8. Dynamic pressure and Mach numbers for test conditions.

The basic approach of this experiment was to fly stabilized test points that would simulate Mach numbers and dynamic pressures experienced by the orbiter on a typical launch. As previously stated, the F-104 was suitable for this experiment because it is capable of flying the portion of the orbiter Mach number and dynamic pressure profile which includes the maximum dynamic pressure condition. Table 1 lists the free-stream conditions and the test orifice pressures for each test point. Each test point consisted of approximately 30 seconds of stabilized flight at the specified Mach number and altitude. Figure 8 shows the test conditions flown in this experiment and the design dynamic pressure profile for the orbiter. Points were flown both at or near the design dynamic pressure and at approximately one-third of the design dynamic pressure to lower the Reynolds number for certain test points.

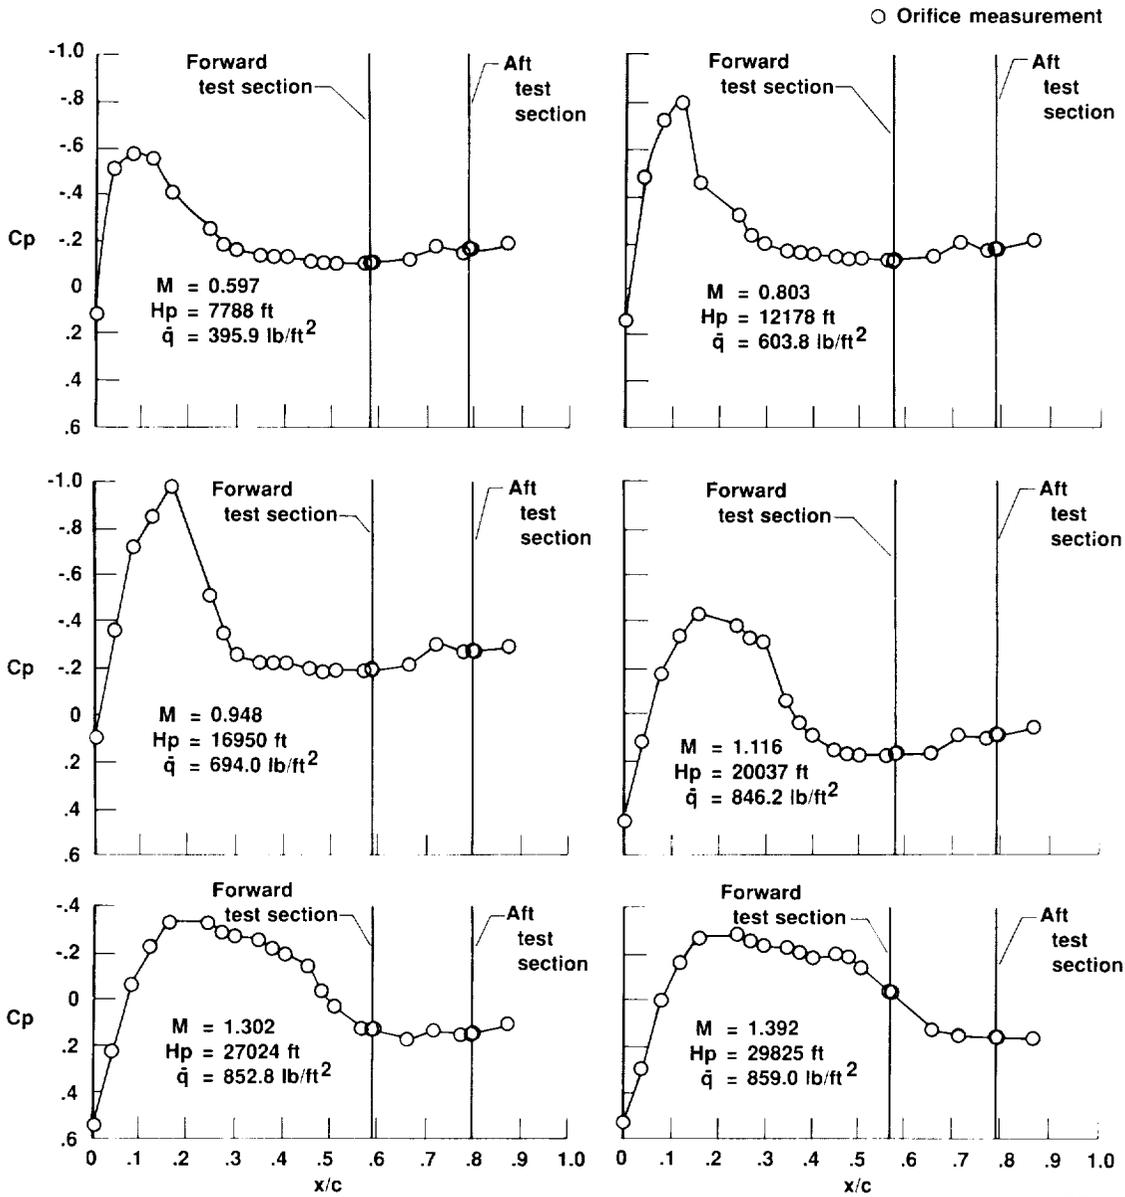
Figure 9. Typical FTF pressure distributions along the chord.

The two tile test sections were located in a region where the pressure distribution on the FTF chord was relatively flat for the range of Mach numbers studied. This would give similar local velocities and pressures at the two test sections even though the boundary layer would be slightly thicker for the aft test section. Figure 9 shows a series of typical pressure distributions along the chord. The forward test section is located at $x/c = 0.584$ and the aft test section is located at $x/c = 0.794$. For the cases below Mach 1.3, the local pressure is slightly more positive (lower local velocities) at the forward test section than at the aft test section. At Mach 1.30, the local conditions are approximately the same for both test sections. At Mach 1.39, the local pressure at the forward test section is considerably lower than the local pressure at the aft test section.

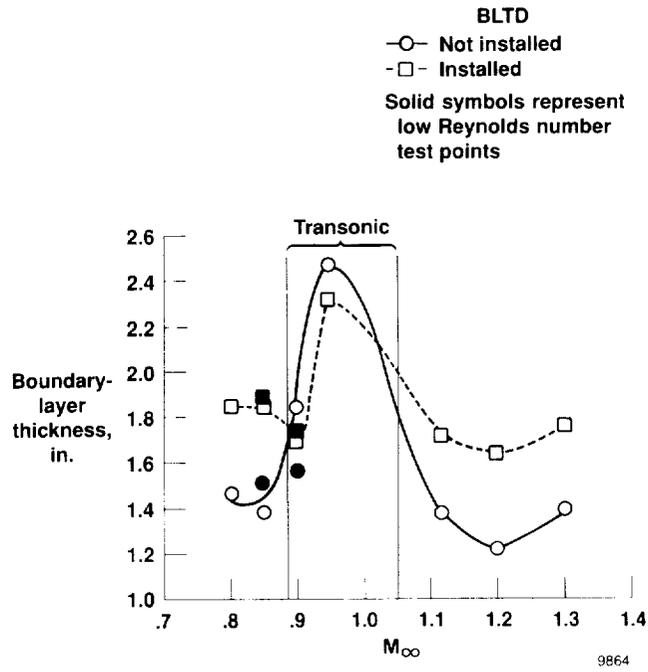
Figure 10. The effects on FTF boundary-layer thickness of the BLTD and of decreased Reynolds number.

As previously mentioned, two approaches were used to increase the thickness of the FTF boundary layer. Typical results from these two methods can be seen in the measured boundary-layer thicknesses shown in figure 10. By decreasing the Reynolds number, a small increase in boundary-layer thickness can be observed for subsonic cases. In the transonic region, data trends are confusing, probably because of the interaction of shock and boundary layer. The BLTD method was more successful in increasing the boundary-layer thickness than flying at lower Reynolds numbers. The installation of the BLTD increased the boundary-layer thickness by approximately 30 percent for the subsonic and supersonic cases.

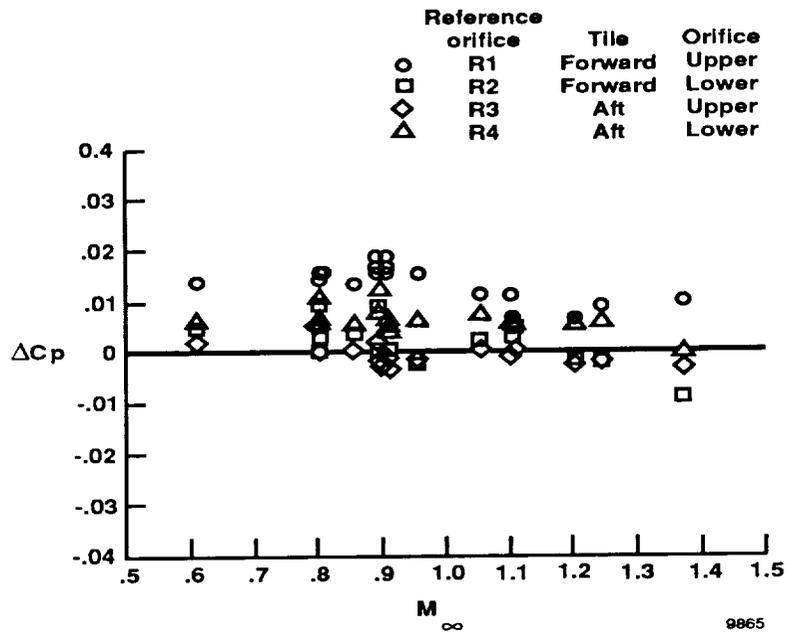
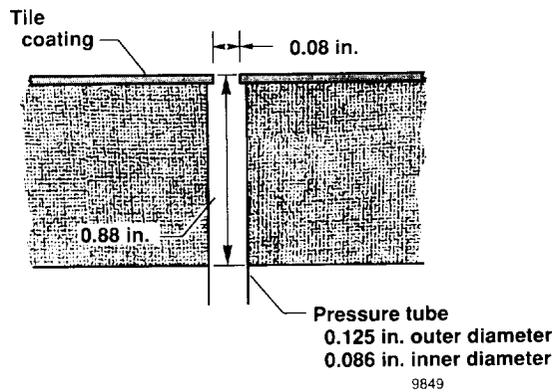
Figure 11. Reference orifices R1 to R4 without the BLTD.

(a) The ΔC_p .

(b) Reference orifices R1 to R4.

The two initial flights of the program were used to document the distribution of test-panel surface static pressures. Comparing pressures measured at the different reference orifices distributed vertically on the tile showed that there were no major vertical pressure gradients. Figure 11 shows the difference in pressure coefficient (ΔC_p) between coefficients of pressure of the reference orifices at the test locations ($C_{p_{test}}$) and those at the center reference orifices ($C_{p_{ref}}$). With the exception of the data for reference orifice R1 (circular symbols), the pressure coefficient differences were less than 0.01. A chip at the edge of reference orifice R1 may have adversely affected the pressure measurement at that location. The other three orifice test locations consistently measured slightly higher pressure than the center orifices indicating slight vertical pressure gradients. However, these gradients were not large enough to mask the effects of the test orifice installations. The data for the test configurations will not be corrected for these small pressure gradients.

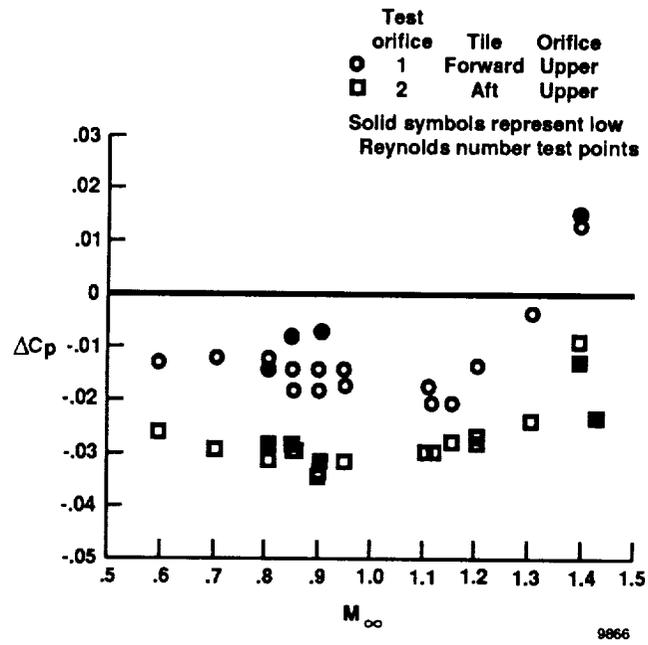
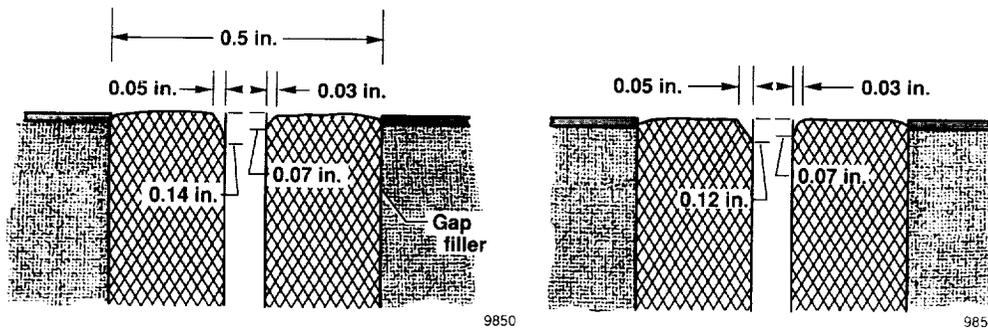
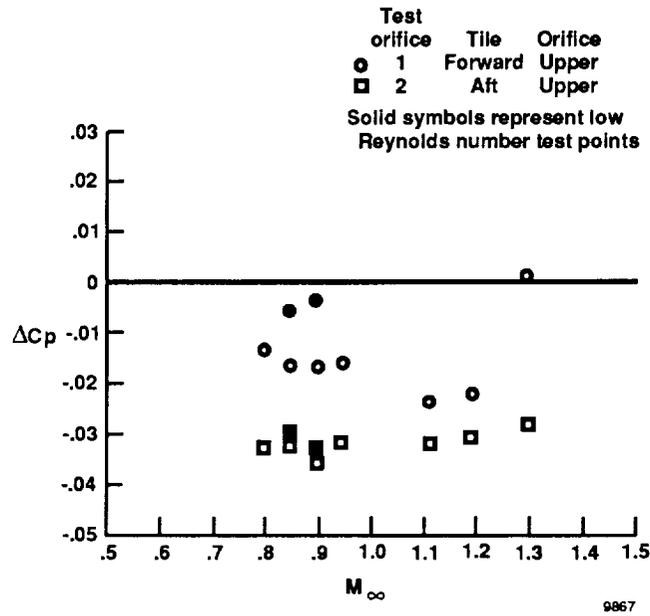
Figure 12. Measurements for test orifices 1 and 2.

(a) The ΔC_p with the BLTD.

(b) Test orifices 1 and 2.

(c) The ΔC_p without the BLTD.

Test orifices 1, 2, 3, and 4 had nearly flush gap filler and showed similar results. Orifices 1 and 2 were installed on tiles with SIP. Because of the similarity of the results between orifices mounted on SIP and those not mounted on SIP, it was determined that the SIP had no affect on the results. The magnitude of the test orifice errors was less than $0.03 C_p$ for the orifices in the forward test section. An error of between $-0.01 C_p$ and $-0.04 C_p$ was observed for the orifices in the aft test section. These results can be seen in figures 12 and 13.

The aft test locations consistently showed a ΔC_p 0.02 more negative than the forward test locations. The lowest (most extreme) ΔC_p values tended to occur near Mach 0.9. The differences in local pressure at the test sections, as well as slight differences in the orifice installations, are believed to cause the discrepancy between the forward and aft test locations. The scatter in the data for each orifice is mostly attributed to the affects of Reynolds number.

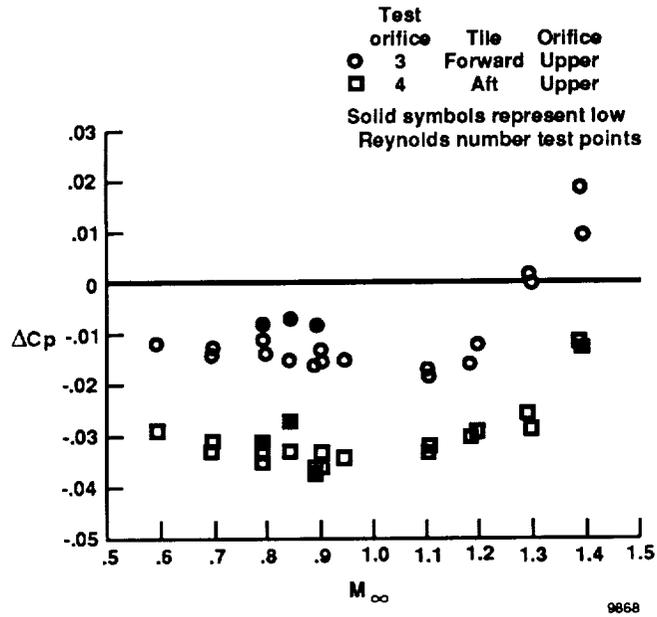
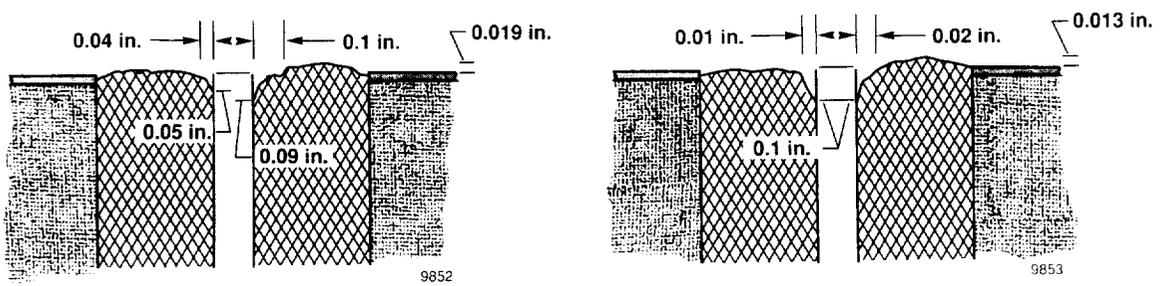
Figure 13. Measurements for test orifices 3 and 4.

(a) The ΔC_p with the BLTD.

(b) Test orifices 3 and 4.

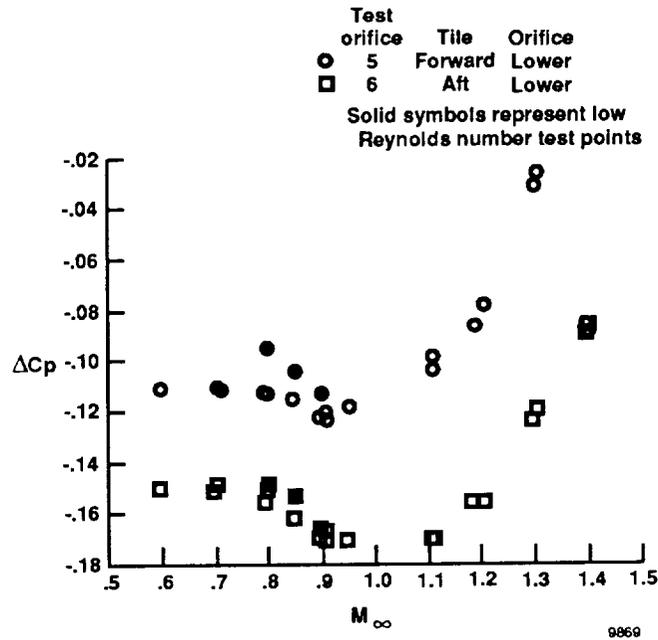
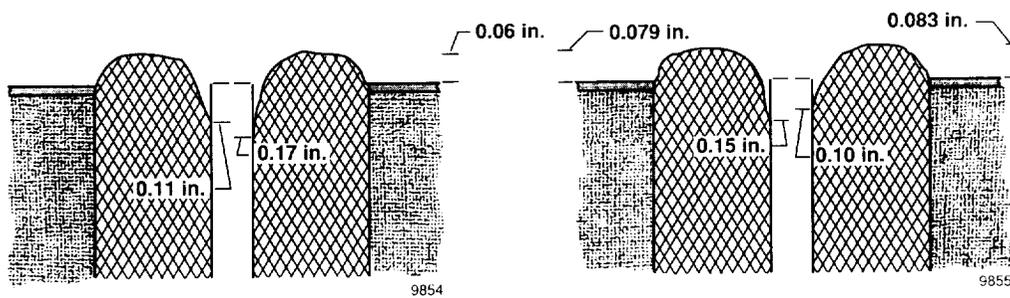
Figure 14. Measurements for test orifices 5 and 6.

(a) The ΔC_p without the BLF.

(b) Test orifices 5 and 6.

Test orifices 5 and 6 both had an excessive amount of gap filler protruding above the tile surface. The ΔC_p values for their test orifices are plotted in figure 14. The maximum magnitude of the ΔC_p values was approximately -0.12 for the forward location (orifice 5) and -0.17 for the aft location (orifice 6). The differences between the forward and aft test locations increased with Mach number, from $0.04 \Delta C_p$ at the low Mach numbers to $0.09 \Delta C_p$ at the high Mach numbers.

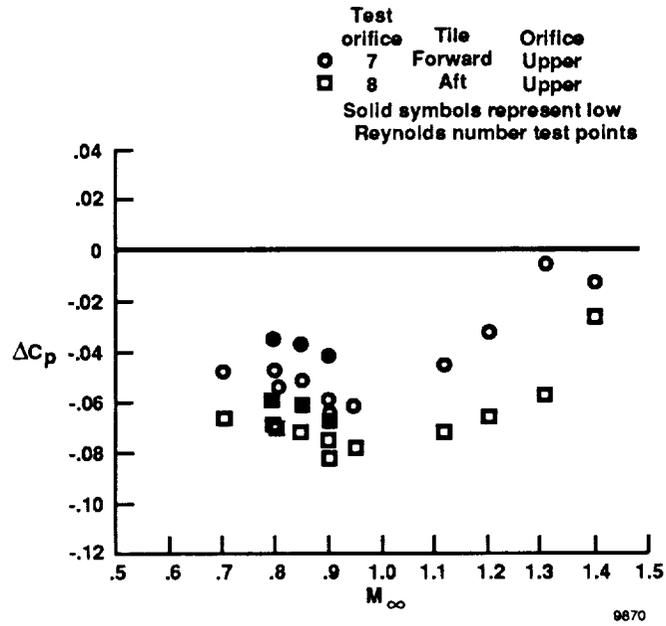
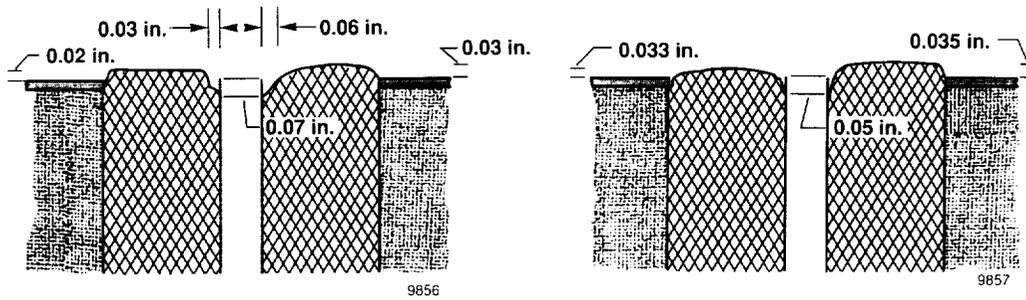
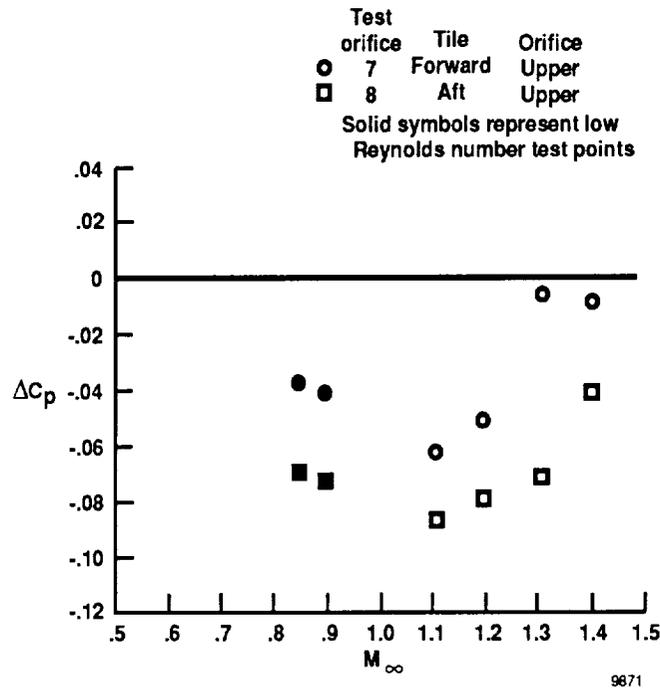
Figure 15. Measurements for test orifices 7 and 8.

(a) The ΔC_p with the BLTD.

(b) Test orifices 7 and 8.

(c) The ΔC_p without the BLTD.

Figure 15 shows data for test orifices 7 and 8. On these orifices, the gap filler protruded slightly above the tile surface. The height of the gap filler above the tile surface was less than that for orifices 5 and 6, therefore the magnitudes of the ΔC_p values were also less. The most extreme ΔC_p values were about -0.08 . The aft location (orifice 8) had ΔC_p values of 0.02 to 0.04 more negative than the forward location (orifice 7).

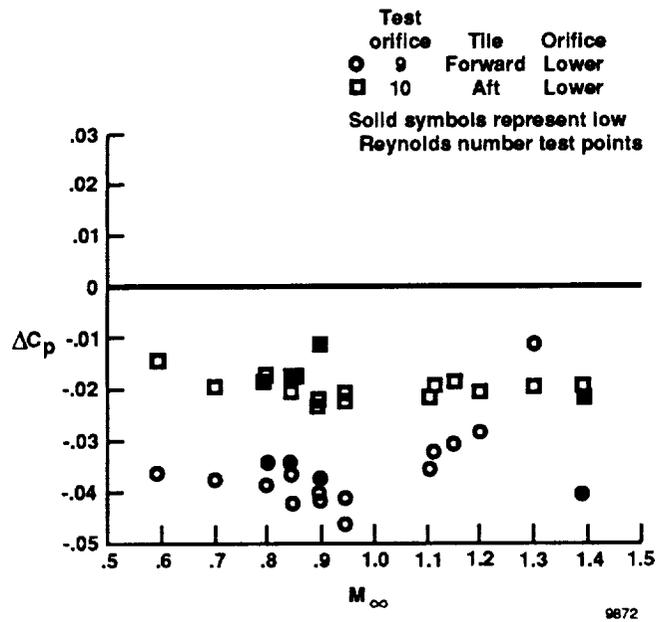
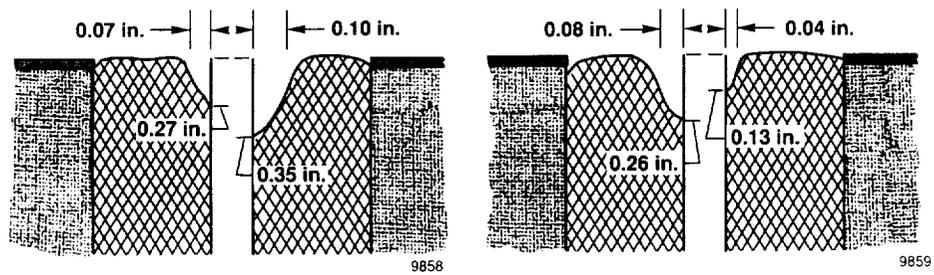
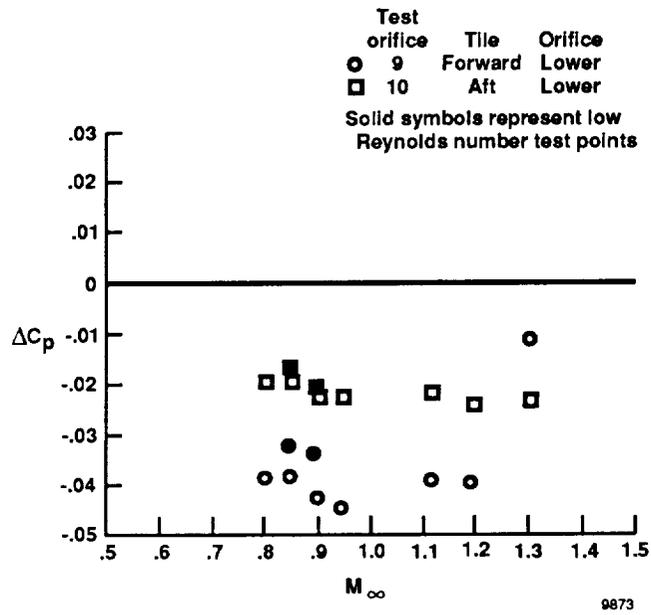
Figure 16. Measurements for test orifices 9 and 10.

(a) The ΔC_p with the BLTD.

(b) Test orifices 9 and 10.

(c) The ΔC_p without the BLTD.

Data for test orifices 9 and 10 are shown in figure 16. These orifices contained gap filler recessed beneath the tile surface and around the pressure tubing. The most extreme ΔC_p values were about -0.05 . Unlike the previous orifices, the aft location (orifice 10) showed a less extreme ΔC_p value than the forward location (orifice 9). The influence of Mach number on ΔC_p for these orifice anomalies was significantly less than for the protruding gap filler anomalies.

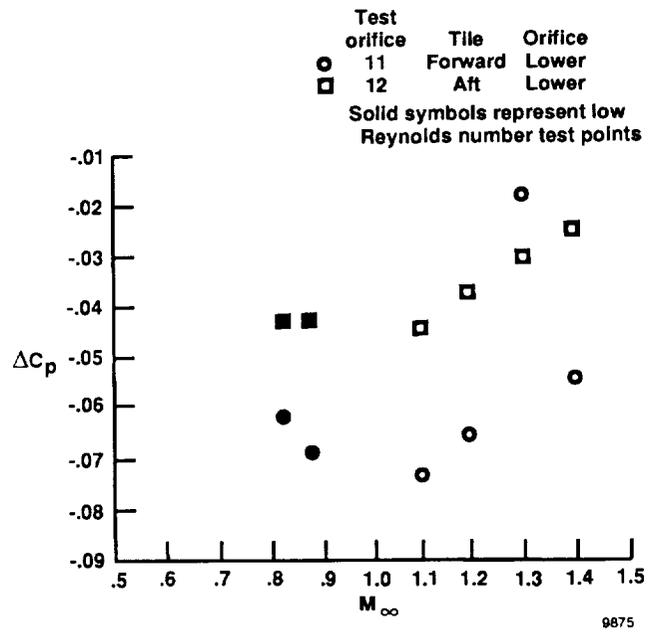
Figure 17. Concluded.

(c) The ΔC_p without the BLTD.

Test orifices 11 and 12 contained gap filler recessed beneath the surface but also had a slight amount of gap filler protruding at the edges of the orifice. The results are shown in figure 17 with ΔC_p s between -0.04 and -0.09 at the low Mach numbers and between -0.01 and -0.05 at the higher Mach numbers. These ΔC_p values were considerably larger than those for the orifices with only recessed gap filler. The slight protrusion of gap filler, therefore, plays a significant role in adversely affecting the pressure measurement. As with the recessed gap filler orifices (9 and 10), the aft location (orifice 12) showed a smaller value of ΔC_p than the forward location (orifice 11). The difference in ΔC_p between the forward and aft locations was approximately 0.03.

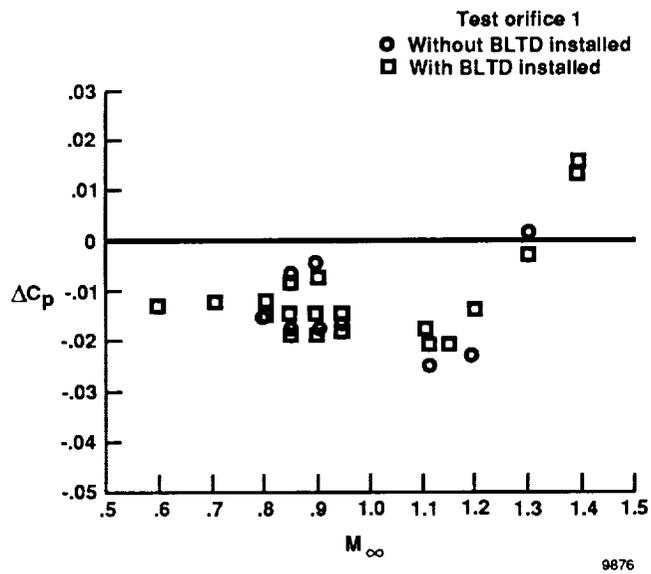
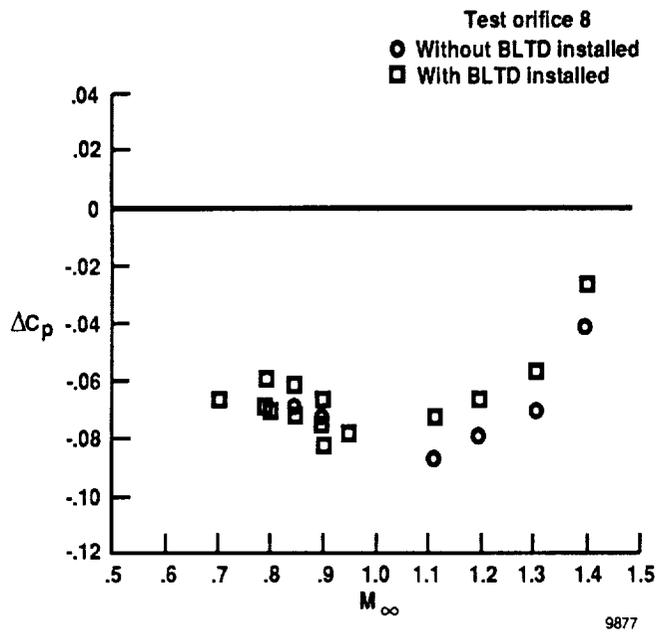
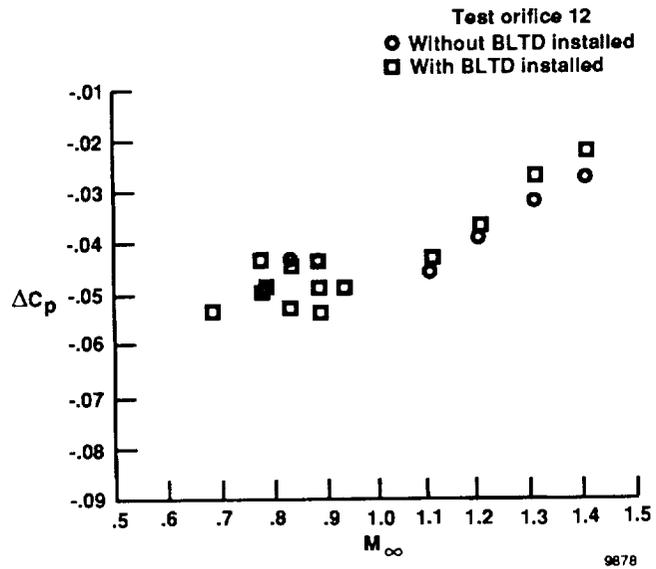
Figure 18. Affects of the BLTD on ΔC_p .

(a) Test orifice 1.

(b) Test orifice 8.

(c) Test orifice 12.

Figure 18 shows the affect of the BLTD on ΔC_p values for test orifices 1, 8, and 12. The thickened boundary layer had a small affect on the local differential pressure coefficients. The affect was largest for the supersonic test points, which in most cases showed a decrease in ΔC_p values (less negative) with the increased boundary-layer thickness. The results from the other orifices (figs. 12 to 17) show similar affects of increased boundary-layer thickness.

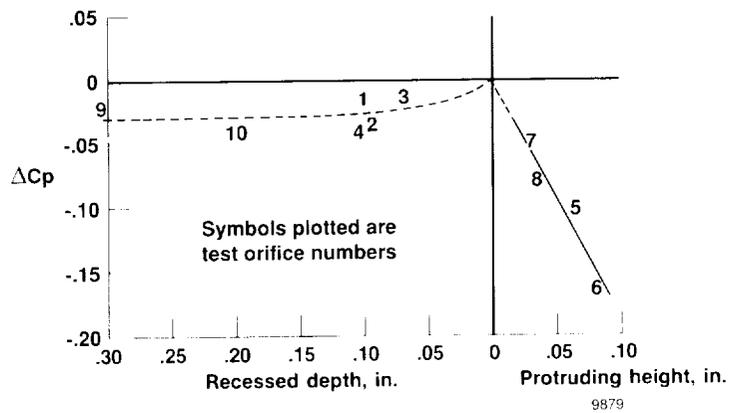
Figure 19. Affect of surface anomalies on orifice measurement errors.

Figures 12 through 17 show that ΔC_p is fairly constant for Mach numbers between approximately 0.7 and 1.2. As Mach number increased beyond 1.2, the affects of the orifice anomalies generally became less. Some ΔC_p values for gap filler anomalies could be approximately characterized by the amount of recession or protrusion of gap filler. These ΔC_p values are compiled in figure 19 and represent the average error for Mach numbers between 0.7 and 1.2. For the protruding gap filler cases, the error associated with the amount of protrusion seemed well defined. The approximate amount of error caused by the recessed gap filler showed no well defined trend. The ΔC_p s are negative, in agreement with results from Gracey (1980). The flushness of the orifice is critical to accurate pressure measurements, and protruding gap filler is a more serious problem than recessed filler.
