**SHUTTLE ENTRY AIR DATA SYSTEM
(SEADS)
HARDWARE DEVELOPMENT
VOLUME I, SUMMARY**

JANUARY 1983

**PREPARED BY
D. M. WHILE
VOUGHT CORPORATION
DALLAS, TEXAS**

Langley Research Center
Hampton, Virginia 23665

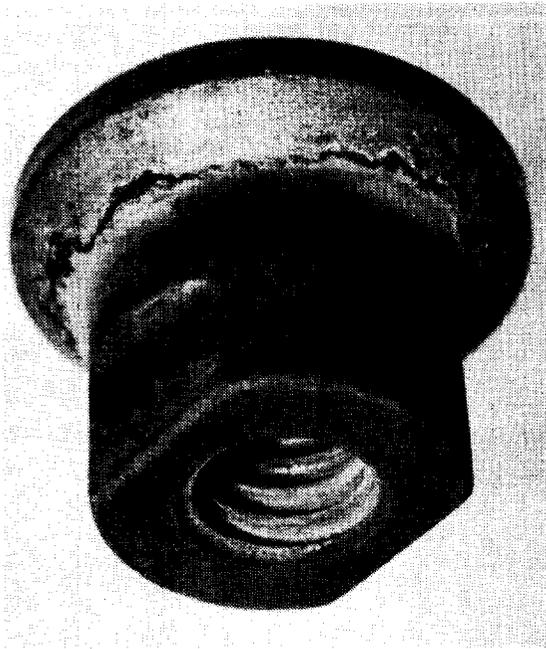
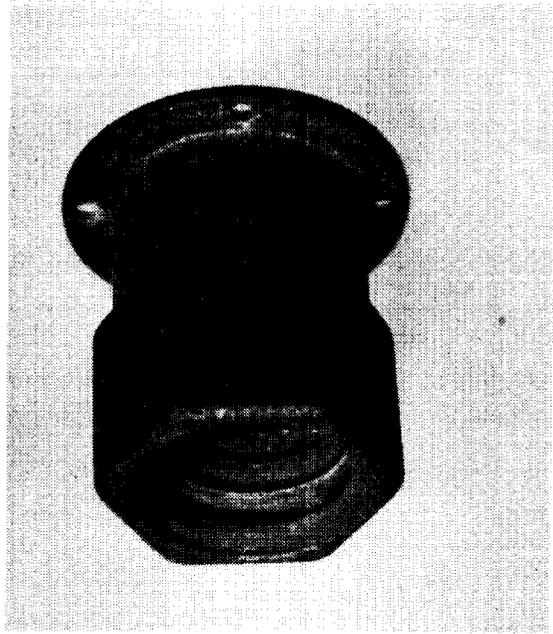
Figure 5-12 Port and Nut at Conclusion of NASA-ARC Test

Inspection of disassembled components (Figures 5-12 through 5-16) produced no observable oxidation damage to parts except a shiny spot on a union thread (without the accompanying oxidation "flowering") and the expected oxidation scalloping of the flared end of the pressure tube, Figure 5-14. It was discovered, however, that the iridium thermocouple mount and coated columbium lockwasher reacted, producing damage to both parts, Figure 5-16. This was not encountered in previous tests, nor was it encountered on the iridium lockwire for this test model. This reaction is somewhat academic, however, due to both the temperature overshoot and the exclusion of a thermocouple mount from the production design penetration assembly.
