Composite Transport Wing Technology Development

*Design Development Tests and
Advanced Structural Concepts*

Charles F. Griffin and William E. Harvill
*Lockheed Aeronautical Systems Company
Burbank, California*

Prepared for
Langley Research Center
under Contract NAS1-17699

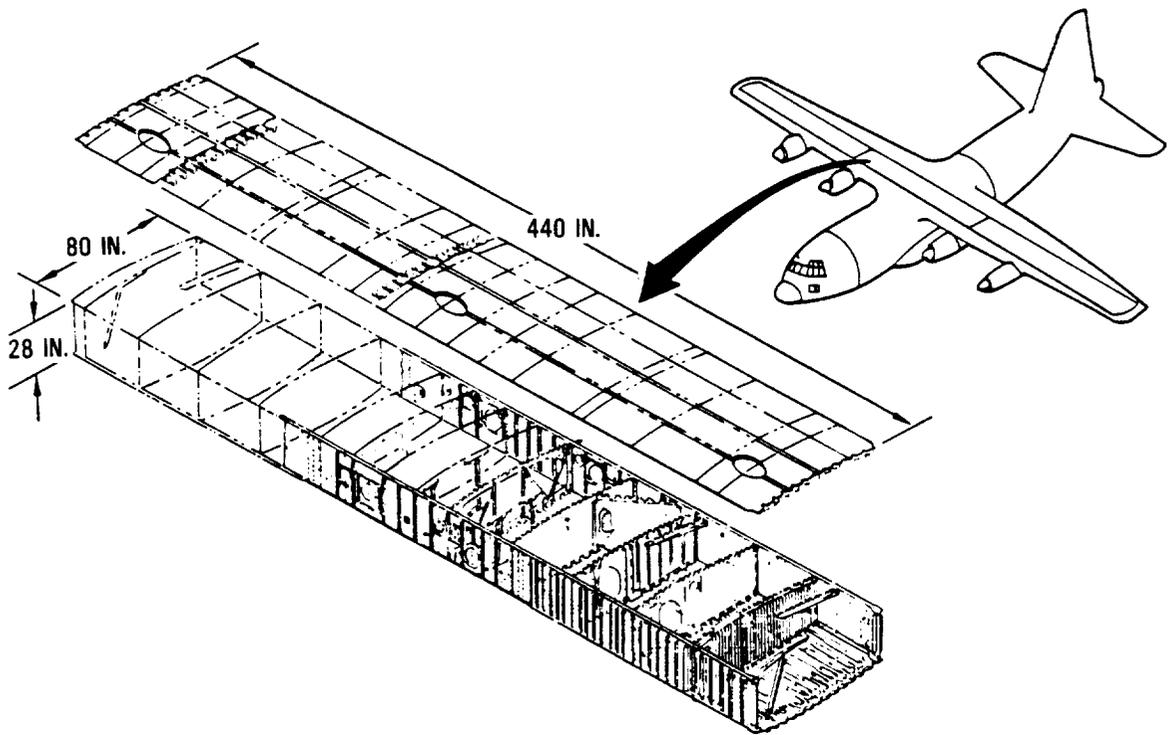
Figure 1. - Existing Lockheed C-130 center wing - metallic design.

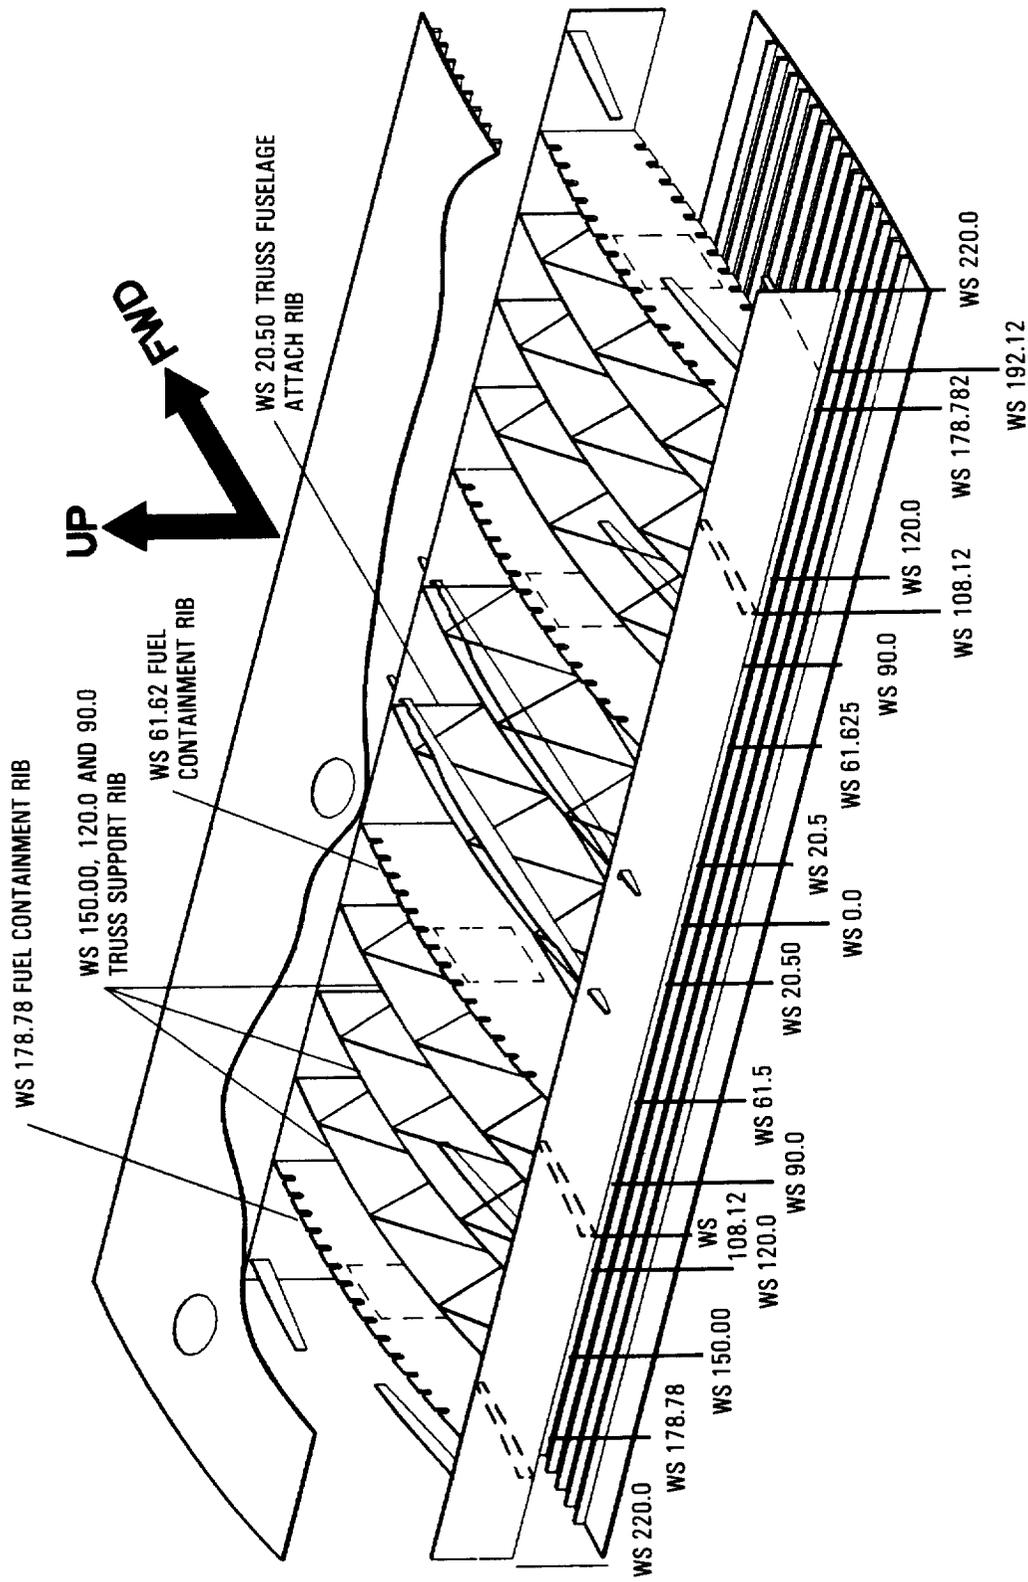
Figure 2. - Wing box assembly.

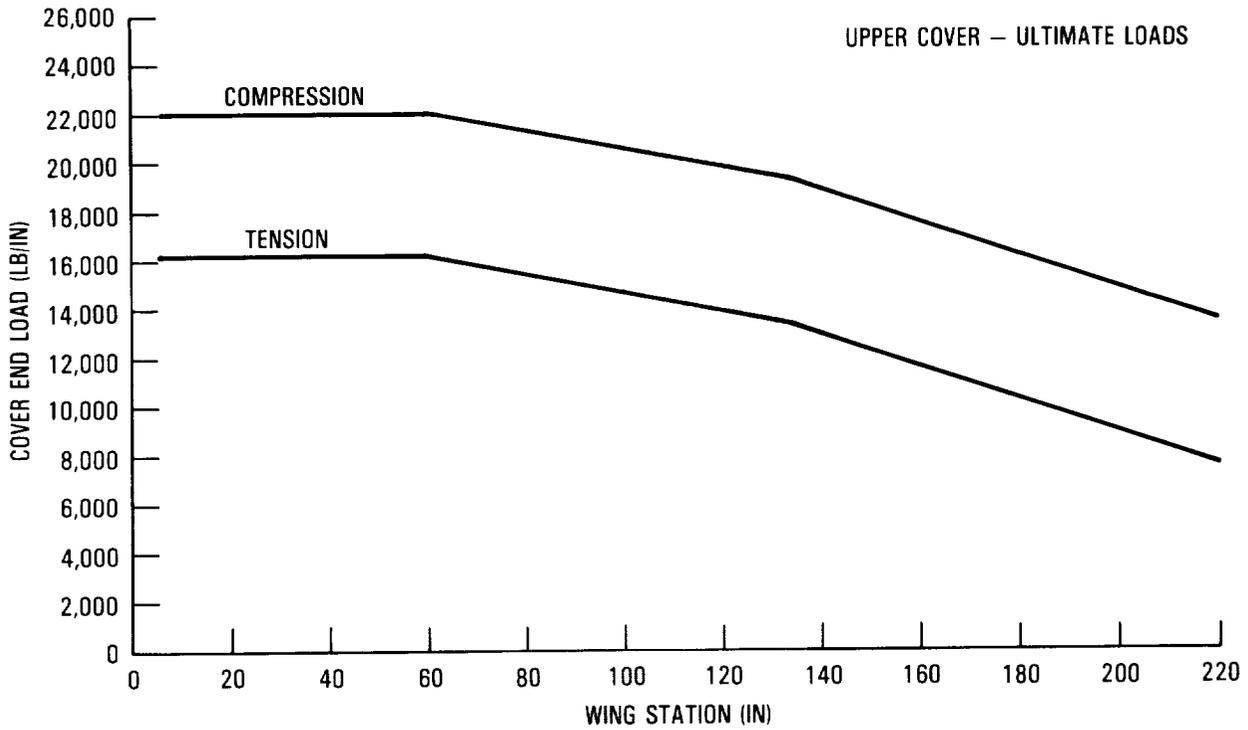
Figure 3. - Cover end loads.

The design loads for the composite wing box are based on the baseline aircraft requirements. Figure 3 presents the maximum spanwise cover end loads as a function of wing station. The maximum level of 22,000 lb/in. is a relatively high value which is representative of design load levels for current and future transport aircraft. The maximum surface loads are developed for an up bending condition which puts the upper cover in compression and the lower cover in tension. Combined with the spanwise loads are inplane shear loads, which have a magnitude less than 20 percent of the axial load and pressure loads due to beam bending curvature and fuel pressures.

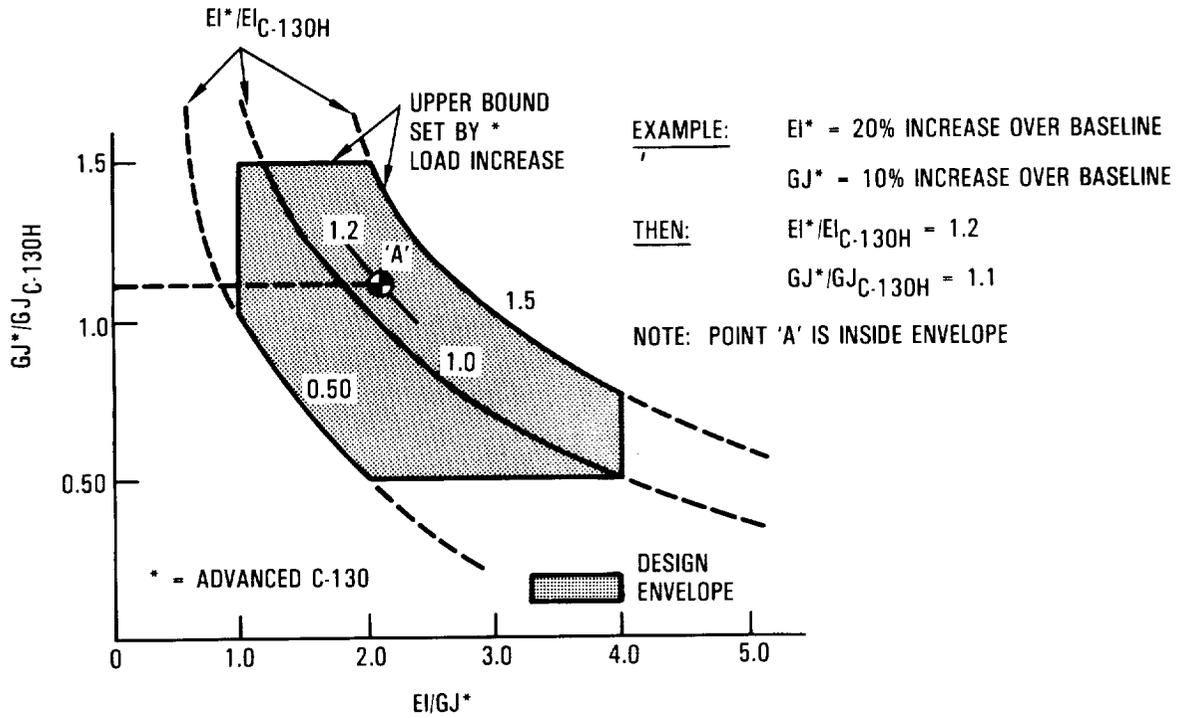
Figure 4. - Flutter envelope.

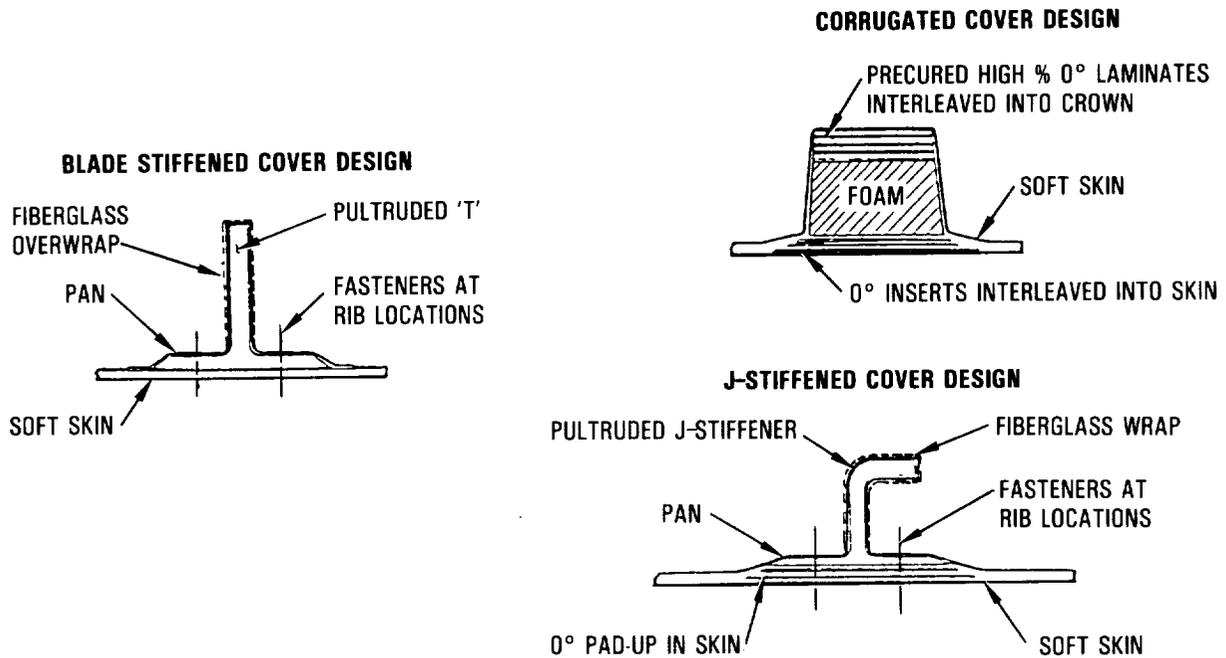
Figure 5. - Cover designs.

The blade stiffened skin represents one of the simplest designs from the manufacturing standpoint. The design consists of a pultruded stiffener cocured to a uniform thickness skin. The shape of the stiffener simplifies fuel sealing where the stiffener penetrates the fuel bulkhead. With this design, the stiffener carries most of the axial load since the skin has been configured with a high percentage of ± 45 degree material to enhance damage tolerance.

The second design is a corrugated skin. This design offers good structural efficiency because the high modulus material can be optimally placed to achieve the required panel bending stiffness for stability. However, the structural efficiency of the design is severely reduced by manufacturing considerations which include a discontinuous inner skin which is lapped at the crown of the stiffener. The discontinuous inner skin is required to simplify layup and eliminate the possibility of bridging in the radii of the stiffener. Furthermore, the stiffener must be filled with foam to eliminate the need for mandrels during fabrication and to prevent fuel transfer from the wet bay to dry bay areas of the wing.

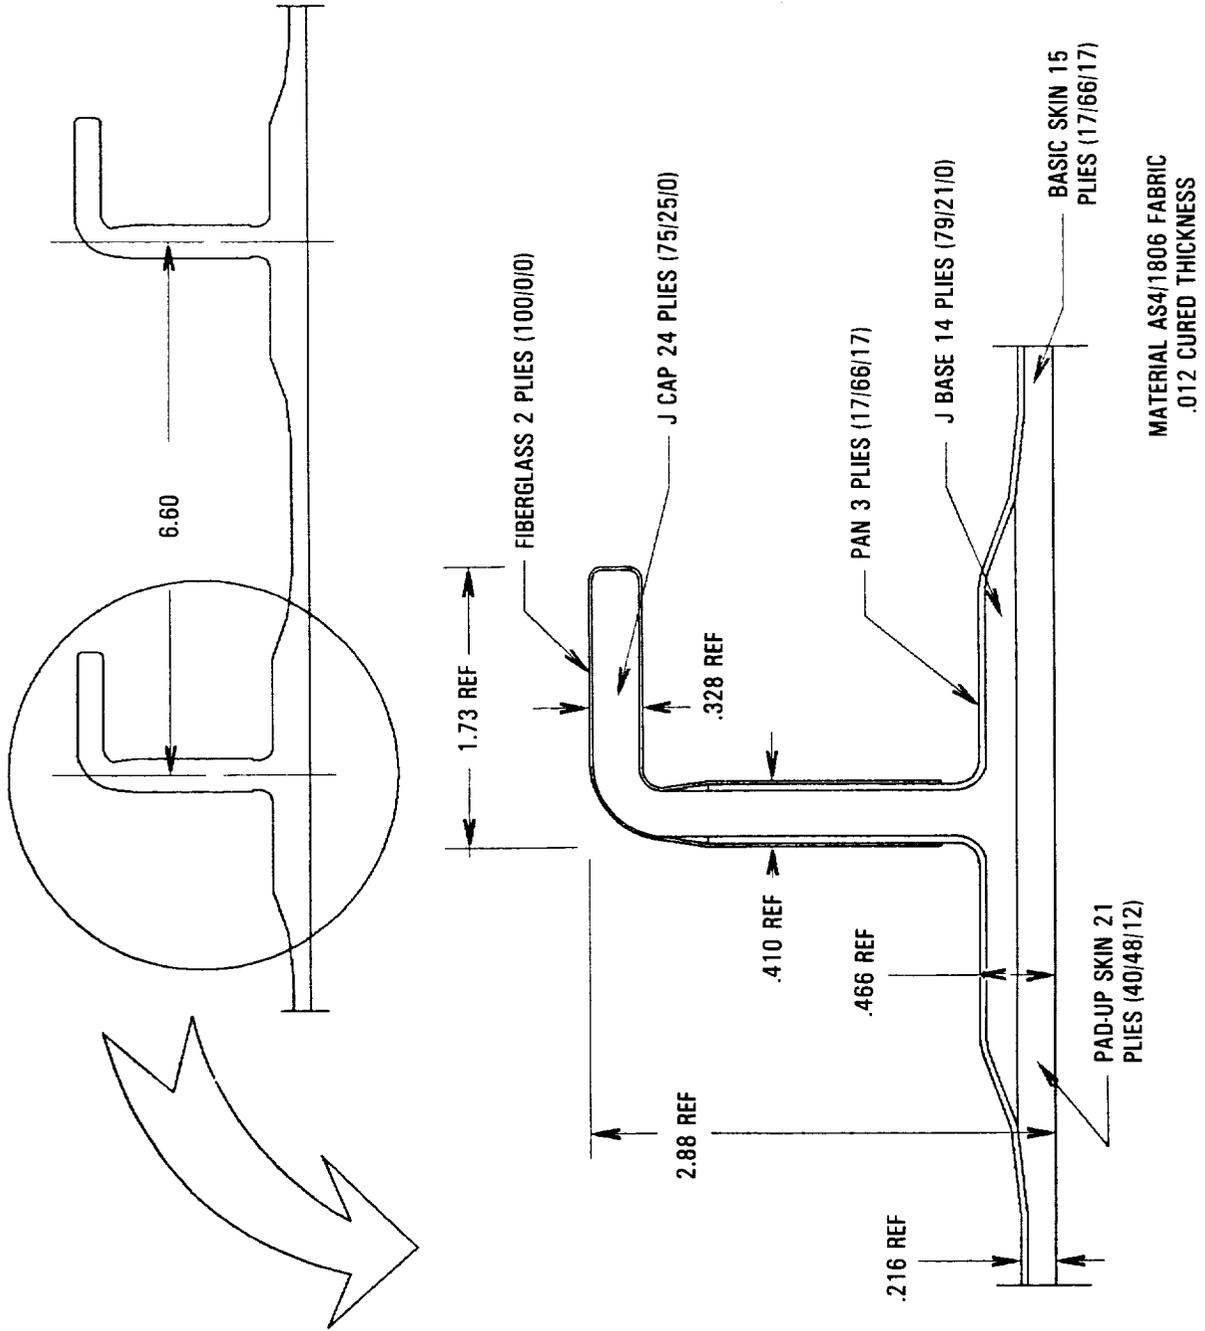
Figure 6. - J-Stiffened panel design.

The test panel design, shown in figure 6, has several unique design features. The principal load carrying element within the panel is the J-stiffener which contains 75 percent 0° plies and 25 percent $\pm 45^\circ$ plies. The stiffener was designed to be pultruded or contact molded and machined prior to being cobonded to the skin laminate. The skin laminate is a "soft" configuration consisting of 16.7 percent 0° plies. Panel optimization studies indicated that the soft skin was most efficient for compression stability and is inherently resistant to delamination due to impact damage. Six 0° plies are interleaved into the skin at the base of the stiffener as a pad-up.

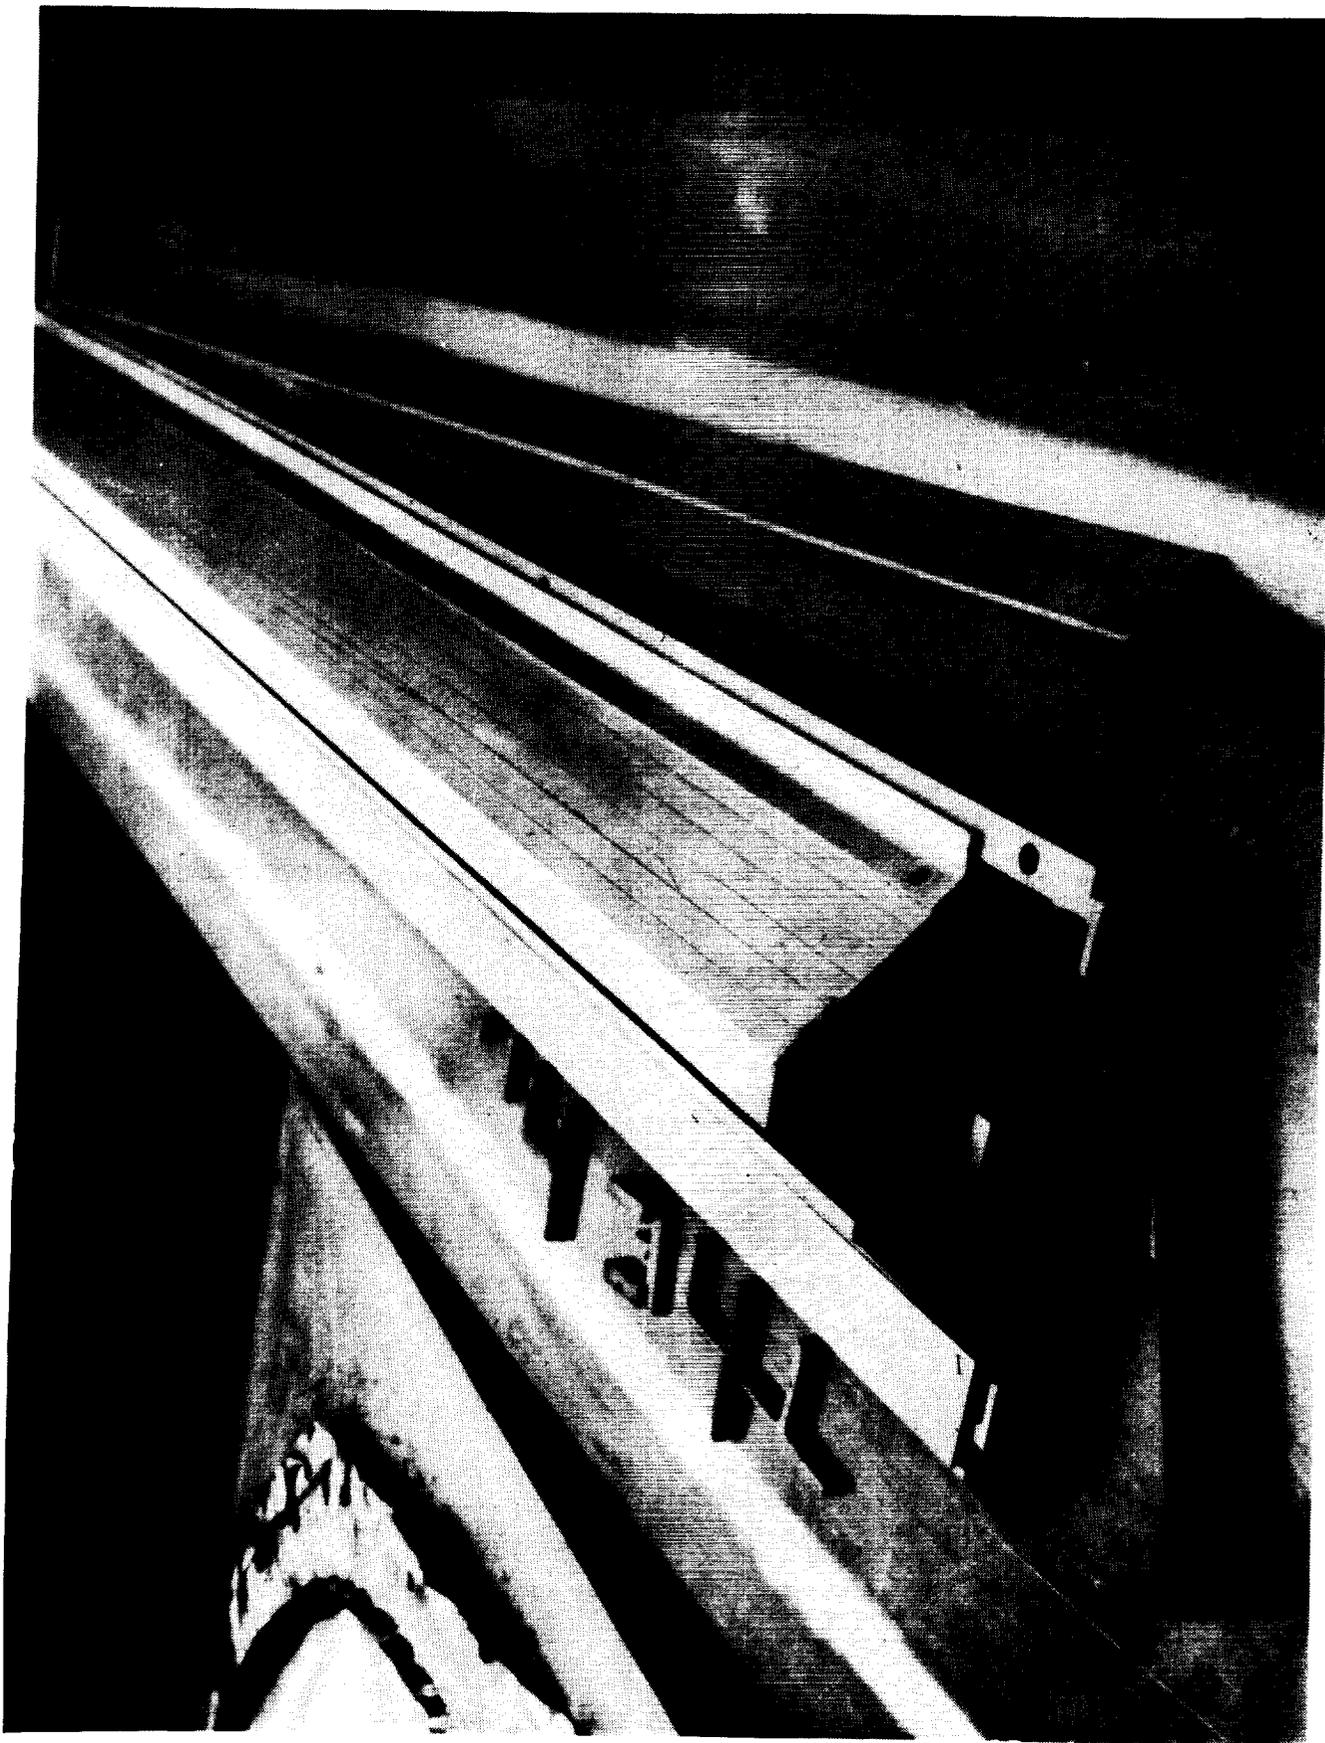
Figure 7. - Stiffener tool (Sheet 1 of 2).

Figure 7. - Stiffener tool (Sheet 2 of 2).

For the test panels, the J-stiffeners were formed by combining three pieces; a 'Z' section, a 'C' section and a flat base. Separate lay-up blocks were employed for each detail. Each piece was vacuum debulked at room temperature for 20 minutes. The details were then assembled in a curing tool, shown in figure 7, and cured in an autoclave. After being cured, the J-stiffeners were ultrasonically inspected and machined to the proper dimensions for the next step in the panel assembly.

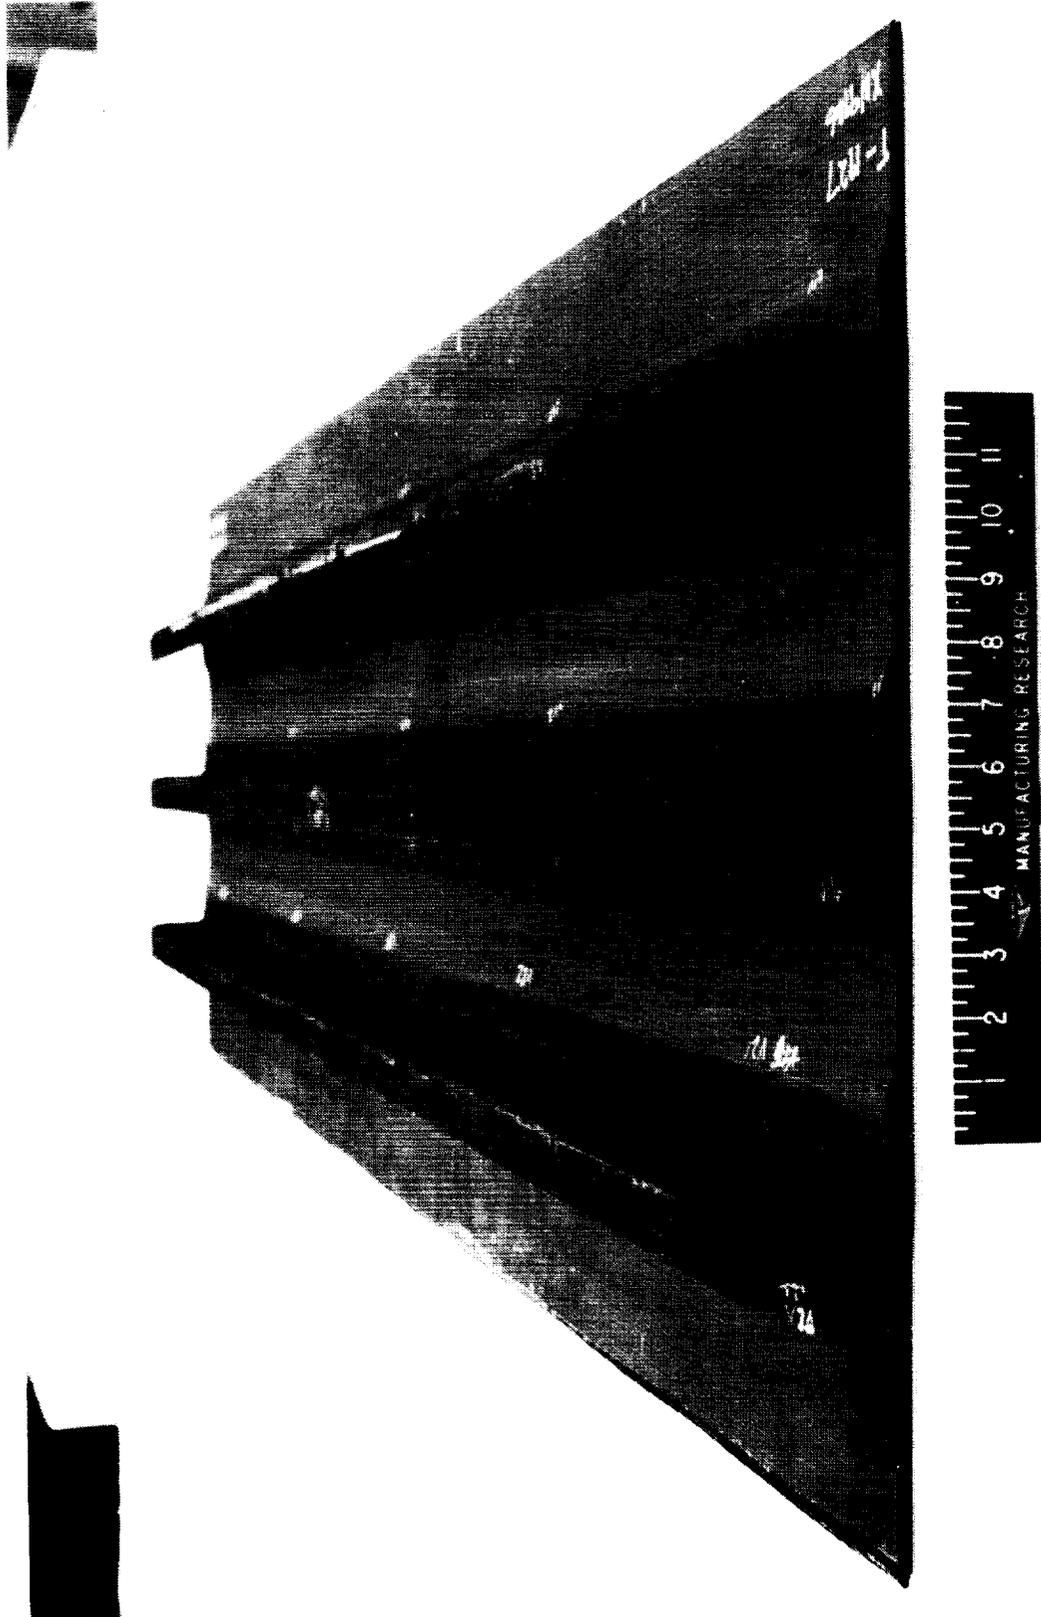
Figure 8. - J-stiffened panel.

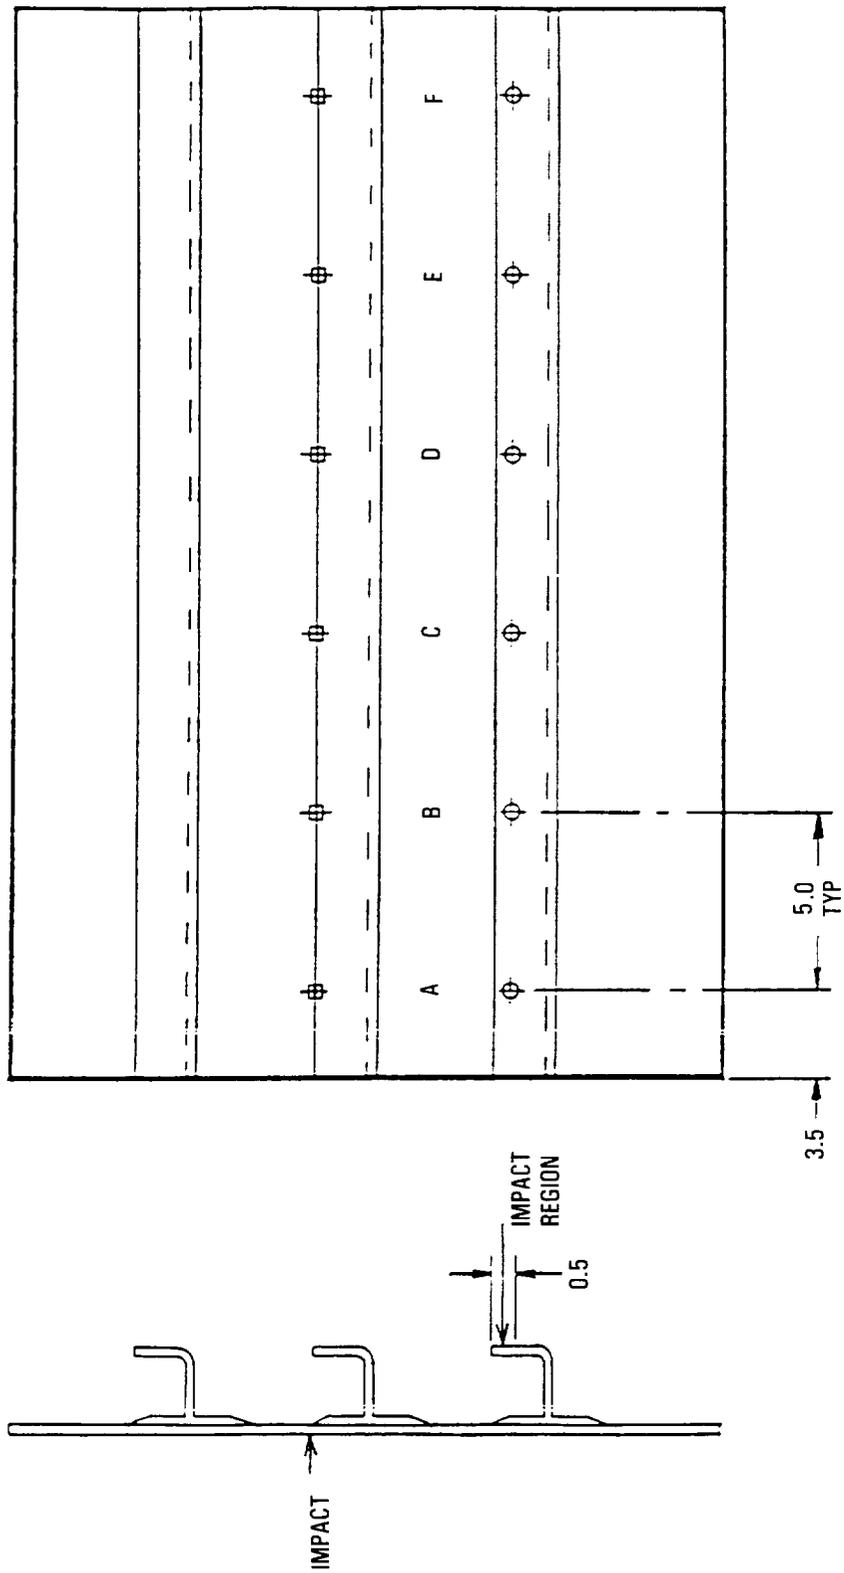
Figure 9. - Impact locations on test panel.

A J-stiffened panel was impacted at numerous locations to determine the relationship between impact energy and the amount of damage. From previous tests, it had been determined that impact damage to the stiffener flange or to the skin/stiffener interface caused the largest reduction in compression strength. The panel was impacted at these locations, see figure 9, using a 12 pound drop weight having a 1.0-inch-diameter-hemispherical tup. For all impacts, the panel was clamped between wooden blocks as shown in figure 10. The spacing between the interior pair of blocks was 8.0 inches.

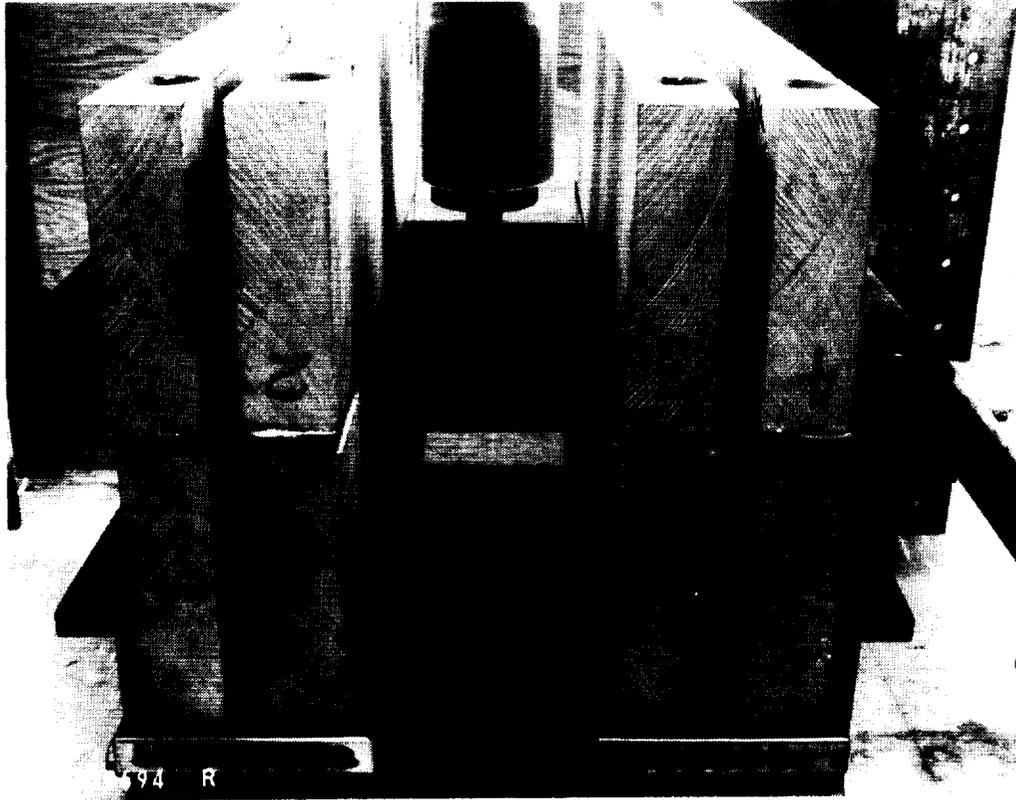
Figure 10. - Impact test fixture.

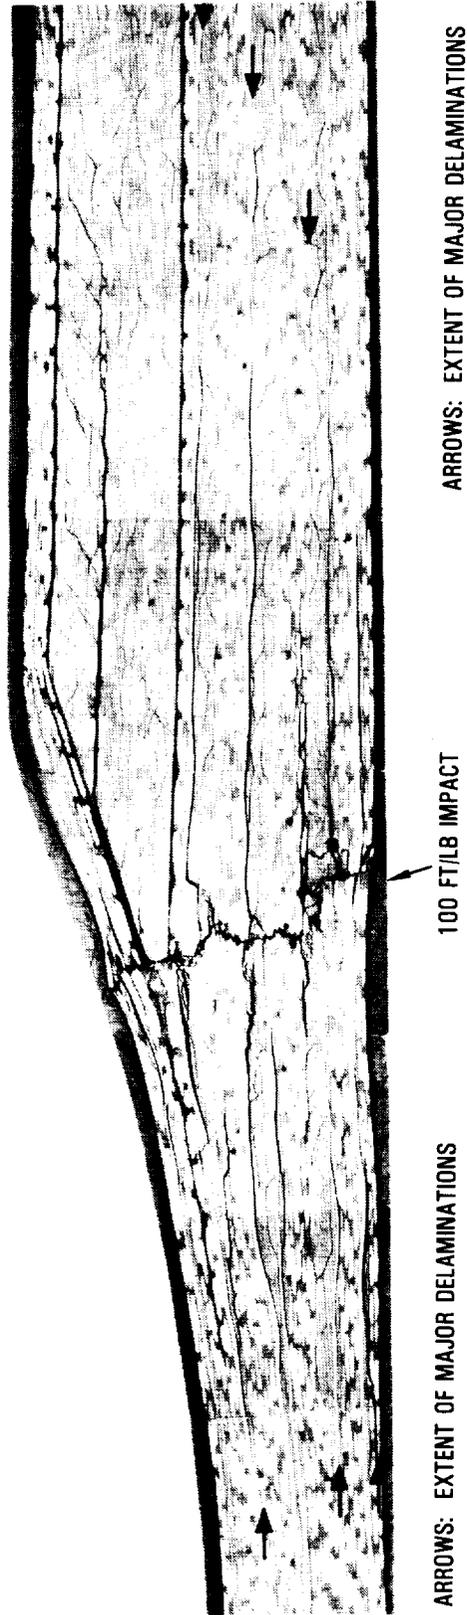
Figure 11. - Photomicrograph of skin impact damage to J-stiffened panel.

After the panel was impacted, it was visually and ultrasonically inspected. A summary of the data from these inspections is shown in Table 3. The impacts to the outside surface of the panel at the skin/stiffener interface caused very little visual damage, even at the higher impact energies. It is interesting to note that, based on the ultrasonic inspections, the 100 ft-lb impact caused less damage than did the 80 ft-lb impact. This behavior has been seen on other stiffened panels. At 100 ft-lb, the impactor partially punctures the surface, as evidenced by the broken fibers on the outside surface. It is theorized that partial puncture reduces the laminate deformation and, thus, the extent of the interlaminar and translaminar damage is decreased. However, the local damage to the laminate, under the head of the impactor, is greater. A micrographic inspection made of a section of the laminate cut through the 100 ft-lb impact damage area is shown in figure 11.

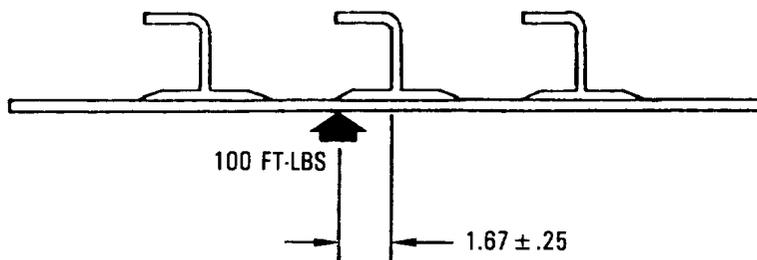
Figure 14. - Impact locations on skin of three stiffener panel.

A second 20.8-inch-wide, three stiffener panel was impacted on the skin as shown in figure 14. The 100 ft-lb impact resulted in a 0.017 inch deep dent which was clearly visible on the unpainted surface. A slight crack was observed on the other side of the panel. Ultrasonic inspections indicated a delamination area of 7.24 in.².

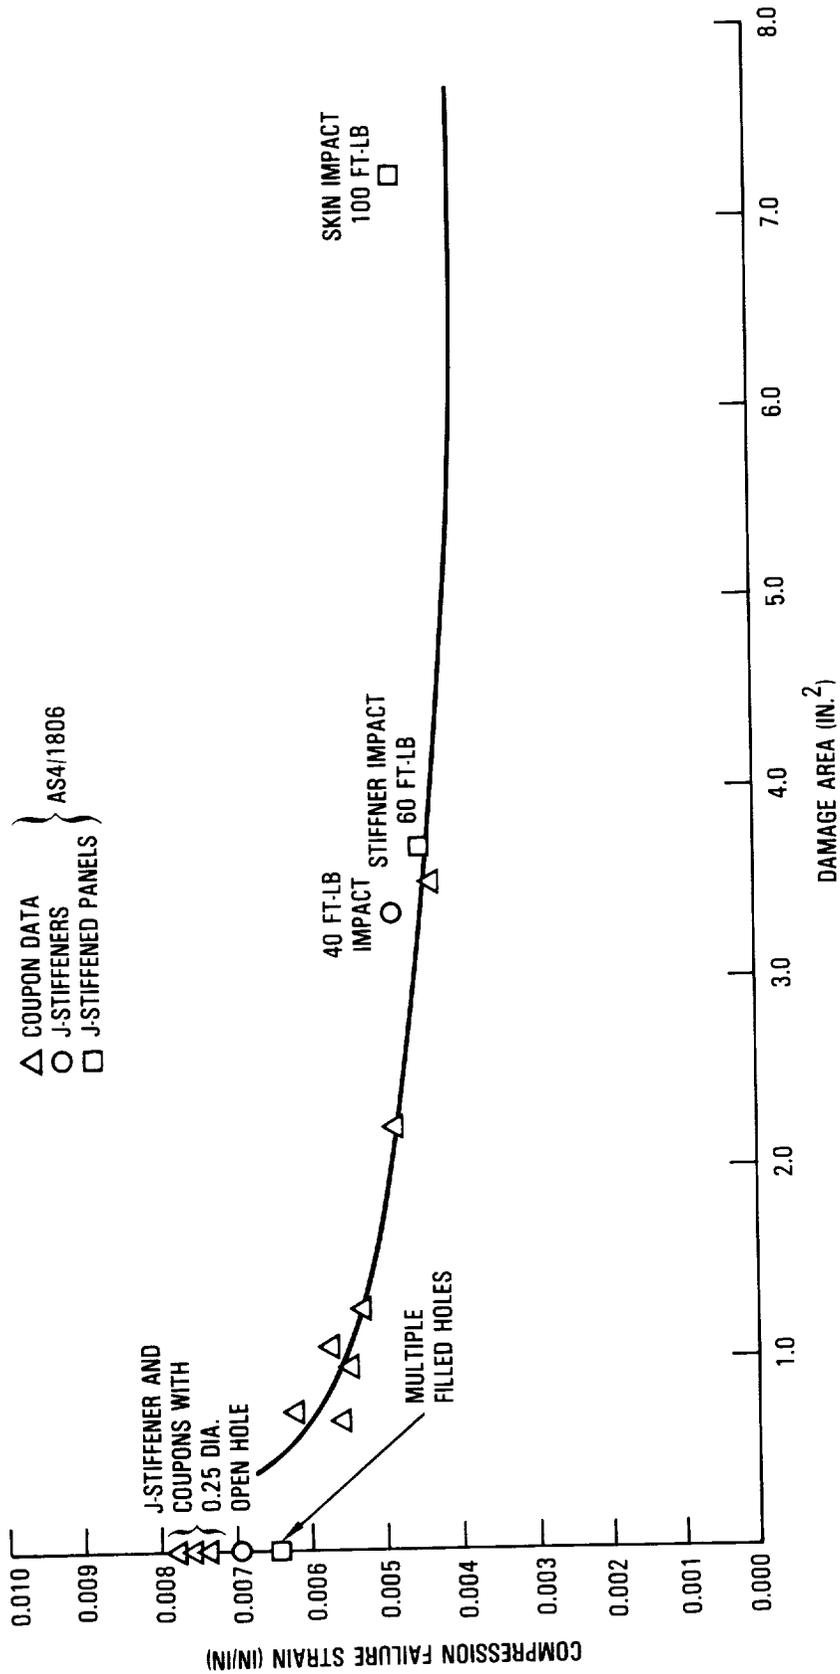
Figure 15. - Comparison of coupon data to J-stiffened panel data.

As a part of a Lockheed funded program, tests were conducted on coupons and J-stiffeners constructed with AS4/1806. Figure 15 compares these data with the results obtained on the J-stiffened panels. Compression failure strains are plotted as a function of the impact damage areas which were obtained from ultrasonic inspections. Note that the data plotted on the ordinate is from test specimens which contain 0.25 inch diameter holes to represent the effects of fasteners. A curve was faired through the coupon data and extrapolated to very large damage sizes. Two observations are made. First, both the notched J-stiffeners and the J-stiffened panel containing fastener holes failed at lower strains than would have been predicted from the

notched coupon data. Secondly, the impacted J-stiffeners and stiffened panels failed at higher strains than the curve would predict. Accurate methods for predicting the strength of impacted panels need to be developed.

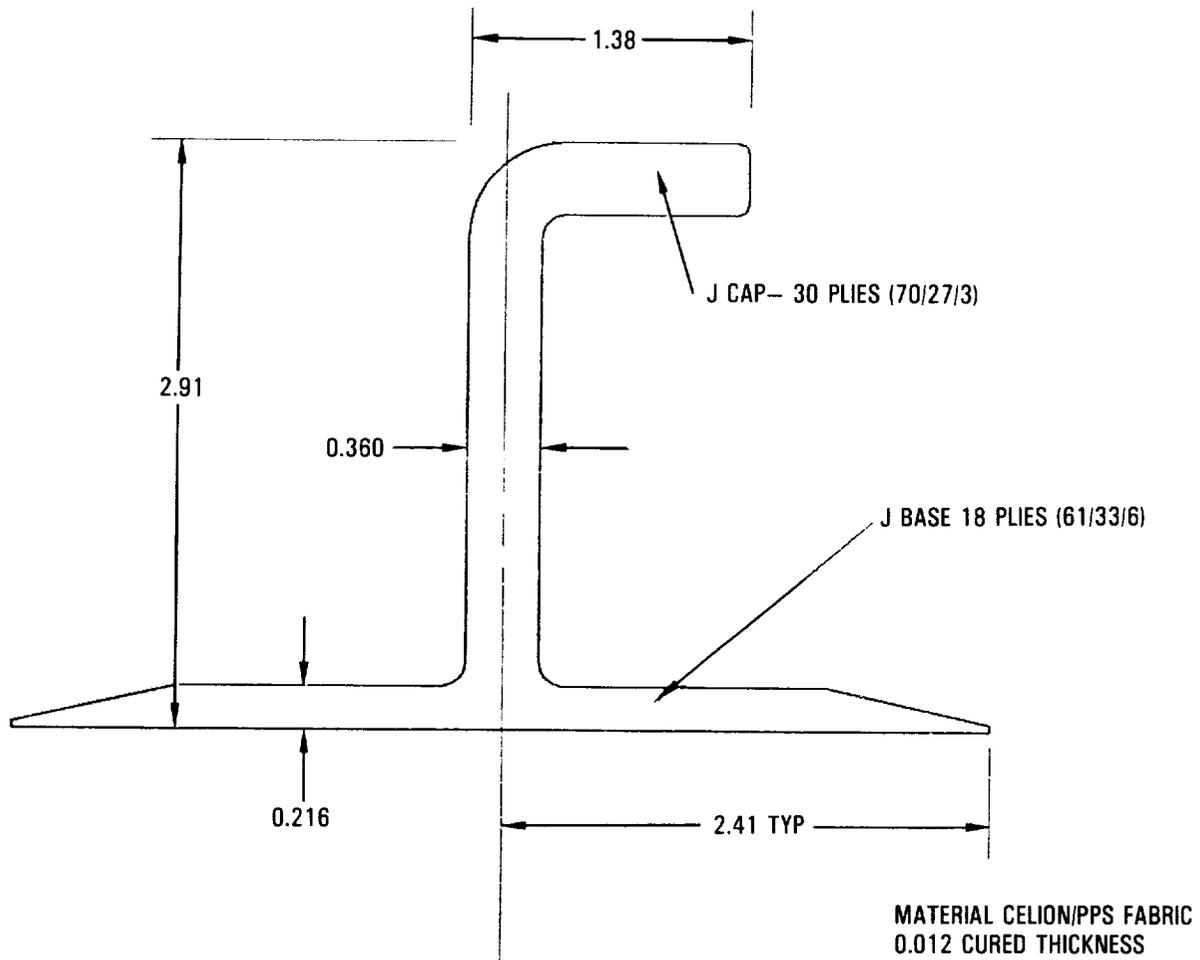
Figure 16. - Thermoplastic J-stiffener designs.

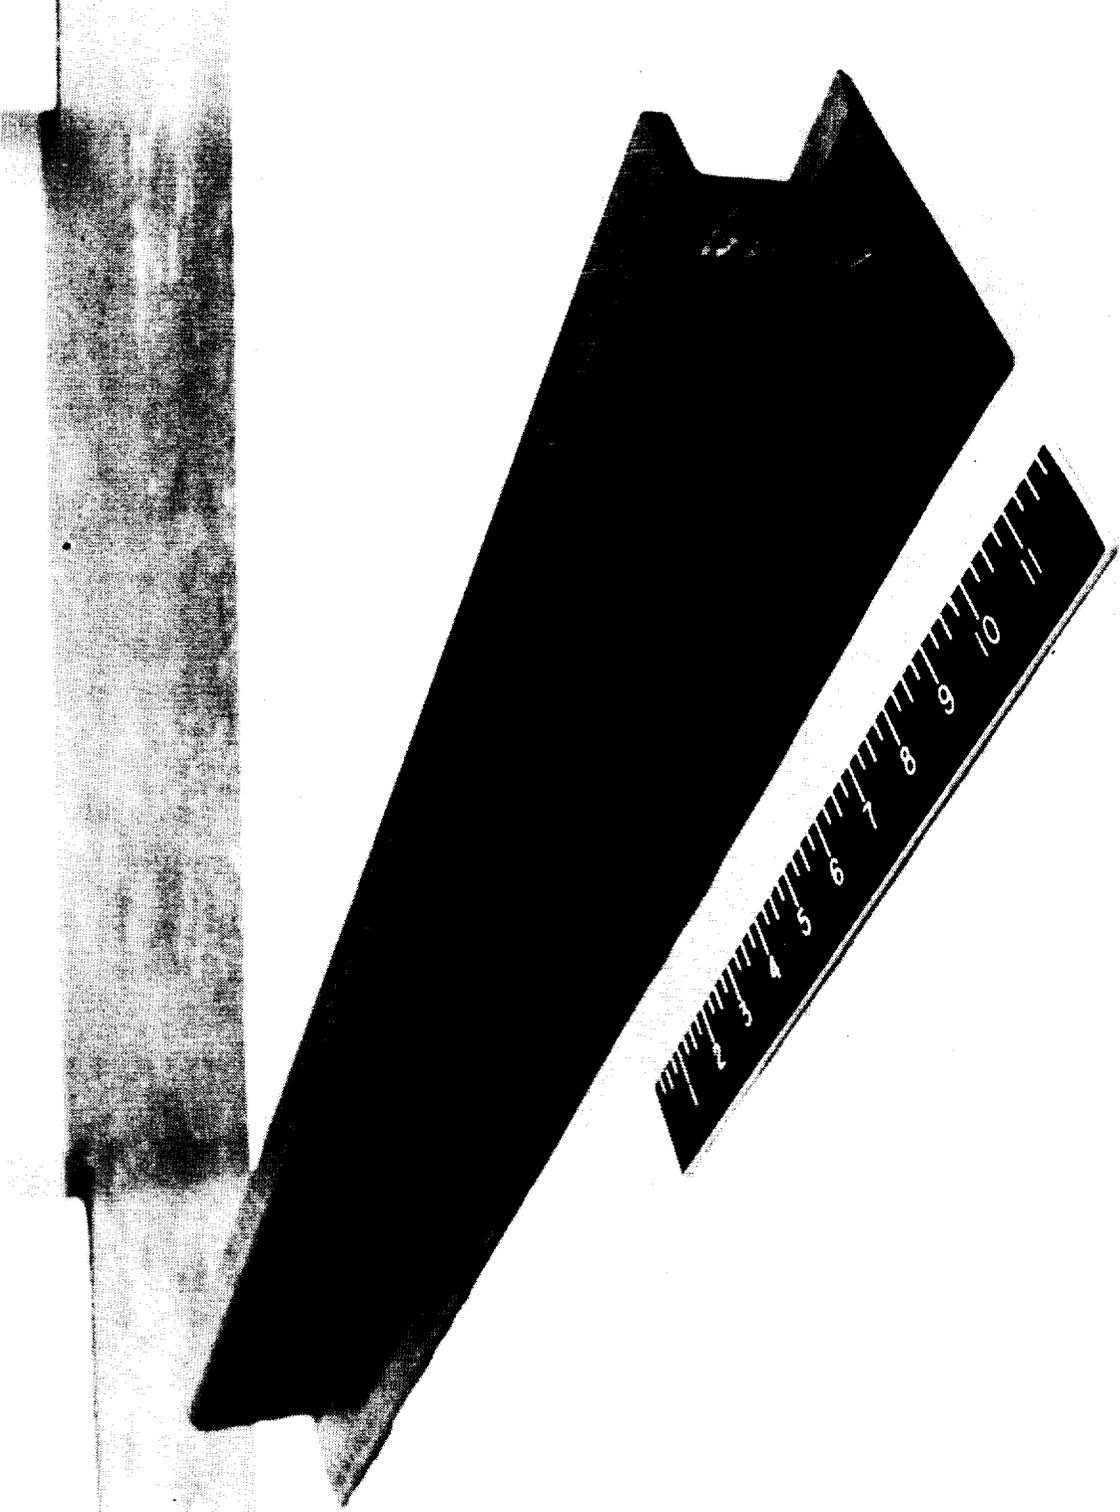
Figure 17. - Thermoplastic J-stiffeners.

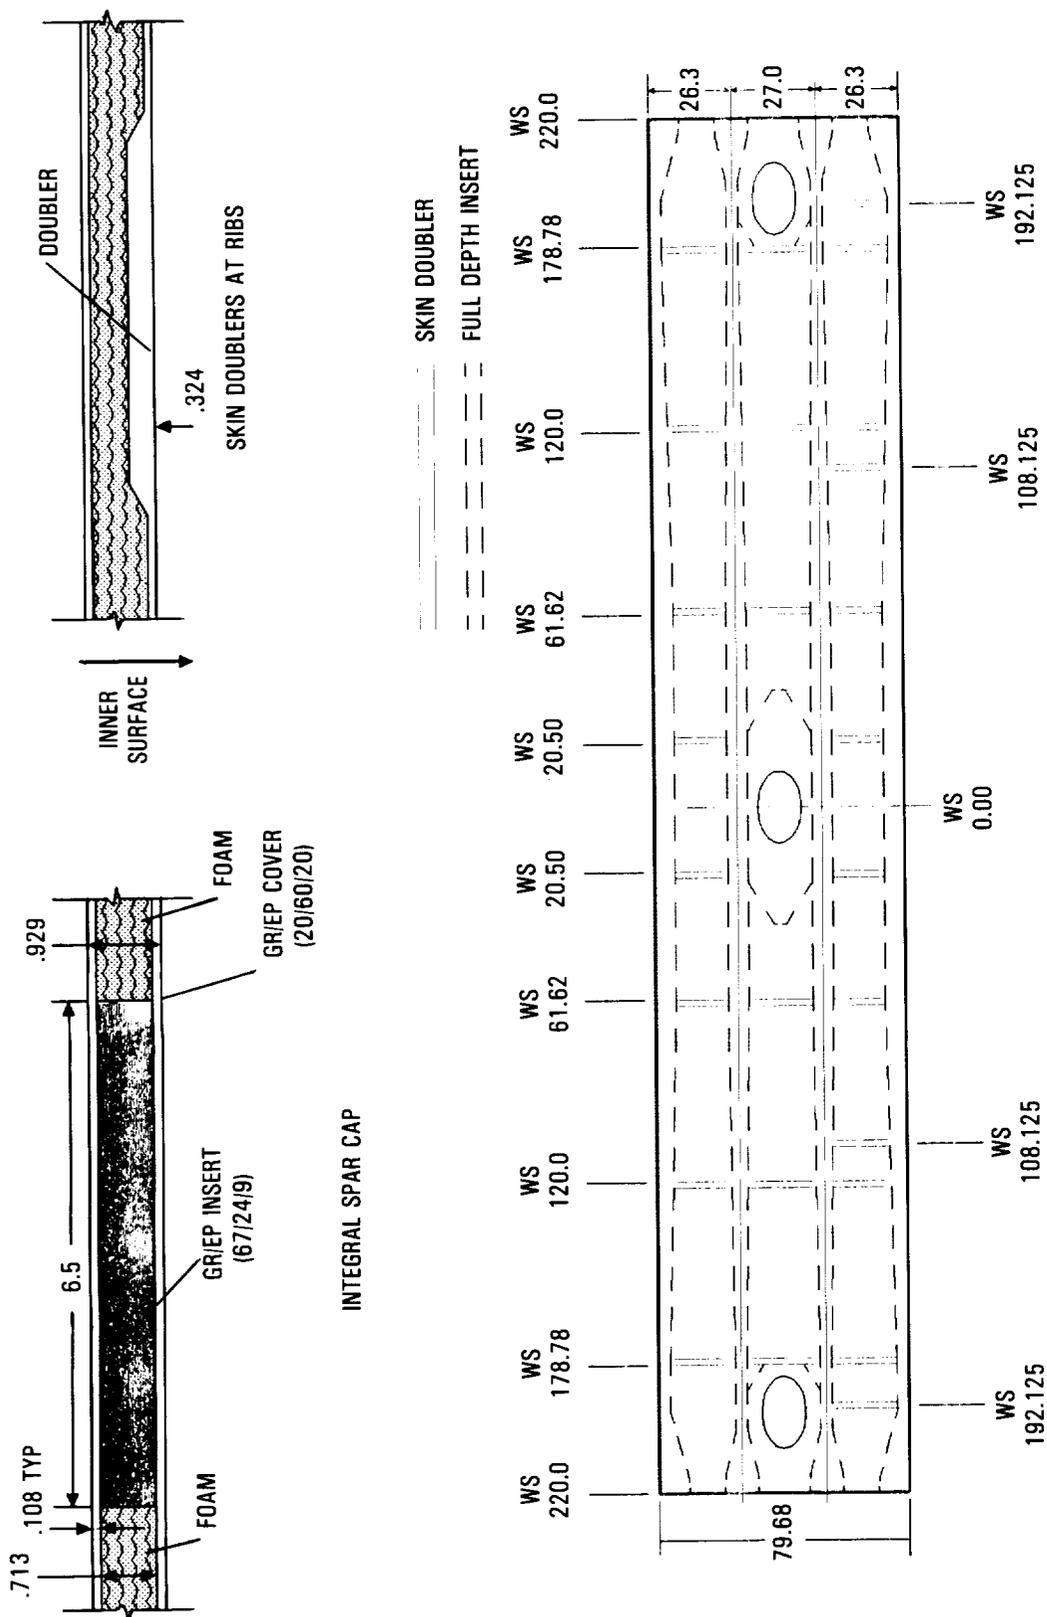
Figure 19. - Sandwich upper cover design.
