Composite Transport Wing Technology Development

*Design Development Tests and
Advanced Structural Concepts*

Charles F. Griffin and William E. Harvill
*Lockheed Aeronautical Systems Company
Burbank, California*

Prepared for
Langley Research Center
under Contract NAS1-17699

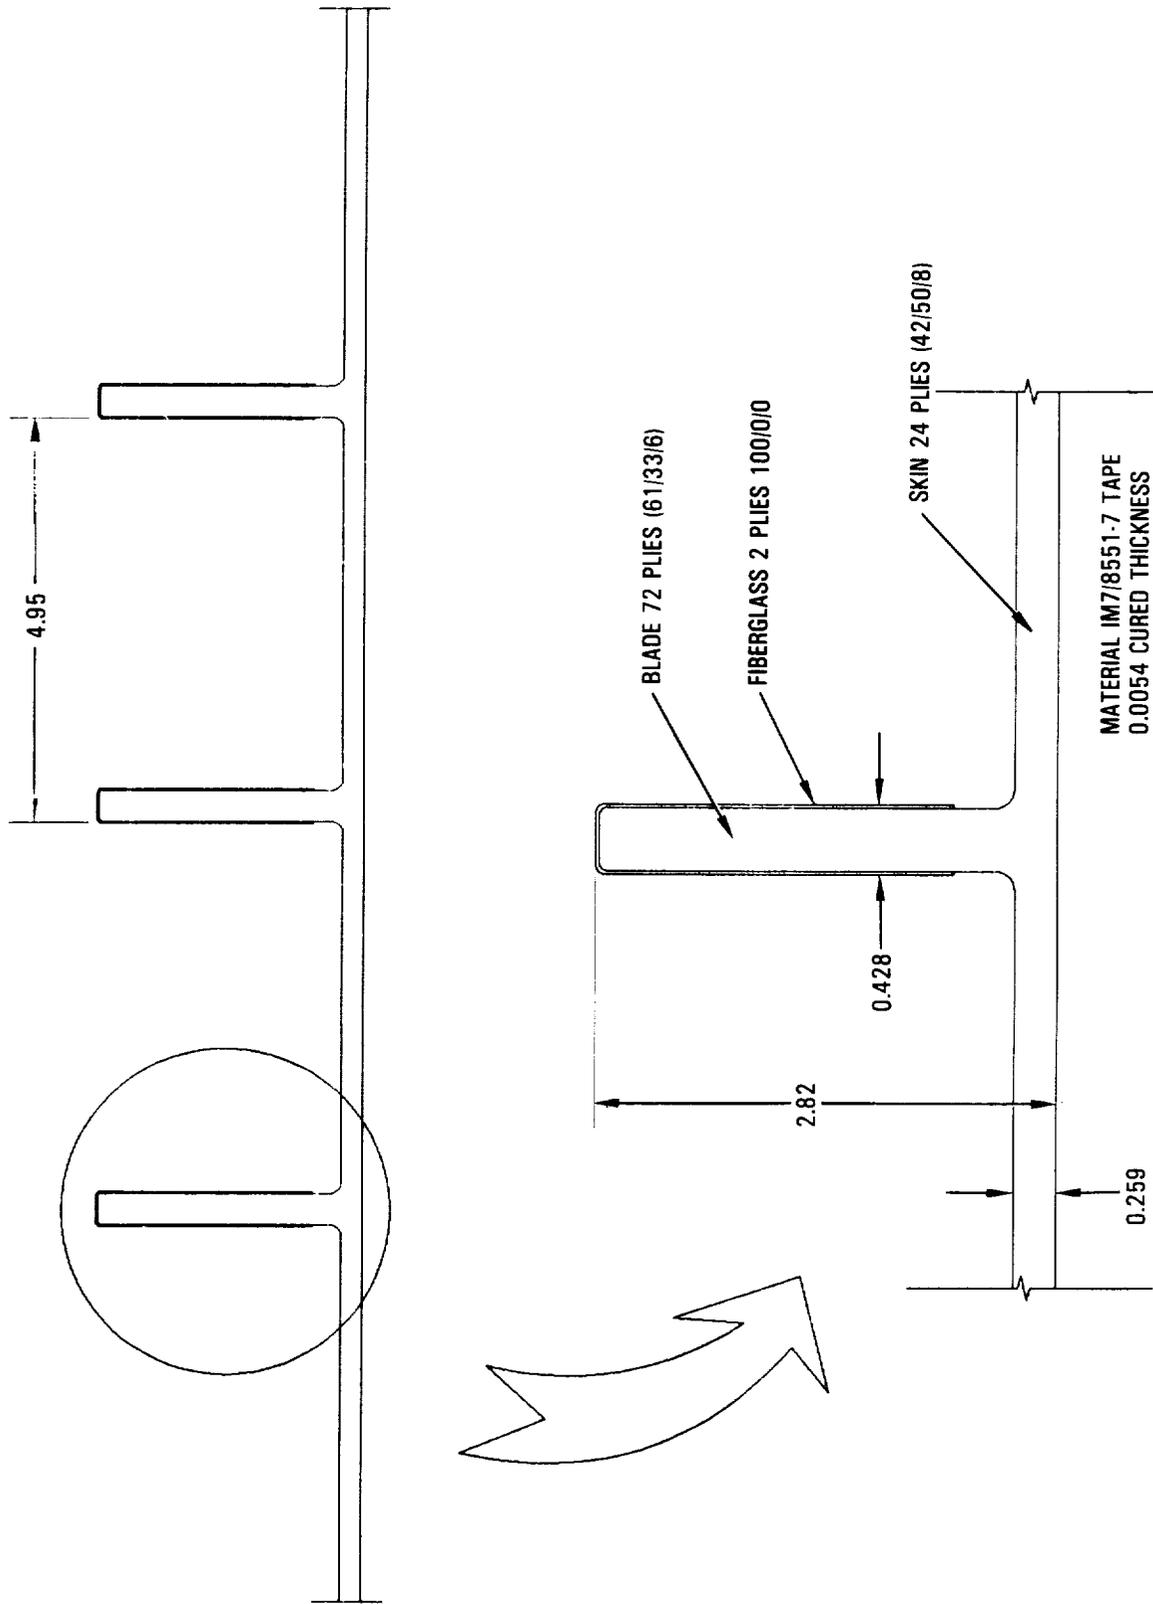
Figure 20. - Blade-stiffened panel design.

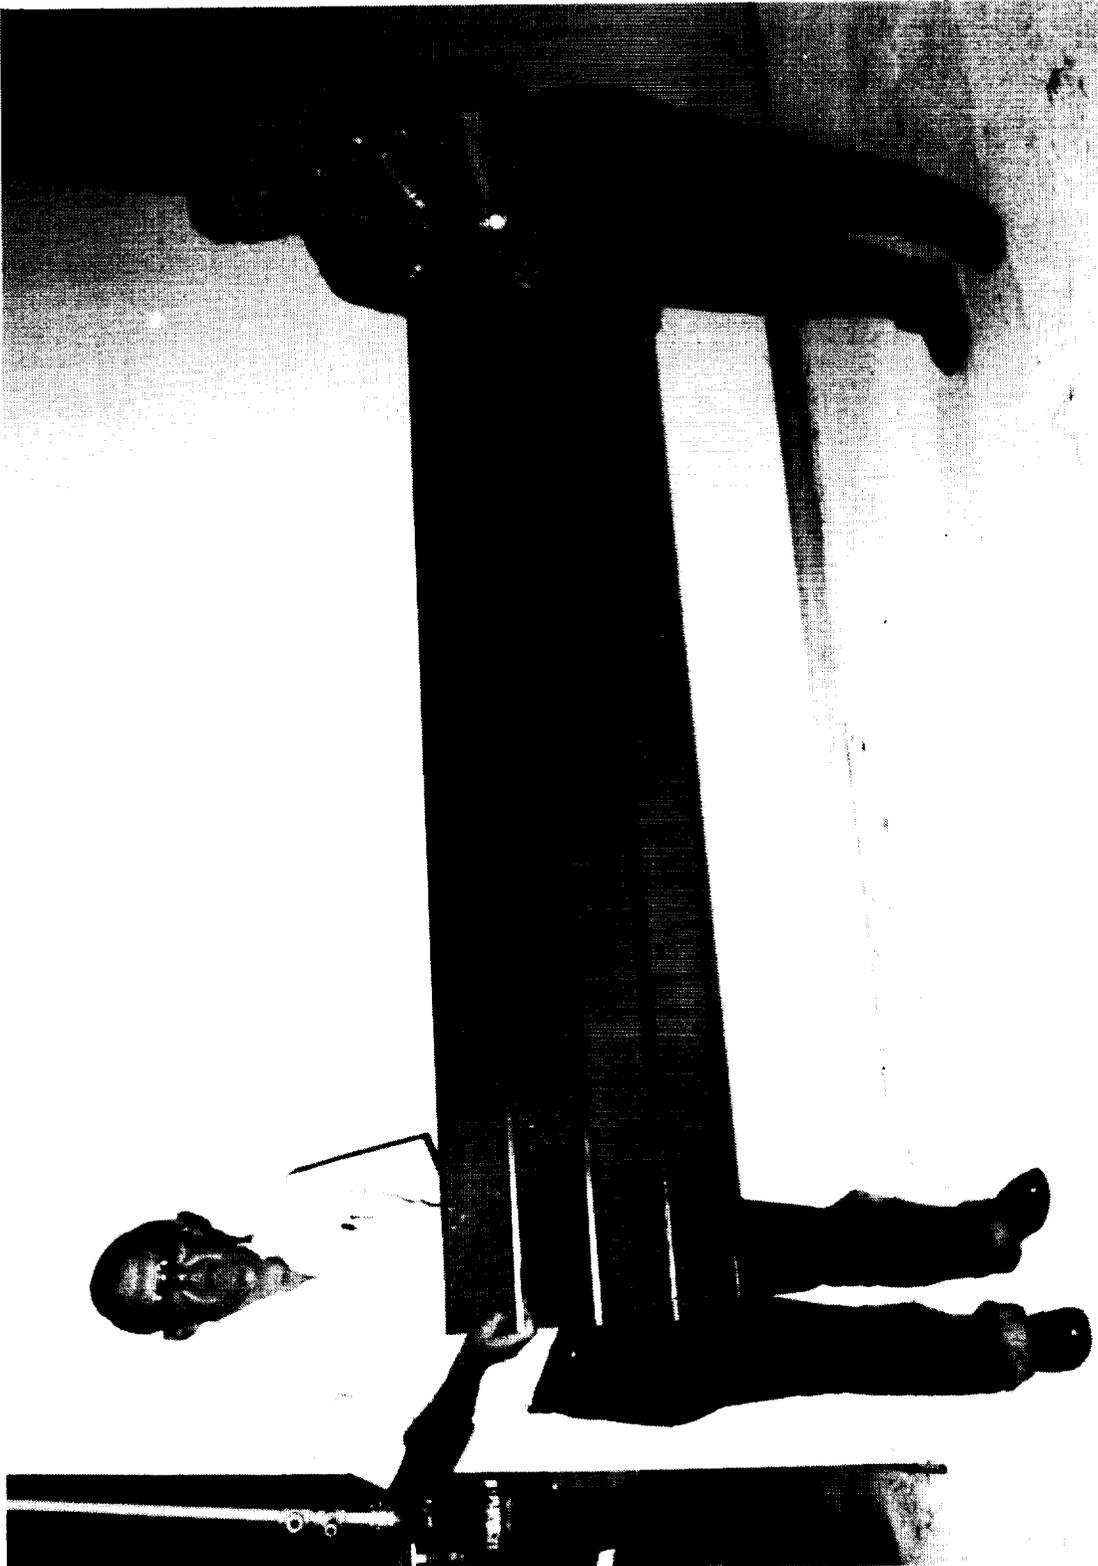
Figure 24. - Blade-stiffened panel.

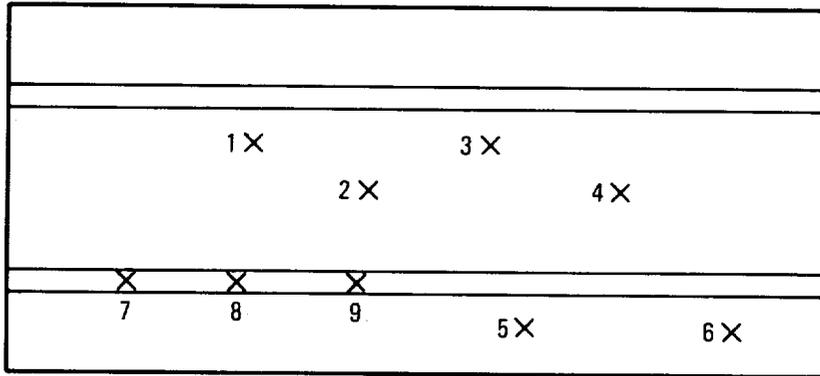
IMPACT LOCATIONS

Location	Energy	Damage Area	Dent Depth
1	80 ft-lb	5.4 in ²	.025 in.
2	80 ft-lb	3.1 in ²	.018 in.
3	100 ft-lb	5.75 in ²	.022 in.
4	100 ft-lb	3.6 in ²	.014 in.
5	80 ft-lb	3.1 in ²	.012 in.
6	100 ft-lb	5.75 in ²	.064 in.
7	20 ft-lb	N/A ^①	N/A ^①
8	40 ft-lb	N/A ^①	N/A ^①
9	60 ft-lb	N/A ^①	N/A ^①

A two bladed panel was impacted at various locations and impact energies with a 12-pound-steel impactor having a 1.0-inch-diameter-hemispherical tup. Prior to being impacted, the panel was clamped to a rigid foundation to represent an area near a rib. After being impacted, the panel was visually and ultrasonically inspected and the dent depths at point of impact were measured. All of the impact locations displayed visual damage. A summary of the inspection results is presented in Table 9. Based on the results of these tests, a 100 ft-lb impact energy was selected for the skin impacts and a 40 ft-lb impact energy was selected for the blade impacts on the compression test panels.

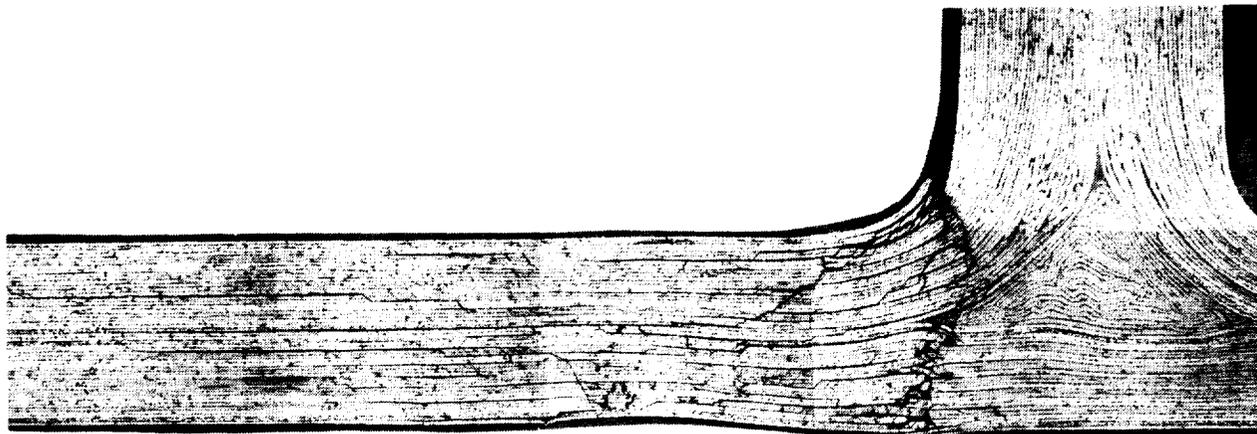
Figure 25. - Photomicrograph of impact to skin near blade.

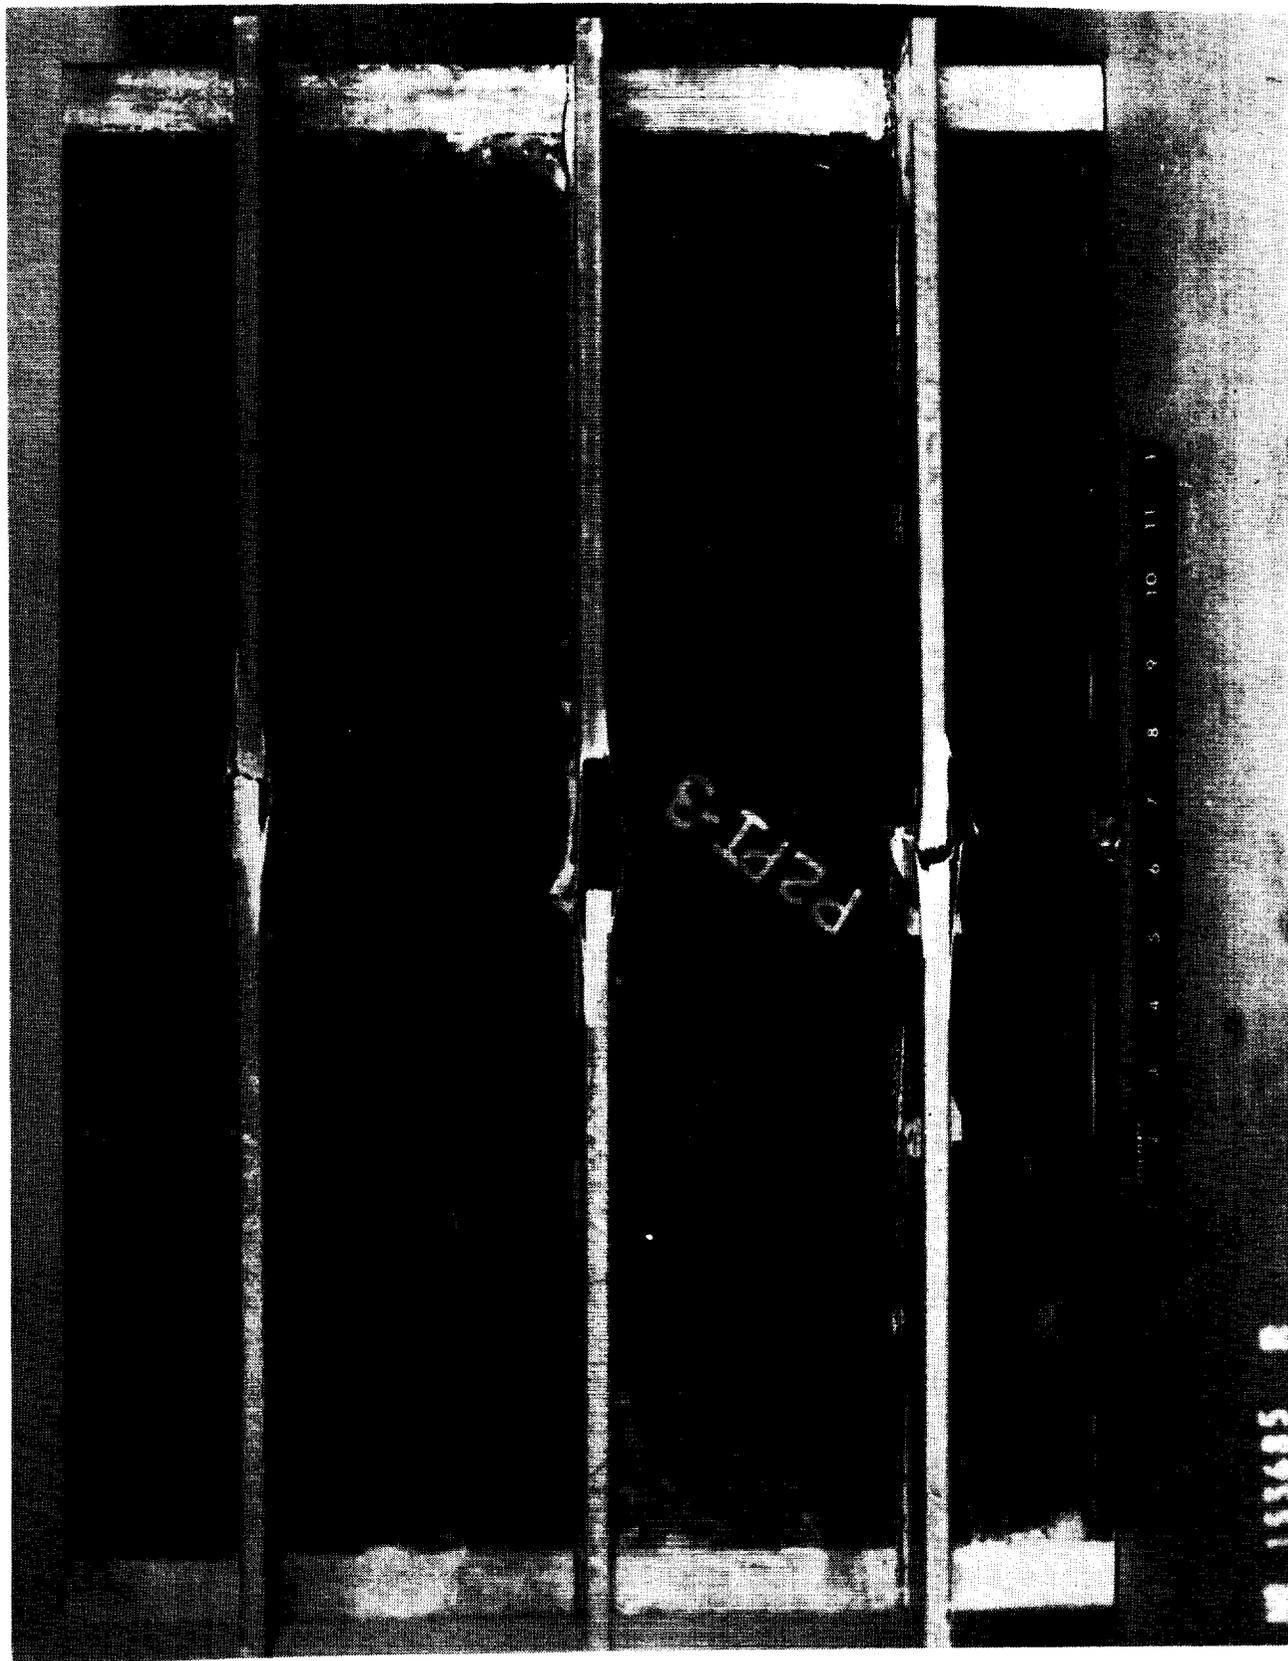
Figure 27. - Failed blade-stiffened panel.

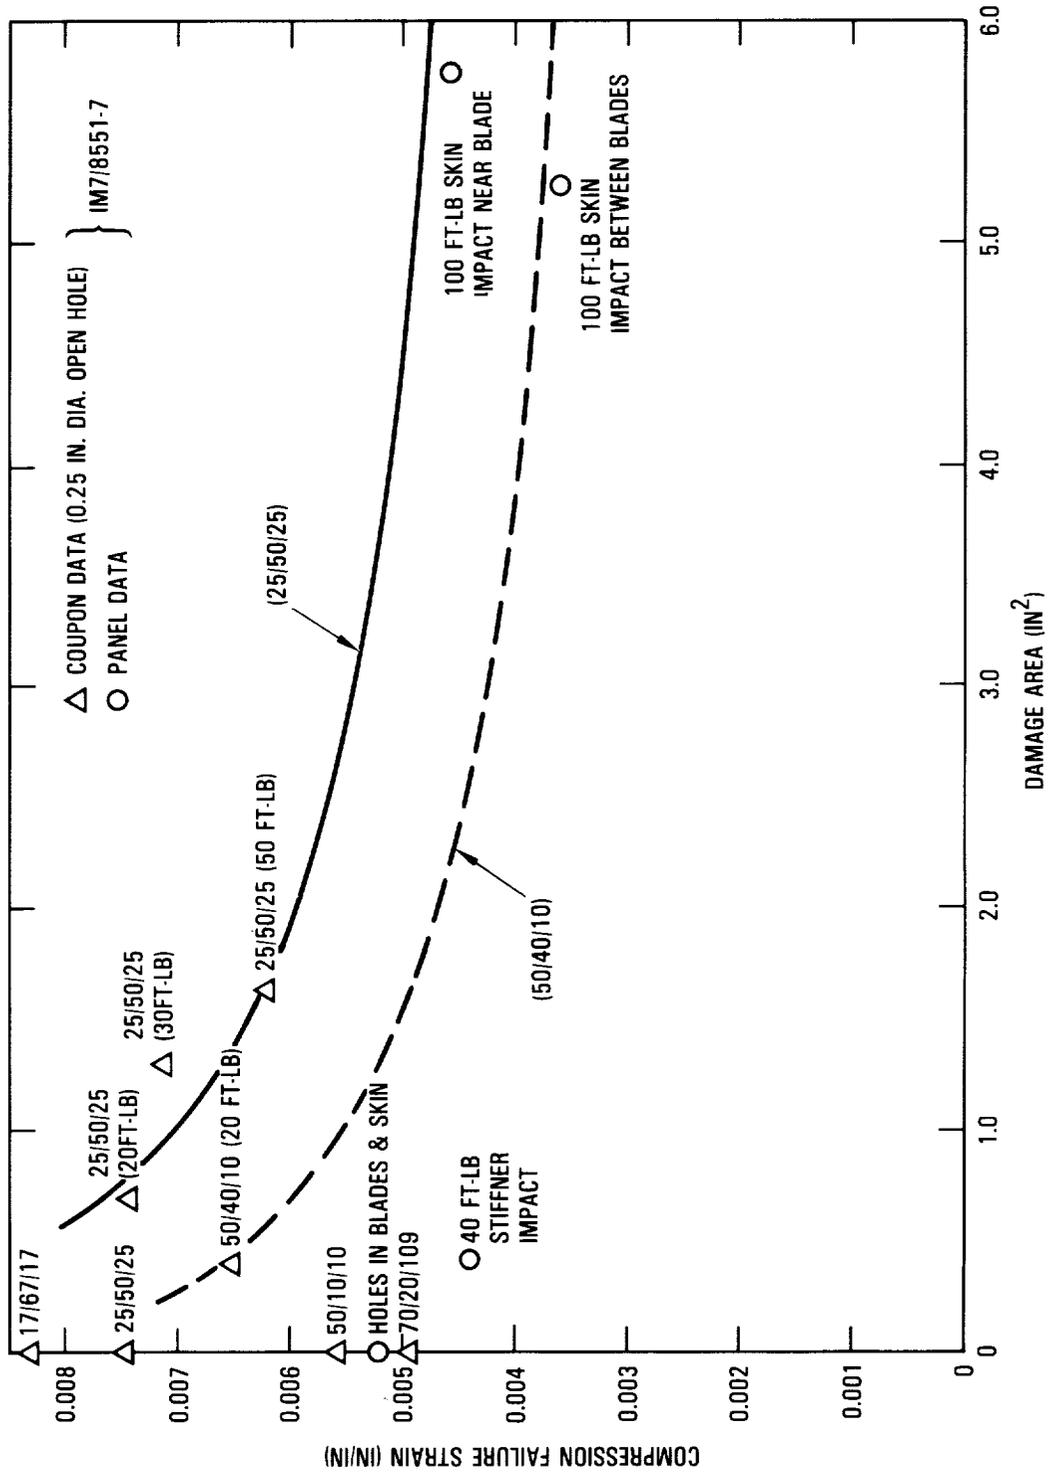
Figure 28. - Comparison of coupon data to blade-stiffened panel data.

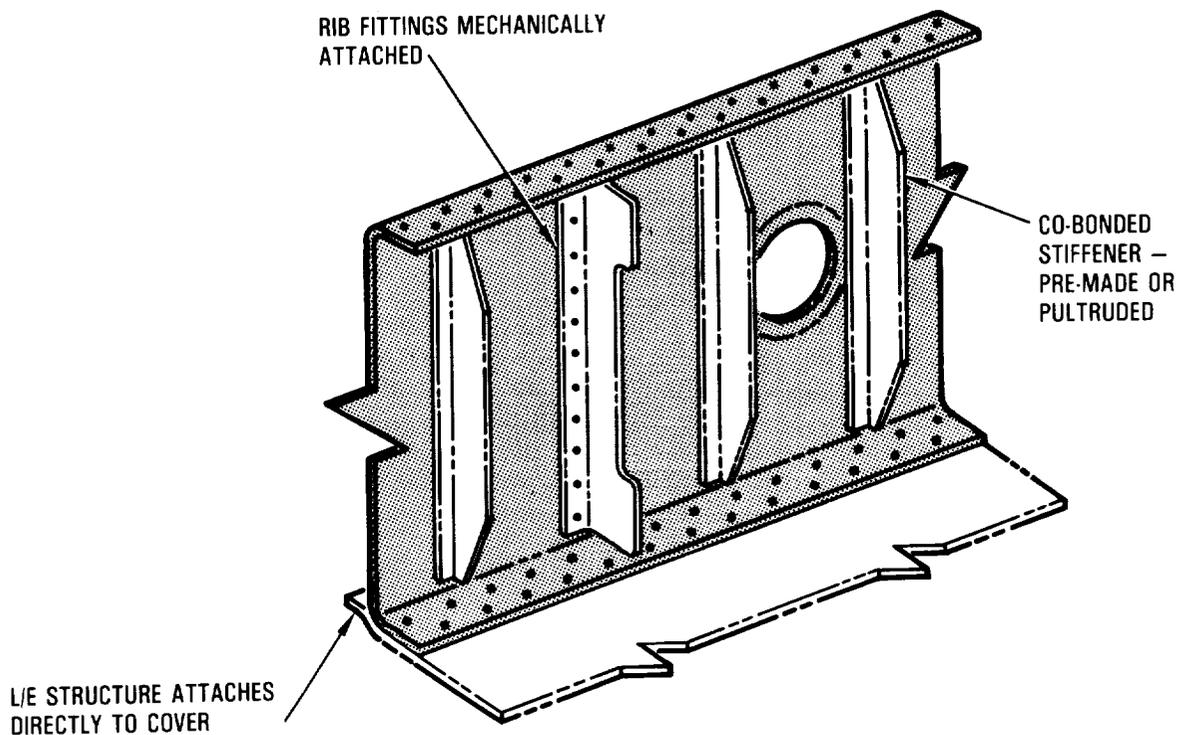
Figure 29. - Stiffened channel spar concept.

With minor variations the C-configuration is adaptable to a wide spectrum of materials and manufacturing processes. In this program, four separate spars were designed, fabricated, and tested to allow direct structural performance comparisons. The four spar concepts evaluated were:

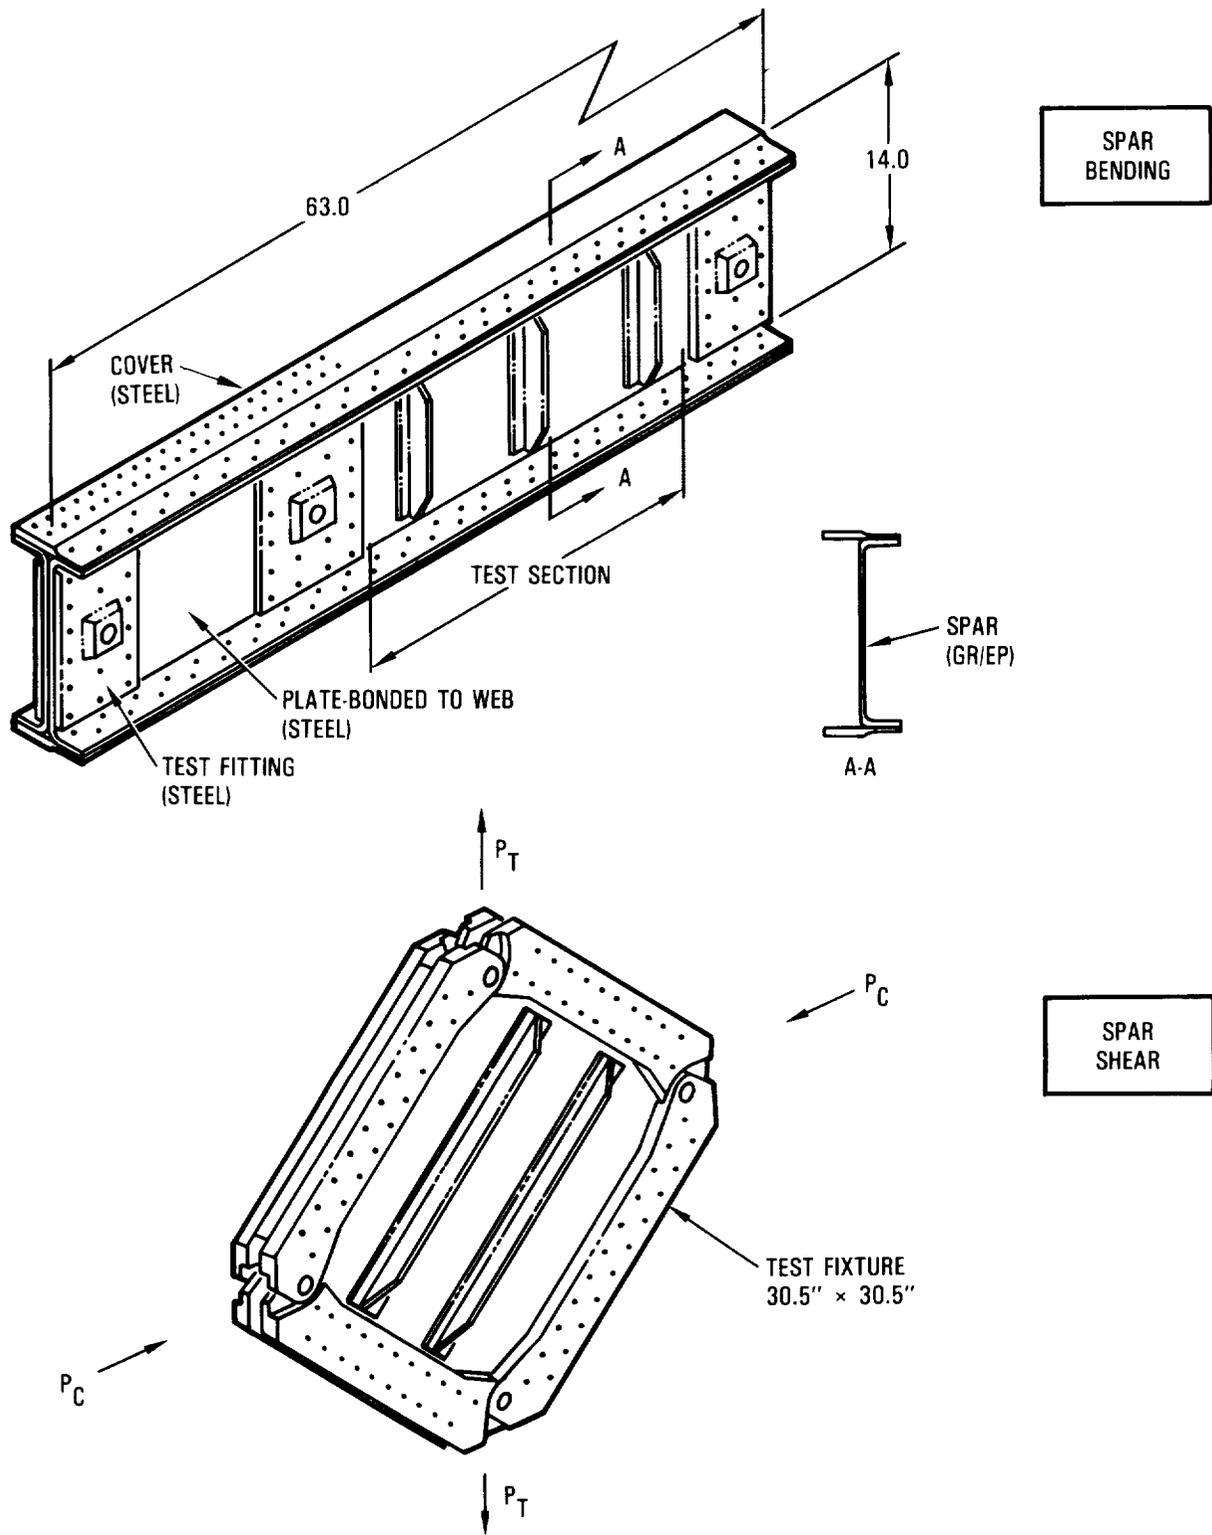
Figure 30. - Spar test specimens.

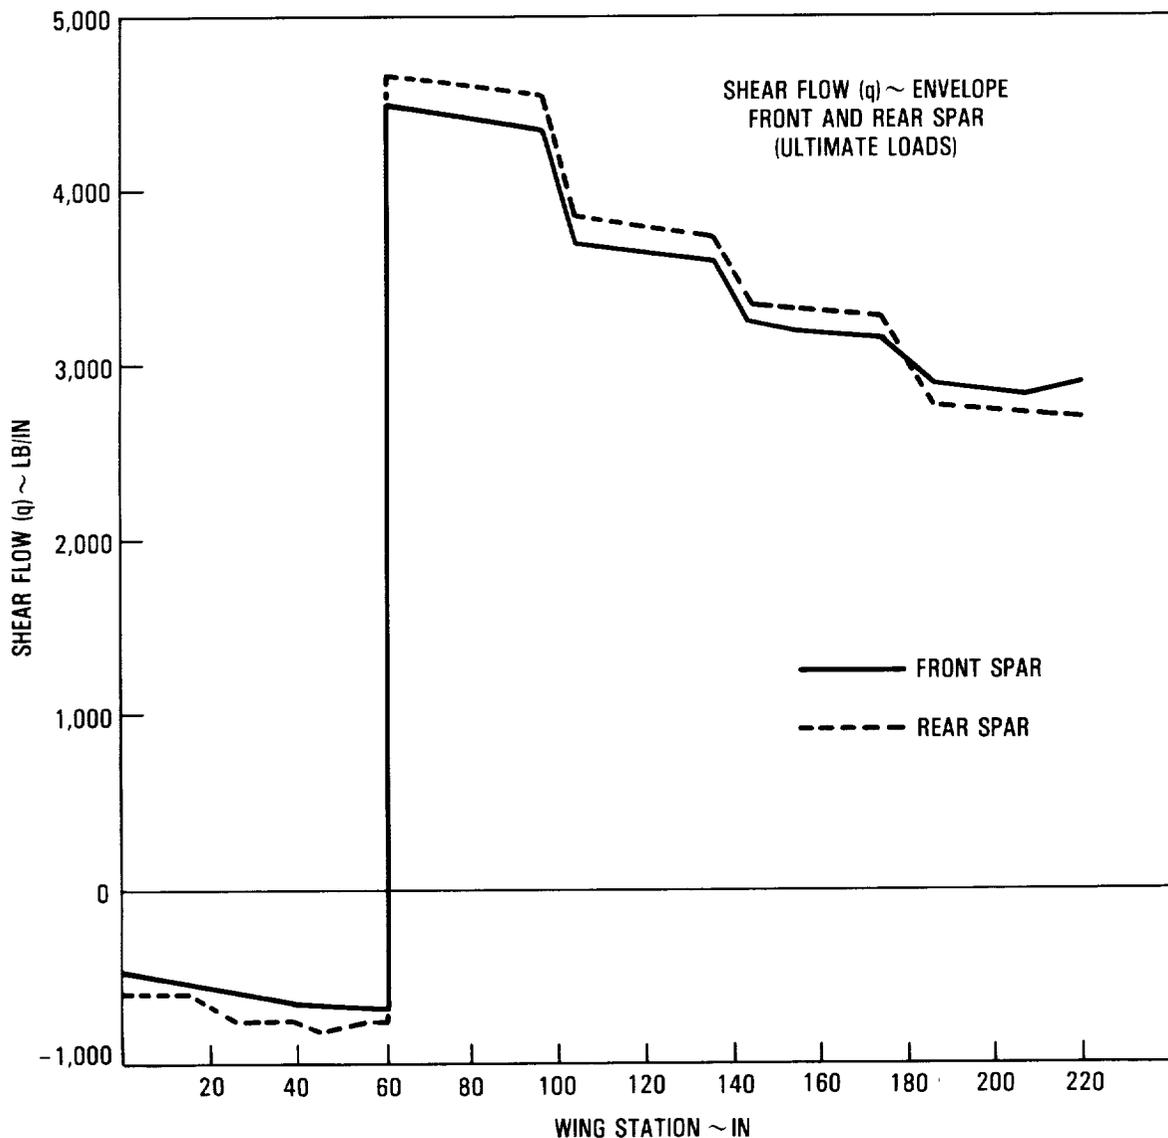
Figure 31. - Shear flow envelope - NASTRAN internal loads.

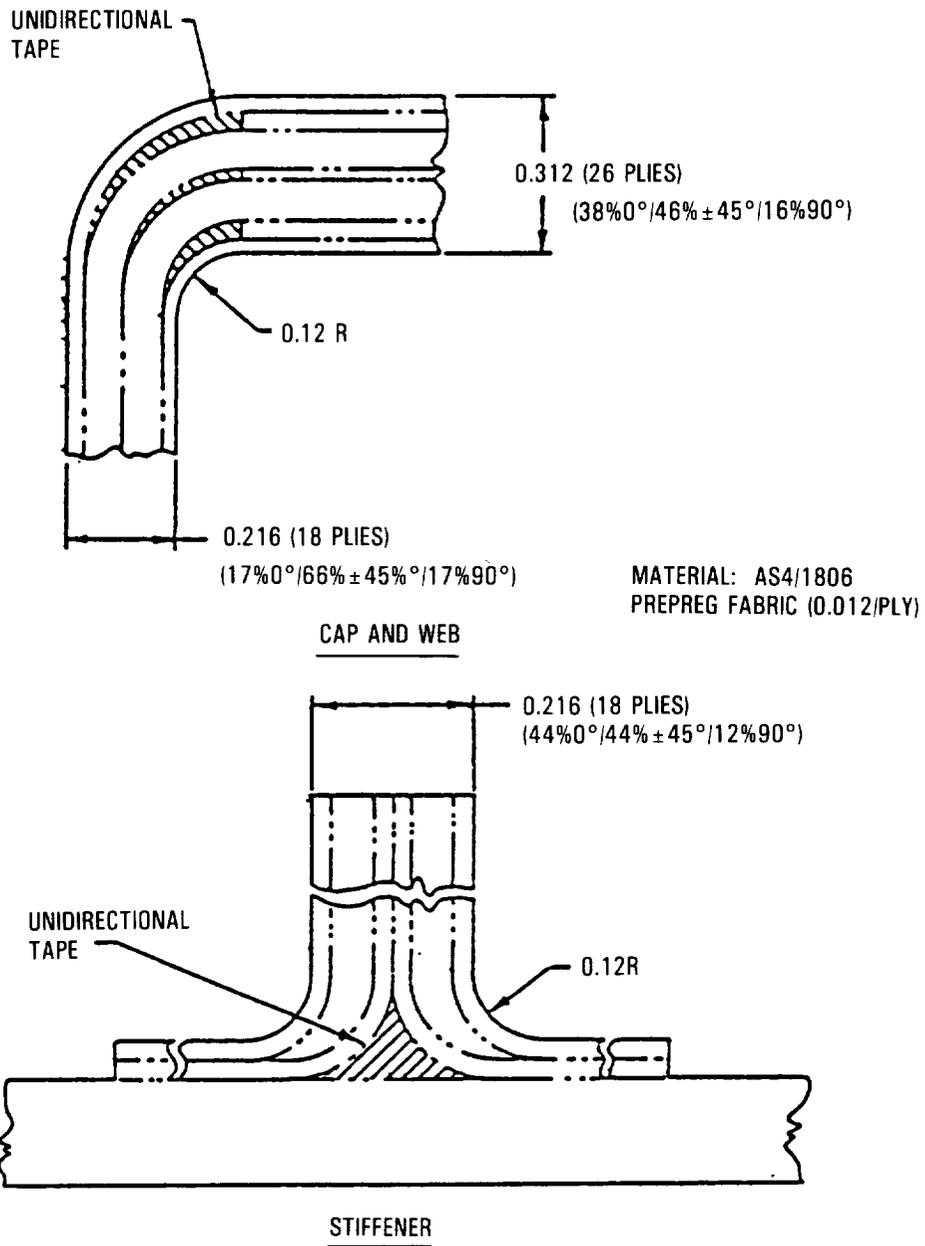
Figure 32. - Baseline design ply layup.

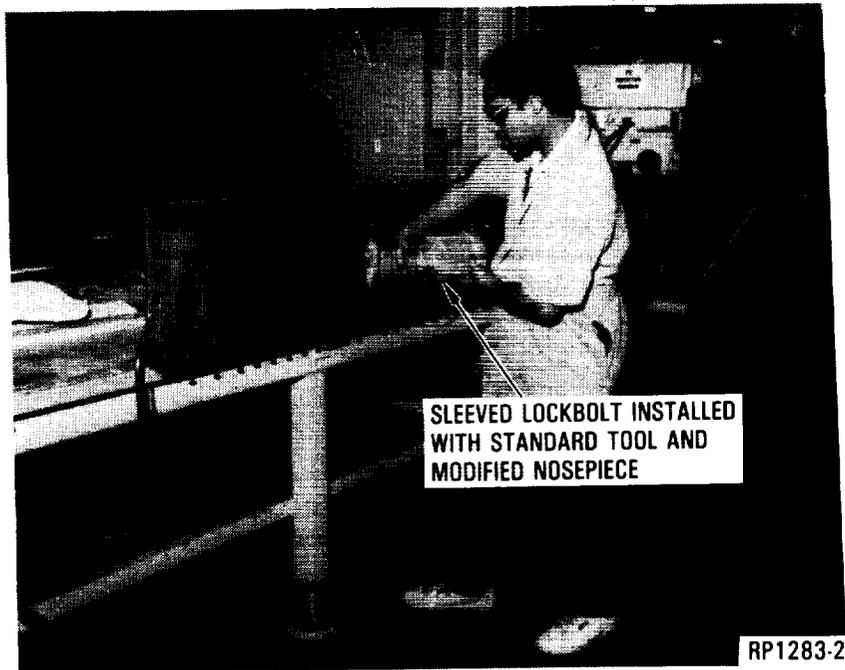
Figure 37. - Installing fasteners in baseline spar test specimen.

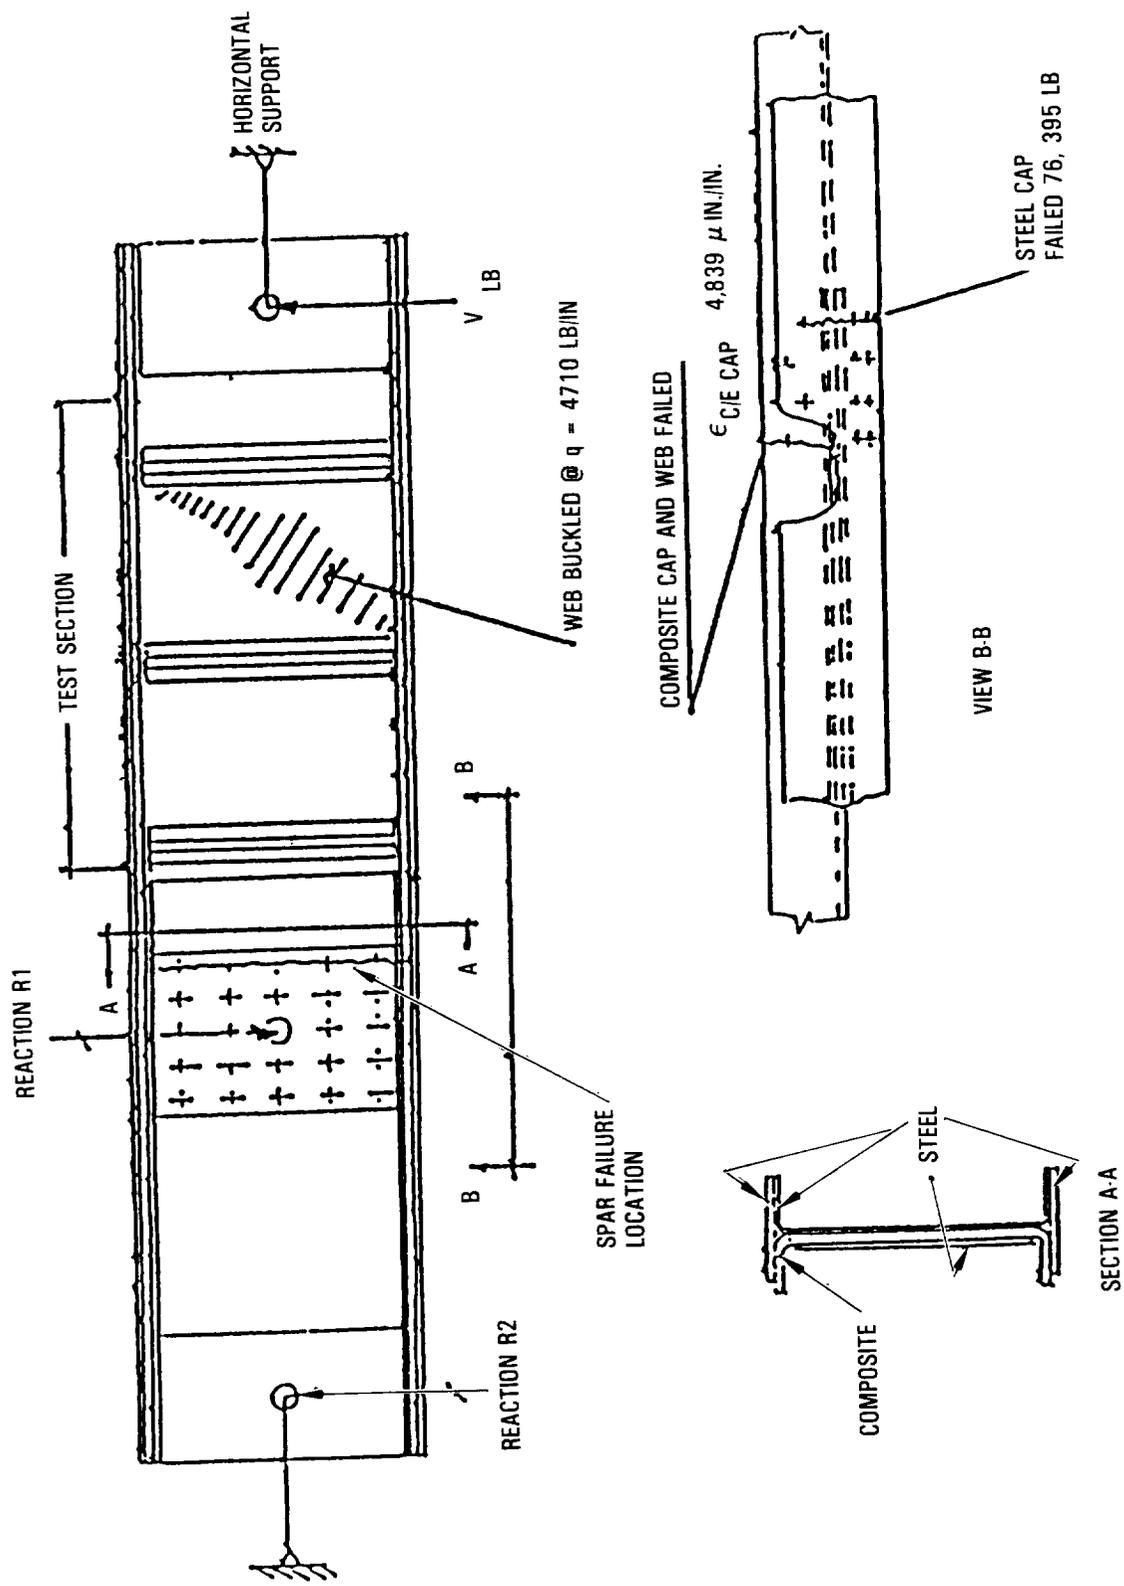
Figure 38. - Baseline spar test results.

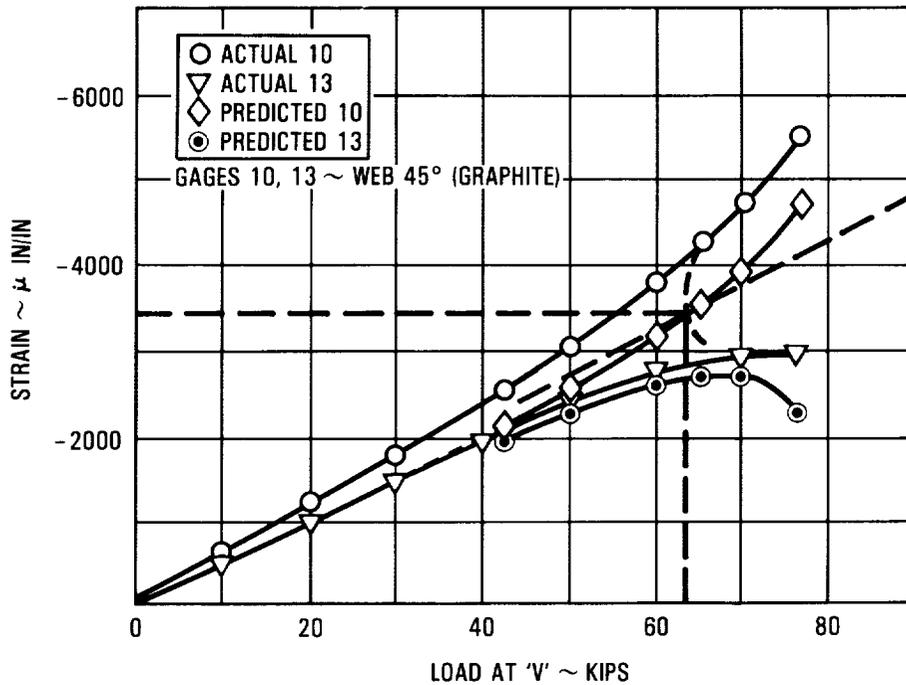
Figure 39. - Baseline spar web strain gage correlation.

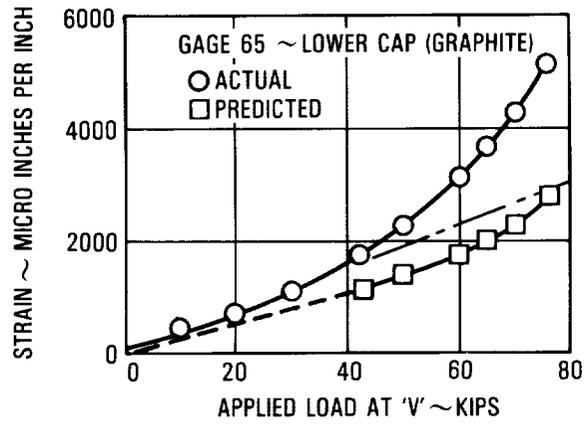
Figure 40. - Baseline spar cap strain gage correlation.

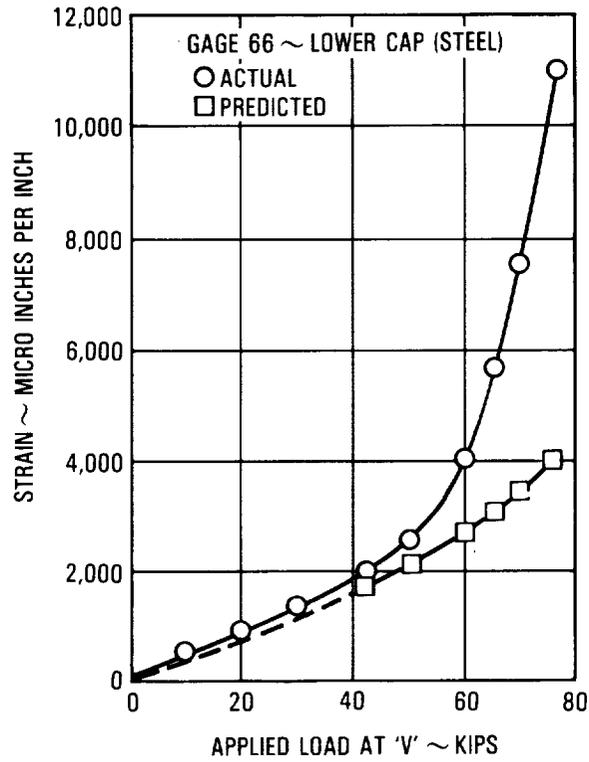
Figure 41. - Baseline shear panel: Strain vs. load level - "as manufactured."

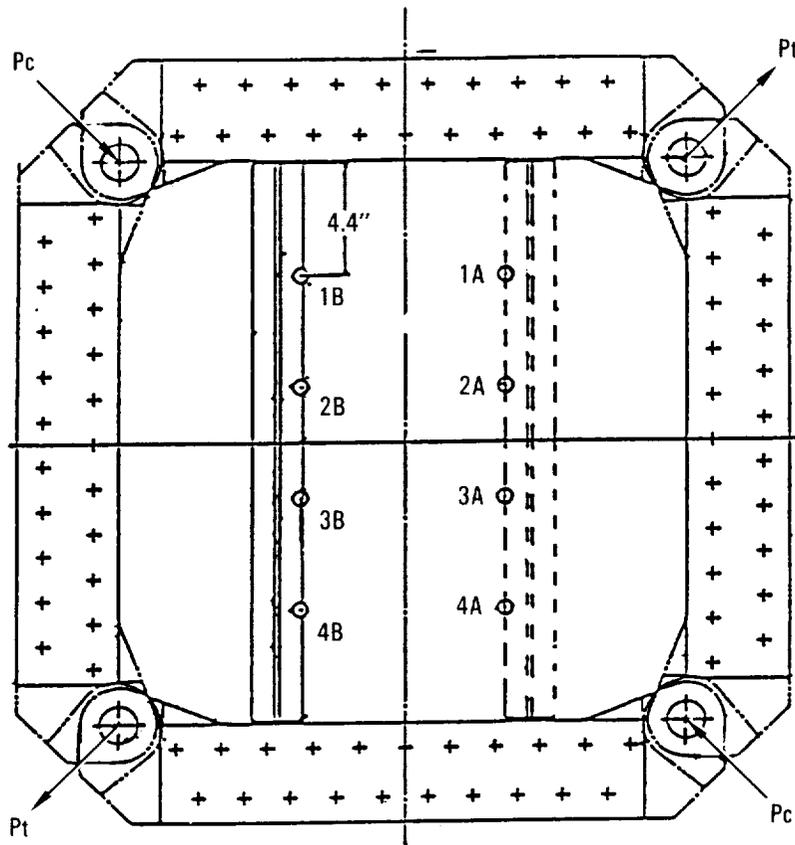
IMPACT SITE	IMPACT ENERGY (FT-LBS)	IMPACTED SIDE DAMAGE DEPTH (IN)	RADIOGRAPHIC DAMAGE AREA (IN ²)
1A	40	.008	0.57
2A	60	.031	1.65
3A	80	.050	2.01
4A	70	.057	1.77
1B	100	.053	1.54
2B	65	.021	1.54
3B	90	.072	1.33
4B	80	.025	0.95

Figure 42. - Trial impact results - baseline spar shear panel.

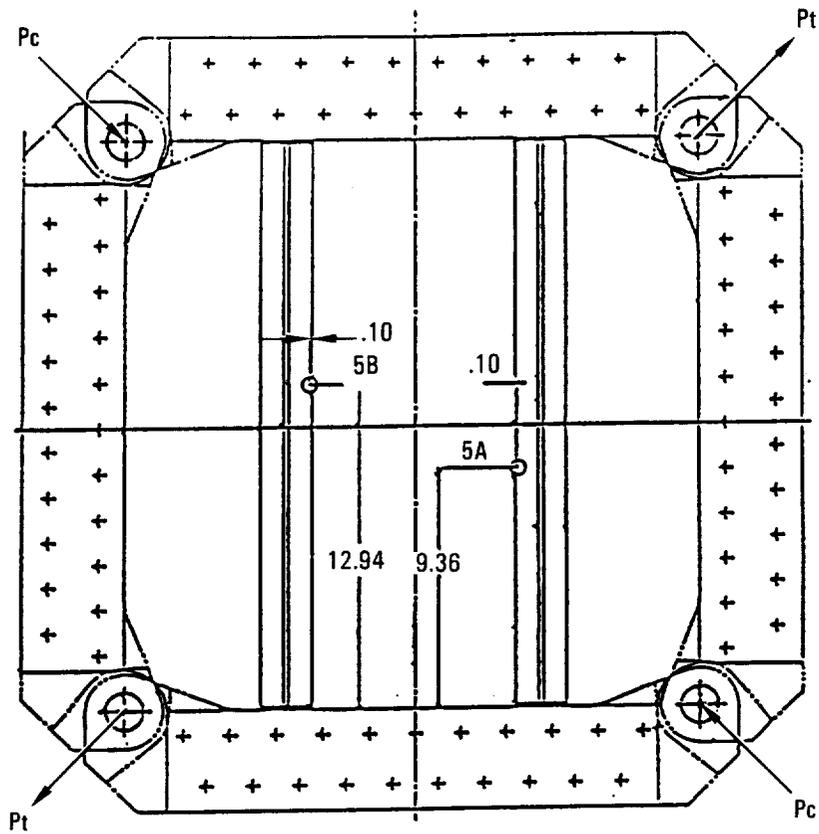
IMPACT SITE	IMPACT ENERGY (FT-LBS)	IMPACTED SIDE DAMAGE DEPTH (IN)	RADIOGRAPHIC DAMAGE AREA (IN ²)
5A	100	.088	3.30
5B	100	.053	2.01

Figure 43. - Impact damage location and extent - baseline spar shear specimen.

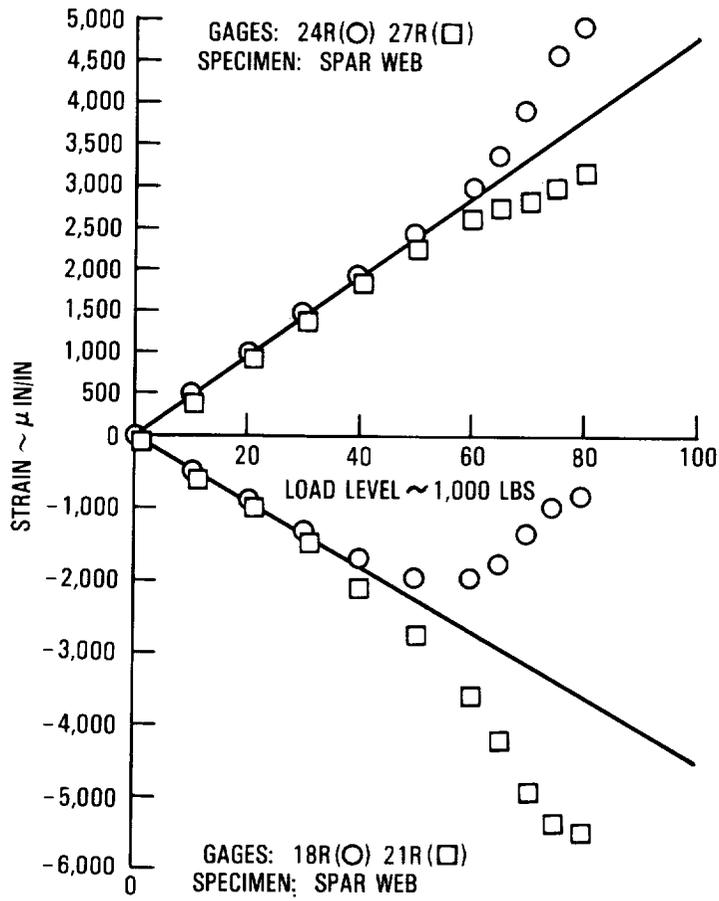
Figure 44. - Strain vs. load level - baseline "damaged" spar shear specimen.

Strain gages for the "damaged" specimen were placed at the same location as those for the "as-manufactured" specimen. Strain versus load level plots (fig. 44) indicated that the onset of buckling occurred at a diagonal load level of 64,000 pounds, as compared to the 75,000 pound level for the "as-manufactured" specimen. This actual buckling load occurred sooner than the predicted value of 73,310 pounds, but the analysis did not account for the impact damage. Eccentricities from the impact damage appear to be the cause

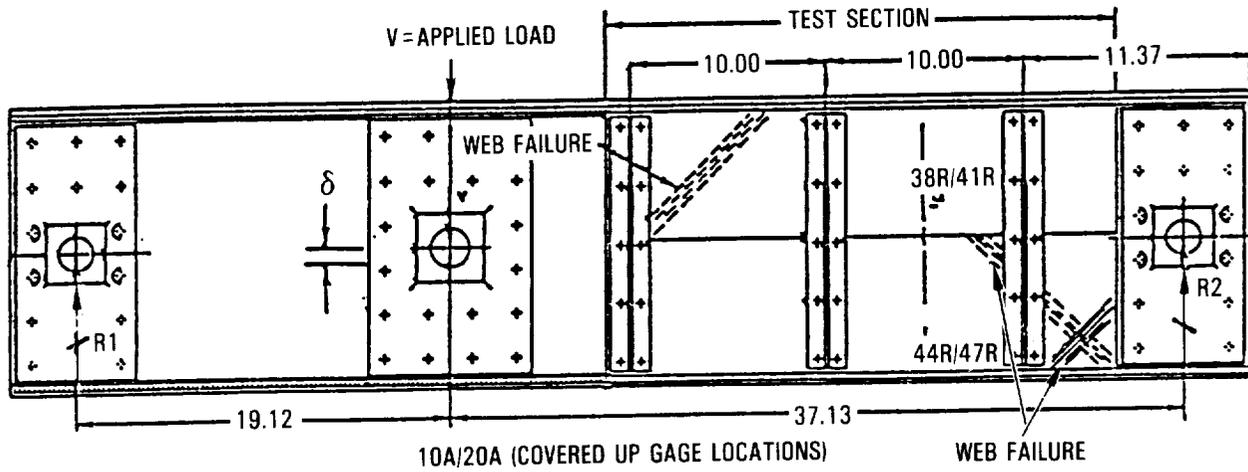
Figure 55. - Strain gage locations and failure description - thermoplastic spar bending specimen.

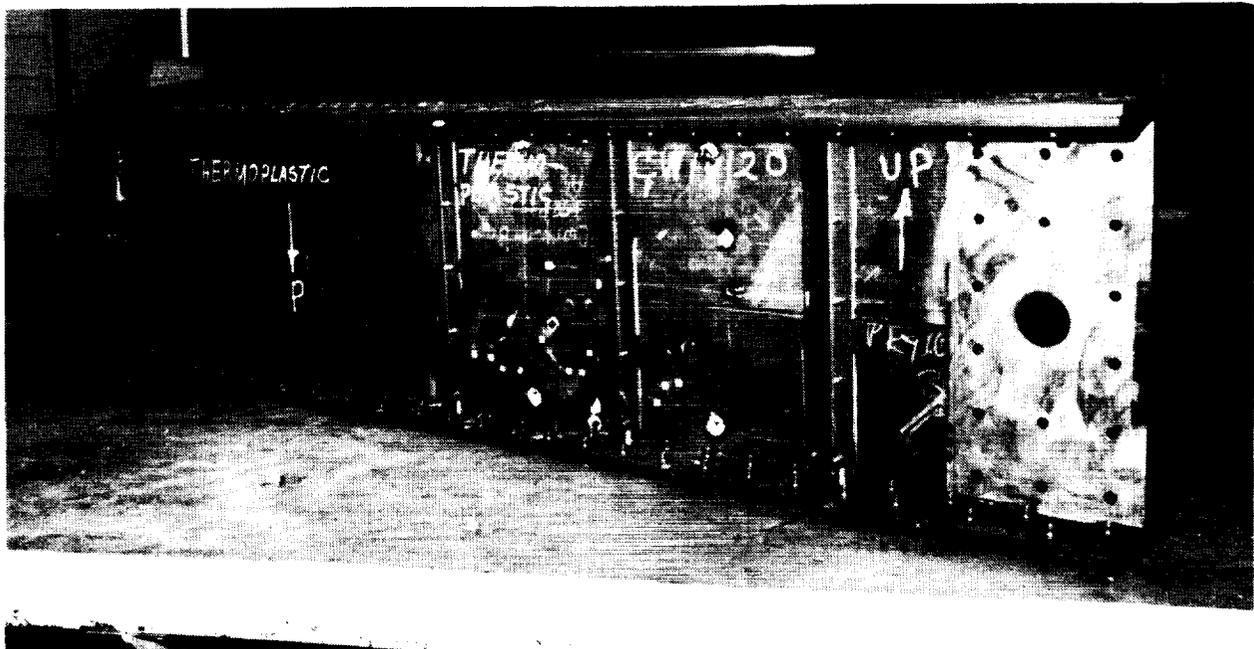
Figure 56. - Thermoplastic spar after test - stiffener side.

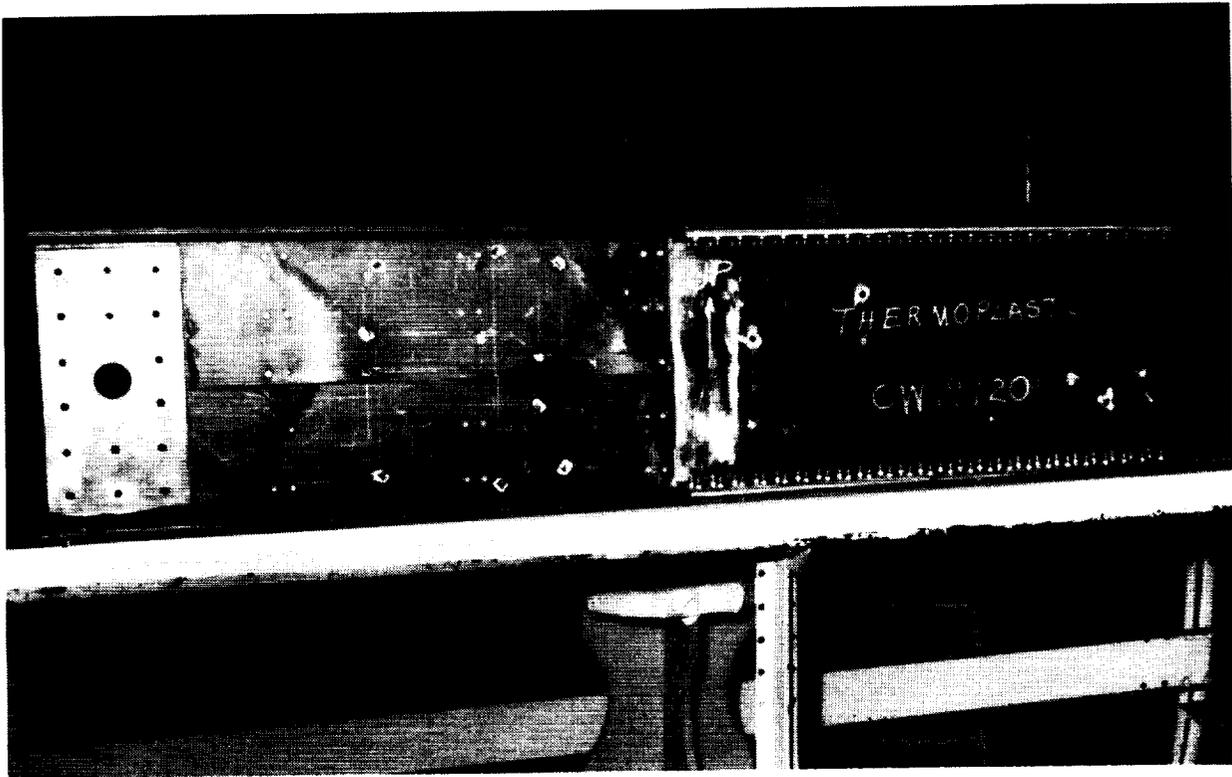
Figure 57. - Thermoplastic spar after test - web side.

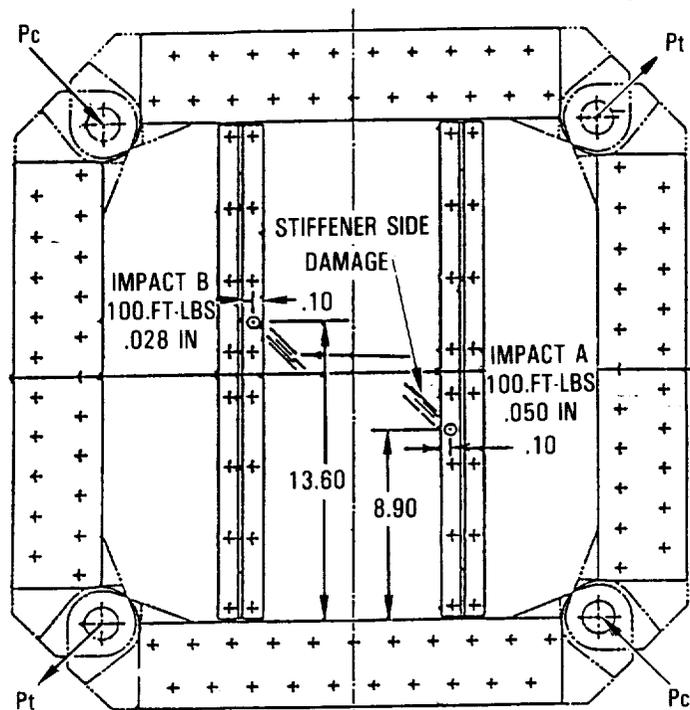
IMPACTS ON WEB SIDE OF PANEL.
STIFFENER SIDE SHOWN.

Figure 59. - Impact locations in thermoplastic "damaged" spar shear specimen
