Composite Transport Wing Technology Development

*Design Development Tests and
Advanced Structural Concepts*

Charles F. Griffin and William E. Harvill
*Lockheed Aeronautical Systems Company
Burbank, California*

Prepared for
Langley Research Center
under Contract NAS1-17699

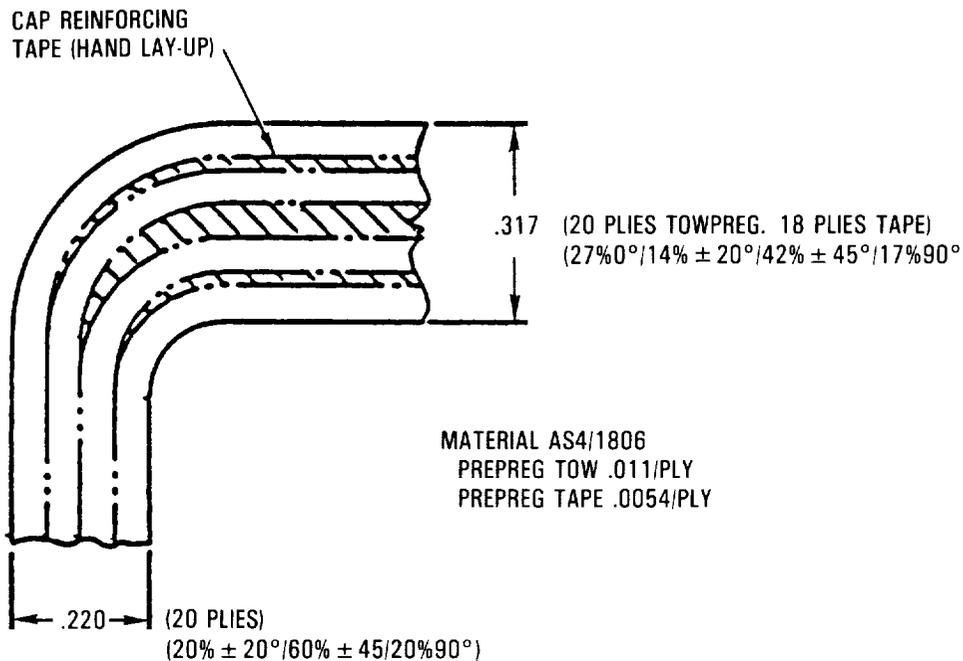
Figure 60. - Filament wound spar ply layup.

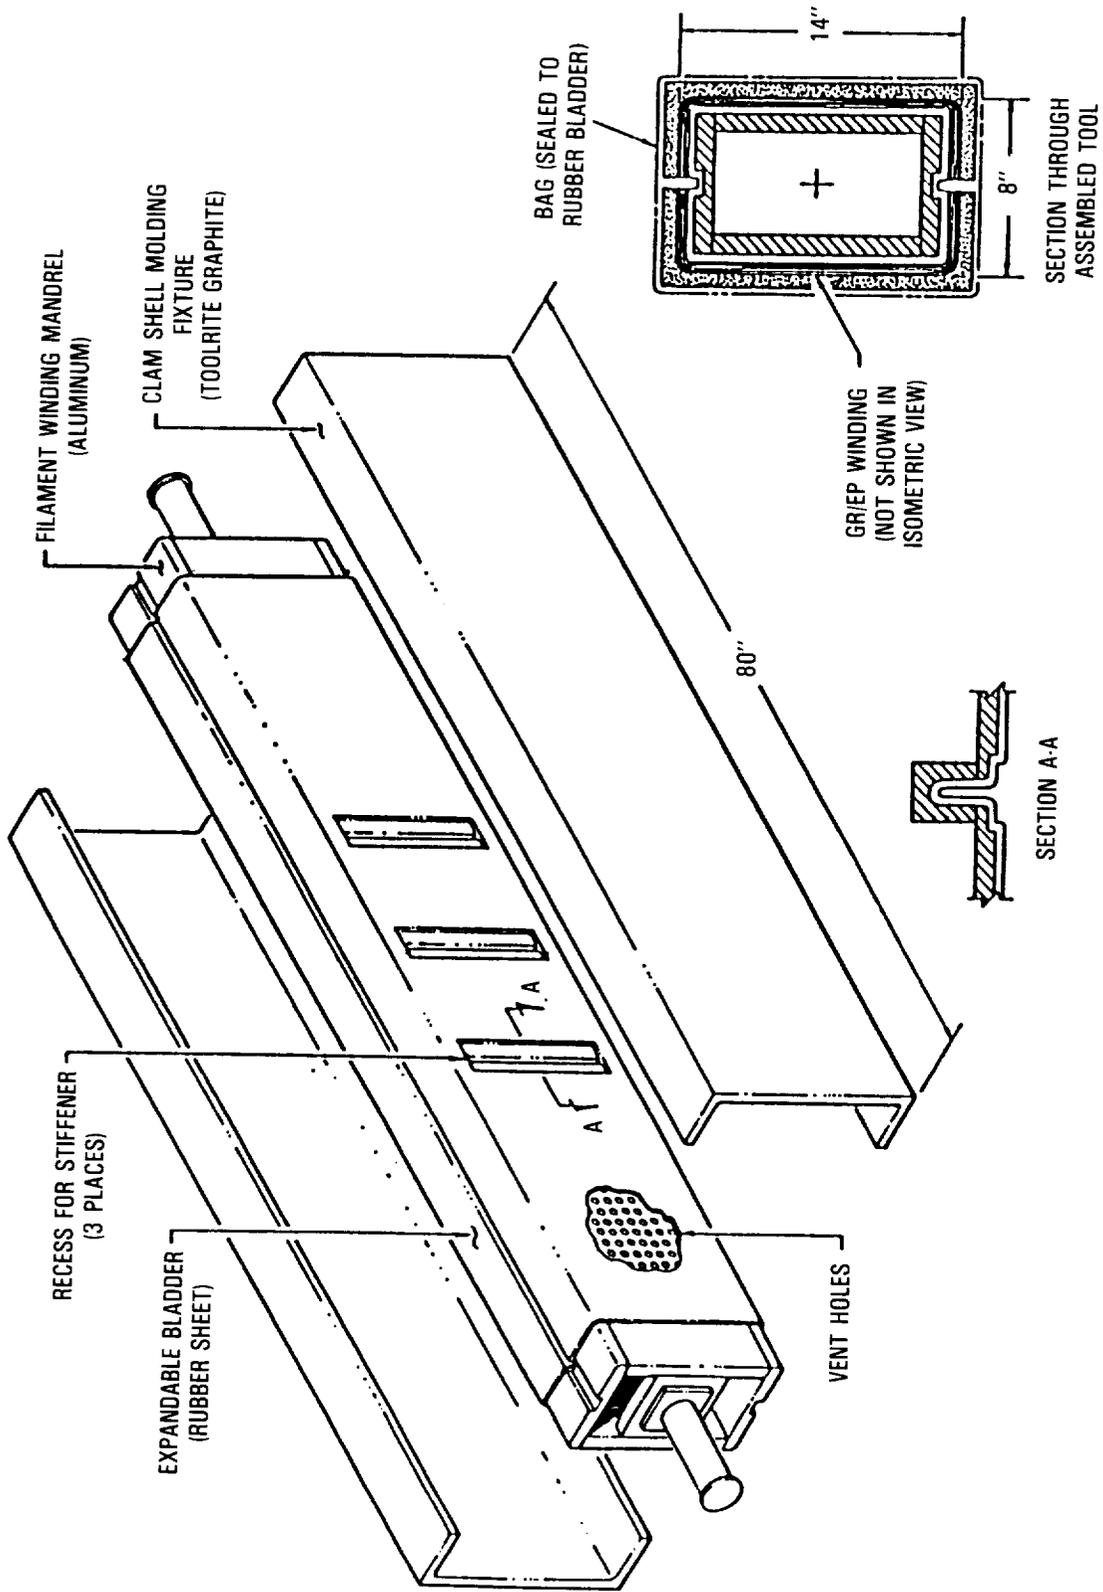
Figure 61. - Filament winding tool illustration.

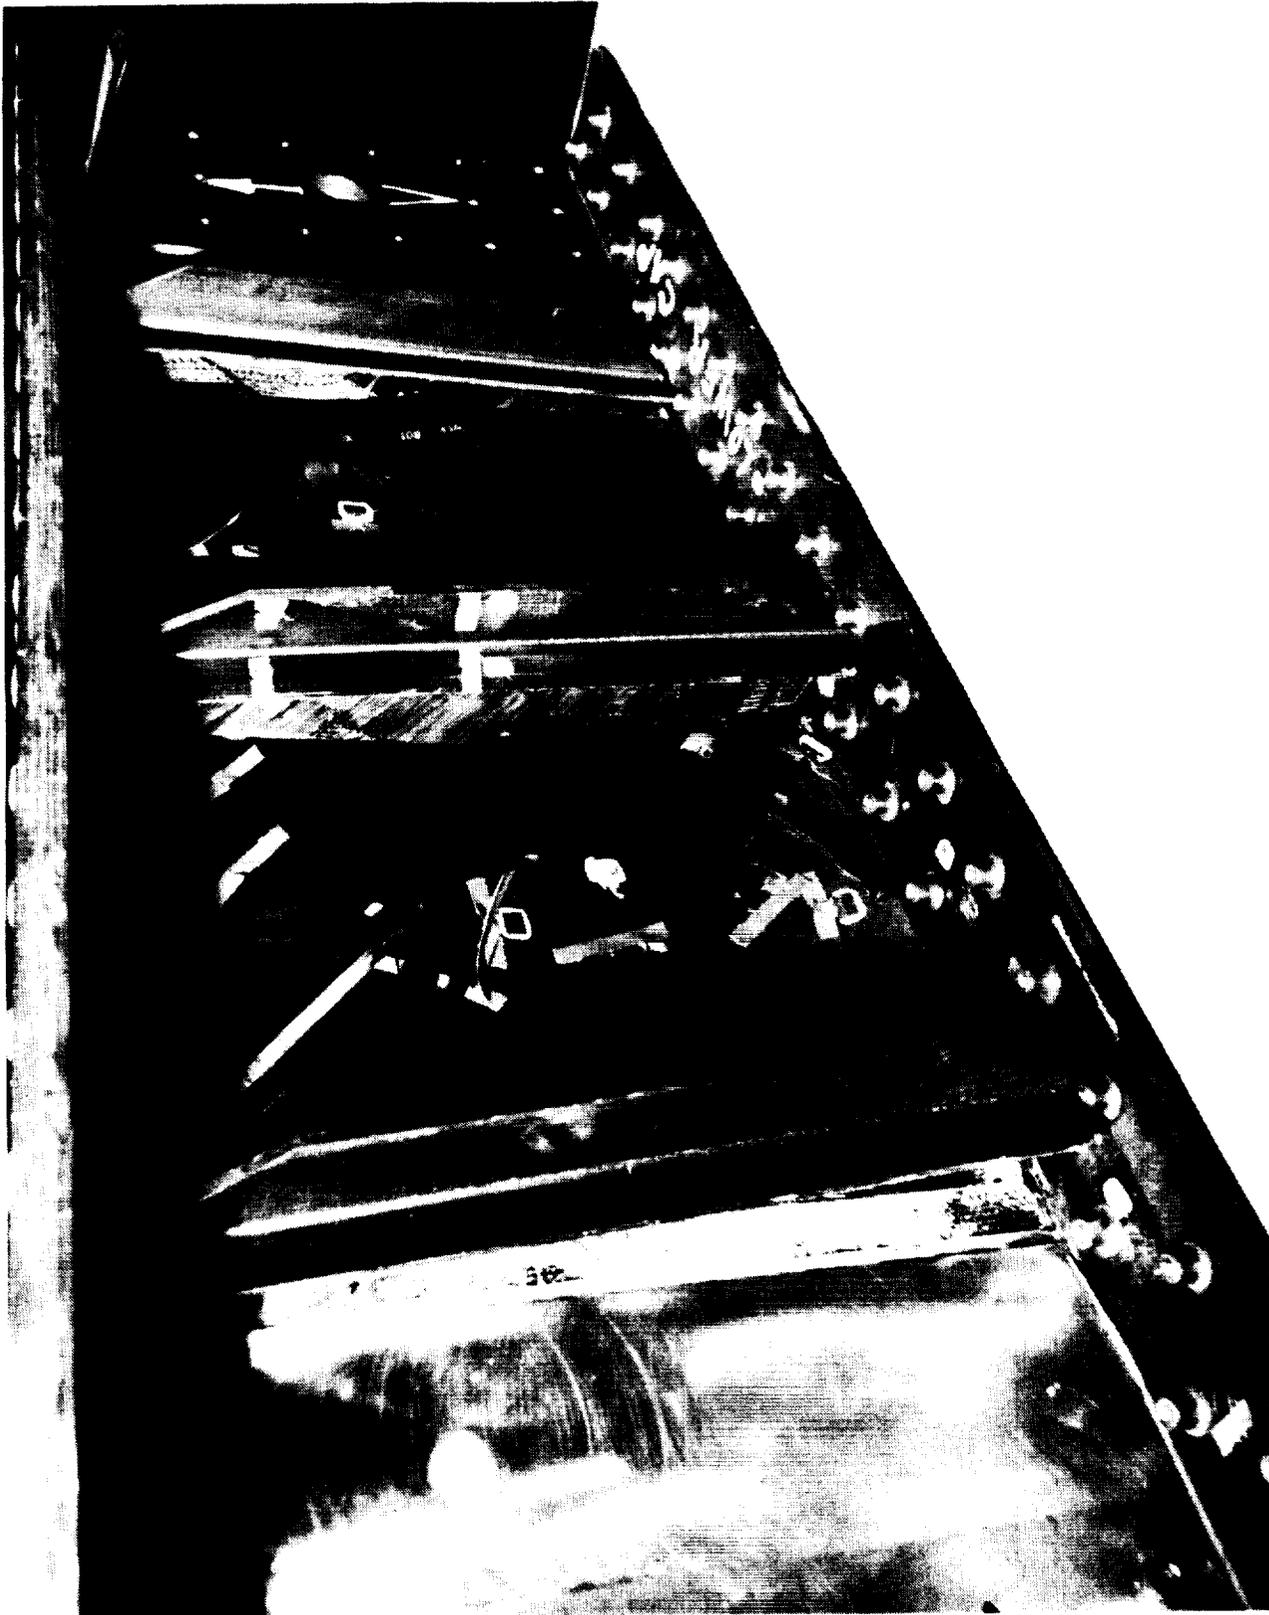
Figure 63. - Failed filament wound spar after test.

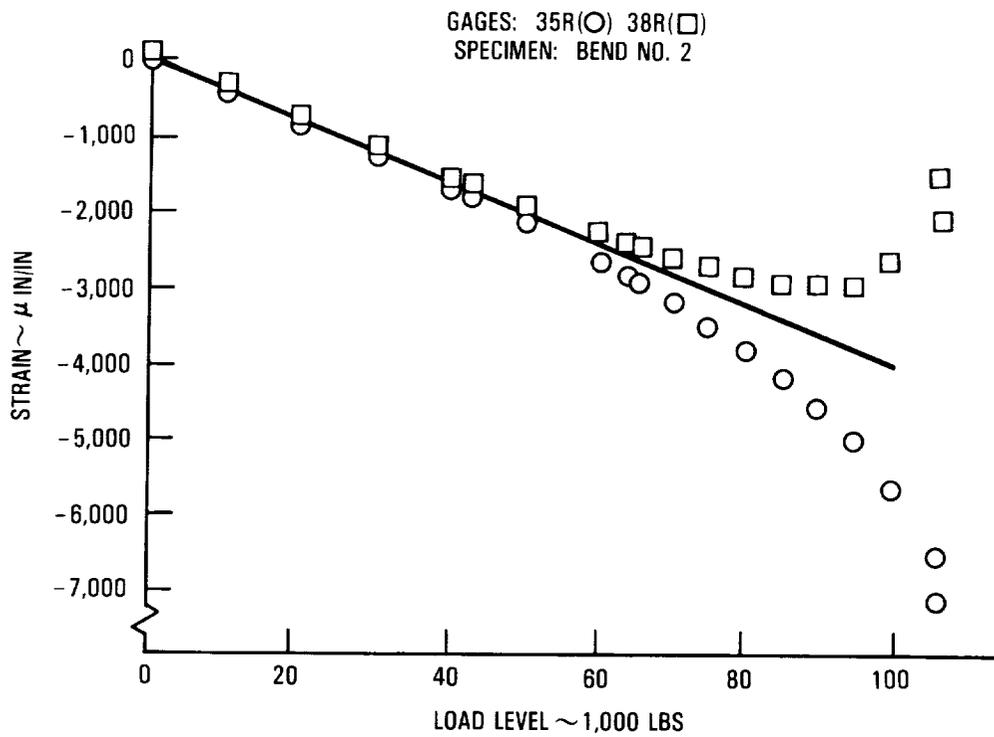
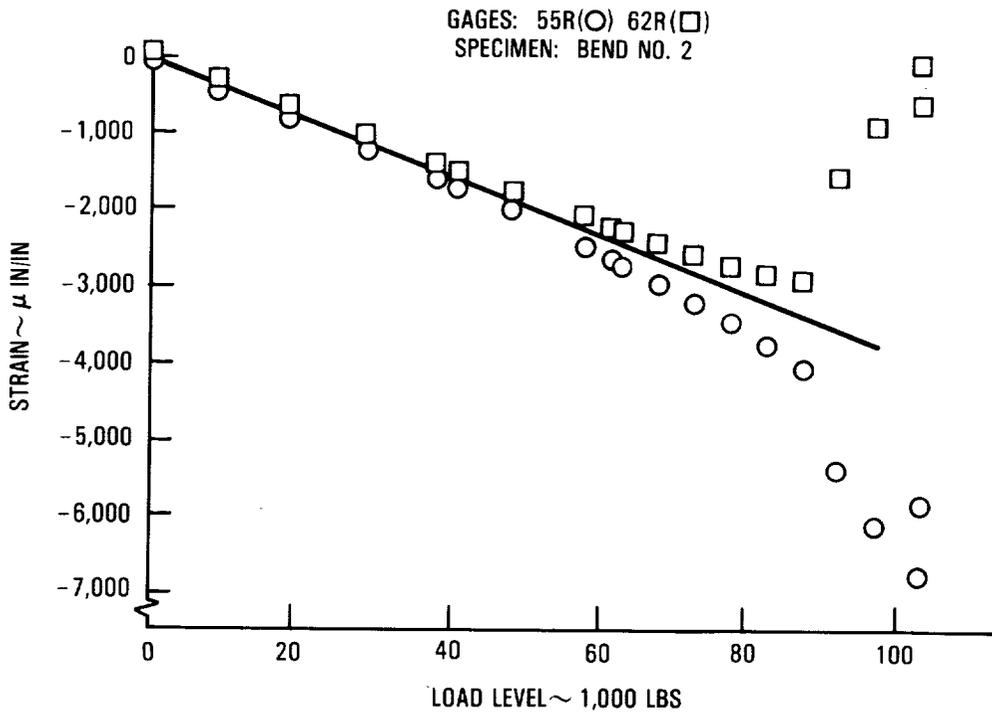
Figure 64. - Strain versus load level - filament wound spar bending specimen - web gages.

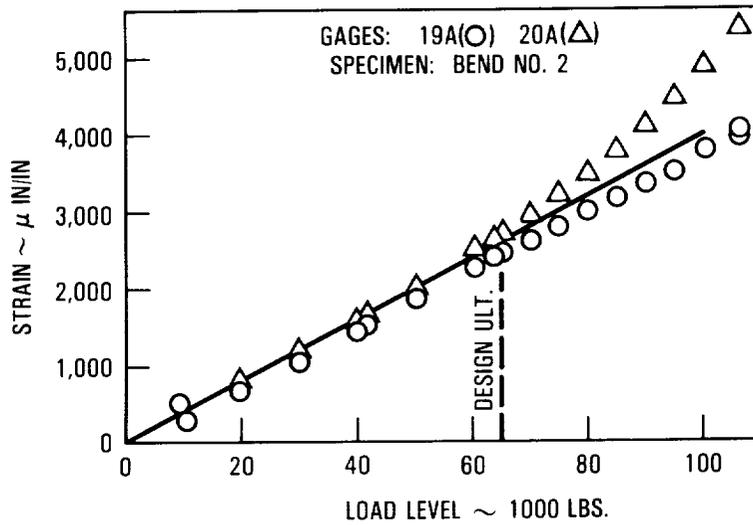
Figure 65. - Strain versus load level - filament wound spar bending specimen - lower cap gages.

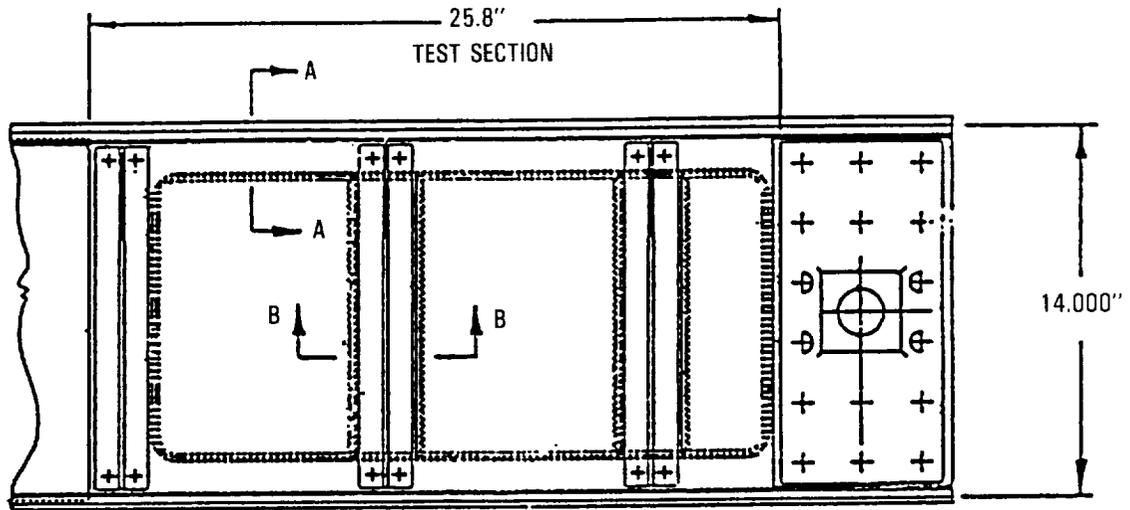
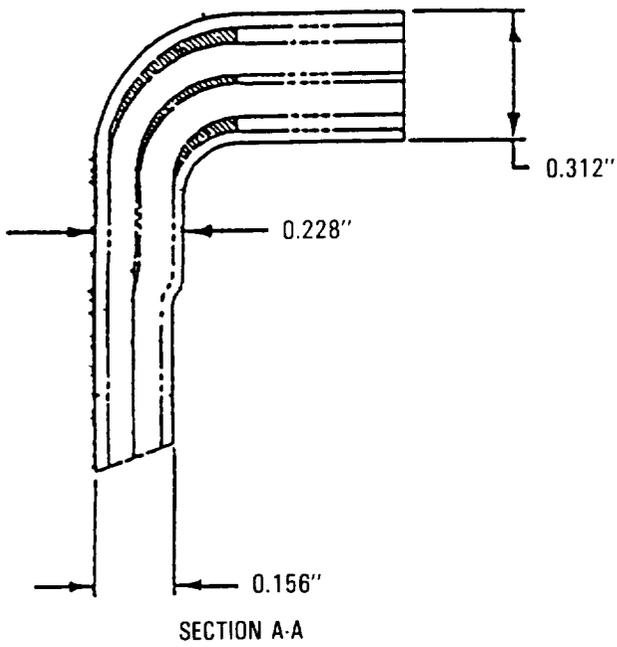
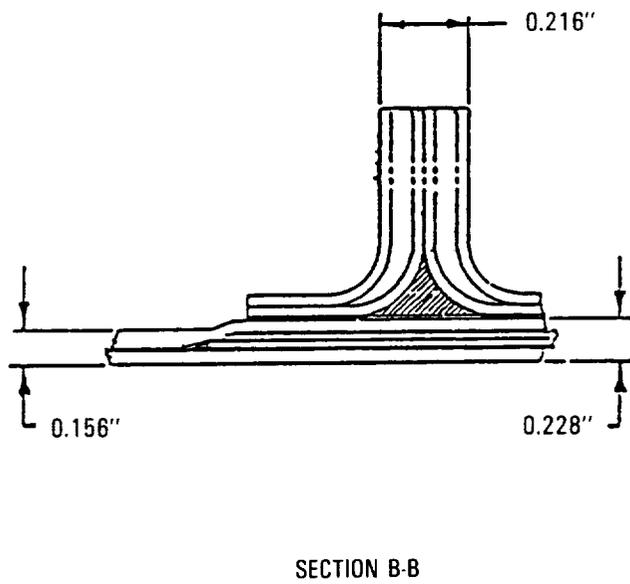
Figure 66. - Postbuckled spar design.

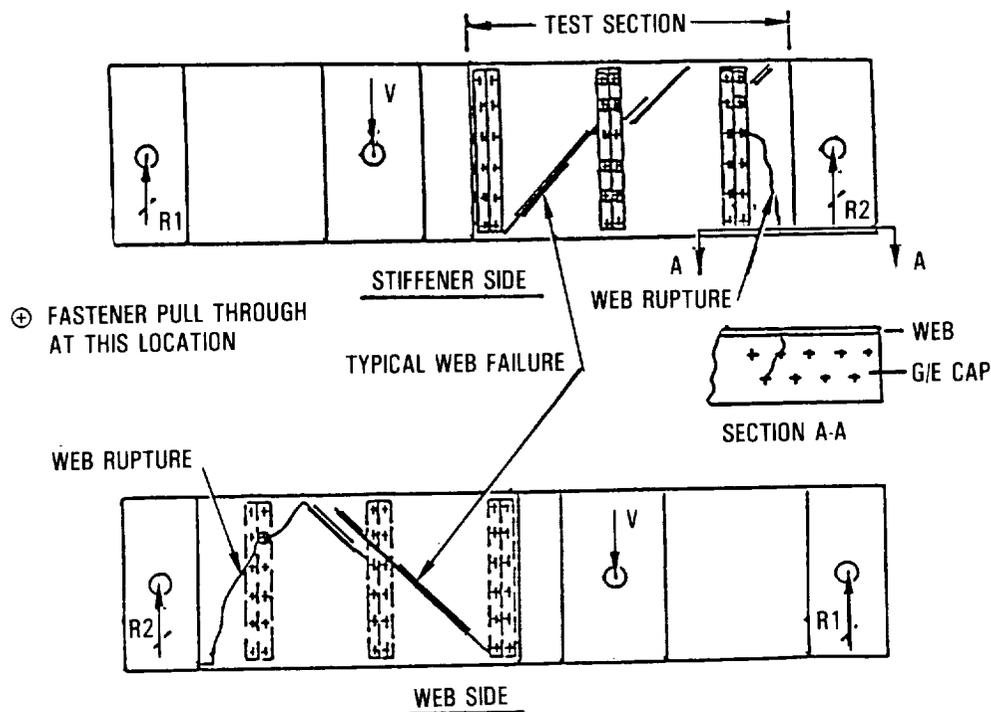
Figure 69. - Failure description - "post-buckled" spar bending specimen.

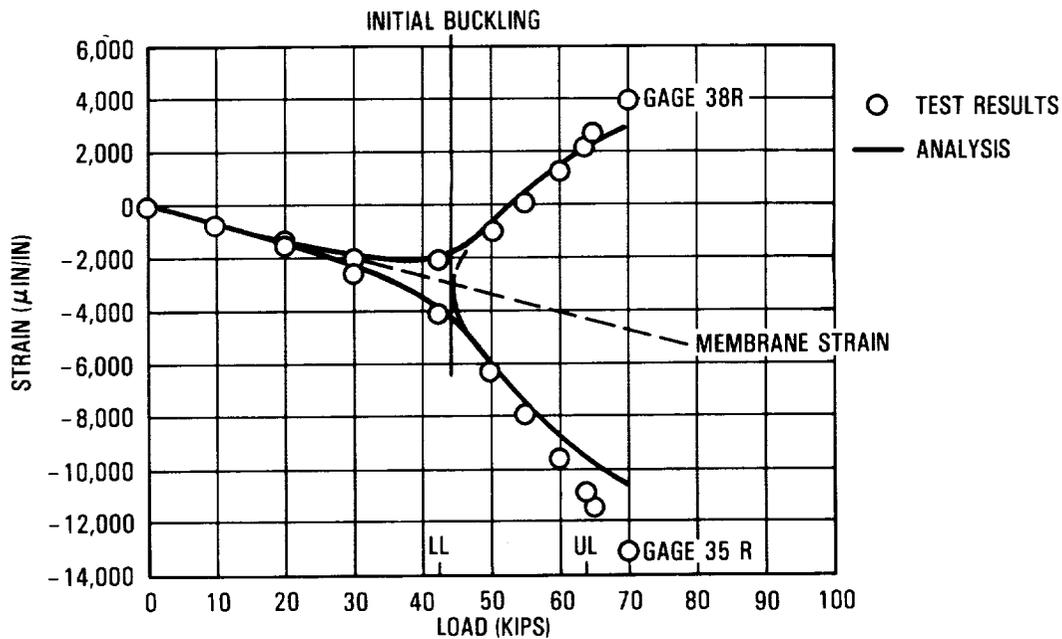
Figure 70. - Strain vs. load level "post-buckled" spar bending specimen.

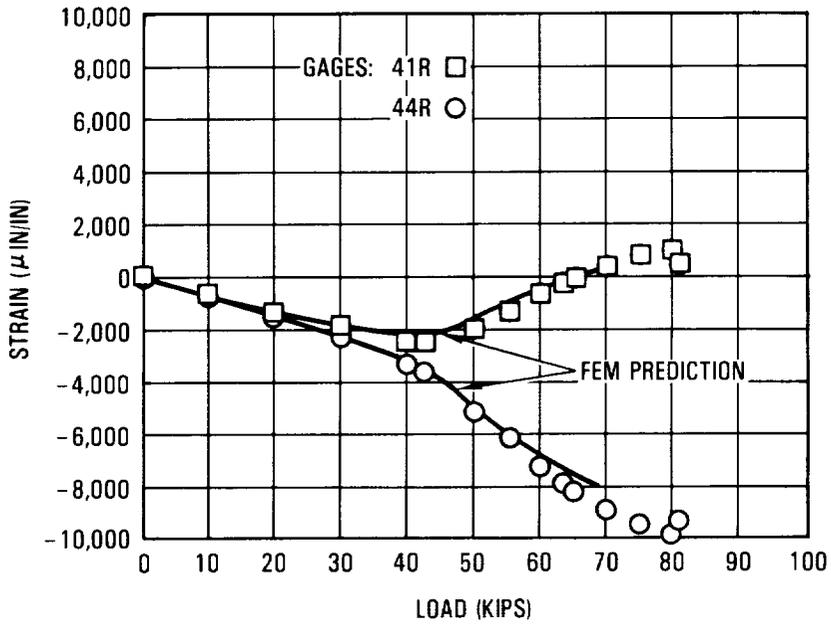
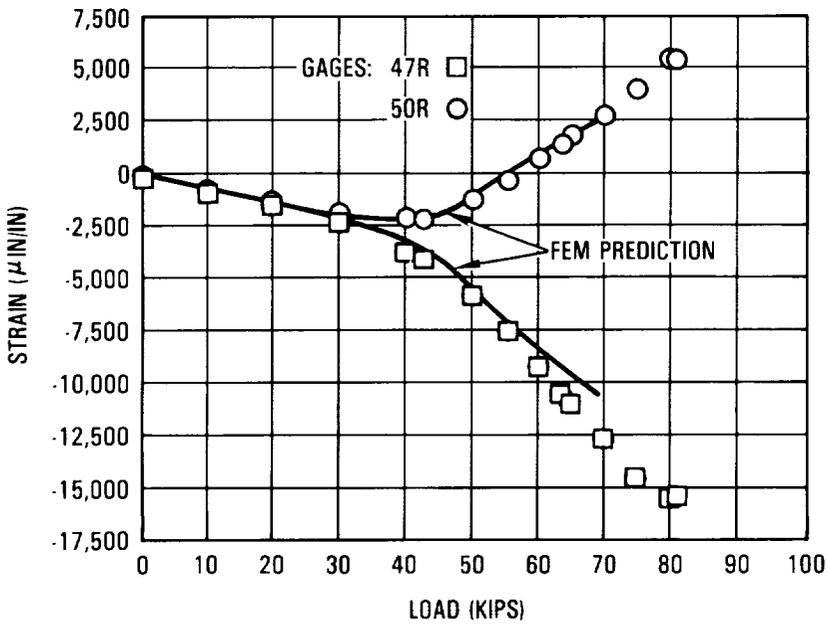
Figure 71. - Strain vs. load level "post-buckled" spar bending specimen.

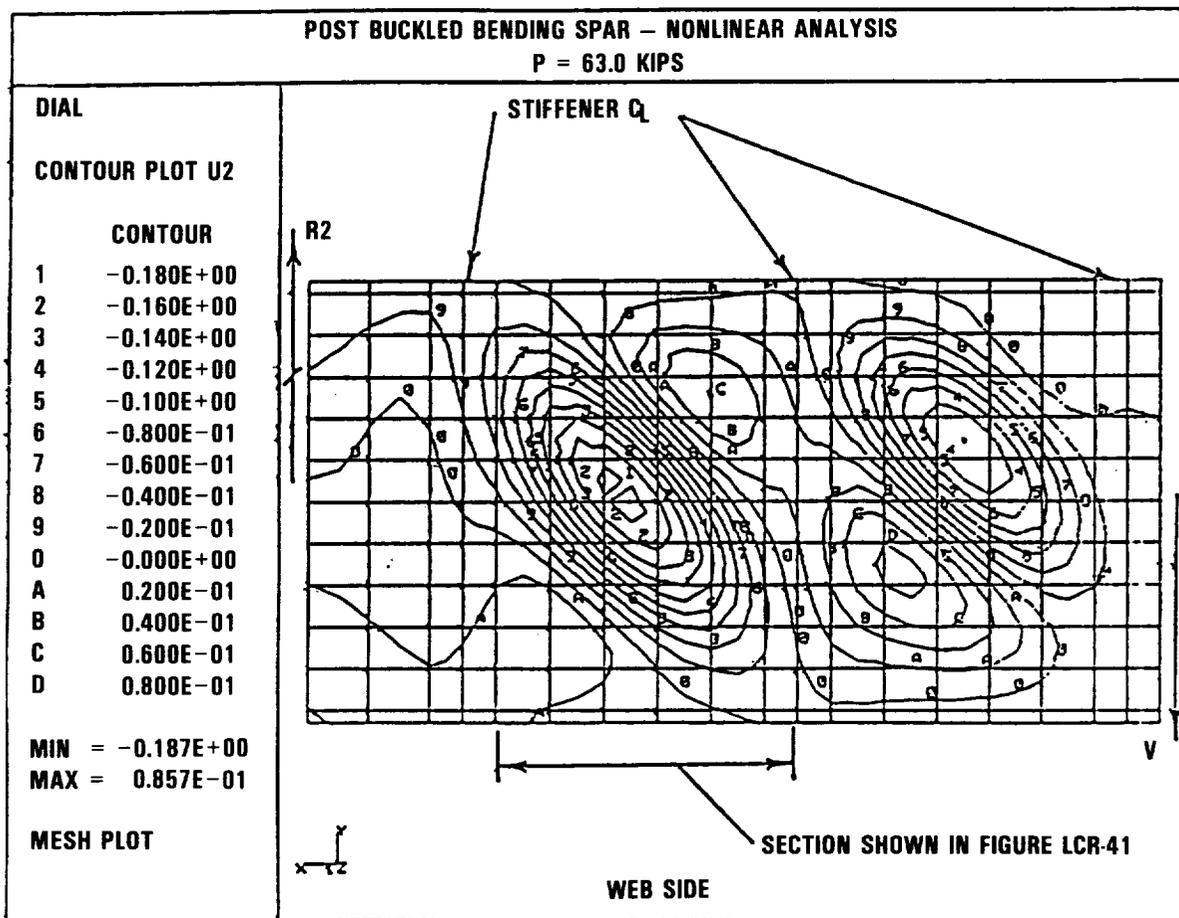
Figure 72. - Analytical deformation plot for the post-buckled web.

Buckling mode shapes and deflection were computed with the finite element model. A typical contour plot slightly below ultimate load is presented in figure 72. The analytic mode shape/web deflections compare favorably with Moire' fringes observed during test. A Moire' fringe pattern from the

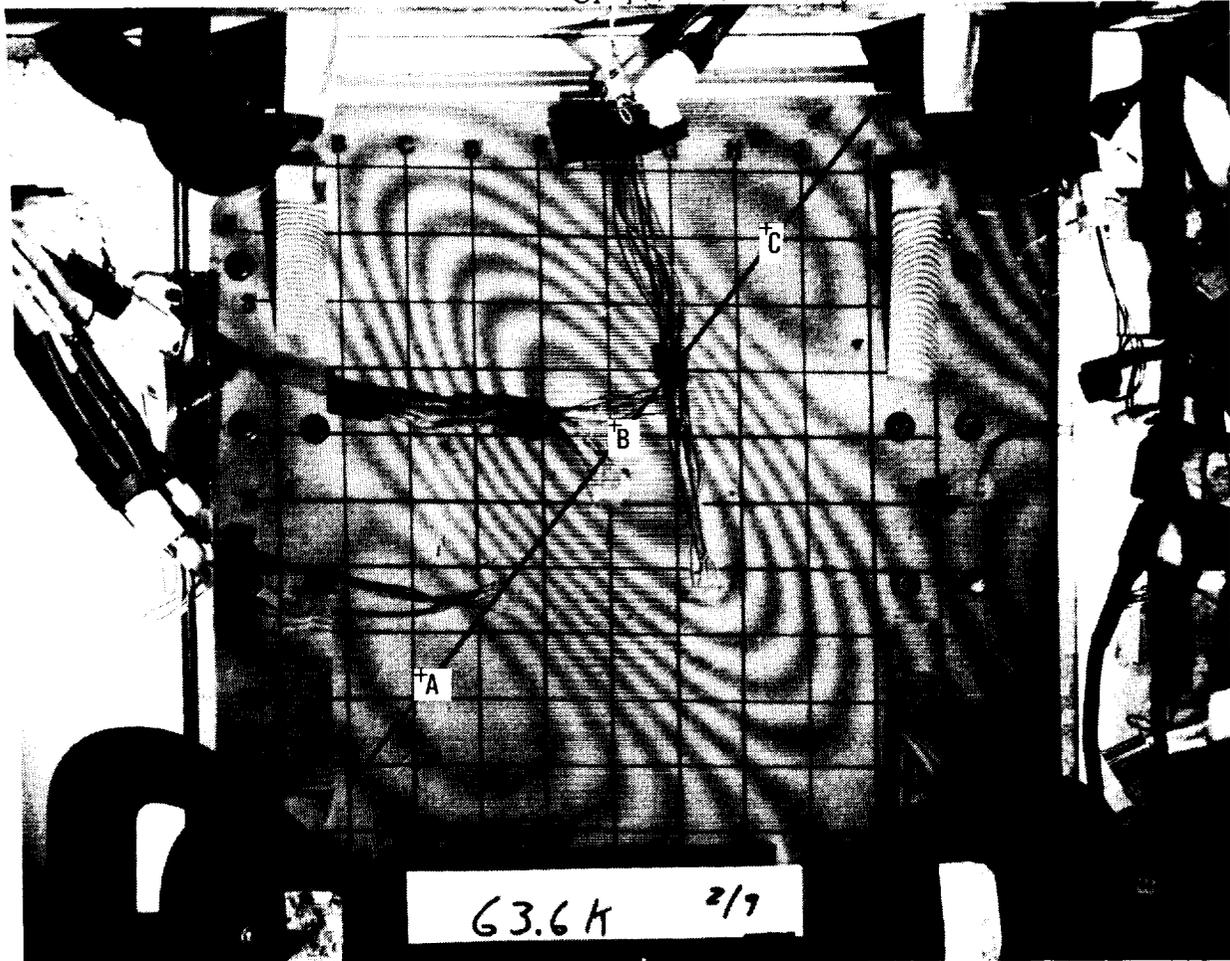
Figure 73. - Moire'fringe at ultimate load - post-buckled spar web.

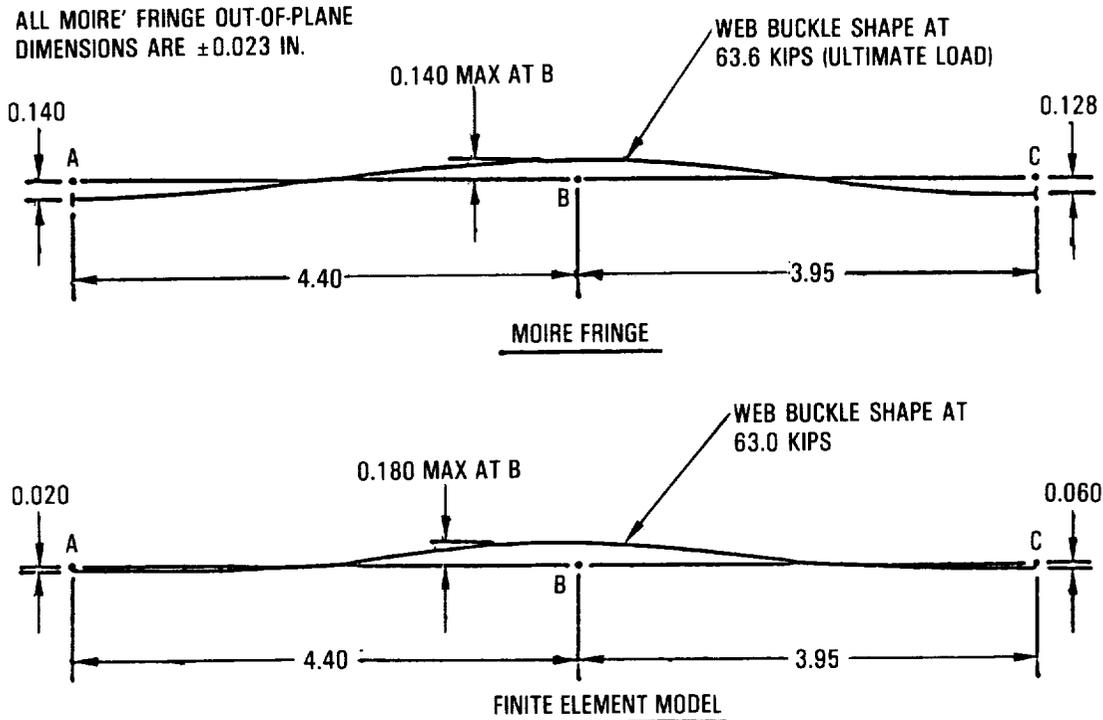
Figure 74. - Moire' vs. Analytical out-of-plane deflection at ultimate load - post-buckled spar web.

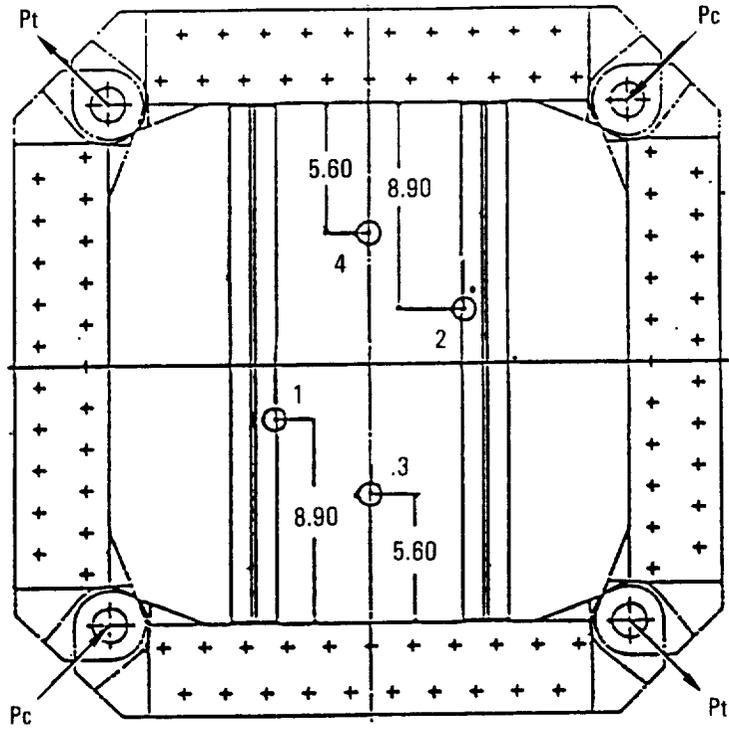
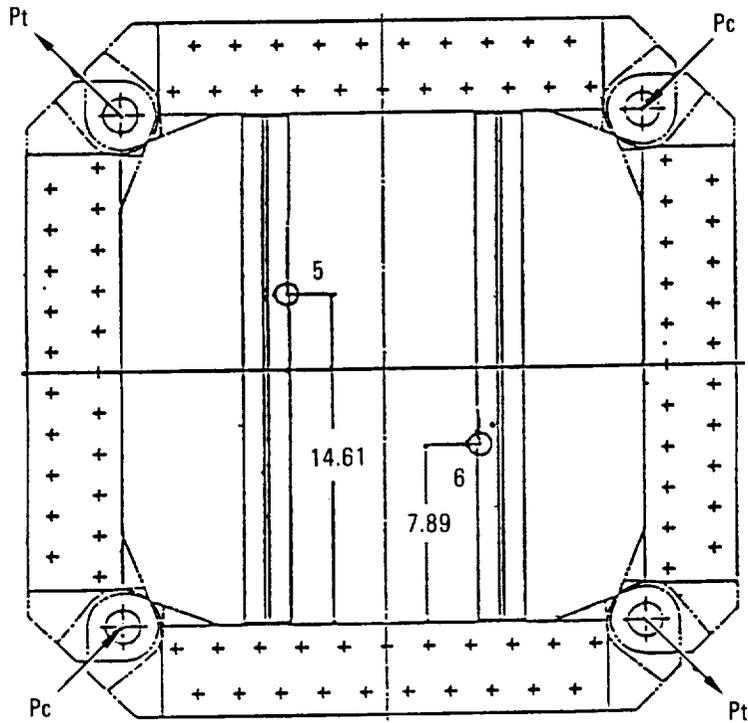
Figure 75. - Impact location - "post-buckled" spar shear specimen.

② Sites 1, 2, 5, and 6 were impacted on smooth side of the web; sites 3 and 4 on stiffener side of web.

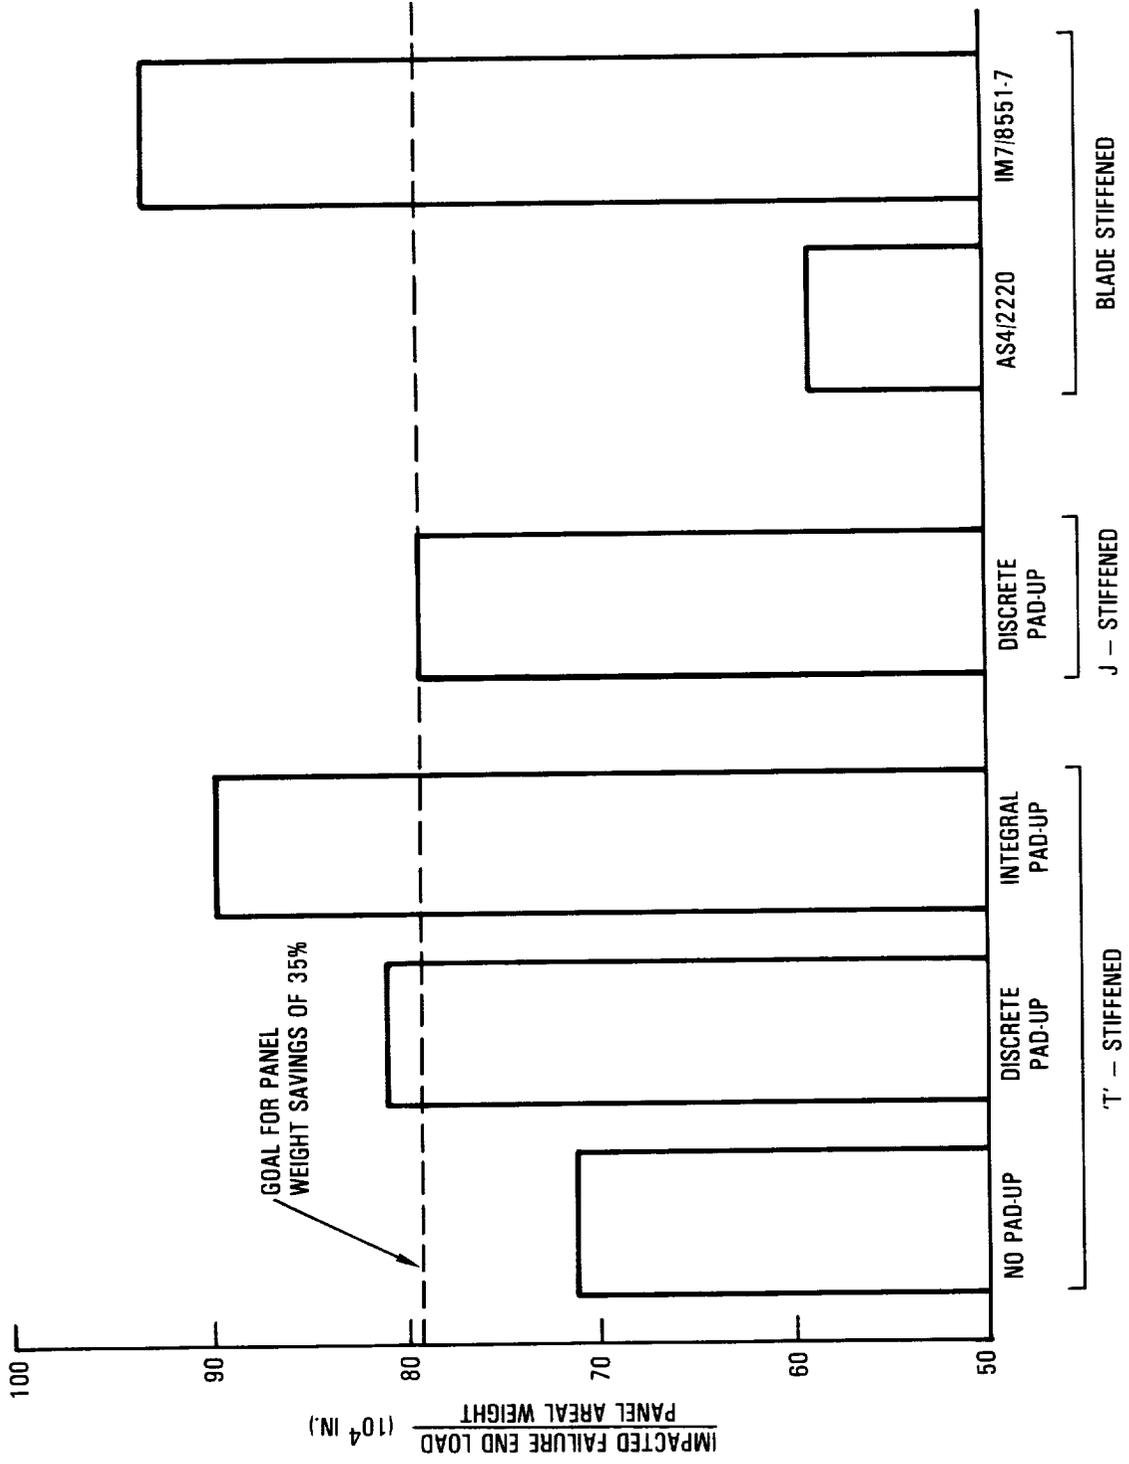
Figure 77. - Stiffened cover designs - structural efficiency comparisons.

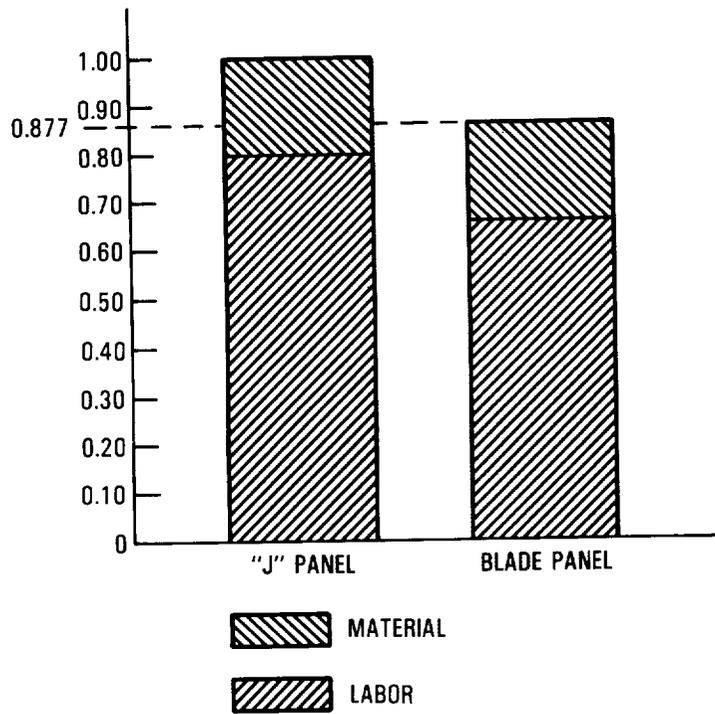
Figure 80. - Relative costs of composite covers.
