**NASA  
Technical  
Memorandum**

NASA TM - 103596

**WEAR MECHANISMS FOUND IN ANGULAR CONTACT  
BALL BEARINGS OF THE SSME'S LOX TURBOPUMP**

By T.J. Chase

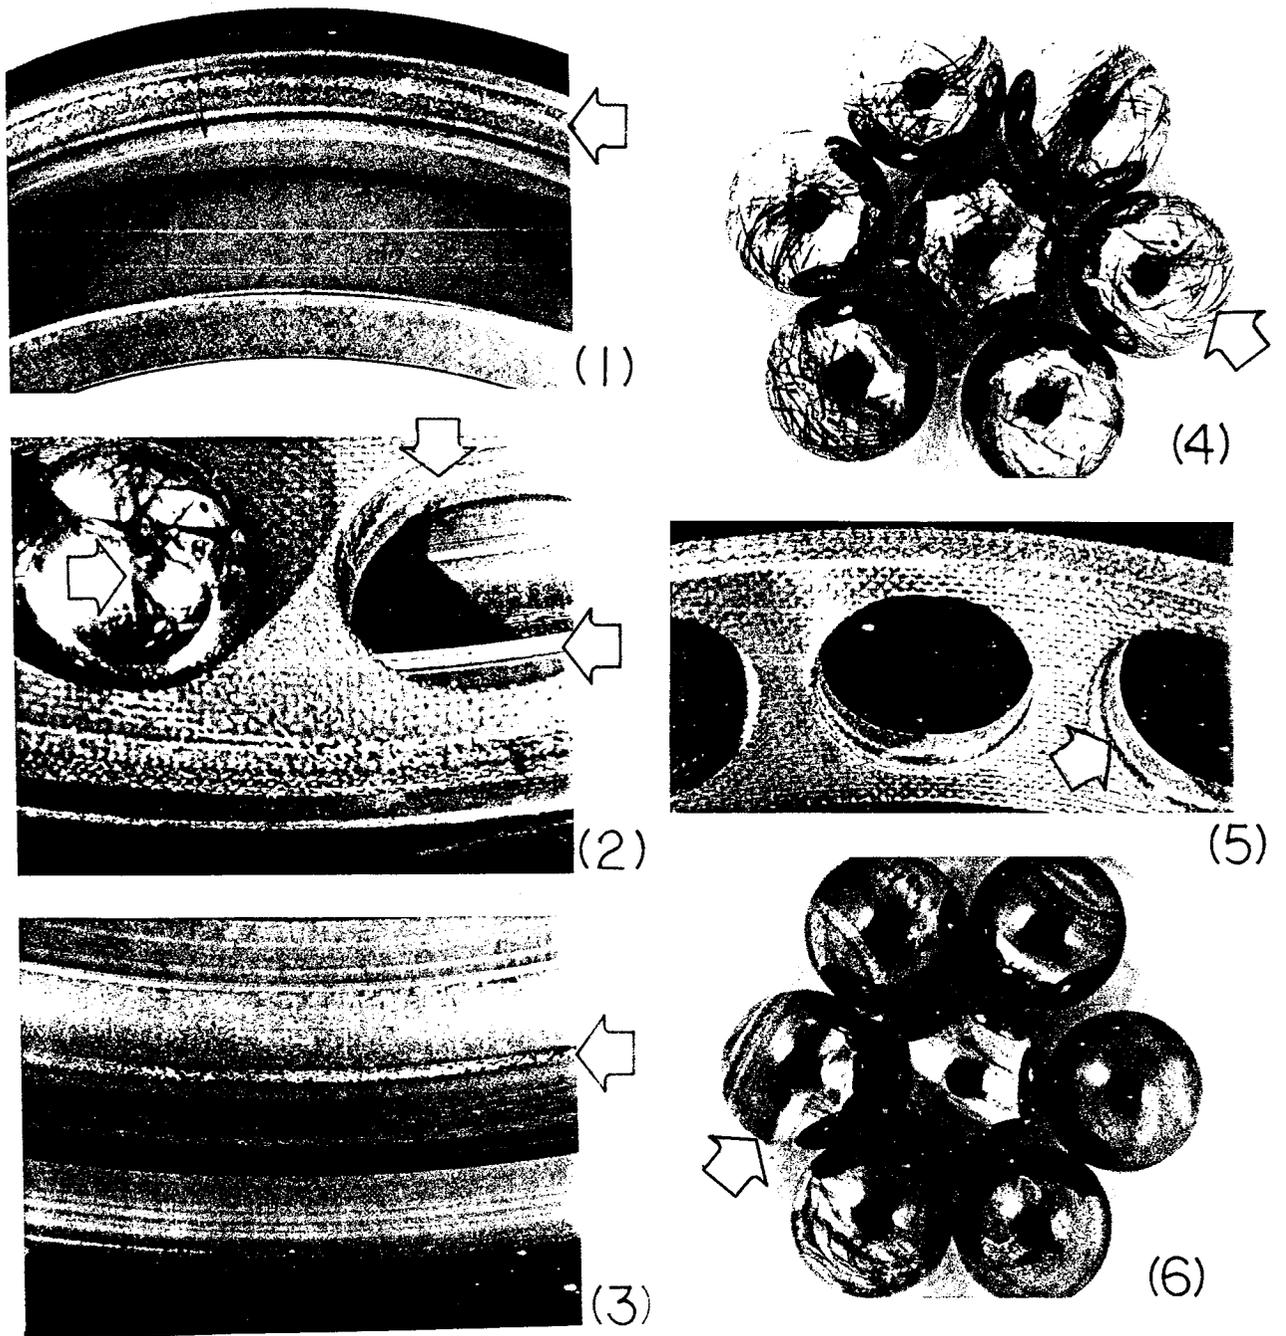
Figure 2. Wear tracks on bearings: (1) inner ring, (2) combined, (3) outer ring, (4) lightly worn balls (note skid marks), (5) cage (note pocket wear), and (6) heavily worn balls.

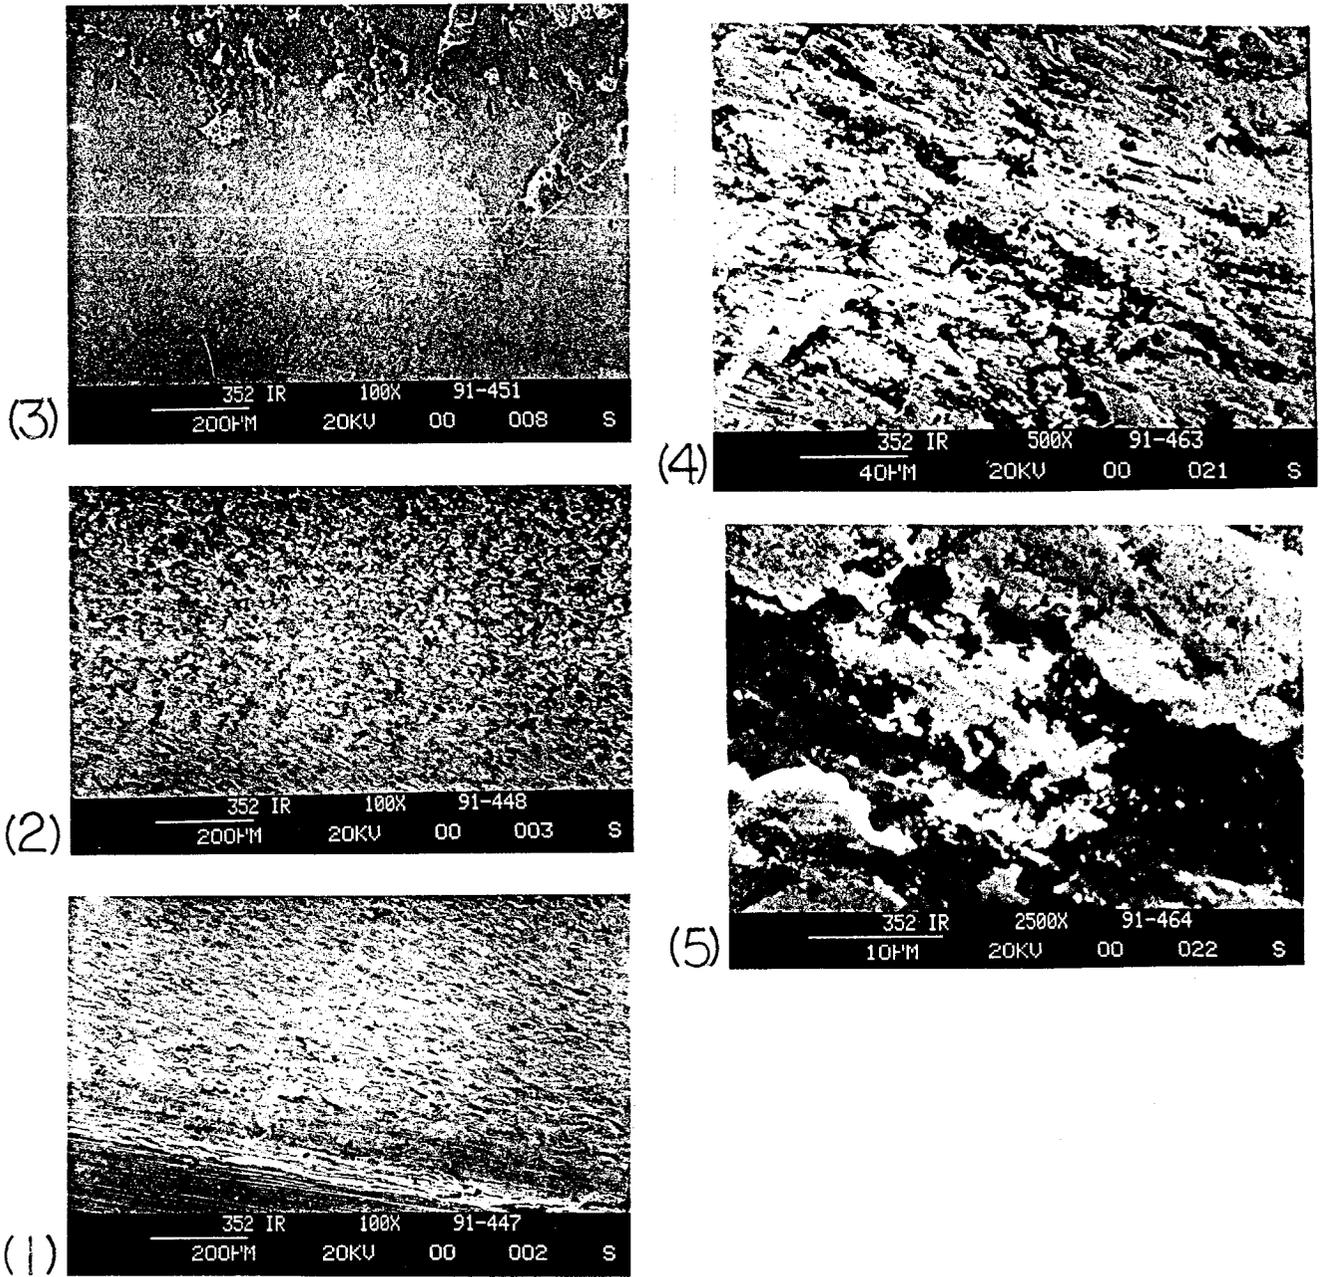
Figure 3. Heavily worn inner ring No. 352. SEM micrographs across the wear track: (1) plastic flow near the land,  $\times 100$ ; (2) adhesive/shear peeling,  $\times 100$ ; (3) contact fatigue,  $\times 100$ ; (4) detail of (2),  $\times 500$ ; and (5) detail of (4),  $\times 2,500$ .

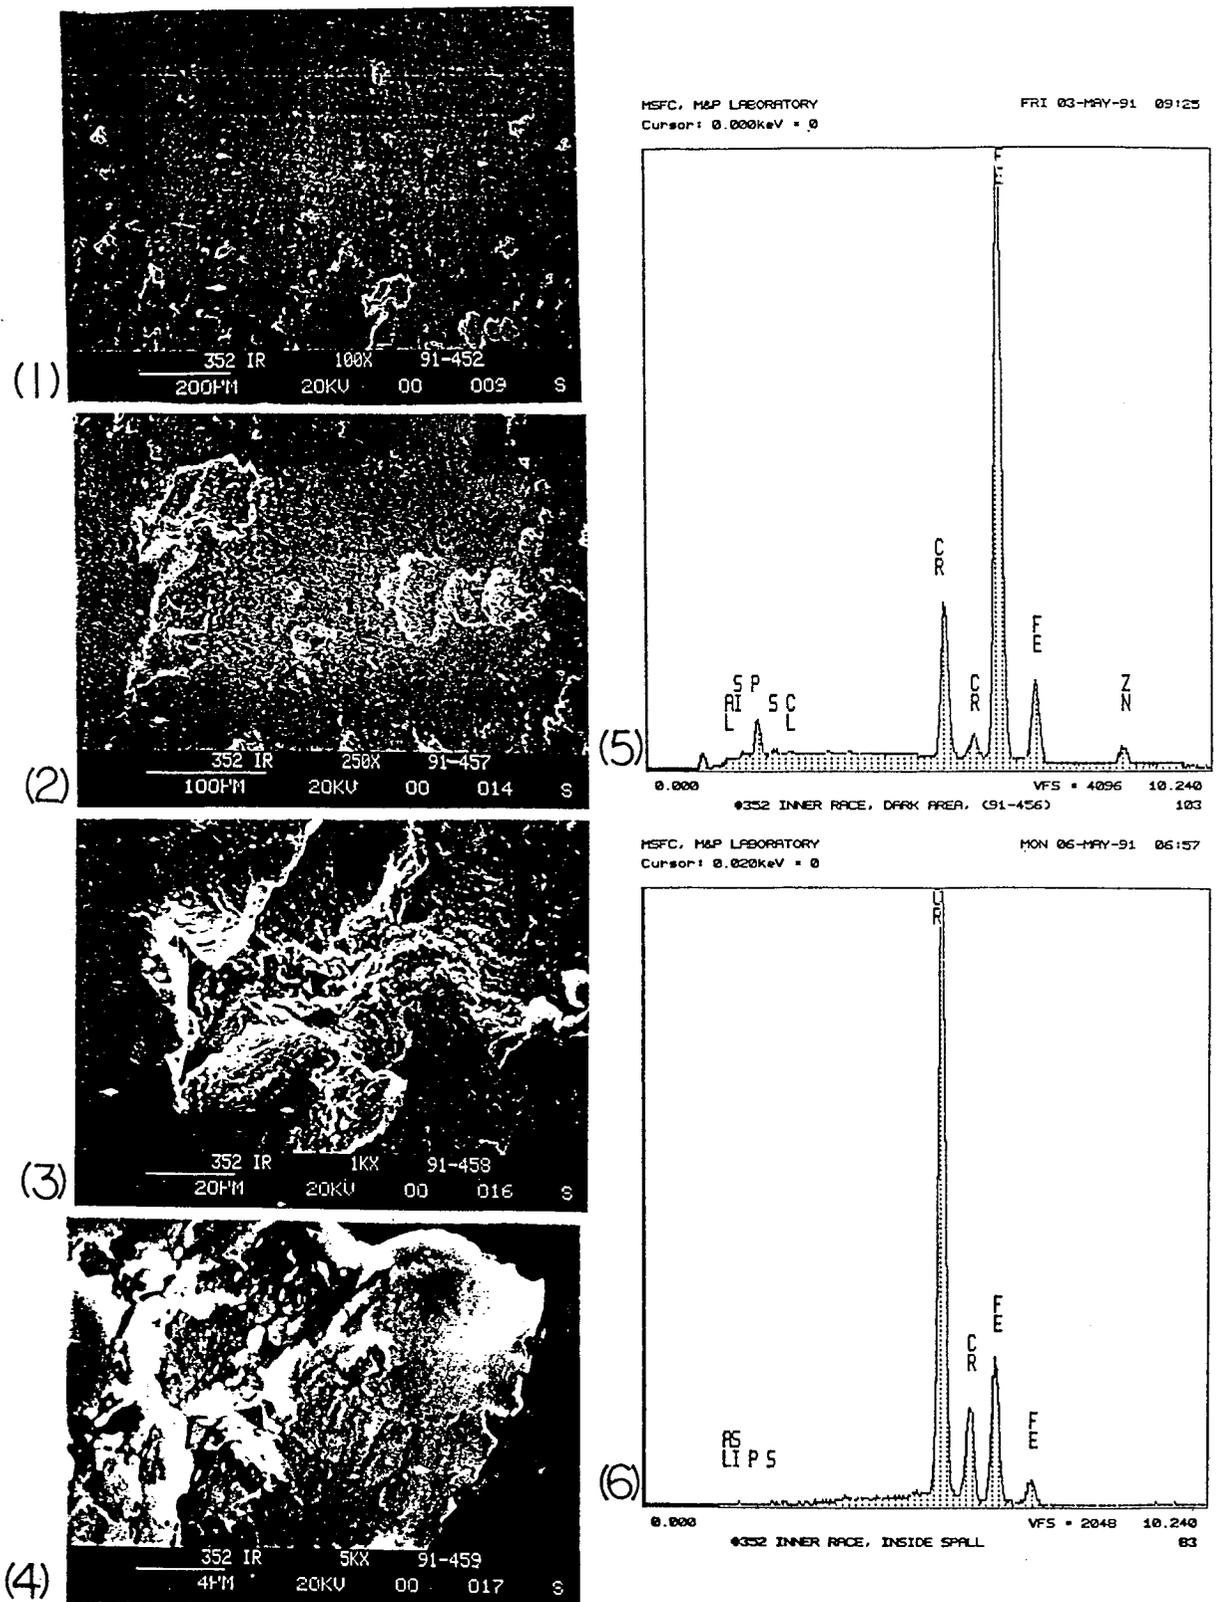
Figure 4. Heavily worn inner ring No. 352 (continued). SEM micrographs across the contact fatigued area of the wear track: (1) spalls,  $\times 100$ ; (2) spalls,  $\times 250$ ; (3) detail of (2),  $\times 1,000$ ; (4) fatigue flake, detail of (3),  $\times 5,000$ ; (5) EDS overall; and (6) EDS inside a spall.

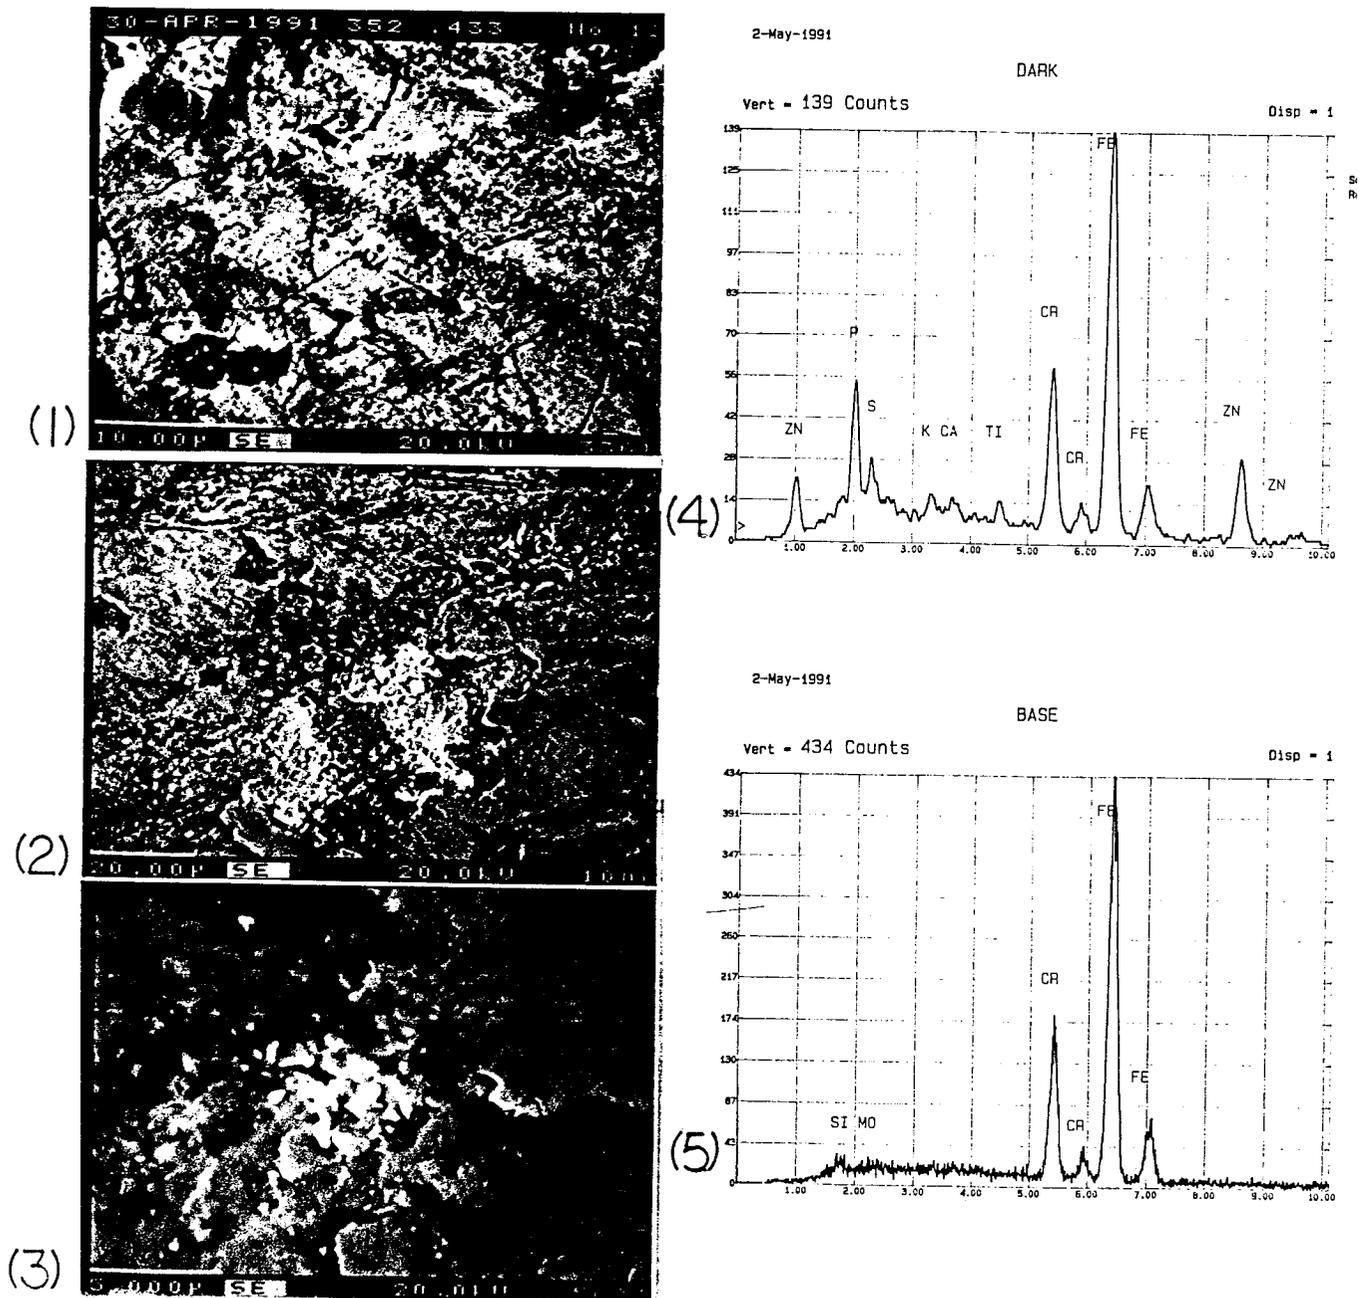
Figure 6. Heavily worn ball No. 12 (bearing No. 352): adhesive/shear peeling wear and early contact fatigue. Microprobe SEM and EDS graphs. (1) Surface cracks,  $\times 3,360$ ; (2) surface peeling and submicron size debris,  $\times 1,000$ ; (3) detail of (2),  $\times 5,000$ ; (4) microprobe EDS inside a spall, and (5) EDS overall.

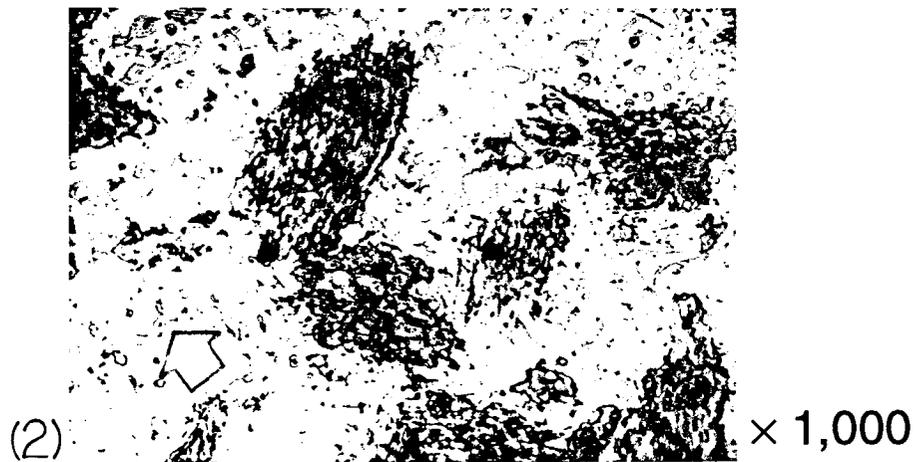
Figure 8. Lightly worn ball No. 1 (bearing No. 500): (1) adhesive/shear peeling (black spots) and virgin surface (white background, actually goldish) with original machining marks (dotted lines) still visible; (2) detail of (1) shows the dotted lines to also have the adhesive/shear origin; (3) finishing marks on a brand new ball. Optical micrographs.

Figures 8(1) and 8(2) show the original machining marks as fine dot-lines still visible on the surface of the lightly worn ball, and figure 8(3) shows a shiny surface of a brand new ball. Under a  $\times 1,000$  magnification, these well-aligned dots proved to be very shallow pits just like those produced by the adhesive/shear wear mode discussed earlier. Obviously, the finish marks come from the sliding (shear) wear in which adhesion plays a major role. Thus, the adhesive/shear peeling mode is quite universal. The difference between high and low wear in this mode lies in the relative size and depth of spalls and their number on the surface, i.e., on the wear kinematics. Wear dynamics is another matter, and it needs further investigation.

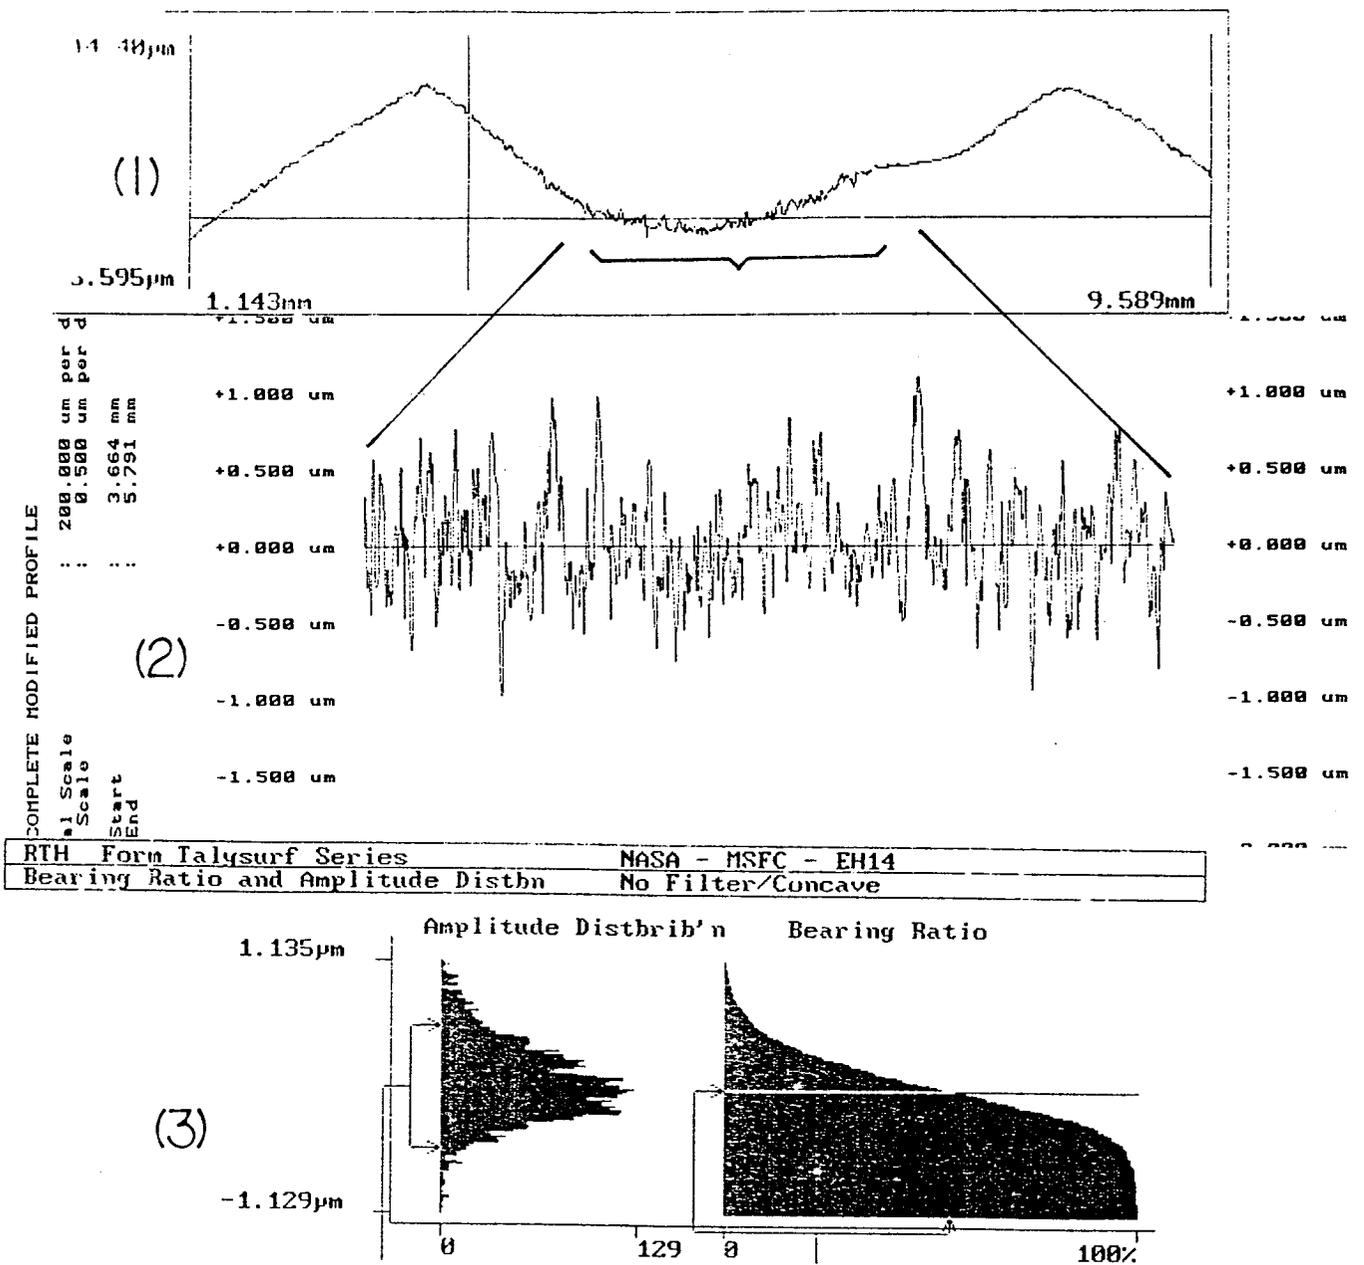
Figure 9. Heavily worn outer ring No. 352. Form Talysurf series (Rank Taylor-Hobson) surface profilograms: (1) modified profile, (2) wear track, detail of (1), roughness statistics of the wear track.

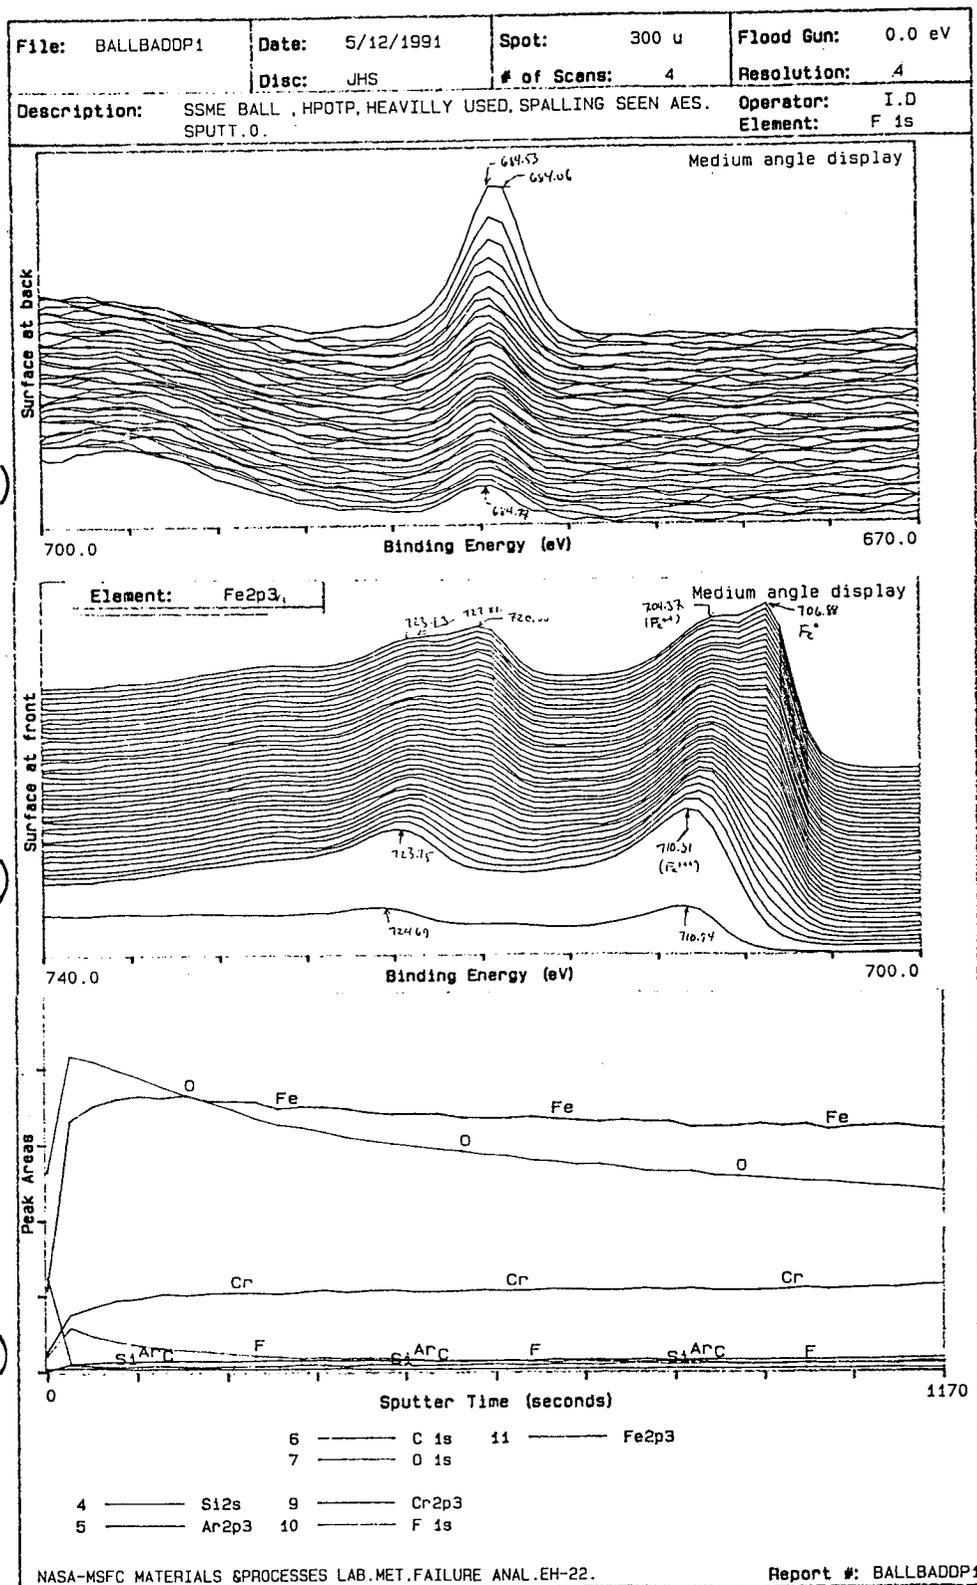
Figure 10. Depth profiling of a heavily worn ball. X-ray photoelectron spectroscopy: (1) fluorine, (2) iron, and (3) combined diagram.

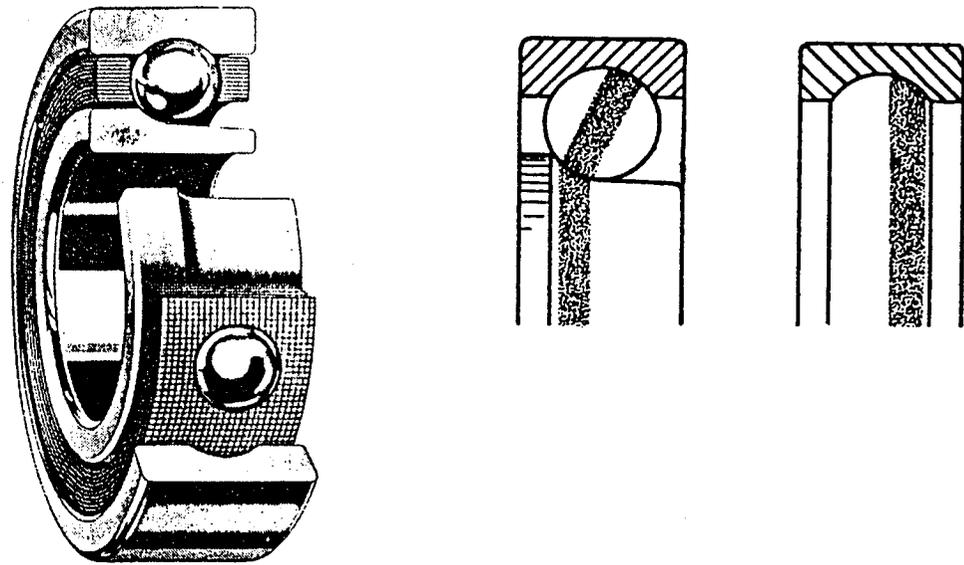
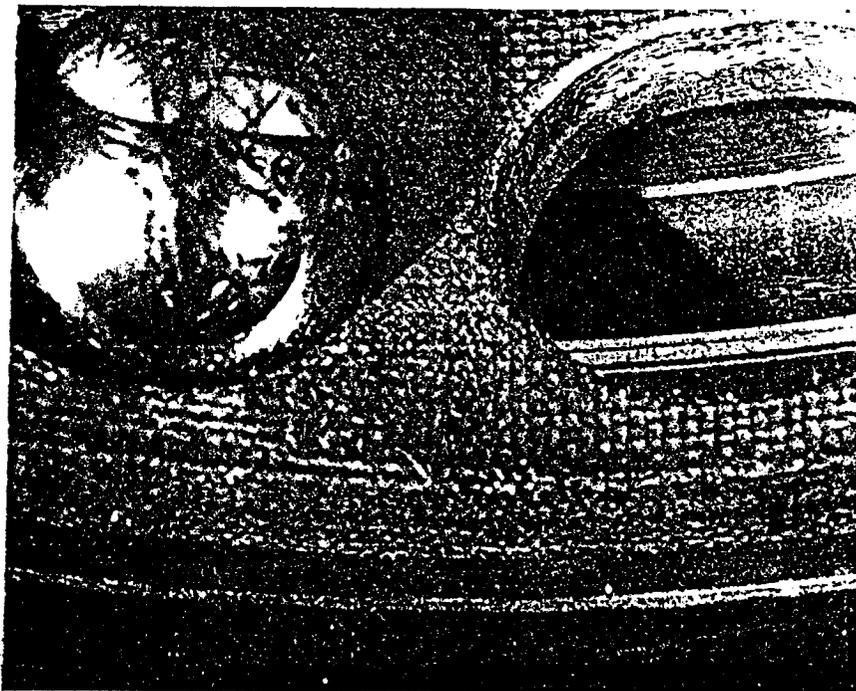
Separable angular contact ball bearing

Figure A-1. Angular contact ball bearing. Wear patterns in axial loading.

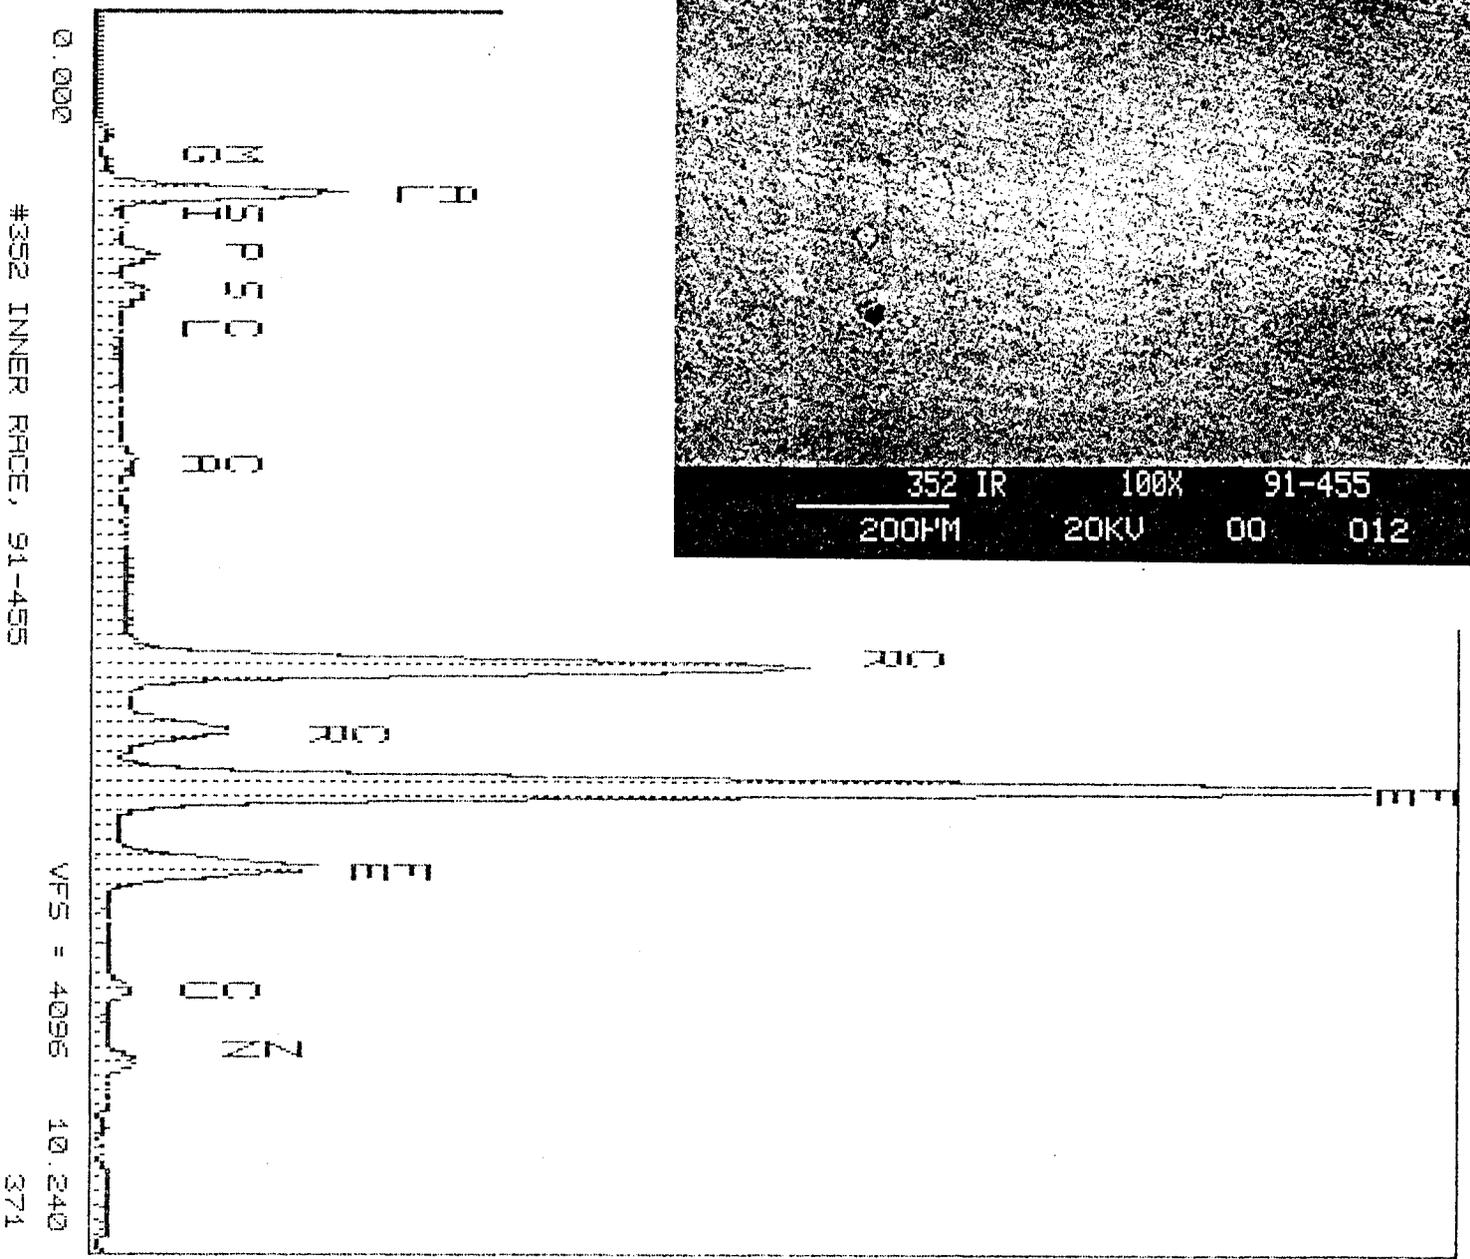
Figure A-3. Overall SEM/EDS of the wear track on the inner ring of bearing No. 352: Note presence of foreign matter like Al, Zn, and Cu. It may have come with the lox stream (compare figs. A-54 through A-62).

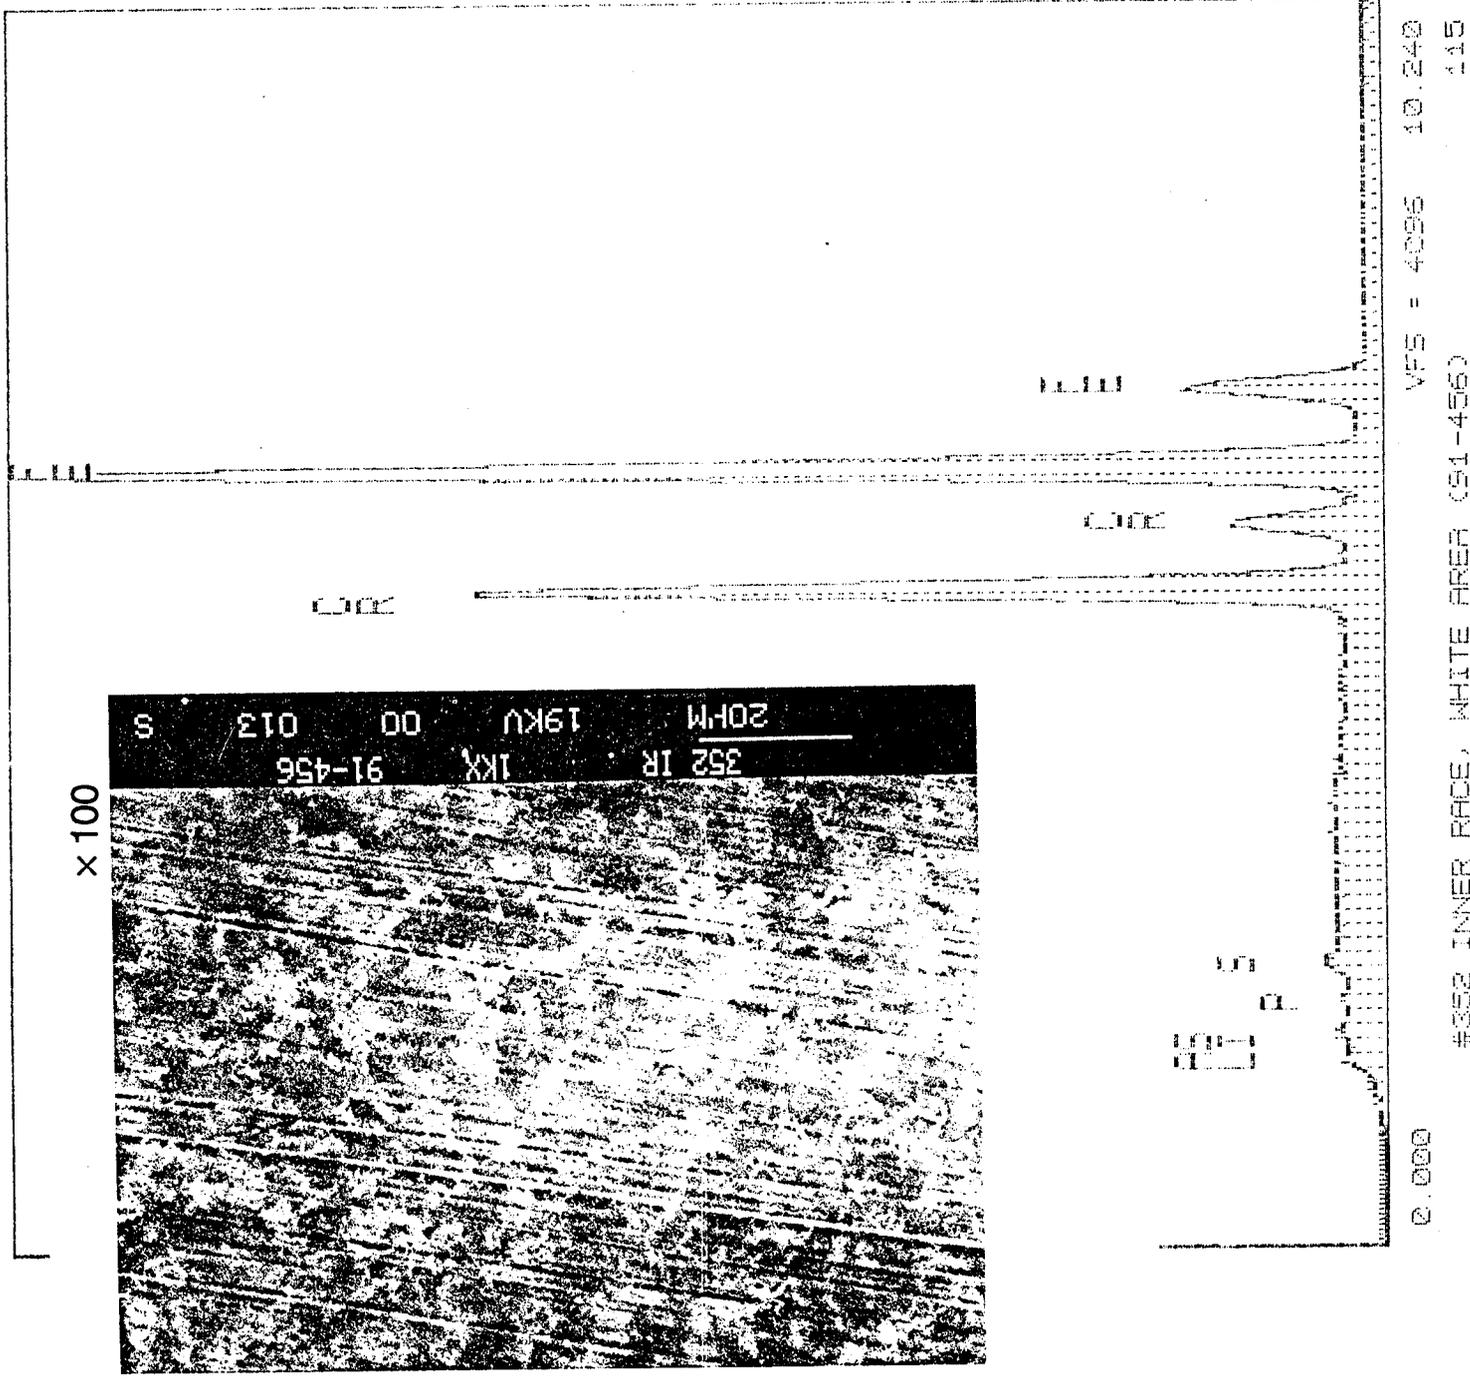
Figure A-4. SEM/EDS of the white area on wear track on the inner ring of bearing No. 352. Note increased Cr/Fe ratio compared to figure A-3.

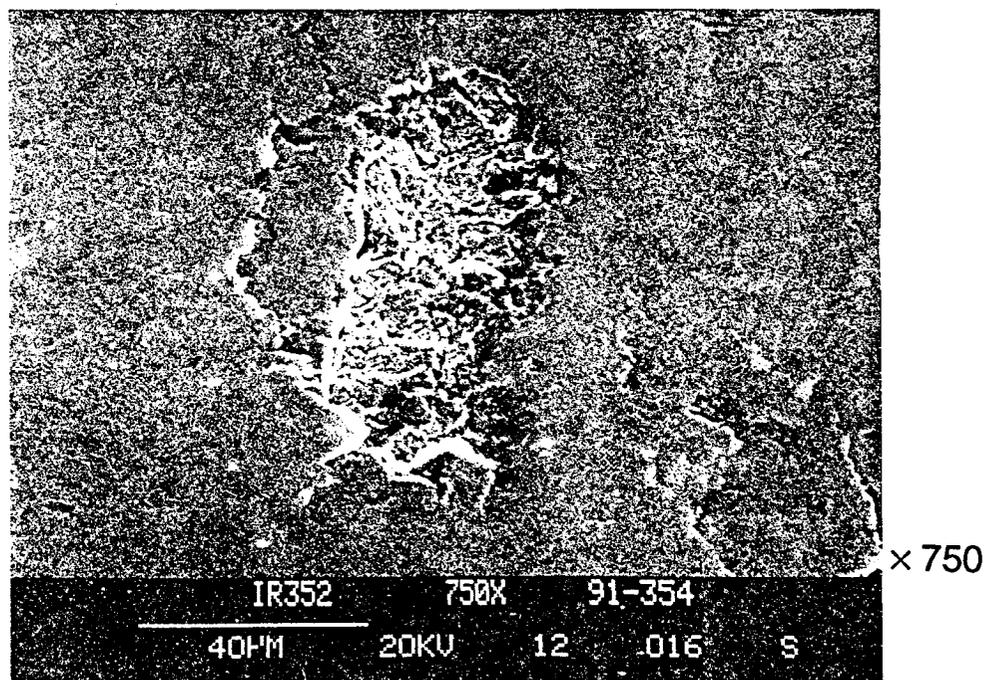
Figure A-5. SEM of the microfatiuged area on wear track of the inner ring of bearing No. 352.

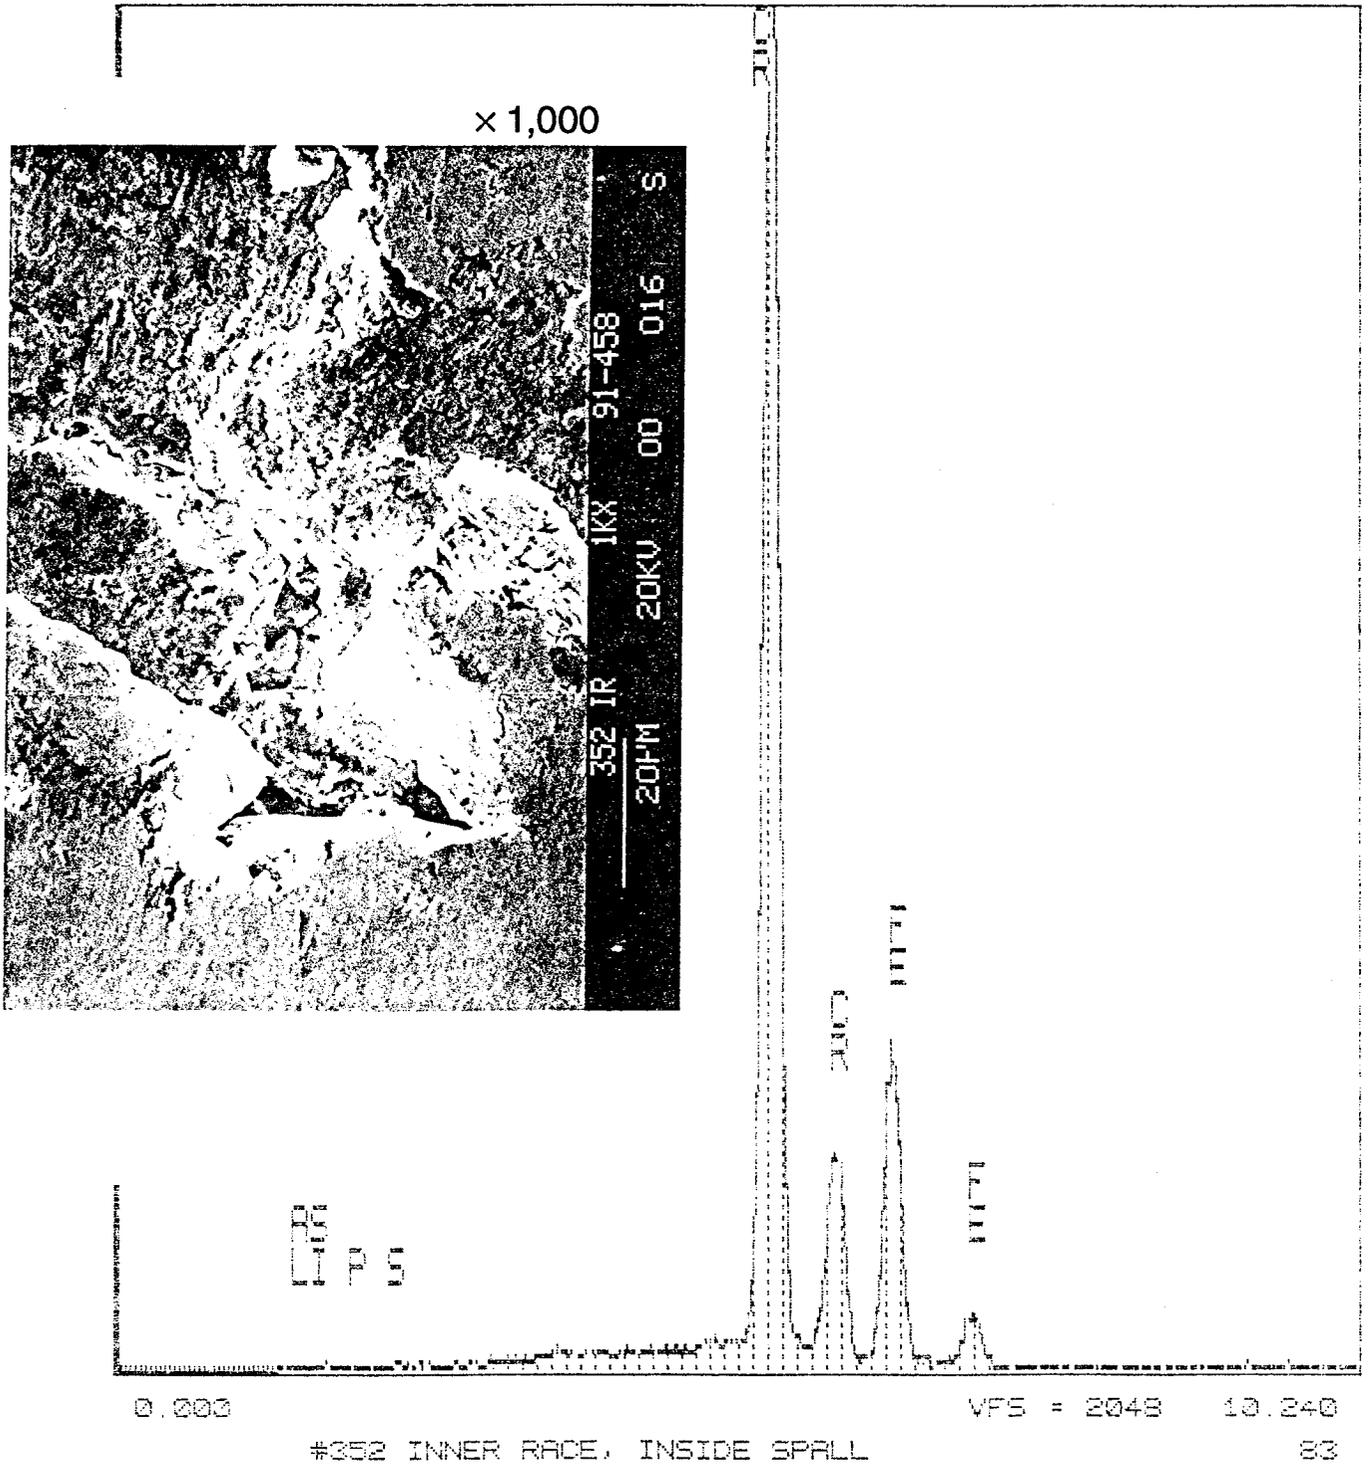
Figure A-7. SEM/EDS on microfatigued area. Wear track of the inner ring of bearing No. 352.  
Note high Cr concentration inside the spall.

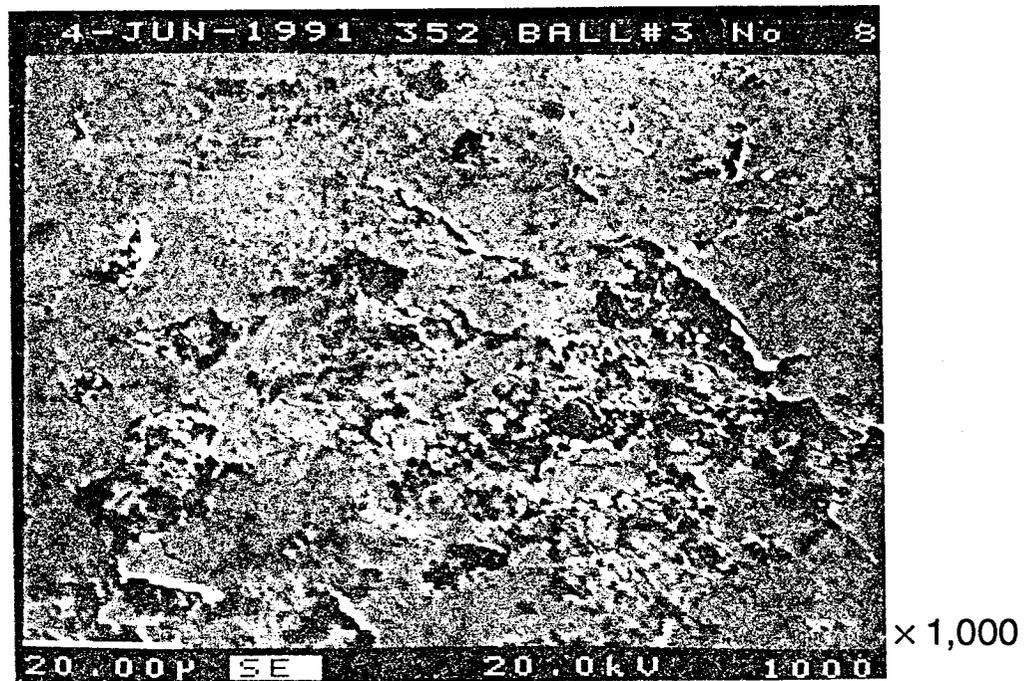
Figure A-11. Microprobe SEM of a ball surface in bearing No. 352. Adhesive/shear peeling of the upper layer. Note many fatigue cracks.

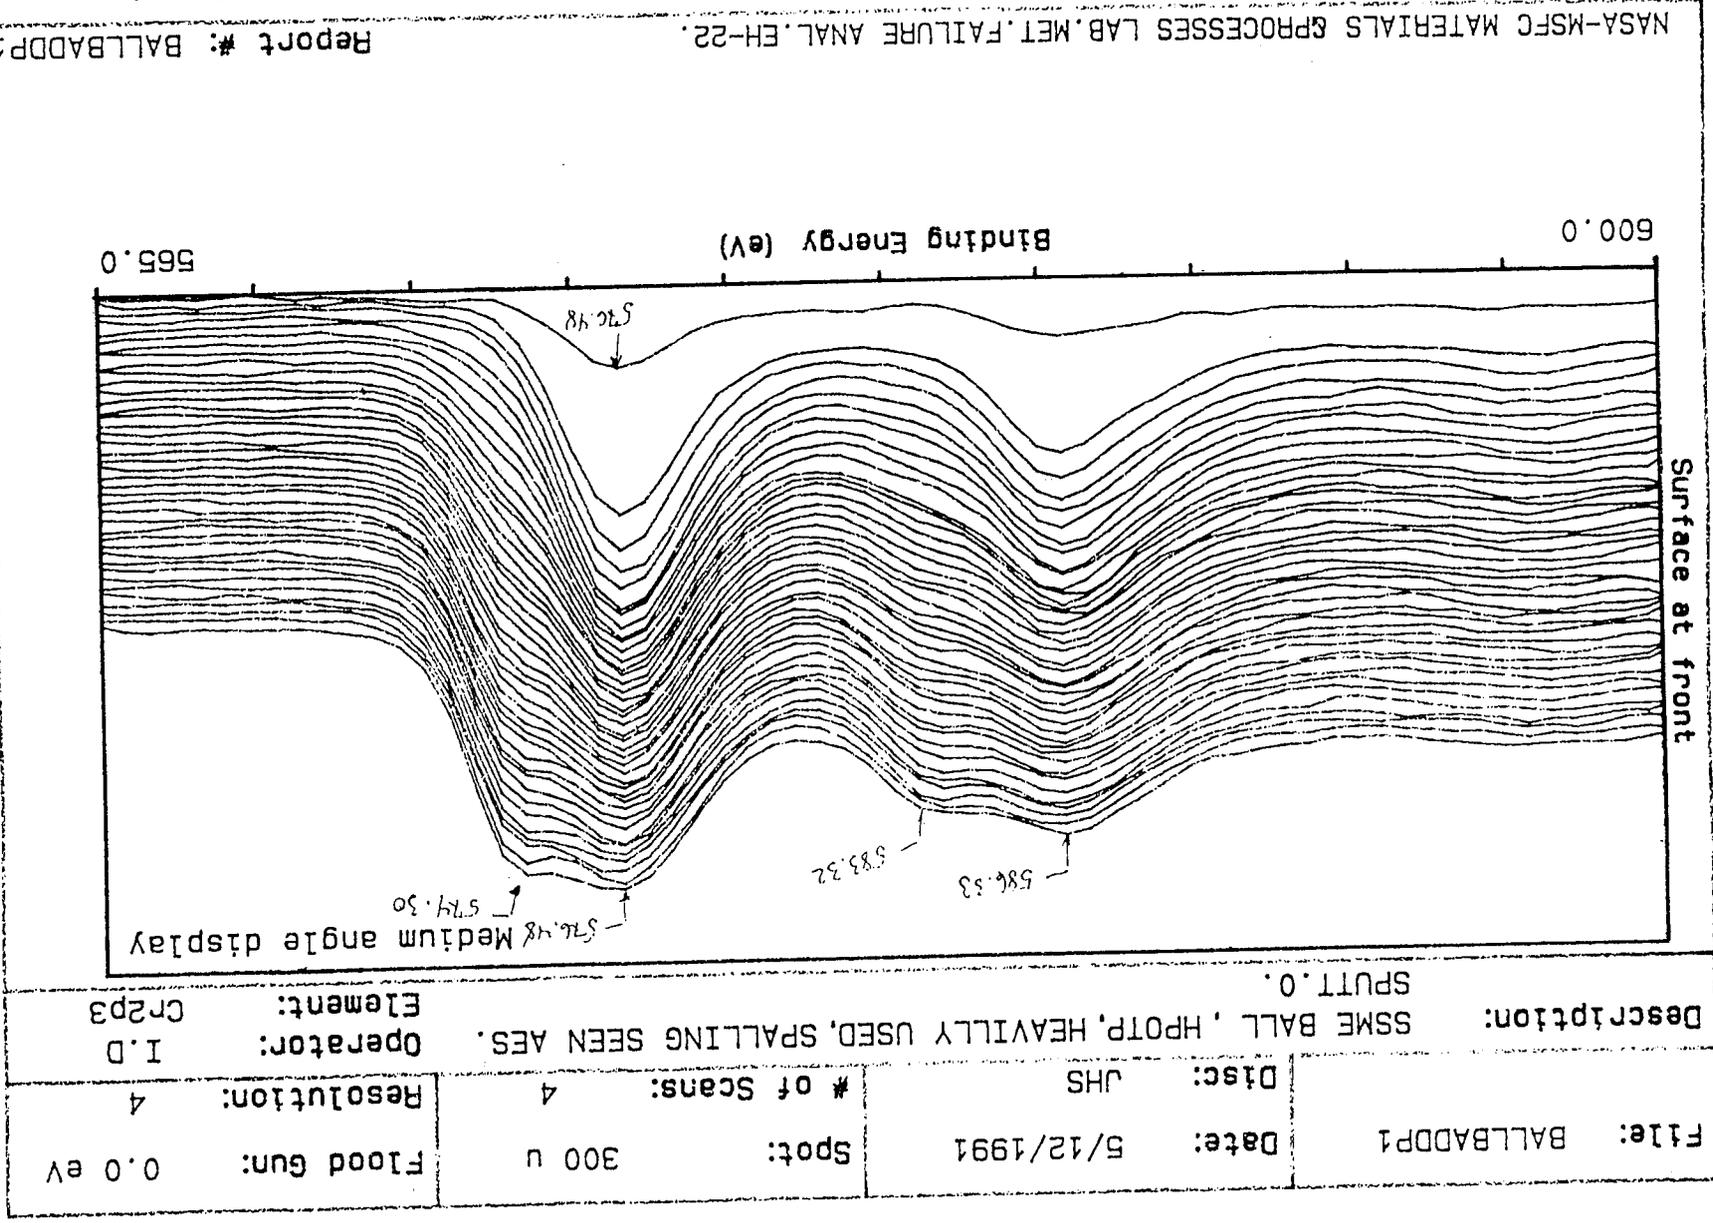
Figure A-16. XPS sputtering for depth profiling on a ball of bearing No. 352. Note chromium (oxide) transformation (indicated by the shift in the position of the peak of binding energy with time).
