**NASA  
Technical  
Memorandum**

NASA TM - 103596

**WEAR MECHANISMS FOUND IN ANGULAR CONTACT  
BALL BEARINGS OF THE SSME'S LOX TURBOPUMP**

By T.J. Chase

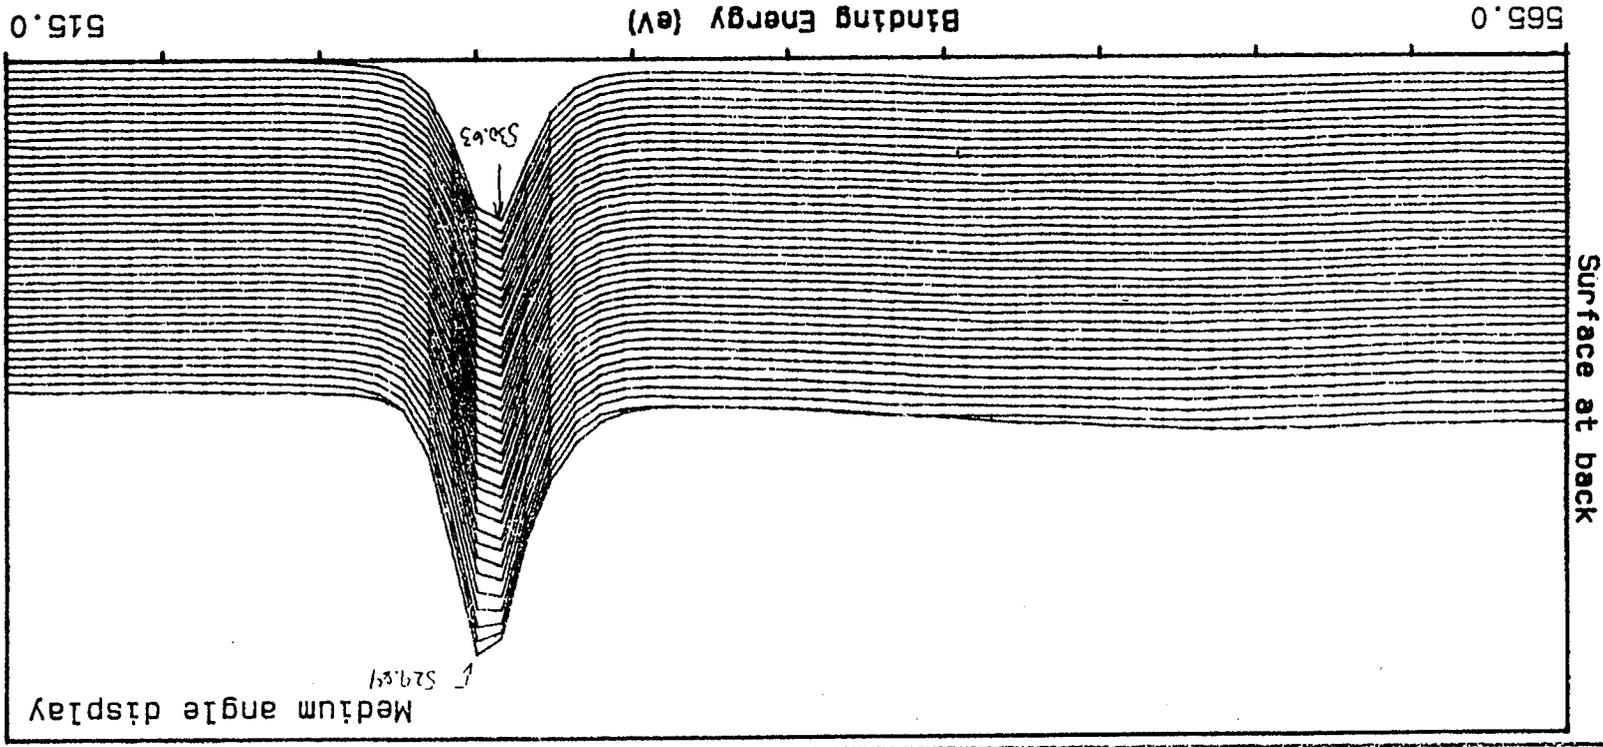
Figure A-17. XPS sputtering for depth profiling on a ball of bearing No. 352. The binding energy peak decreases with depth (sputter time), thus showing a drop in oxygen concentration below the surface. Note the "surface at back" reference.

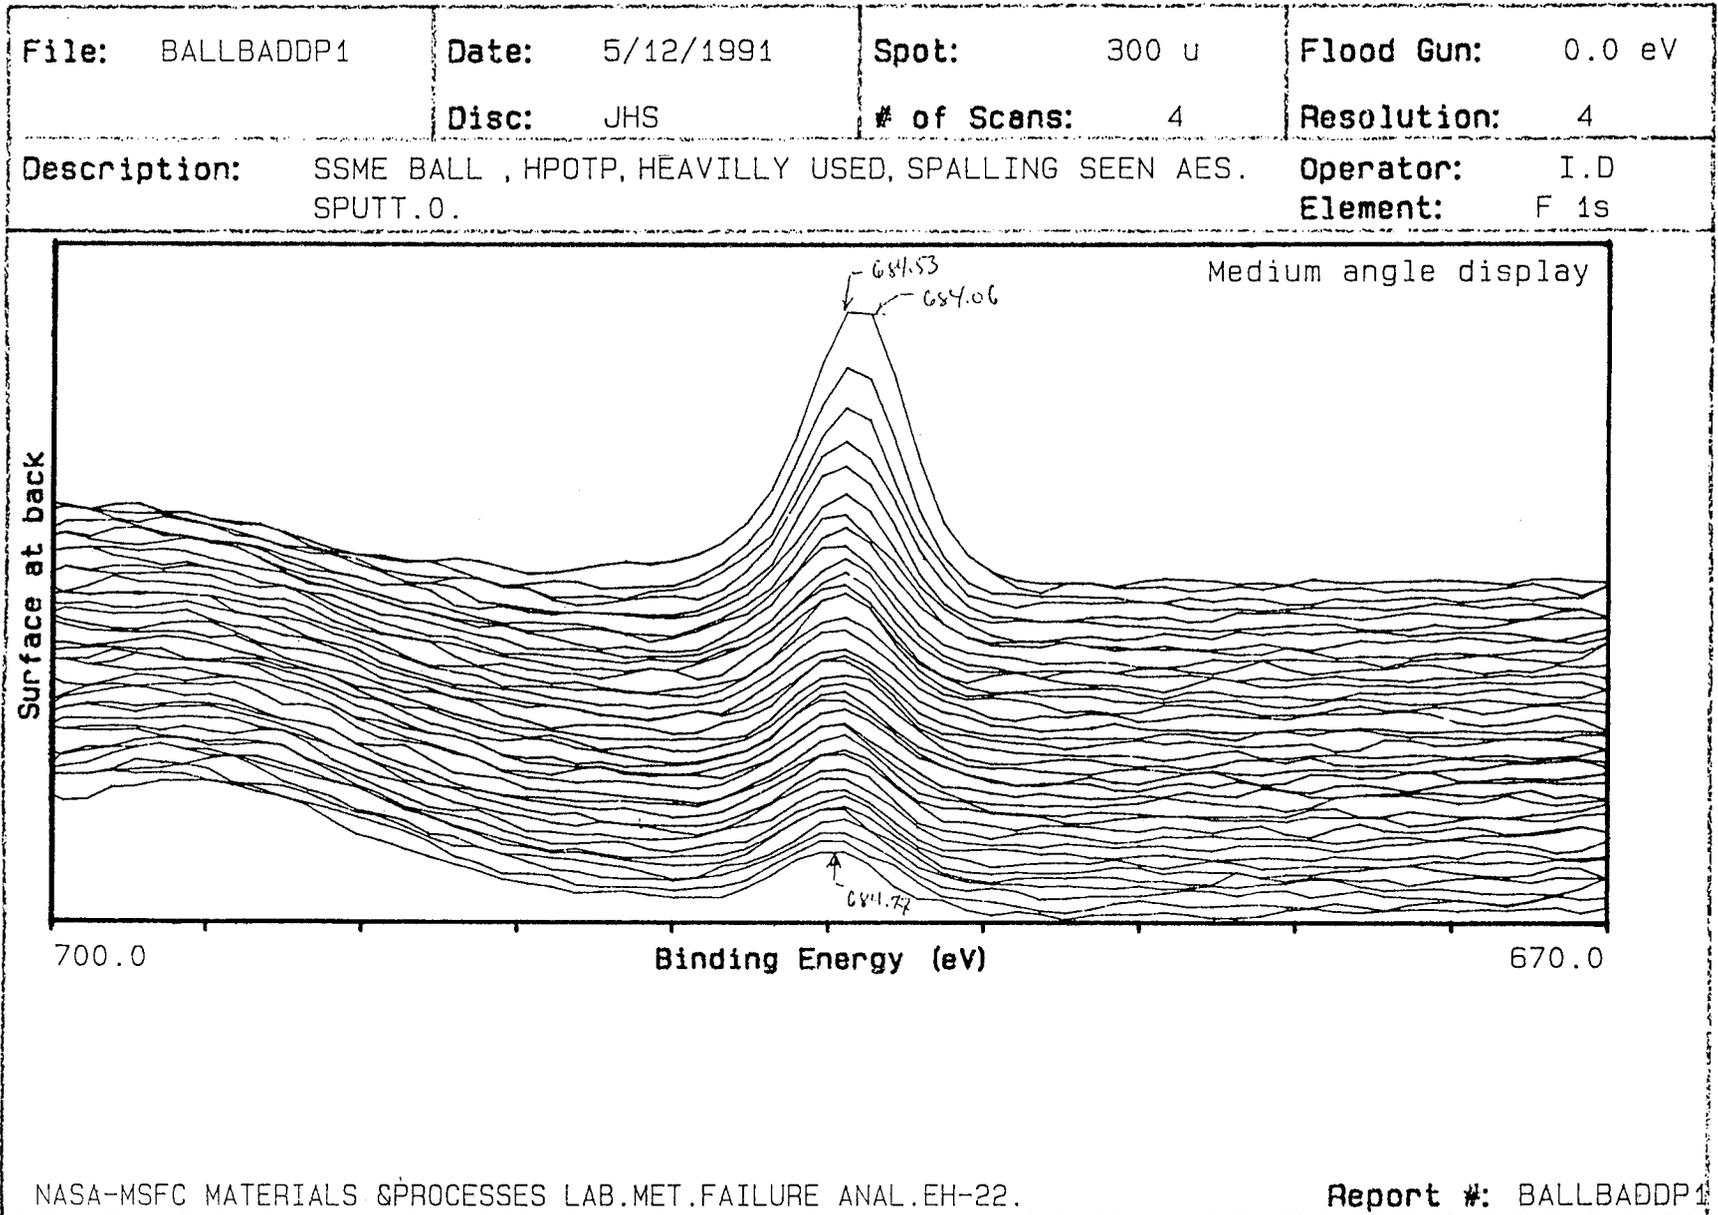
Figure A-19. XPS sputtering for depth profiling on a ball of bearing No. 352. Note how the surface peak of fluorine (basic constituent of PTFE) quickly vanishes with depth, thus indicating that a lubricant layer is very shallow.

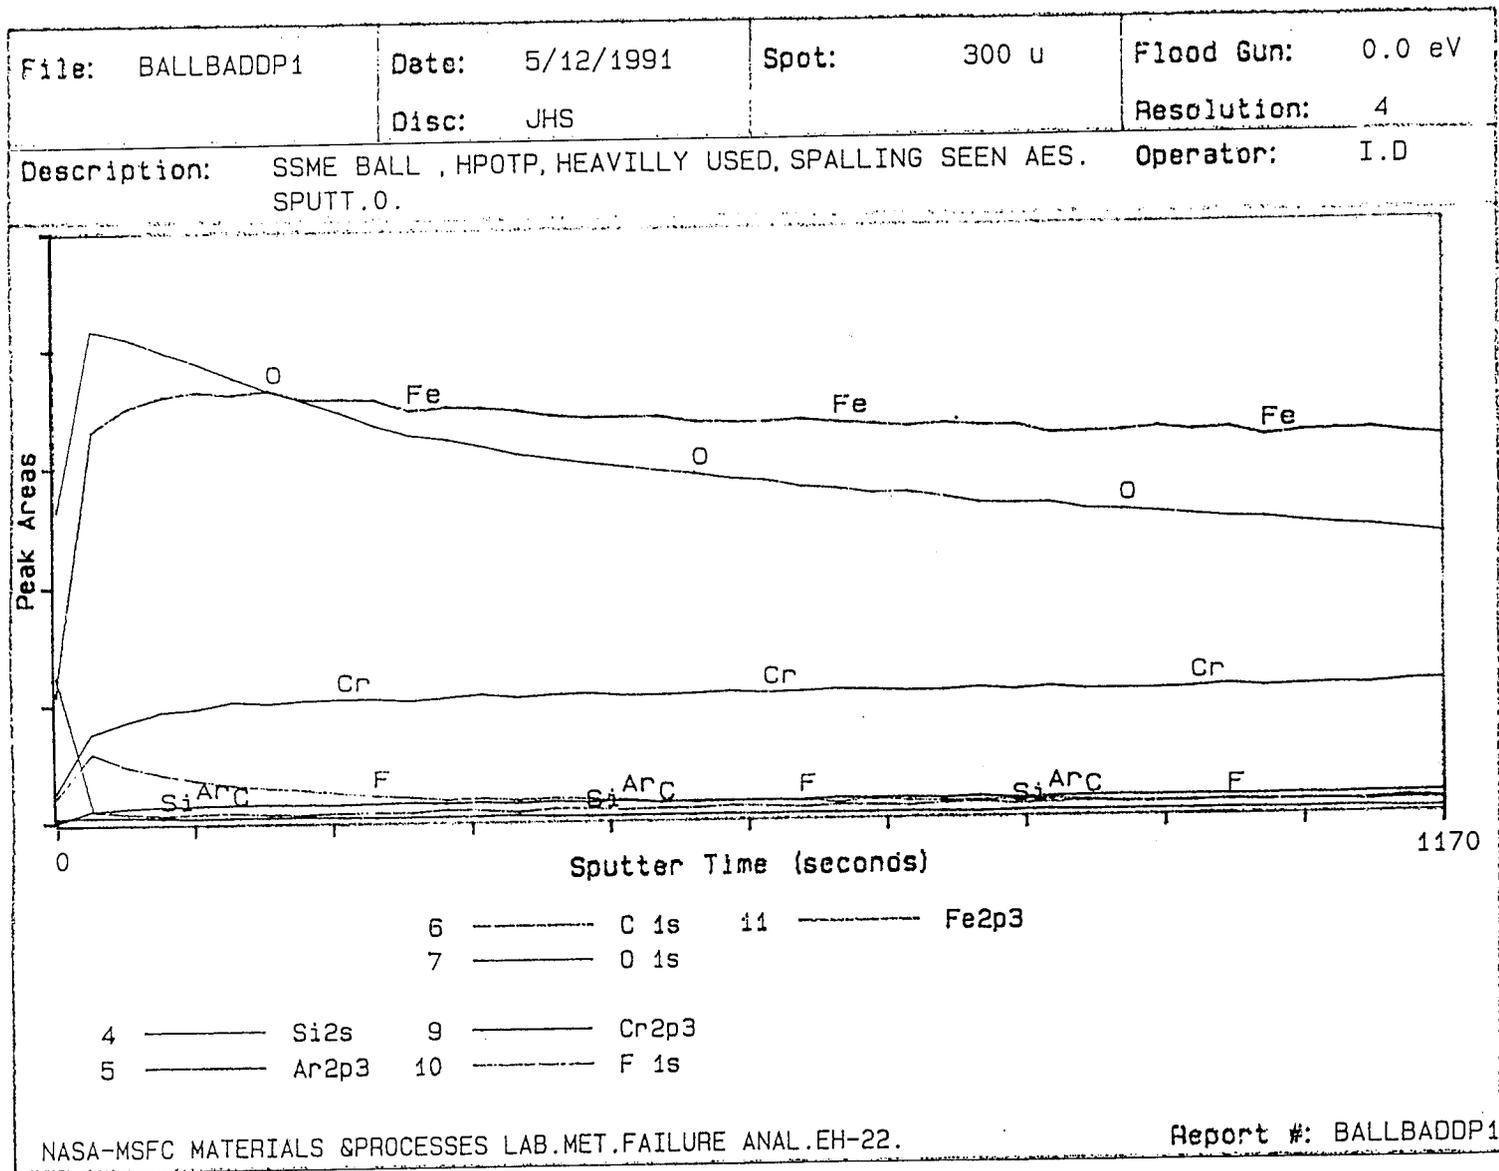
Figure A-20. XPS sputtering for depth profiling on a ball of bearing No. 352. Combined results.

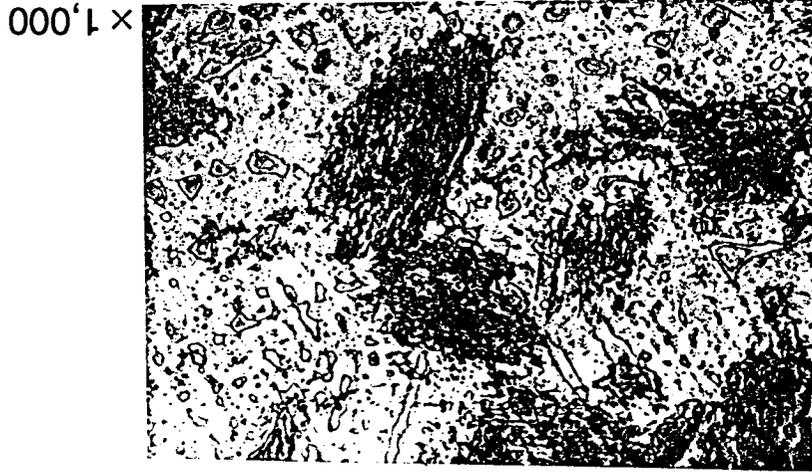
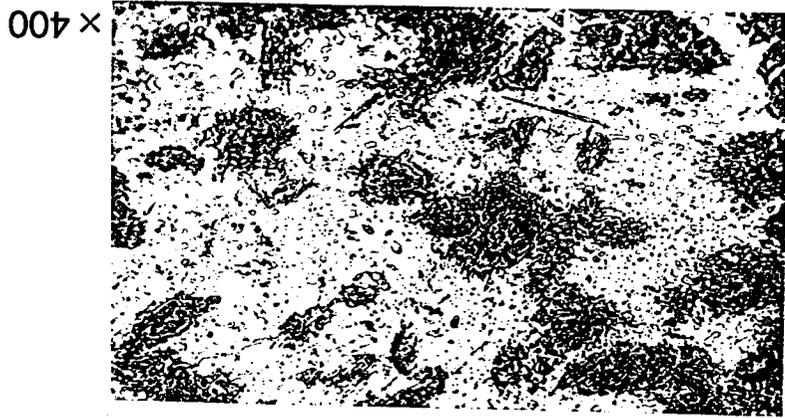
Figure A-29. OM of a very lightly worn ball of bearing No. 493. The focus is on a curious large pit (possibly a skid mark).

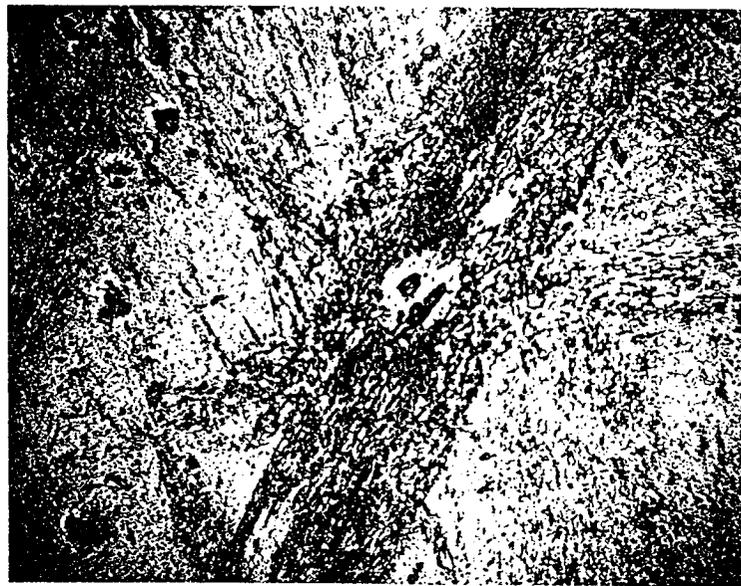
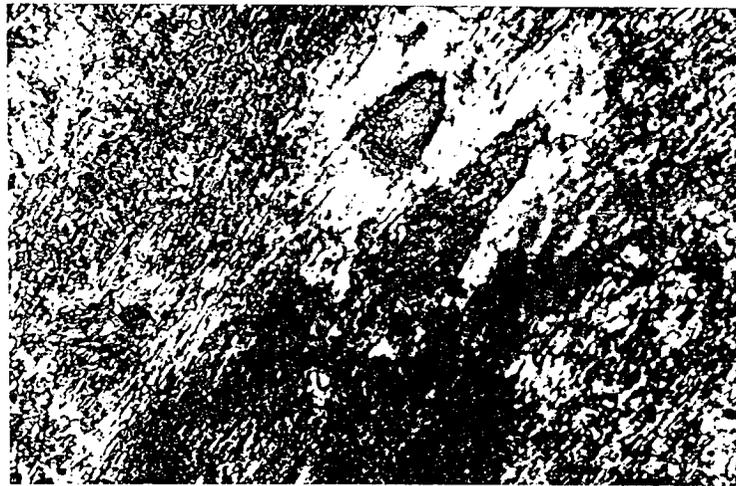
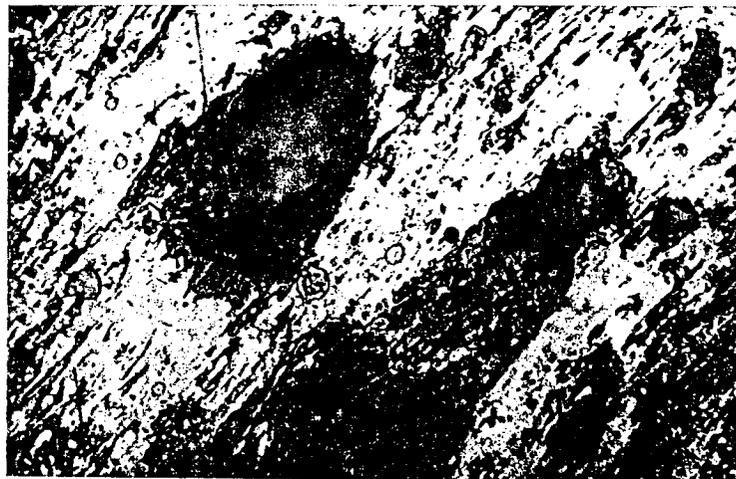
Figure A-33. OM of a lightly worn ball of bearing No. 543. The focus is on the crossing of wear tracks which show adhesive/shear peeling, material transfer, and some deeper pits due to a possibly violent contact with either a cage material or a contaminant debris.

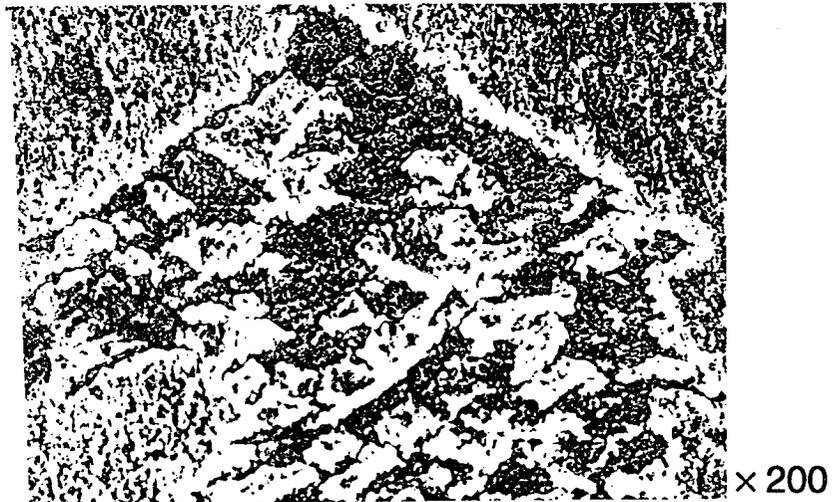
Figure A-34. OM of a lightly worn ball of bearing No. 543. The focus is on an arrow-like scratch, a single event producing the adhesive/shear effects like those of the predominant wear mode in all bearings examined.

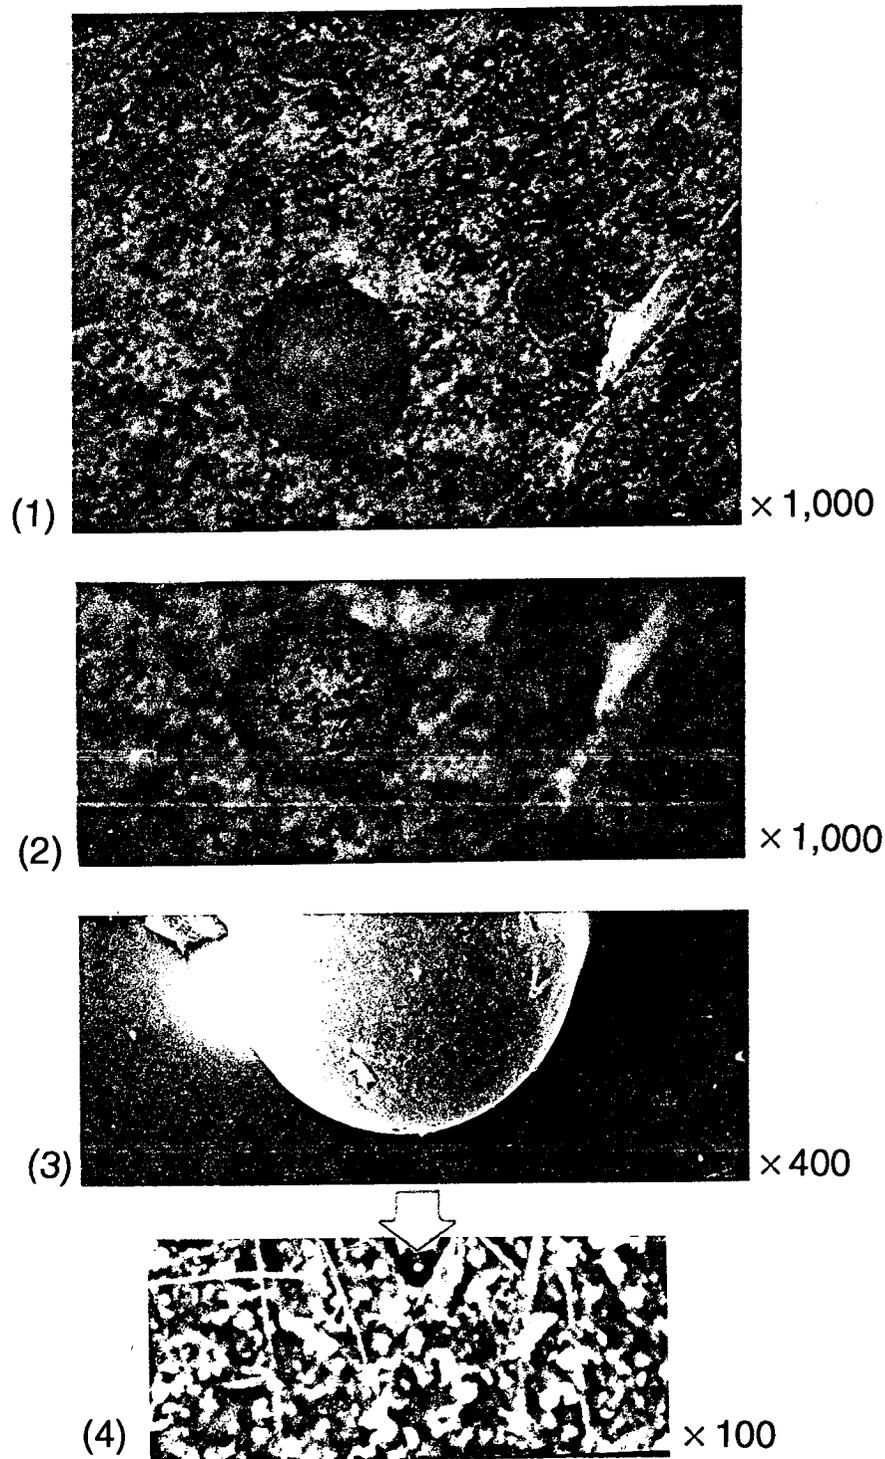
Figure A-36. Surface damage (ball, bearing No. 493) by a spherical contaminant particle: (1) focus on the top, (2) focus on the bottom, (3) a particle found on the BSMT inlet filter, and (4) a black spherical particle found on the BSMT outlet filter. Optical microscopy.

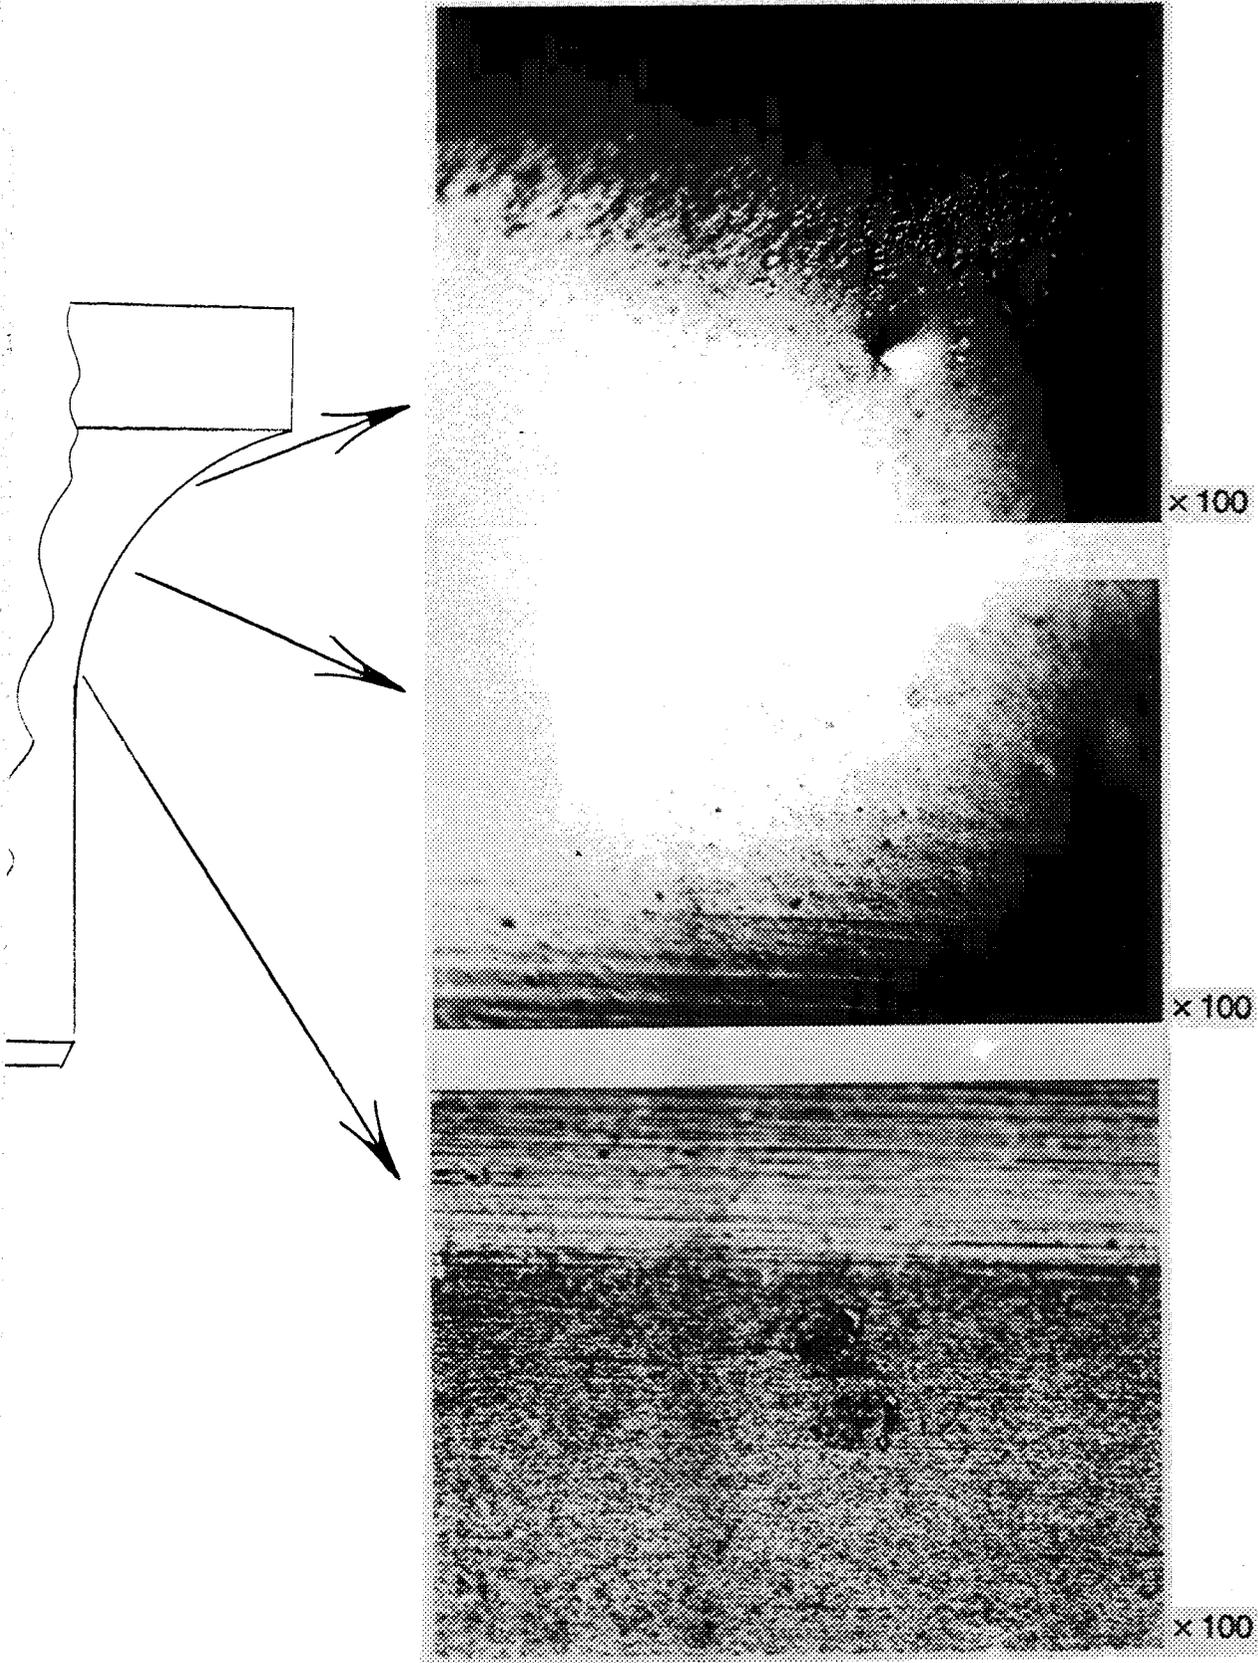
Figure A-38. Surface damage (inner ring, bearing No. 611) by contaminant particles and adhesive/shear peeling. Note a very light corrosion on the unworn surface. Optical microscopy.

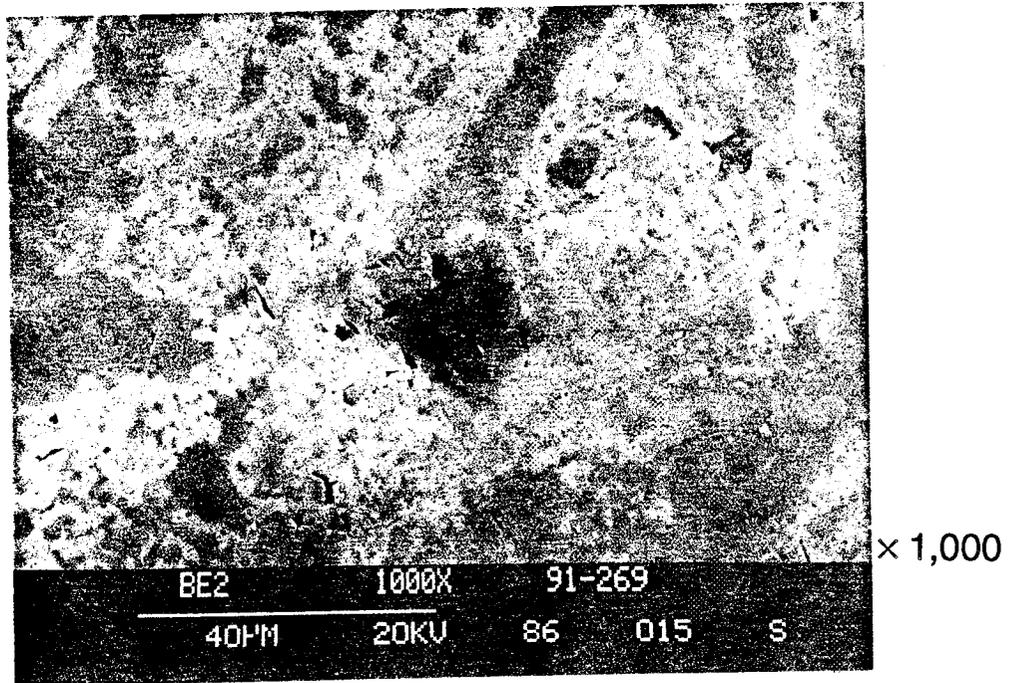
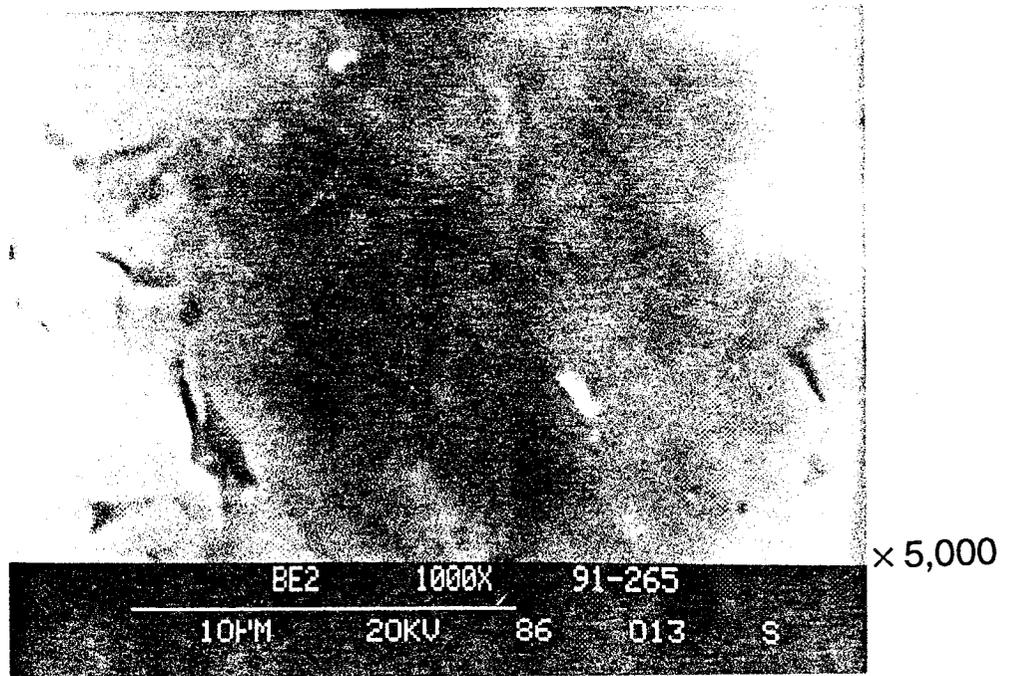
Figure A-39. Surface damage (inner ring, bearing No. 611) by contaminant particles and adhesive/shear peeling (SEM).

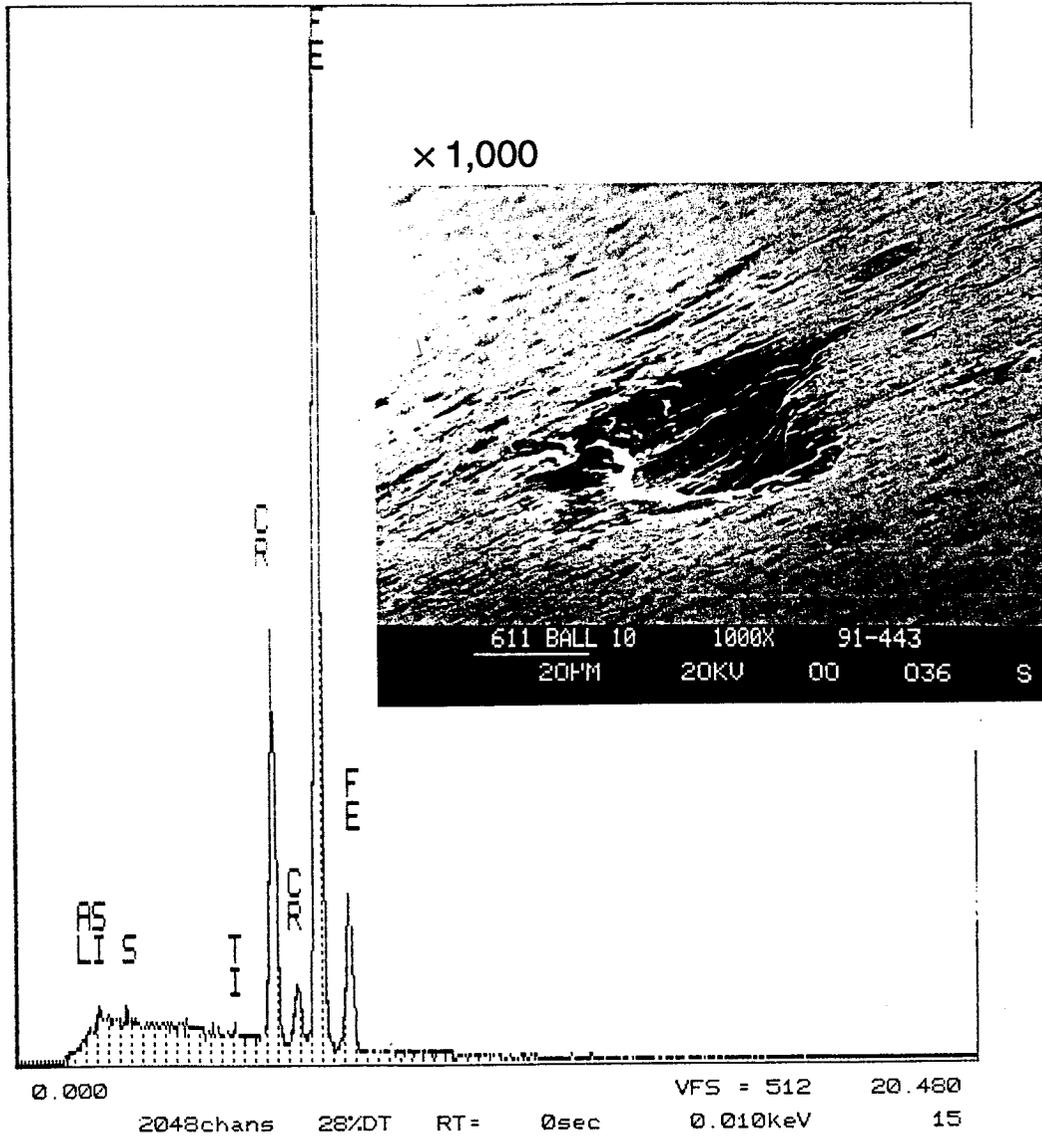
Figure A-40. SEM/EDS of a lightly worn ball of bearing No. 611. A microspall of classic proportions. Note wear debris whose shape and chemistry (Al, Si) are not inconsistent with those of the glass fibers in the Armalon cage.

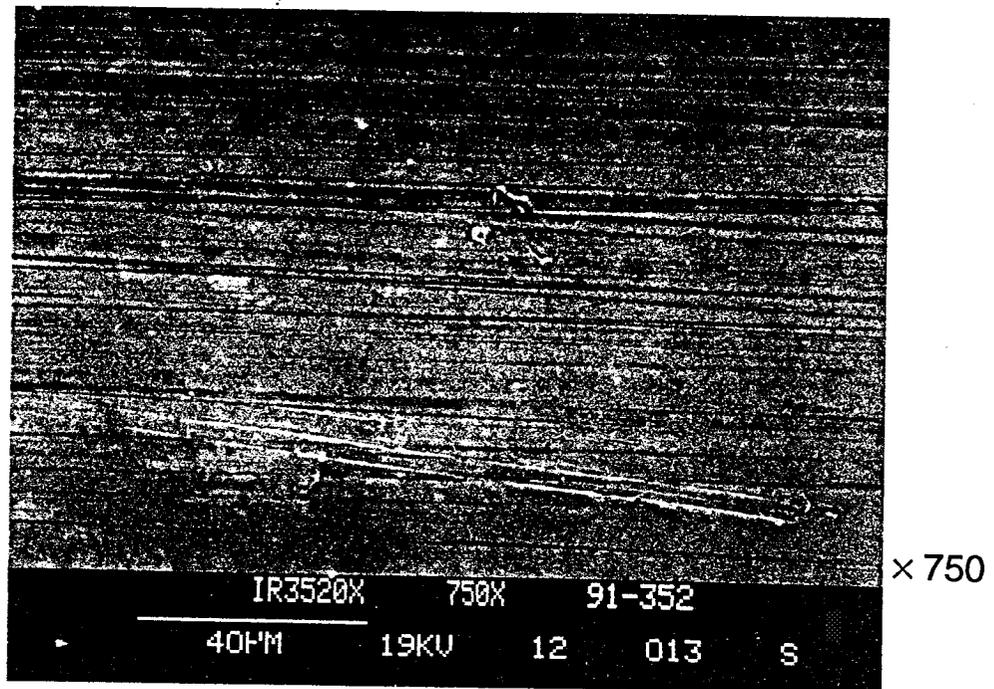
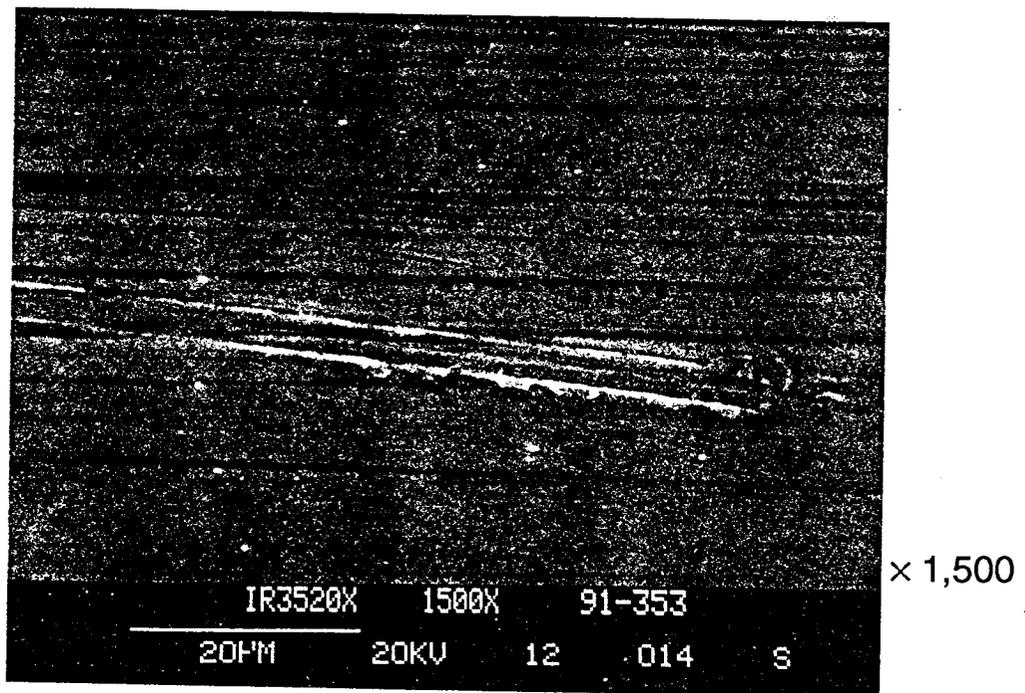
Figure A-41. SEM of the inner ring of bearing No. 352: a scratch mark on the worn surface at an angle to the track. It may have been caused by a contaminant particle or a glass fiber on a ball which changed its running trajectory due to a side-load induced by the particle.

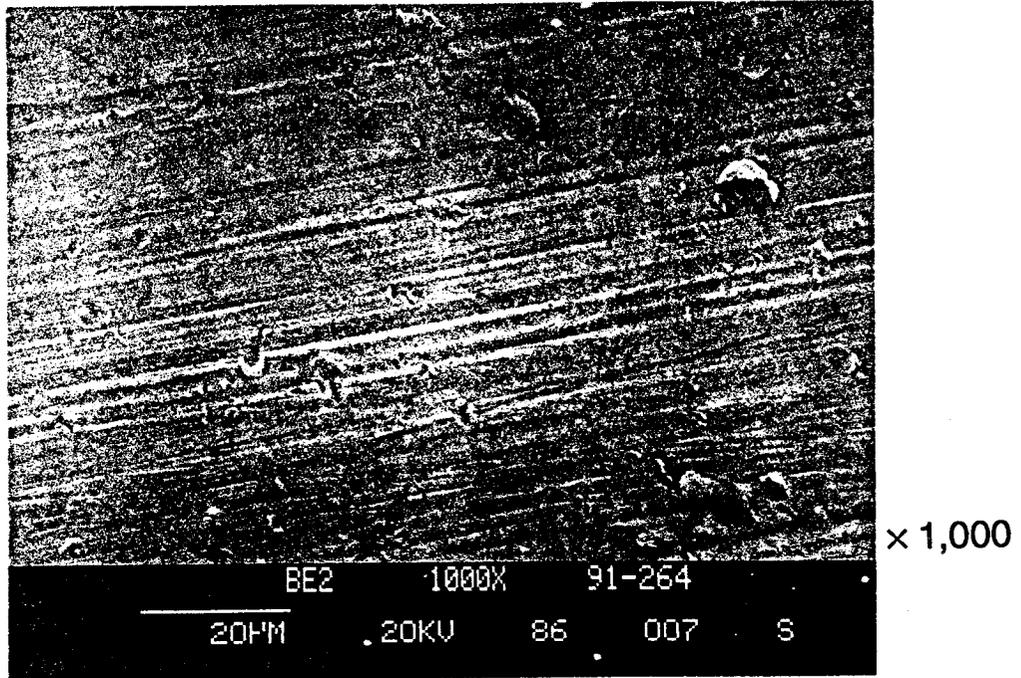
Figure A-42. SEM of the inner ring of bearing No. 352. Machining marks on the upper fillet for comparison with figure A-41.

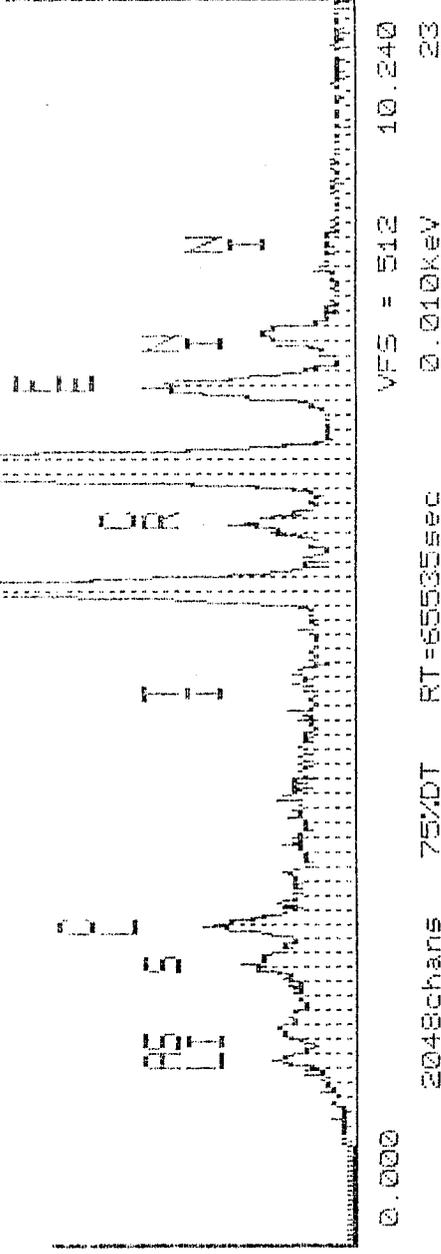
Figure A-43. SEM/EDS of a dark patch on a very lightly worn ball of bearing No. 611. Note presence of Cl (harmful and unexplained), Ni, and Ti (compare figs. A-54 through A-62).

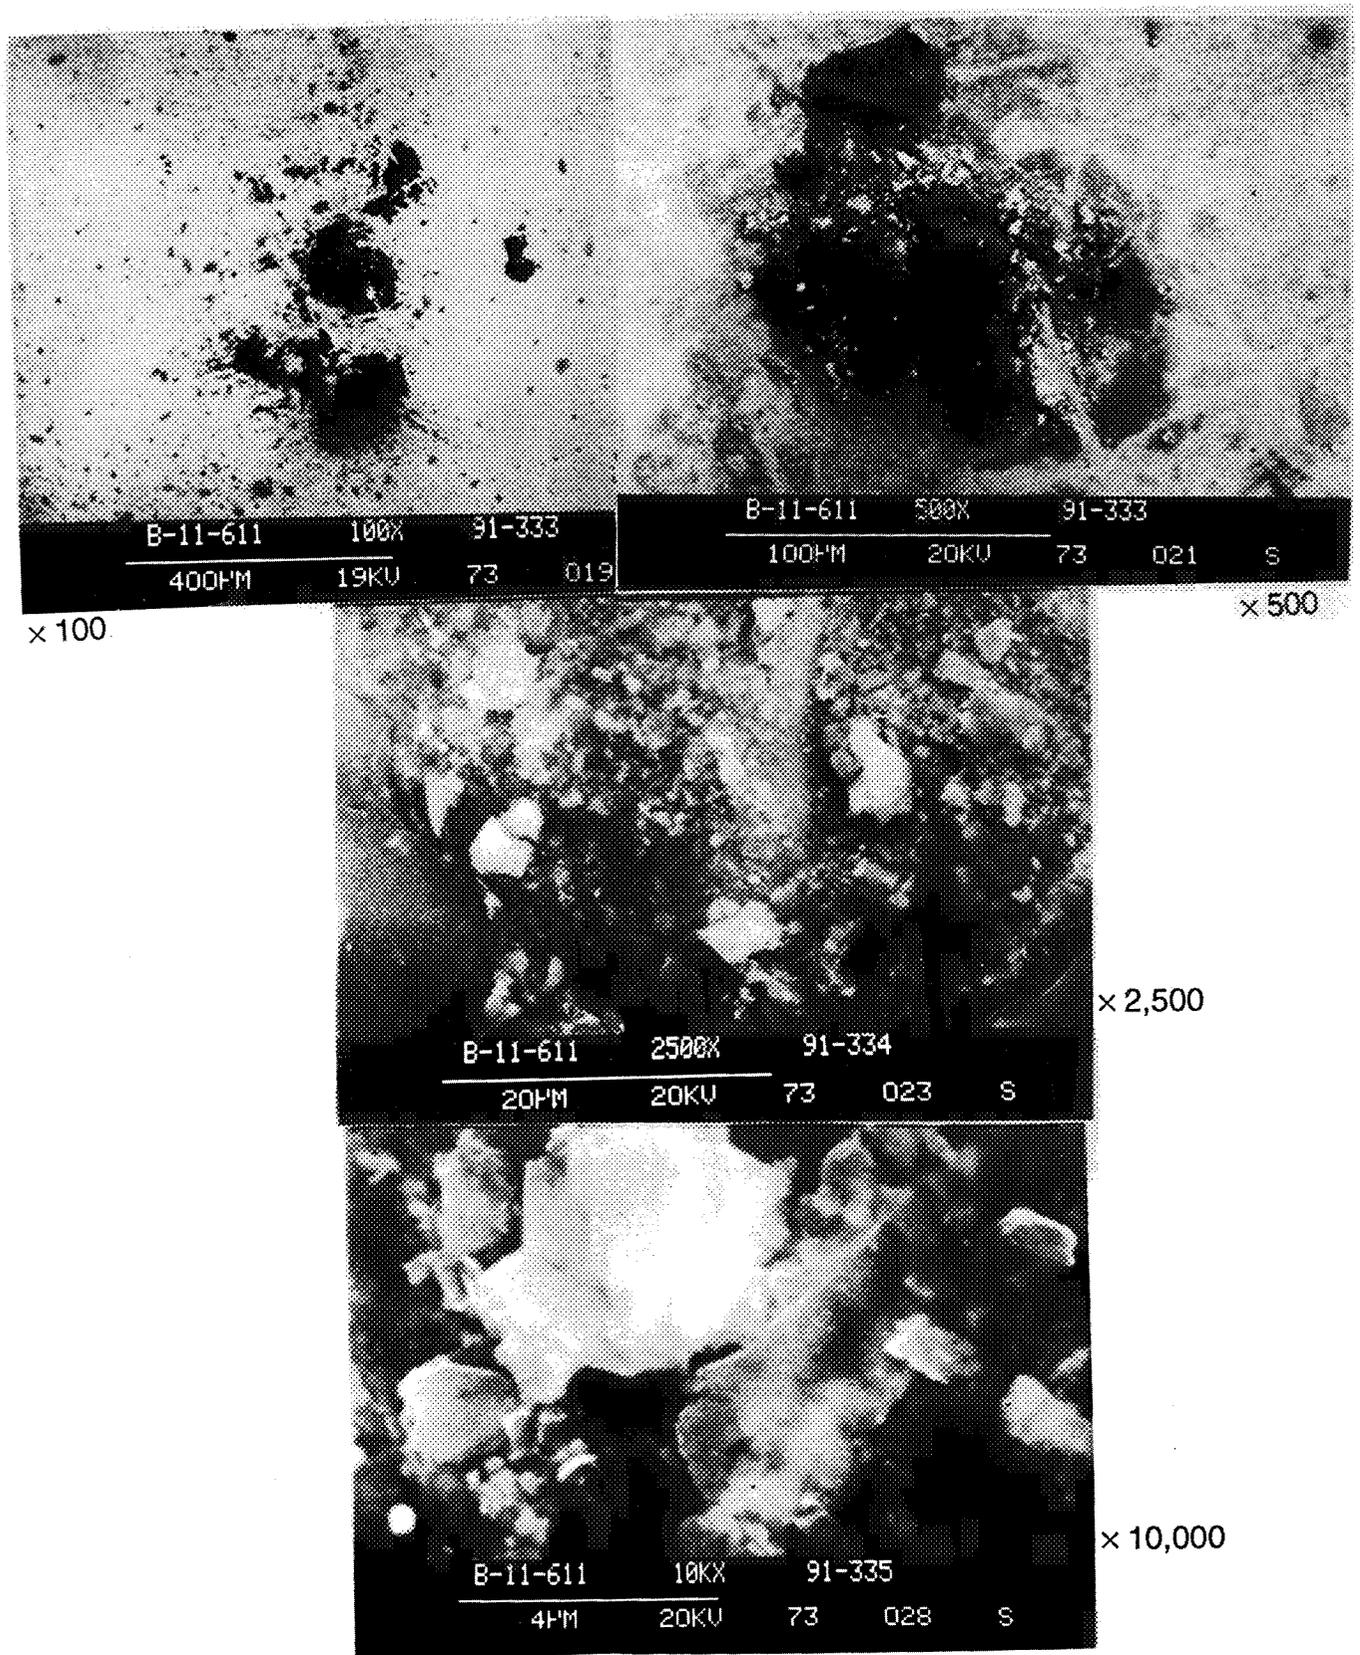
Figure A-44. SEM/EDS of a dark patch on a very lightly worn ball of bearing No. 611. Analysis at a high magnification reveals a laminar structure of the residue, characteristic of molybdenum disulfide, an ingredient of the solid lubricant initially applied to the bearings at the assembly.

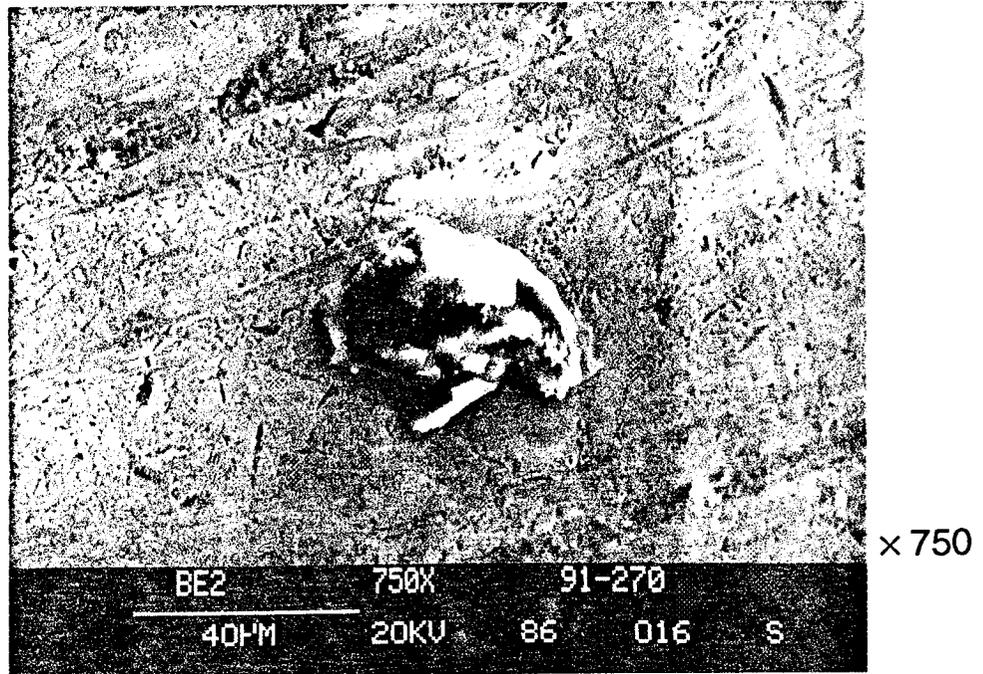
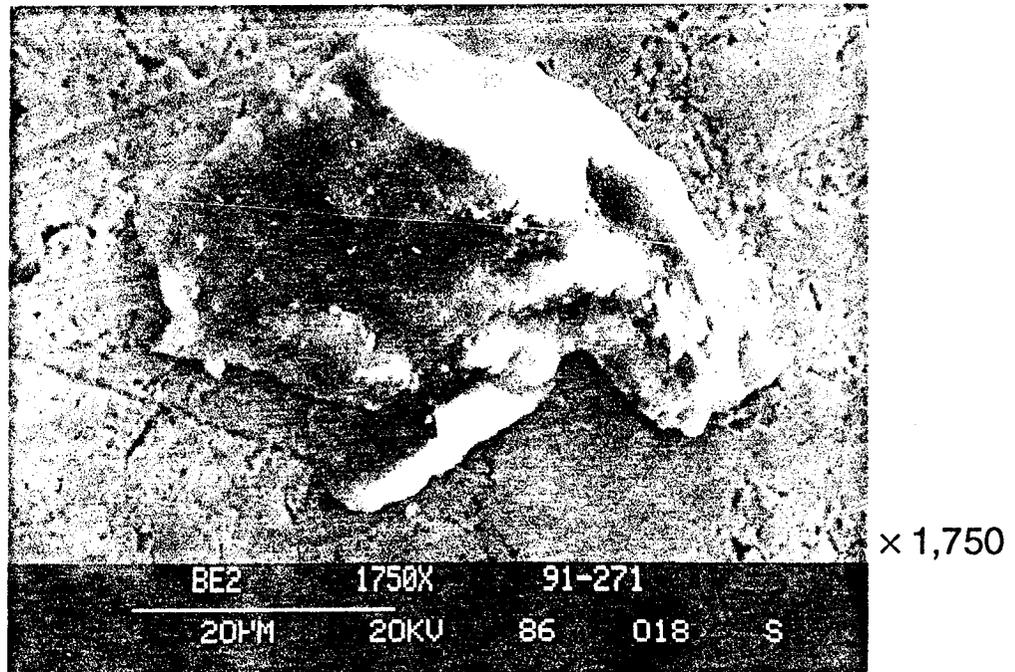
Figure A-45. SEM of a particle found on the inner ring of a very lightly worn bearing No. 611. Its origin is uncertain. Also, note many cuts, scratches, and pits on the ring. Compare figures A-46 and A-47.

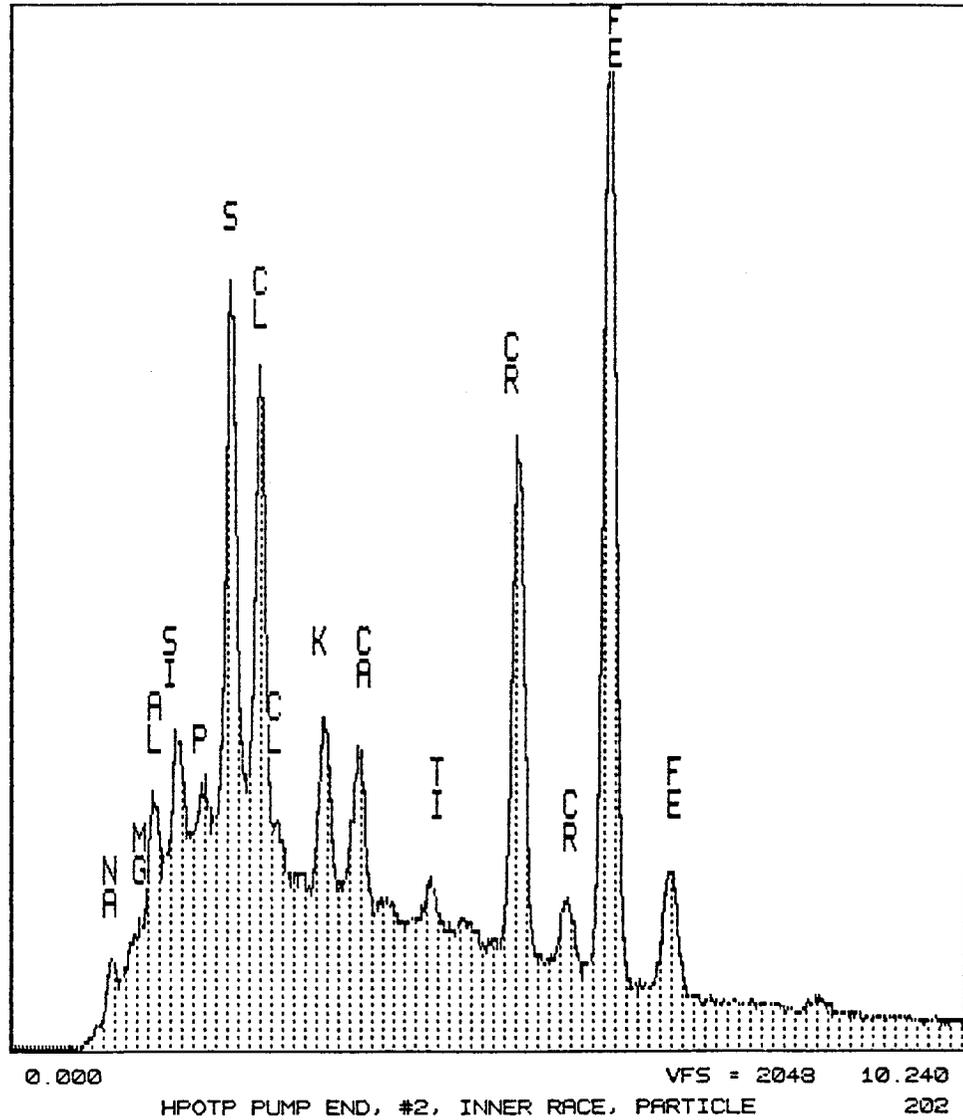
Figure A-46. EDS of a particle found on the inner ring of a very lightly worn bearing No. 611. Note presence of many contaminants which can be seen in figures A-54 through A-62 (inlet filter).

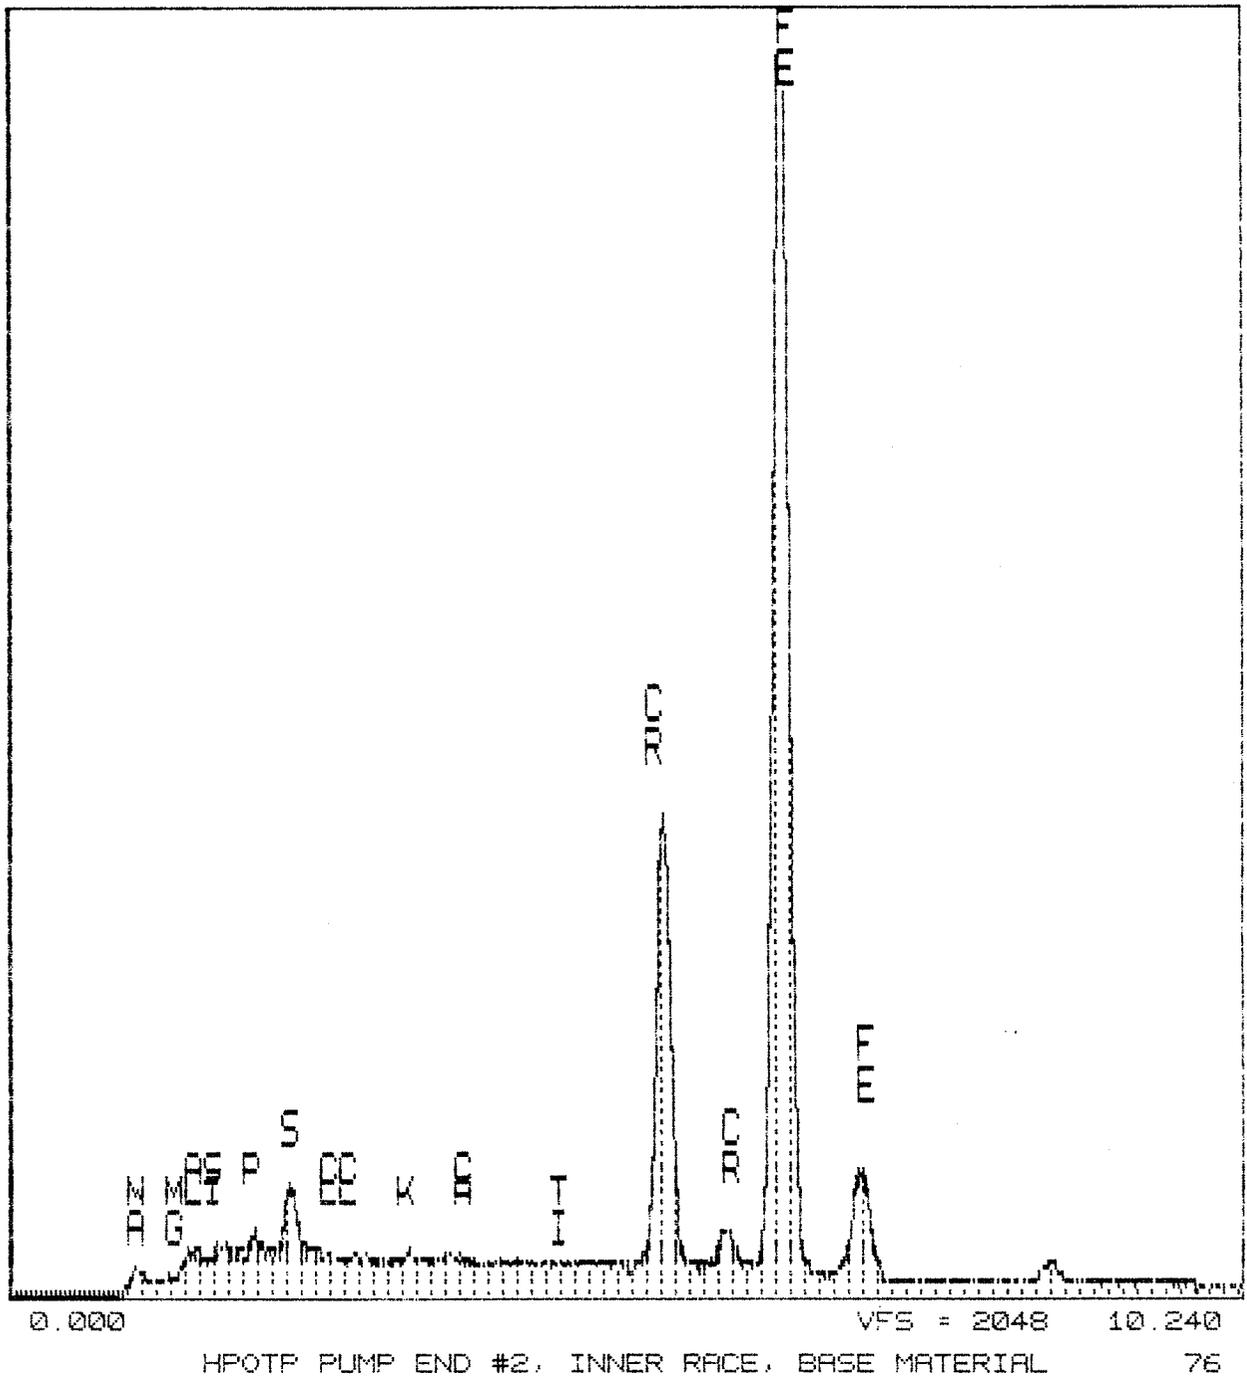
Figure A-47. EDS of the background of the particle shown in figure A-46, bearing No. 611.  
Note absence of many contaminants found there.
