**NASA  
Technical  
Memorandum**

NASA TM - 103596

**WEAR MECHANISMS FOUND IN ANGULAR CONTACT  
BALL BEARINGS OF THE SSME'S LOX TURBOPUMP**

By T.J. Chase

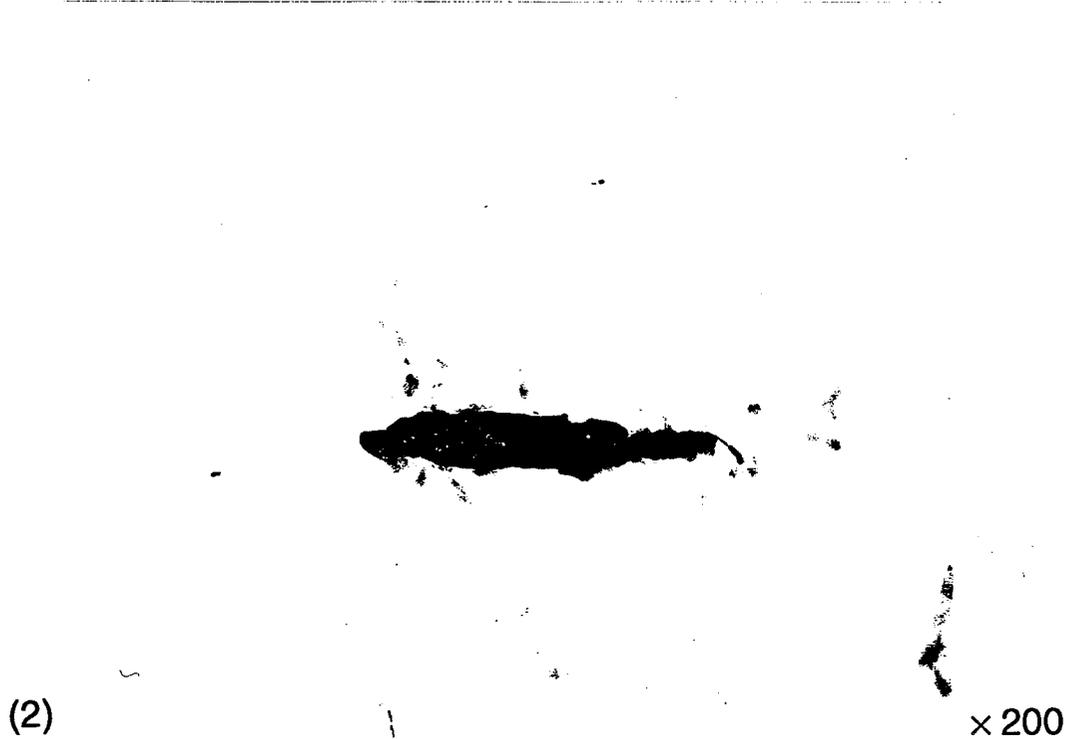
Figure A-53. OM of a lightly worn ball of bearing No. 543. Focus on the background (1) shows adhesive/shear peeling; focus on the wear particle (2) shows a piece of the cage Teflon and a glass fiber.

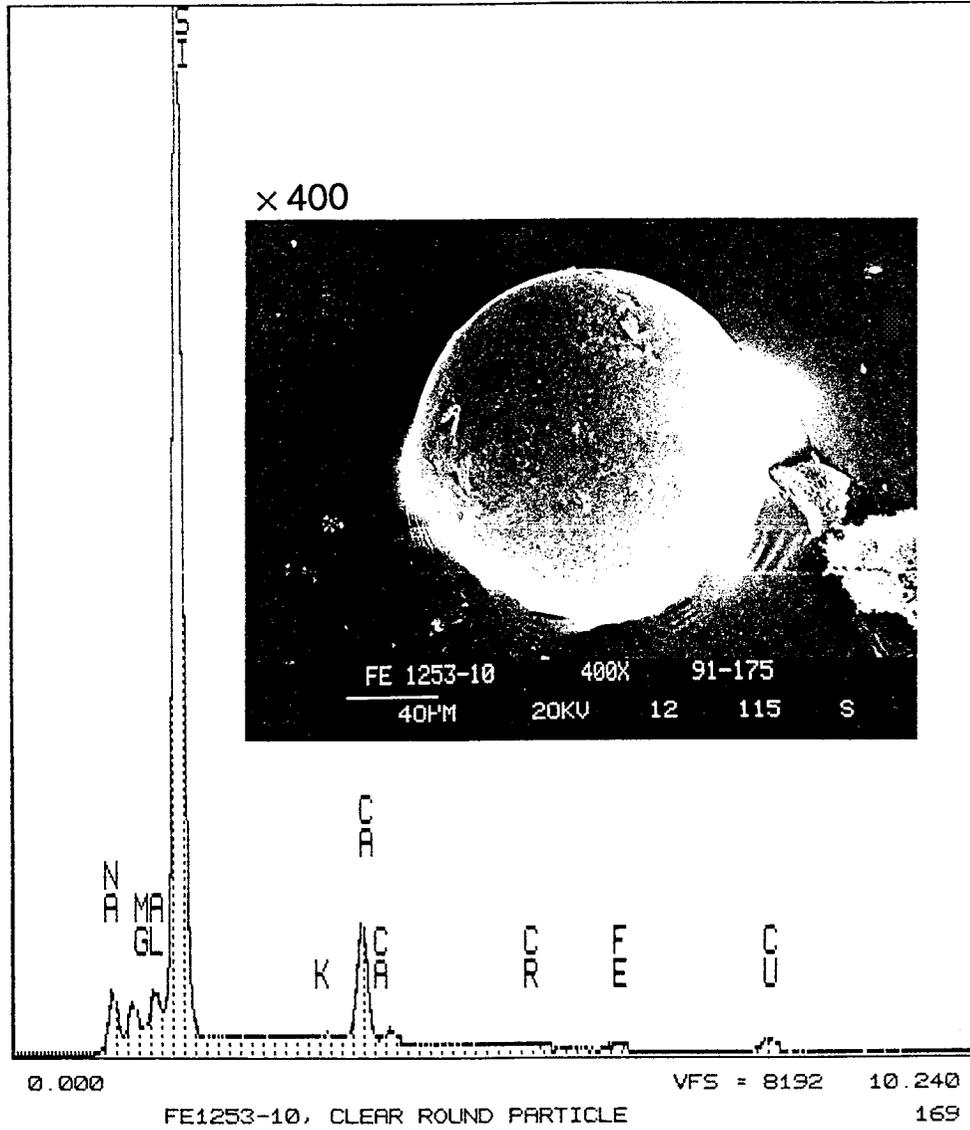
Figure A-56. SEM/EDS of a large Si contaminant particle found on the BSMT inlet filter.

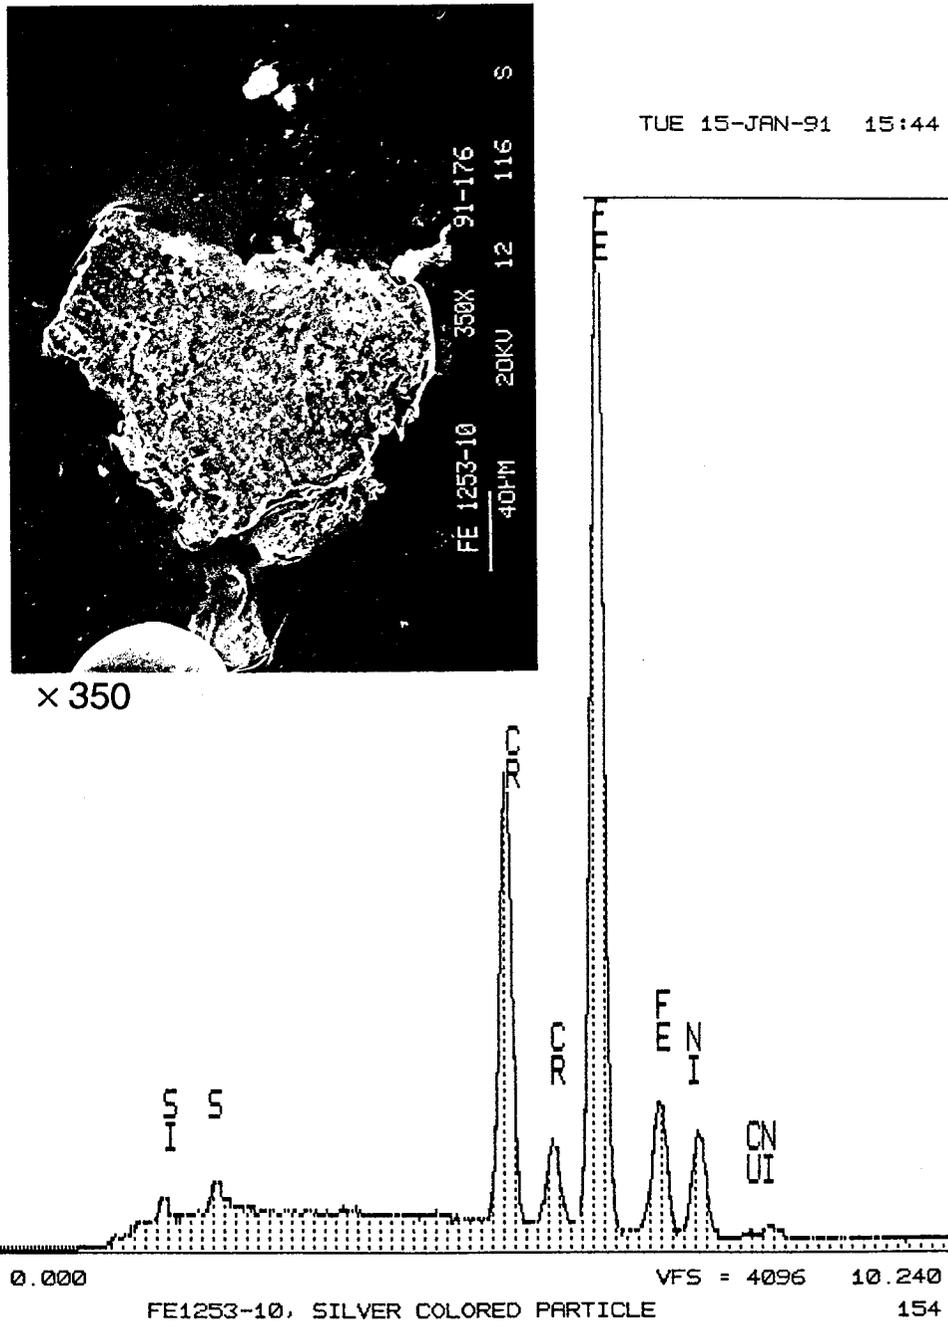
Figure A-57. SEM/EDS of a large 440C contaminant particle found on the BSMT inlet filter. It is unclear how it was deposited there.

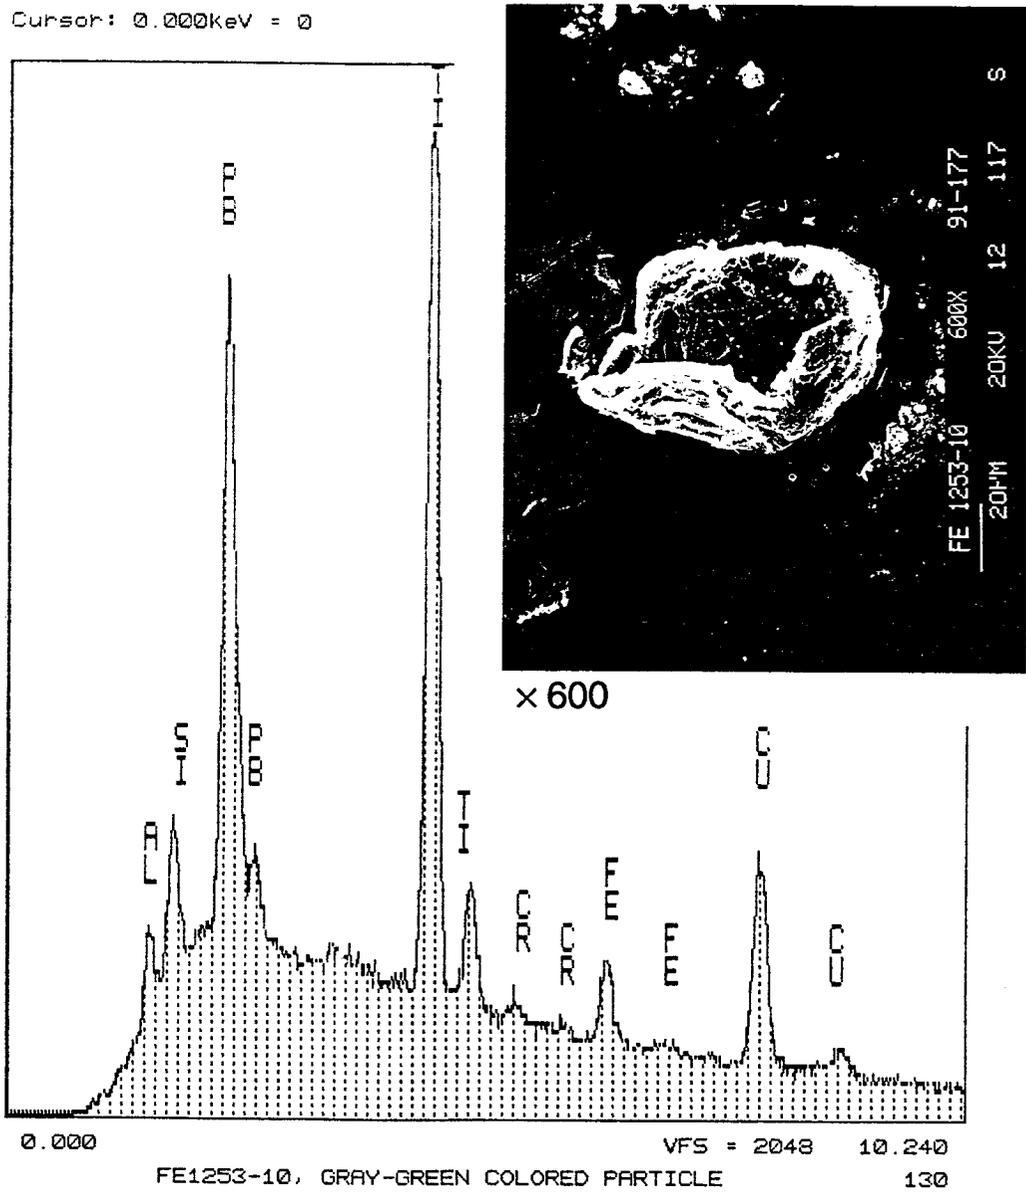
Figure A-58. SEM/EDS of a large Ti-Pb contaminant particle found on the BSMT inlet filter.

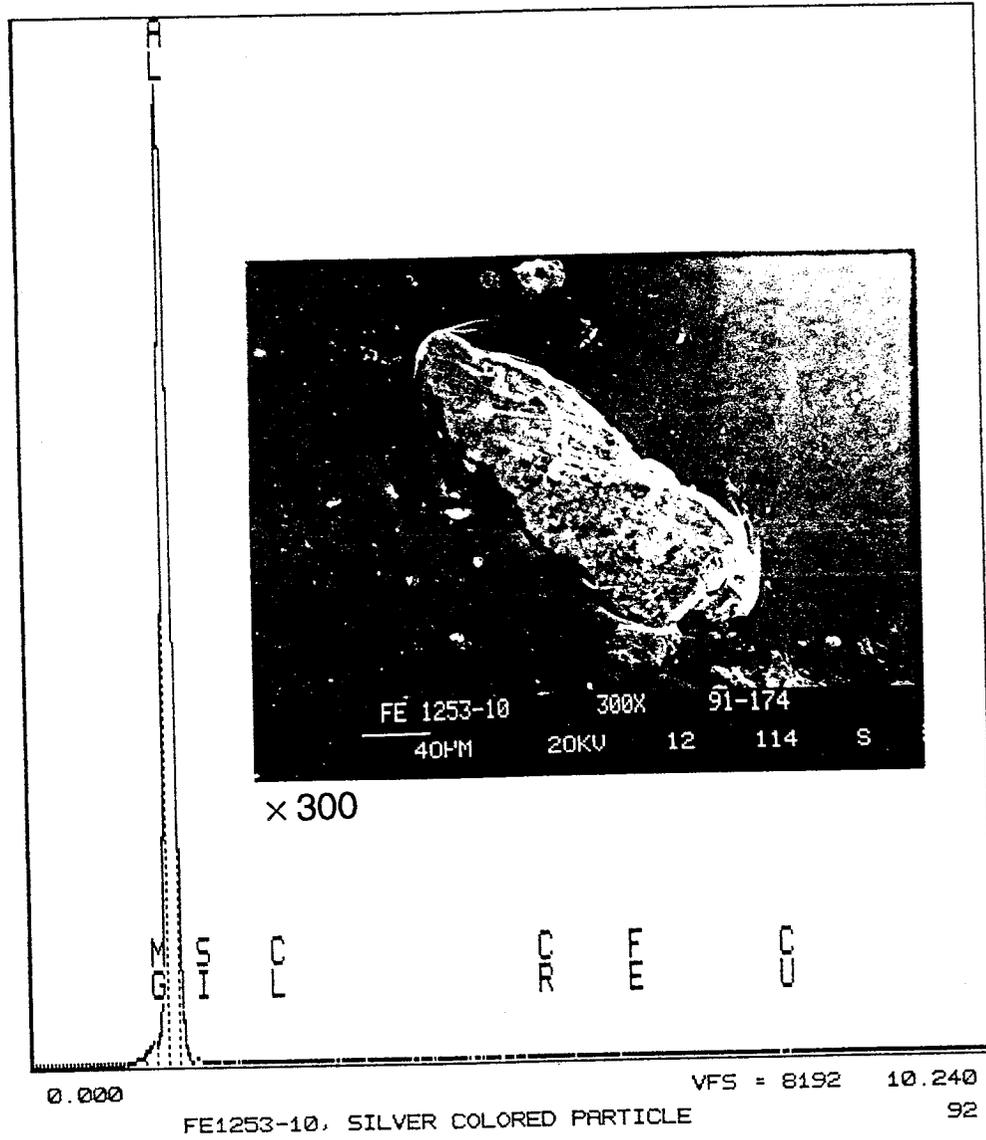
Figure A-59. SEM/EDS of a large Al contaminant particle found on the BSMT inlet filter.

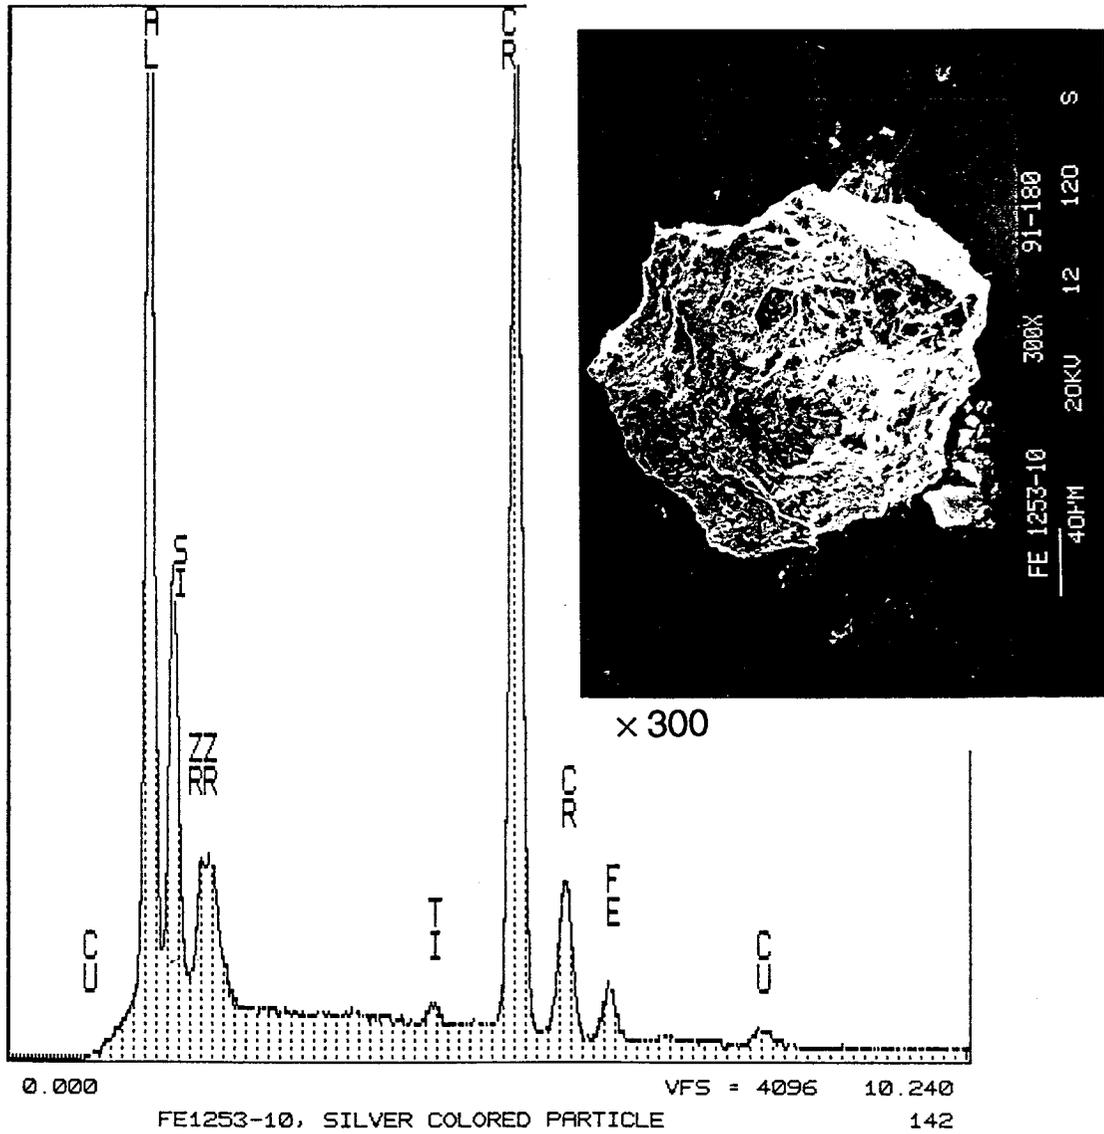
Figure A-60. SEM/EDS of a large Al-Cr-Si-Zr contaminant particle found on the BSMT inlet filter.

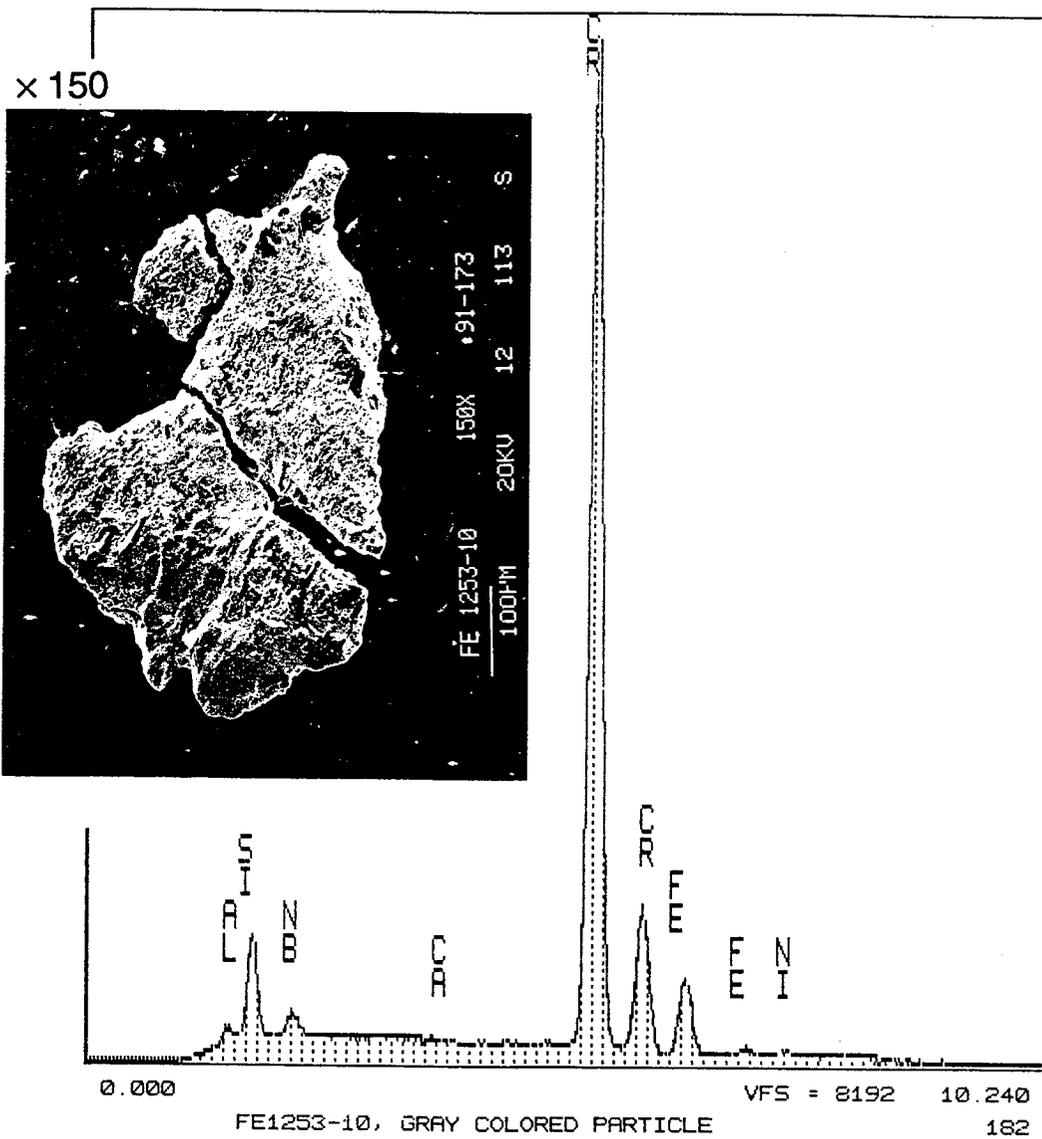
Figure A-61. SEM/EDS of a large Cr contaminant particle found on the BSMT inlet filter.

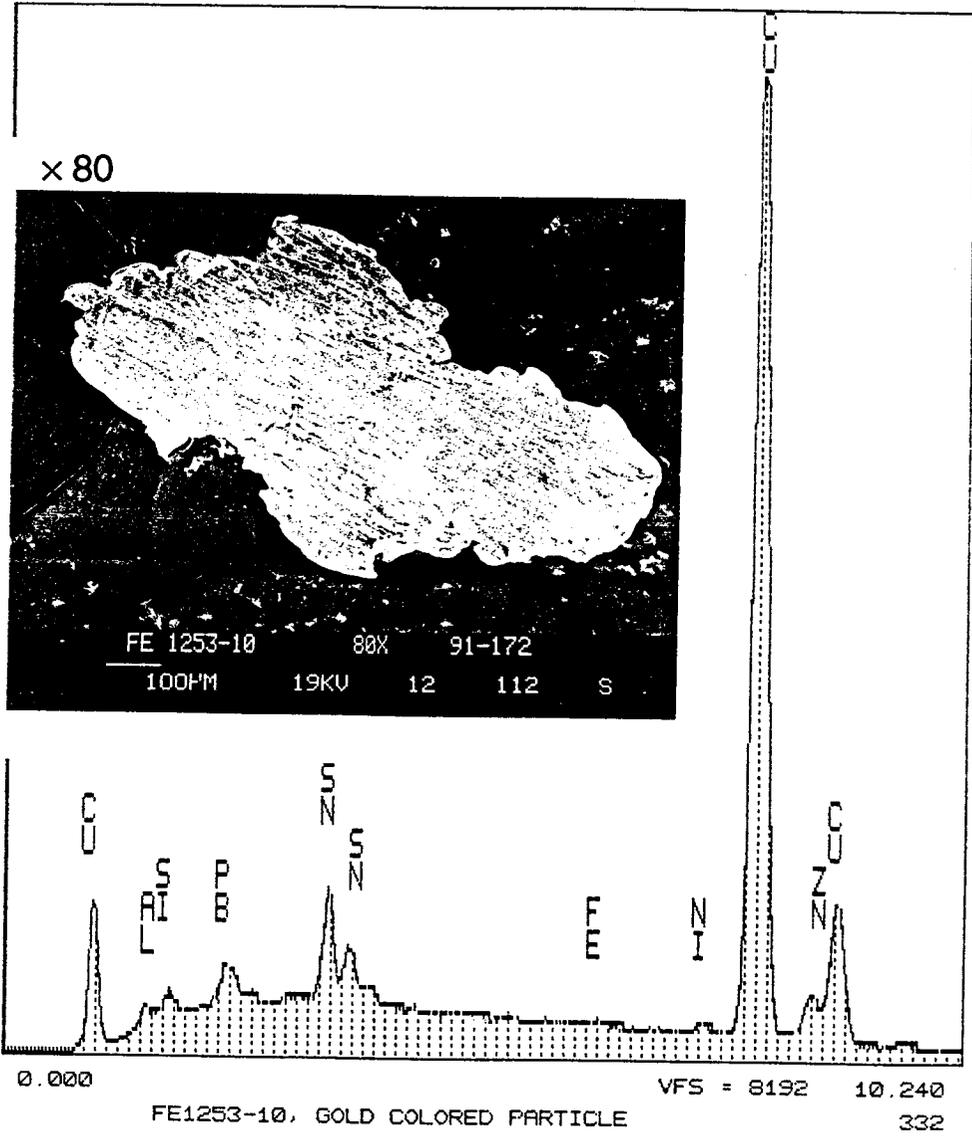
Figure A-62. SEM/EDS of a large Cu-Sn contaminant particle found on the BSMT inlet filter.

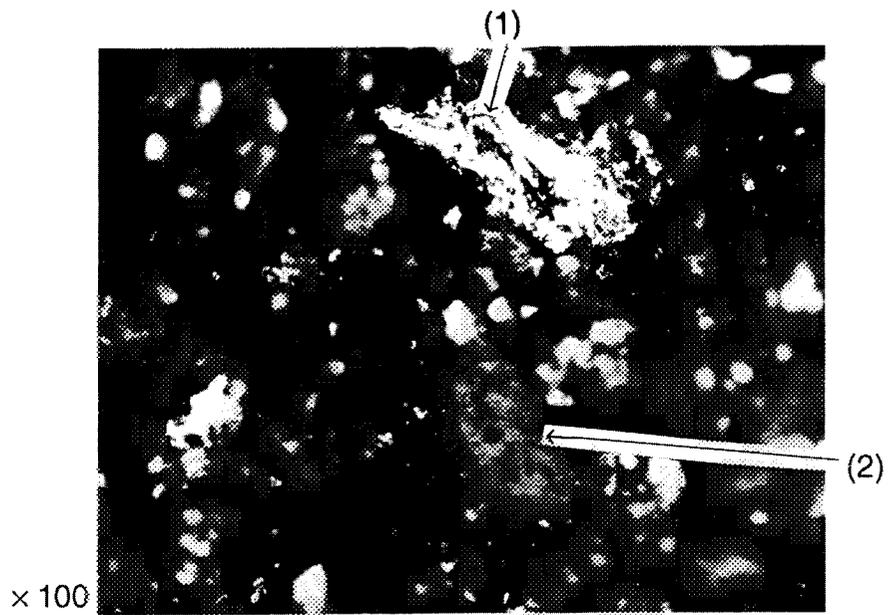
Figure A-63. OM of the wear debris found on the BSMT outlet filter: (1) large metallic flake, (2) large PTFE chunk, (3) glass fiber, and (4) overall.

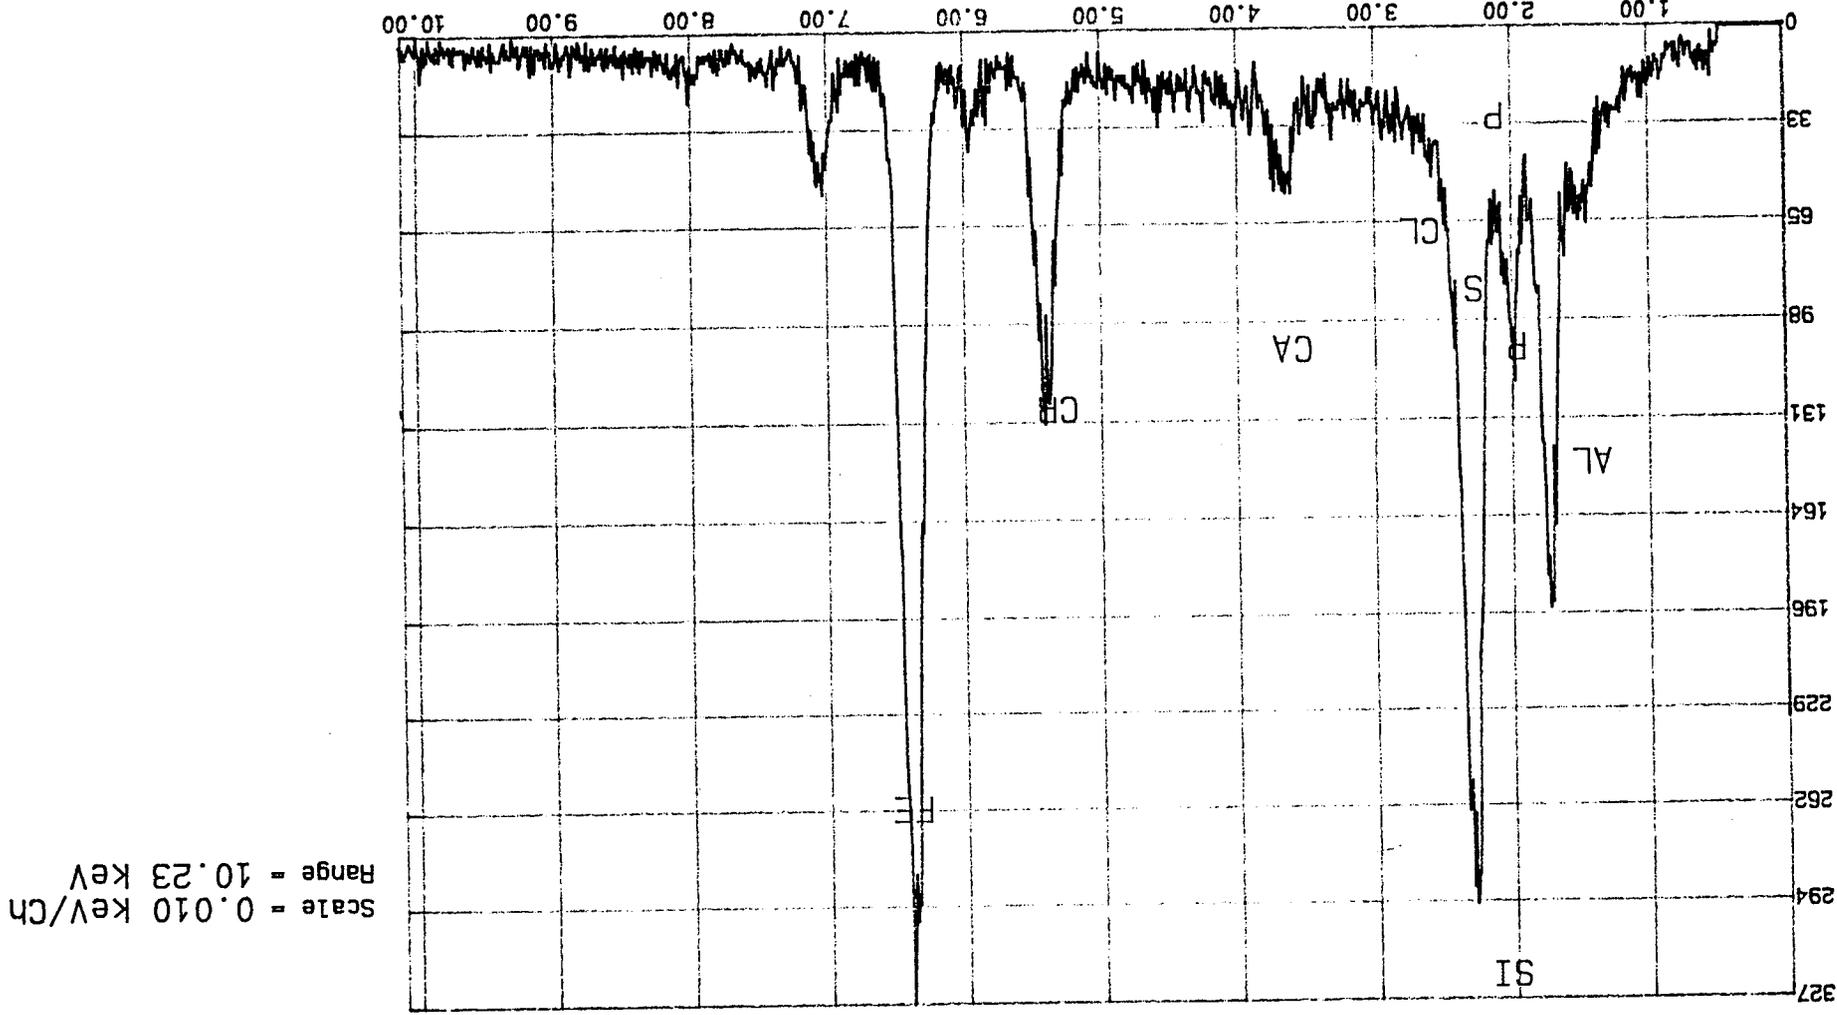
Figure A-64. Microprobe EDS of a dark particle found on the BSMT outlet filter: cage material and base 440C. Base material spectrum may have come from the background because the particle analyzed was small and thin.

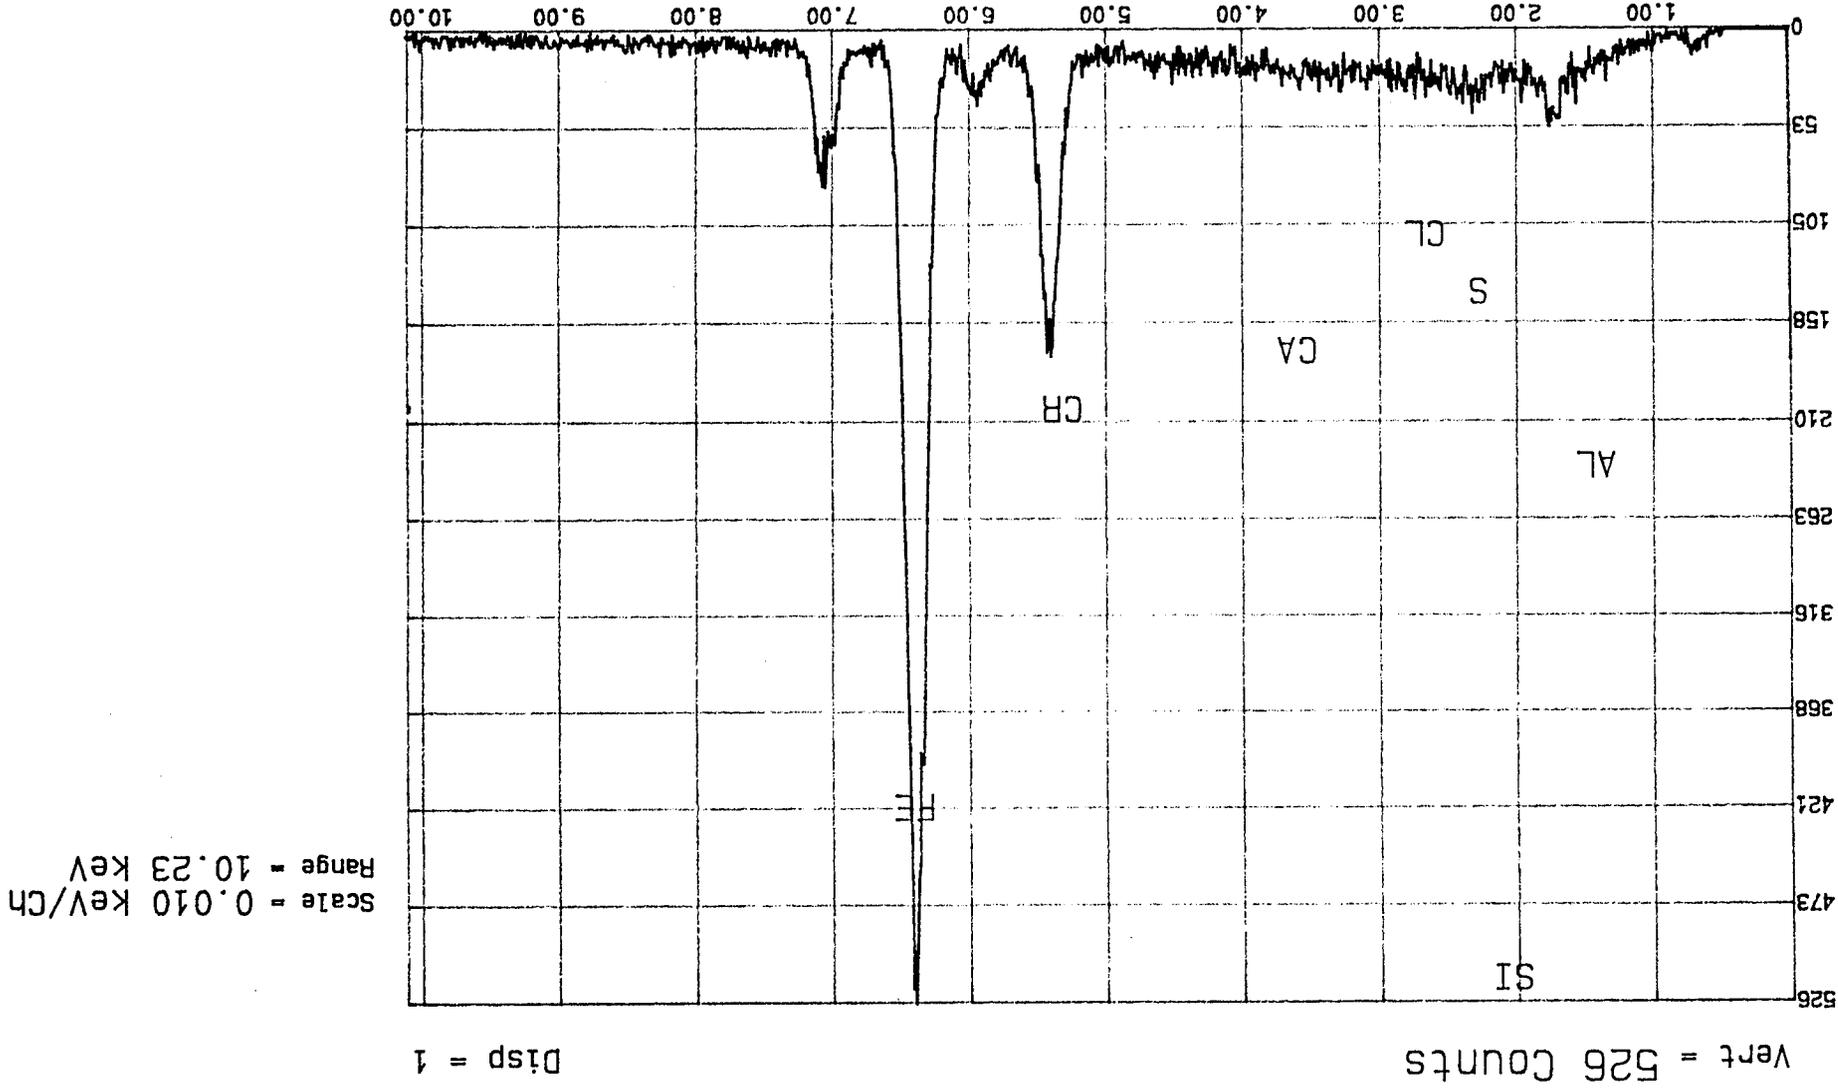
Figure A-65. Microprobe EDS of a light metallic particle found on the BSMT outlet filter: base 440C and some contaminants. The chemistry of this particle is just like that of the base ring (compare fig. A-4) or the base ball material (compare fig. A-13).

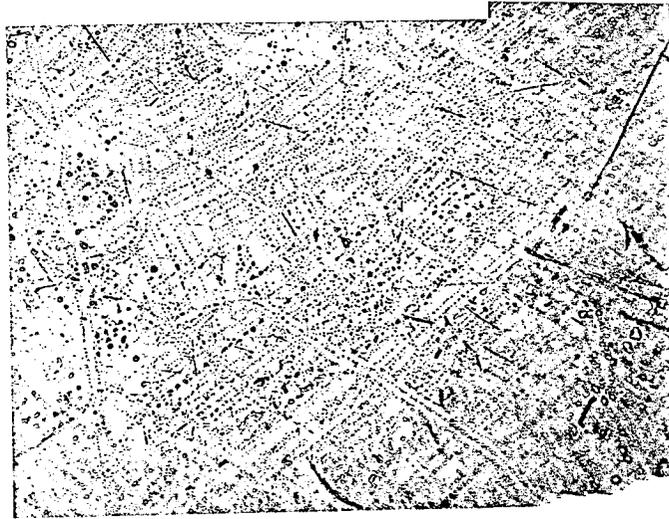
Figure A-67. OM of the surface of a brand new 440C ball. Note adhesive/shear peeling-like appearance of the finish marks.

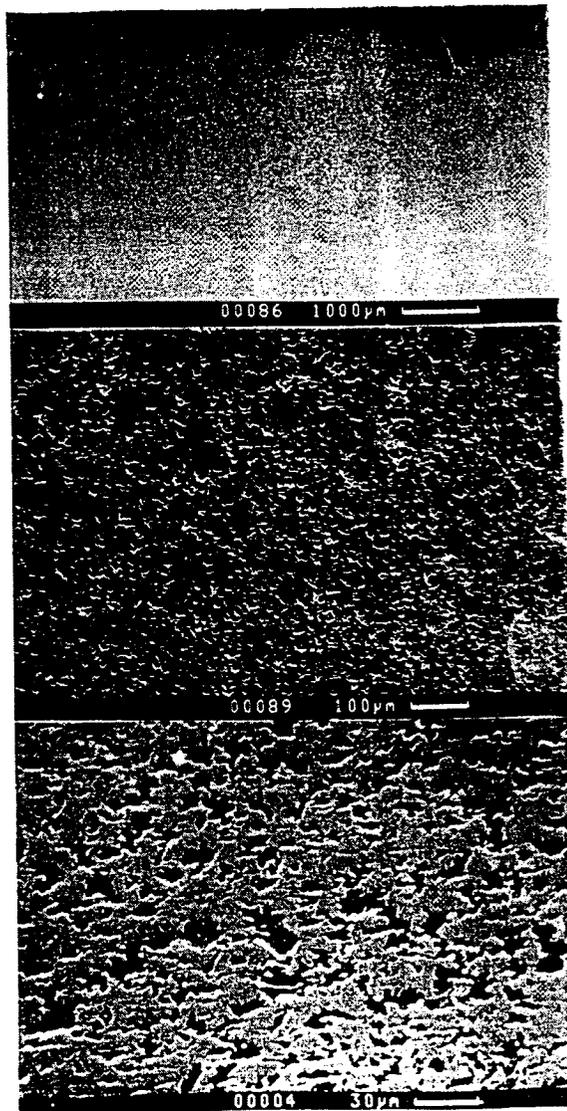
Fig. 2—Surface damage resulting from ball skidding
