NASA CONTRACTOR REPORT 189678

TENSION AND COMPRESSION FATIGUE RESPONSE OF UNNOTCHED 3D BRAIDED COMPOSITES

M. A. Portanova

**Lockheed Engineering & Sciences Company
Hampton, VA**

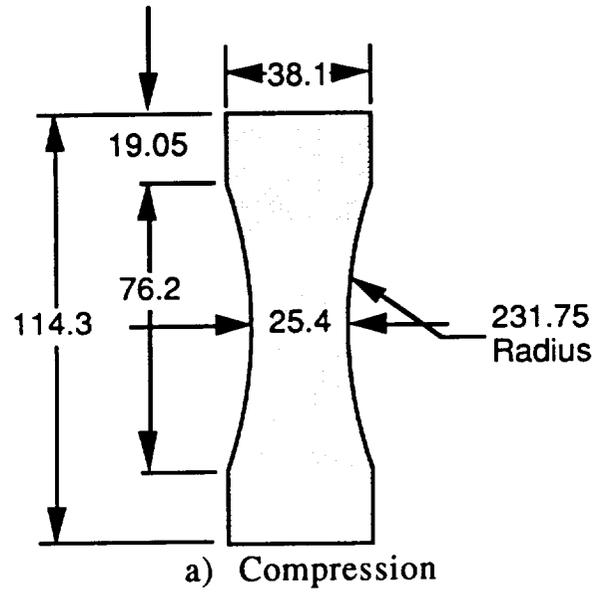
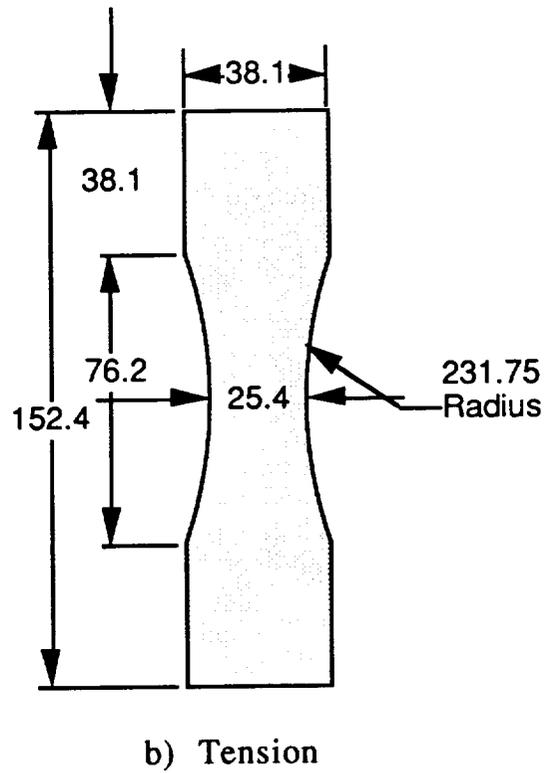
Figure 1. Fatigue Test Specimen Geometry.

All specimens were machined with a diamond saw and all edges ground smooth and parallel. Because composites tend to be fairly notch sensitive, it was decided to machine a large radius in the test section of the unnotched specimens. The test section for both tension and compression specimens were reduced from an overall width of 38.1 mm (1.5 in.) to 25.4 mm (1.0 in.). An illustration of the tension and compression fatigue specimens is shown in Figure 1.

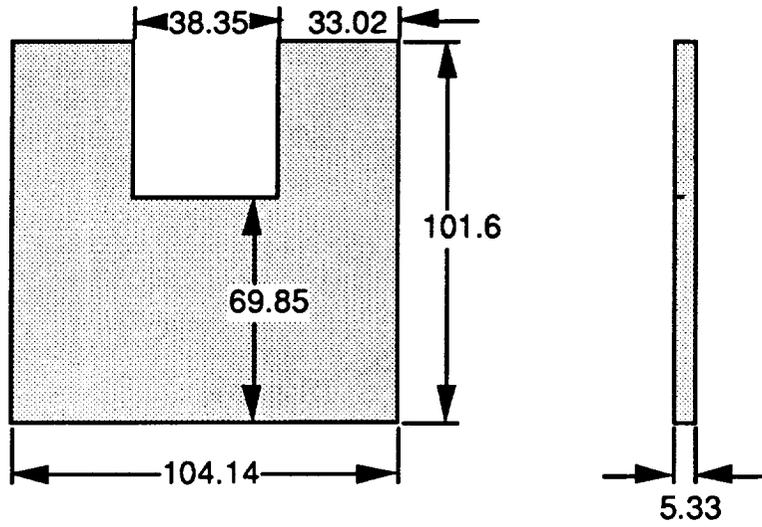
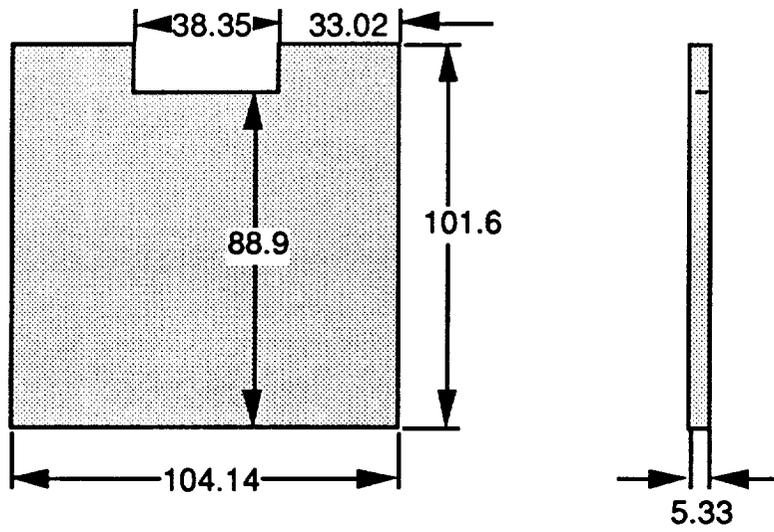
Figure 2. Dimensions for end loading plates used inside the hydraulic grips.

The compression fatigue specimens were mostly end loaded so only a minimal amount of material was inserted in the hydraulic grips. Accordingly, steel plates, approximately 0.762 mm (0.03 inch) thinner than the compression specimen, were placed in the grips. These plates are shown in Figure 2. The specimen ends bore on the plates inside the hydraulic grips. Only a minimal amount of clamping pressure was used. Thus, the coupons were mostly end loaded without brooming deformation of the ends of the specimens. The gauge length was kept short at 76.2 mm (3.0 in.) to prevent buckling/instability.

The tension fatigue specimens were clamped tightly in the hydraulic grips using approximately 3.45 MPa (5000 psi) grip pressure in order to transfer the load into the specimen through friction. The area of gripped surface was 1451.6 mm² (2.25 in.²) to prevent crushing. To insure that the gage length was constant, the tension specimens were also seated on top of the steel plates illustrated in Figure 2. Photographs of the load frame, test specimens, and data acquisition system are provided in Figure 3.

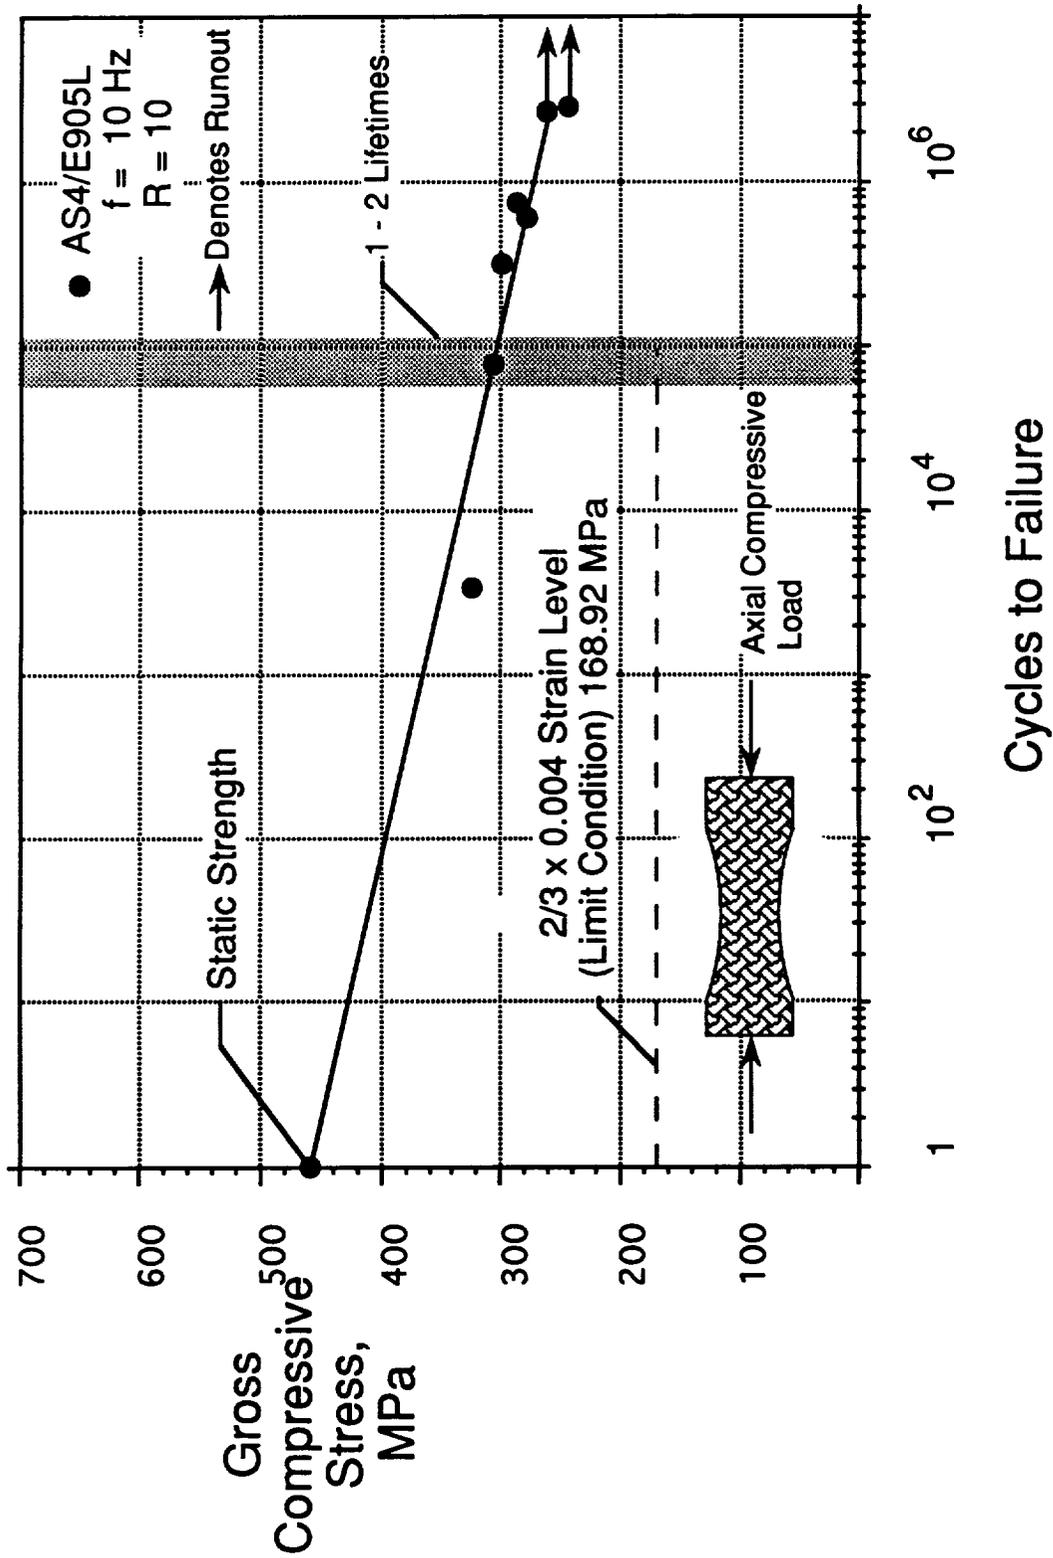
Figure 4. Compression Fatigue of 3D Braids.

Maximum compressive load is plotted against cycles to failure in Figure 4. The fatigue test results are listed in Table 1. The values plotted at one cycle are the static failure stresses from the room temperature short block compression tests which are also reported in Table 1. Linear least squares regression fits to the data are also plotted. The braids exhibited a wide range of fatigue lives for a fairly narrow range of cyclic stresses. This response is typical of that for tape materials of similar constituents. At 10^6 cycles, the strengths were 43 to 44% less than the static values.

Airframe manufactures typically design aircraft for a fatigue life of two lifetimes, where one lifetime is approximately 20 years or 60,000 flights. A design allowable of 0.004 strain has been suggested for tape laminates on the basis of damage tolerance. To evaluate the fatigue performance of the braided material, a region covering one to two lifetimes has been shaded and a dashed line placed at a $\frac{2}{3} \times 0.004$ strain level (limit condition), based on the materials initial modulus. At one lifetime, the fatigue strength is about 1.8 times the limit stress. For wing bending on a typical transport aircraft, the strains reach limit condition only a few times in a lifetime, which is much less than 60,000 cycles. Therefore this material, in an unnotched form, has more than adequate fatigue strength.

The notched static strength of the 3-D braid is about $\frac{3}{4}$ the unnotched strength. Assuming that the slopes of the notched and unnotched S-N curves are similar, the fatigue strength of the notched material may be marginal. Future open hole fatigue tests will

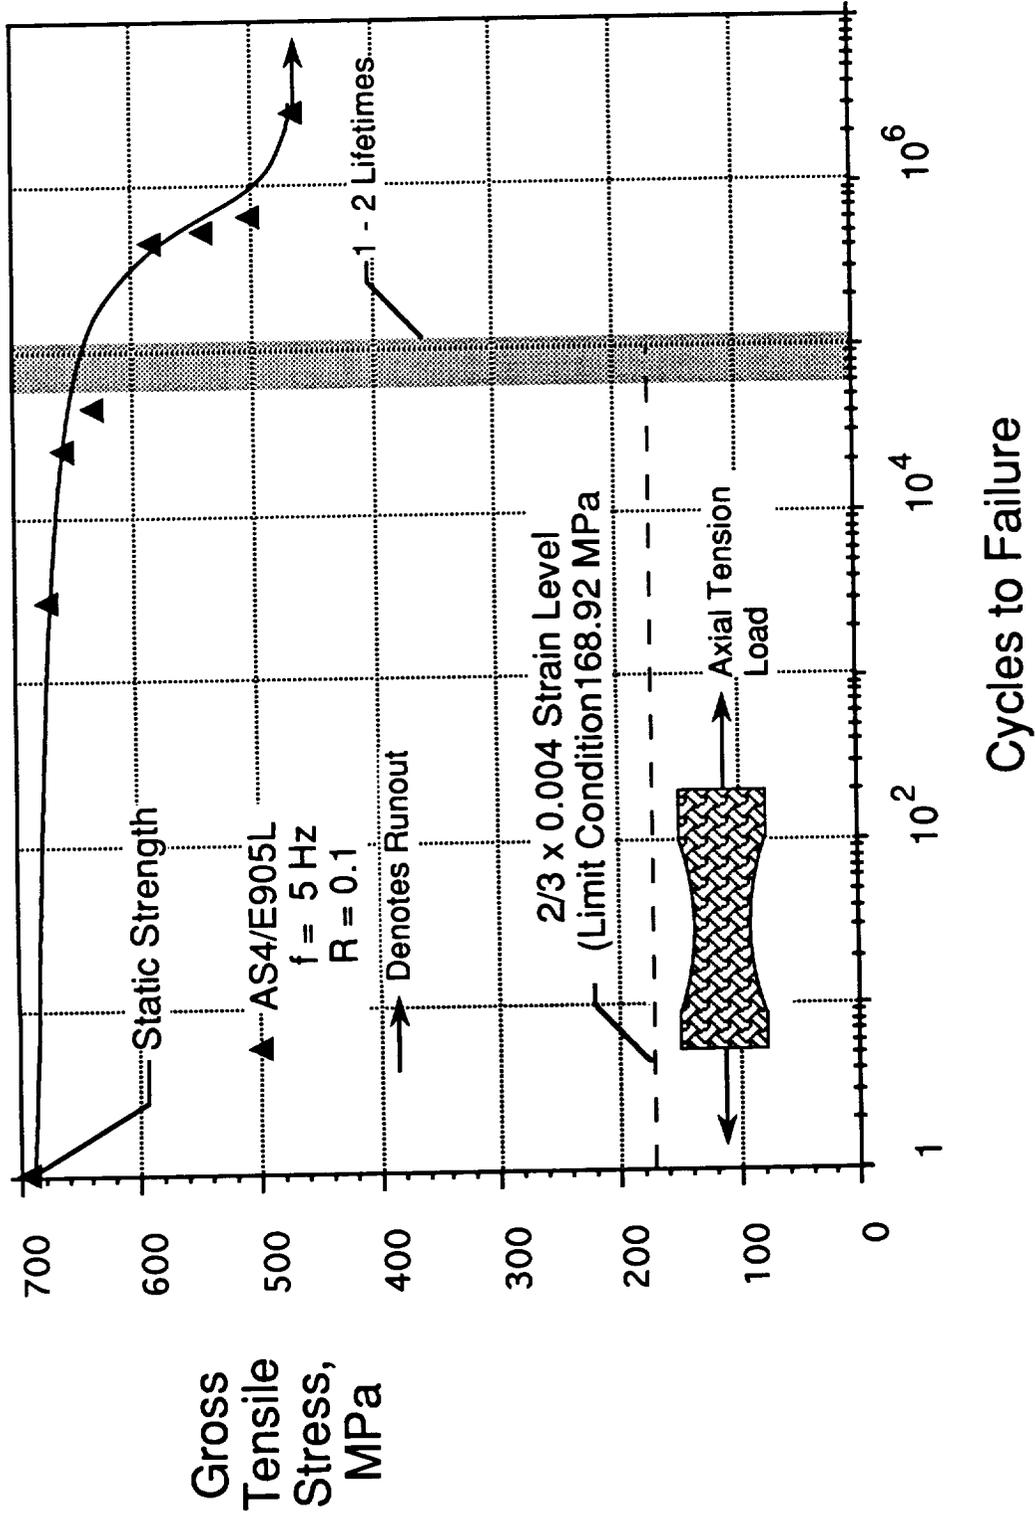
Figure 5. Tension Fatigue of 3D Braids.

Maximum tensile stress is plotted against cycles to failure in Figure 5. Results are also listed in Table 2. The values plotted at one cycle are the static failure stresses from the monotonic room temperature tension tests reported in Table 2. A polynomial curve was fit to the data. The 3-D braids experienced a reduction in tensile strength with constant amplitude tension fatigue cycles of between 21 and 22% at 10^6 cycles. For cycles less than 10^6 , the strength reduction was much less than that for the compression fatigue data. The fatigue response of this material suggests that, although the off-axis yarns may delaminate or fail early in the life, the strength, being mostly dependent upon the 0° fibers, retains most of its initial value.

Again, a region representing one to two design lifetimes has been shaded and the design limit strain of $\frac{2}{3} \times 0.004$ is shown. The unnotched tension fatigue response of this material is more than adequate. The notched static tension strength is approximately 28% below the unnotched strength. Assuming that the slope of the S-N curve is similar, the notched fatigue response should also be more than adequate.

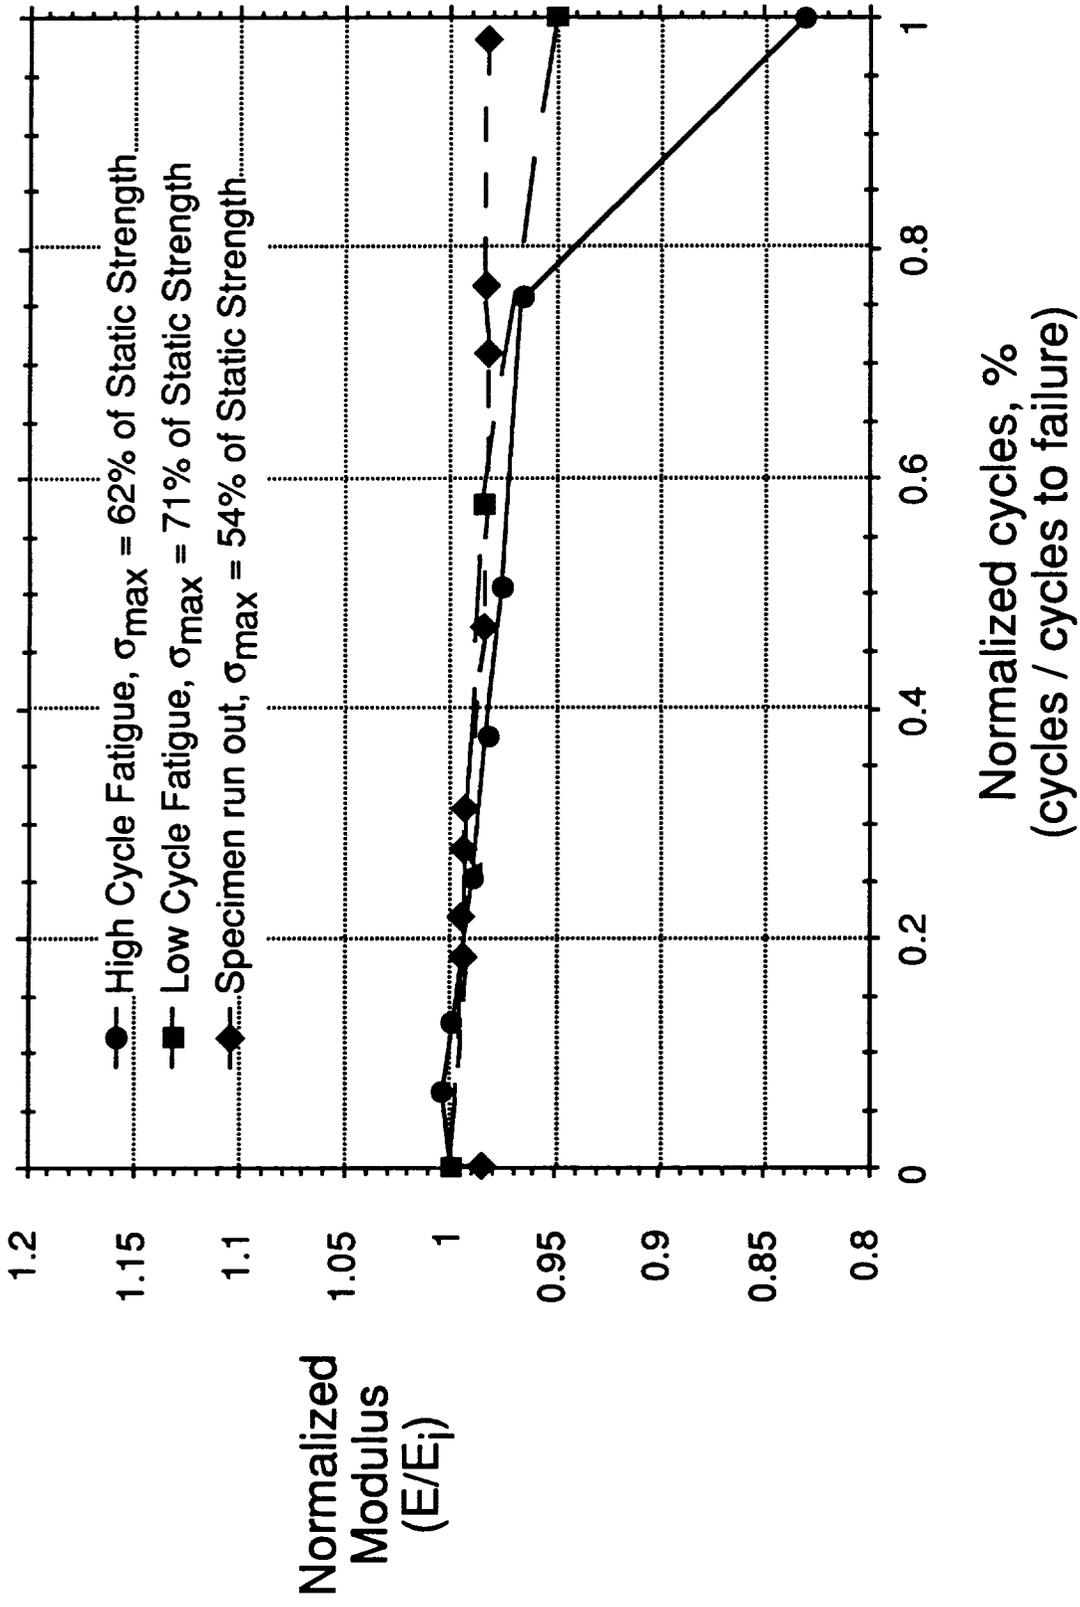
Figure 6. Normalized Compression Modulus -vs- Normalized Life
High Cycle, Low Cycle, Run-out Fatigue.

Compliance change during cyclic loading provides a measure of damage accumulation. The specimen stiffness was monitored in situ throughout the fatigue life, including the fracture cycle with a digital storage scope. Figure 6 is a plot of the in situ elastic modulus normalized by the initial modulus versus the corresponding cycle count normalized by the number of cycles to failure for a typical high cycle, low cycle and run-out compression fatigue test.

With the compression fatigue specimens, stiffness loss started early in the fatigue life but progressed very slowly. The material typically retained 96% of its original elastic modulus over 75% of its fatigue life. With high cycle fatigue, the stiffness can be seen to drop rapidly after about 75% of its life. Surface damage also developed very rapidly at this point. At failure, the loss of elastic modulus ranged

from 16 to 18.5%. With low cycle fatigue, the loss of elastic modulus ranged from 4.5 to 6% at failure. Surface damage was not observed during low cycle fatigue. Specimen runout (10^6 cycles) yielded a 1 to 3% reduction in modulus. Some edge surface damage was observed mid-way in the life but did not appear to grow across the width or through the thickness to any significant degree.

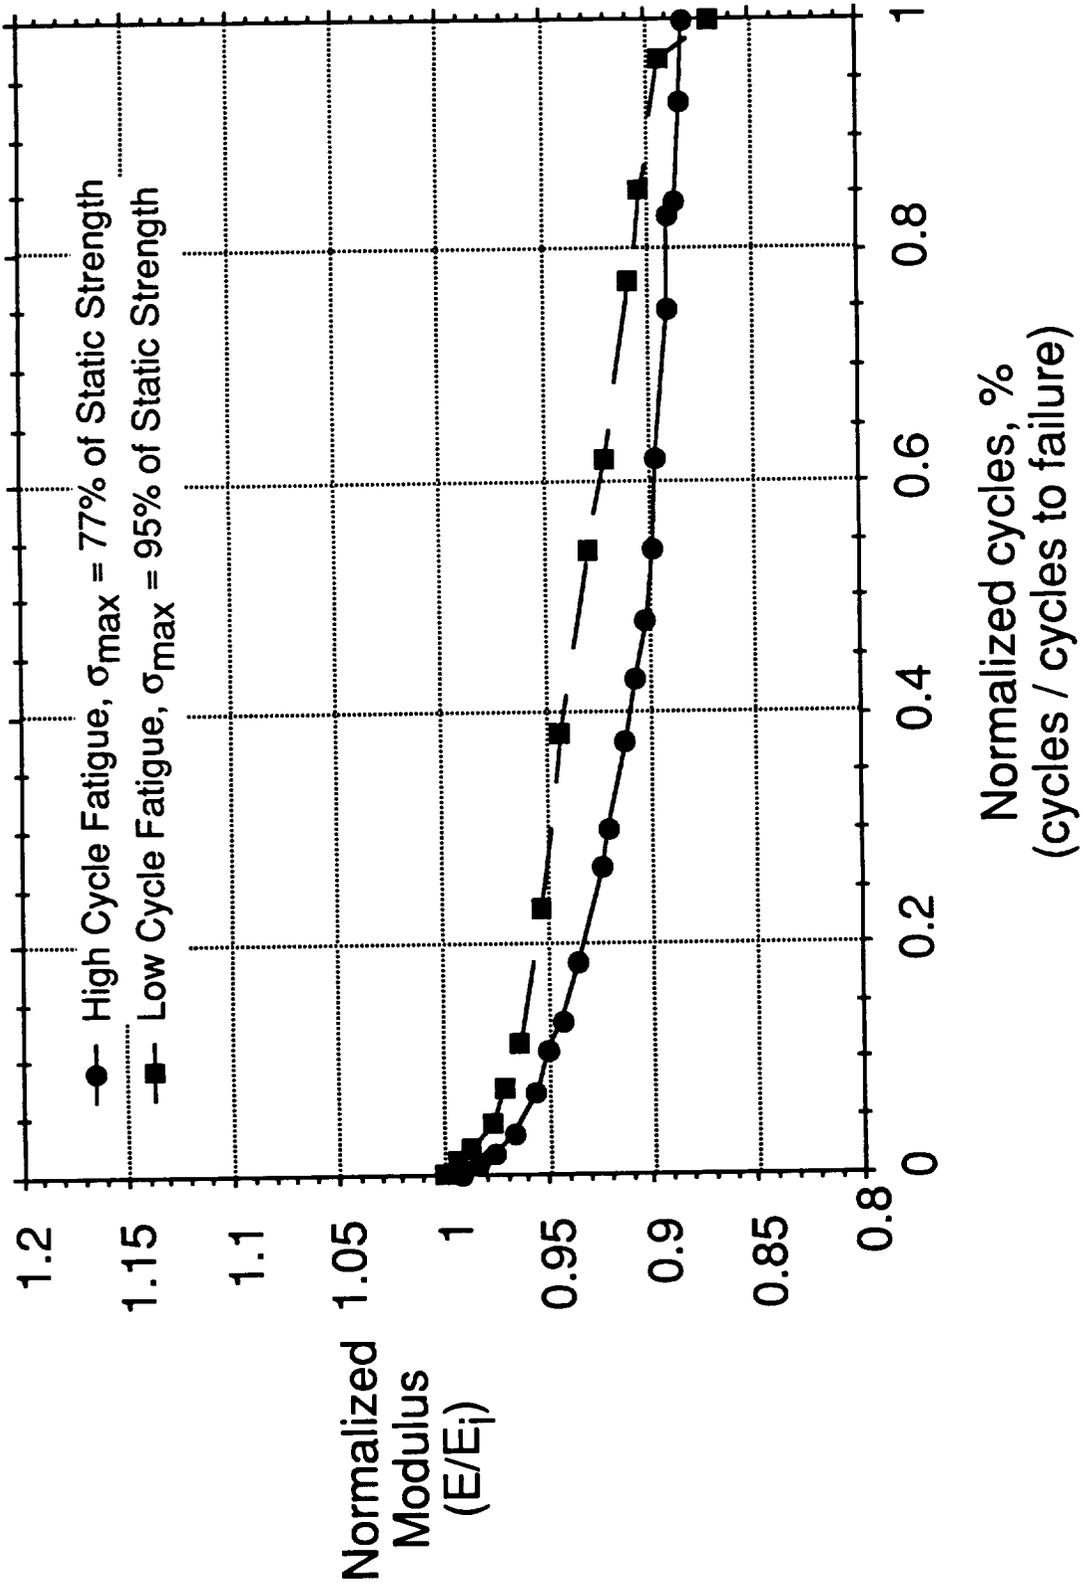
Figure 7. Normalized Tension Modulus -vs- Normalized Life
High Cycle, Low Cycle Fatigue.

Figure 7 is a plot of the in situ elastic modulus normalized by the initial modulus versus the corresponding cycle count normalized by the number of cycles to failure for a typical high cycle and low cycle fatigue test. Stiffness loss for a runout specimen was not measured. The tension fatigue specimens exhibited faster initial damage growth rates than the compression specimens. Visually, damage was not apparent on the specimens surface but was concentrated at the edge of the specimen. Figure 7 reveals an immediate loss of stiffness for both high and low cycle fatigue tests.

With high cycle fatigue, edge damage again was observed early in the life but grew little there after. Examination of Figure 7 reveals that with high cycle fatigue the stiffness drops 6% to 8% during the first 20% of the fatigue life. Damage did not grow along the surface of the coupon until late in the fatigue life. Some edge damage was observed mid-way in the life but did not appear to grow across the

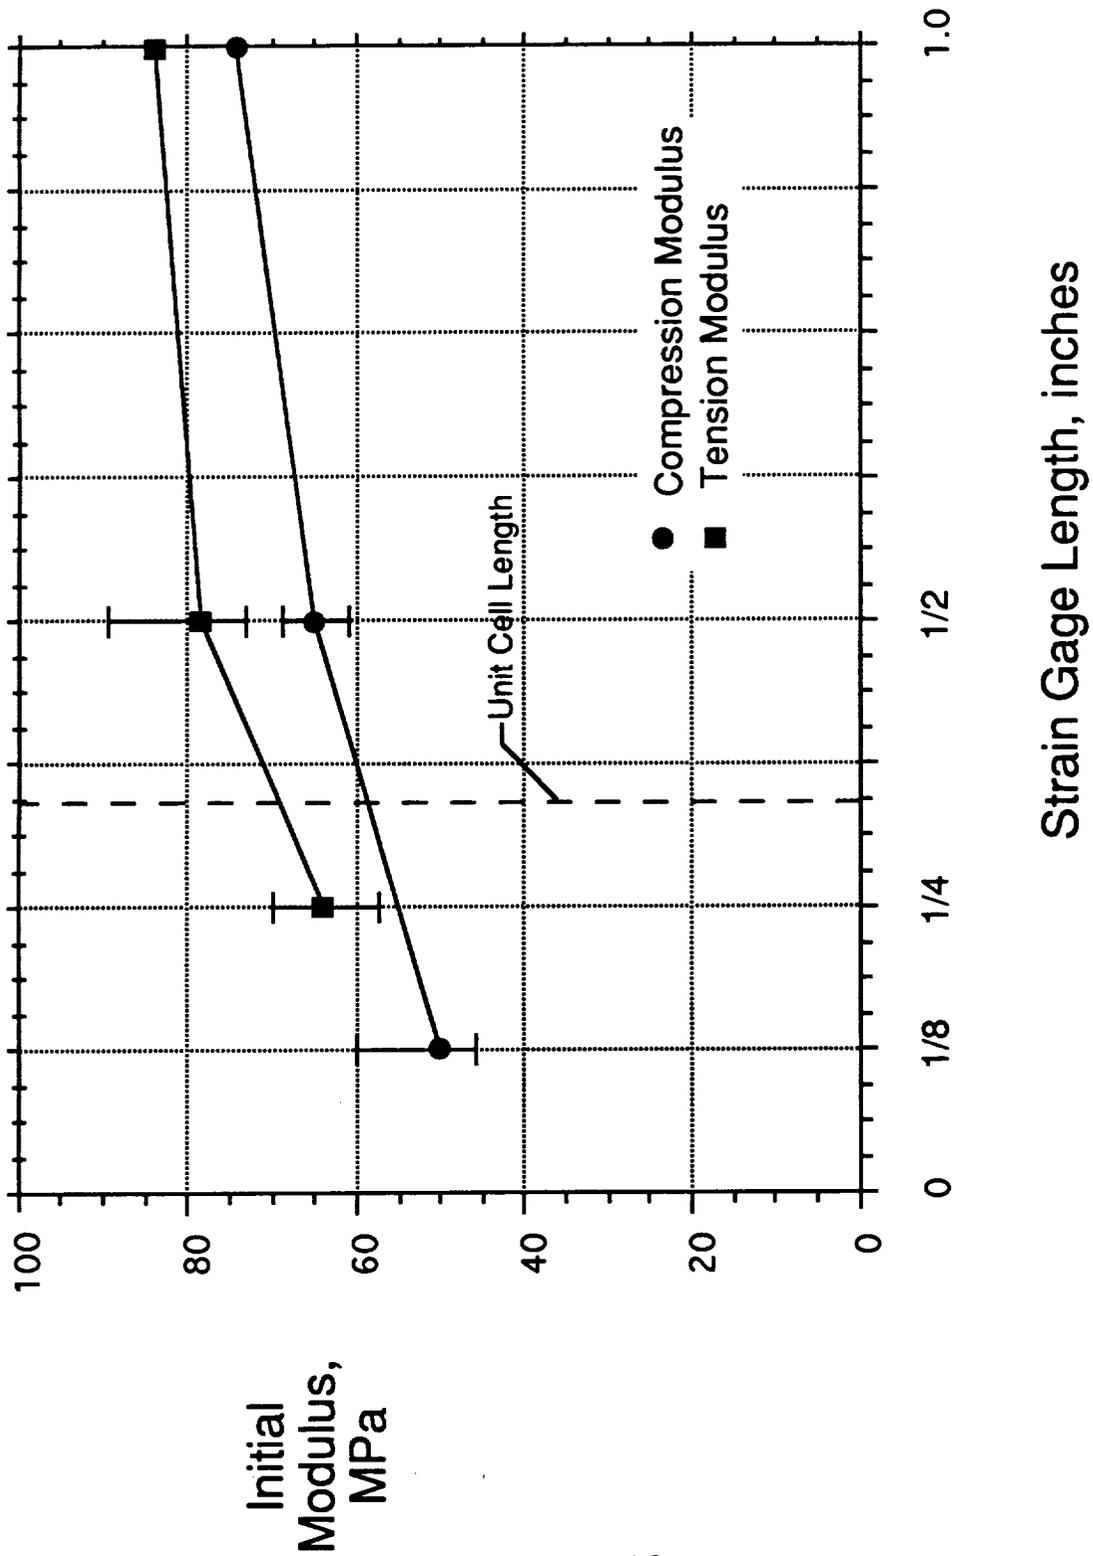
Figure 8. Effect of Strain gage Length on Elastic Modulus.

Figure 8 is a plot of the initial modulus versus strain gage size for the static and fatigue test; data scatter is also displayed with error bars. Strain gage sizes are given in Tables 1 & 2. Examination of this figure reveals that different strain gage sizes produced different elastic modulus values. Tension modulus was larger than compression modulus for each of the tested gage sizes. For static compression loading and 3.18 mm (0.125 inch) strain gages, the elastic modulus averaged 50.12 GPa (7.27 Msi.). For static tensile loading and 6.35 mm (0.25 inch) gages, the average elastic modulus was 63.98 GPa (9.28 Msi.). For compression fatigue loading and 12.7 mm (0.5 inch) and 25.4 mm (1.0 inch) strain gages, the elastic moduli were 65.08 Gpa (9.44 Msi) and 75.50 GPa (10.81 Msi) respectively. A textile composite is not a homogeneous material at the strain gage levels. Thus, the strains vary with gage size.

Of the gages used, the 3.18 mm (0.125 inch) gage, which is much smaller than one unit cell, yielded the lowest modulus values. The 6.35 mm (0.25 inch) gage, which is only slightly smaller than one unit cell, provided an average elastic modulus very similar to the values obtained with the 12.7 mm (0.5 inch) gages. Both the 6.35

mm (0.25 inch) and 12.7 mm (0.5 inch) gages provided average modulus values 30% larger than the 3.18 mm (0.125 inch) gages. The 25.4 mm (1.0 inch) gage, which is approximately 3 unit cells in length, yielded a modulus 49% larger than the 3.18 mm (0.125 inch) gage but only 14% larger than the 6.35 mm (0.25 inch) and 12.7 mm (0.5 inch) gage. The tension fatigue moduli had similar variations. For tension fatigue loading, 12.7 mm (0.5 inch) and 25.4 mm (1.0 inch) strain gages produced values of 74.73 GPa (10.70 Msi) and 84.09 GPa (12.04 Msi) respectively.
