THERMAL PROTECTION SYSTEMS  
MANNED SPACECRAFT FLIGHT EXPERIENCE

Donald M. Curry  
NASA/Johnson Space Center  
Houston, Texas

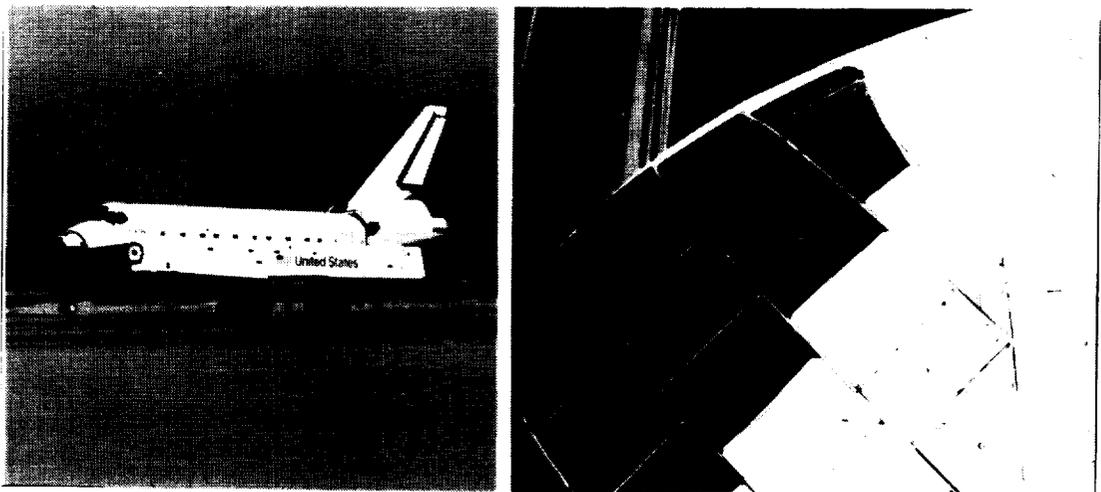
Figure 10b. OMS-POD tile redesign.

The RSI system thermal/structural integrity for the most part has been excellent for all STS flights. The major areas of TPS requiring repair/refurbishment, replacement and/or design change have involved impact damage, gap filler degradation, gas heating in joint regions, seal performance, and penetrations and prevention of hot gas radiation leaks. An example of aerodynamic flow damage occurred on STS-6. The leading edge area of the orbital maneuvering system (OMS) pod was covered with AFRSI material. As can be seen in figure 10a, the AFRSI sustained severe damage from loss of the outer fabric to complete removal of thermal insulation. Postflight and laboratory investigations indicated no evidence of thermal degradation, therefore, the damage was attributed primarily to mechanical loading of the AFRSI blankets due to aerodynamic flow forces. This area was subsequently redesigned using rigid ceramic tiles (fig. 10b).
