NASA  
Contractor Report 191079

# Sikorsky Aircraft Advanced Rotorcraft Transmission (ART) Program— Final Report

Jules G. Kish  
*United Technologies Corporation*  
*Stratford, Connecticut*

March 1993

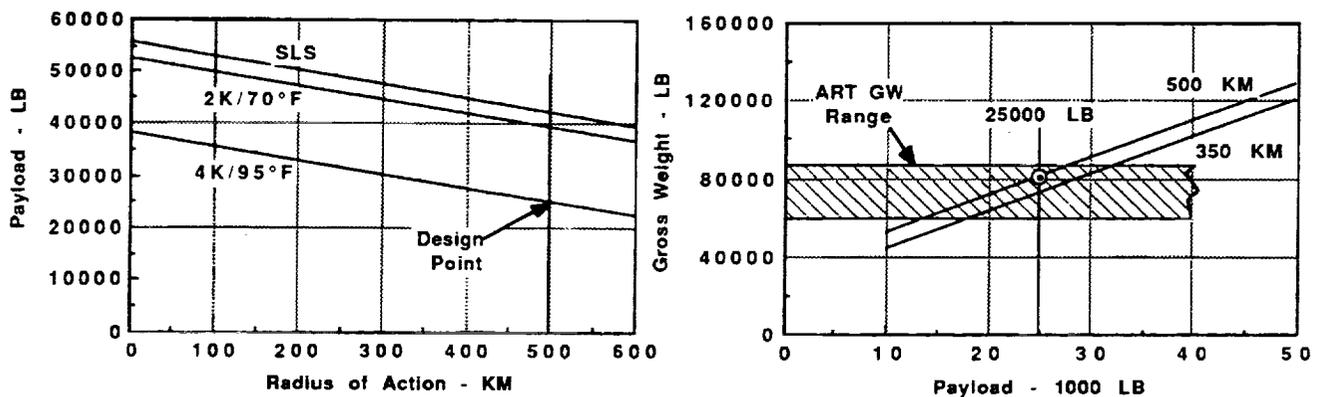
Figure 1. ACA Gross Weight, Payload, and Performance

Figure 1 shows a plot of payload vs radius of action for various ambient conditions and also shows how the gross weight of the ACA solution will vary with payload and radius of action. The plots are made on the assumption of 1995 airframe technology, scaled engines of the MTDE technology, and a disc loading of 10 pounds per square foot. A payload of 25,000 pounds at 500 km mission radius was chosen as a reasonable compromise between the most demanding requirements of the O&O plan and an affordable ACA solution. Gross weight is between 80,000 and 85,000 pounds for this aircraft.

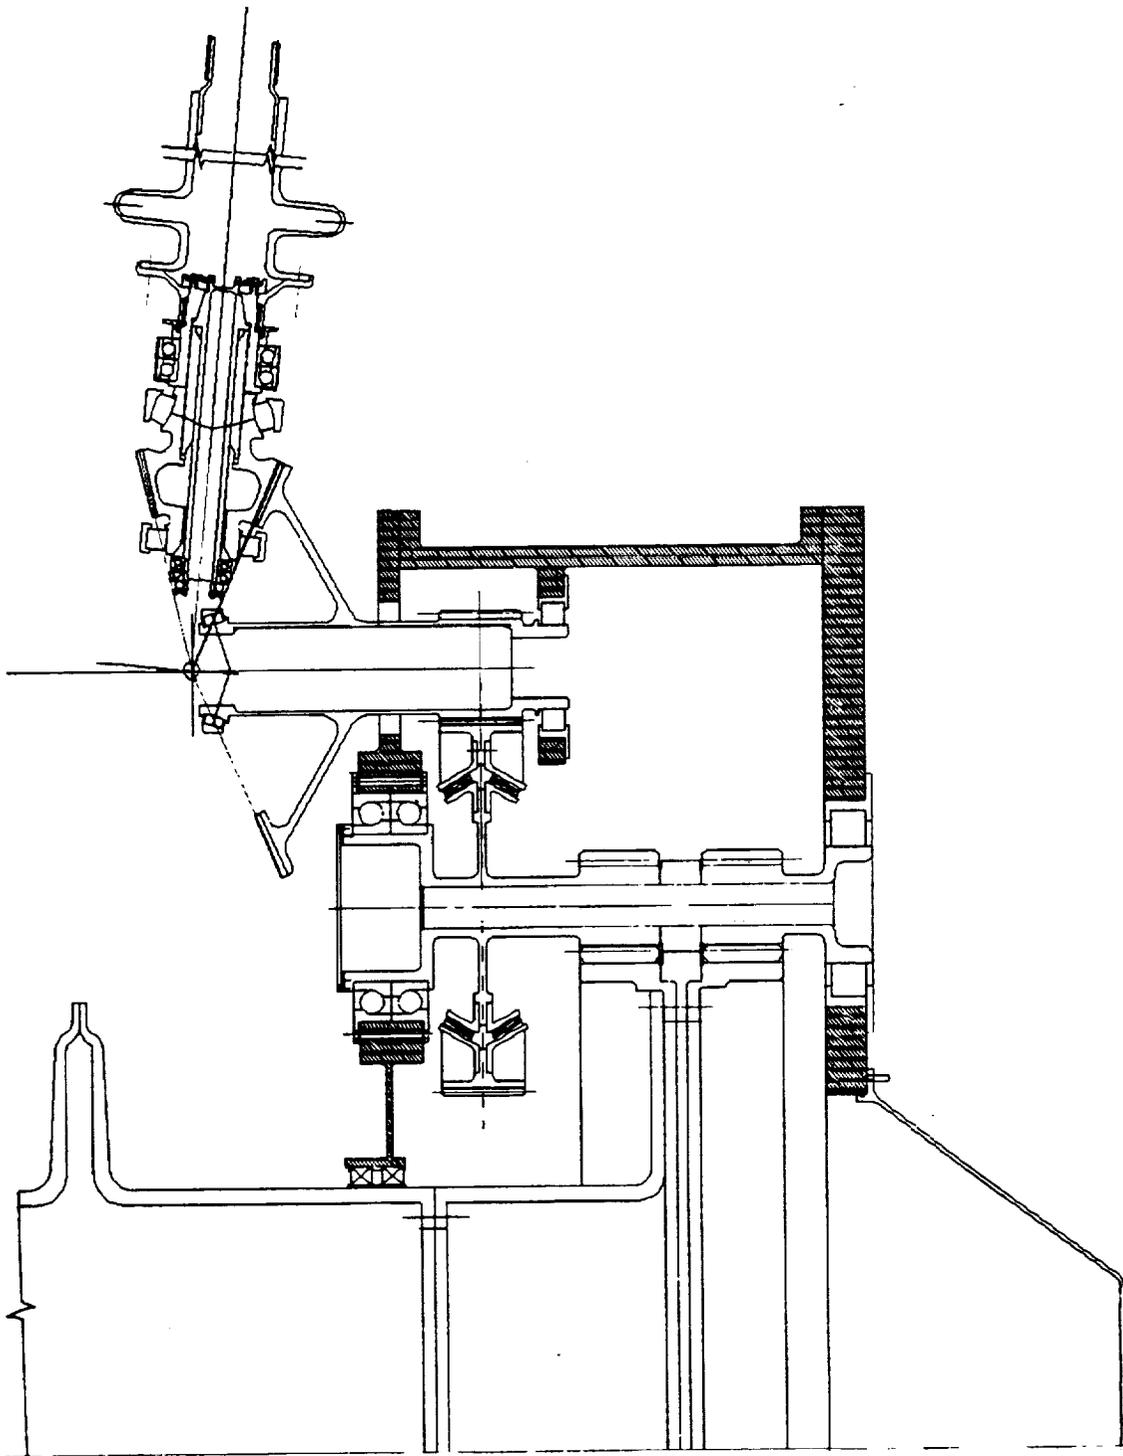
Figure 12. 11:1 Split Path Cross Section

Figure 12 is a cross section of the split path gearbox. Load sharing between torque splitting assemblies must be controlled in the split path gearbox. A new load sharing device is shown in Figure 12 located on the flange of the spur gear and between the spur gear and herringbone pinion. The device shown contains alternate layers of rubber and metal forming a torsionally soft but radially and axially stiff member (See "Load Sharing Devices" section of this report for further discussion). A plan view of the split path gearing arrangement is shown in Figure 13. Since the bull pinions are equally spaced in groups of three about the bull gear, the resultant bearing reaction is zero if

all inputs have the same power. For this reason a design was developed for a bull gear without any bearings that relies for support on the central rings which are the same size as the pitch diameters of the gears. Under normal conditions, the rings do not touch because of deflections of the rims. Under OEI conditions, the bull gear will be forced to one side and the rings will act as supports through the bull pinion shafts. (See "Bearingless Bull Gear Design" section of this report for further discussion). If a spur gear is used in the second stage, the shaft assembly consisting of the second stage gear and bull pinion can be designed to float on roller bearings and the bull gear can be fixed. This is the normal state-of-the-art method of load control between halves of a herringbone gear set. When using this design however, the bearingless bull gear can not be used since by definition the bull gear must be free to float. In the final detail design as will be seen, the bearingless bull gear design was not used so that the bull gear could be fixed and the bull pinions floating. The output composite quill shaft is approximately 24 inches in diameter and transmits only torque to the main rotor. Main rotor loads are reacted by the upper truss assembly (See "Composite Main Rotor Shaft/Quill/Standpipe" section of this report).

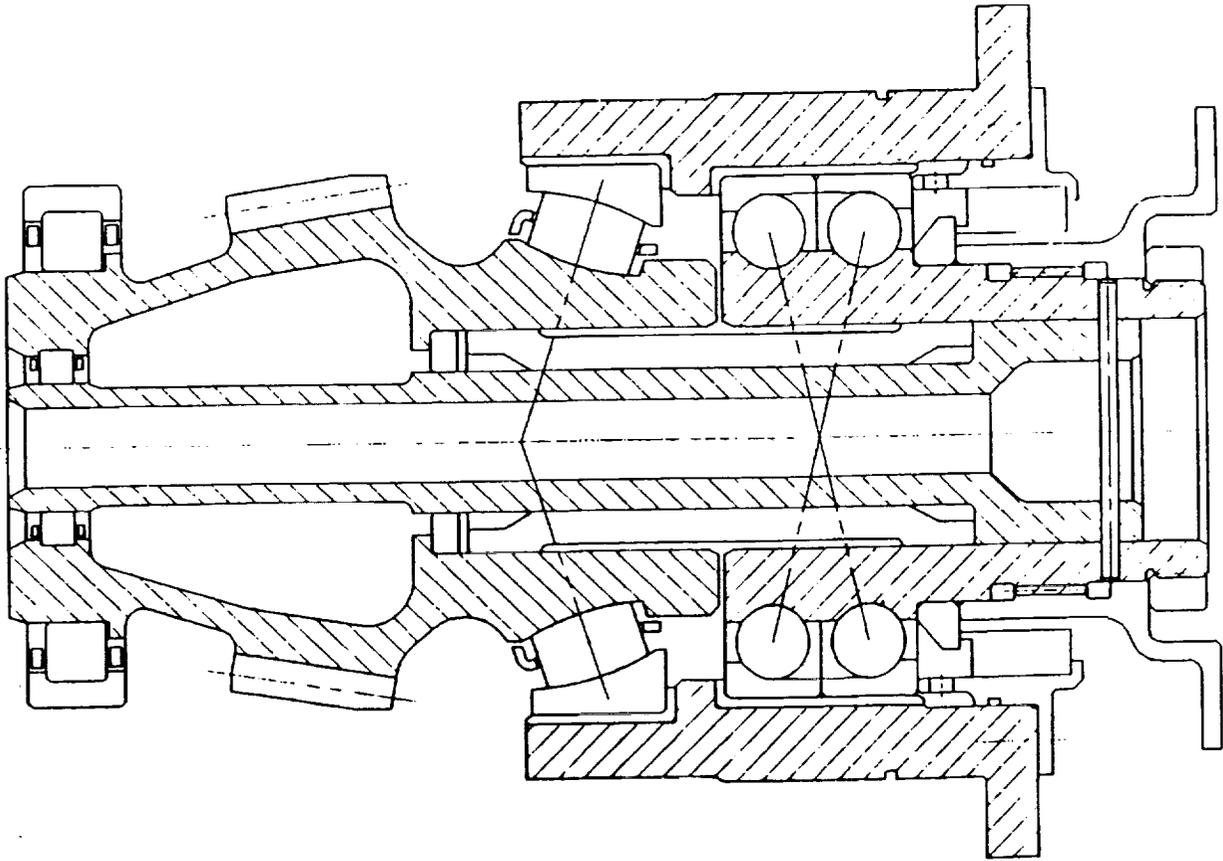
**Figure 23. ART Input Bevel Pinion With Spring Clutch**

A layout of the spring clutch on the input section of the ART main gearbox is shown in Figure 23. An arbor is used to support the spring during overrunning. The inside diameter of the spring is interference fit with the arbor when there is no torque tending to unwind the spring. The arbor acts as a guide to keep the coils straight in the overrunning mode. A squeeze film damper is provided at the outside diameter of the duplex bearing set to reduce the spring rate of the bearing support and to provide damping for the first rigid body mode that the spring/input shaft/and engine drive shaft system must traverse on the way to operating speed. The spring arbor extends through the input bevel pinion and has a support bearing at the end. This bearing provides a large bearing spread and acts in conjunction with the duplex bearing to support the engine drive shaft. The input bevel pinion shaft forms the spring clutch output housing. A single angular contact spherical tapered roller bearing carries combined thrust and radial load and replaces the conventional state-of-the-art ball/roller combination used normally. The spherical bearing is manufactured with an outer land guided cage and the inner race is integral with the input pinion shaft.

The preliminary designs of the spring clutch assembly were weighed. Each input spring clutch was found to be 38.45 pounds for a total of 115.35 pounds for the 3 engine aircraft. For comparison purposes, a ramp roller clutch was designed to operate on the input bevel gear. The input bevel gear rotates at 4,935 rpm vs 15,000 rpm for the pinion where the spring clutch operates. A layout was made of the ramp roller clutch at the bevel gear and it was found to weigh 161.59 pounds per engine for a total of 484.77 pounds for the aircraft. Thus the spring clutch on the input bevel pinion is 369 pounds lighter than a conventional ramp roller clutch on the output bevel gear. Considering that the baseline main gearbox weighs 6882 pounds, the savings in weight for the spring clutch alone amounts to 5.4% of the main gearbox weight and also represents 3.4% of the entire transmission system weight.

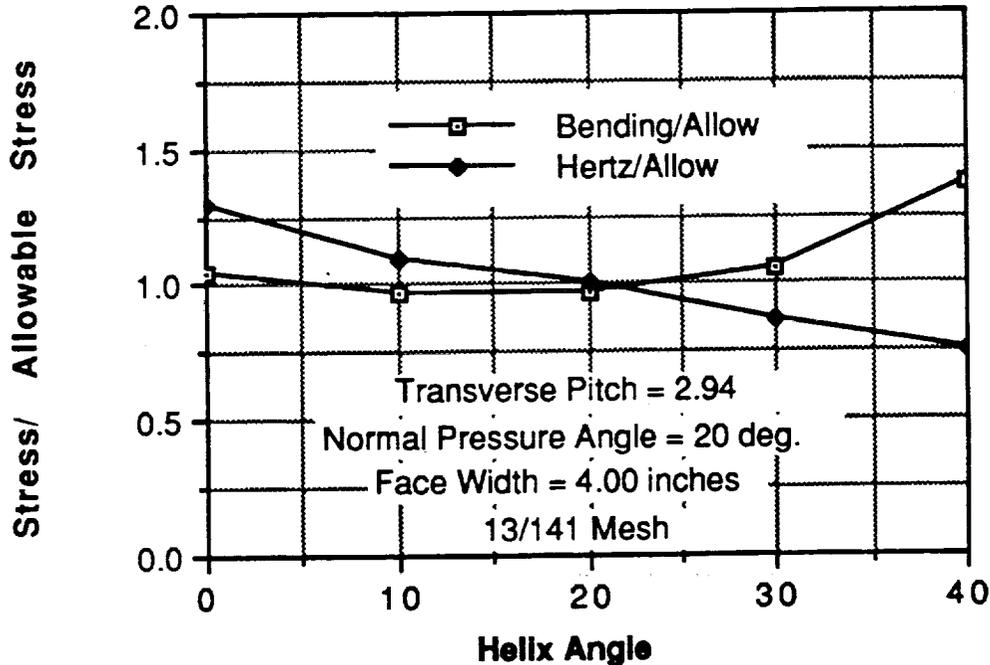
Figure 25. Herringbone Gear Mesh Design Parameters

A typical result can be seen in Figure 25 which is a plot of stress divided by the allowable stress (or factor of safety) vs helix angle. The plot is for the 13/141 mesh. As helix angle increases, contact stress continues to decrease whereas bending stress decreases slightly to about 20°, then increases slightly to about 30°, and then increases sharply above 30°. This is a typical plot for all designs. The maximum helix angle used was reduced as a result of this phenomenon to approximately 30°.

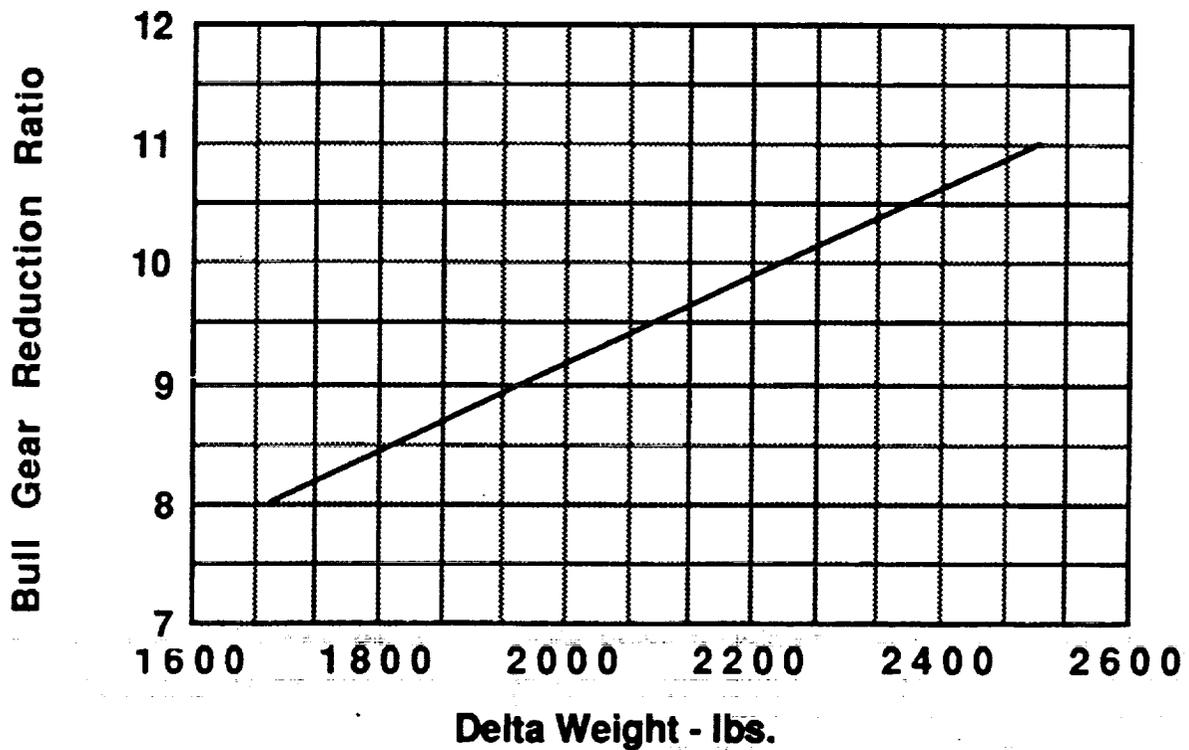
Figure 26. ART/ACA Weight Savings vs Reduction Ratio

Preliminary layouts were prepared for 8:1 and 11:1 ratio bull gears. It was found that last stage reduction ratio had a profound effect on weight. This fact is illustrated in Figure 26. The reason for the weight savings can be realized when considering for a moment what happens when the output bull gear is left alone and the bull pinion pitch diameter is decreased. First of all, the bull gear face width remains the same since the output torque, and hence output tangential tooth load has not changed. Secondly, the weight of the bull pinions themselves is reduced since the size of the pinion is smaller. Lastly, the reduction ratio is increasing and hence the speed of the bull pinions is increasing. This results in less torque on the bull pinions and in fact, all stages prior to the bull gear can now have reduced ratios and reduced weight because of the lower torque and lower reduction ratio requirements. Therefore, increasing the reduction ratio at the last stage has the direct effect of reducing sizes of all gearing prior to the output bull gear.

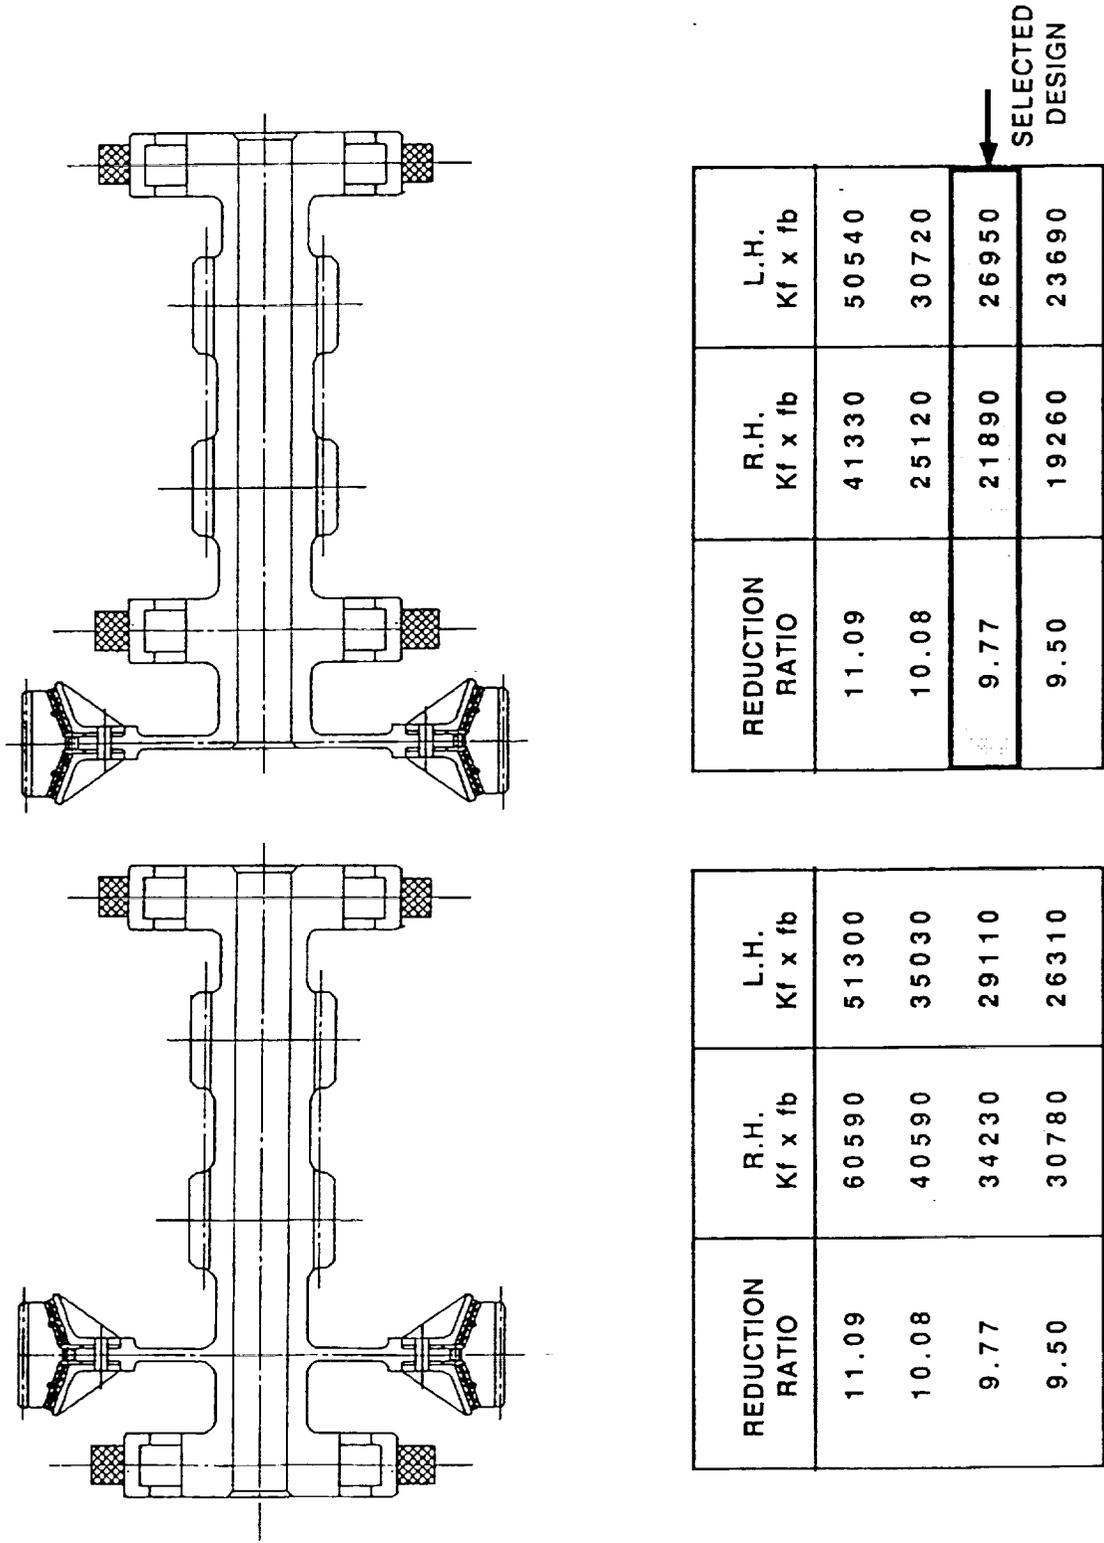
Figure 27. Bull Pinion Bearing Configuration Comparison

It was also found that the reduction ratio of the output bull gear mesh is limited by the basic diameter of the pinion when considering induced fatigue bending in the pinion shaft. Bending of the pinion is influenced by geometry and such basic considerations as to where to put the support bearings. Figure 27 illustrates what happens to the bending stresses in the shaft section

between left and right hand helix members when the bearing is located on the outside of the spur gear or when the bearing is located between the spur gear and herringbone pinion. The bull gear pitch diameter was fixed at 48 inches for the calculations. The configuration with the bearing between gears reduces the peak stress by approximately 30% and was selected for this reason. Note that the critical stress occurs on different sides of the torque splitting pairs depending on configuration. In all cases the highest stress on the selected configuration is lower than the lowest stress on the outboard bearing configuration. This is a somewhat surprising result since transmission designers often select "straddle mounted" designs for improved rigidity.

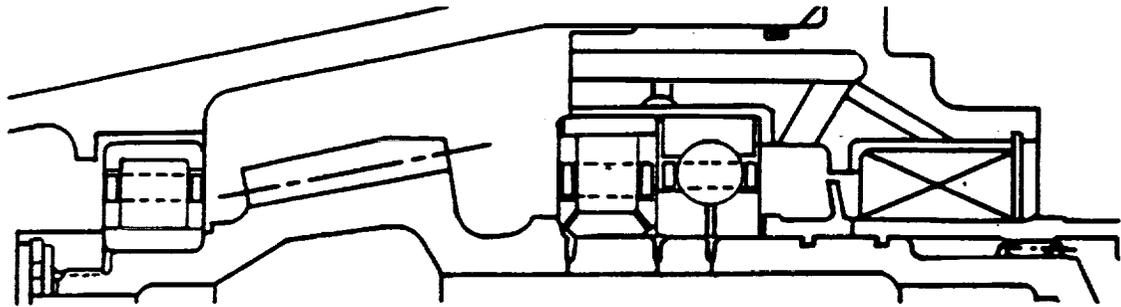
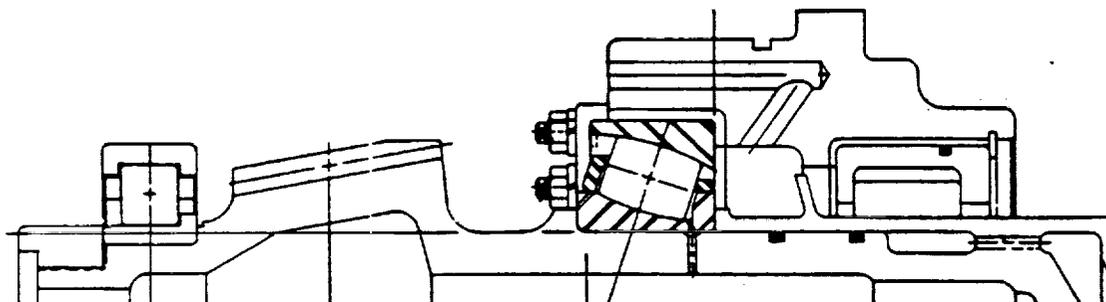
**Figure 34. Single Bearing Configurations Which Replace Ball/Roller**

**BALL/ ROLLER BEARING COMBINATION**

**TAPERED ROLLER BEARING**

**SINGLE ROW ANGULAR CONTACT SPHERICAL ROLLER BEARING**

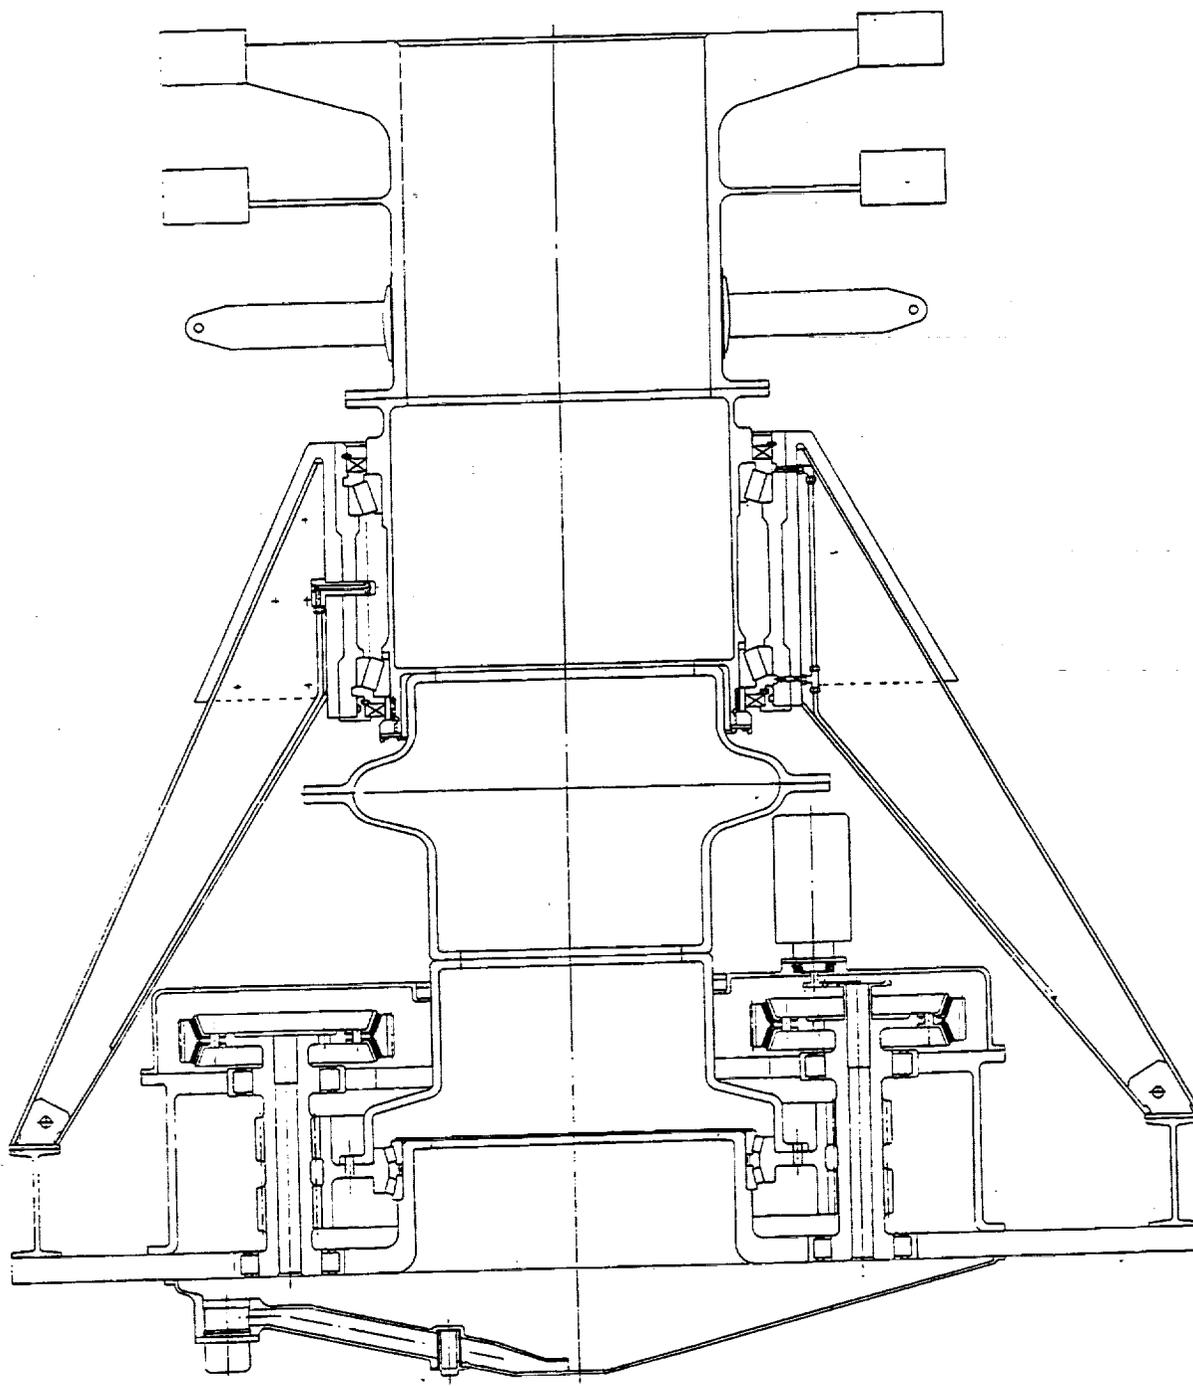
**Figure 54. Composite Quill, Main Rotor Shaft, Truss Cross Section**

Torque is transferred from the main gearbox to the main rotor by means of a composite quill shaft on the ART/ACA. The quill shaft is 26 inches in diameter and is 0.8 inch thick. It carries over 7 million inch pounds torque at the 100% power condition transmitting 14825 HP. A titanium main rotor shaft is located inside of a composite housing with six truss member legs which attach to the airframe. A cross section of the truss, main rotor shaft, rotor head, quill shaft and main transmission are illustrated in Figure 54. Rotor loads are transmitted from the rotor head to the main rotor shaft, through the main rotor shaft bearings into the truss structure. Since there is some bending stiffness to the quill shaft assembly, some moment will be redundantly transmitted to the quill shaft. The bolted connection with integral coupling is intended to reduce the redundant load carried by the truss. A finite element analysis of the structure was conducted. The model is exhibited in Figure 55. The analysis showed that in forward flight at the limit rotor load condition with limit head moment, limit thrust and limit side load applied, the quill shaft reacts only 0.1% of the moment (3,450 inch pounds moment compared to the head moment of 3,020,000 inch pounds). The finite element analysis load conditions are listed in Table 28.

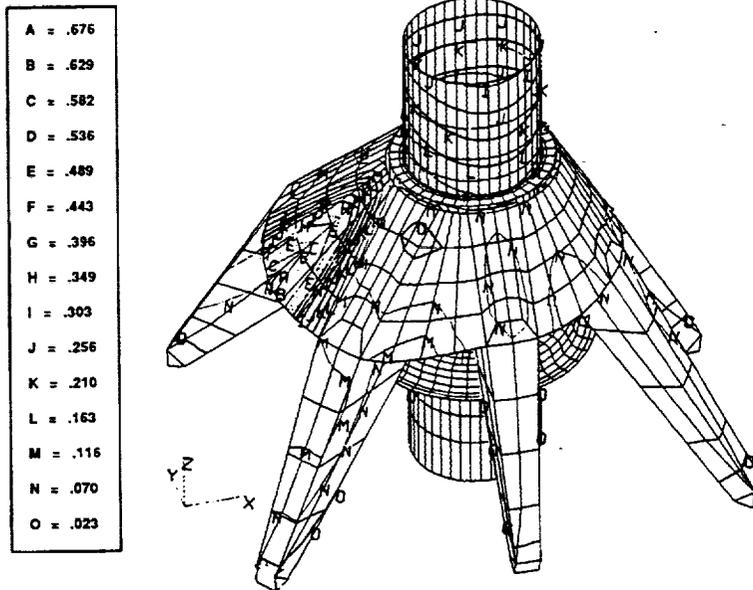
Figure 56. Composite Standpipe/Truss Total Deflection

The composite truss is designed by strain rather than deflection. The deflection can be relatively high in the truss member since no gearing is involved. Figure 56 shows deflection levels of .676 inch maximum. This deflection occurs at the center of the forward servo mount and is caused by the limit servo load of 80,000 pounds. This magnitude of deflection is in the direction of the applied servo loads and merely causes an extra extension of the servo. The deflection at the rotor head of .256 inch is low relative to other Sikorsky helicopters considering the size of the structure.

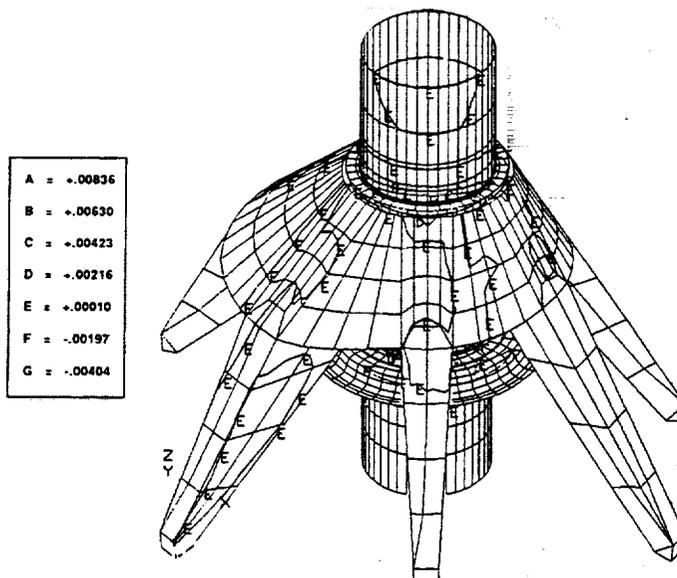
Figure 57. Composite Standpipe/Truss Strain in the Y Direction

Figure 57 presents the strain values for the assembly. The maximum strain of approximately .008 inch per inch is caused by the method of constraint used and does not represent a true value. This conclusion is based on the extremely confined area of the high strain concentrated at the point where the multi-point constraint equations are written. The real strain in the part is closer to the values shown by "E", or 0.001 inch per inch which is well within the allowable of .004 inch per inch. The material used is the same as for the gearbox housings, graphite-polybismalimide.

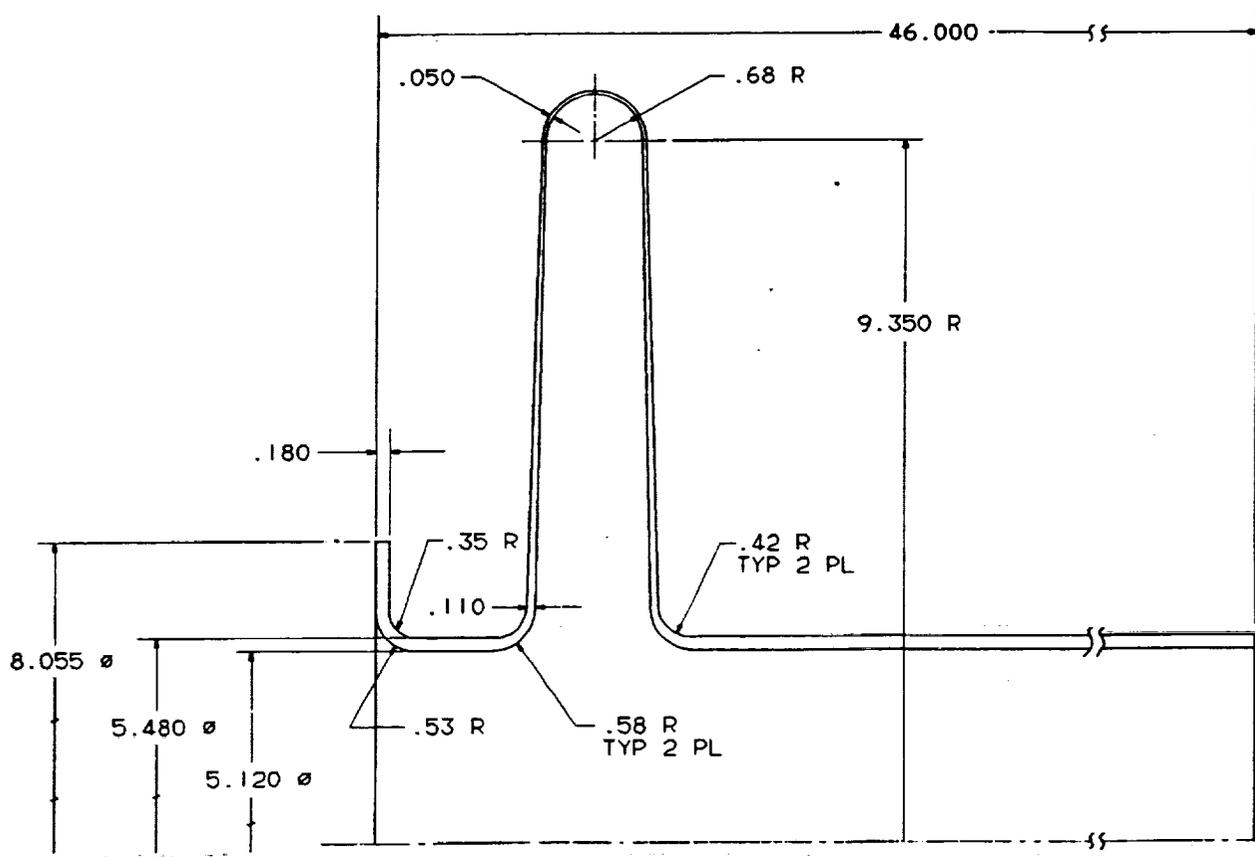
**Figure 58. Composite Integral Shaft/Coupling Basic Dimensions**

The ART engine drive shaft has the integral shaft and coupling on the transmission input side and a metal spline on the engine output side. The metal male spline is bonded and riveted to the composite shaft on the engine end. An elastomeric gimbal is located on the transmission input with the center of rotation at the center of the integral coupling. The engine is supported at the transmission through the gimbal and at the rear of the engine by struts. Any motion induced during flight is transferred to the coupling as an angular misalignment only, without any axial or side motions. Figure 58 displays some of the basic dimensions of the final composite shaft and coupling design.

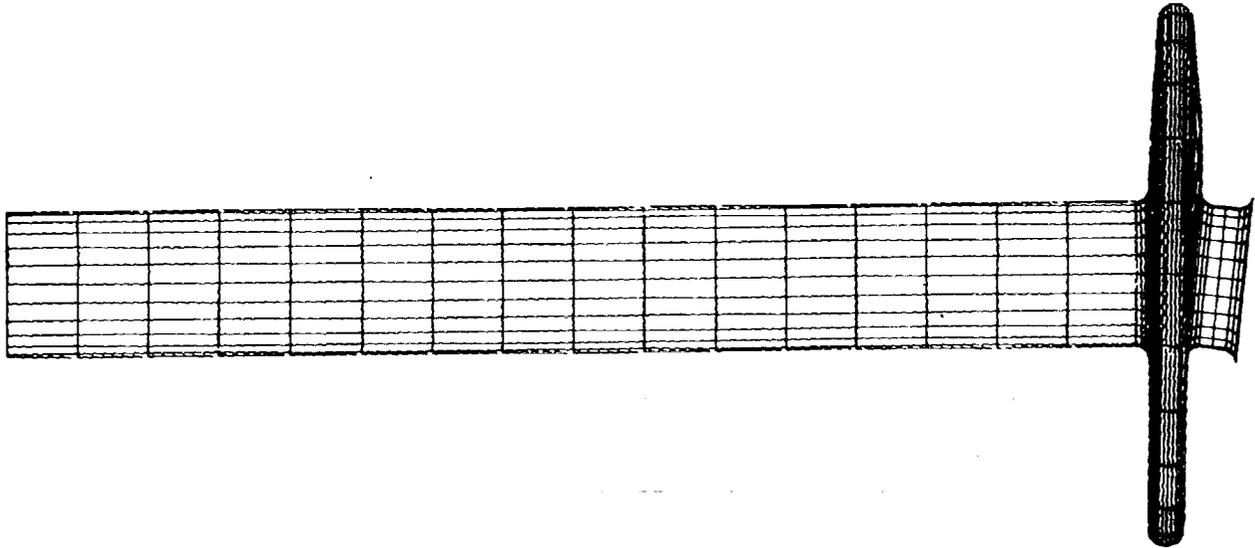
**Figure 59. Composite Integral Shaft/Coupling Angular Misalignment**

A finite element analysis was conducted of the integral shaft and coupling to determine structural adequacy for transmitting torque and for angular misalignment capability. Figure 59 shows the deflected position for enforced angular misalignment.

Spring rates of the assembly were calculated for use in conducting dynamic analysis. In the side or lateral direction, the spring rate was calculated to be 1985 pounds per inch. In the bending direction of angular misalignment, a rate of 4715 inch pounds per radian was found. The torsional spring rate was found to be 1,083,000 inch pounds per radian. The maximum shear strain was calculated to be 0.0018 inch per inch in the tube part of the shaft which is well within the allowable for the composite material.

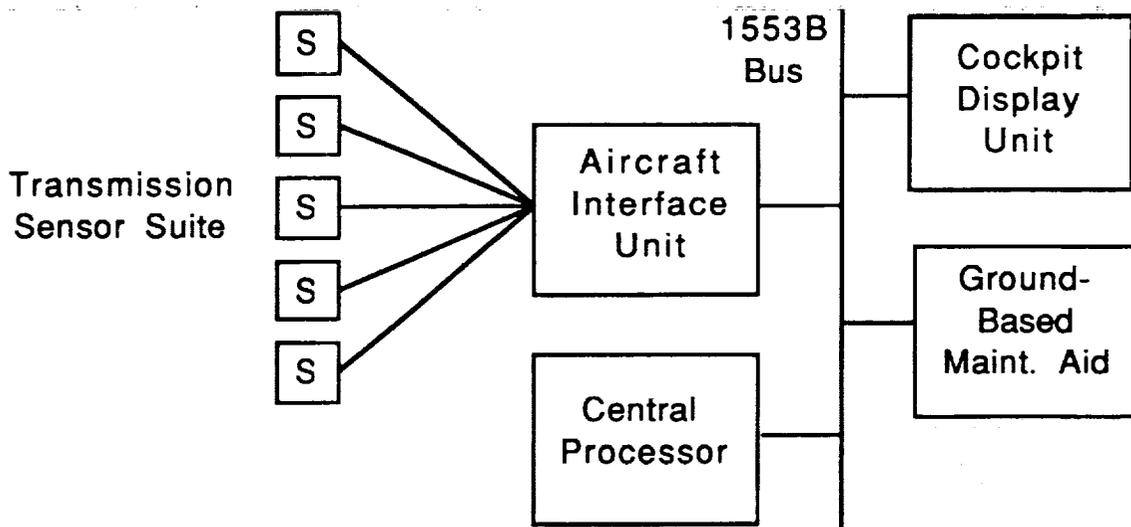
Figure 64. Generalized Diagnostic System

The ART diagnostic system includes all aspects of the diagnostic process including sensors, signal conditioning, conversion, data, information processing software and hardware, and information display. The data and information processing software and hardware include both on-aircraft and off-aircraft sub-systems. The diagnostic system is shown conceptually in Figure 64.

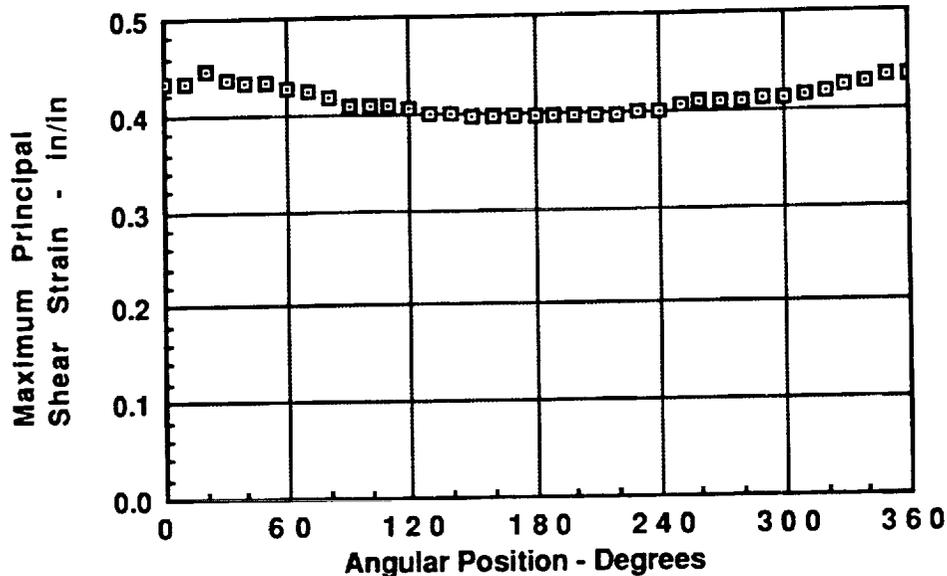
Figure 77. Maximum Principal Shear Strain vs Angular Position

shearing strain in the  $\phi$ -Z direction is caused by the gear loads and in the R-Z direction by the preload. The maximum principal shear strain is plotted in Figure 77. Vibratory strain from the applied gear loads was a concern during the design of the isolator. The finite element analysis shows that the vibratory strain is low and shows how the rubber attempts to "spread" the load more so than metal parts would do.

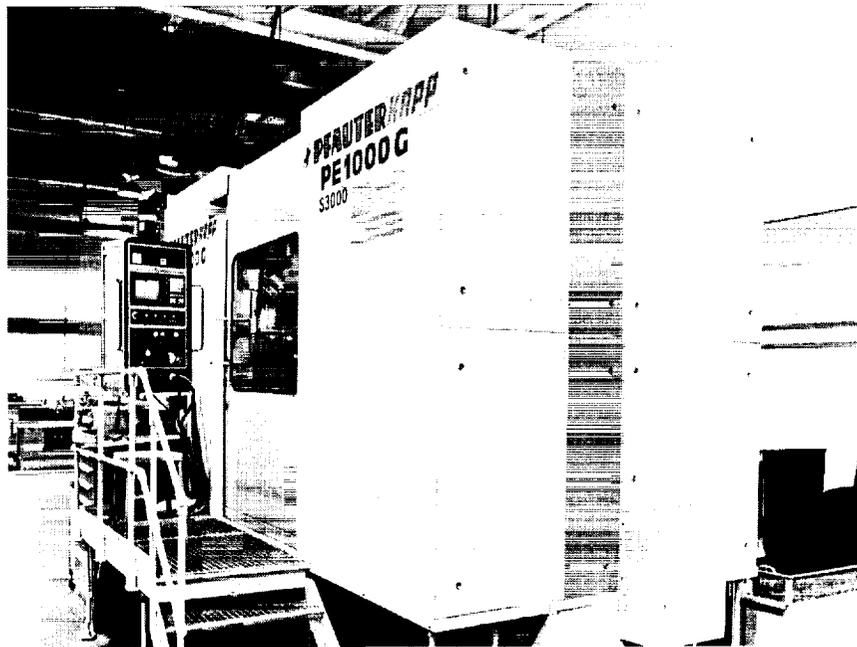
Figure 86. Phauter Kapp Grinding Machine

The spur gears and double helical gears were ground on the Phauter Kapp Grinder as shown in Figure 86. This machine is a form grinder and is designed to use cubic boron nitride (CBN) cutting wheels as shown in Figure 87. CBN is a form of "imitation diamond" and is the next hardest material next to a natural diamond. On a relative hardness scale, it is much harder than silicon nitride used in current state-of-the-art grinding wheels. The advantage of CBN wheels is two fold: (1) The wheel is so hard that there is very little wear. There is no wheel dressing but rather the wheel is sent back for replating after a number of gears are ground which can reach to 50 or 100 gears or more, and (2) The majority of the heat generated in the grinding process is transferred to the wheel rather than to the part being ground as in conventional grinding because of the differences in specific heat of the material hence there is little chance of grinding burns. Since there is less

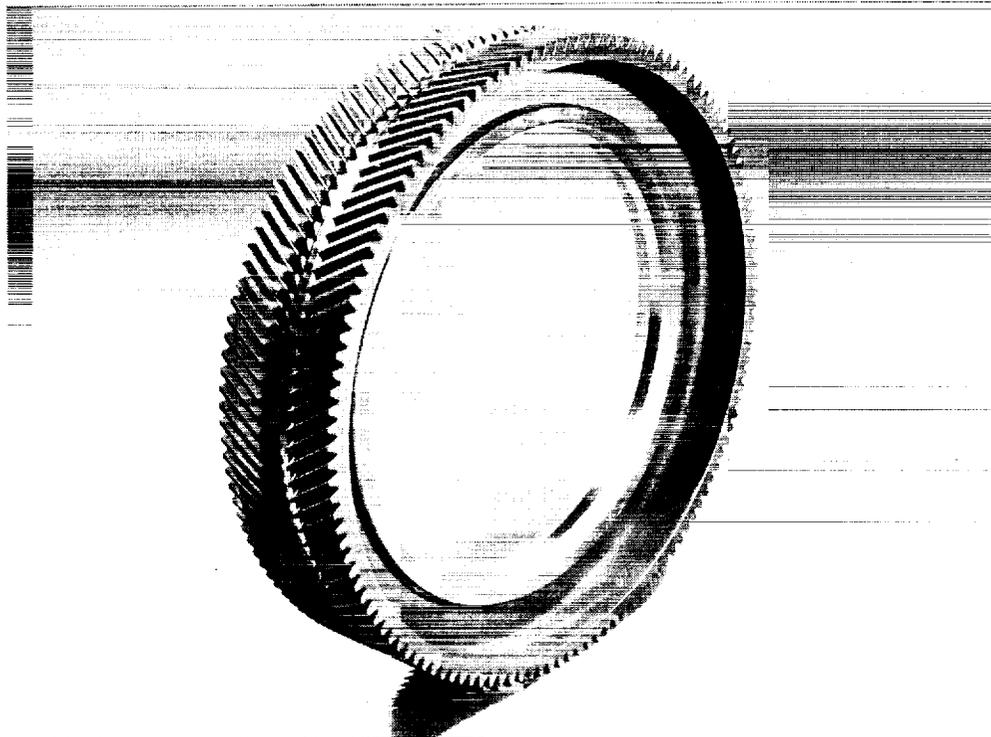
**Figure 88. Bearing Outer Race/Double Helical Gear Assembly**

The 1/2 size tapered roller bearing outer race/double helical gear assembly is shown in Figure 88. The helical gears, having a pitch diameter of 24 inches, were form ground using CBN wheels on the Phauter Kapp machine. The two halves of the gear are bolted together thereby permitting individual gear grinding and permitting a large grinding wheel diameter to be used.

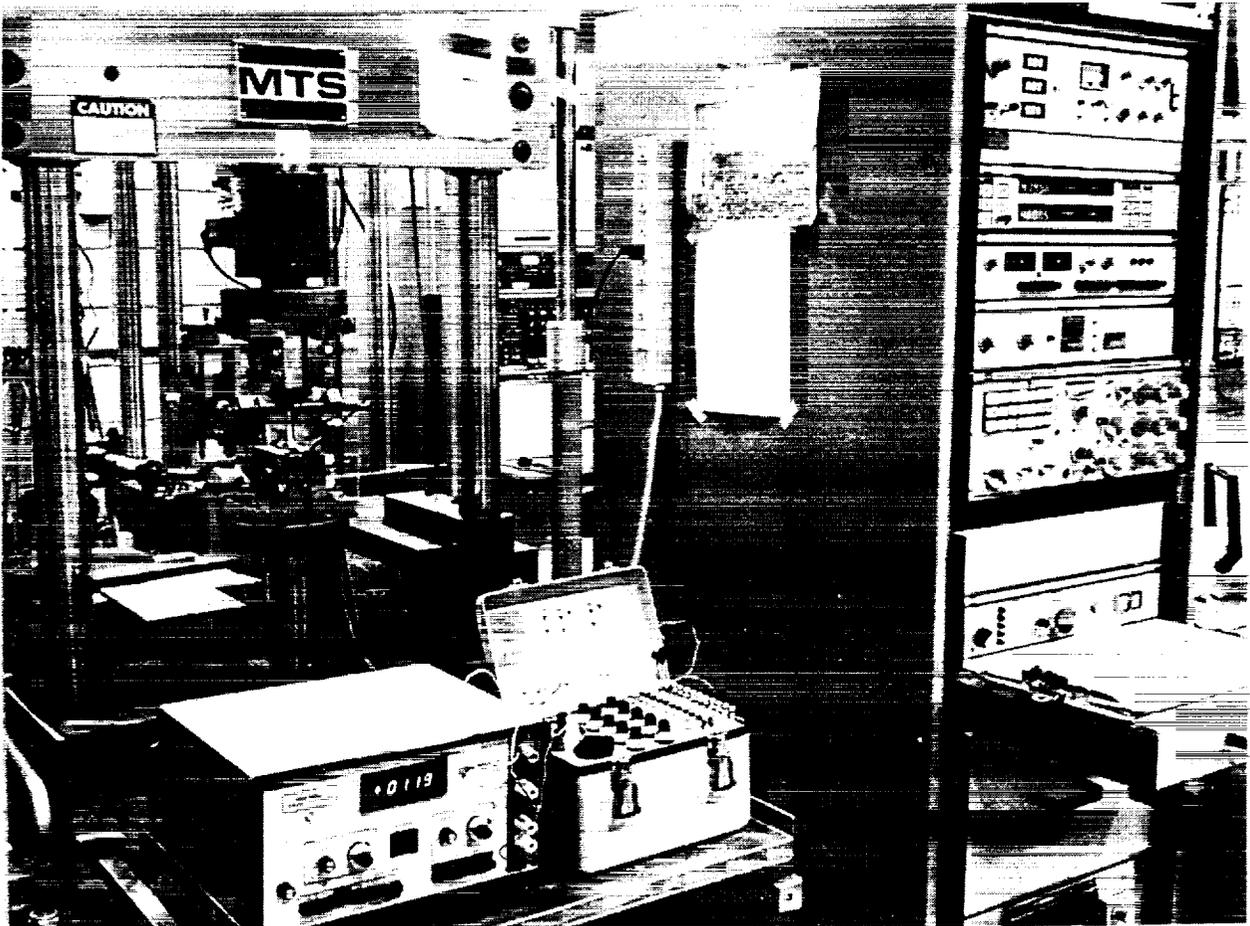
Figure 103. Fatigue Test Machine

Fretting fatigue testing was conducted on an MTS Series 810 servohydraulic unit with 20,000 pound capacity as shown in Figure 103. The fatigue test machine applied fatigue axial loads to the test coupon while a special fixture was used to preload the fretting contact pins in a fixed position at the center of the test coupon. The fretting pins were accurately located on each side of the test coupons by means of the special fixture. The pins were preloaded with belleville washers to maintain preload in the event there was any fretting wear. Figure 104 shows the fixture with belleville washers installed. The clamping bars that were used to preload the fretting pins are in three point bending and were calibrated with strain gages on the side of the bar to accurately ascertain the preload magnitude.

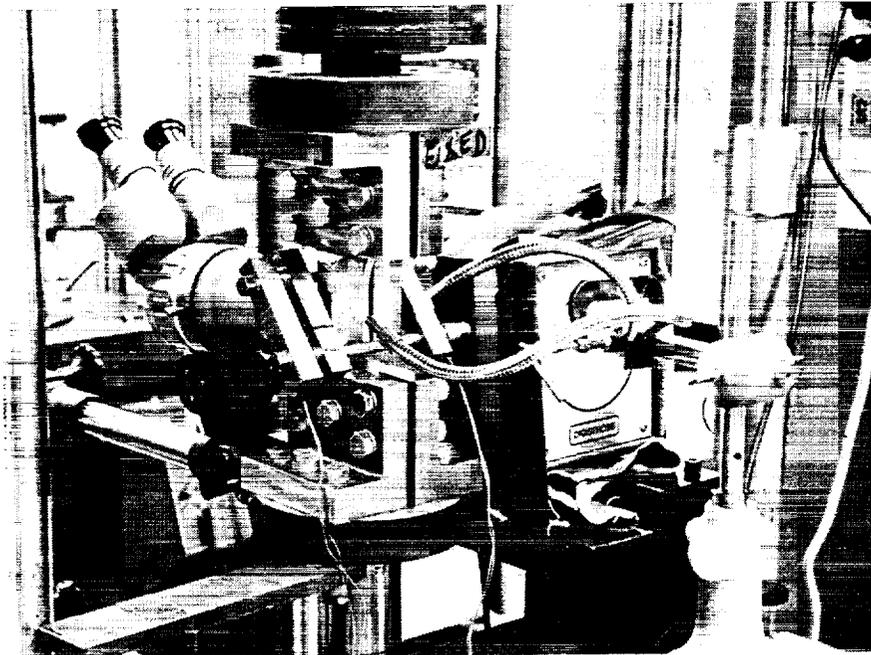
Figure 104. Slip Amplitude Measurement Apparatus

A technique was developed for viewing the pin/coupon contact interface for in-situ measurement of fretting slip amplitude. The technique involves attaching a strain gage to the coupon adjacent to the point of pin contact. Micro Measurements Catalog Number EA-06-031EC-350 strain gages were employed. These gages have an extremely fine, repeatable series of parallel lines within the grid pattern which are used as miniature rulers to measure slip amplitudes directly. For each pin to be observed, one gage was carefully trimmed across the grid lines and bonded to the test coupon adjacent to the anticipated contact area. Grid line orientation was transverse to the coupon fatigue loading direction. Using a standard stereo-microscope at 40x magnification and strobe lighting set to correspond to the fatigue loading frequency (30 to 31 Hertz), the fretting slip, if any, was observed in slow motion allowing direct measurement of the peak-to-peak amplitude. Resolution of this method is within approximately 20 microns under ideal conditions. Figure 104 shows the slip amplitude measurement apparatus.

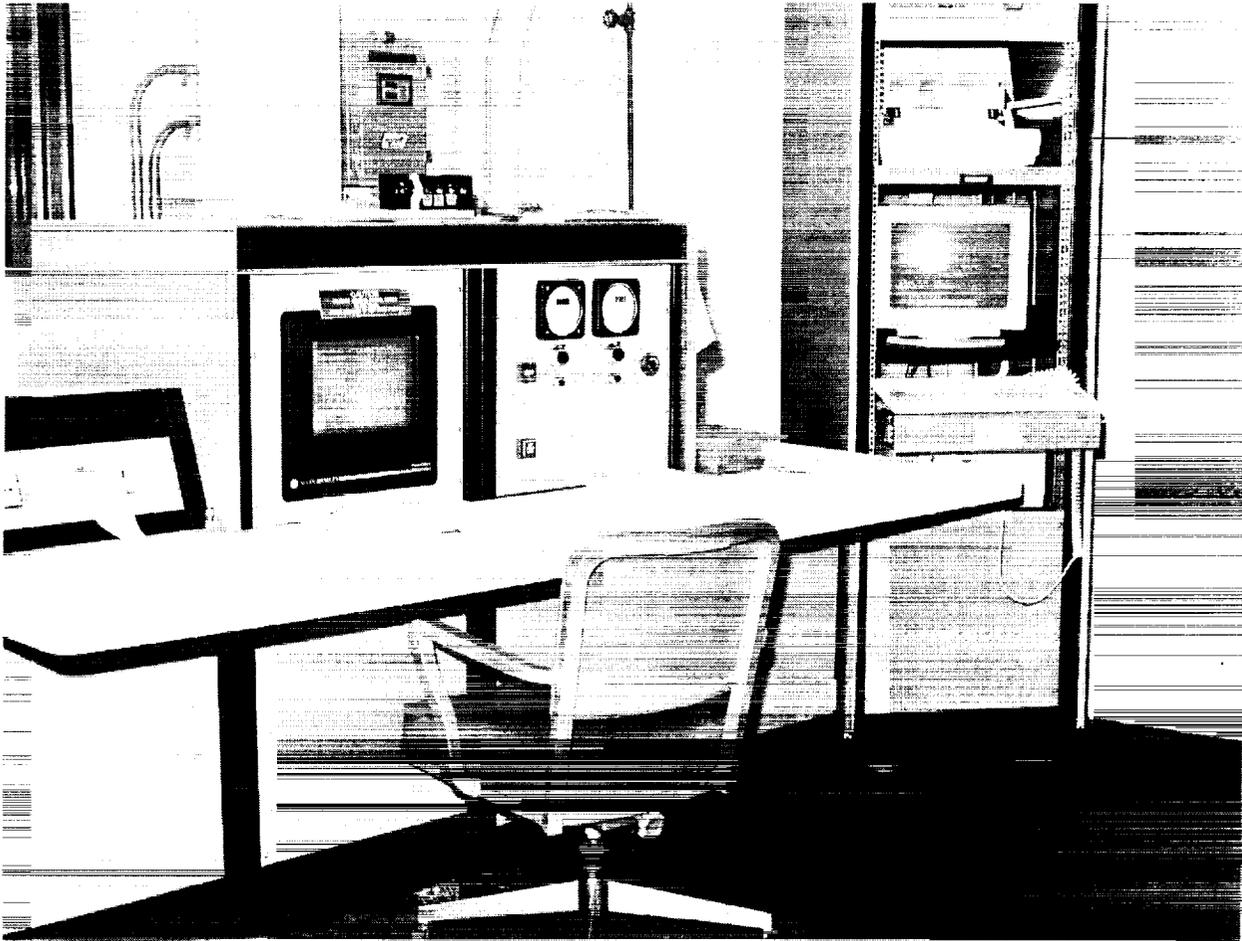
Figure 106. Operators Console

All testing for the 1/2 size gearbox was performed using the tail drive shaft and coupling facility shown schematically in Figure 105. This facility is configured as a regenerative loop powered by a 300 HP electric motor. Variable speeds between 1500 - 8000 rpm were available. A maximum torque equivalent to 2000 HP was also available between a range of 4000 - 8000 rpm. Controls were automated to include integral fault and test parameter monitoring. The operators console is shown in Figure 106.

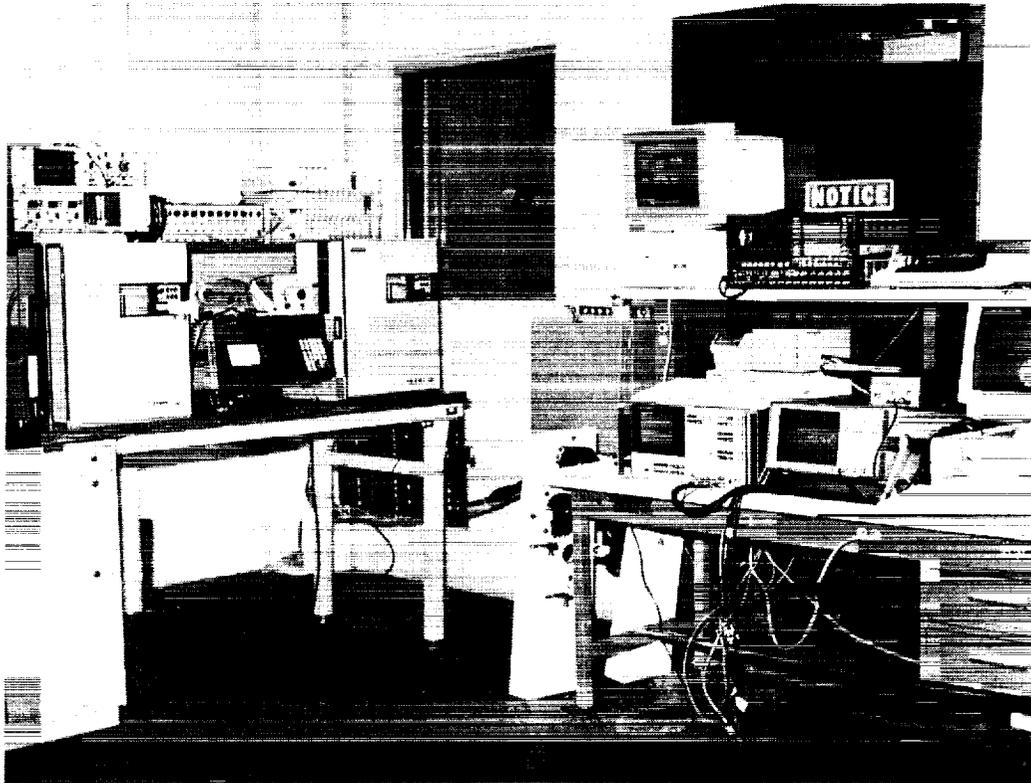
Figure 111. ART Instrumentation Console

The slip ring installation for the output double helical gear is shown in Figure 109 while the slip ring installation for the input pinion and the upper and lower spur gear/double helical pinion are shown in Figure 110. A view of the instrumentation console for the facility is shown in Figure 111. A photograph of the transmission error encoder installation is depicted in Figure 112.
