NASA  
Contractor Report 191079

# Sikorsky Aircraft Advanced Rotorcraft Transmission (ART) Program— Final Report

Jules G. Kish  
*United Technologies Corporation*  
*Stratford, Connecticut*

March 1993

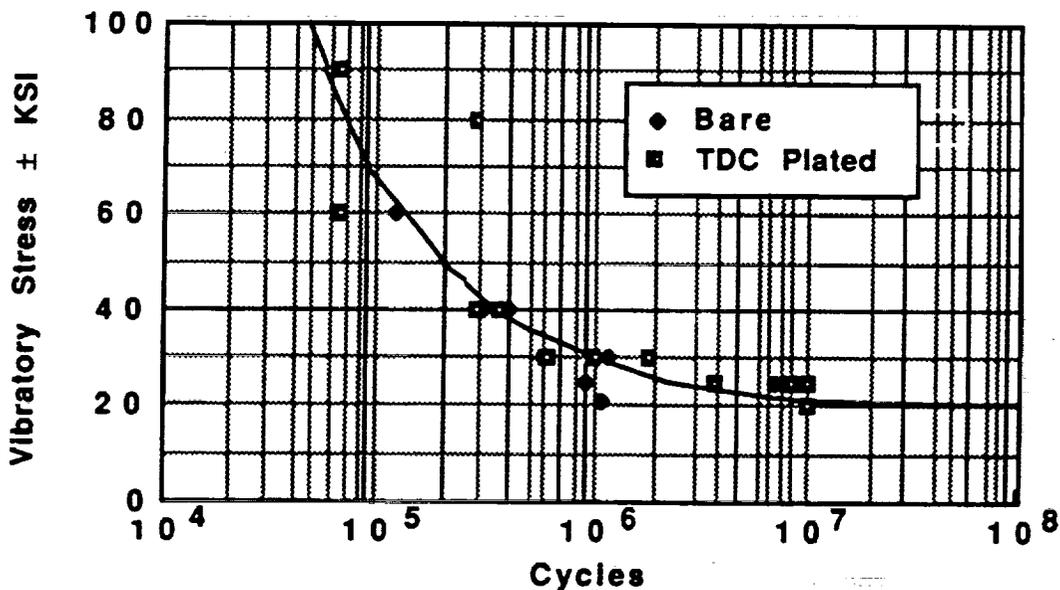
Figure 116. Fretting Fatigue S-N Curve for TDC Plated Pyrowear

All curves and curve shapes are derived using standard Sikorsky fatigue methodology for steel with fretting. The fretting fatigue data points at the 60 KSI level were not included in the mean curve calculations since they were below the 0.2 million minimum cycles recommended for application of standard curve shapes. Polished Coupon #1 test points were combined into an equivalent fracture point at the total number of cycles by finding an equivalent vibratory stress. The equivalent stress is calculated by finding the endurance limit for each test point individually using the standard curve shape for steel with fretting, finding the average, and then calculating the stress at the total combined number of cycles for the average curve.
