**NATIONAL ADVISORY COMMITTEE
FOR AERONAUTICS**

TECHNICAL NOTE

No. 1186

REVIEW OF AN INVESTIGATION OF CERAMIC COATINGS FOR
METALLIC TURBINE PARTS AND OTHER
HIGH-TEMPERATURE APPLICATIONS

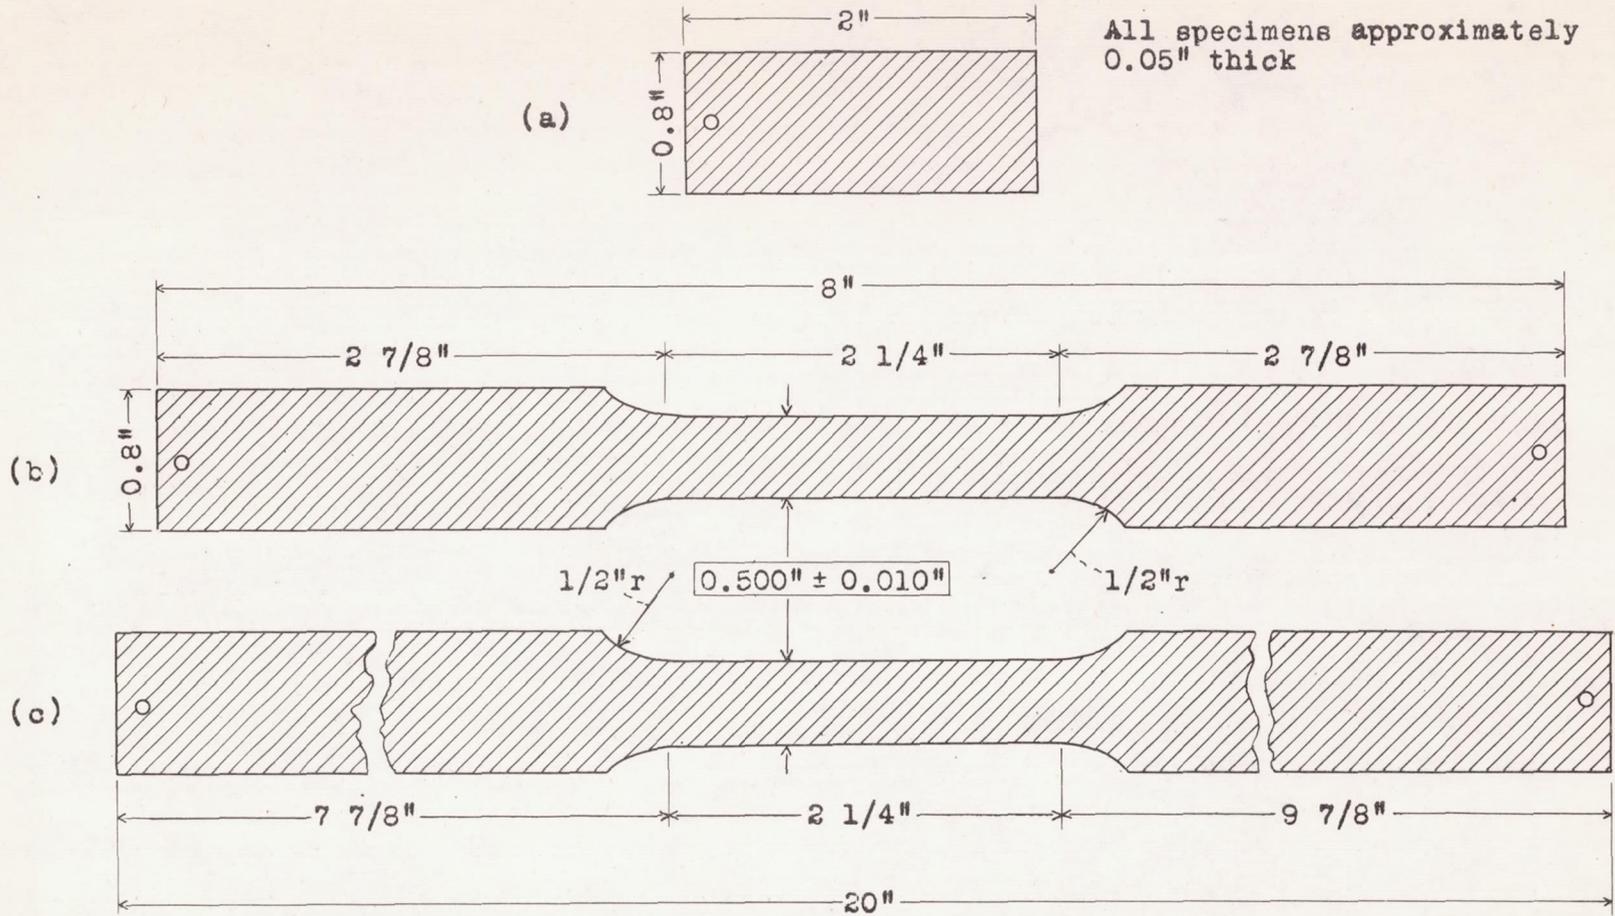
Figure 1.- Sketch of specimens used in the investigation of ceramic coatings.
 (a) Specimens used for heating without load.
 (b) Specimens for heating without load followed by tensile tests at room temperature.
 (c) Specimens for heating while under load. The 20-inch length provides for gripping outside the furnace.

Equipment for heating specimens in air without load.- The furnace used for long-time heating in air without load was electrically heated. A recorder-controller was used for obtaining constant temperatures within the range 1000° to 2200° F. The dimensions of the specimens subjected to this treatment were approximately 0.05 by 0.8 by 2 inches, as shown in figure 1(a).

Equipment for controlled-atmosphere tests.— Two resistance-type vitreous-silica-tube furnaces were used for controlled-atmosphere heating tests. The inside diameter of the fused silica tube was 2 inches and a platinum hanger was so arranged that eight tensile specimens 0.05 by 0.8 by 9.0 inches (see fig. 1(b)) could be suspended in parallel for test.

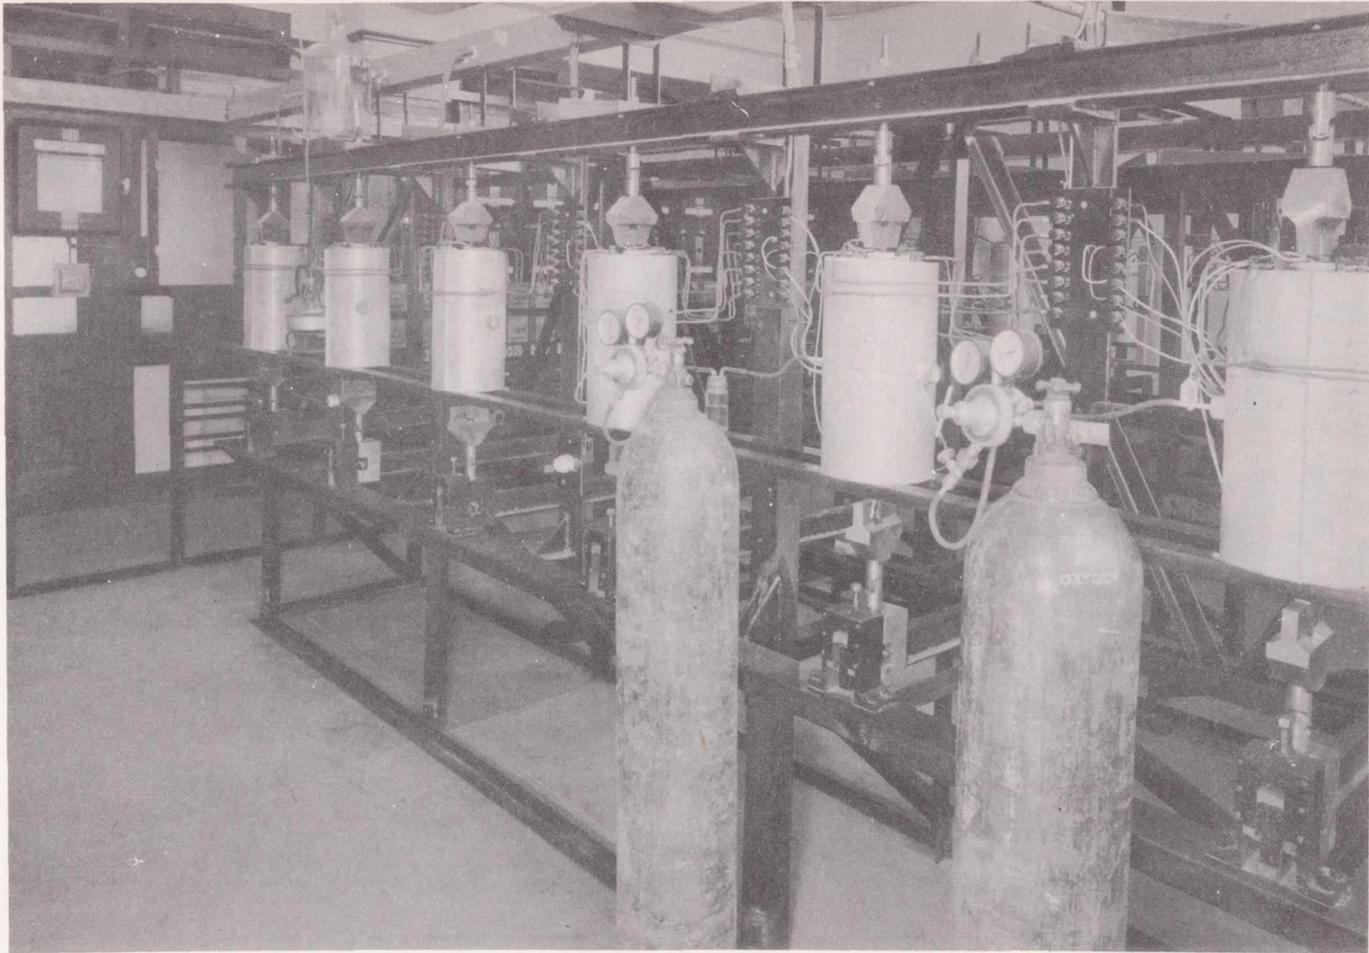
Figure 2.- Furnaces and lever systems for applying loads to 20-inch specimens. The pair at the left are operating with a steam atmosphere supplied by water dripping into a flask containing a filler of broken ceramic material and heated with an electric hot plate. The pair in the middle have an air atmosphere, and the pair at the right are operating with an oxygen atmosphere supplied from separate tanks provided with regulators.

Equipment for treating specimens at high-temperature under load.- Six resistance-type tube furnaces with individual temperature controllers were used. Temperature distribution over the gage length of the specimen was regulated by three variable transformers connected with separate sections of the furnace winding. Temperature measurements of the specimen were made by means of two thermocouples, one at the shoulder above the neck and one at the shoulder below. The two wires of each thermocouple were spot welded to opposite sides of the specimen. The temperature of each specimen as indicated by these thermocouples was held constant during the test to within $\pm 5^\circ$ F. The specimens were 20 inches long to permit gripping outside the furnaces (see fig. 1(c)). Figure 2 shows the furnaces and parts of the lever system for applying controlled loads to the specimens while heated.

Tensile tests at high temperatures were made with a Southwark-Tate-Emery testing machine, used in connection with a furnace wound and controlled similarly to those shown in figure 2.

It was thought that stress-rupture tests might bring out the effect of the coatings but, since the equipment shown in figure 2 was not suitable for such tests with most alloys, it was necessary to use an alloy which would fail with little elongation, and the 2520 alloy was selected. By reference to table III and figure 9 it can be seen that, in air, the

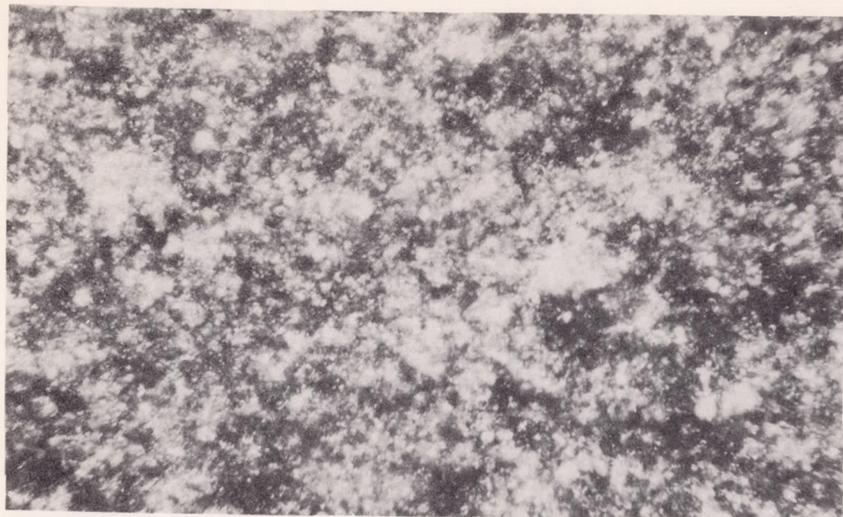
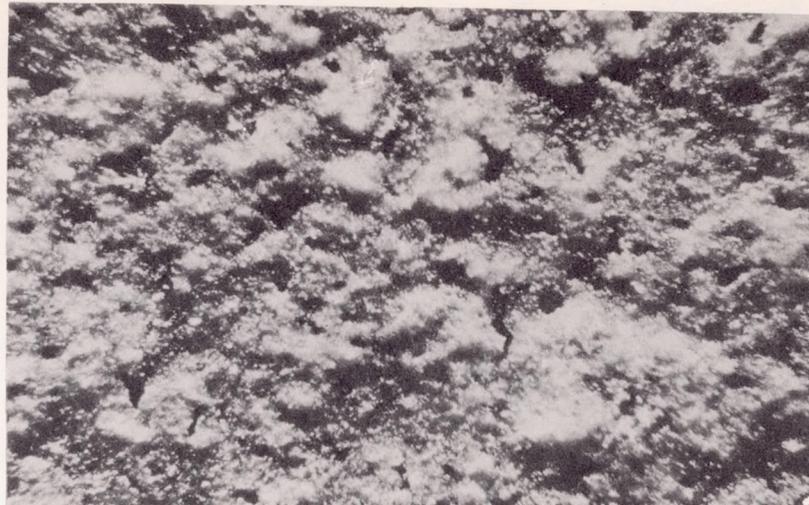
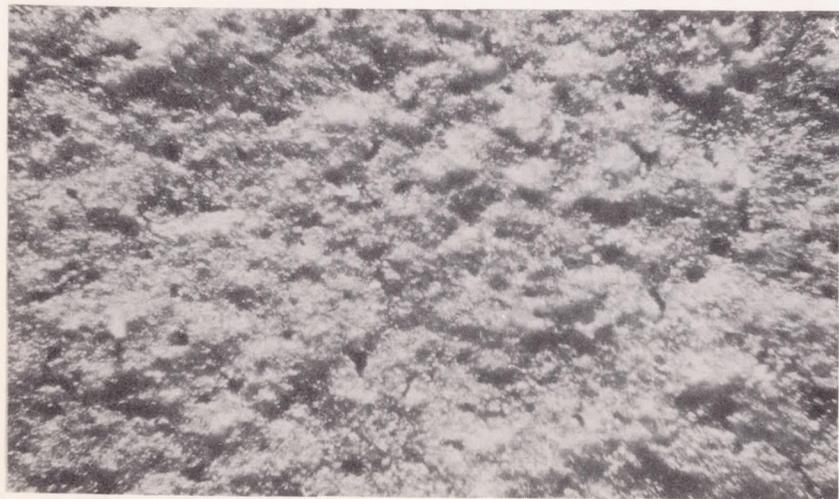
(a) Before heat treatment.

(b) After 200 hours at 1500°F in air.

(c) After 500 hours.

Figure 3.- Photomicrographs at 120X of coating L-6A on alloy S-590. Note the development of discontinuities that did not initially exist. This coating underwent considerable deterioration during the first 200 hours with very little change in the next 300 hours.

During the 500 hours of heating there were considerable changes in microstructure of some of the coatings, whereas others showed little or no change. Photomicrographs of the same field on selected specimens were taken at 120 magnification before treatment and after 200 and 500 hours, respectively. Figure 3 shows three such views of coating L-6A on alloy S-590, which is an example of a type of coating that showed considerable deterioration during heating in air at 1500° F. Figure 4 is a series of photomicrographs of coating A-309 applied on alloy S-816, which is an example of a coating type that showed no appreciable change in the microstructure during the 500-hour heating treatment in air. The only visible change that occurred with this specimen was a small decrease in glossiness from a slightly glossy original condition. Figure 5 represents coating L-5AC as applied on alloy S-816, and illustrates the unusual property of self-sealing of discontinuities that were initially present.

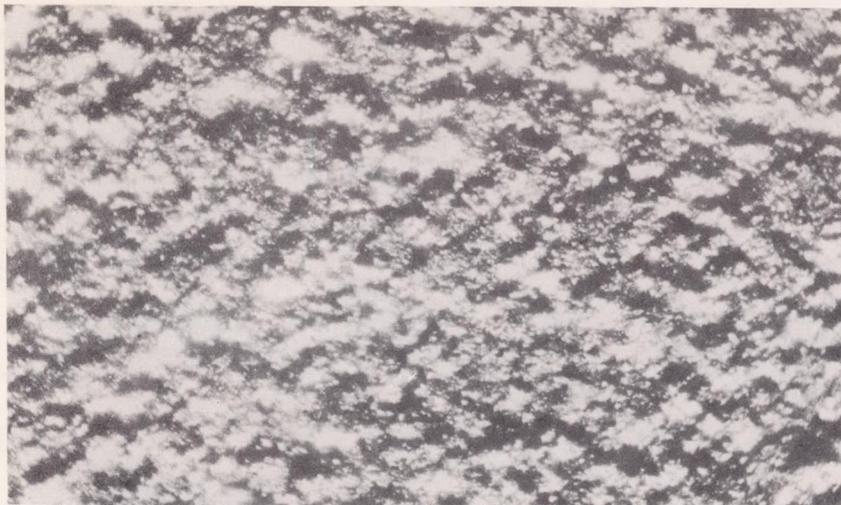
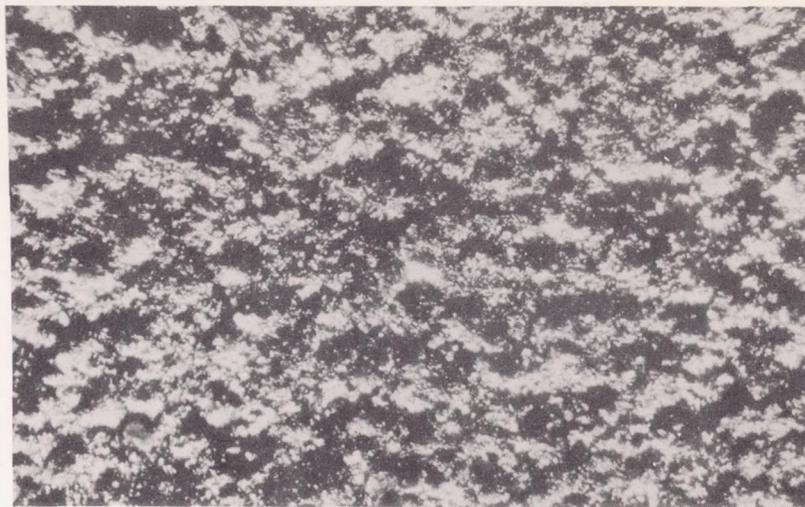
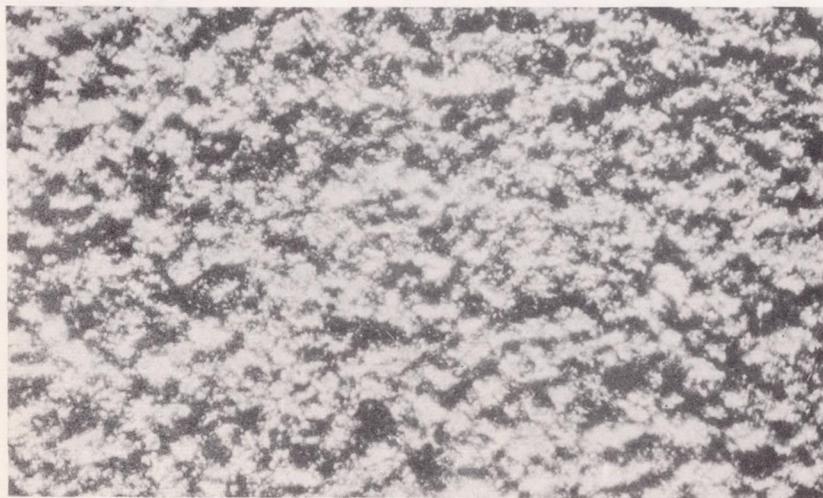
(a) Before starting treatment.

(b) After 200 hours.

(c) After 500 hours.

Figure 4.- Photomicrographs at 120X of coating A-309 on alloy S-816, showing little or no change during 500 hours of heating in air at 1500°F.

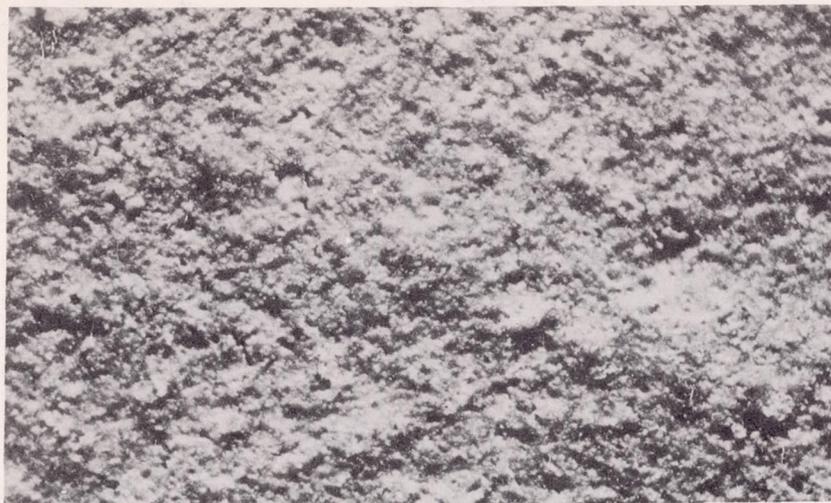
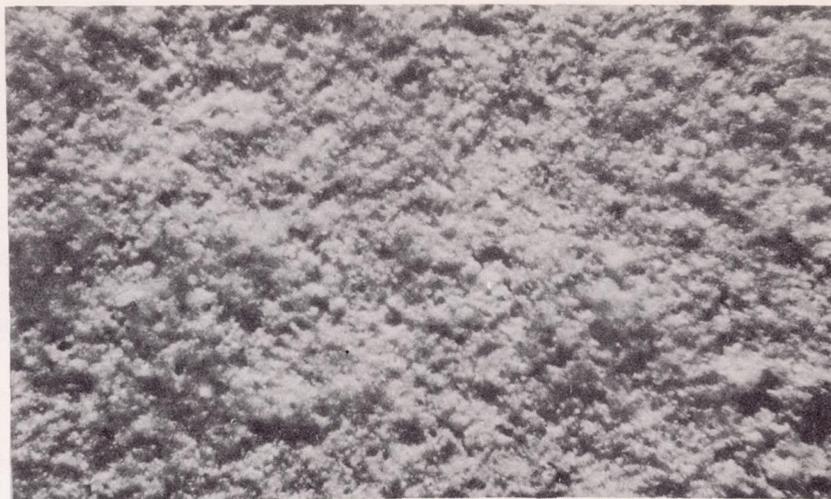
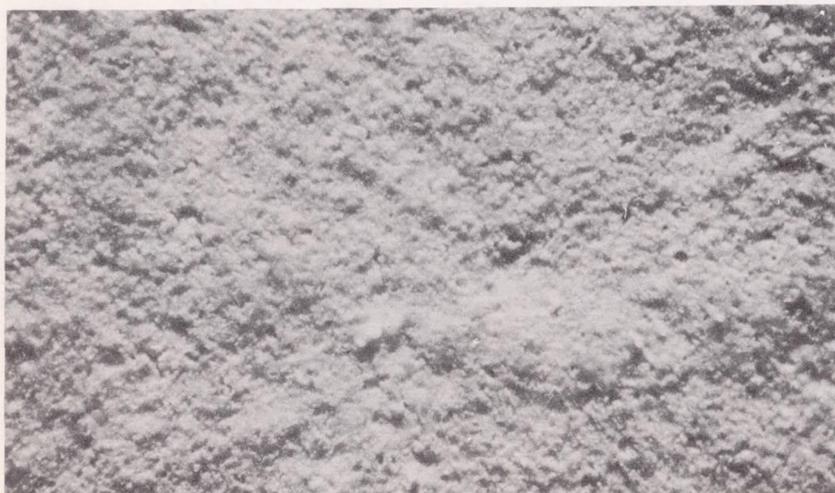
(a) Before heating.

(b) After 200 hours.

(c) After 500 hours.

Figure 5.- Photomicrographs at 120X of coating L-5AC on alloy S-816, showing a gradual healing of discontinuities initially present as the specimen was heated in air at 1500°F.

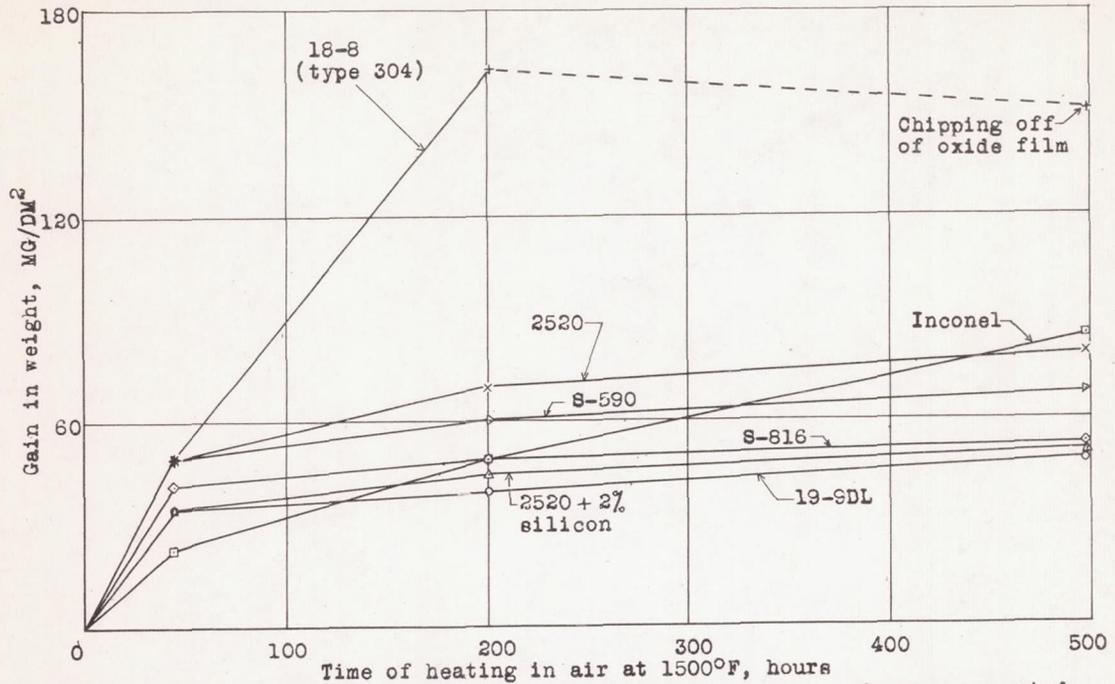
Figure 6.- Graph showing gain in weight, per unit surface area, of seven uncoated alloys due to oxidation during heating in air at 1500°F for 500 hours. The gain in weight of 18-8 alloy beyond 200 hours is not apparent because the oxide film flaked off in sufficient quantity to mask it.

For the specimens that did not undergo appreciable chipping and consequent vitiation of the significance of the results, a comparison of the gains in weight of uncoated specimens and the data obtained by weighing the coated specimens before and periodically during the heating tests indicated the degree of protection afforded the alloys against oxidation. Figure 6 shows change-in-weight curves of the seven uncoated alloys included in the latest test. Figure 7 shows similar curves of two specimens having coating L-4A fired to different stages of vitrification and an uncoated specimen of alloy S-590. The average thickness of the L-4A coatings was approximately 1 mil while that of the scale or oxide film on the bare alloy was about 0.3 mil. The advantage of the more vitrified (less porous) coating is demonstrated in this figure.

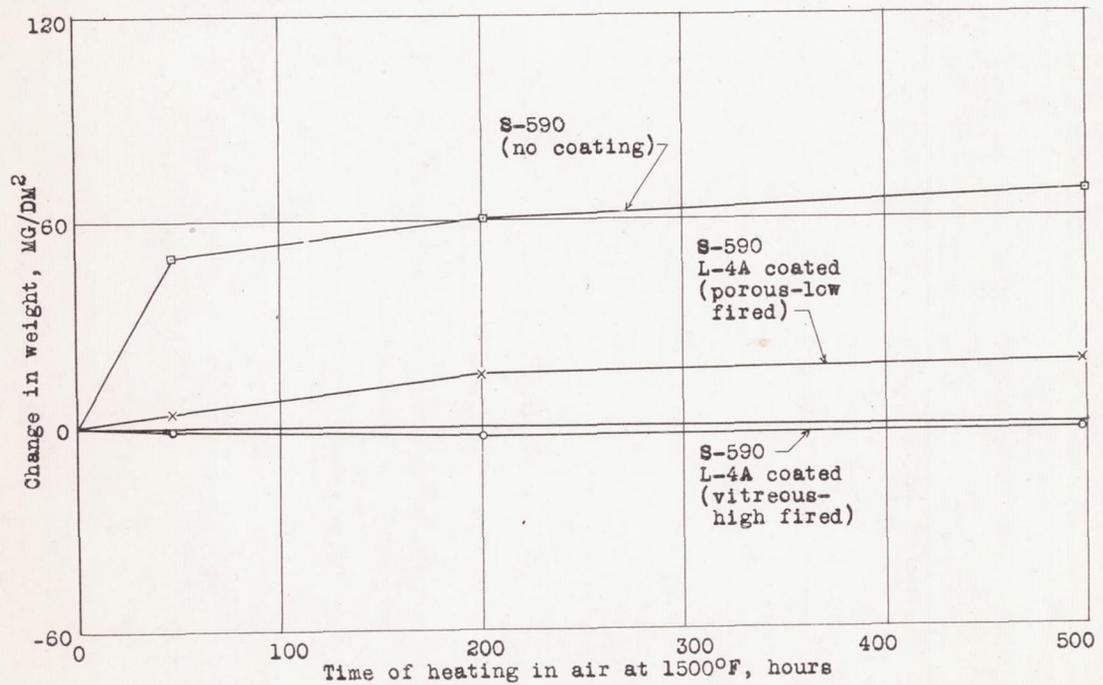
Figure 7.- Graph showing oxidation of uncoated alloy S-590 in terms of gain in weight, per unit surface area, when heated in air for 500 hours at 1500°F, and the inhibition of such oxidation when a porous coating or a sealed vitreous coating is applied.

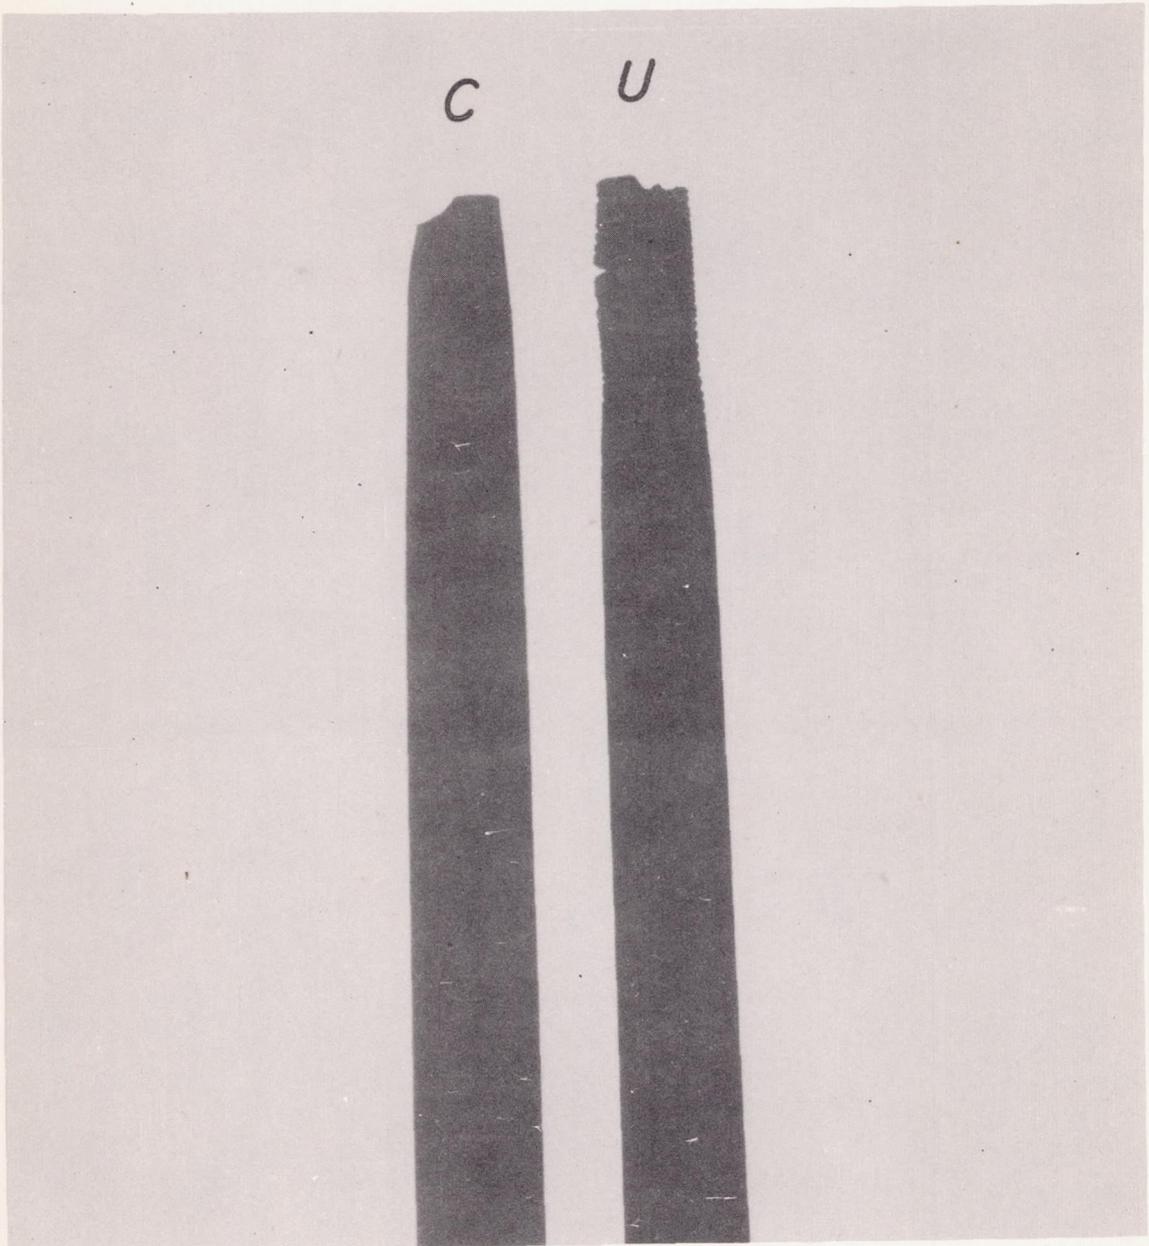
Figure 8.- Coated (C) and uncoated (U) specimens of 19-9 DL alloy held under tensile stress of 5,000 pounds per square inch at 1350°F for 172 hours and subsequently broken in a short-time tension test at 1350°F (table I, test 5). Note irregular silhouette (saw-tooth effect) of uncoated specimen resulting from widening of cracks produced in tension.

⁴ Arbitrary rating in which A indicates virtual absence of saw-tooth effect and D indicates severe saw-tooth effect (fig. 8).

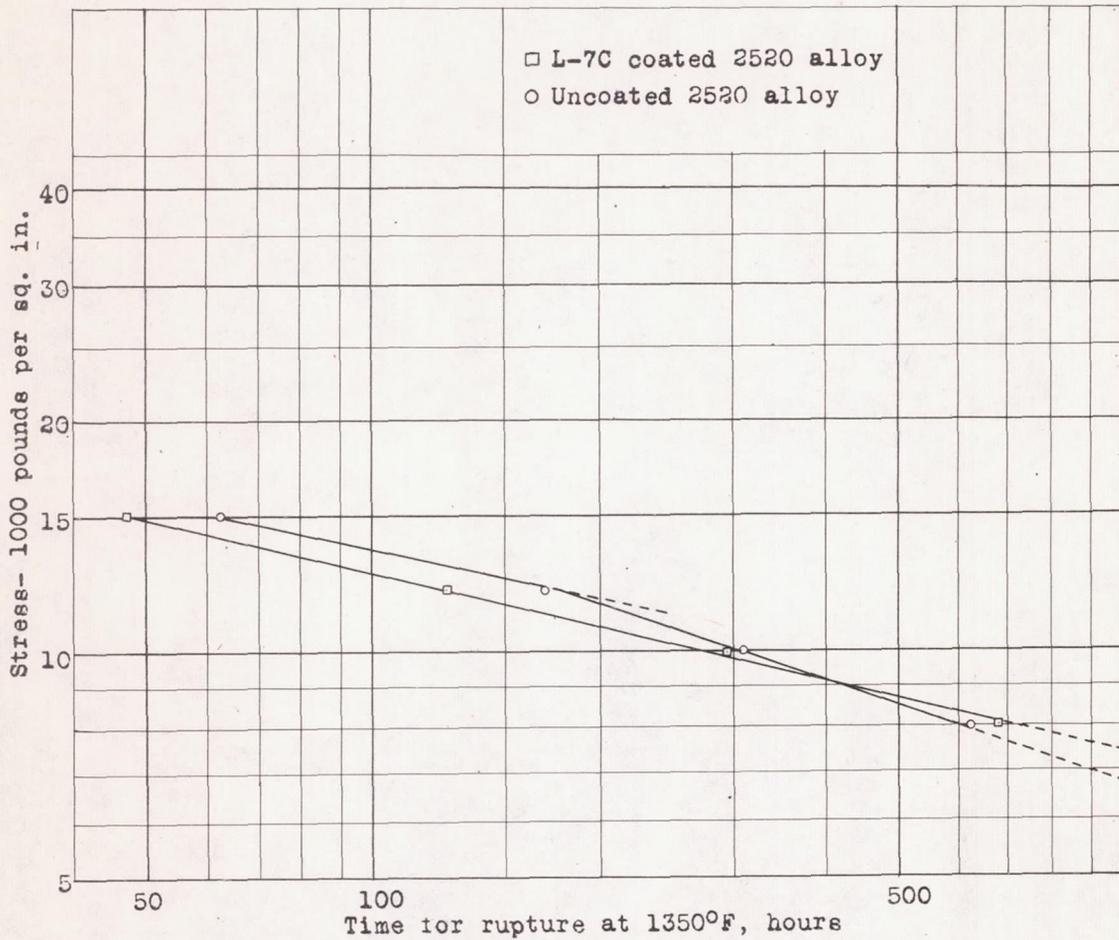
Figure 9.- Stress-rupture curves for uncoated and L-7C coated specimens of alloy 2520. Tests were made at 1350°F in air. Note that a "knee" occurs at 168 hours for the uncoated metal, but had not occurred for the coated specimens up to 672 hours.

coated specimens broke somewhat sooner at the high loads, but for the stress range within which the alloy might be used, this relation was reversed. A "knee" in the stress-rupture curve for the uncoated metal occurred at 168 hours, while for the coated specimens none had occurred up to 672 hours. The values for the L-6A coatings and the uncoated companion specimens are not comparable with those having coating L-7C as the firing temperatures for applying the coatings were different.

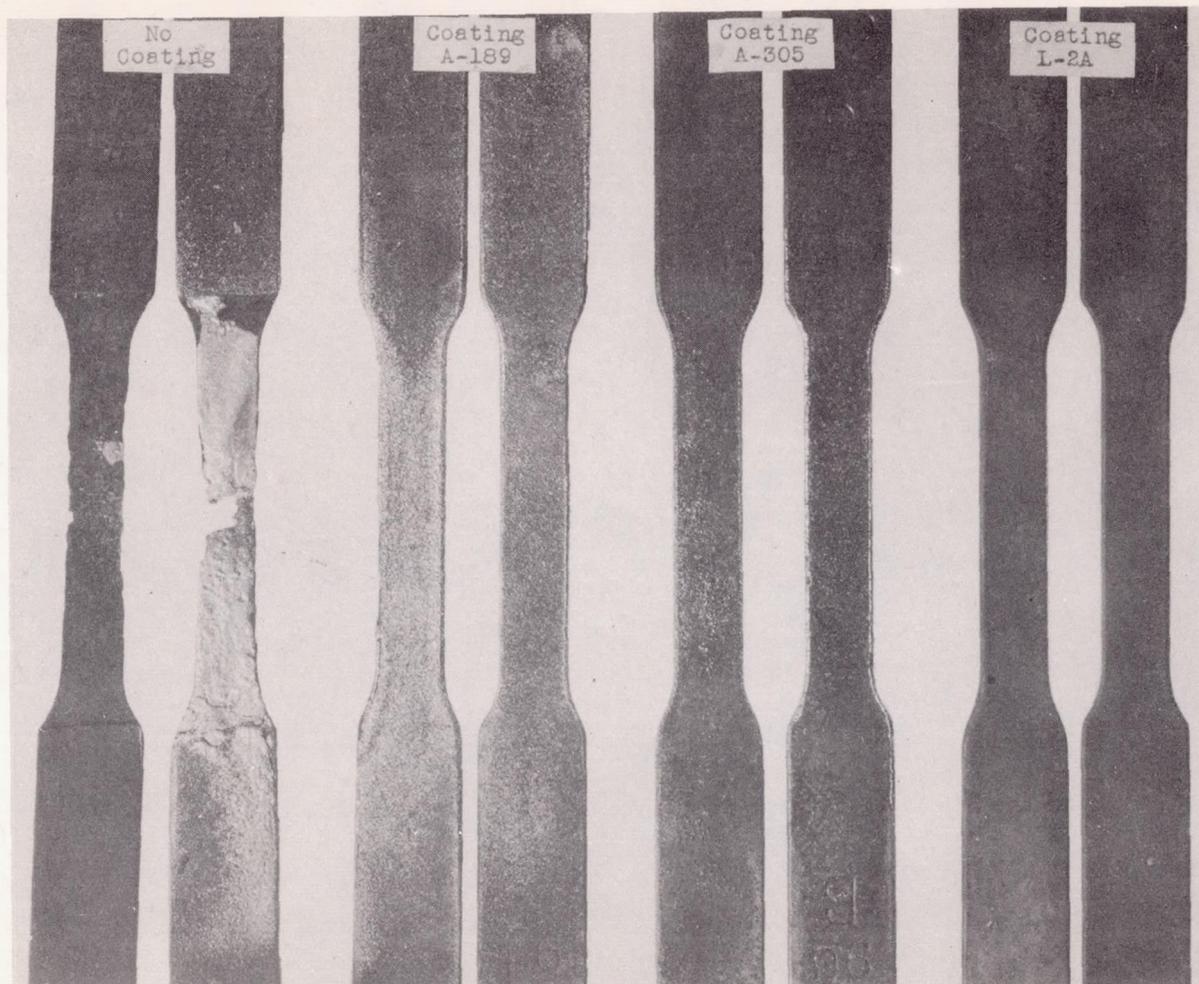
Figure 10.- Specimens of alloy S-590, coated and uncoated, which have been treated in an atmosphere of H_2S for 189 hours at $1350^{\circ}F$. The uncoated specimens at the left were almost completely corroded. The other three pairs of specimens have three different coatings as indicated, single coat at the left and double coat at the right in each pair. Attack through the coatings took the form of tubercules, which are apparent as light specks in the photograph. Note the decreasing number of such tubercules, indicating improved protective action of the coatings, from left to right.

Figure 10 shows the specimens of alloy S-590, coated and uncoated, that were treated in an atmosphere of H_2S for 189 hours at $1350^\circ F$. At the left are the uncoated specimens which were almost corroded through; one of them broke of its own weight during the treatment. The coated specimens show increasing degrees of protection from left to right.

The attack through coatings A-189 and A-305 took the form of tubercles, consisting probably of sulfides of the alloying elements, and these are apparent in figure 10 as white specks. Very few of them, if any, are visible on coating L-2A. The specimens with coating A-305 shown in figure 11 offer a favorable opportunity for a study of the mechanism of the attack. The locations of the tubercles on these specimens correspond to the locations of discontinuities in the coating, which were visible under the microscope before the H_2S treatment and which appeared to result from gas evolution during firing of the coating. Figure 11(a) shows the appearance of coating A-305 at a magnification of 30X before the tubercles had begun to form; 11(b) shows the early stages of tubercle formation and 11(c) a more advanced stage. With continued treatment, growth of the nodules continues. The selective attack on the metal is illustrated in figures 12(a) and 12(b), which are photographs taken at 30X after the coating was removed by sandblasting. Figure 12(a) corresponds to 11(a), and 12(b) to 11(c). Figure 12(b) shows cavities resulting from selective attack where discontinuities occurred in the coating. Figure 12(c), which is a photomicrograph of coating L-2A as shown in figure 10, illustrates the appearance of a coating that gave successful protection of the alloy against the attack by H_2S at $1350^\circ F$. Figure 12(c) should be contrasted with figure 11(c).

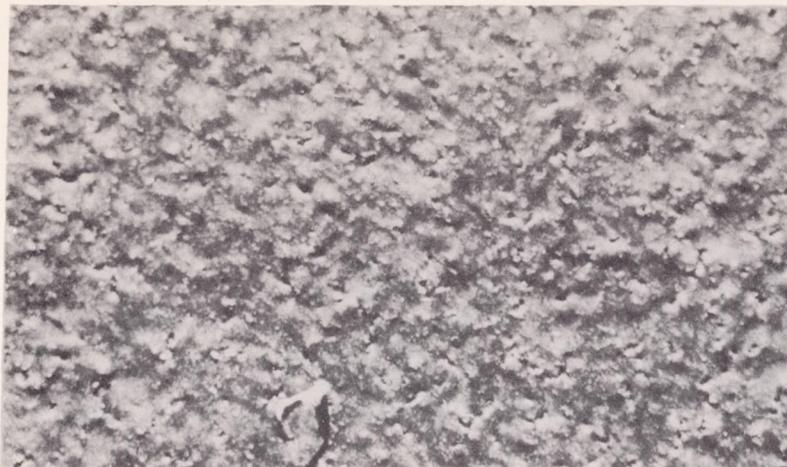
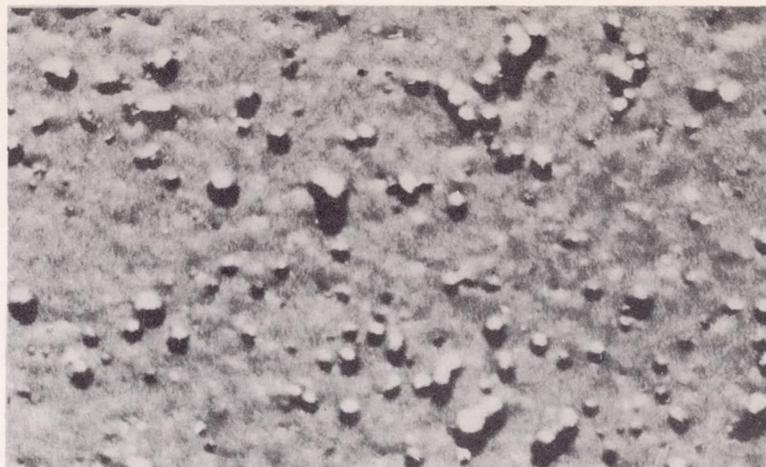
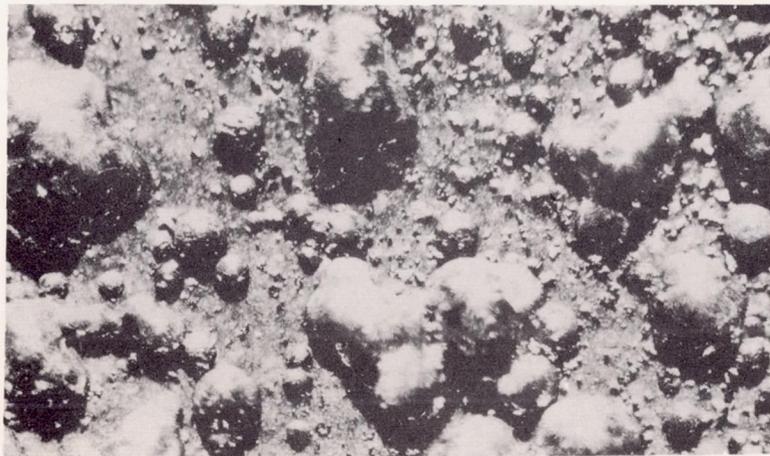
(a) Condition of coating before tubercules had begun to form. Note discontinuities in the coating (probably caused largely by gas evolution from the metal during the firing process).

(b) Early stage of tubercule formation.

(c) Advanced stage of tubercule formation.

Figure 11.- Photomicrographs at 30X, showing development of tubercules. Areas shown are from specimen with coating A-305 (see fig. 10), which was treated at 1350°F in H₂S for 189 hours. Locations of the tubercules are controlled by the locations of the original discontinuities.

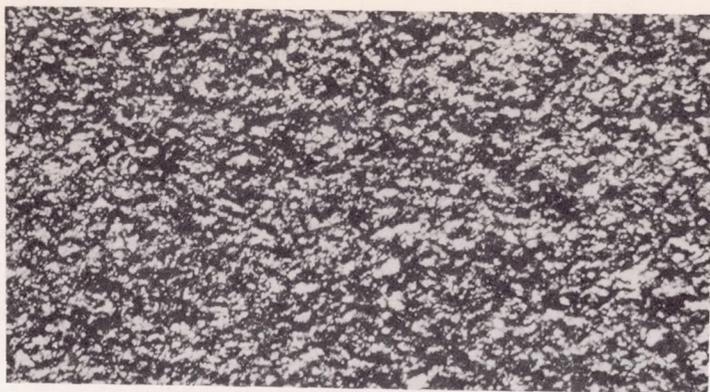
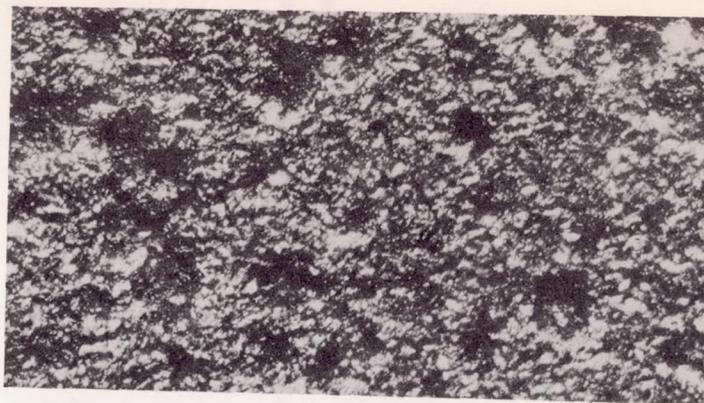
(a) No tubercles yet formed; corresponds to figure 11a.

(b) Cavities in the alloy beneath the tubercles caused by attack of the H_2S atmosphere at $1350^{\circ}F$; corresponds to figure 11c.

(c) 30X magnified view of coating L-2A (see fig. 10) which withstood treatment with little or no formation of tubercles. This photomicrograph should be contrasted with figure 11c, which is a magnified view of coating A-305 (see fig. 10) after formation of tubercles.

Figure 12.- Photomicrographs at 30X, showing appearance of specimens shown in figure 11 after removal of coating by sand-blasting.
