TECHNICAL NOTE

No. 1573

FLIGHT MEASUREMENTS OF THE FLYING QUALITIES OF  
FIVE LIGHT AIRPLANES

By Paul A. Hunter

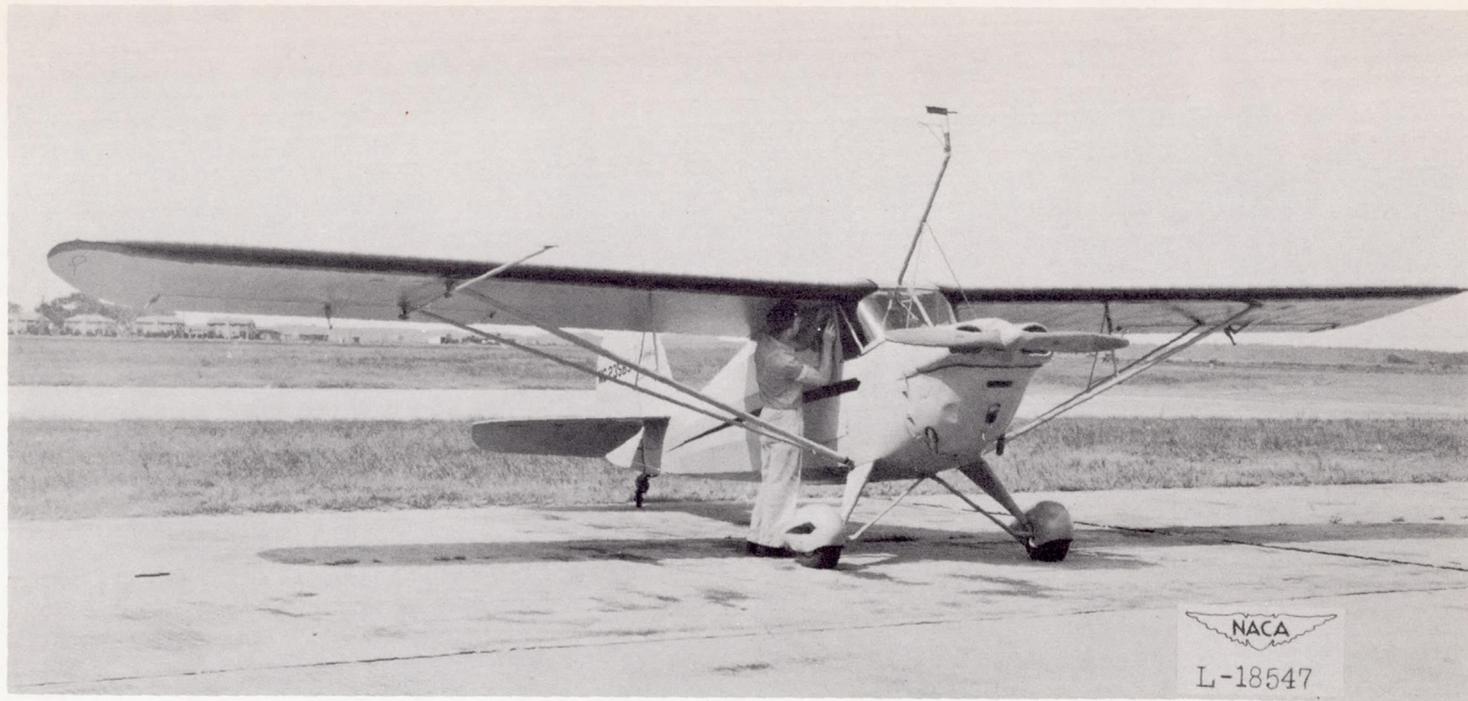
(a) Airplane 1.

Figure 1.- Three-quarter front views of airplanes tested.

Descriptive characteristics of the five light airplanes are given in table I. Photographs of the five light airplanes are shown as figure 1 and three-view drawings are shown in figure 2. All five airplanes were two-place or three-place cabin land monoplanes and, except for airplane 2, all had fixed landing gears. Airplane 4 was the only one that had wing flaps and/or slots. The control-surface gaps were unsealed, except in the case of the rudder and elevator of airplane 2. The longitudinal trimming device consisted of an elevator trim tab for airplanes 1, 2, and 4; an adjustable stabilizer for airplane 3; and an independent airfoil mounted below the horizontal tail for airplane 5.

The airspeed recorder was connected to a swiveling pitot-static head set a distance of 1 wing chord ahead of the leading edge of the wing at about the middle of the semispan. Both the airspeed recorder and the airspeed indicator were calibrated by means of a trailing airspeed head for airplanes 1 and 2, and the corrections derived for airplane 1 were assumed to apply to airplanes 3, 4, and 5 because of their similar configurations. The swiveling pitot-static head may be seen on the right wing in figures 1(a), 1(c), and 1(e) and on the left wing in figures 1(b) and 1(d).

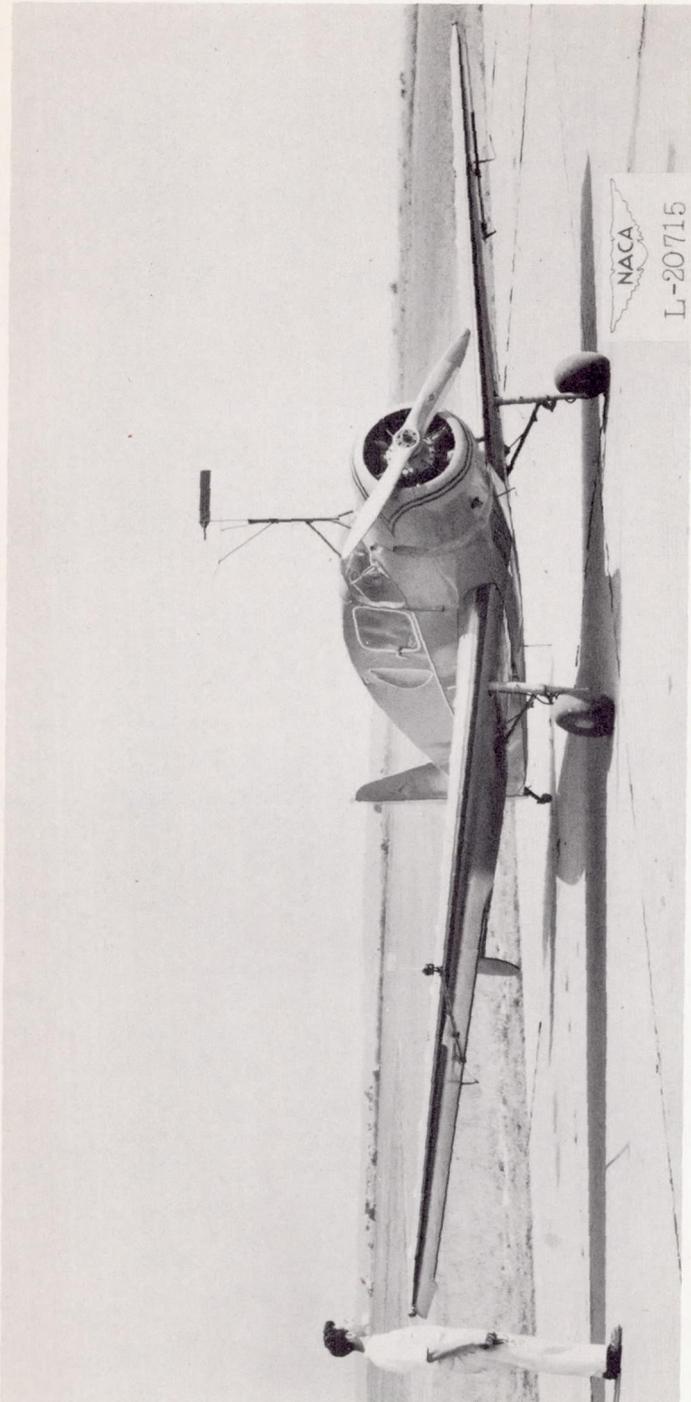
(b) Airplane 2.

Figure 1.- Continued.

In addition to the instrumentation previously described, airplane 2 was equipped with an indicating accelerometer and a sideslip-angle recorder. Airplane 4 carried a sideslip-angle recorder and a recording inclinometer as well as the standard instrumentation. The sideslip-angle recorder vanes may be seen mounted ahead of the right wing in figures 1(b) and 1(d).

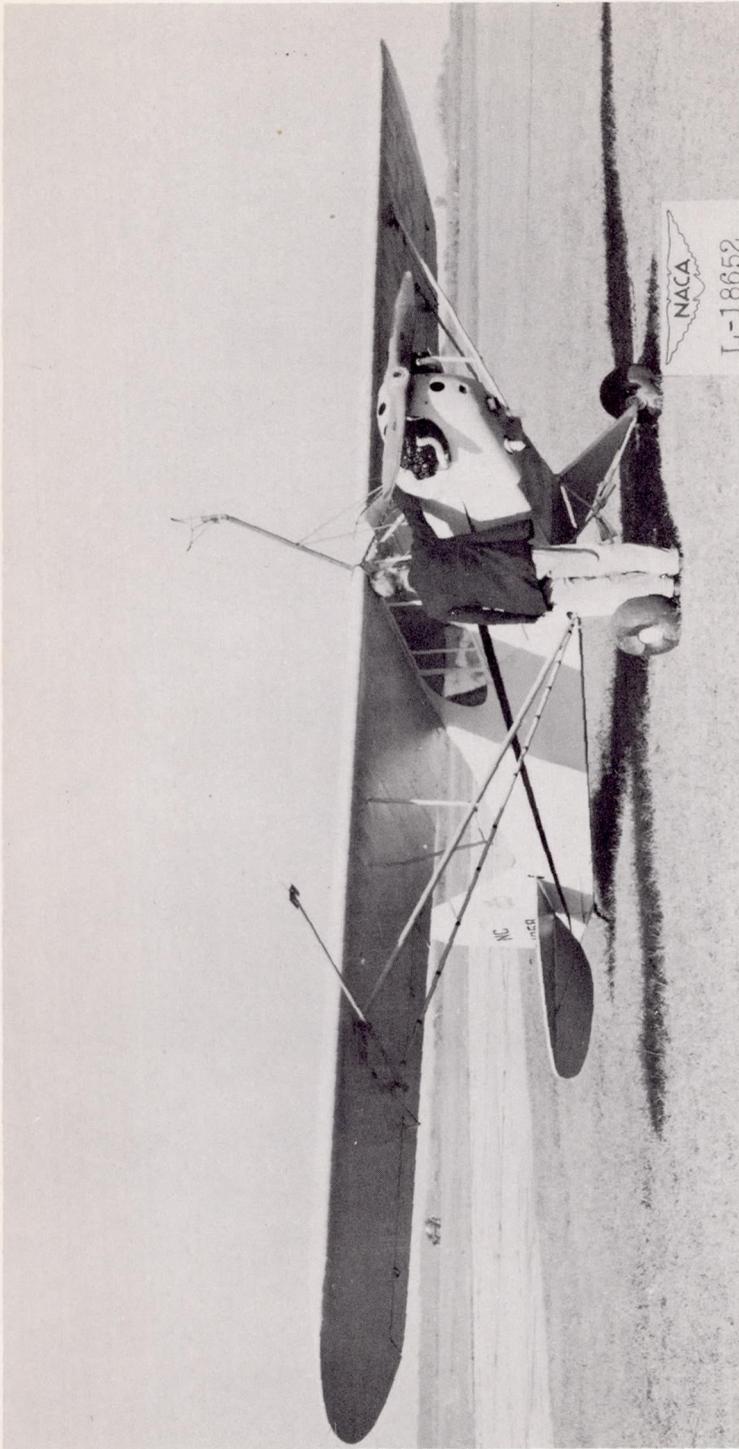
(c) Airplane 3.

Figure 1.- Continued.

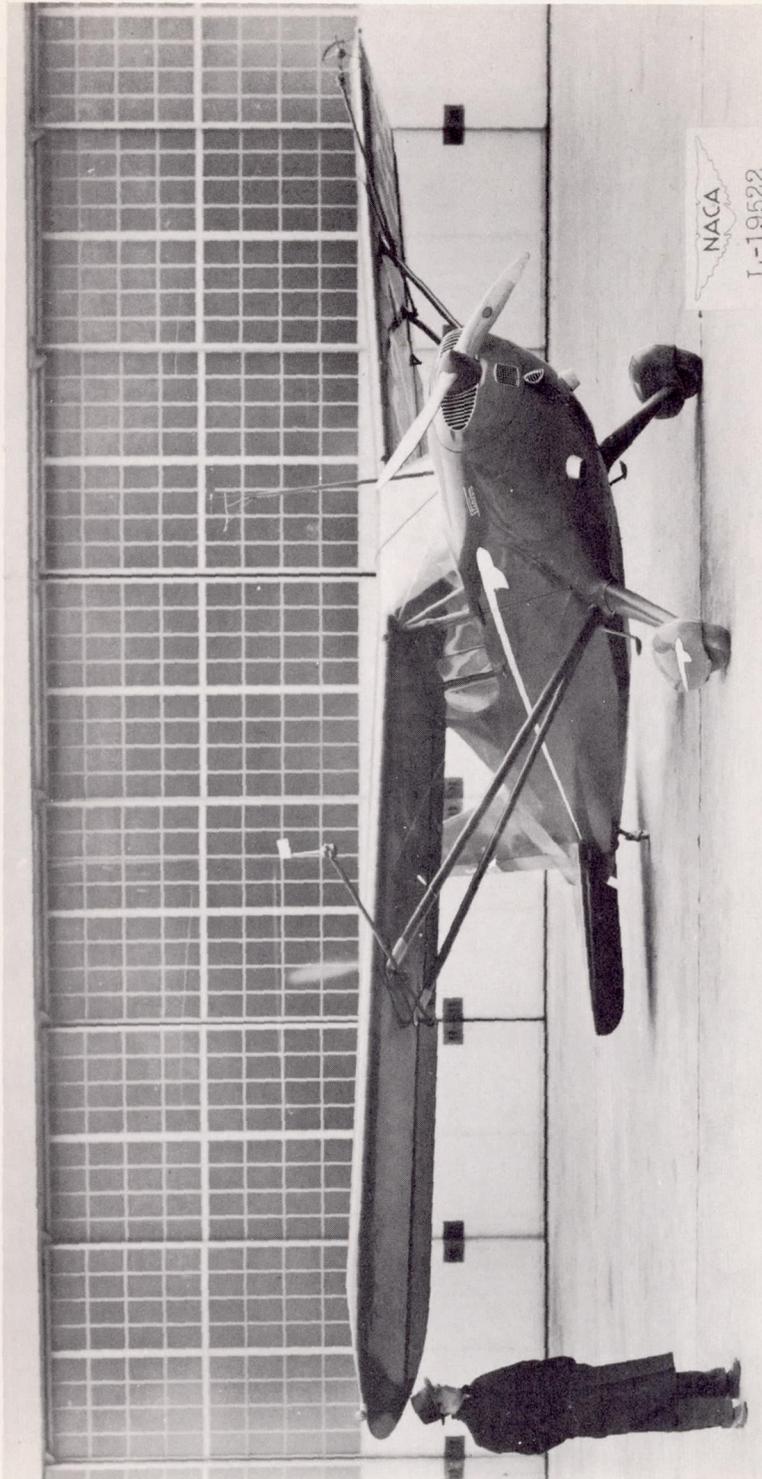
(d) Airplane 4.

Figure 1.- Continued.
