TECHNICAL NOTE 3269

ADDITIONAL STATIC AND FATIGUE TESTS OF HIGH-STRENGTH
ALUMINUM-ALLOY BOLTED JOINTS

By E. C. Hartmann, Marshall Holt, and I. D. Eaton

Aluminum Company of America

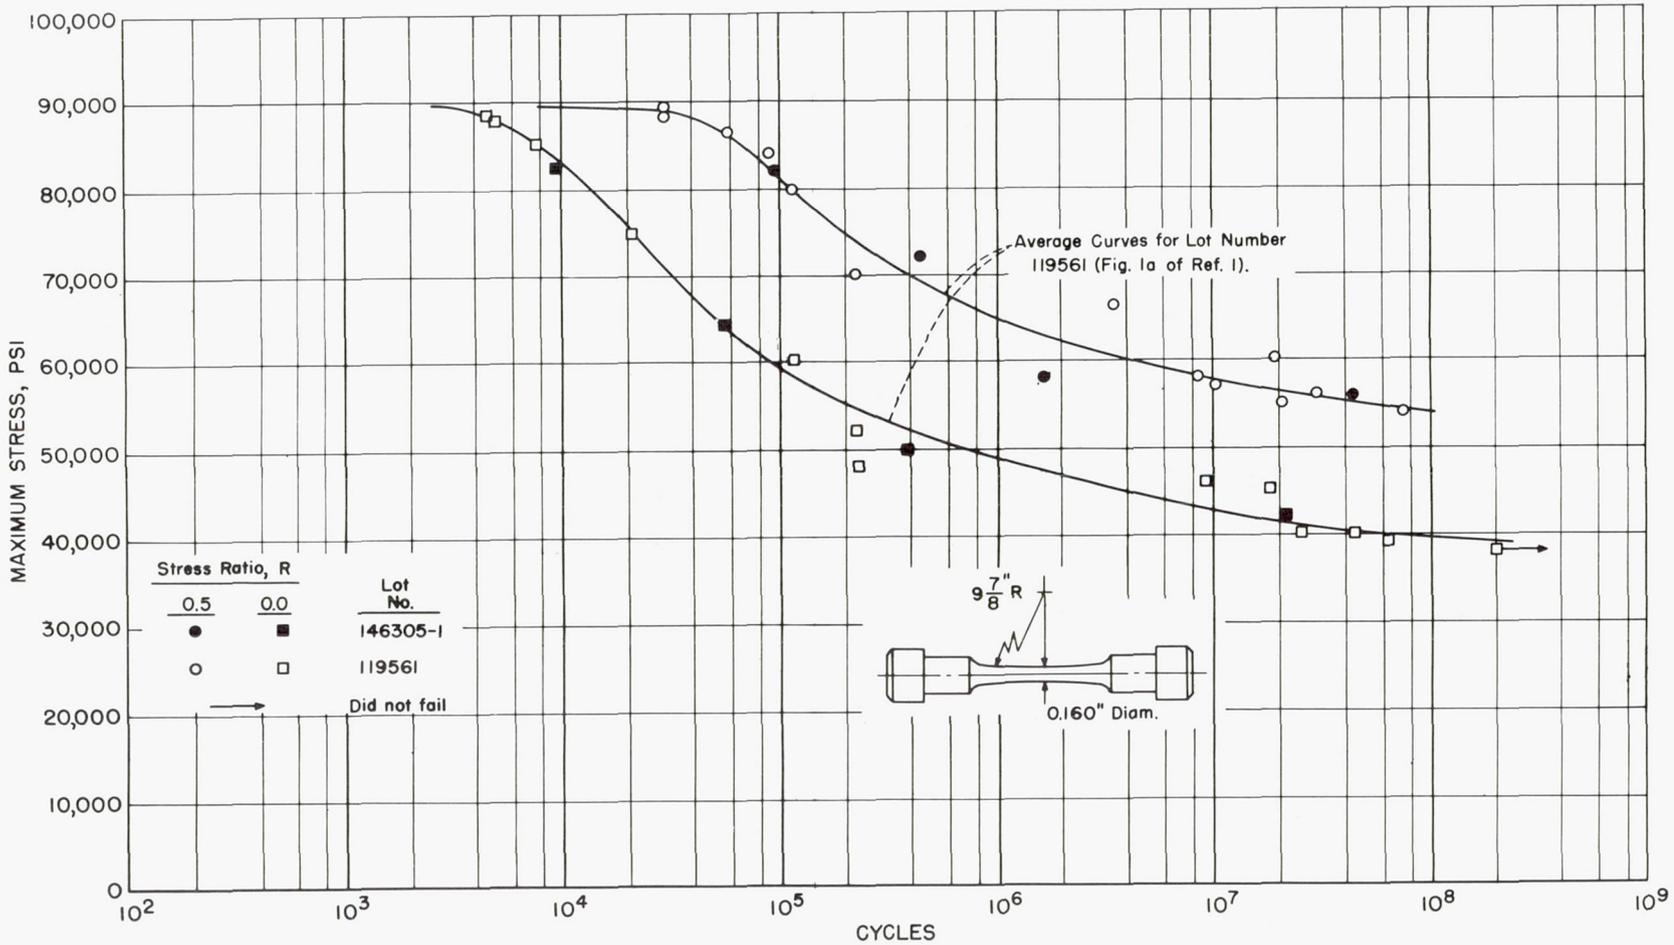
Figure 1.- Direct tension-compression fatigue data for 75S-T6 extruded bar
 (1 1/4 by 4 inches).

Direct-stress fatigue tests were made on polished round specimens as described in reference 1 to determine the degree of agreement of basic fatigue strengths for the old and new lots of 75S-T6 and 24S-T4 aluminum alloys. The fatigue test results for the two lots of each alloy are plotted in figures 1 and 2 where it is seen that the direct-stress fatigue strengths for the two lots of 75S-T6 compare very well and that the fatigue strengths of the new lot of 24S-T4 are slightly higher than the results obtained on the original lot, but such small differences are not considered significant in light of the data in reference 3.

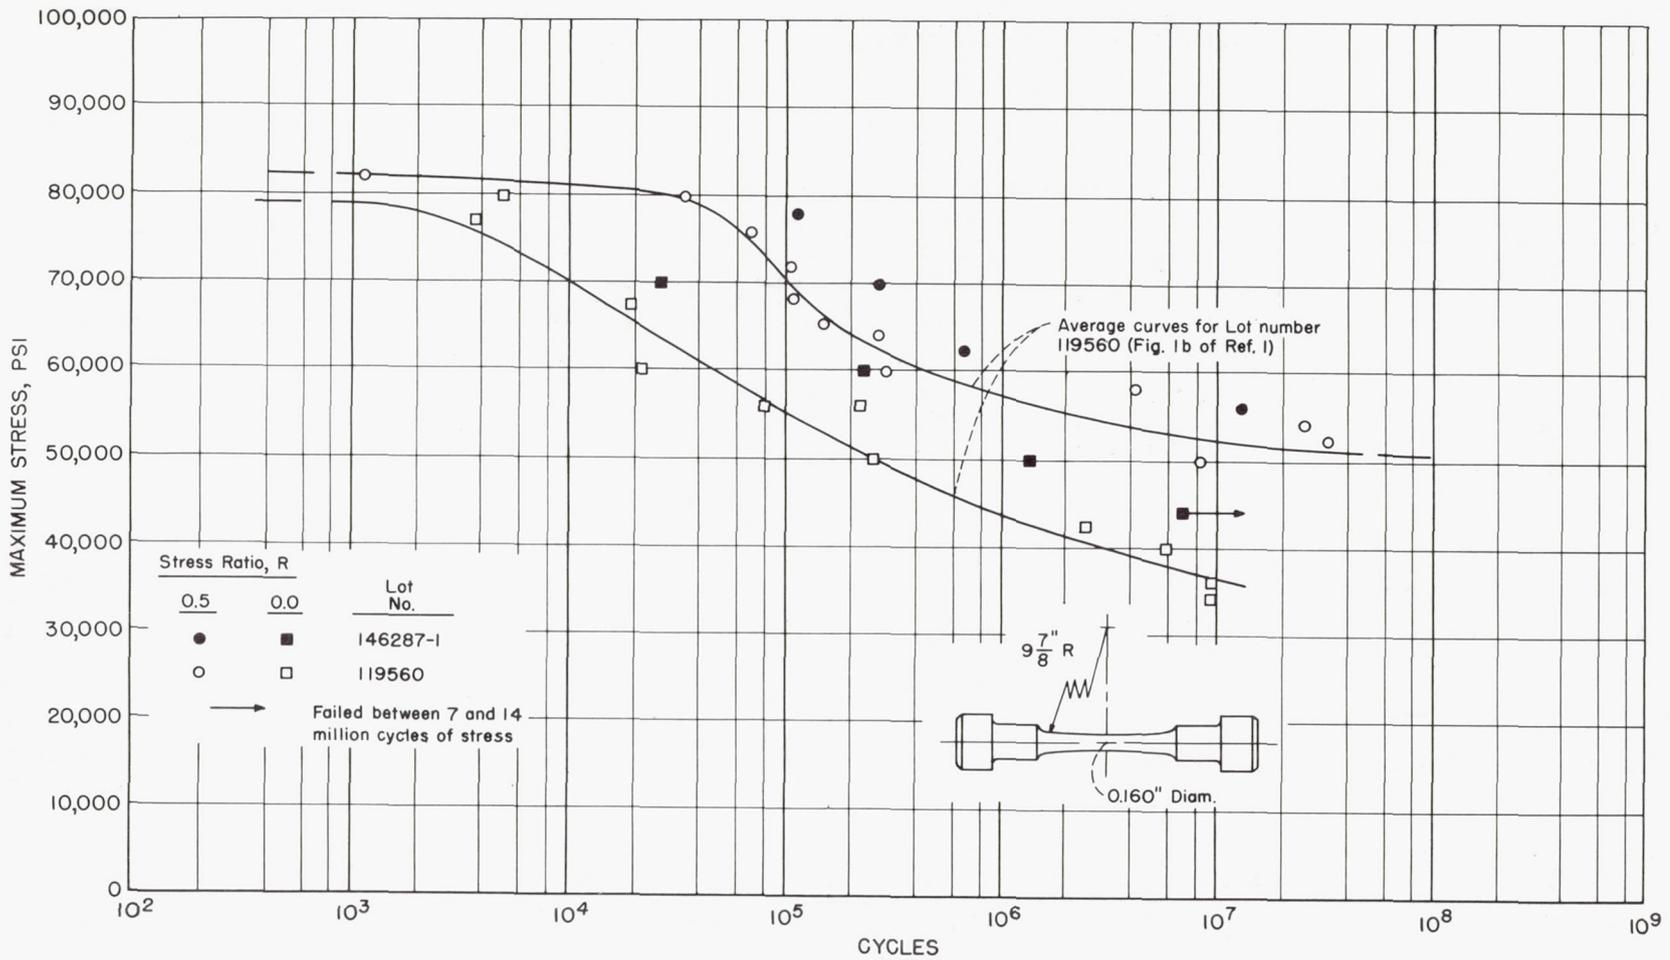
Figure 2.- Direct tension-compression fatigue data for 24S-T4 extruded bar ($1\frac{1}{4}$ by 4 inches).

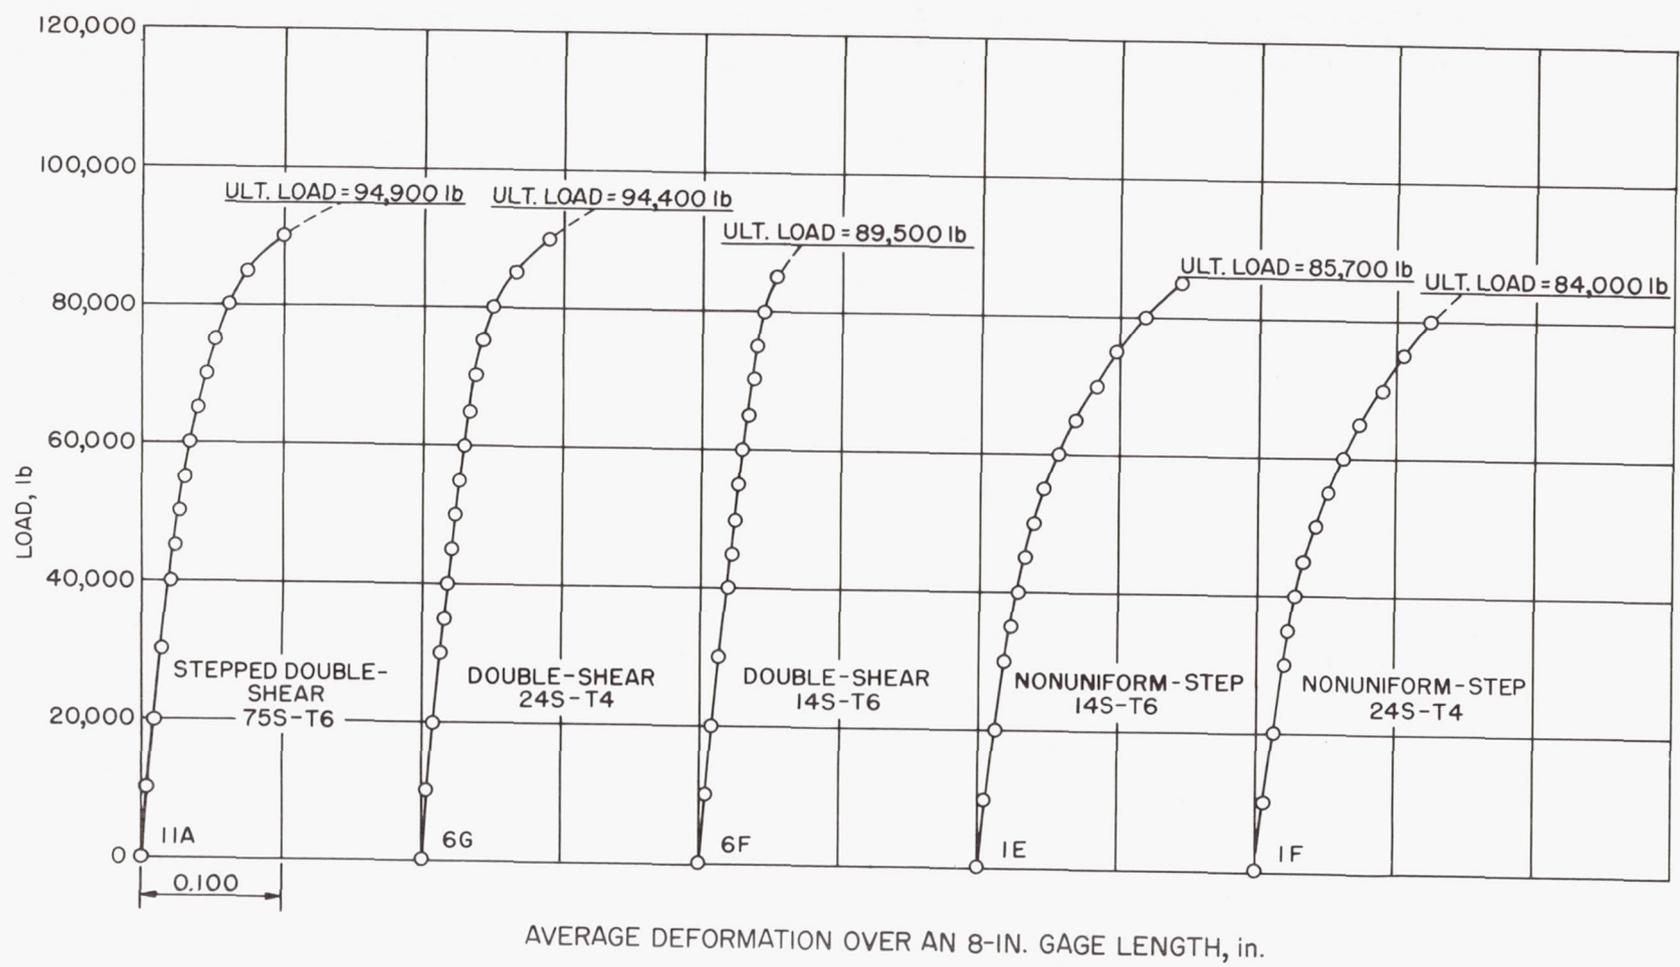
Figure 4.- Curves of static tensile load against deformation for high-strength aluminum-alloy bolted joints.

The results of the additional static tests are presented in figure 4 and are summarized in table II, together with the results for the 75S-T6 nonuniform-step and double-shear joints taken from table IV of reference 1.

The stepped double-shear joint, the new joint design tested in this investigation, withstood an ultimate load of 94,900 pounds, in other words, 29,200 pounds per pound of joint weight. The deformation in an 8-inch gage length under a load of 16,000 pounds was 0.0060 inch. When compared with the static test results of the other 75S-T6 aluminum-alloy joints given in reference 1, it is found that the ultimate load of the stepped double-shear joint is lower than that of the double-shear (115,250 pounds), the uniform-step (107,800 pounds), the plain-scarf (107,250 pounds), and the nonuniform-step (100,000 pounds) joints. The ultimate load of the new stepped double-shear joint exceeds the ultimate loads of the bolted-keyed, double-scarf, single-shear, serrated, and clamped-keyed joints. The load per pound of weight and deformation in 8 inches at 16,000-pound load are also intermediate to the values obtained for the other types of 75S-T6 joints.

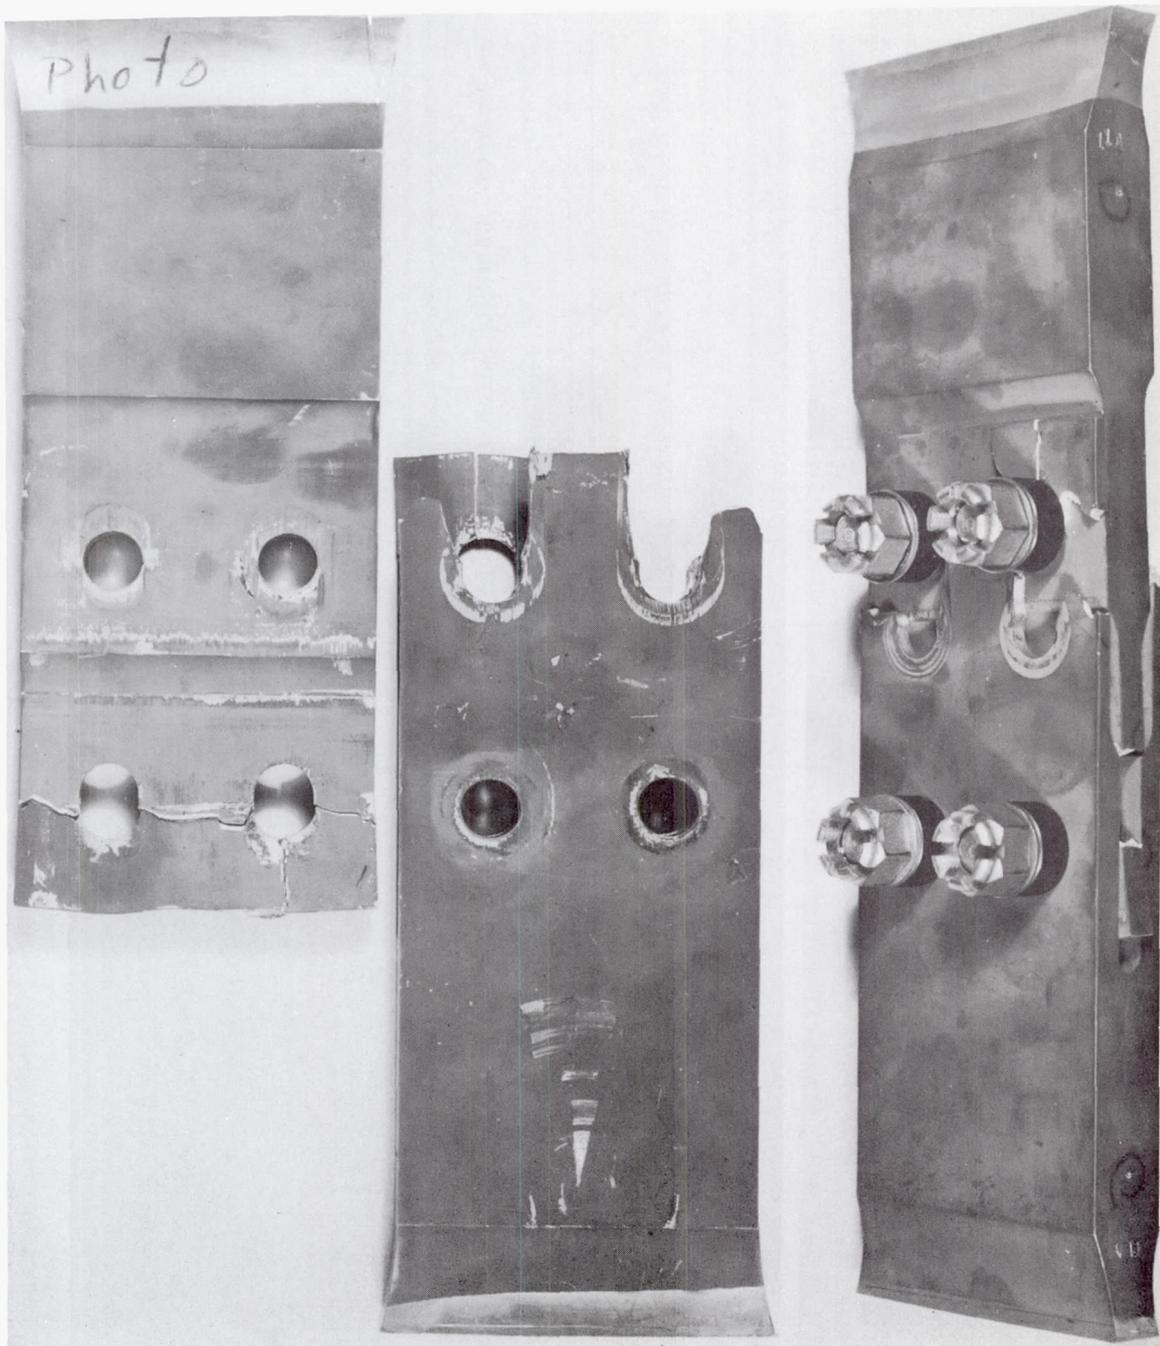
Figure 5.- Static fracture of 75S-T6 stepped double-shear joint. L-83690

The static failure of the stepped double-shear joint shown in figure 5 was by combined bearing and tension on the thin portions of both the tongue and outside members of the joint representing the main plate and splice plates, respectively, of an ordinary double-strap butt joint. It is reasonable to believe that the load-carrying capacity might be increased by minor changes in the proportions of the joint. The paths of the static fractures in the 24S-T4 and 14S-T6 nonuniform-step and double-shear joints were almost identical to the paths of the fractures in like 75S-T6 joints shown in figure 7(b) of reference 1 (specimens 1B and 6A, respectively).

3. The static failure in the stepped double-shear joint was by combined tension and bearing in the thin portions of both the tongue and outside members of the joint.

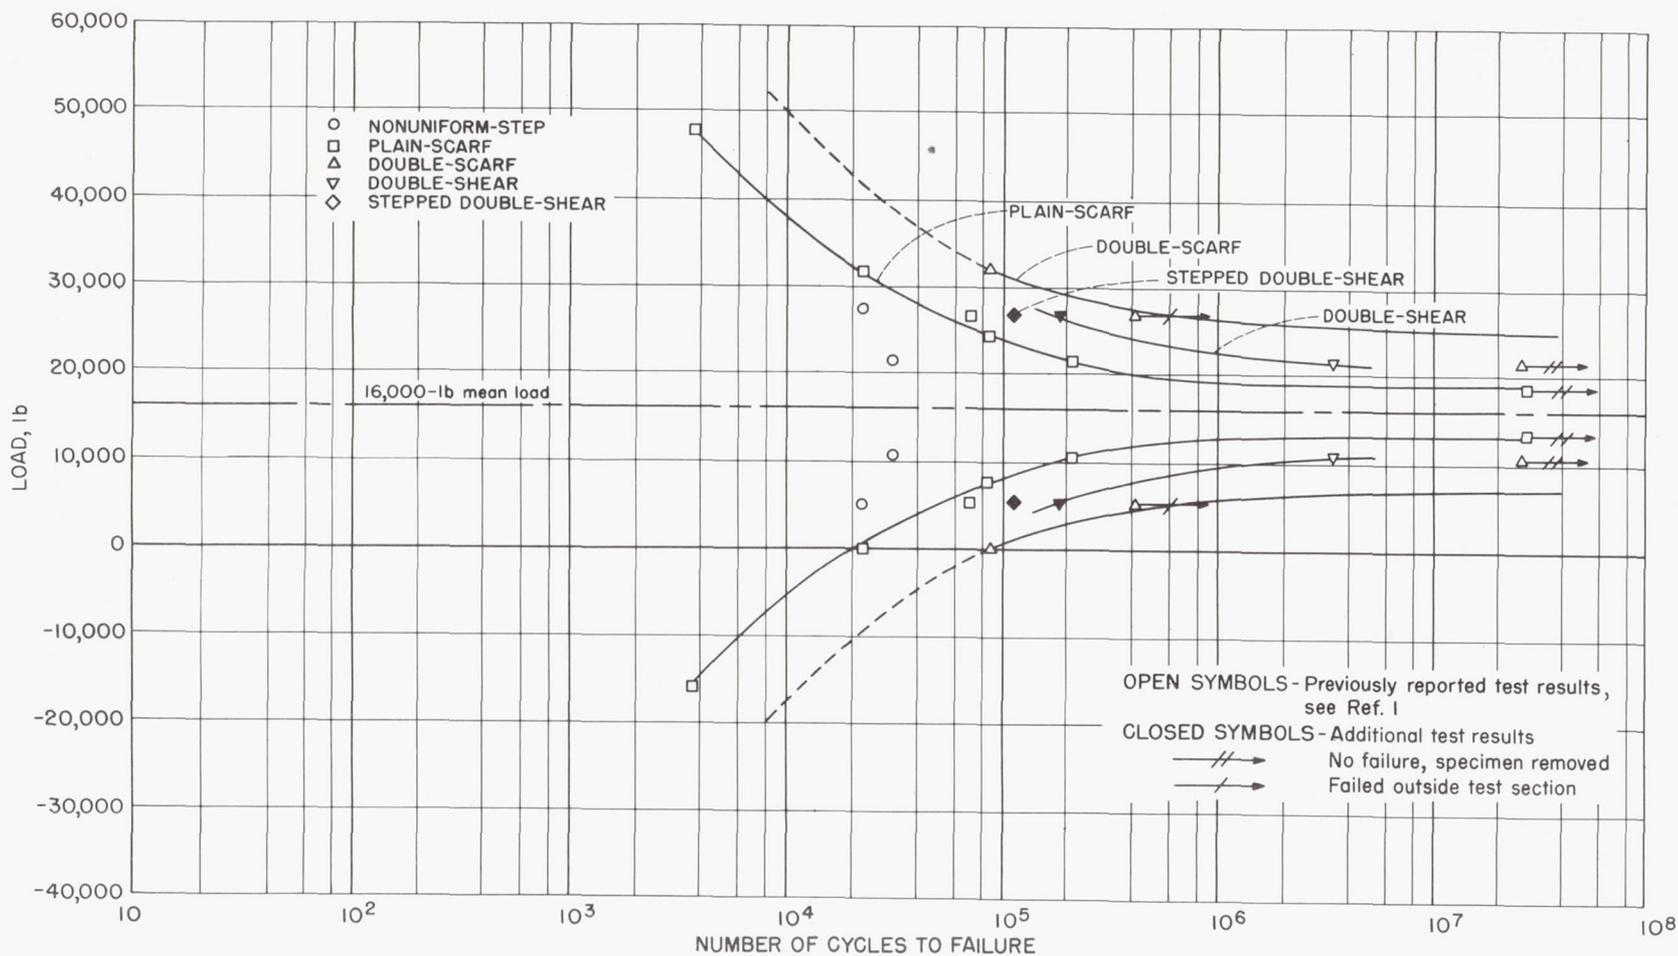
Figure 6.- Direct-stress fatigue curves for 75S-T6 aluminum-alloy bolted joints. Mean load, 16,000 pounds.

The result of the fatigue test on the stepped double-shear joint is included in table IV and is plotted with other results from this and the initial part of the investigation in figure 6. It can be seen that, of the 75S-T6 joints tested, the fatigue life of the stepped double-shear joint (111,400 cycles) is exceeded by that of the double-scarf (418,000 cycles) and double-shear (187,400 cycles) joints. The fatigue fracture shown in figure 7 occurred at the bolt holes in the thin portion of the tongue. No additional fractures were found, either in the tongue or in the outside members.

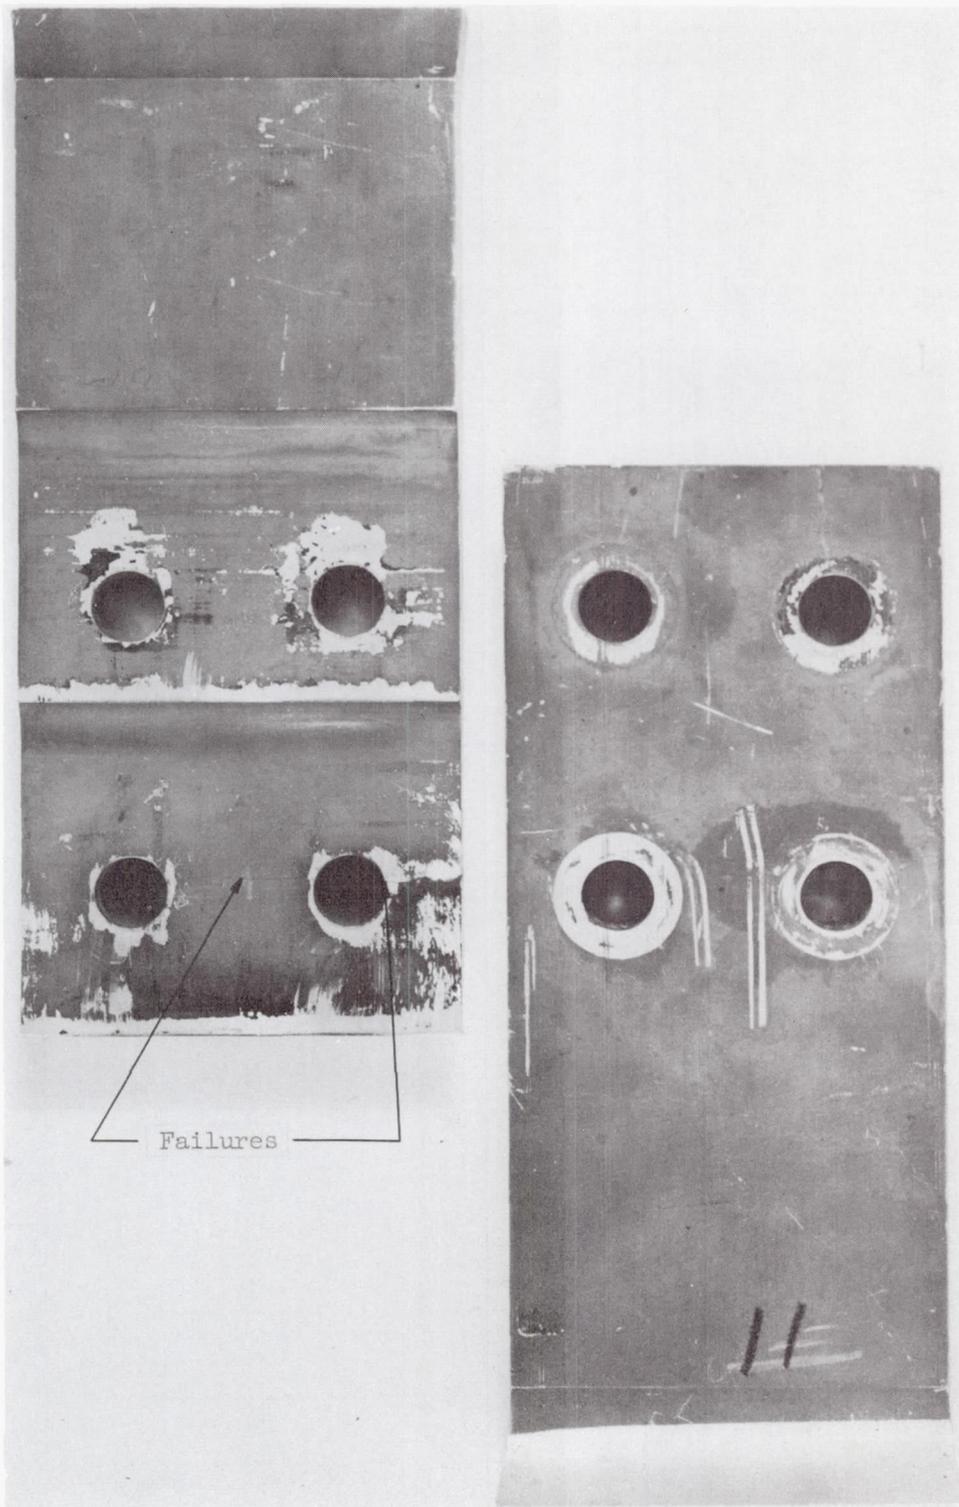
L-83691
Figure 7.- Fatigue failures in stepped double-shear joint.

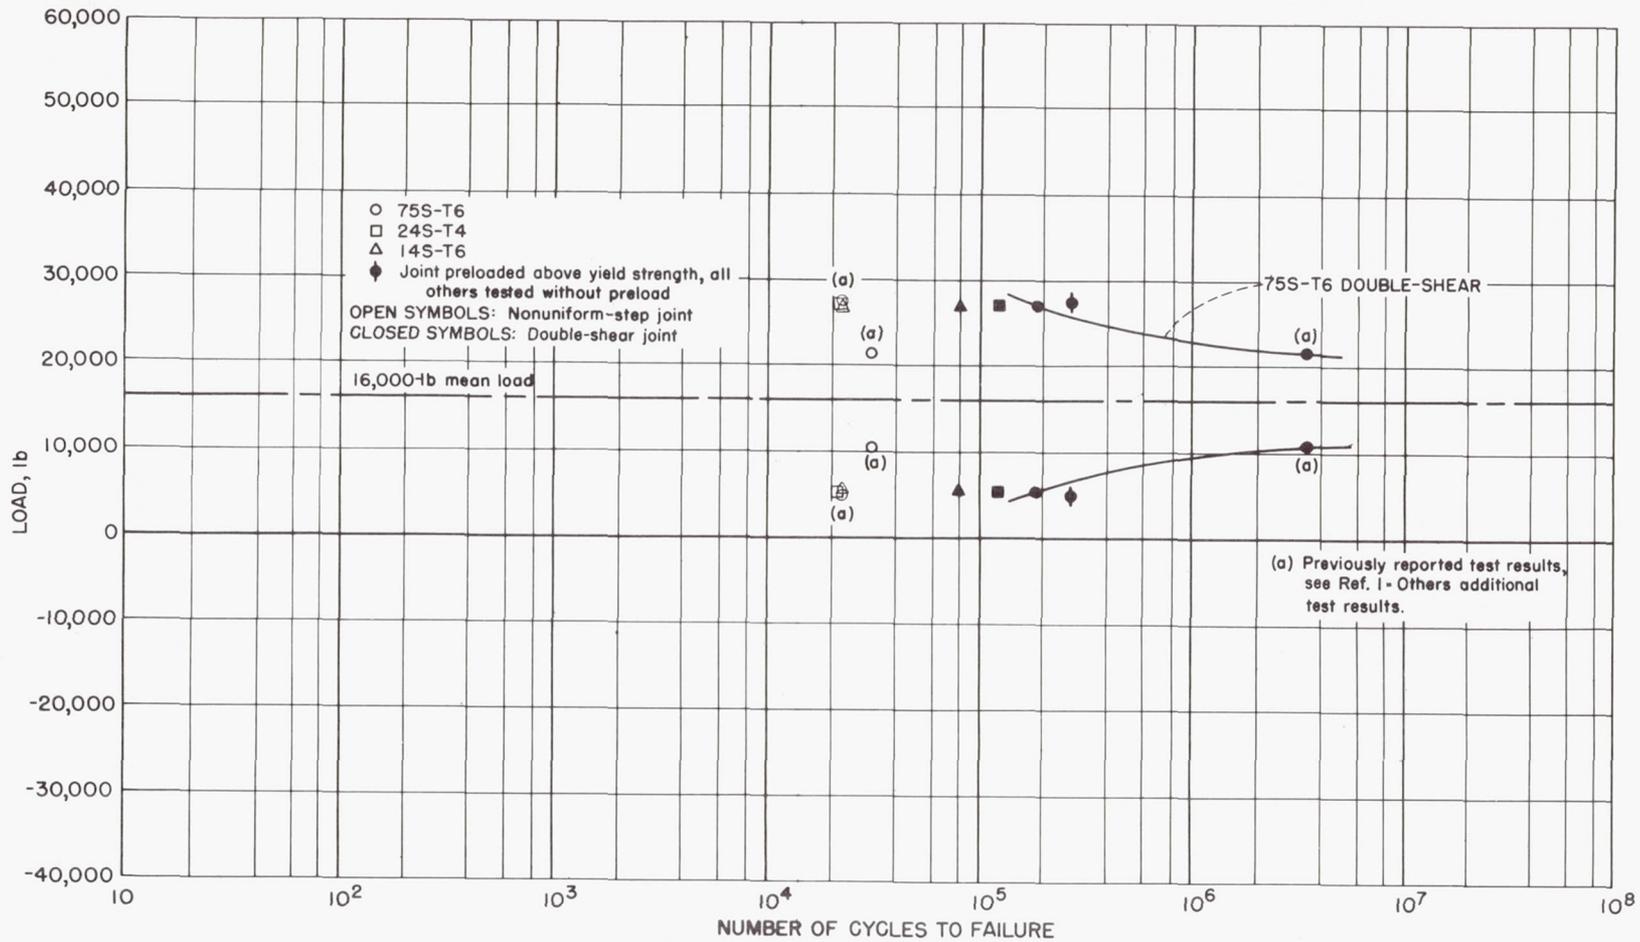
Figure 8.- Direct-stress fatigue curves for double-shear and nonuniform-step joints of 75S-T6, 24S-T4, and 14S-T6 aluminum alloys. Mean load, 16,000 pounds.

Direct-stress fatigue test results for the double-shear and nonuniform-step joints of the three aluminum alloys under consideration are plotted in figure 8 and are included in the summary of table V. For the conditions of 16,000-pound mean load $\pm 10,670$ pounds, it can be seen that there is no significant difference in the fatigue lives of the nonuniform-step joint in any of the three alloys studied. At a load of 16,000 pounds $\pm 10,670$ pounds, the fatigue life of the 75S-T6 double-shear joint exceeds the fatigue lives of the 24S-T4 and 14S-T6 double-shear joints by ratios of 1.5:1 and 2.3:1, respectively.

The direct-stress fatigue test results for the plain-scarf and double-shear aluminum-alloy joints, which had been preloaded with a static load, have been plotted in figures 8 and 11 and are included in the summary in table VI. It can be seen that the ratio of the fatigue life of the plain-scarf joint with preload to that of plain-scarf joint without preload is 5.9:1. The preloaded plain-scarf joint failed through the first row of bolt holes similar to the failure of the plain-scarf joint without preload shown in figure 15(b) (joint 2) of reference 1. The like ratio for the double-shear joints was found to be 1.4:1. As shown in figure 15, the preloaded double-shear joint failed in one of

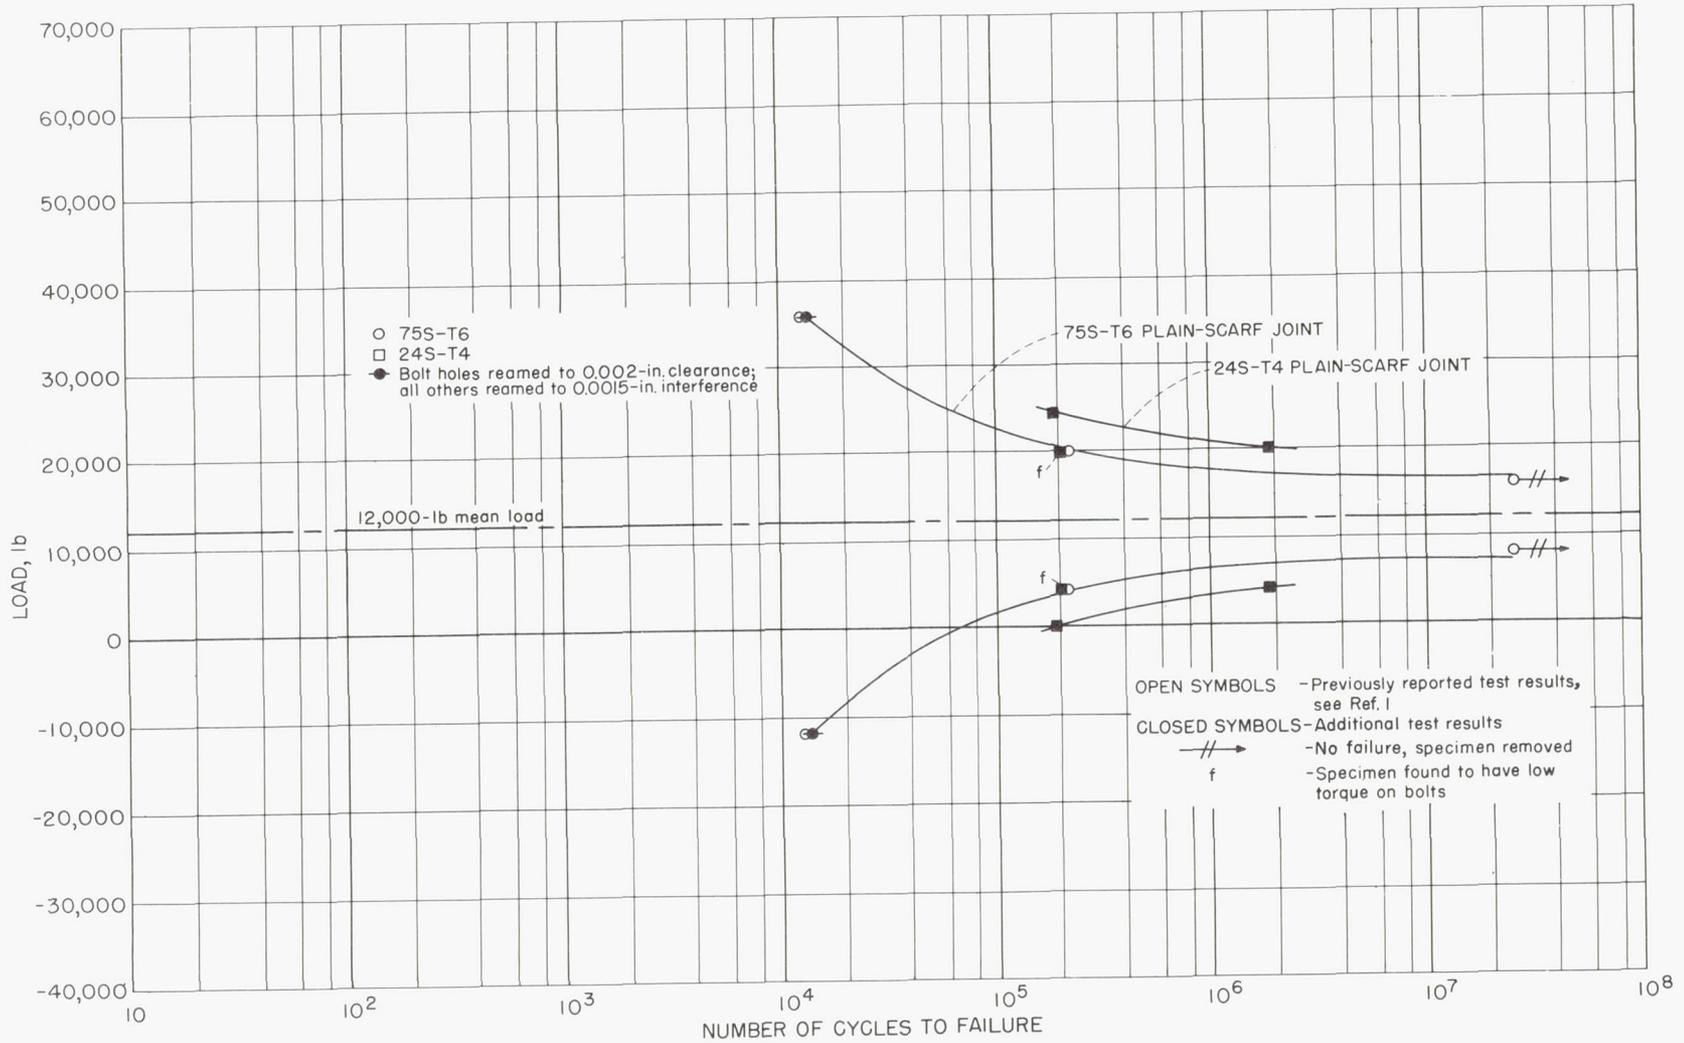
Figure 9.- Direct-stress fatigue curves for plain-scarf joints of 75S-T6 and 24S-T4 aluminum alloy. Mean load, 12,000 pounds.

The summary of results of direct-stress fatigue tests for the plain-scarf joints of 75S-T6, 24S-T4, and 14S-T6 at a mean load of 16,000 pounds and various variable loads, given in table X of reference 1, is extended in table V and figure 9 to include similar comparisons of 75S-T6 and 24S-T4 plain-scarf joints tested with a 12,000-pound mean load and various variable loads. It can be seen that the 24S-T4 plain-scarf joint gives consistently greater fatigue life than the 75S-T6 joint with the ratios of fatigue lives ranging from 1.4:1 to 18.5:1 for the mean loads and stress ratios used in these tests. For like stress ratios the fatigue-life ratios are larger in favor of 24S-T4 at the 12,000-pound mean load than at the 16,000-pound mean load.

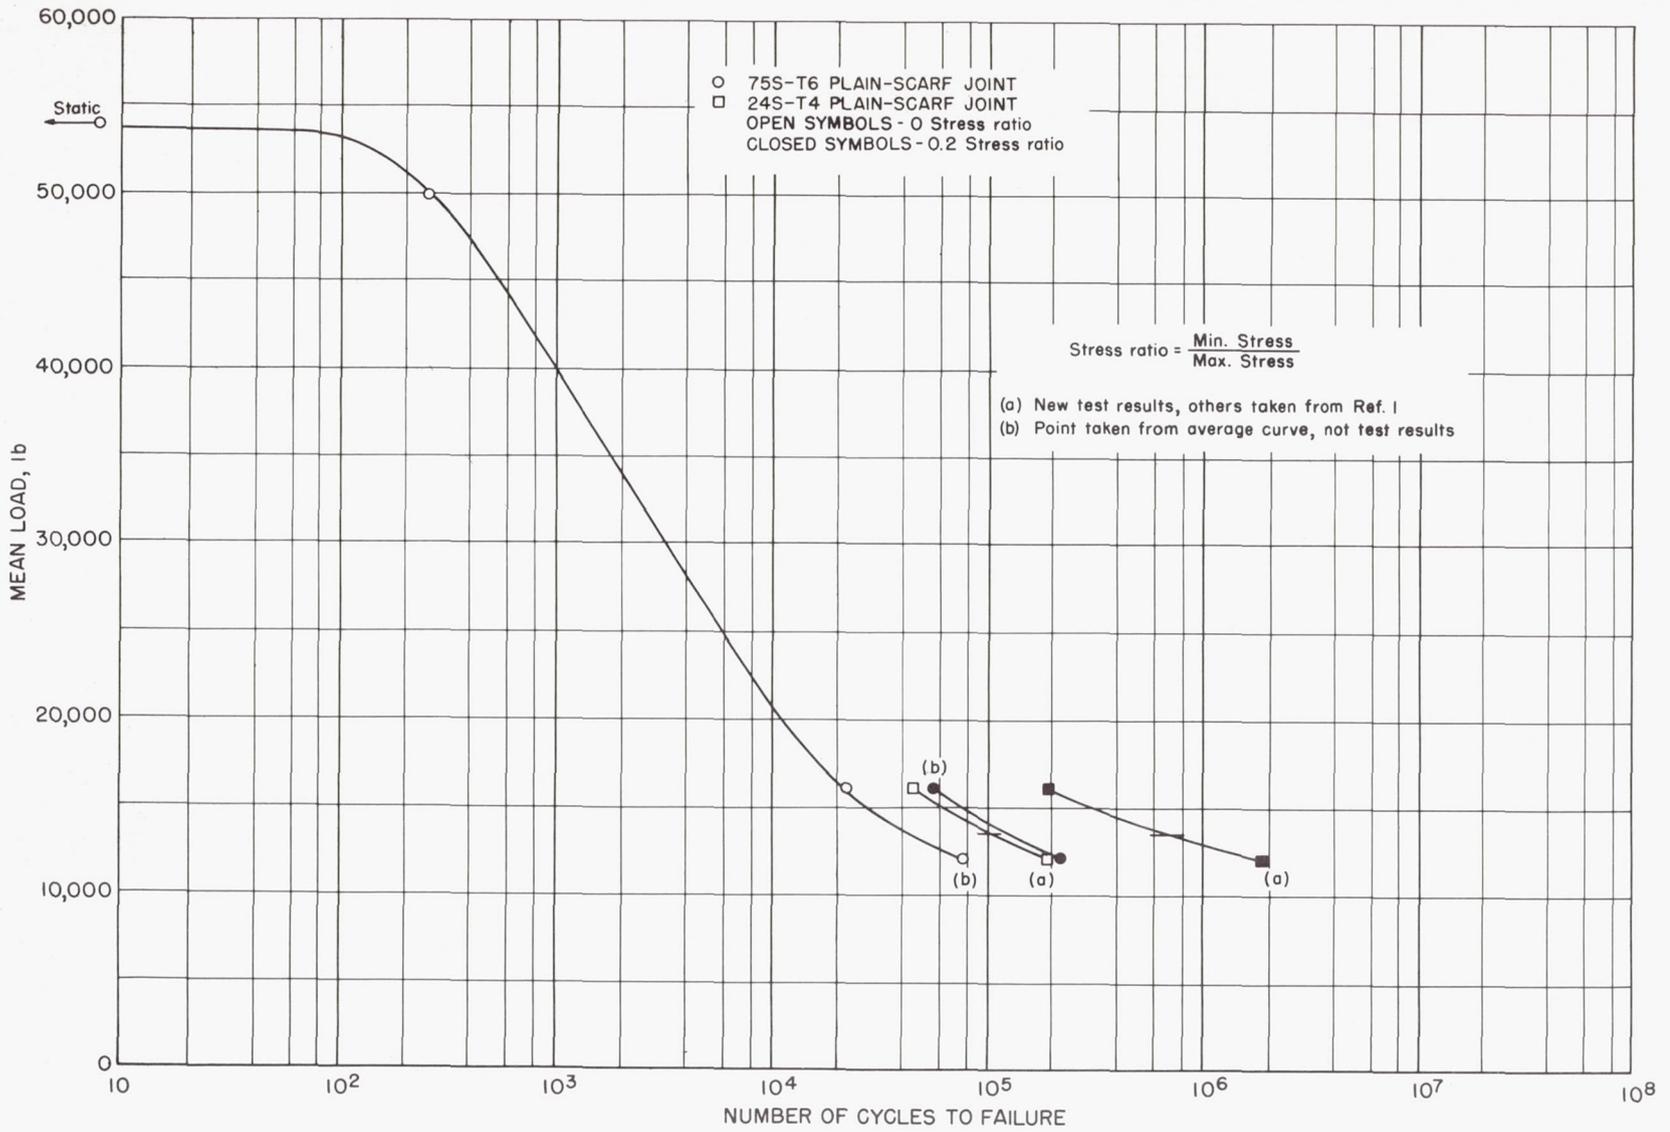
Figure 10.- Direct-stress fatigue curves for plain-scarf joints of 75S-T6 and 24S-T4 aluminum alloy. Mean load versus number of cycles to failure.

The direct-stress fatigue test results for the 75S-T6 and 24S-T4 aluminum-alloy plain-scarf joints at 0 and 0.2 stress ratios have been replotted in figure 10. In order to take care of differences in the static properties of the 75S-T6 and 24S-T4, the fatigue results for the 75S-T6 and 24S-T4 joints should be compared at lower loading conditions for the 24S-T4 joint than for the 75S-T6 joint, that is, on the basis of mean loads of 13,600 pounds and 16,000 pounds, respectively, which are proportional to the ultimate static strengths of the joints. Thus it can be seen in figure 10 that at a mean load of 13,600 pounds the 24S-T4 plain-scarf joint would be expected to fail at 100,000 and 680,000 cycles for the 0 and 0.2 stress ratios, respectively. Included in table V are comparisons of these results with the results for the 75S-T6 plain-scarf joints at the higher mean load of 16,000 pounds and at like stress ratios. The ratio of fatigue lives for the 24S-T4 joint to that of the 75S-T6 joint, when the load on the 24S-T4 joint is adjusted to take account of differences in the static strengths of the joints, is 4.6:1 and 12.4:1 for the 0 and 0.2 stress ratios, respectively. Had the loading on the 24S-T4 joint been adjusted on the basis of the ratio of the ultimate tensile strengths of the materials the mean load would be 14,600 pounds and the ratios of the fatigue life of the 24S-T4 joint to the fatigue life of the 75S-T6 joint would have been 3.2:1 and 6.7:1 for stress ratios of 0 and 0.2, respectively. Further, had the adjustment been made on the basis of the applicable guaranteed minimum values given in reference 2, the adjusted load on the 24S-T4 would have been 13,000 pounds and ratios of fatigue lives of the 24S-T4 to the 75S-T6 joints would have been 6.0:1 and 16.6:1. On the other

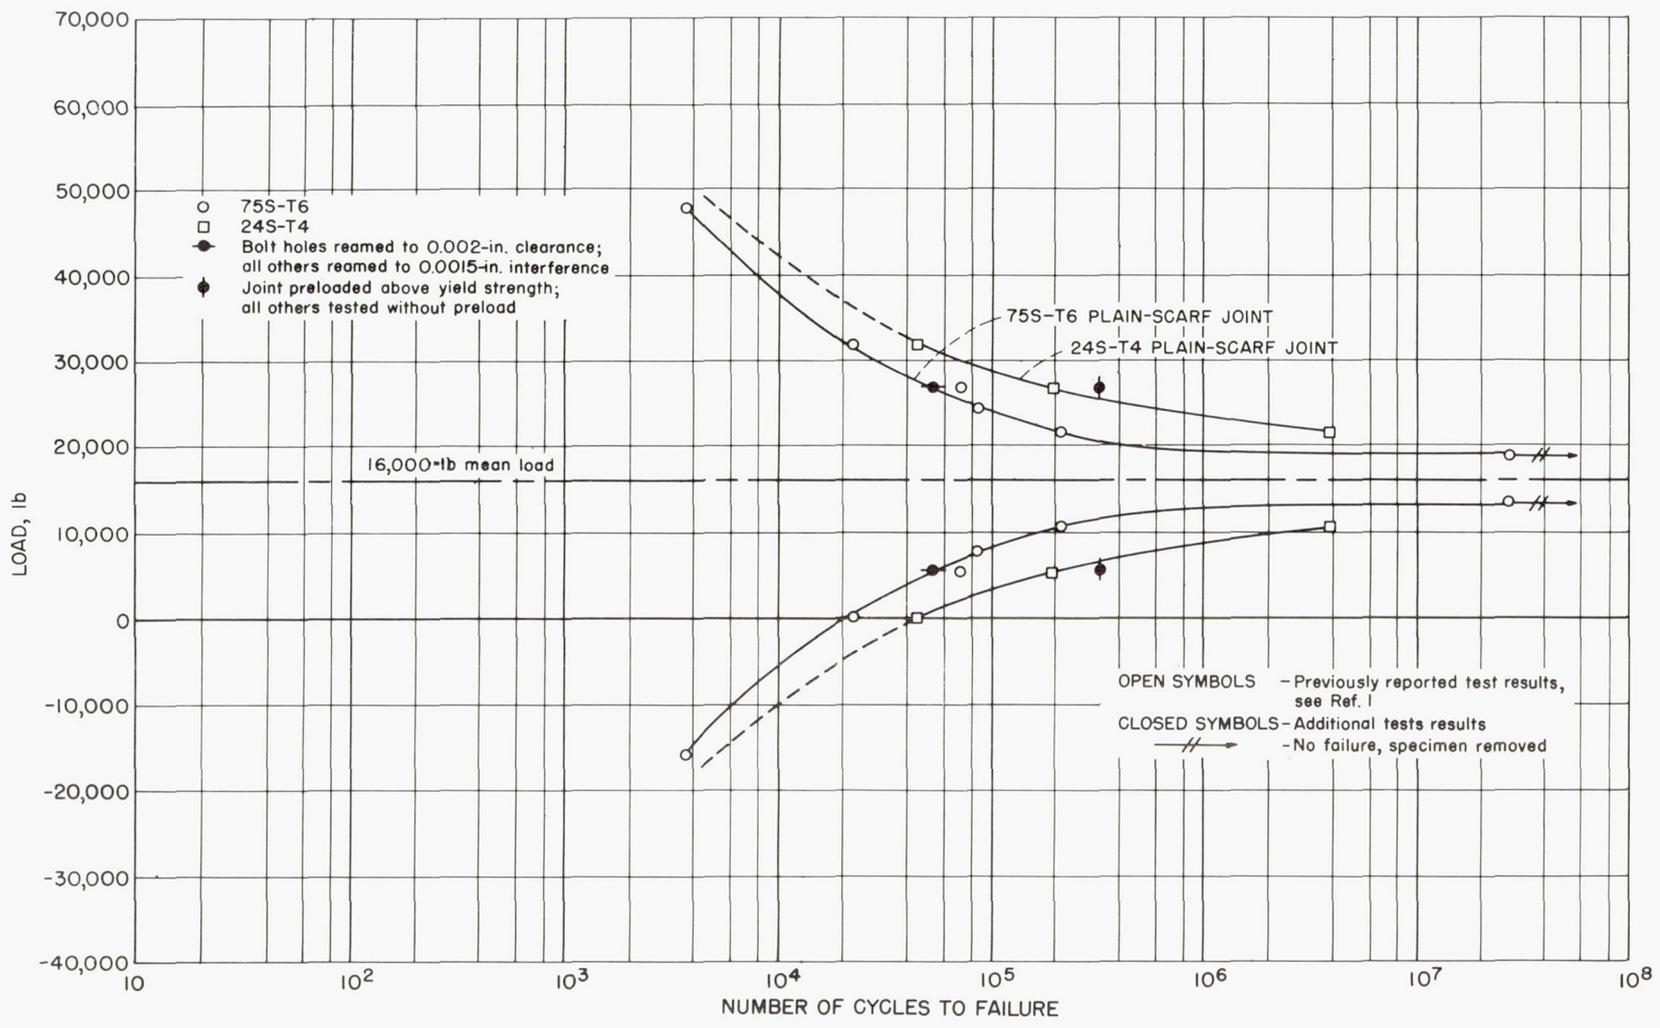
Figure 11.- Direct-stress fatigue curves for plain-scarf joints of 75S-T6 and 24S-T4 aluminum alloy. Mean load, 16,000 pounds.

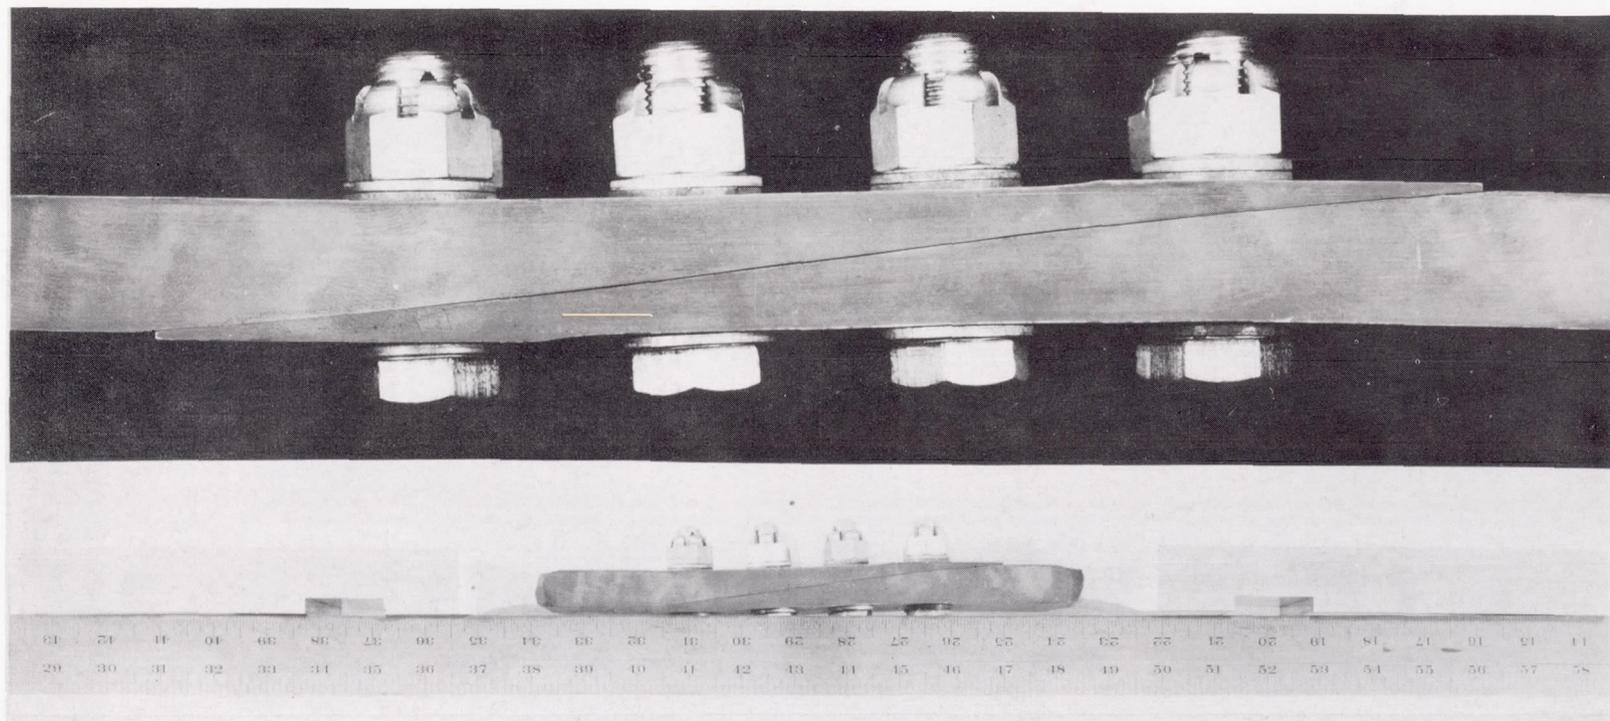
Figure 12.- Permanent deformation in plain-scarf joint after static preloading to above the yield strength.

As has been described earlier in this report, a plain-scarf joint and a double-shear joint, each of 75S-T6 aluminum alloy, were loaded in static tension to an average stress halfway between the yield and ultimate strengths previous to fatigue testing. The plain-scarf joint developed considerable visible plastic deformation under the static load imposed, as shown in figure 12. The deformations at the bolt holes, revealed by disassembly after the fatigue test, are shown in figure 13. The fracture is shown in figure 14. Measurements of the distance between the keyways of the plain-scarf joint indicated a permanent elongation of 0.110 inch. Bolt tightness of the joint was checked after completion of the fatigue test and the torque to tighten the nuts further was found to average about 60 percent of the torque used in the assembly of the joint. There was no visible permanent deformation in the double-shear joint which had been subjected to static preload; however, a permanent elongation of 0.009 inch was measured between the keyways of the specimen. After the fatigue test, the torque to tighten the nuts further was found to average only about 40 percent of the torque used in the assembly of this joint. The nuts in both preloaded joints had not been retightened after the preload was applied.

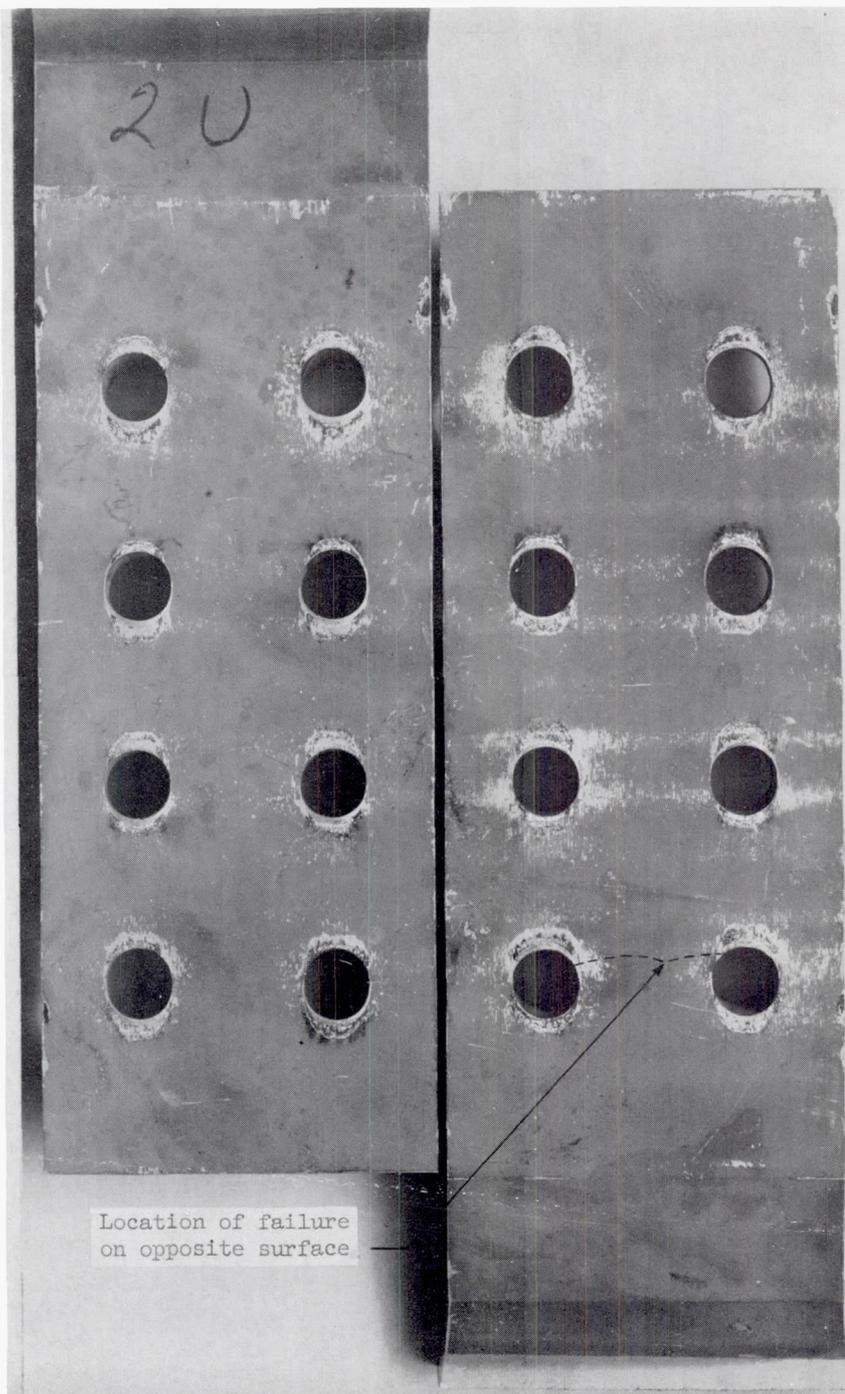
Figure 13.- Plastic deformation at bolt holes of faying surfaces of plain-scarf joint which had been loaded to high static loading previous to fatigue test. Photographed after fatigue test. (For views of failure on opposite surface see fig. 14.)

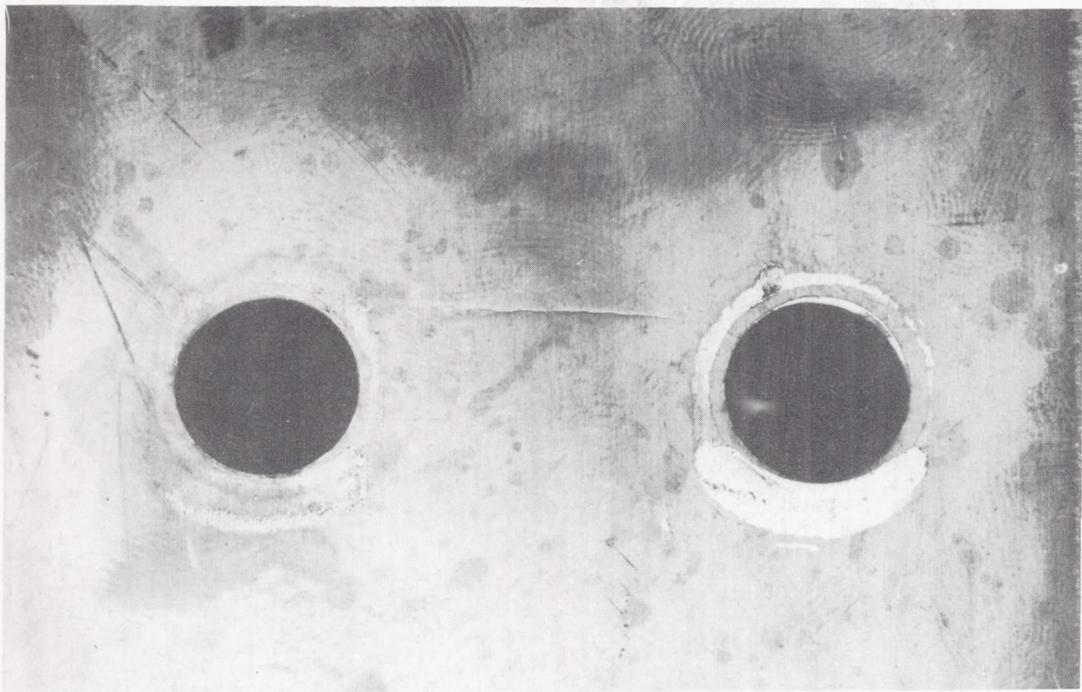
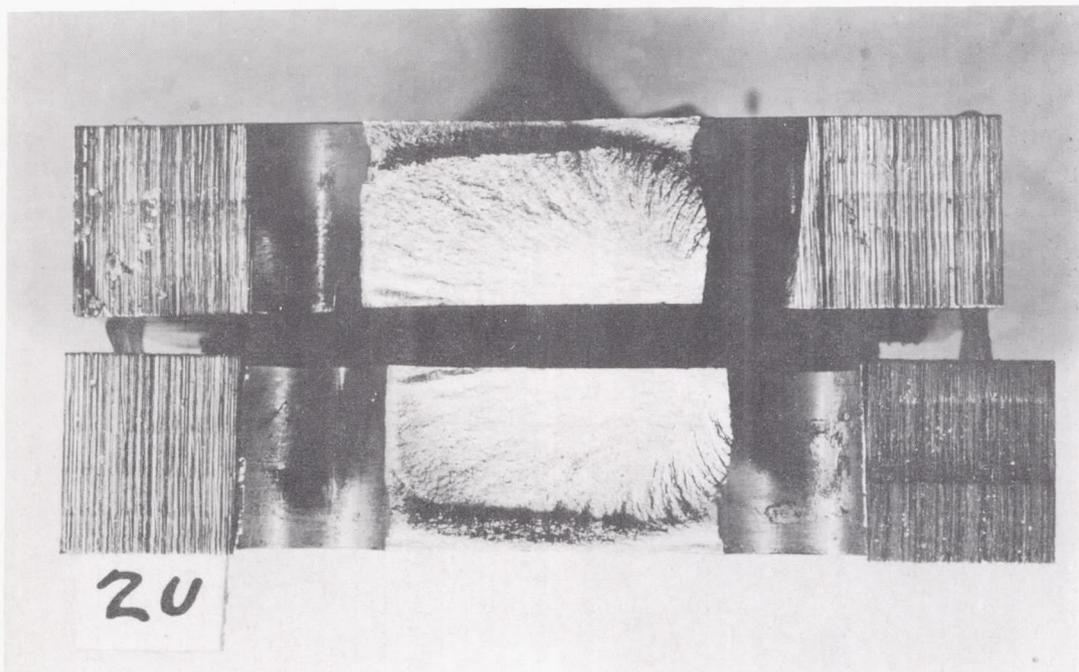
L-83694
Figure 14.- Fatigue failure of plain-scarf joint which has been loaded to high static loading previous to fatigue test. (For location of bolt holes see fig. 13.)
