TECHNICAL NOTE 3269

ADDITIONAL STATIC AND FATIGUE TESTS OF HIGH-STRENGTH
ALUMINUM-ALLOY BOLTED JOINTS

By E. C. Hartmann, Marshall Holt, and I. D. Eaton

Aluminum Company of America

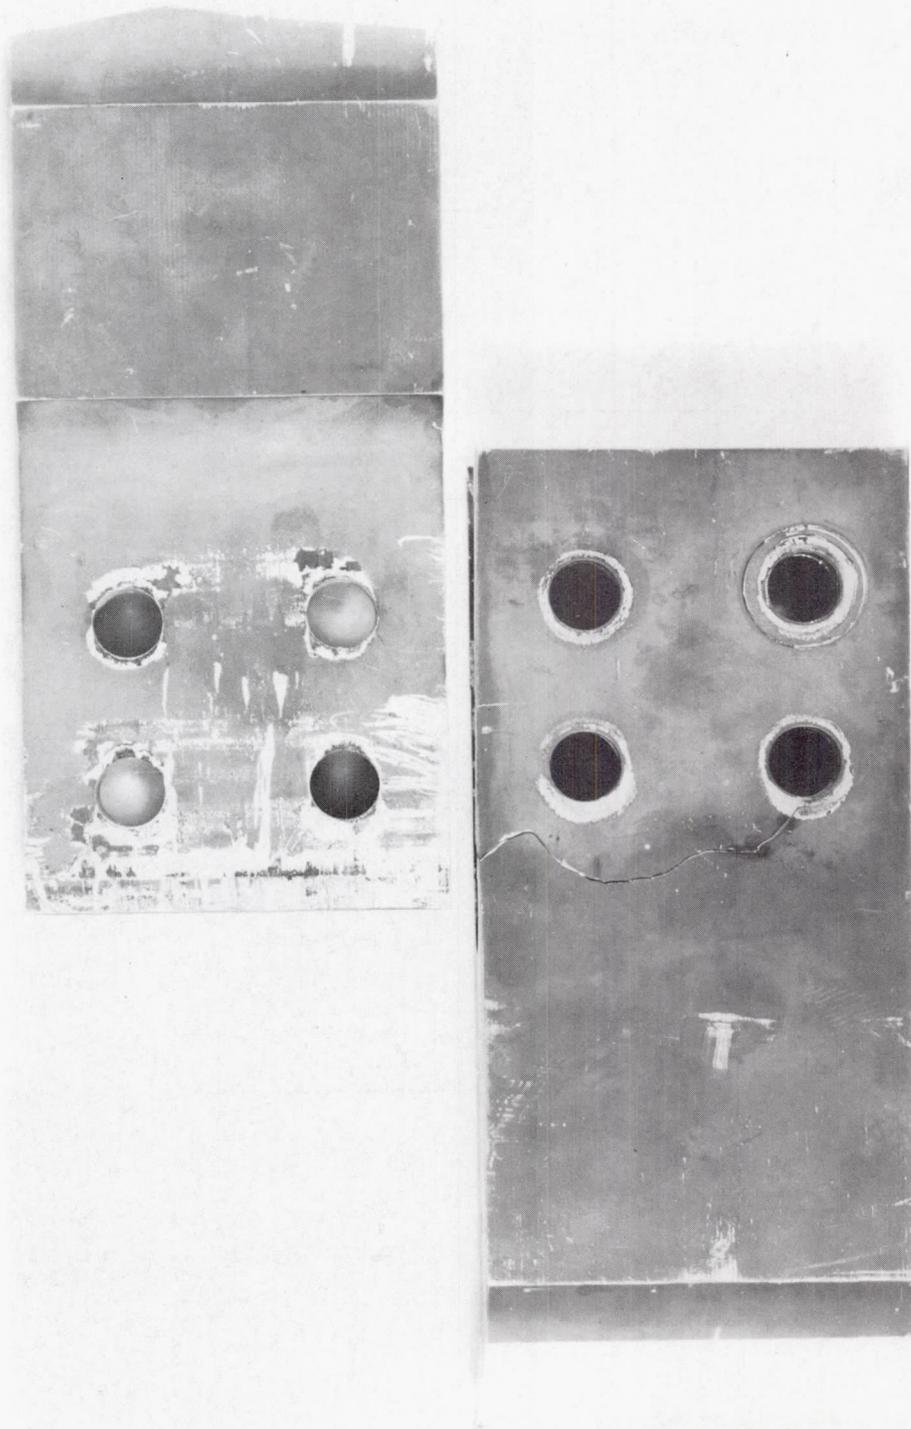
L-83695
Figure 15.- Fatigue failure in double-shear joint which had been loaded to high static loading previous to fatigue test.

The direct-stress fatigue test results for the plain-scarf and double-shear aluminum-alloy joints, which had been preloaded with a static load, have been plotted in figures 8 and 11 and are included in the summary in table VI. It can be seen that the ratio of the fatigue life of the plain-scarf joint with preload to that of plain-scarf joint without preload is 5.9:1. The preloaded plain-scarf joint failed through the first row of bolt holes similar to the failure of the plain-scarf joint without preload shown in figure 15(b) (joint 2) of reference 1. The like ratio for the double-shear joints was found to be 1.4:1. As shown in figure 15, the preloaded double-shear joint failed in one of

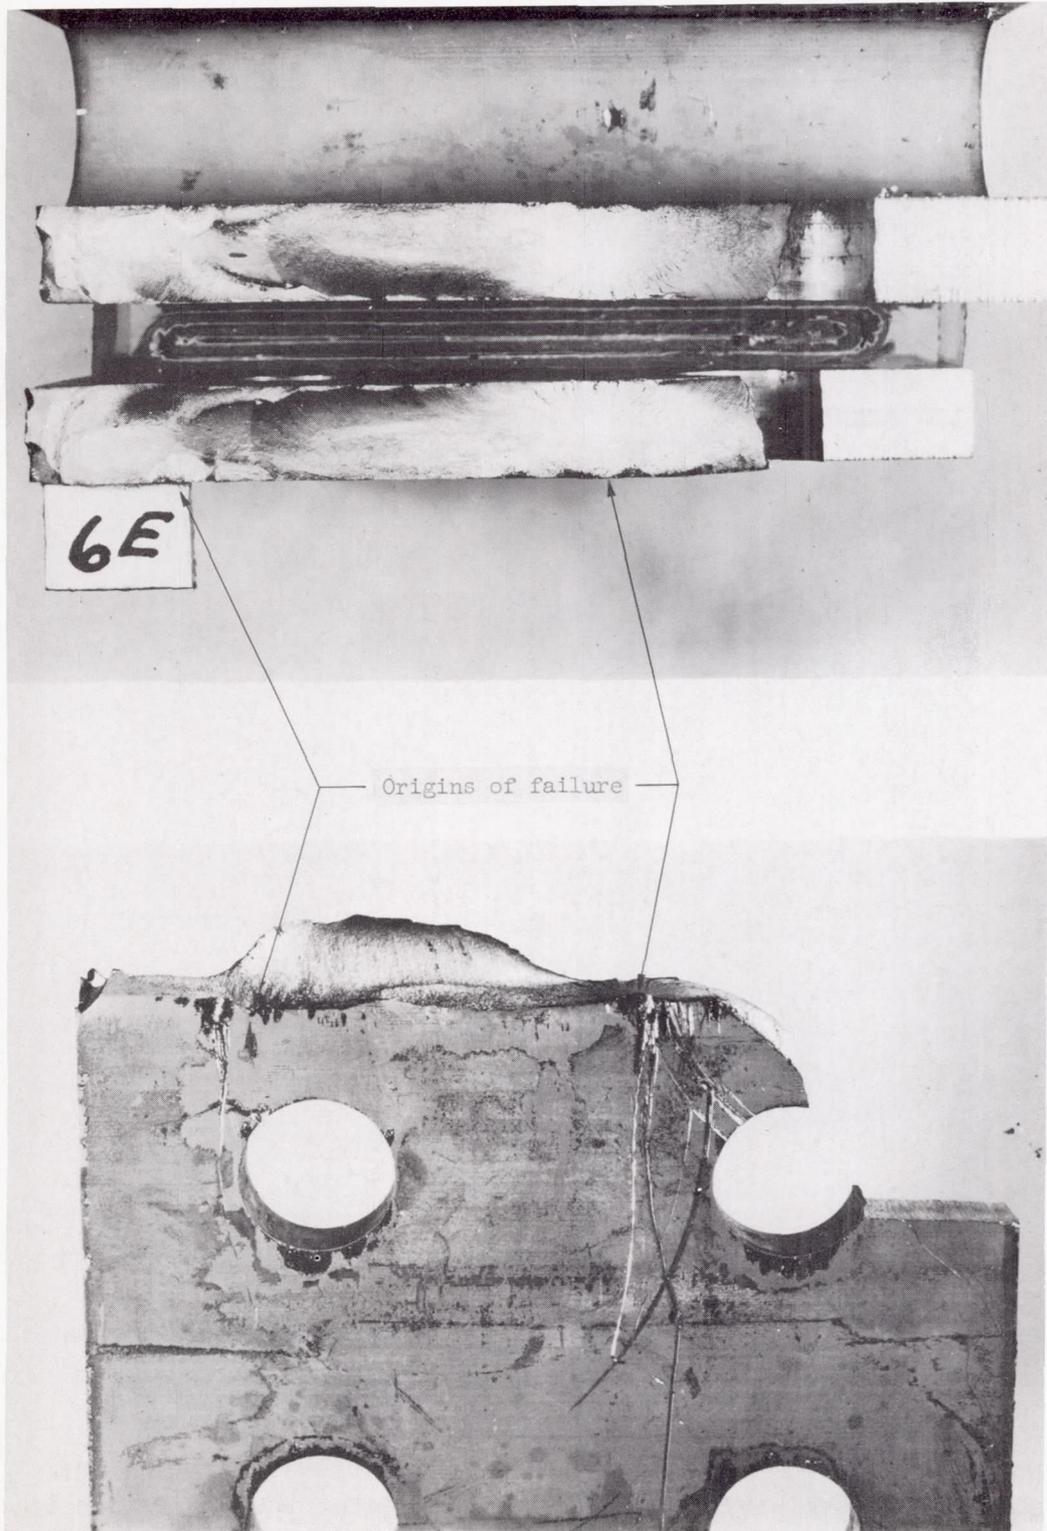
Figure 16.- Failure of double-shear joint which had been loaded to high static loading previous to fatigue test. L-83696

the outside members in a pattern quite unlike that of the corresponding joint without preload shown in figure 15(b) (joint 9B) of reference 1. Figure 16 shows the fractured surface of the preloaded specimen. Metallographic examination indicated that the fracture originated in a fretted area on the faying surface. No sign of additional fractures was evident in the tongue of this specimen. Unless the galling caused some reduction in life of this specimen, it would appear that the location of the critical section in the double-shear joint was changed by the preload imposed with little gain in fatigue life of the joint. It has been said that preloading to 67 percent of ultimate strength increases the fatigue life from two to tenfold. The result of the test on the preloaded plain-scarf joint is in agreement with such a statement. The National Bureau of Standards has reported results of fatigue tests on sheet with static preload (ref. 4) which show beneficial as well as detrimental effects of preloading on fatigue life. It would appear from the two tests made on bolted joints that preloading may or may not have significant beneficial effects on the fatigue life of a joint.

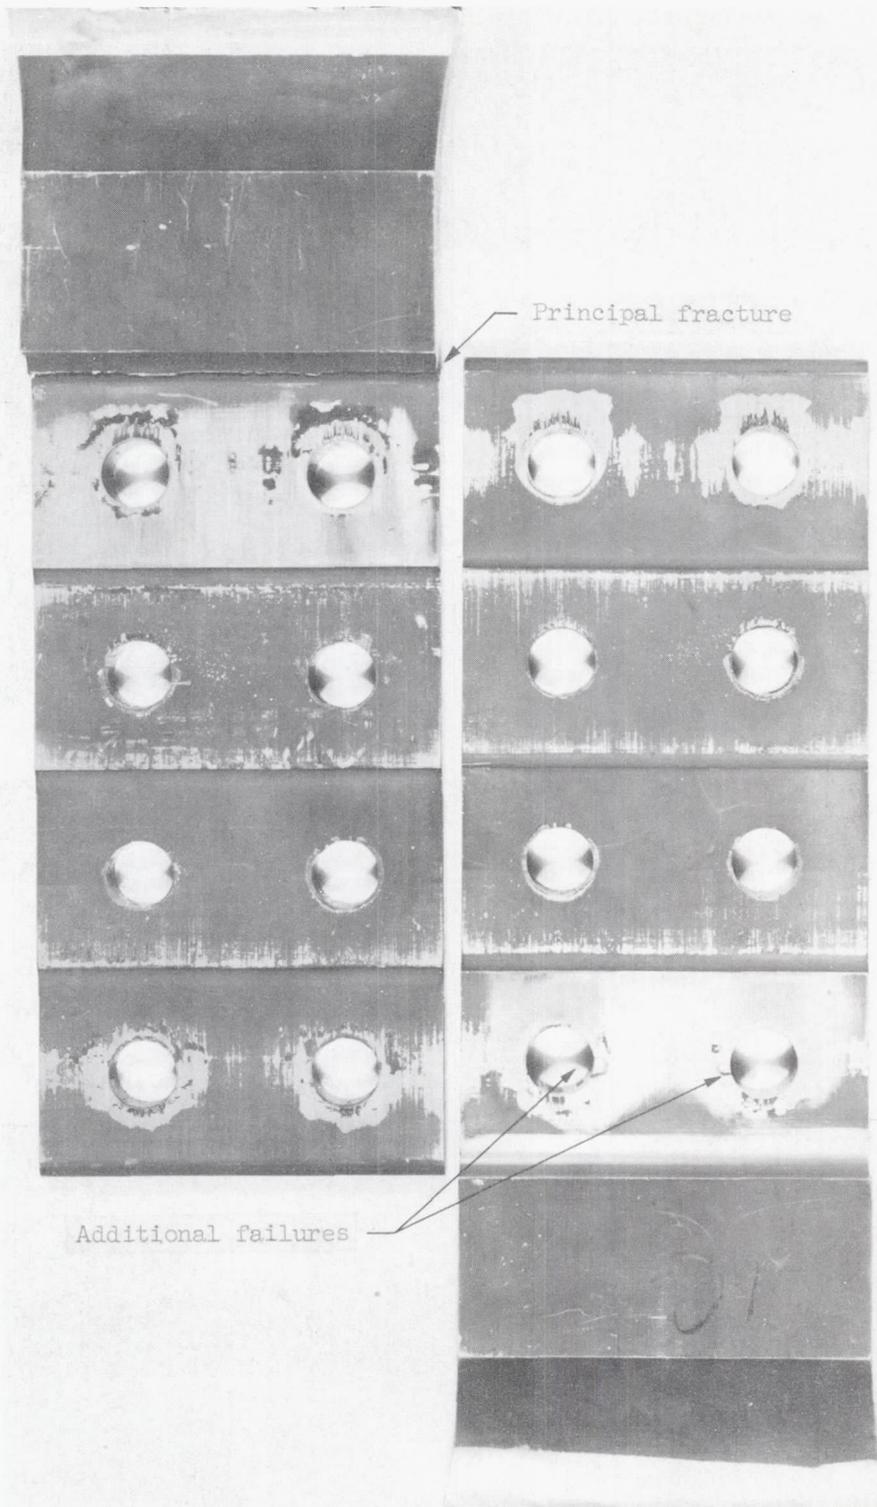
L-83697
Figure 17.- Failures in 24S-T4 nonuniform-step joint.

When the bolts were removed individually from the reassembled joints, it was found exceedingly difficult to obtain evidence of the existence of some of the cracks by means of the penetrant inspection methods used. In the case of the smallest crack no evidence of its existence was found. Further, no indication was obtained of the existence of the crack, about 0.009 inch long, shown in figures 17 and 18 when the methods were used with this joint in the disassembled condition.

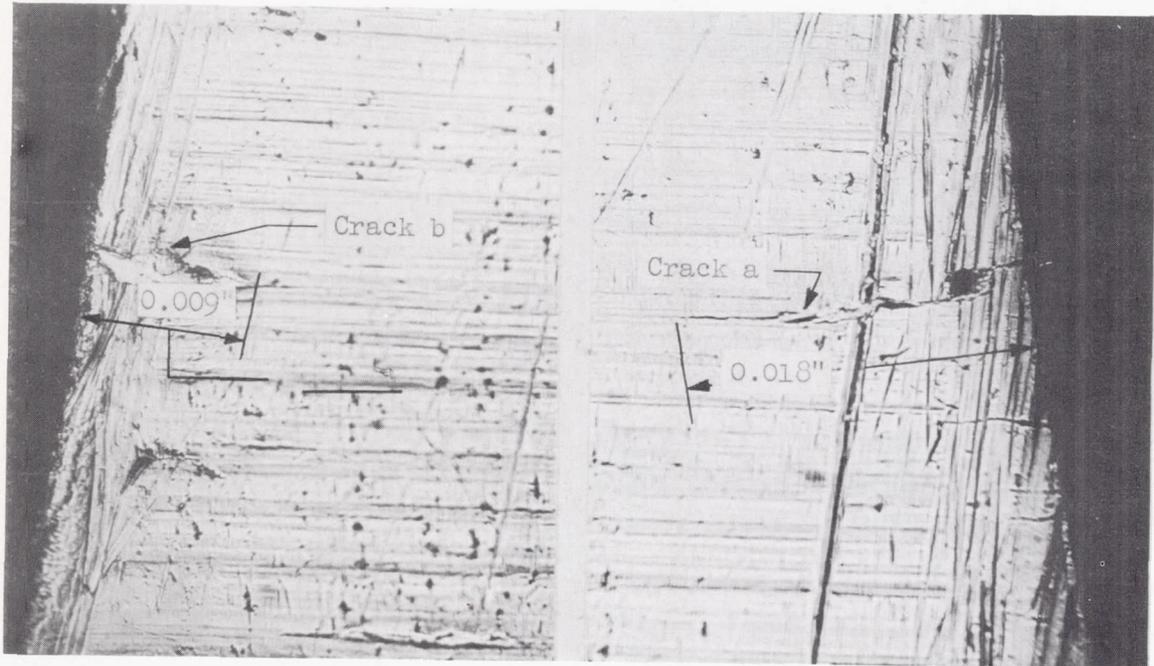
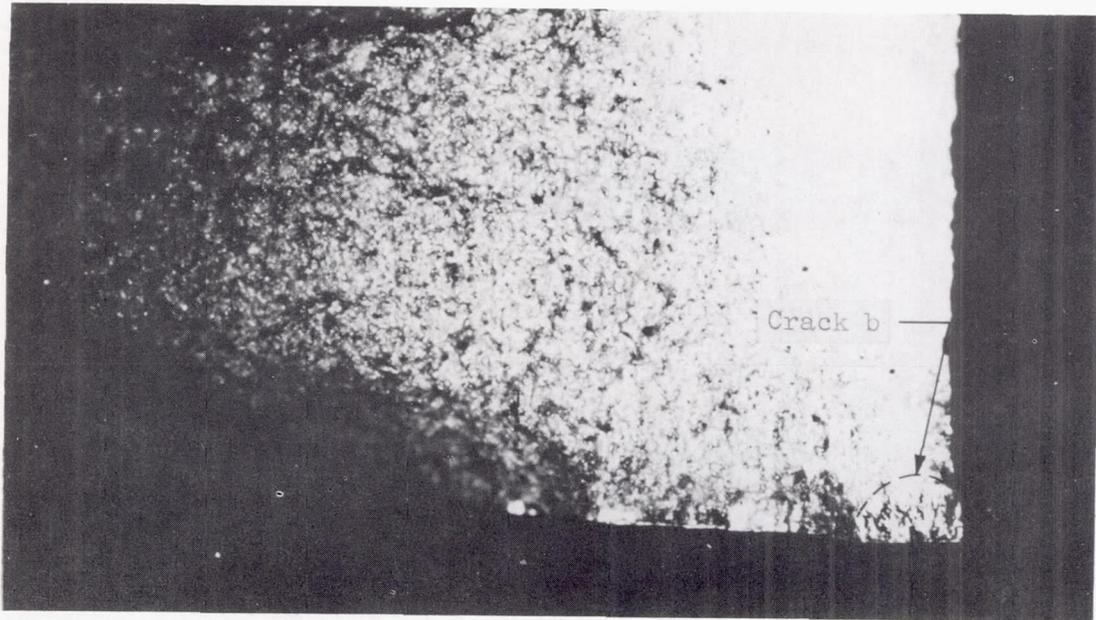
Figure 18.- Enlargements of additional failures in 24S-T4 nonuniform-step joint. (For locations, see fig. 17.) Two photographs at top are of Faxfilm replicas.

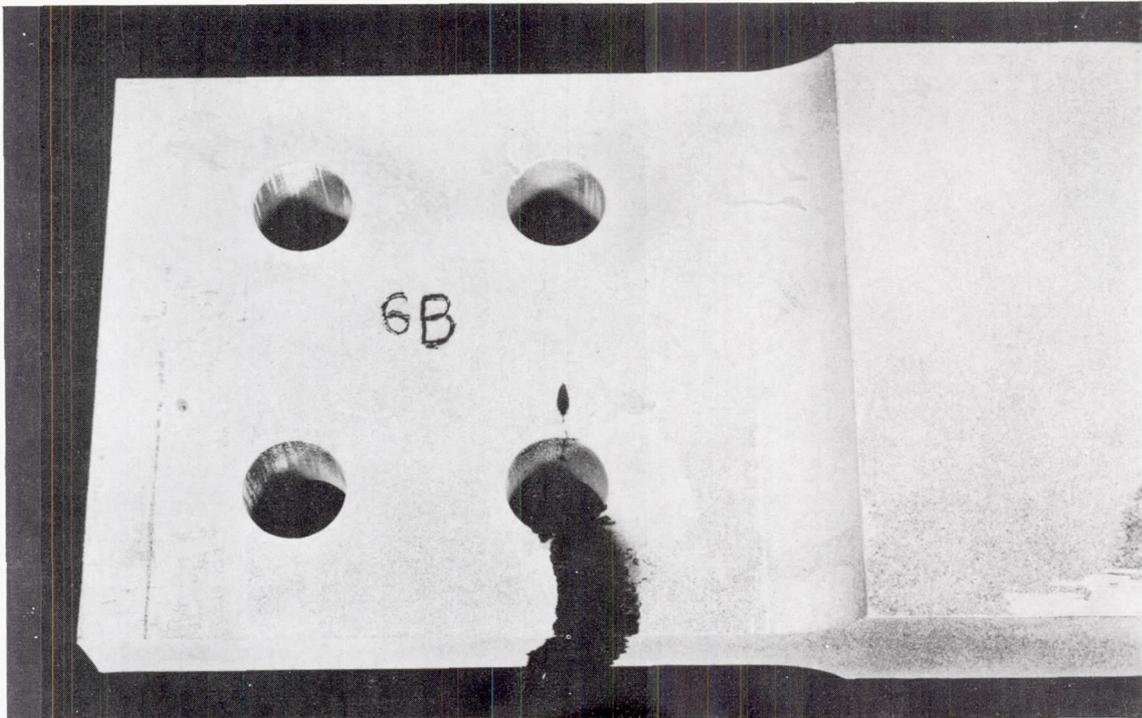
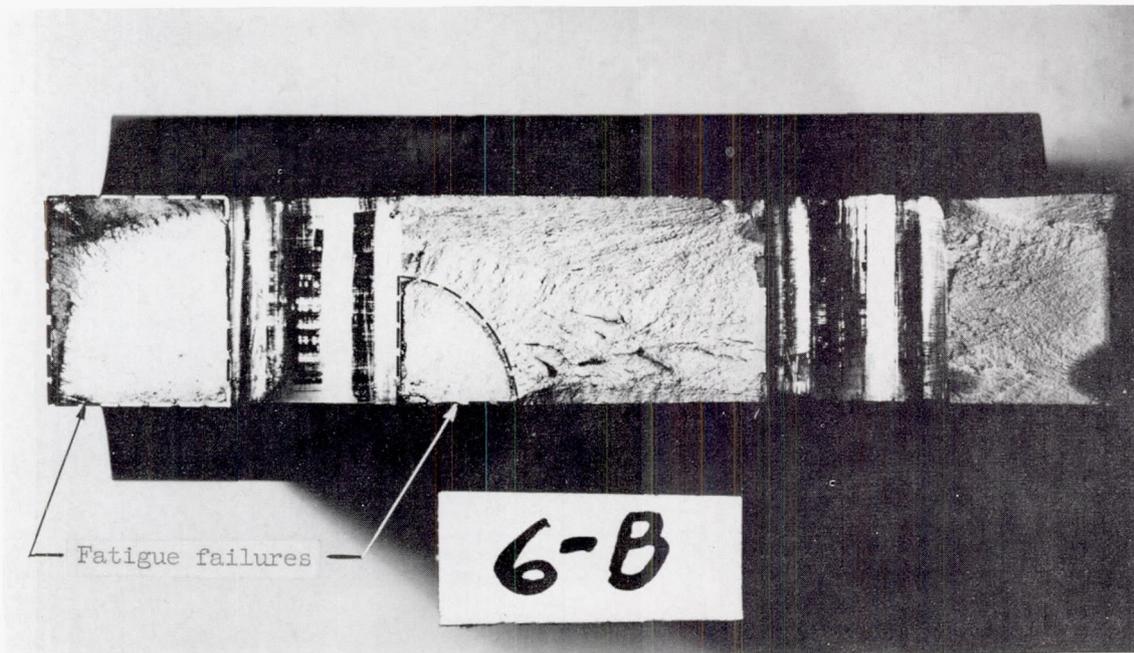
Figure 19.- Failures in 75S-T6 double-shear joint.

The static loads required to fail the 75S-T6 and 24S-T4 double-shear joints after the fatigue cracks shown in figures 19 and 20 had been developed are given in table VII. Included in the table are comparisons with the expected load based on the net area obtained by correcting for the cracks and the load-carrying capacity of a similar joint not having previous cyclic-stress history. Outlined on the fractured surfaces in figures 19 and 20 are the areas involved in reducing the net area for estimating the effective load-carrying section of the specimens. It can be seen that one section of the 75S-T6 joint between the bolt hole and the outside edge was completely fractured by the fatigue loading whereas the 24S-T4 joint did not completely fracture in this area. Before subjecting the 24S-T4 joint to the static loading, however, a saw cut was made into the bolt hole from the outside edge in order to produce more nearly identical conditions in the two specimens. The location of the cut is shown in figure 20. Thus for purposes of the comparison this section of the joint has been considered as though it had been completely fractured in fatigue. Further, the additional failure in the centrally located portion of the joint adjacent to the bolt hole in the 75S-T6 joint caused a substantially larger reduction in the section than was the case in the 24S-T4 joint. Thus the cracked 75S-T6 joint would be expected to be subjected to a larger eccentricity of loading than the cracked 24S-T4 joint.

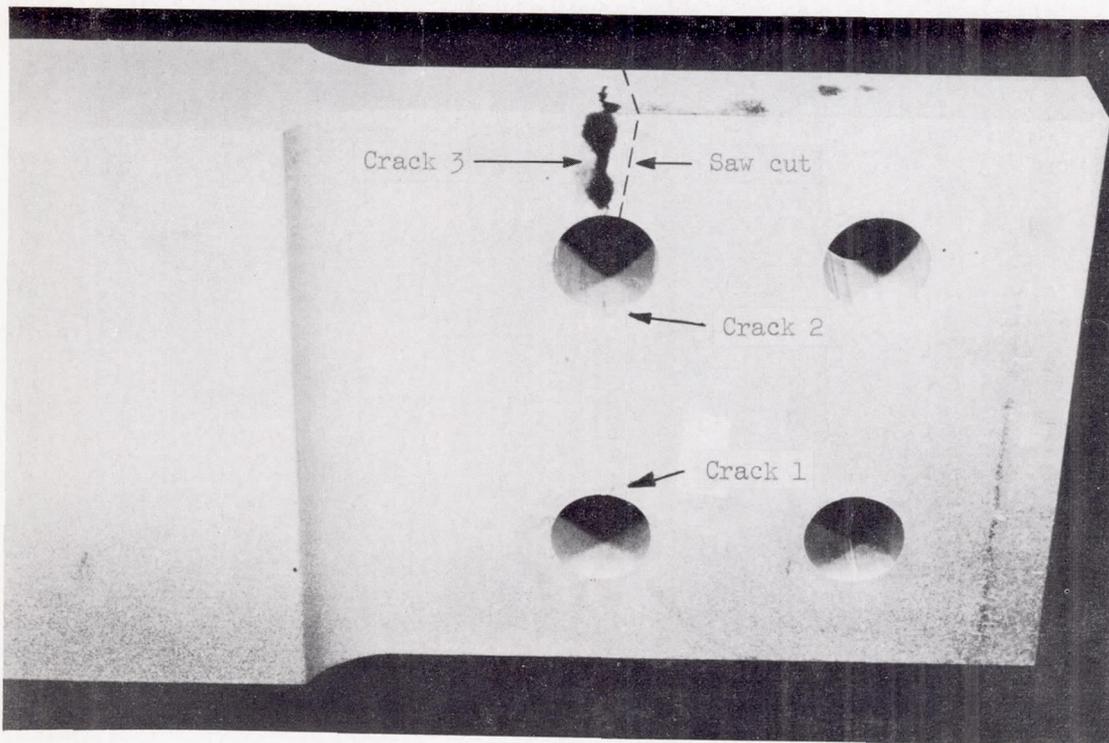
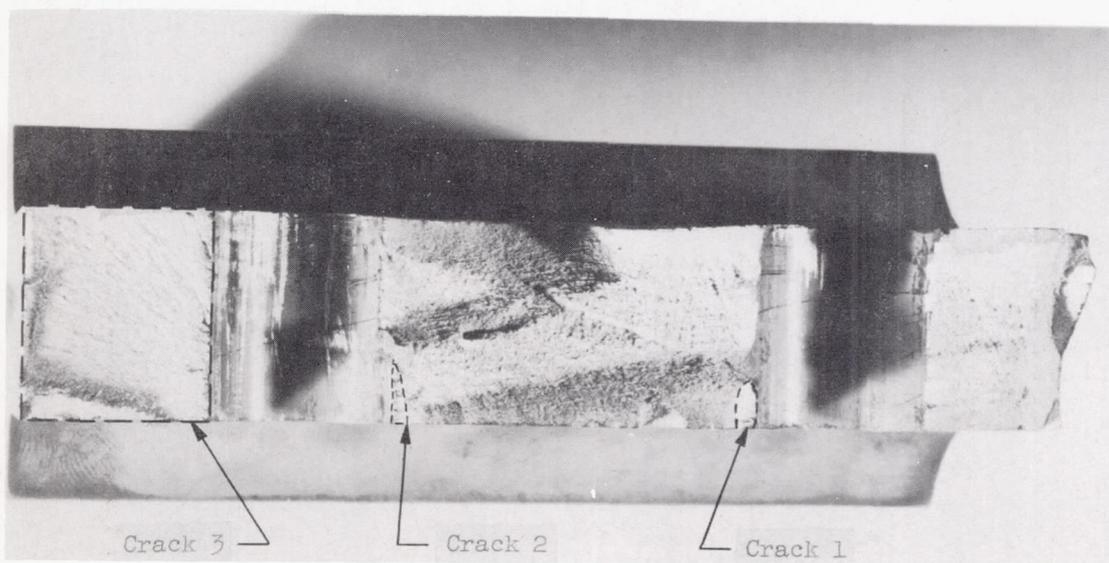
Figure 20.- Failures in 24S-T4 double-shear joint. Specimen 6D. (For enlargement of small cracks see fig. 21.)

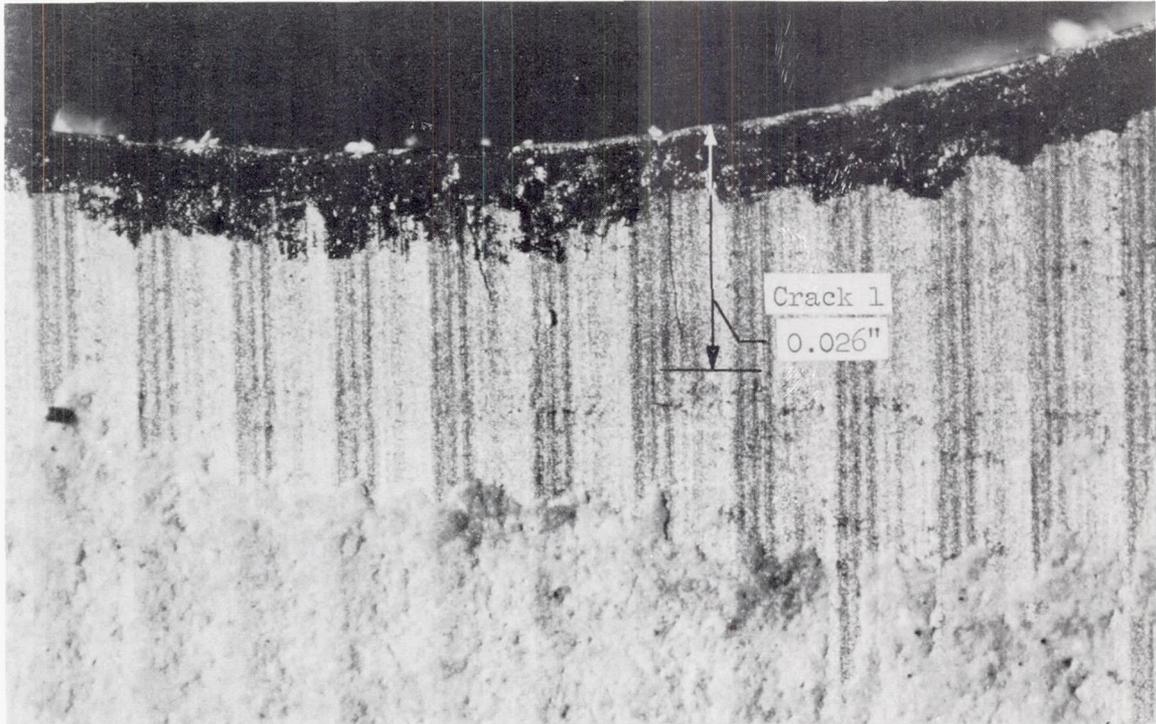
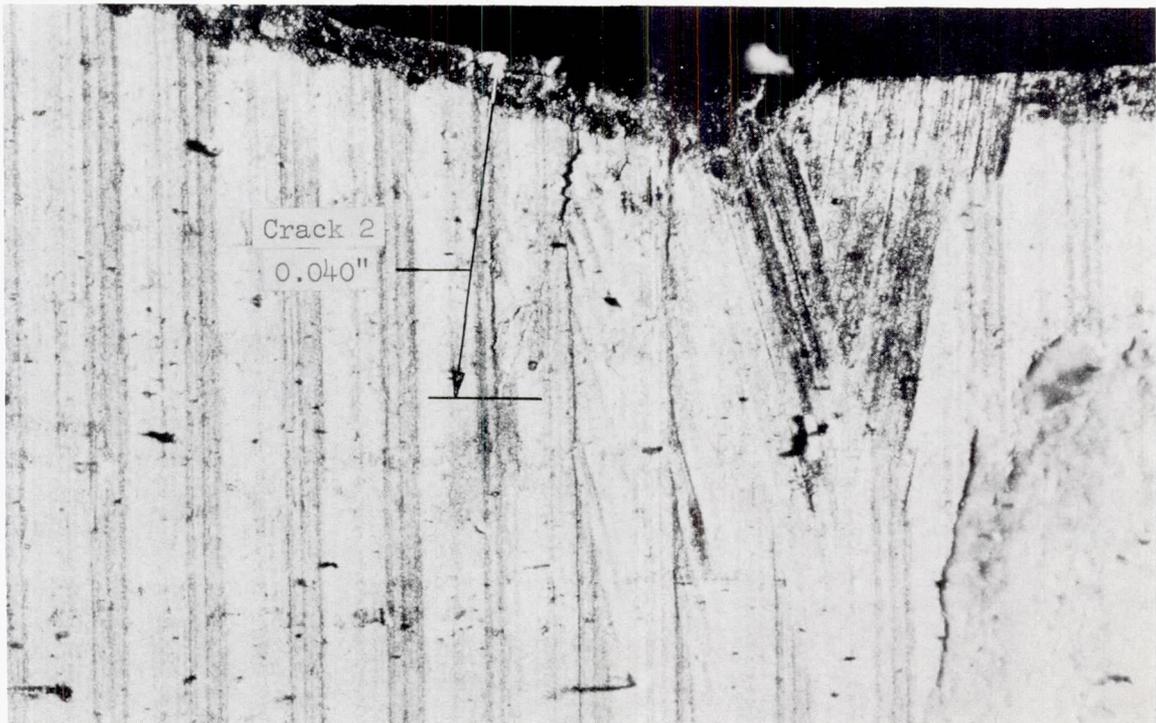
L-83701
Figure 21.- Enlargement of failures in double-shear joint. 50X. (For location see fig. 20.)

^aExtent of fatigue cracks shown in figs. 20 and 21.
