TECHNICAL NOTE 4100

VIBRATION SURVEY OF FOUR REPRESENTATIVE TYPES OF
AIR-COOLED TURBINE BLADES

By Howard F. Calvert and Gordon T. Smith

Lewis Flight Propulsion Laboratory
Cleveland, Ohio

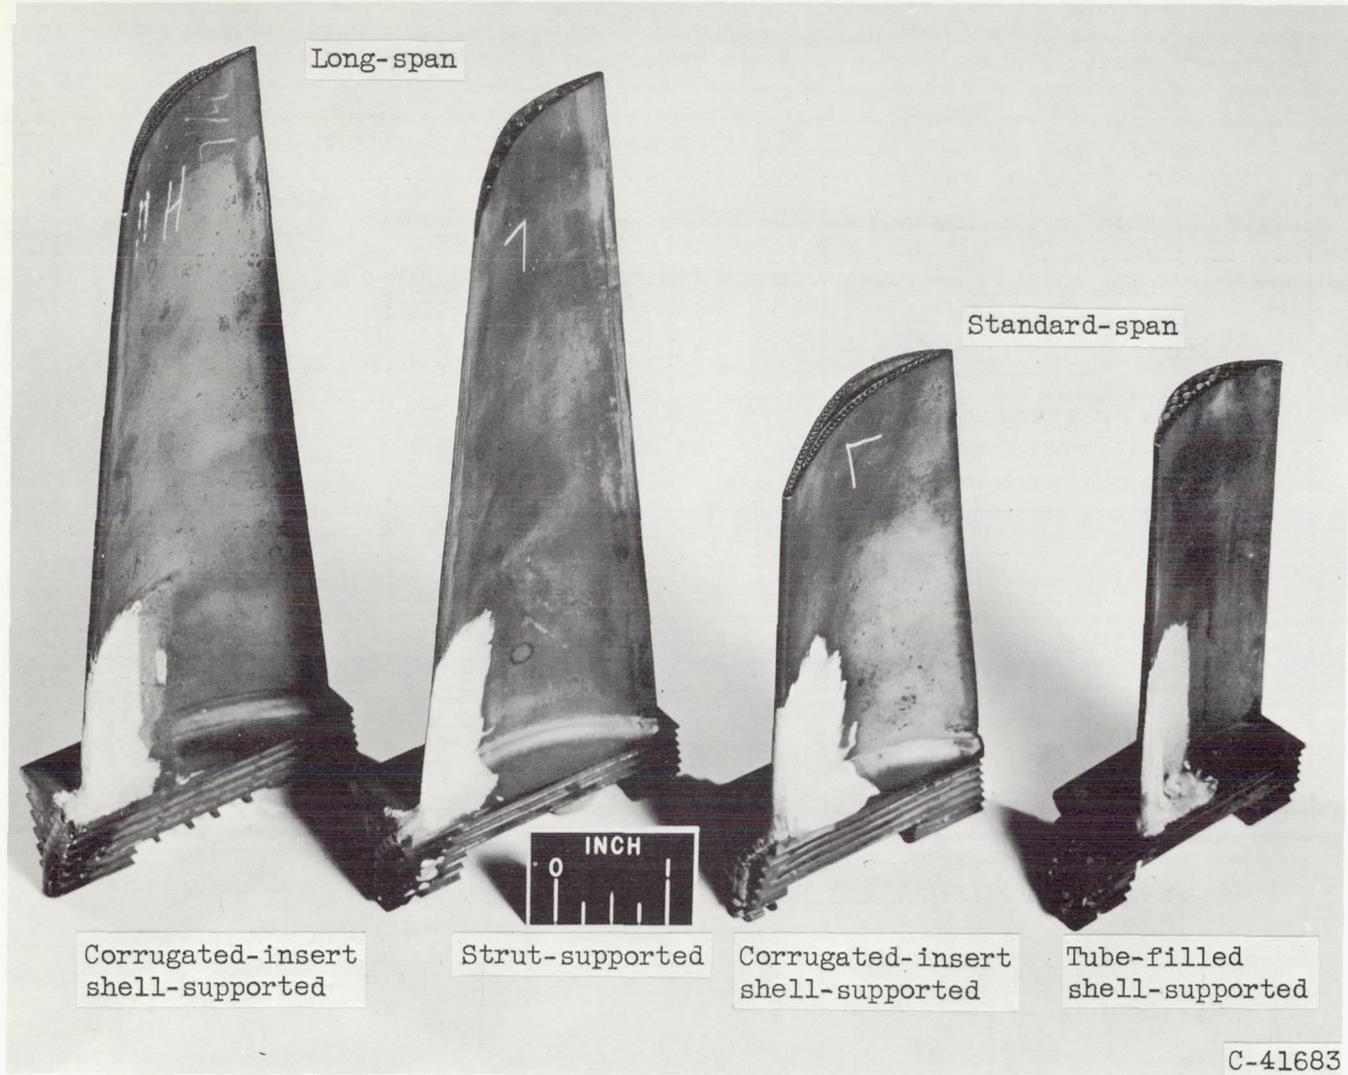
Figure 1. - Four blade types tested.

A blade of each of the four types of air-cooled turbine blades investigated is shown in figure 1. The reference name for each blade is indicated. Table I shows the sketches of the tip cross sections, and

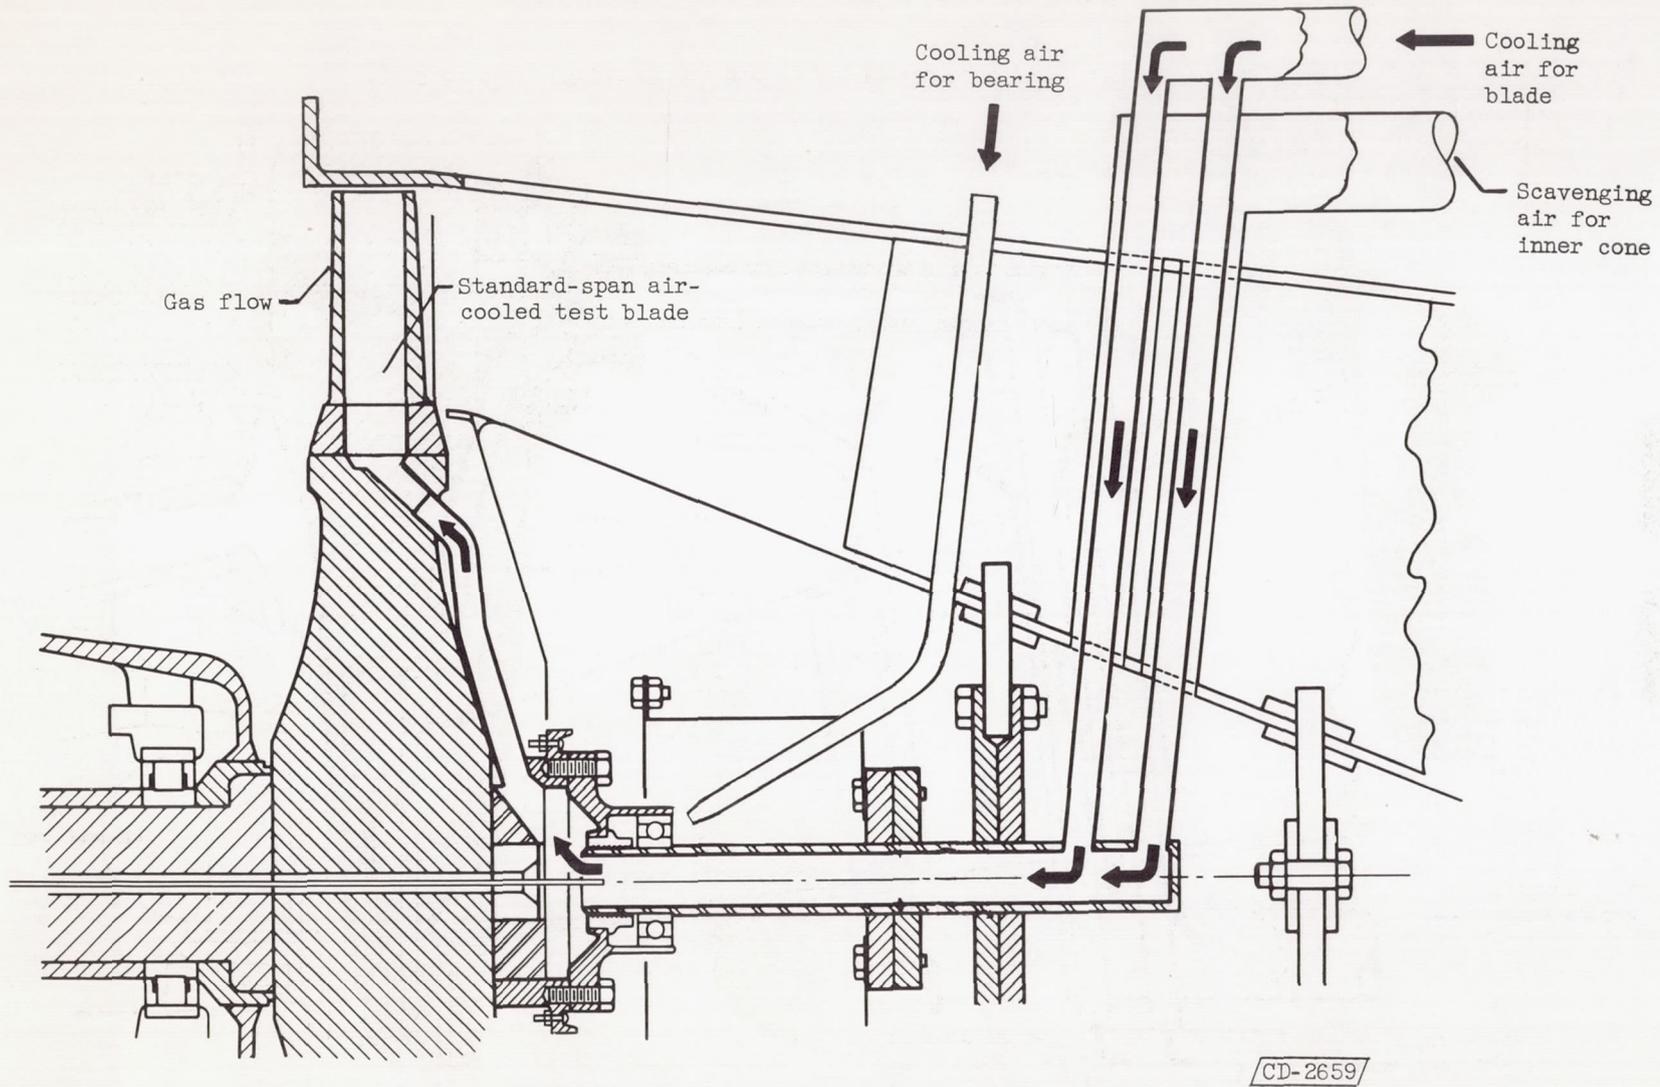
Figure 2. - Tailcone and air-supply system used for short-span blades.

The engine investigation was conducted with a turbojet engine operated in a sea-level static test stand. The test engine had a centrifugal compressor and a single-stage turbine modified to supply cooling air to two test blades located 180° apart. The cooling air was supplied to the two test blades from the rear face of the turbine wheel through a special tailcone assembly shown in figure 2. The details of the modification of the turbine rotor and tailcone are given in reference 5.

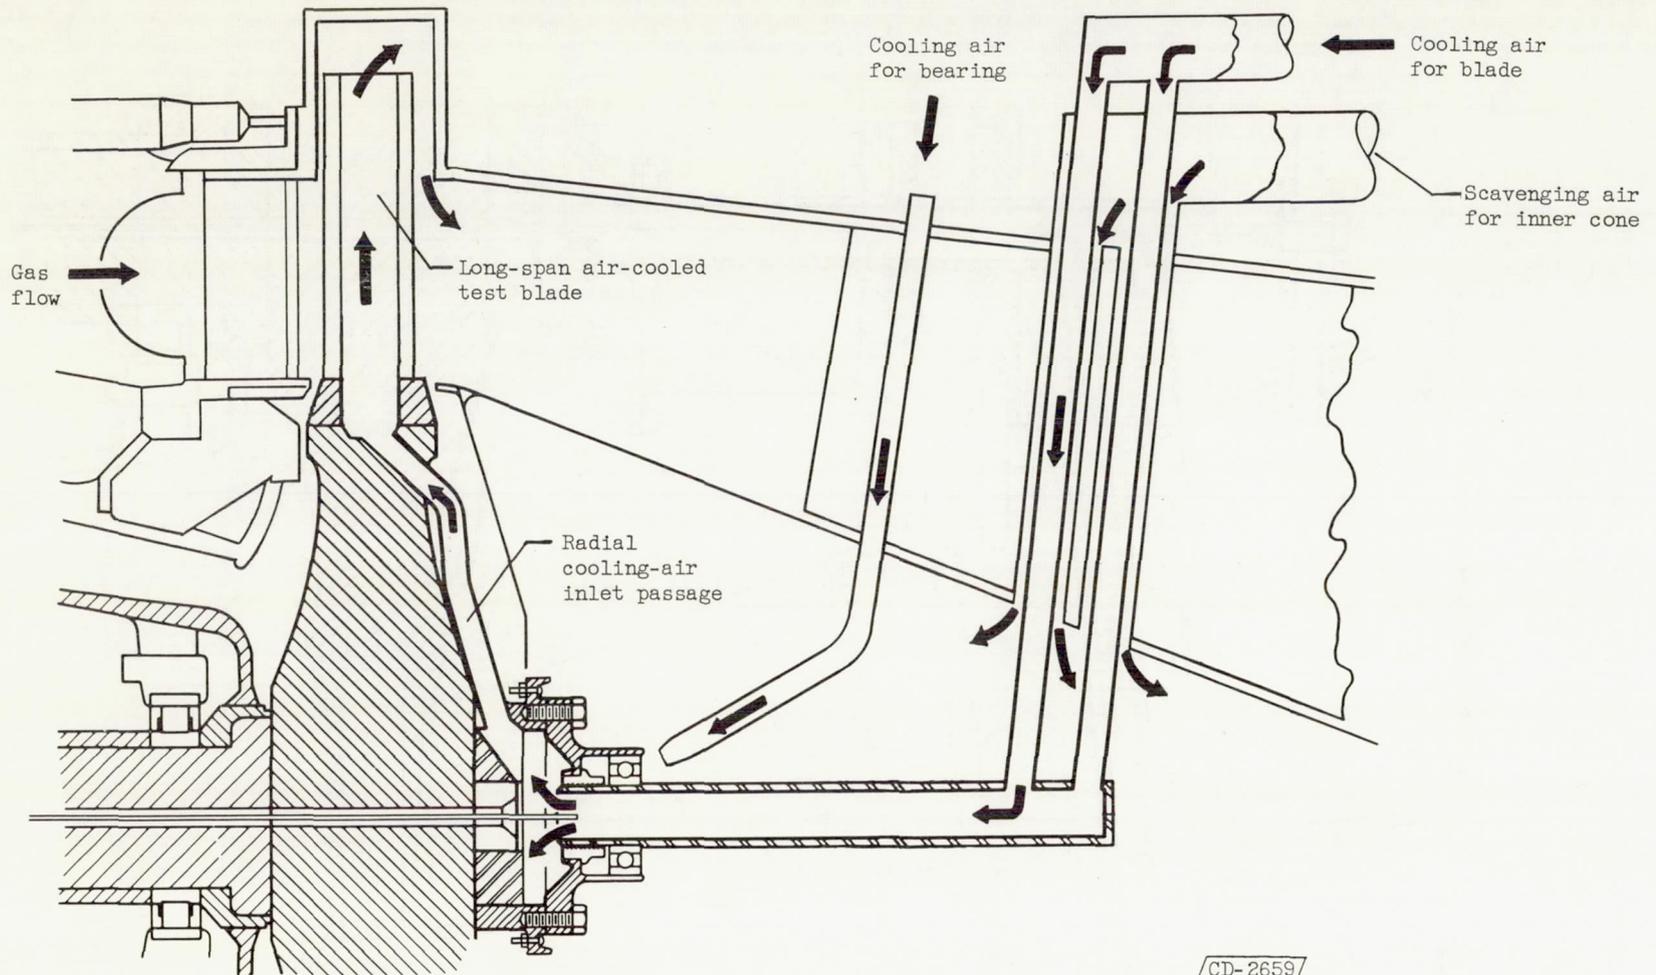
Figure 3. - Tailcone and air-supply system used for long-span blades.

The tailcone modifications reported in reference 5 were used only with the standard-span (4-in.) blades (standard production length for blades in the engine of this investigation). Additional modifications of the turbine shroud were made to accommodate the long-span ($6\frac{1}{4}$ in.) blades. Figure 3 schematically shows the special shroud that was used for this part of the investigation. The "nontest" blades were the same for the testing of all four types of blades. Therefore, the long-span blades extended radially approximately $2\frac{1}{4}$ inches beyond the tip of the other turbine blades. These portions of the test blades were partially shielded from the high-velocity working gas stream. The time and expense of providing a test facility in which a rotor, fully bladed with the long-span blades, could be tested was regarded as prohibitive. Therefore, the tailcone modifications described herein were utilized. The possible effect of this arrangement on the test results is discussed later.

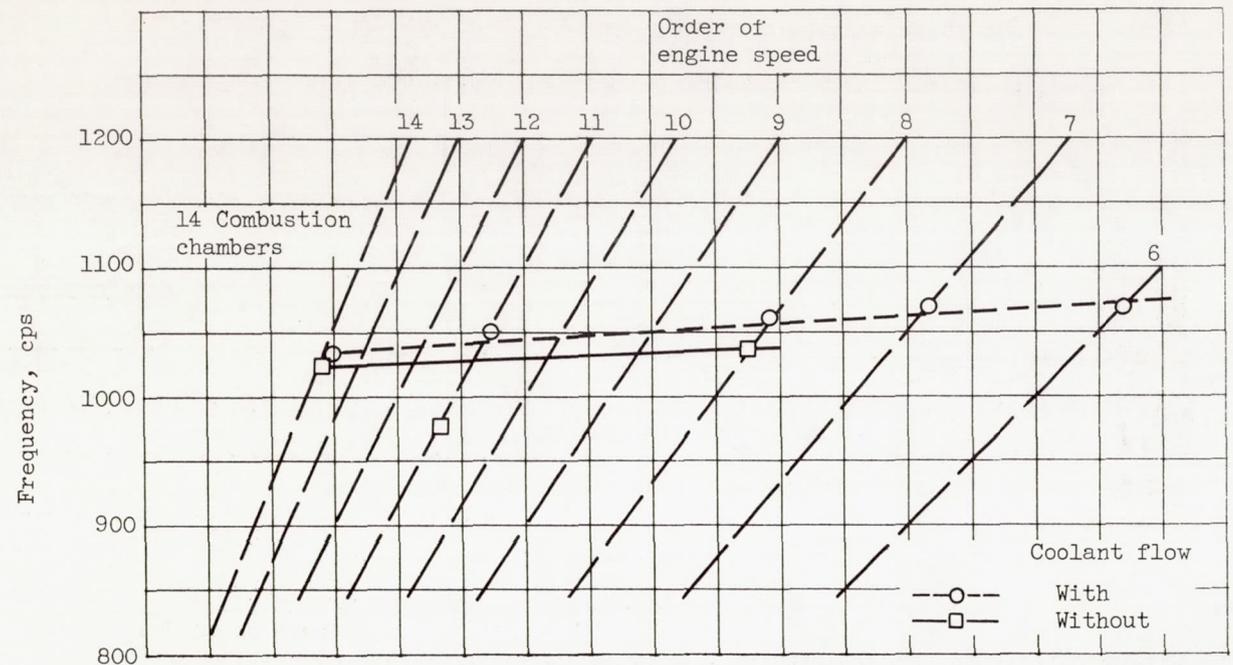
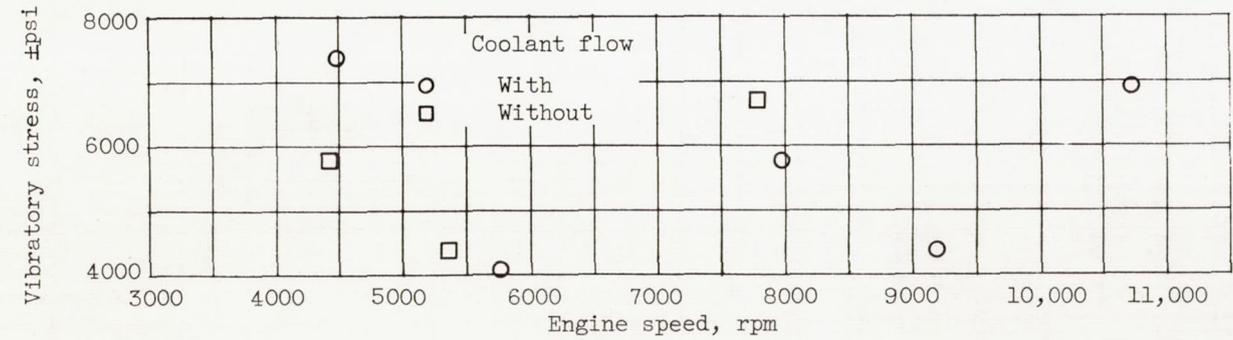
(a) Critical speed diagram.

(b) Measured vibratory stress.

Figure 4. - Measured blade frequencies and vibratory stress of standard-span tube-filled shell-supported blades.

Tube-filled shell-supported blade. - Figure 4 presents vibratory frequency and stress data. These data include the number of peaks or critical vibrations, the change in vibration frequency with coolant flow, and the vibratory stress at each critical speed. It can be noted in figure 4(a) that the sixth- and seventh-order vibrations were observed only with coolant flow. Hence, this blade type was more susceptible to vibration with coolant flow than without; that is, more vibrations were observed with coolant flow. Also, with a coolant flow rate of about 8 percent the vibrational frequency was increased approximately $2\frac{1}{2}$ percent. For example, with the eighth-order vibration the frequency was increased from approximately 1035 to 1060 cycles per second. Calculations based on temperature measurements from previous heat-transfer investigations indicated that the frequency increase was due to the increase in the blade-material modulus of elasticity with a decrease in blade-material temperature. The fourteenth-order vibration was probably excited by the presence of 14 combustor cans.

The peak vibratory stresses reported in figure 4(b) varied between ± 4000 to ± 7500 psi; however, the peak stress measured either with or without coolant flow was approximately the same, indicating that coolant flow had little effect on peak vibratory stress. These peak vibrations occurred over a narrow speed range and the resonant peaks were sharp and often difficult to obtain. Figure 5(a) presents a typical oscillogram showing the resonant-type vibration signal obtained with the tube-filled-type, air-cooled turbine blade.

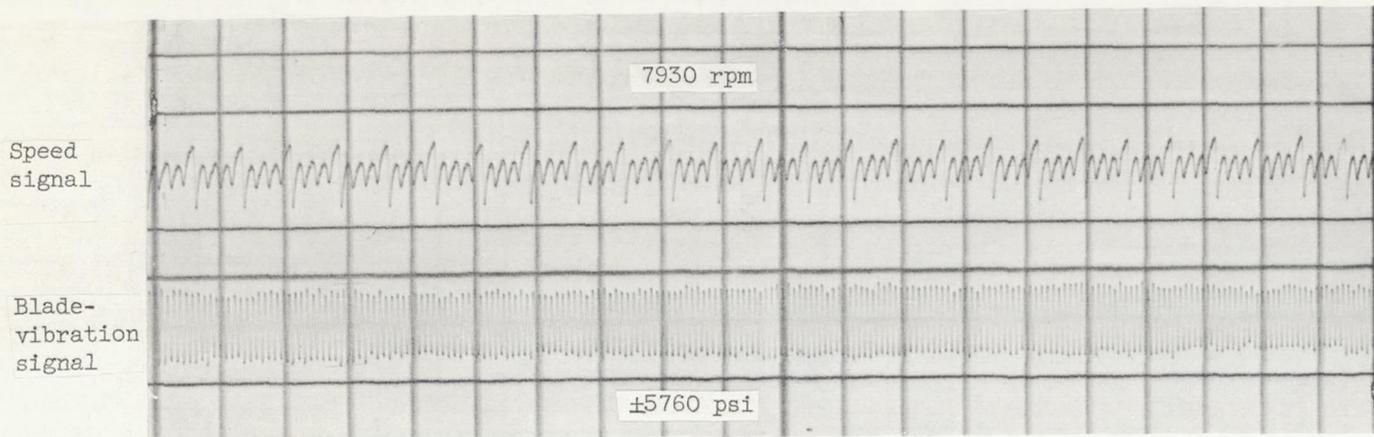
(a) Resonant-type vibration characteristic of standard-span tube-filled shell-supported blade.

Figure 5. - Typical oscillograms of air-cooled turbine blades.

signals for the corrugated-insert, shell-supported and solid blades were the same as for the tube-filled blade shown in figure 5.

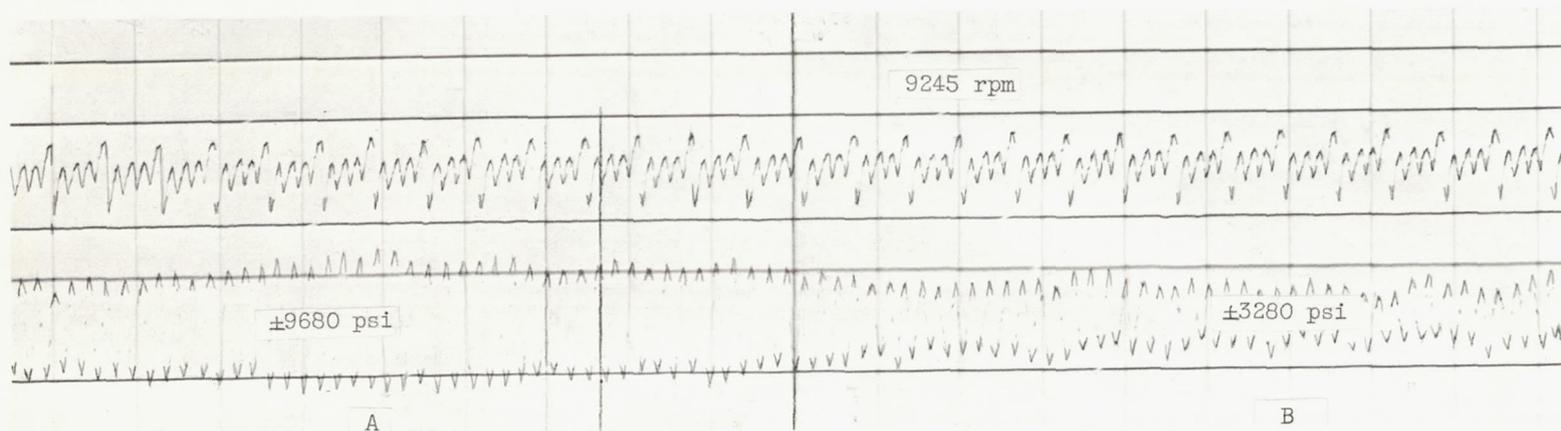
(b) Characteristic vibration signal for long-span, strut-supported blade.

In figure 7(b) the maximum vibratory stress was approximately ± 9680 psi at 9250 rpm without coolant flow. At speeds below 8700 rpm, the maximum stresses were measured with coolant flow. Figure 5(b) presents a typical oscillogram showing the characteristic vibration for a long-span strut-supported blade. Close examination of figure 5 shows that the amplitude of the long-span blade vibration is constantly changing. With the standard-span blade the amplitude was relatively constant. In figure 5(b) the stresses vary from approximately ± 3280 to ± 9680 psi, and the stresses varied in a like manner at all speeds. The excitation of these blades may have been associated with or influenced by the testing environment described in APPARATUS AND INSTRUMENTATION and shown in figure 3. The varying-amplitude-type vibration signal is considered to be associated with a stalling condition in axial-flow compressors. Since the tips of

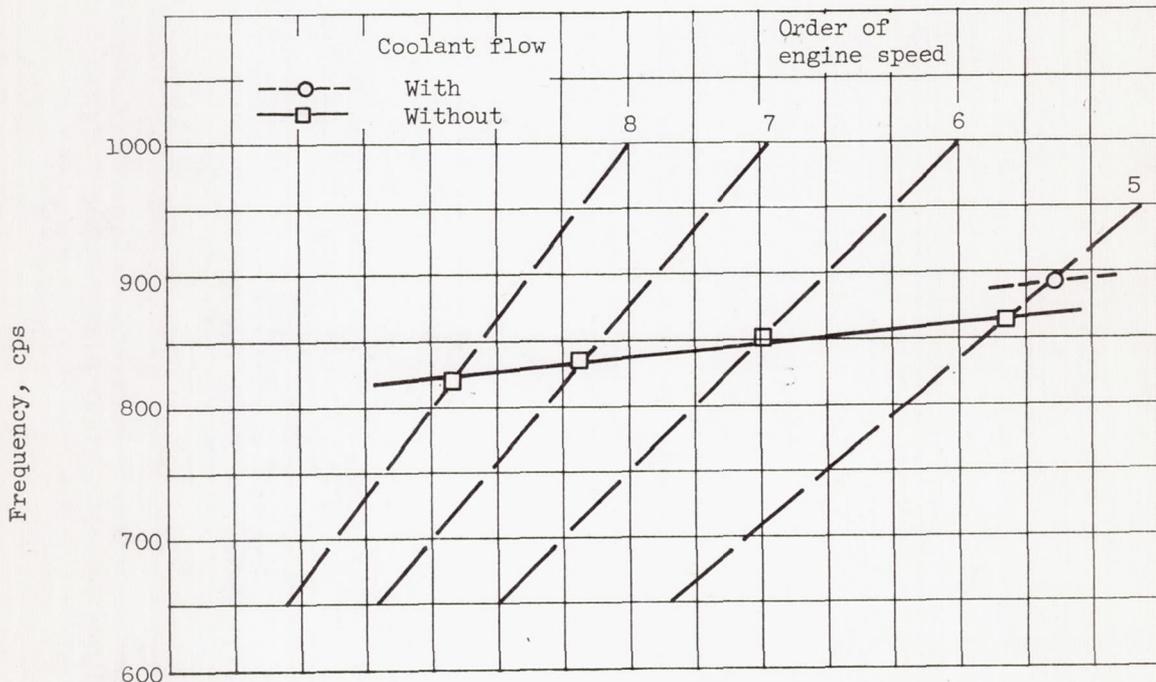
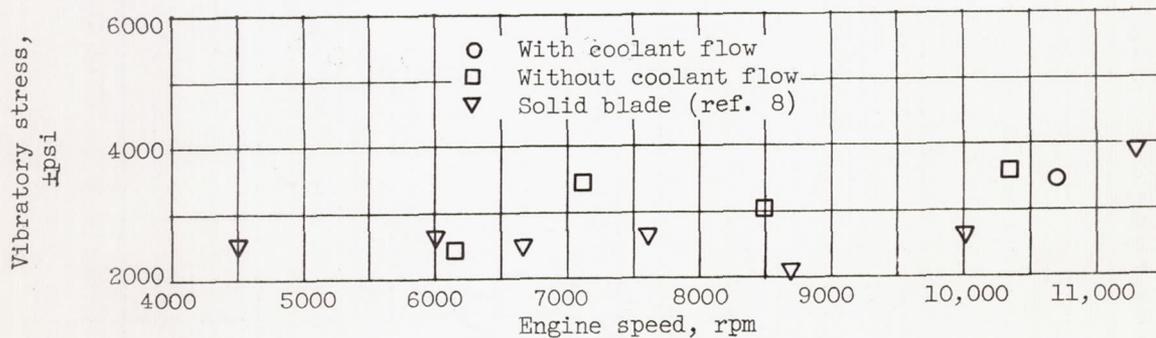
(a) Critical speed diagram.

(b) Measured vibratory stress.

Figure 6. - Measured blade frequencies and vibratory stresses in standard-span corrugated-insert shell-supported blade.

Corrugated-insert shell-supported blade. - The frequency and stress data are plotted in figure 6. The only vibration that was observed when the corrugated-insert shell-supported blade was operated with coolant flow was the fifth-order vibration. The fifth, sixth, seventh, and eighth orders of vibration were observed when the blade was operated without coolant flow. Therefore, this blade type was more susceptible to vibration when operated without coolant flow, or just the opposite result of that obtained with the tube-filled blade. The vibrational frequency was raised about 3 percent when the blade was operated with coolant flow.

The peak vibratory stresses measured were approximately ± 3500 psi (fig. 6(b)) or approximately one-half as high as for the tube-filled blades. These peak vibrations also occurred over a narrow speed range. Also plotted in figure 6(b) are the vibratory stresses measured in another investigation and reported in figure 4 of reference 8. These data were obtained with high-temperature strain gages mounted on solid blades used in the same type engine as this investigation. The vibratory stresses were of approximately the same magnitude as those reported herein for the corrugated-insert shell-supported blade. The characteristic vibration

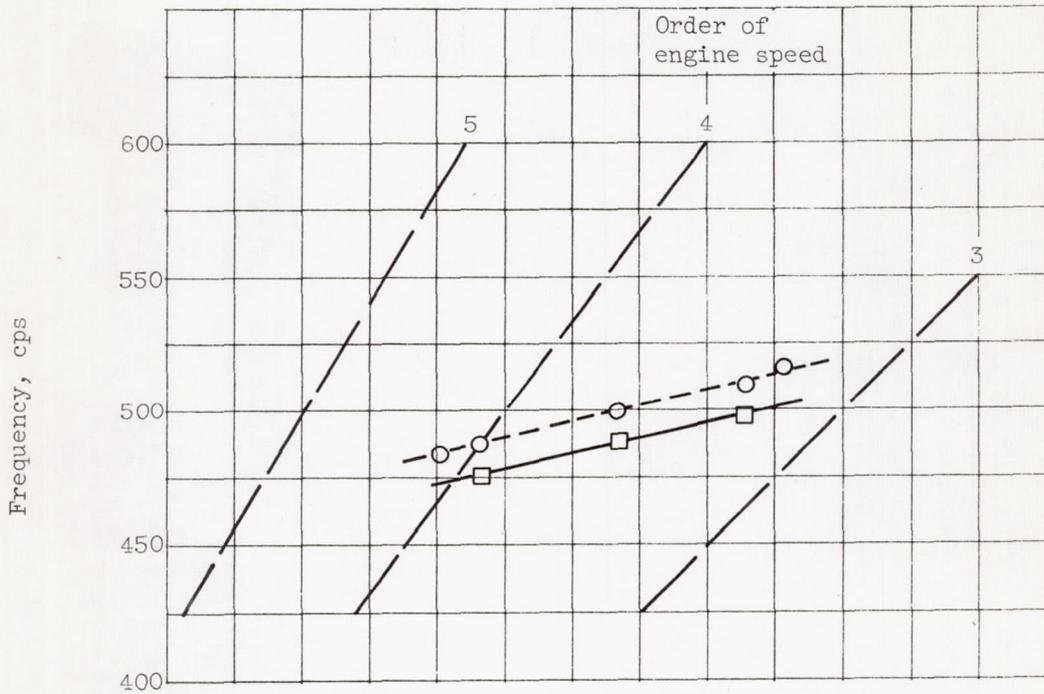
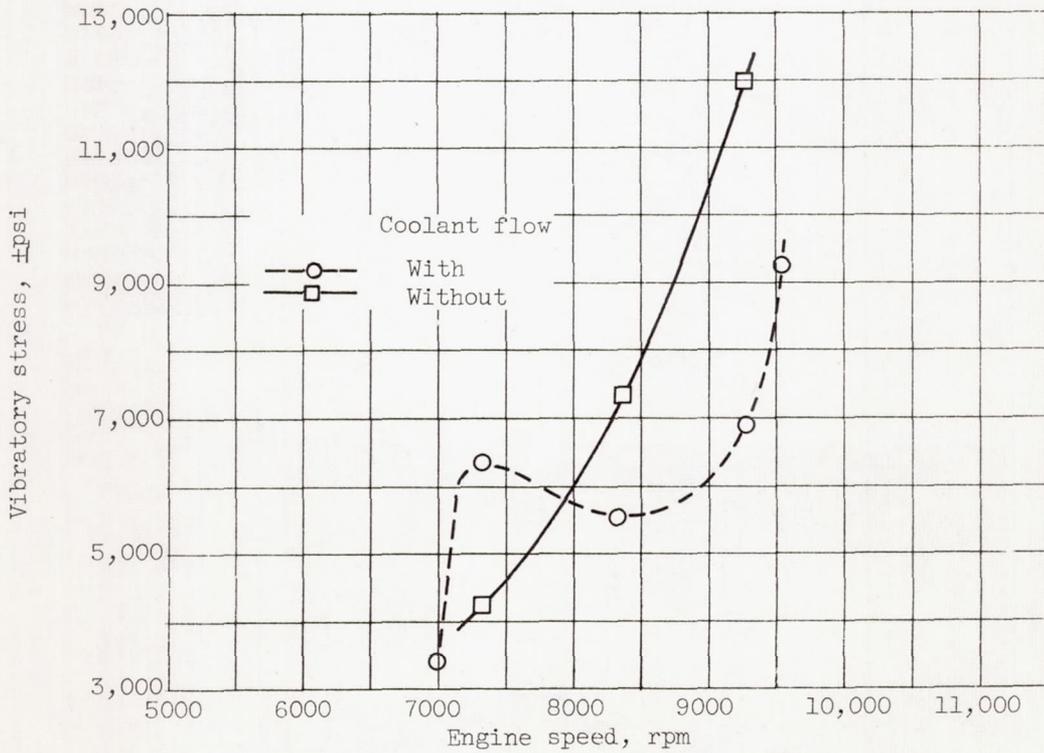
(a) Critical speed diagram.

(b) Measured vibratory stress.

Figure 8. - Measured blade frequencies and vibratory stresses in long-span corrugated-shell-supported blade.

Corrugated-insert shell-supported blades. The vibration data for the corrugated-insert shell-supported blades are reported in figure 8. The vibration frequency and character of the strain-gage signals were the same for both the strut-supported and corrugated-insert, shell-supported long-span blades. That is, the blades were vibrating at all speeds with an irregular amplitude. With the corrugated-insert, shell-supported blades, the vibration frequency was increased approximately 3 percent with coolant flow.

The maximum vibratory stress of $\pm 12,000$ psi (fig. 8(b)) was measured at 9250 rpm without coolant flow. Above 8000 rpm the stresses increased very rapidly with increased engine speed either with or without coolant flow.

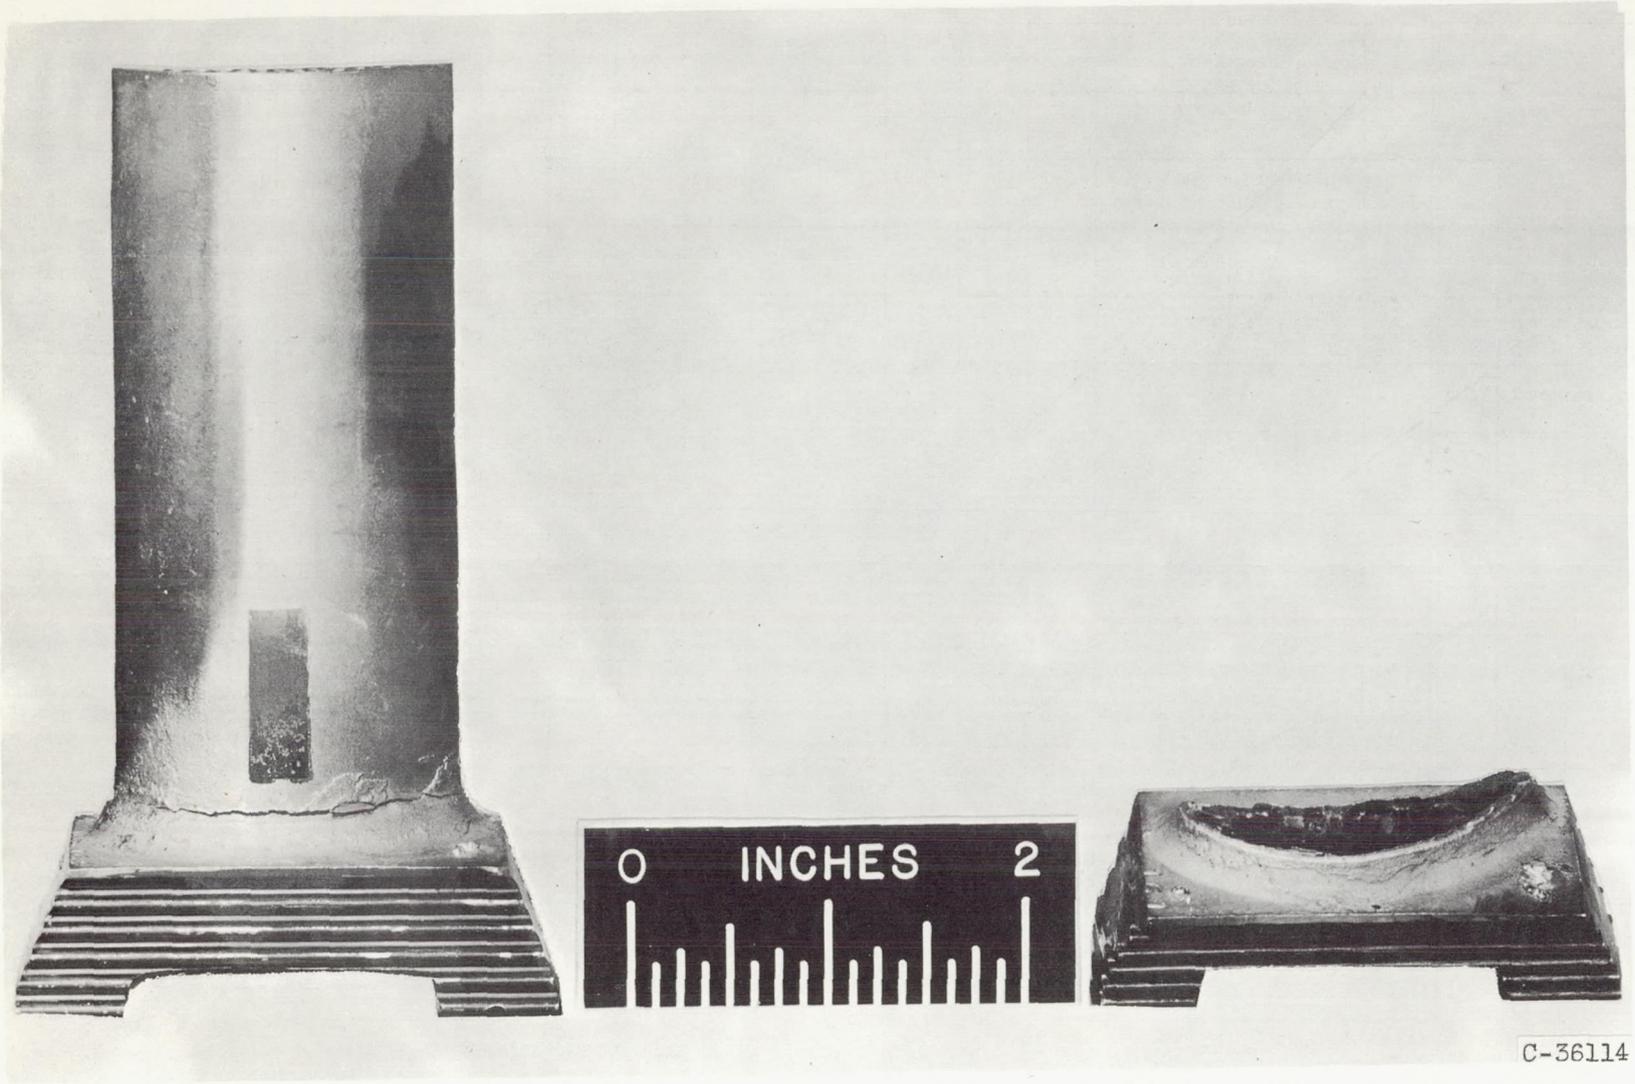
Figure 9. - Typical failures of short-span tube-filled shell-supported blades.

Tube-filled shell-supported blade. - Figure 9 shows a typical tube-blade failure obtained during engine operation and reported in reference 1. Blades 1 and 2 of static investigation reported herein (table II) also exhibited fatigue failures at the same location. With a vibratory stress of $\pm 10,000$ psi, blade 2 failed in only $7\frac{1}{2}$ hours. Figure 4 shows that vibratory stresses as high as approximately ± 7500 psi were measured during engine operation. A vibratory stress of ± 7500 psi may appear to be too low to cause blade failure; however, because of stress concentrations at the fillet, the stress at the point of failure would be many times higher or high enough to cause blade failure.
