November 1944 as  
Advance Restricted Report 4J06

A STUDY OF PISTON AND RING FRICTION

By W. A. Leary and J. U. Jovellanos  
Massachusetts Institute of Technology

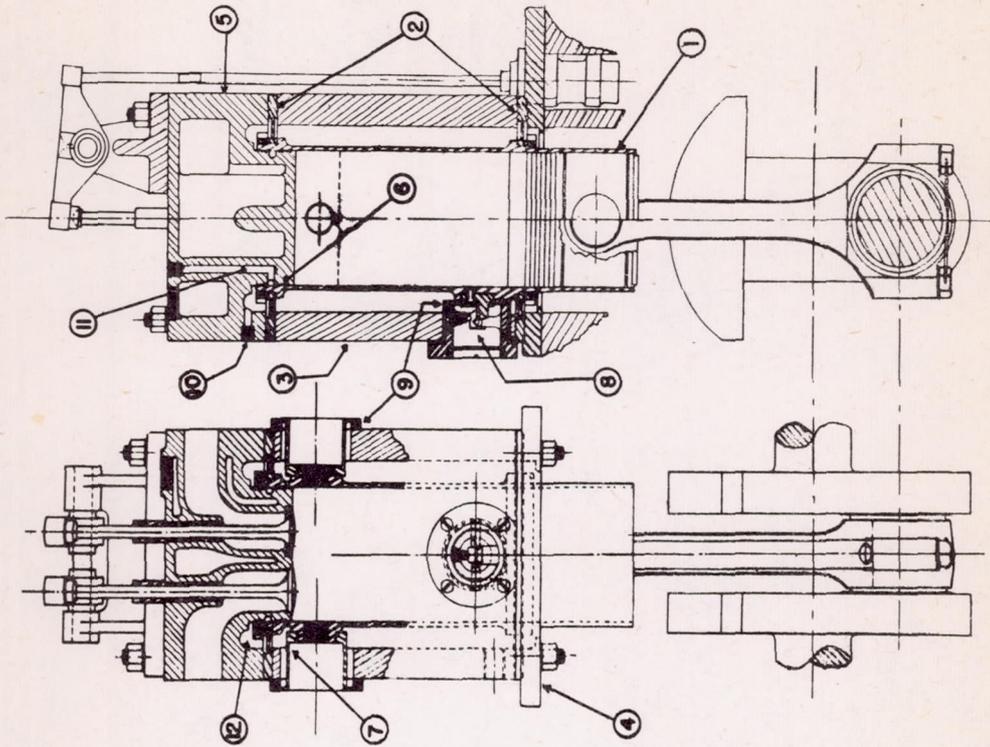
Figure 1.- Assembly drawing of friction engine cylinder.

The cylinder head closed the combustion chamber by means of a piston-shaped section which fitted closely, but did not touch, the cylinder sleeve. A series of grooves machined in this section formed a labyrinth seal (6) which reduced the leakage of gases from the cylinder. This cylinder head will be referred to in this report as "no. 1 cylinder head".

of flexible neoprene seals (9). Leak-off holes (10) drilled in the side of the cylinder head into the space (12) above the diaphragm took care of gas and oil leakage through the labyrinth and assured atmospheric pressure on the upper diaphragm.

Gas leakage was minimized by pumping oil into the labyrinth through a duct (11) leading through the top of the cylinder head. The oil then passed out the leak-off holes and to the oil reservoir, except for a small amount which leaked into the combustion chamber. The oil was supplied to the head at about 50 pounds per square inch pressure, and was of the same type as the oil used in the crankcase.

A beam of light, thrown on the mirror (8), was reflected onto a photographic film which moved at right angles to the piston motion. Thus, as the sleeve was pulled up and down on the flexible diaphragms by the friction force of the moving piston, a wave form was impressed on the film. The wave form provided a means of determining piston friction under actual operating conditions.

by means of a thin strip of steel to a blind plug screwed in the spare spark plug hole (see fig. 1). Oscillations of the cylinder sleeve imparted a motion to the phonograph needle, and the output was fed through an integrating circuit and pre-amplifier to a cathode-ray oscillograph where the wave form could be continuously observed. A certain amount of extraneous mechanical vibration was taken up by the pickup unit, and an electrical disturbance was observed at the occurrence of spark, but with a little experience it was an easy matter to correlate this somewhat distorted wave form with the true wave form recorded by the optical system. Another valuable feature of the visual system was that it gave an instantaneous indication as to whether or not the apparatus was working satisfactorily. Lacking this information, a whole run might be wasted. Also the visual system was of assistance in determining the correct oil supply for the new head.

During the calibration the jacket water was maintained at 180° F because this was the standard jacket temperature for all runs. What change, if any, took place in the over-all sensitivity of the apparatus under firing conditions is unknown, but such change was probably small since the diaphragms were in no way exposed to cylinder temperatures, and, moreover, the diaphragms formed the upper and lower surfaces of the water jacket (see fig. 1) through which a good circulation was maintained.

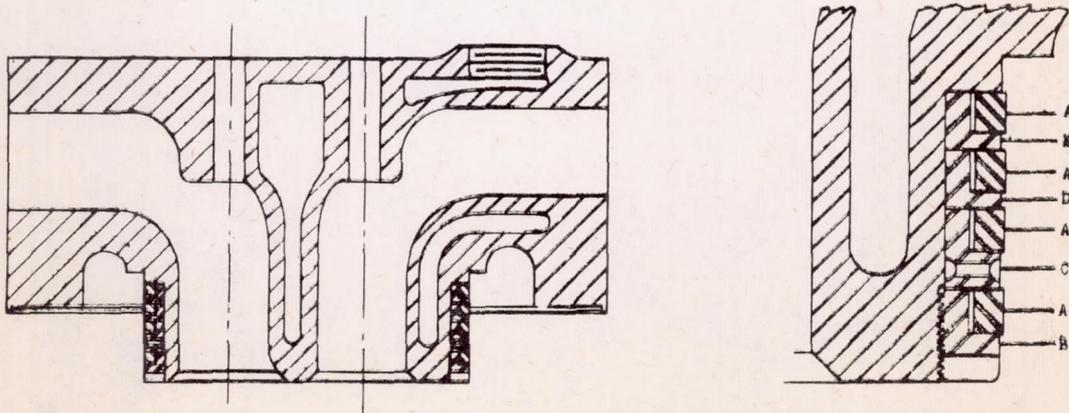
Enlarged section of ring assembly

Figure 3.- Sectional view of cylinder head No. 2 showing junk ring assembly.

The spacer ring C was grooved circumferentially inside and out, and drilled with eight radial holes. These grooves and holes allowed the passage of an oil stream which was fed into the head through a duct similar to that shown at (11) in figure 1. The oil was supplied at the rate of about 40 drops per minute by means of a Bosch fuel-injection pump, rotated at slow speed by an electric motor. The oil provided a film which helped to close the clearance space between the rings and sleeve, thereby reducing gas pressure leakage as well as providing lubrication.

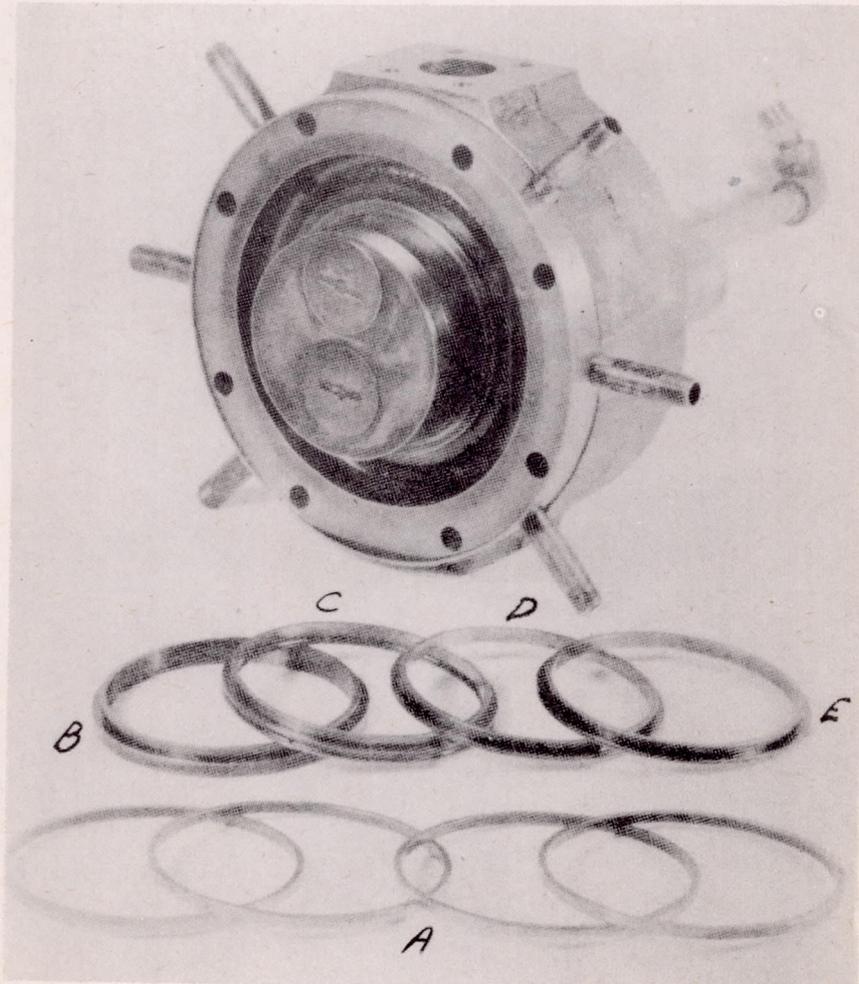
Figure 2.- Photograph of cylinder head no. 2, showing junk rings A, and spacer rings B, C, D, E.

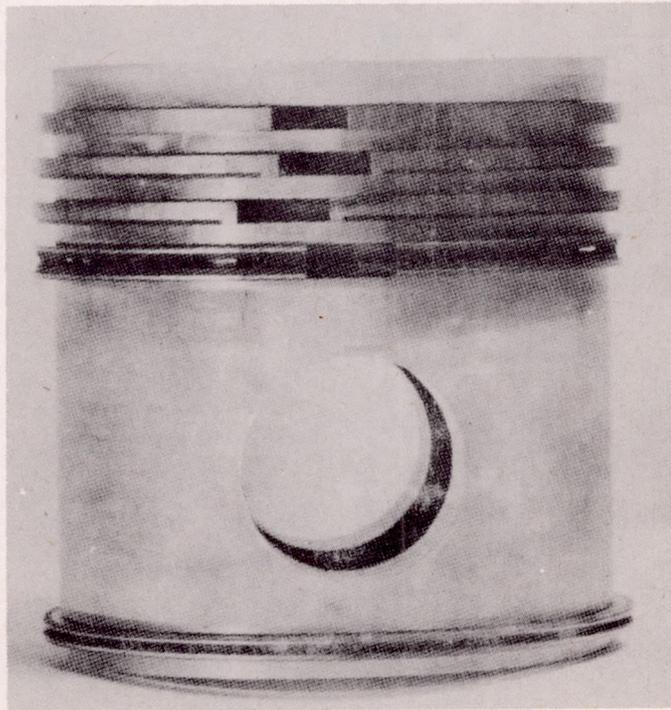
Figure 5.- Photograph of aluminum piston no. 2, and automotive-type cast-iron piston rings used in scuffing tests.

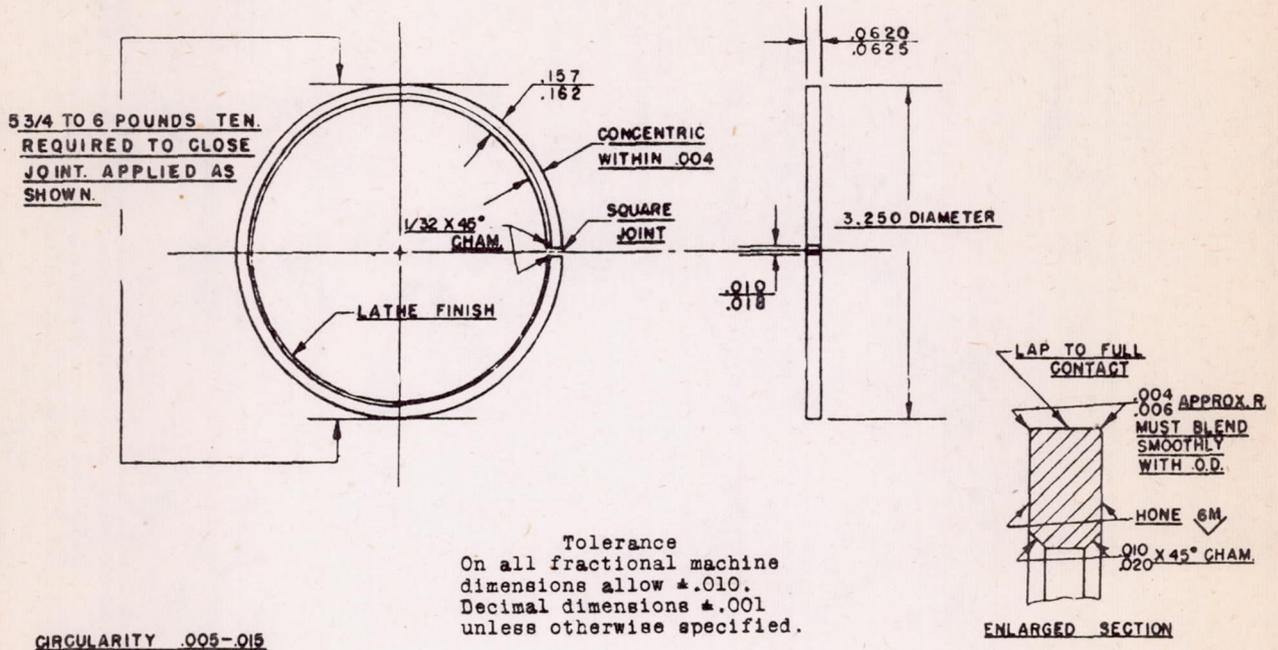
Figure 6 . Detail drawing of straight face, high tension compression rings used in Runs 13A and 13B.

(a) Surface of unused, straight face, compression ring lapped to full contact. The vertical lines are lapping marks, (see also Figure 6), 25 micro-inches r.m.s.

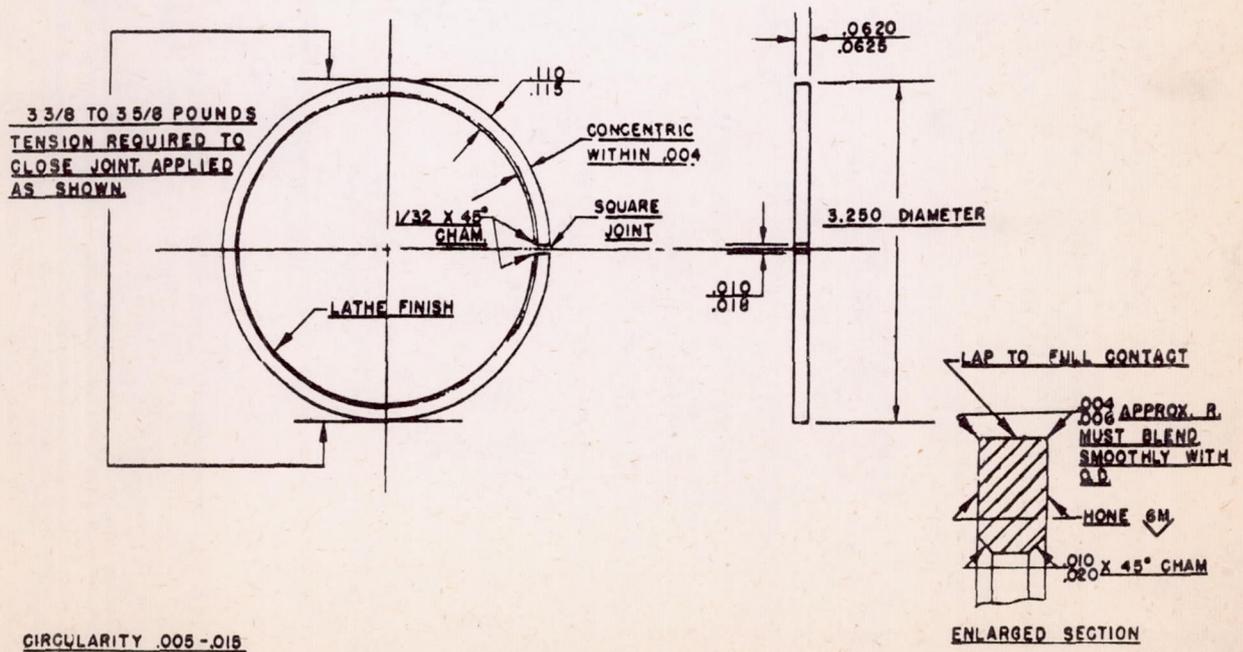
Figure 7 . Detail drawing of straight face, low tension compression rings used in Runs 14A and 14B.

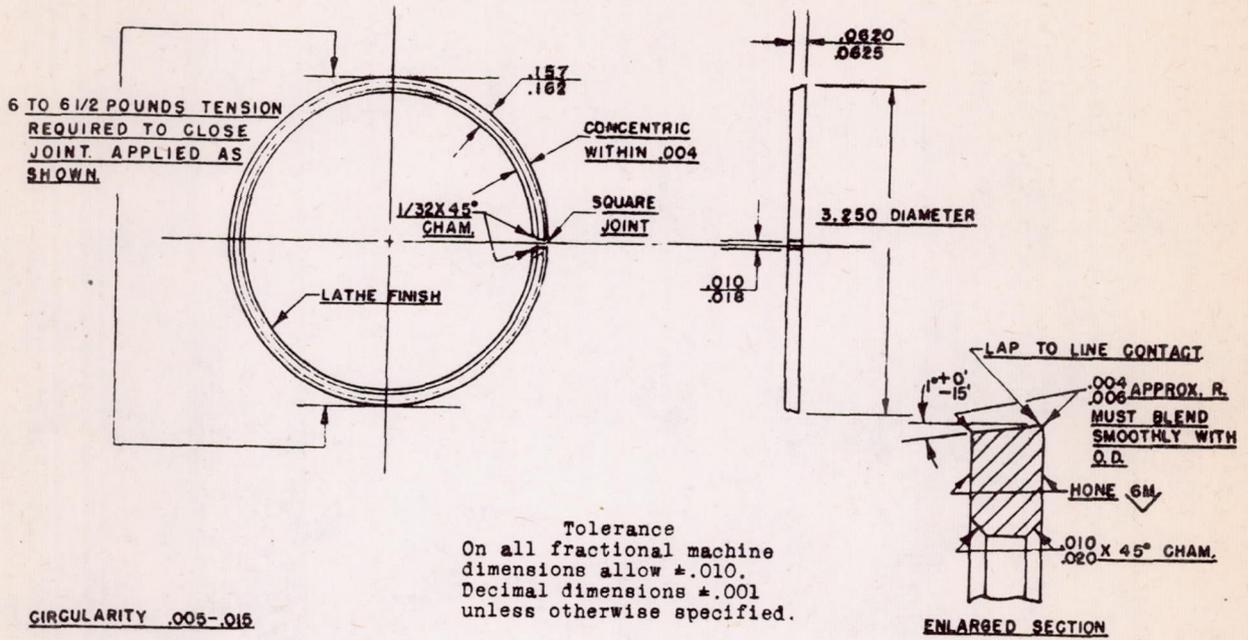
Figure 8 . Detail drawing of tapered face, high tension compression rings used in Runs 15A and 15B.

(c) Surface of unused, tapered face compression ring, lapped to "line" contact. The vertical lines on the lower edge are lapping marks (see also Figure 8).

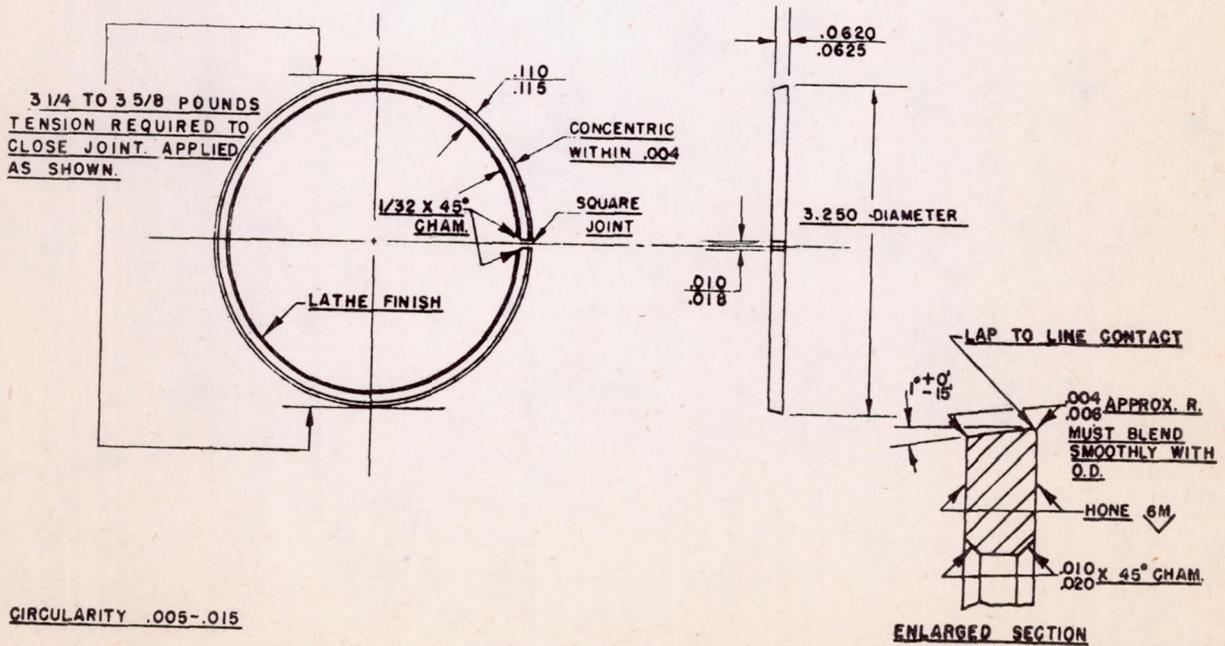
Figure 9 . Detail drawing of tapered face, low tension compression rings used in Runs 16A and 16B.

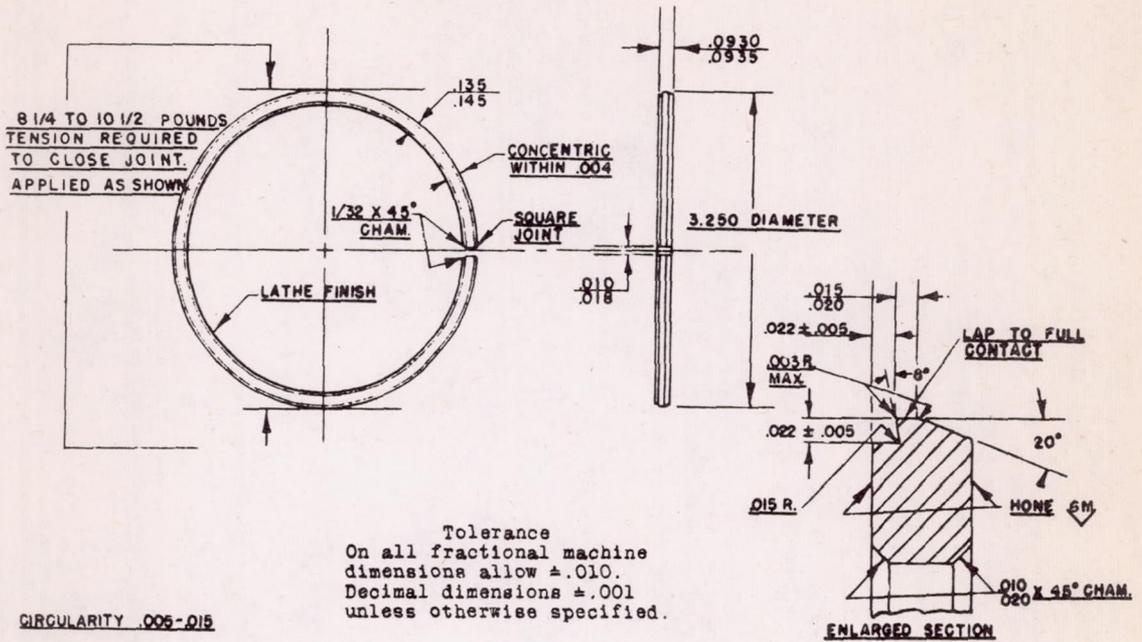
Figure 10. Detail drawing of beveled scraper rings

(b) Bearing surface of unused, beveled scraper ring lapped to full contact. The vertical lines are lapping marks (see also figure 10).

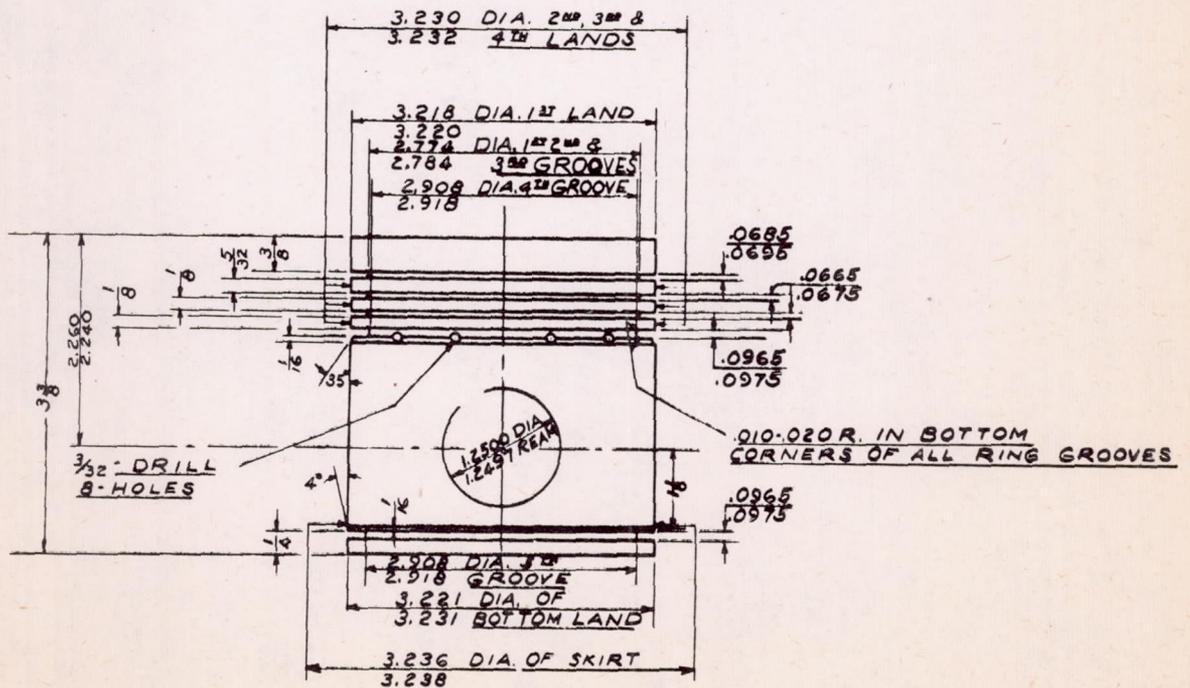
Figure 11.- Modified design of Ethyl Gasoline Corporation aircraft-type aluminum piston used in run-in tests.

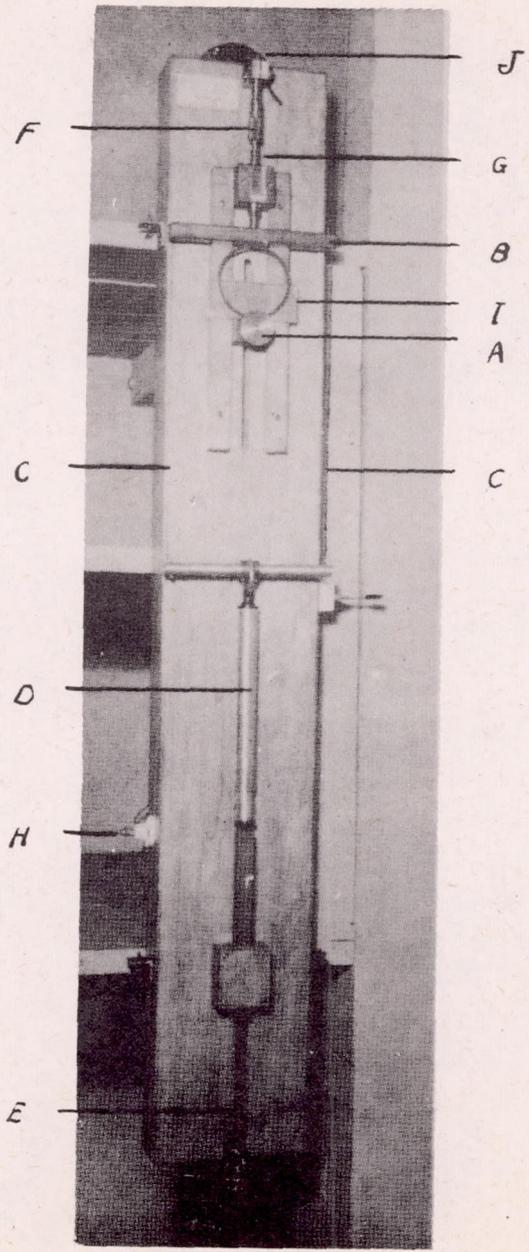
Figure 12.- Photograph of apparatus used for measuring diametral ring tensions.

The ring was then placed in the apparatus and the micrometer screw F tightened until the ring was compressed to the correct gap clearance. When the micrometer screw was in contact with the vertical shaft G on the sliding arm, a circuit was closed which caused the small lamp H to light.

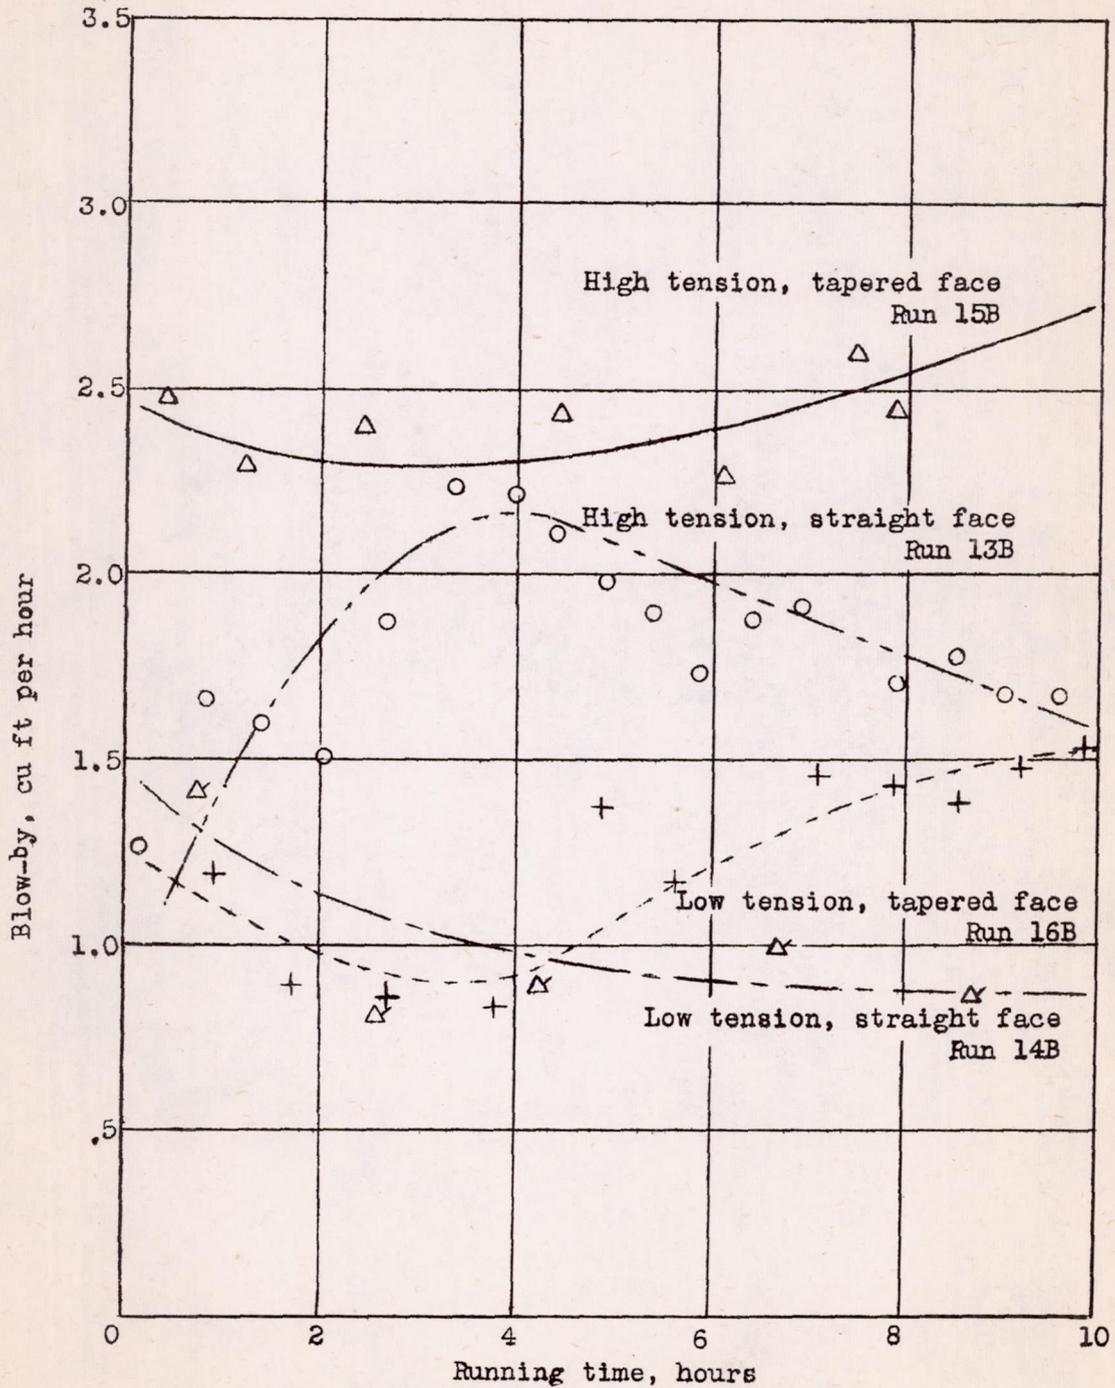
Figure 19.- Effect of running time on blow-by during the run-in period for various types of piston rings.

During each 10-hour run many observations of blow-by were taken (usually ten to twenty), although only a few of these data are shown in tables 2 to 5. However, all values of blow-by for the 10-hour runs are plotted in figure 19, where it will be observed that the scatter is large and the trends erratic.

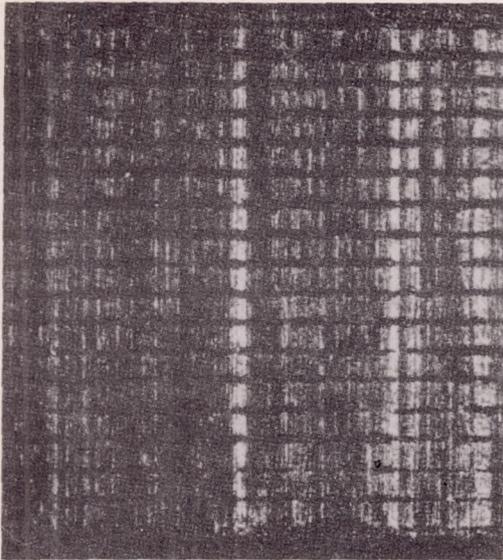
(a) Surface of unused, straight-face, unlapped compression ring. The horizontal lines are tool marks; the vertical lines are scratches.

(b) Surface of ring of the type shown at (a) after many hours of normal operation.

(c) Surface of ring of the type shown at (a) which was scuffed in run 11.

Figure 20.- Photomicrographs of surfaces of specimen automotive-type piston rings used in scuffing tests. Magnification 25 X.

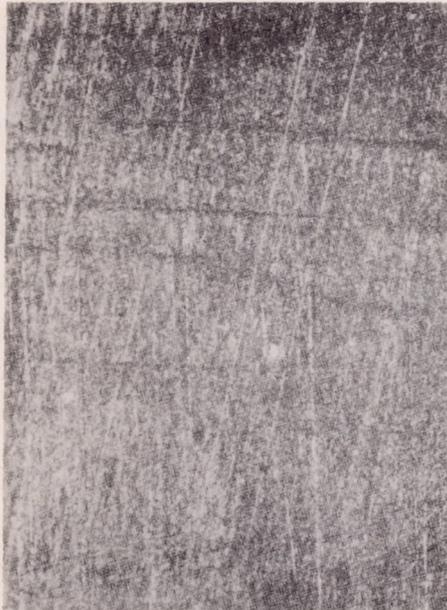
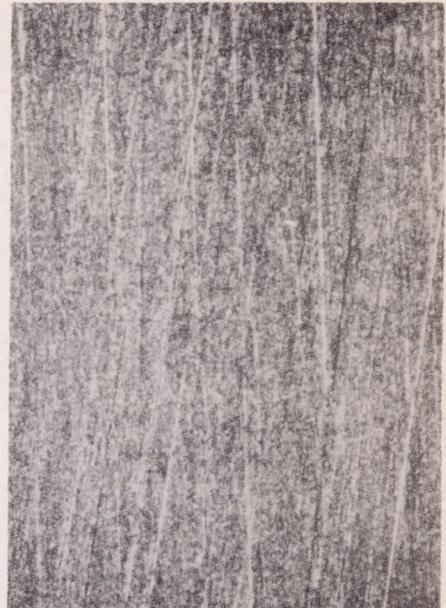
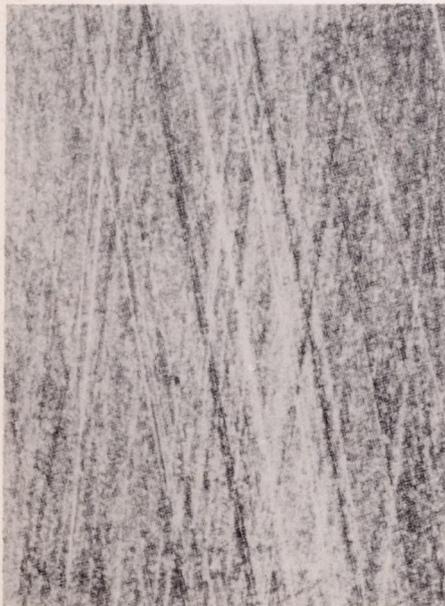
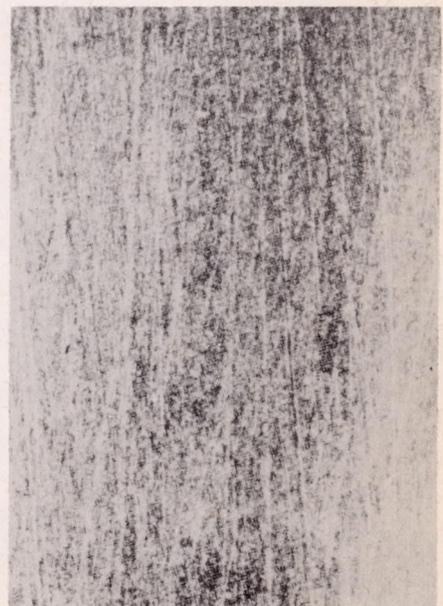
(a) Surface before run 13A,  
15 micro-inches rms.

(b) Surface before run 14A,  
14 micro-inches rms.

(c) Surface before run 15A,  
10 micro-inches rms.

(d) Surface before run 16A,  
15 micro-inches rms.

Figure 21.- Photomicrographs of surface replicas of cylinder sleeve no. 2 after lapping with no. 600 compound. The oblique vertical lines are lapping marks. Magnification 25 X.

Photomicrographs of the cylinder surface replica taken after lapping are shown in figure 21. The lapping marks are clearly visible as the oblique crisscross lines extending from the top to the bottom of the pictures. These lines are the result of turning the lapping piston while moving it in and out of the cylinder. In figure 21(a), which shows the lapped surface before run 13A, several heavy, horizontal, dark lines may be observed. These lines are probably grinding marks as the sleeve was new at the beginning of run 13A. The lines do not appear in any of the other photographs showing, probably, that they have been worn off.

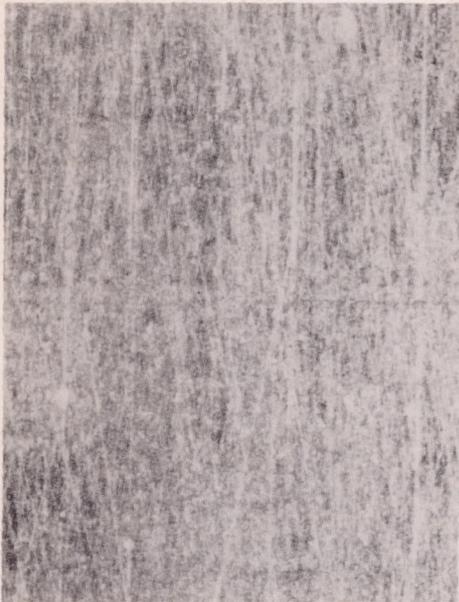
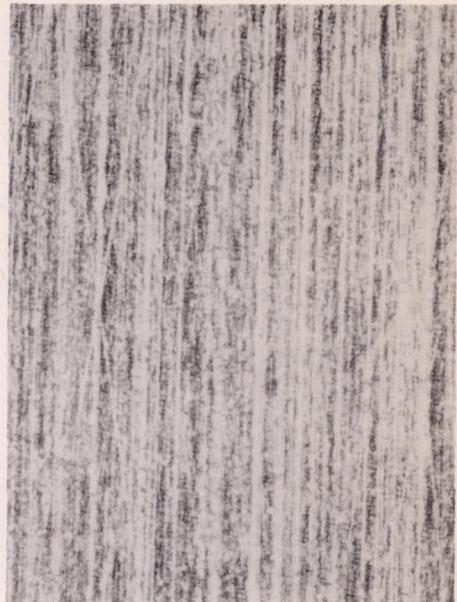
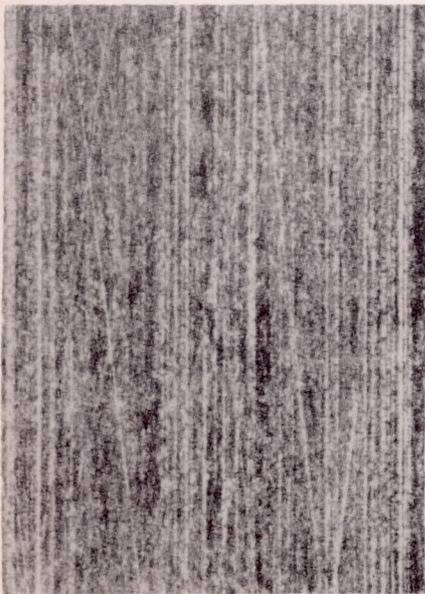
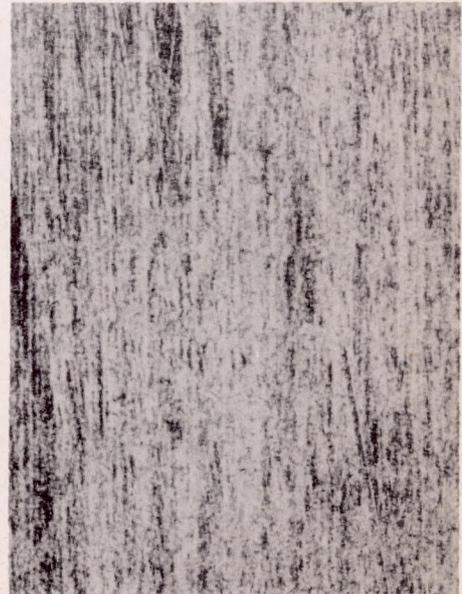
(a) Surface after run 13A,  
10 micro-inches rms.

(b) Surface after run 14A,  
10 micro-inches rms.

(c) Surface after run 15A,  
10 micro-inches rms.

(d) Surface after run 16A,  
12 micro-inches rms.

Figure 22.- Photomicrographs of surface replicas of cylinder sleeve no. 2. These photographs show the effect of about 1 1/4-hours running time on the lapped surfaces shown in Figure 21. Magnification 25 X.

The oblique crisscross lines are fainter in these photographs showing that the lapping marks have been worn off by the piston motion. The scratches made by the piston and rings now predominate and can be recognized as the series of heavy vertical lines. The horizontal, dark lines can still be seen at (a) although they are fewer and less distinct.

The profilometer indicated that the lapped surfaces were worn smoother by running except in the case of run 15A. The average increase in smoothness was about 3 microinches.

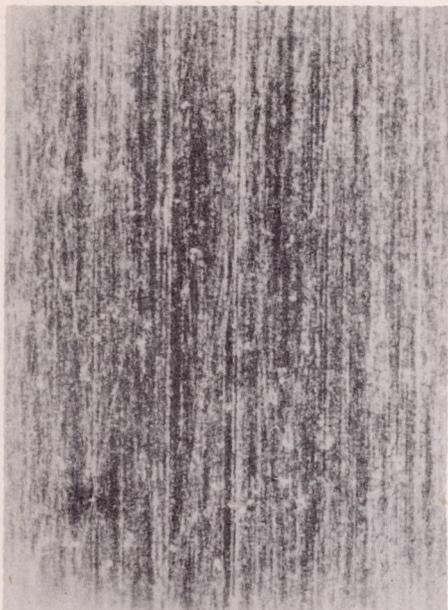
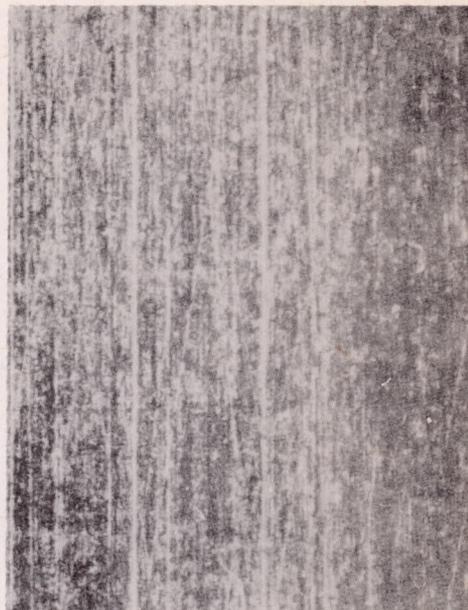
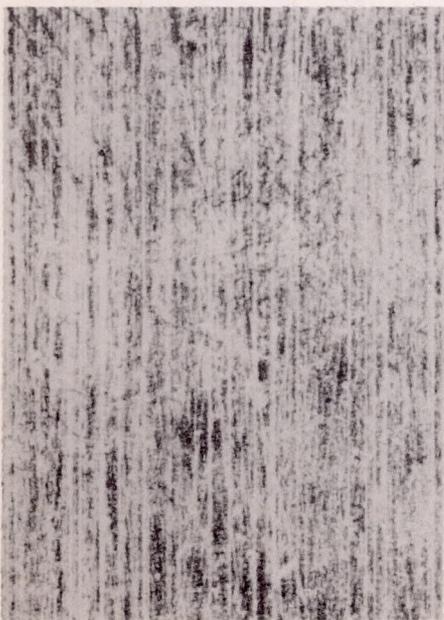
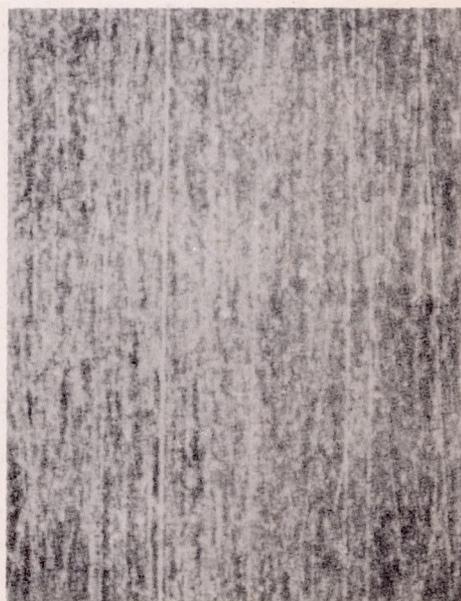
(a) Surface after run 13B,  
9 micro-inches rms.

(b) Surface after run 14B,  
10 micro-inches rms.

(c) Surface after run 15B,  
10 micro-inches rms.

(d) Surface after run 16B,  
10 micro-inches rms.

Figure 23.- Photomicrographs of surface replicas of cylinder sleeve no. 2. These photographs show the effect of about 10 hours additional running time on the surfaces shown in Figure 22. Magnification 25 X.

Figure 23 shows the condition of the same surfaces<sup>1</sup> after each has been subjected to about 10 hours' additional running. There does not appear to be any great difference between the surface after a 1-hour run as compared with a 10-hour run. This observation would seem to indicate that, after lapping, the surface approaches its ultimate condition in about an hour's running time. This observation also agrees with the measurements made on piston-ring gap clearances.

<sup>1</sup>As noted previously the surface was lapped before starting run 15B in order to remove a trace of rust. The lapping does not appear to have affected the condition of the surface at the end of this 10-hour run.

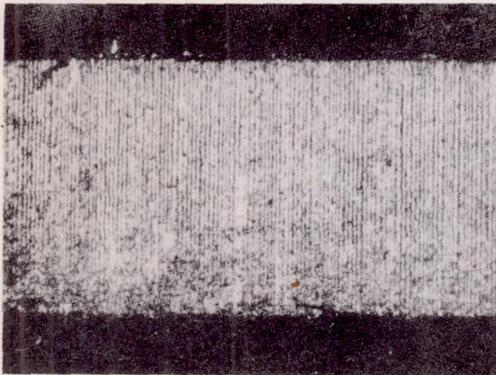
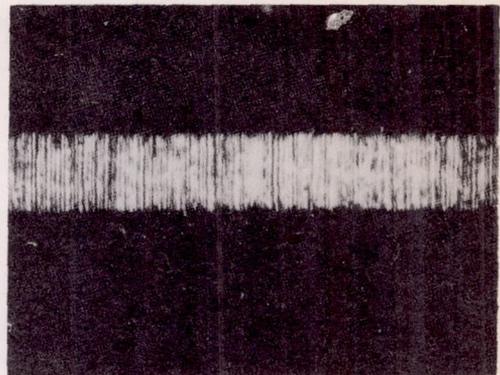
Figure 24.- Photomicrographs of surfaces of specimen aviation-type piston rings used in run-in tests. Magnification 25 X.

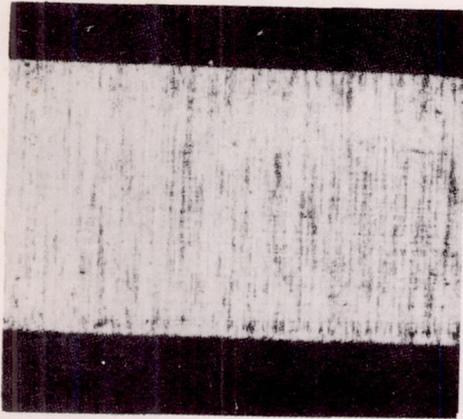
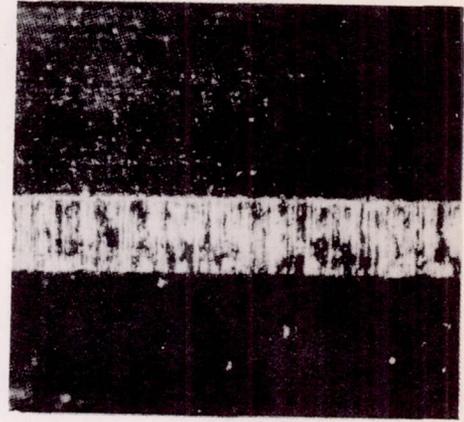
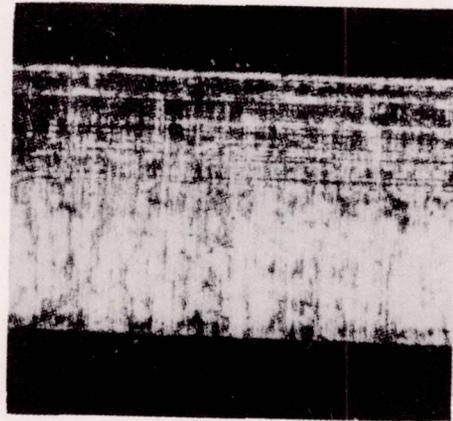
(a) Surface of straight-face, compression ring; 14 micro-inches r.m.s.

(b) Bearing surface of beveled scraper ring

(c) Surface of tapered-face compression ring.

Figure 25.- Photomicrographs of surfaces of specimen aviation-type piston rings. These photographs show the effect of about 12 hours running time on the lapped surfaces shown in Figure 24. Magnification 25 X.

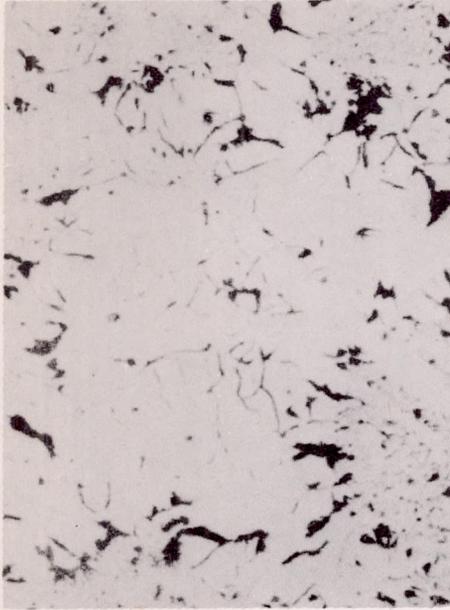
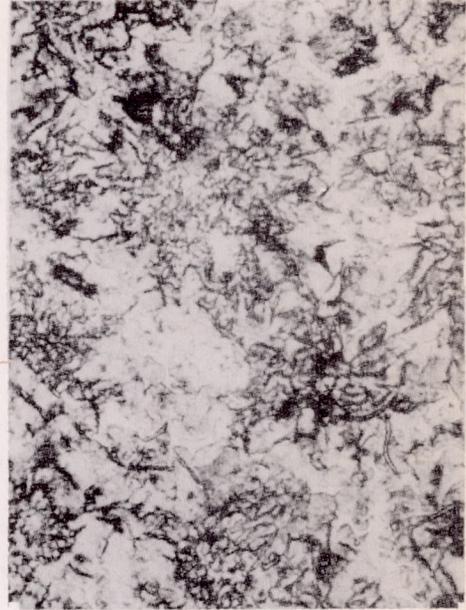
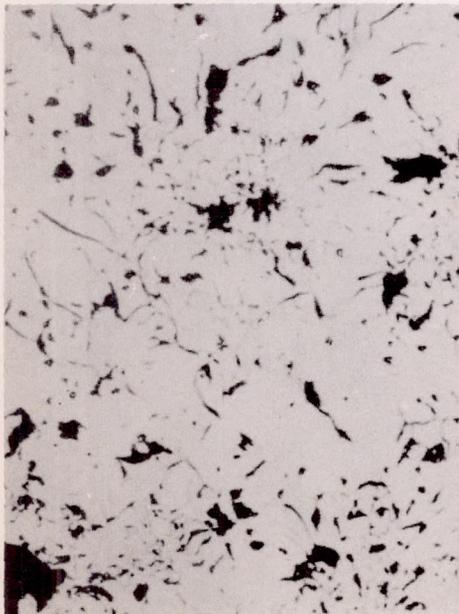
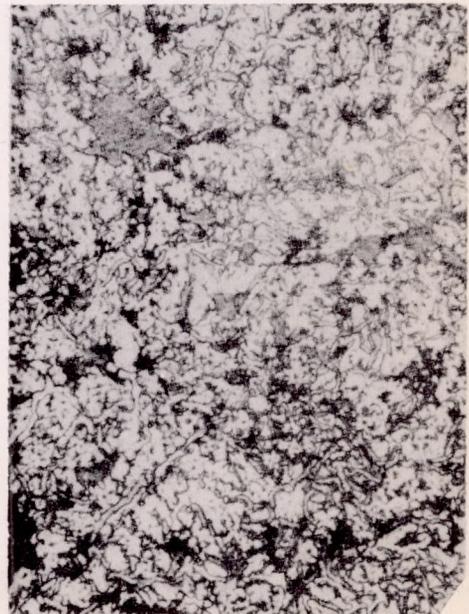
(a) Automotive type; surface unetched.

(b) Automotive type; surface etched.

(c) Aircraft type; surface unetched.

(d) Aircraft type; surface etched.

Figure 26.- Photomicrographs of surfaces of piston rings used in scuffing tests and run-in tests. Magnification 350 X.

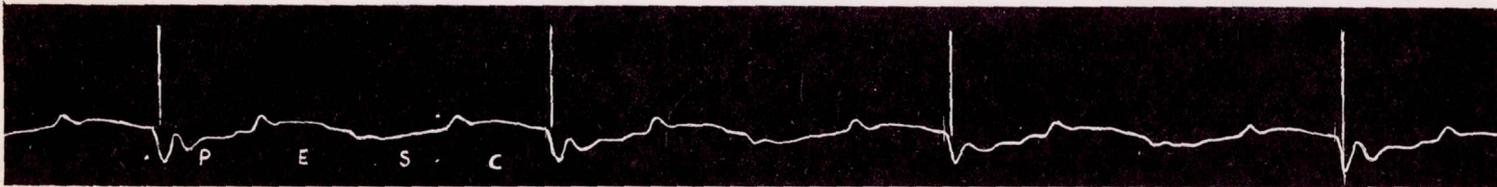
Figure 27.- Friction record taken during the run made to check the reproducibility of the apparatus. Compare with Figure 146).

be duplicated. A new set of piston rings, having the same diametral tensions, were selected, and the cylinder was lapped, oil system flushed, and so forth, so that at the start of the check run the apparatus was very nearly in the same condition as at the start of run 13A.

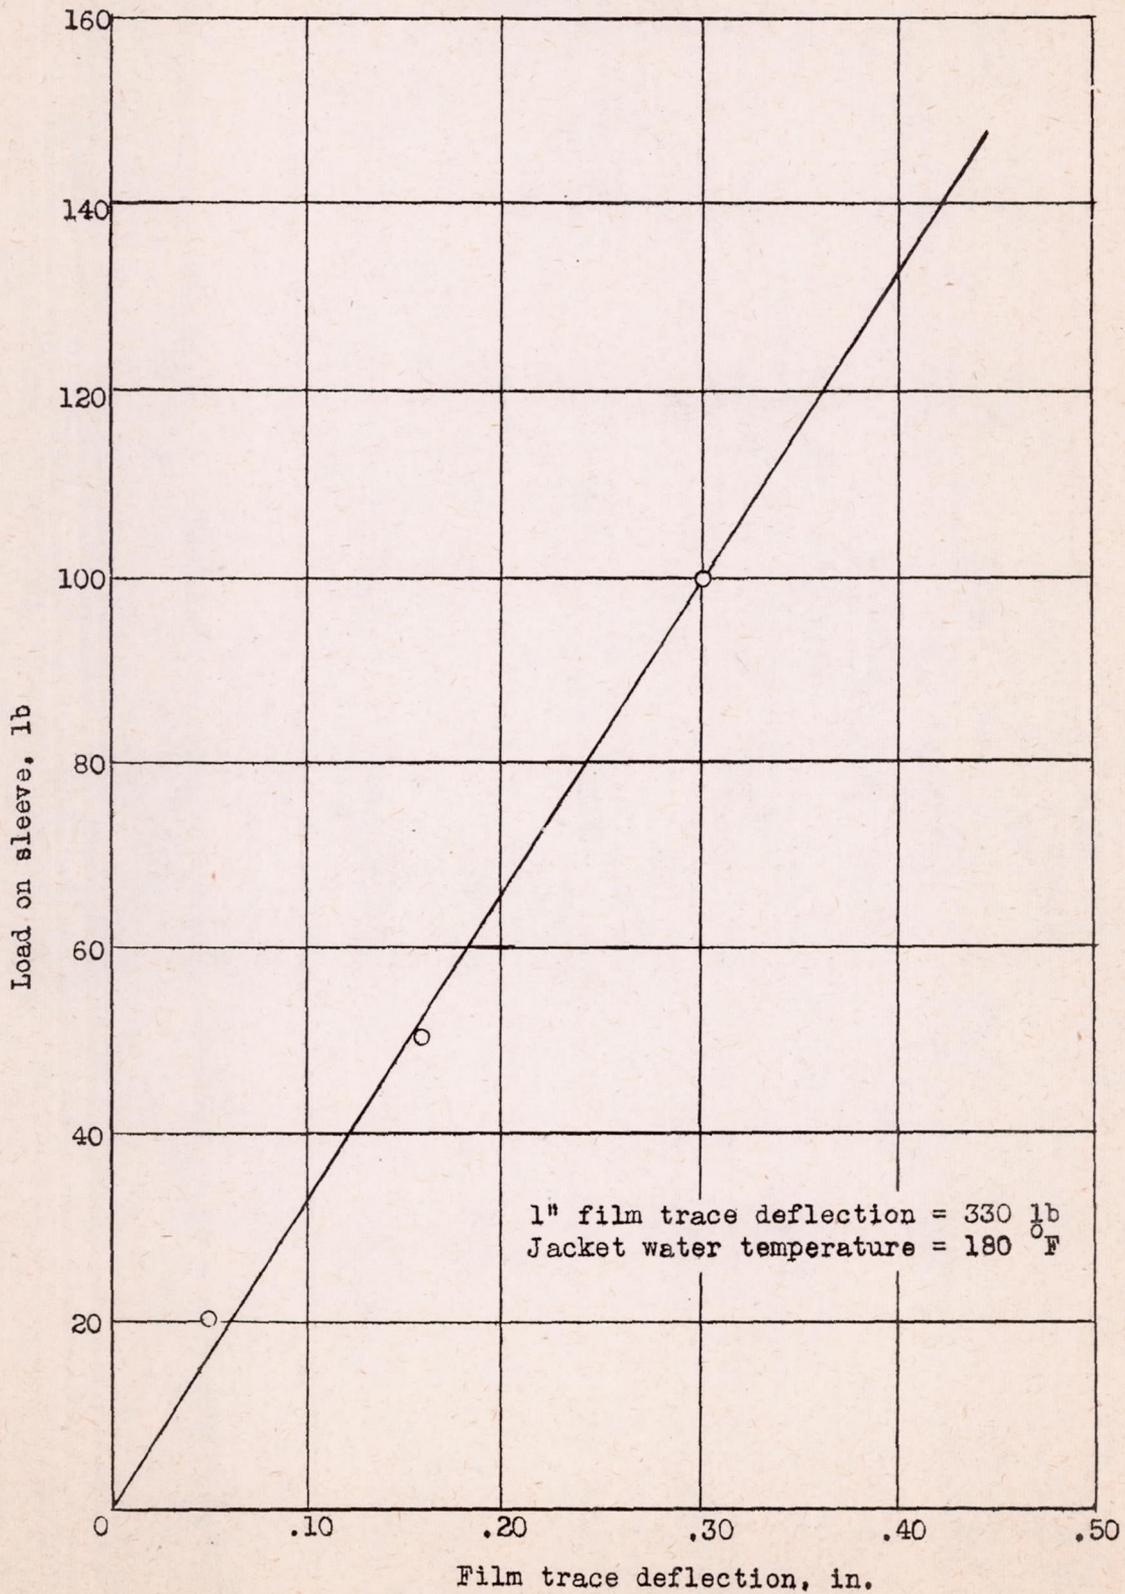
Figure 28.- Calibration curve for sleeve-diaphragm system No. 1 used in scuffing tests.

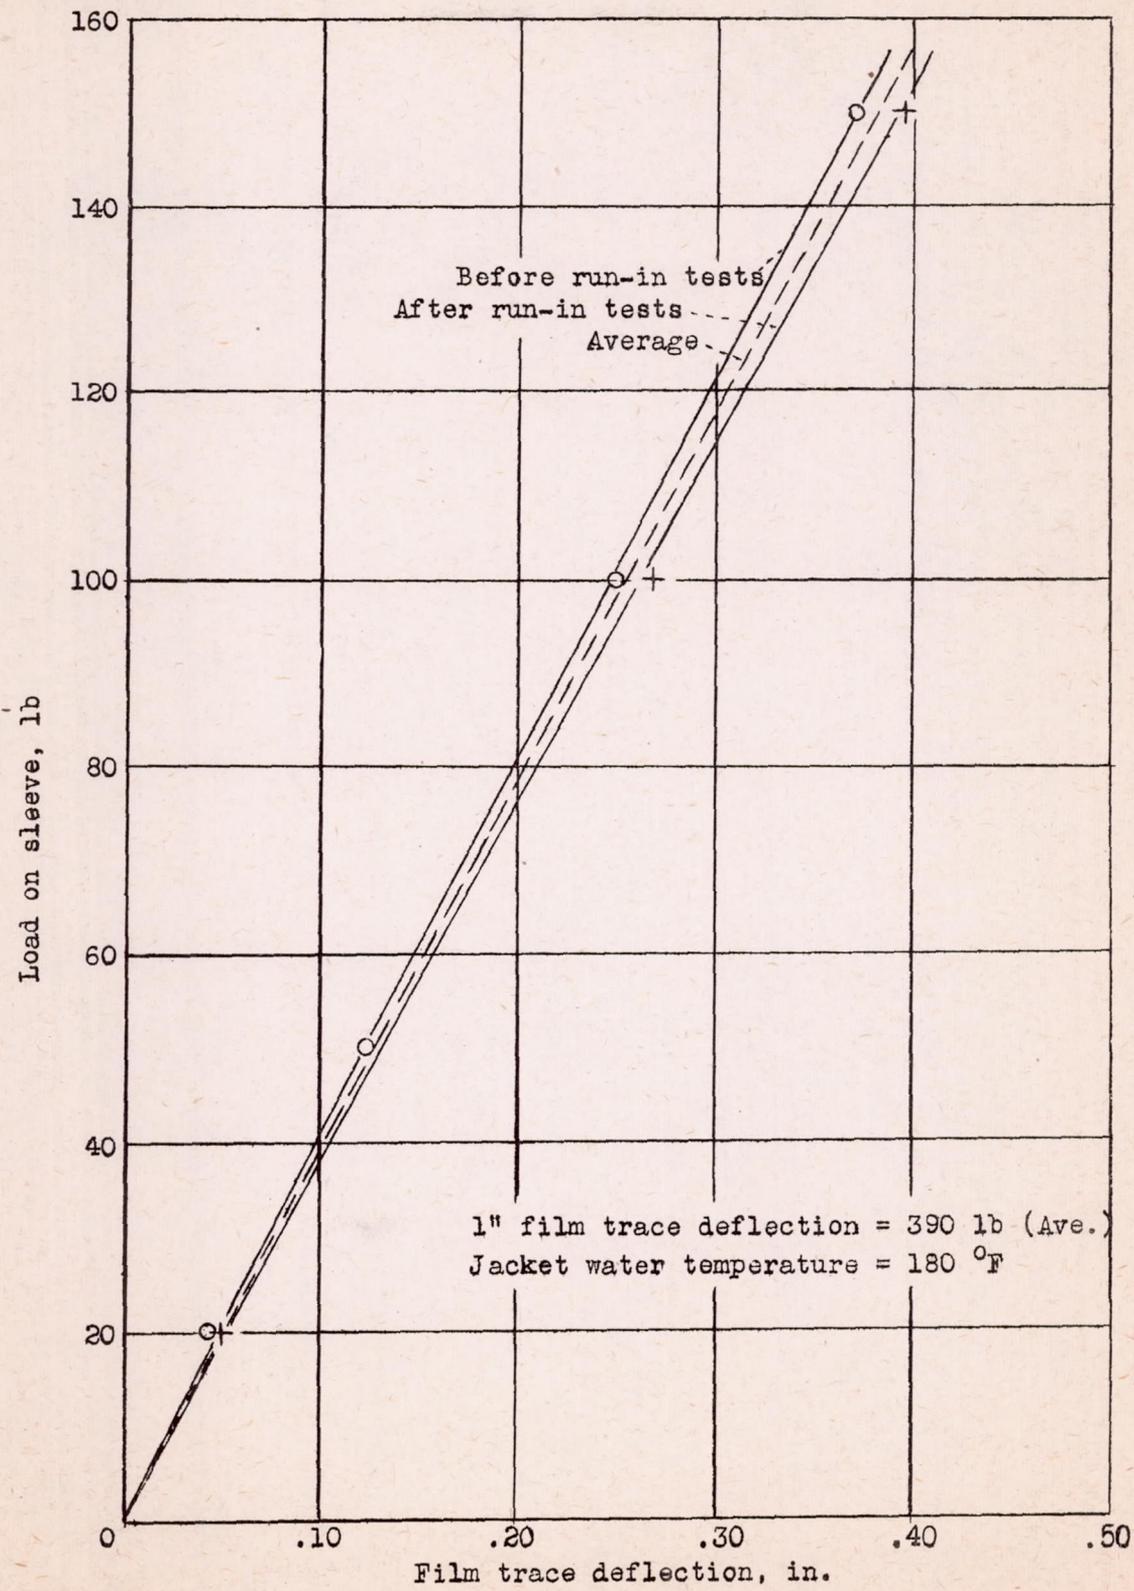
Figure 29.- Calibration curves for sleeve-diaphragm system No. 2 used in run-in tests.

In the case of sleeve-diagram system no. 2, which was used in the run-in tests, the experimental work occupied a period of about 4 months and involved well over 100 hours' running time. A calibration curve was determined before the runs, when the sleeve and diaphragms were new, and another curve was determined after the runs were completed. A maximum change of 5 percent in the over-all sensitivity was noted. An average value of over-all sensitivity was therefore assumed, giving a calibration error of  $\pm 2\frac{1}{2}$  percent. The calibration curves are shown in figure 29.

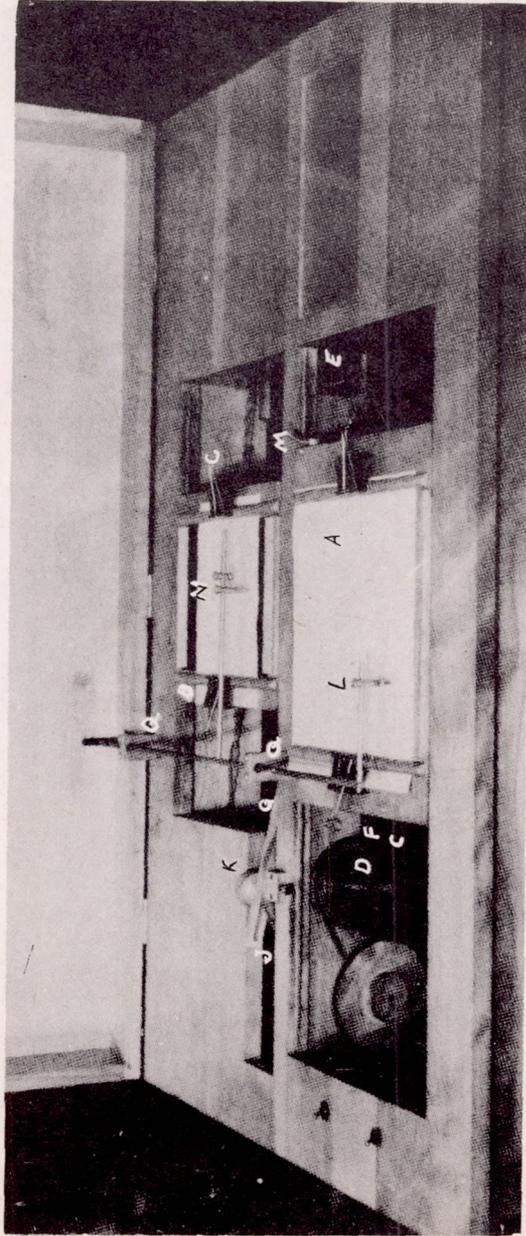
Figure 30.- Photograph of M.I.T. Transfer Machine.
