November 1944 as  
Advance Restricted Report 4J06

A STUDY OF PISTON AND RING FRICTION

By W. A. Leary and J. U. Jovellanos  
Massachusetts Institute of Technology

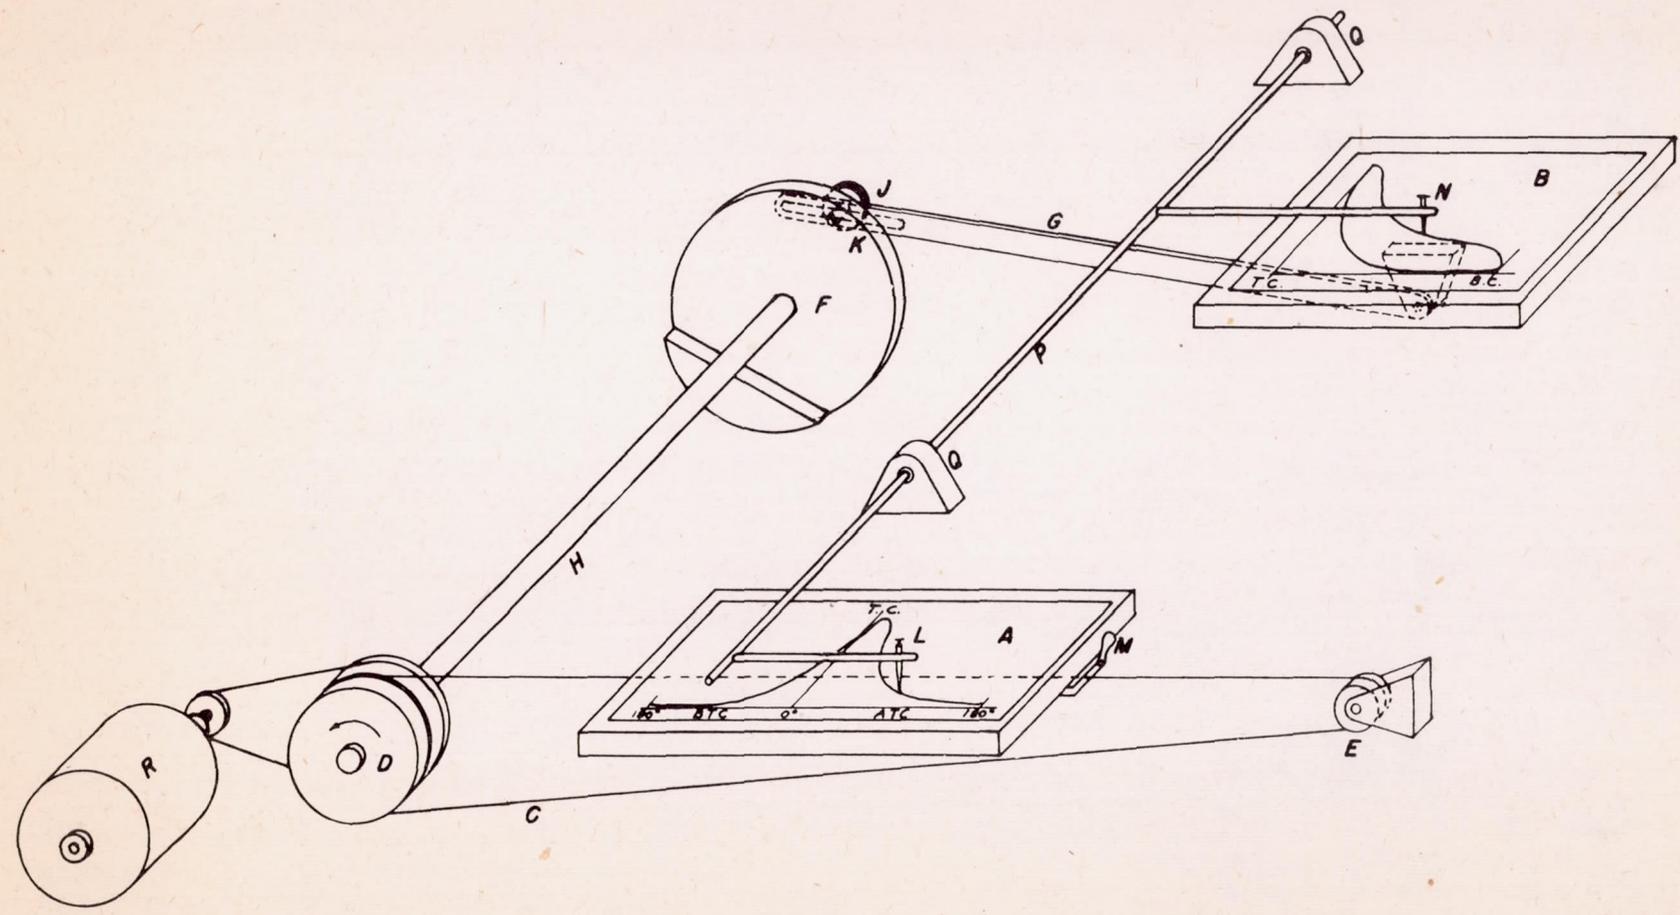
Figure 31.- Schematic diagram of M.I.T. transfer machine.

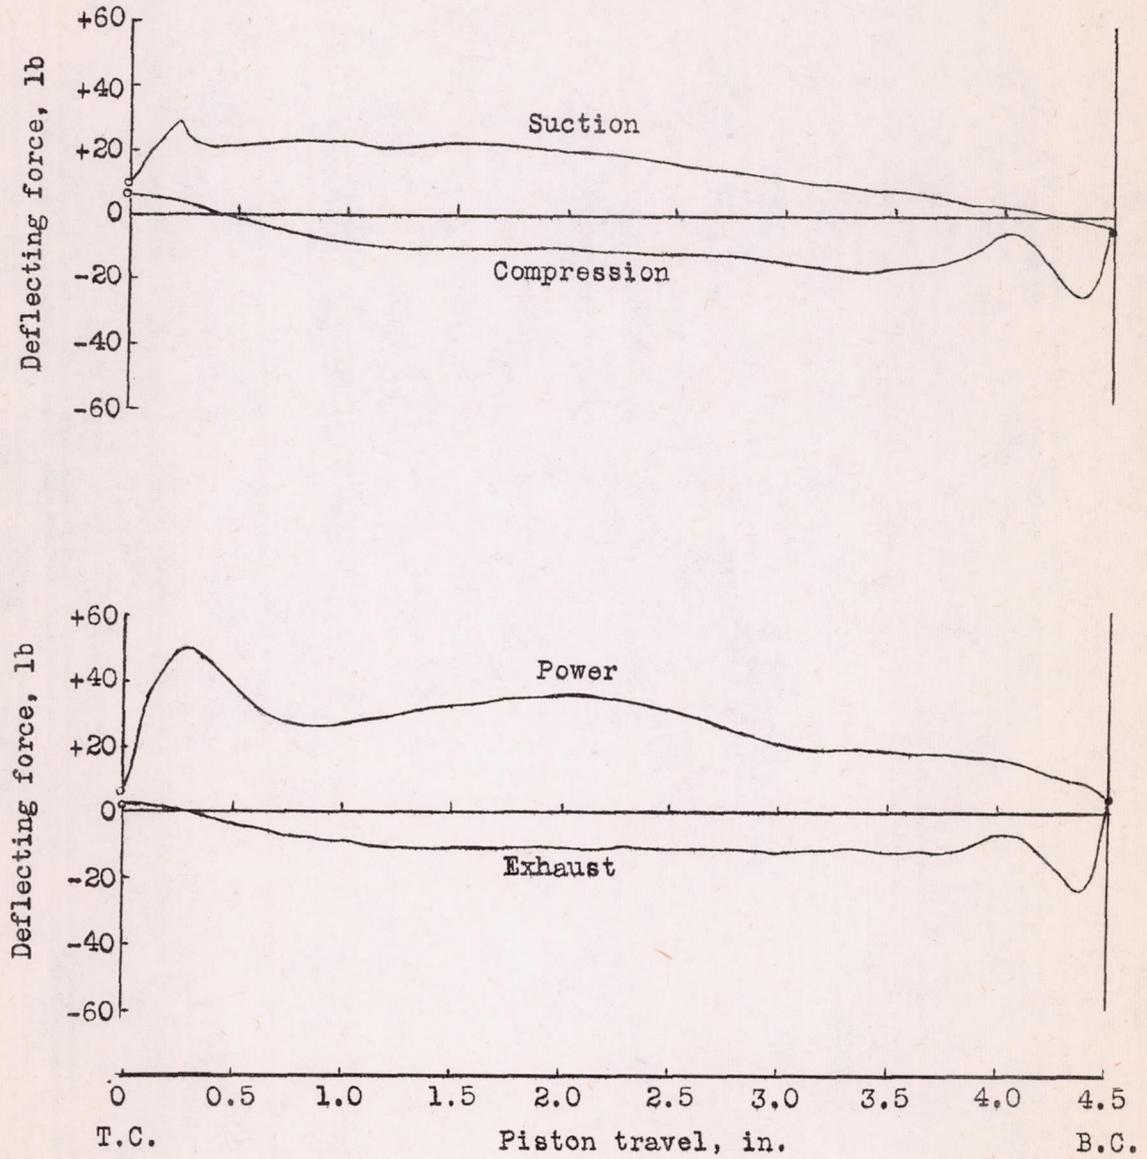
Figure 32.- Friction work loops for the film record shown in Figure 17(c).
