NATIONAL ADVISORY COMMITTEE FOR AERONAUTICS

WARTIME REPORT

February 1945 as
Advance Confidential Report E4J25

AN ELECTRON-DIFFRACTION EXAMINATION OF CAST-IRON PISTON RINGS
FROM SINGLE-CYLINDER AIRCRAFT-ENGINE TESTS

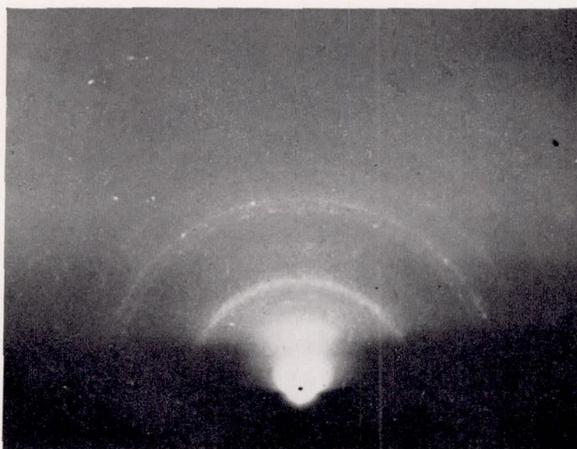
Figure 5.—Electron-diffraction pattern of graphite from a new cast-iron ring abraded then etched with 2-percent nital. Camera constant, 14.0. $\times 2$.

Specimens of new rings were abraded with No. 280 emery paper and then etched in a 2-percent nital solution (2 percent nitric acid in methyl alcohol) for 30 seconds. When the specimens were removed from the nital, they were washed in methyl alcohol and immediately placed in the diffraction chamber. The sharp ring pattern obtained (fig. 5) is shown in column 2 of table 2 to be a graphite pattern. Four graphite rings that could not be seen in the standard graphite pattern appeared here. The occurrence of pure graphite upon etching can be explained by the dissolving of iron at the surface, which left some graphite protruding.

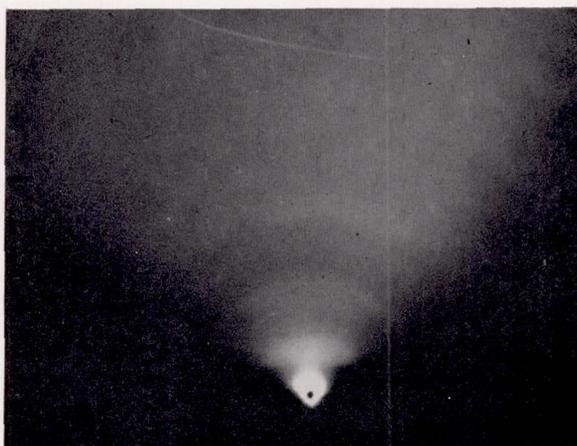
Figure 6.—Electron-diffraction pattern from a lopped cast-iron ring showing α -iron plus graphite. Camera constant, 14.0. $\times 2$.

Occurrence on lapped rings. - Examination of lapped cast-iron rings gave a pattern that was poorer, but not greatly different, from the abraded cast iron. (See column 4, table 2 and fig. 6.) The pattern from lapped rings was taken as the control for the examination of the used rings because all rings were lapped previous to running.

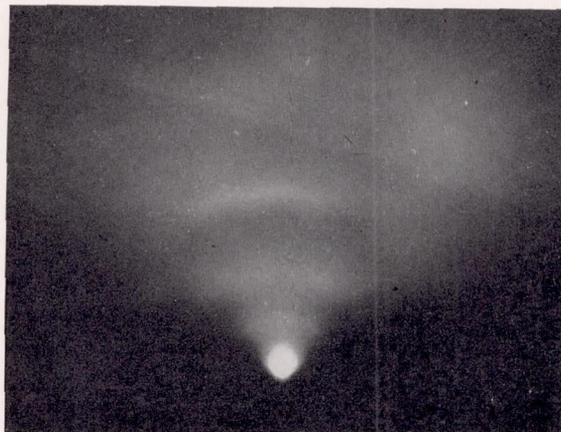
Figure 7.—Representative electron-diffraction pattern of highly oriented graphite from cast-iron ring. Test 5; camera constant, 14.0. $\times 2$.

Occurrence on used rings. - The diffraction patterns of several specimens from each of the cast-iron rings listed in table 1 were photographed. The patterns obtained in all cases correspond to graphite with varying degrees of orientation. Figure 7 is a highly oriented graphite pattern from test 5 and figure 8 is a randomly oriented graphite pattern from ring 3 of test 3. These figures are, respectively, representative of the types of highly and randomly oriented graphite patterns obtained from the various used piston rings. In no case was the presence of a iron on the surface indicated. Column 3 of table 2 lists the diffraction rings obtained from used piston rings from all the tests of table 1 with the range of relative intensities observed on the various exposures. (The designation $I = 0$ indicates the absence of the ring from some of the negatives.) The greater the orientation, the fewer and heavier the rings appear (see fig. 7); therefore, the more precise measurements were made from patterns showing lesser degrees of orientation.

The graphite layer appearing on the used rings exhibited variations from sharp line patterns to those in which heavy arcs appear due to preferred orientation. In figure 7 these arcs are seen to cover about 20° and show that the normals to the characteristic cleavage plates vary in tilt over $\pm 10^\circ$ around the position of the normal to the ring surface.

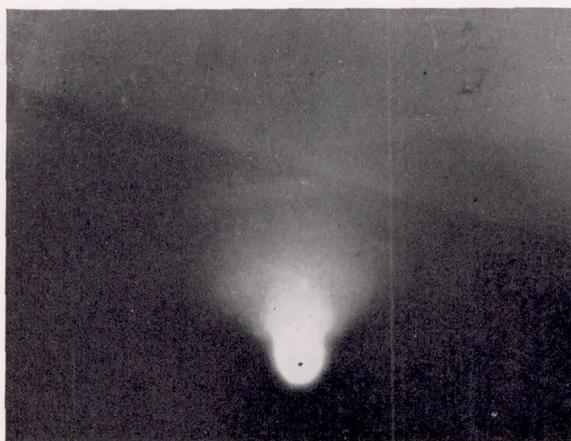
Figure 8.—Representative electron-diffraction pattern of randomly oriented graphite from cast-iron ring. Ring 3; test 3; camera constant, 14.0. $\times 2$.
