TESTS OF A THERMAL ICE-PREVENTION SYSTEM FOR A WING
LEADING-EDGE LANDING-LIGHT INSTALLATION

By Wesley H. Hillendahl

MEMORANDUM REPORT

Air Technical Service Command, U. S. Army Air Forces

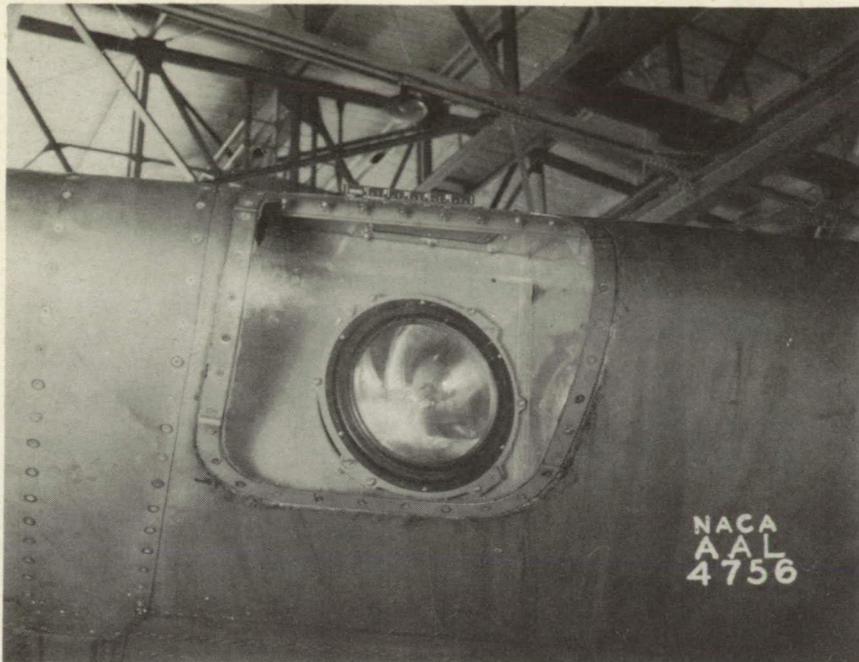
(a) Standard installation.

Photographs of the standard leading-edge landing-light installation in the test airplane and of the test installation, modified in accordance with reference 1, are shown in figures 1(a) and 1(b), respectively. A plan view of the test installation showing its relationship to the outer-wing-panel thermal ice-prevention system is presented in figure 2.

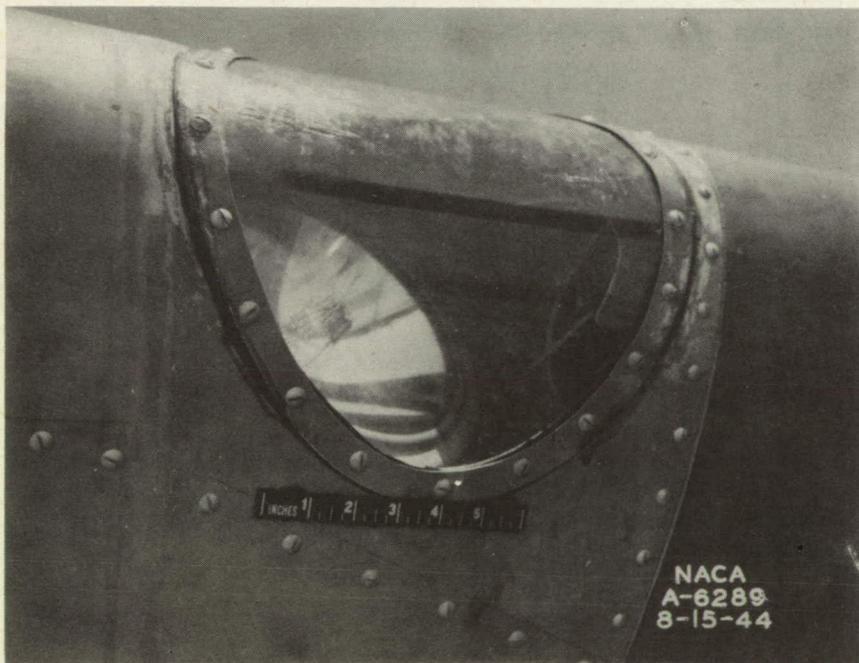
(b) Installation fitted with ice-prevention equipment.
Figure 1.- Landing-light installation on test airplane.

The analysis of reference 1 indicated that a reduction in the space between the sealed-beam light and the leading edge would be necessary to prevent the formation of ice on the transparency, and that a reduction in the surface area of the transparent fairing would be desirable from strength considerations. Accordingly, the landing light was moved forward from a location at approximately 6 percent chord to about 3 percent chord and the surface area of the transparent fairing reduced in accordance with reference 2, which governs the area of the light beam.
