NATIONAL ADVISORY COMMITTEE FOR AERONAUTICS

WARTIME REPORT

SOME YAWING TESTS OF A 1/30-SCALE MODEL OF THE HULL
OF THE XPB2M-1 FLYING BOAT

By F. W. S. Locke, Jr.
Stevens Institute of Technology

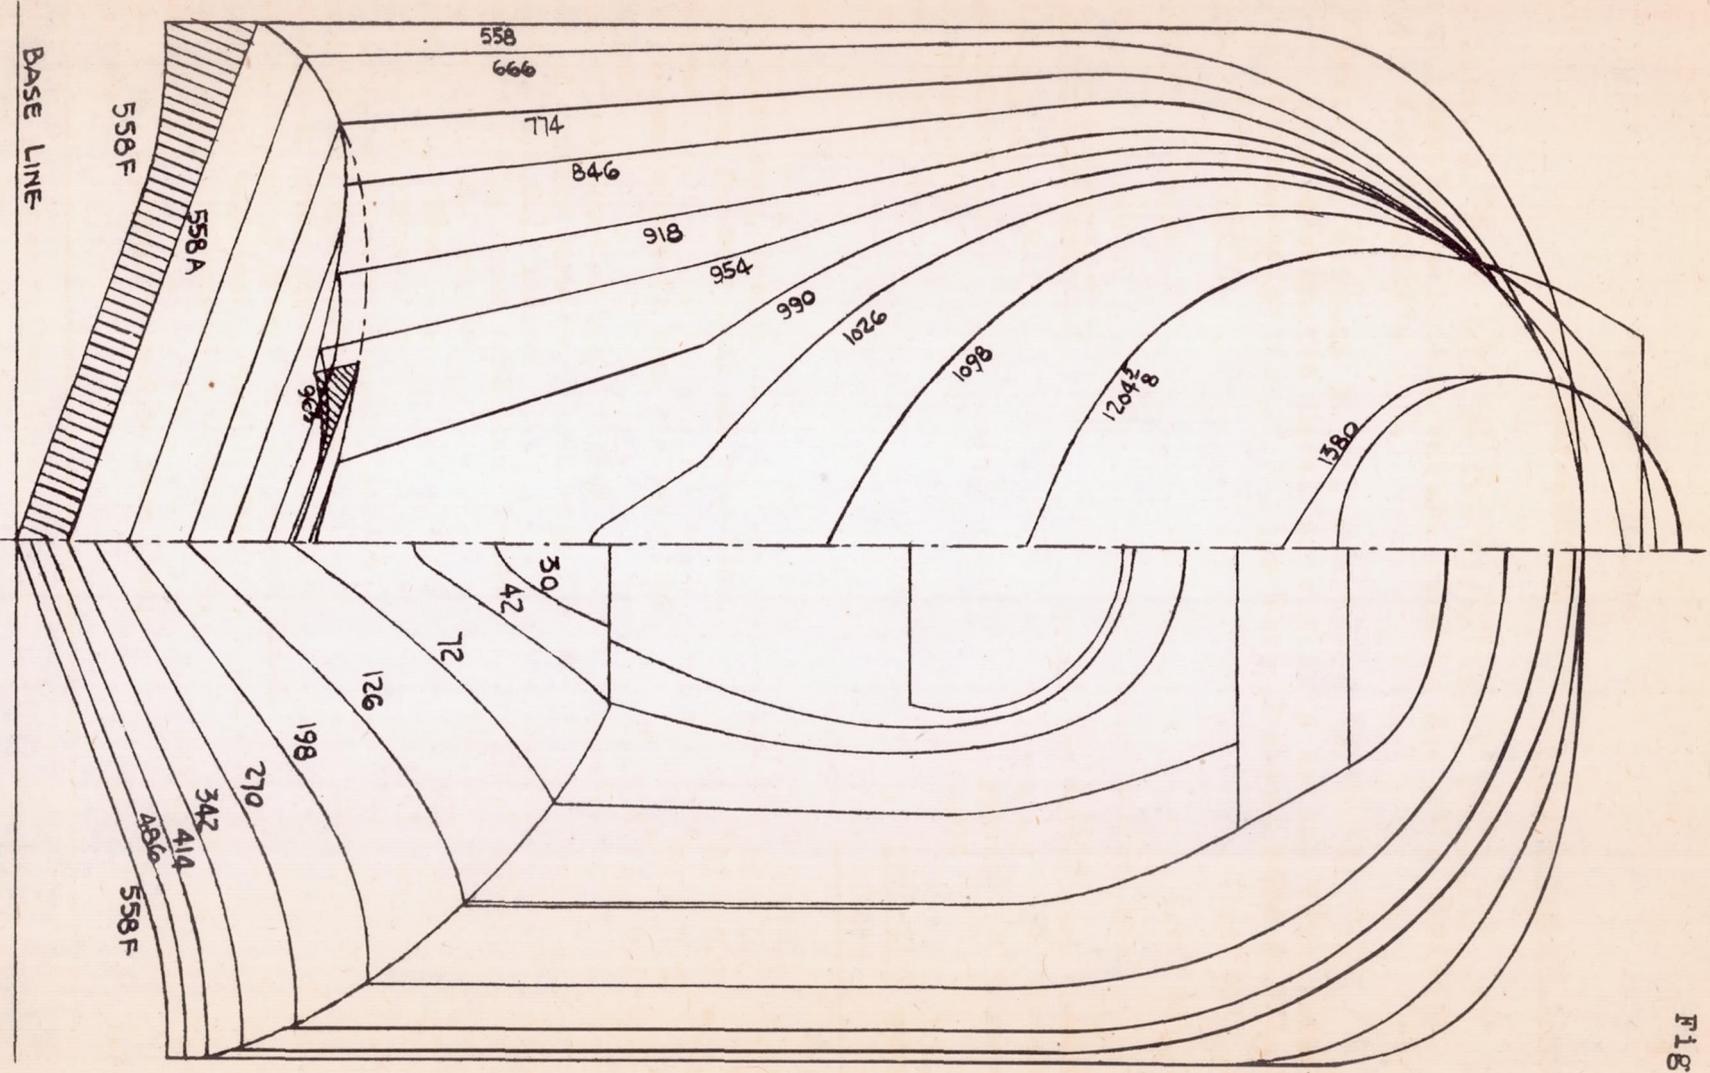
Figure 1. - Body plan of model XPB3M-1.

The model was built for The Glenn L. Martin Company, to their Drawing No. R240078, and was used by them for several investigations. It was used for the present investigation, in preference to other models, because it was a full model of the hull, complete with top and tail cone. The body plans are given in figure 1.

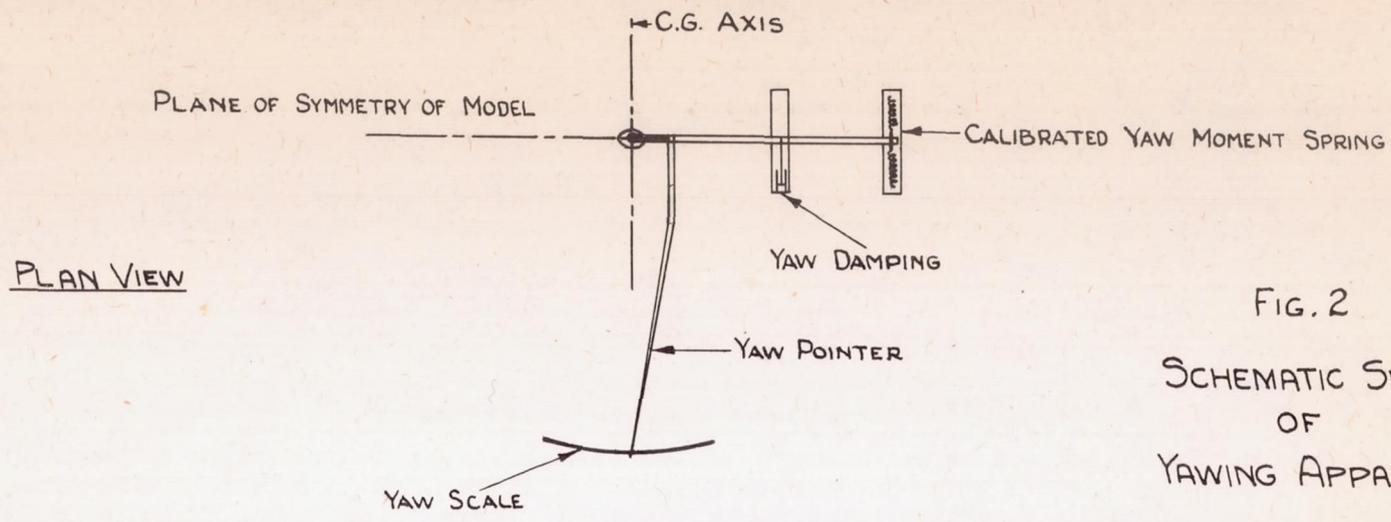
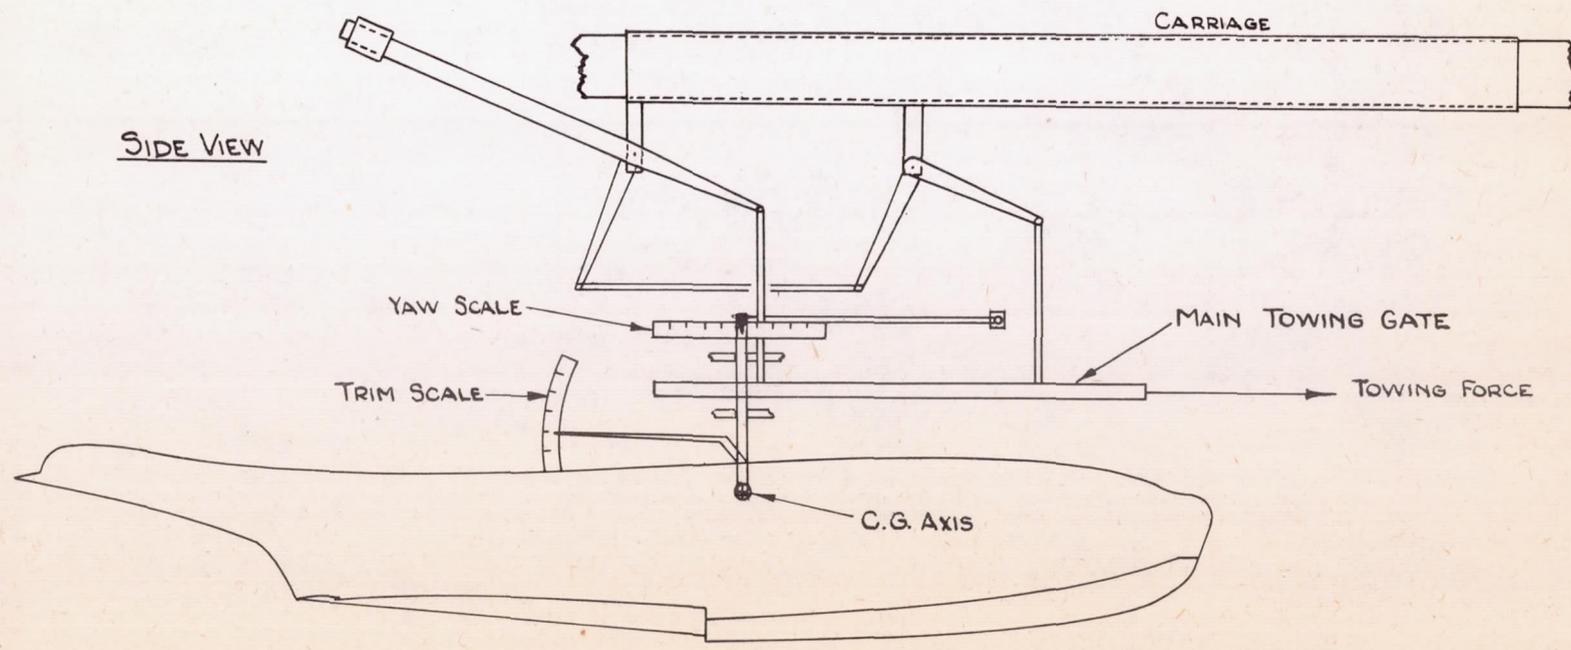
Fig. 2

FIG. 2
SCHEMATIC SKETCH
OF
YAWING APPARATUS

The model was mounted on bearings in a yoke. The bearings allowed pitching freedom and the yoke could be adjusted to produce fixed heel angles. The yoke was attached to a staff which allowed freedom in yaw and heave.

The angular motion of the staff was restrained by a calibrated spring, thus allowing determination of the yawing moment. A dashpot was provided for damping in yaw, which some preliminary experience had shown to be desirable. A sketch of the apparatus is shown in figure 2 and a photograph in figure 3.

The calibrated spring mentioned previously constituted the yawing moment dynamometer. The spring was relatively weak, and provision was made for changing its stiffness. The magnitude and direction of the yawing moment, at the running yaw angle, was determined by noting the difference between the angles of yaw when stationary and in motion. All moments and angles are referred to the wind axis (i.e., to the horizontal plane).

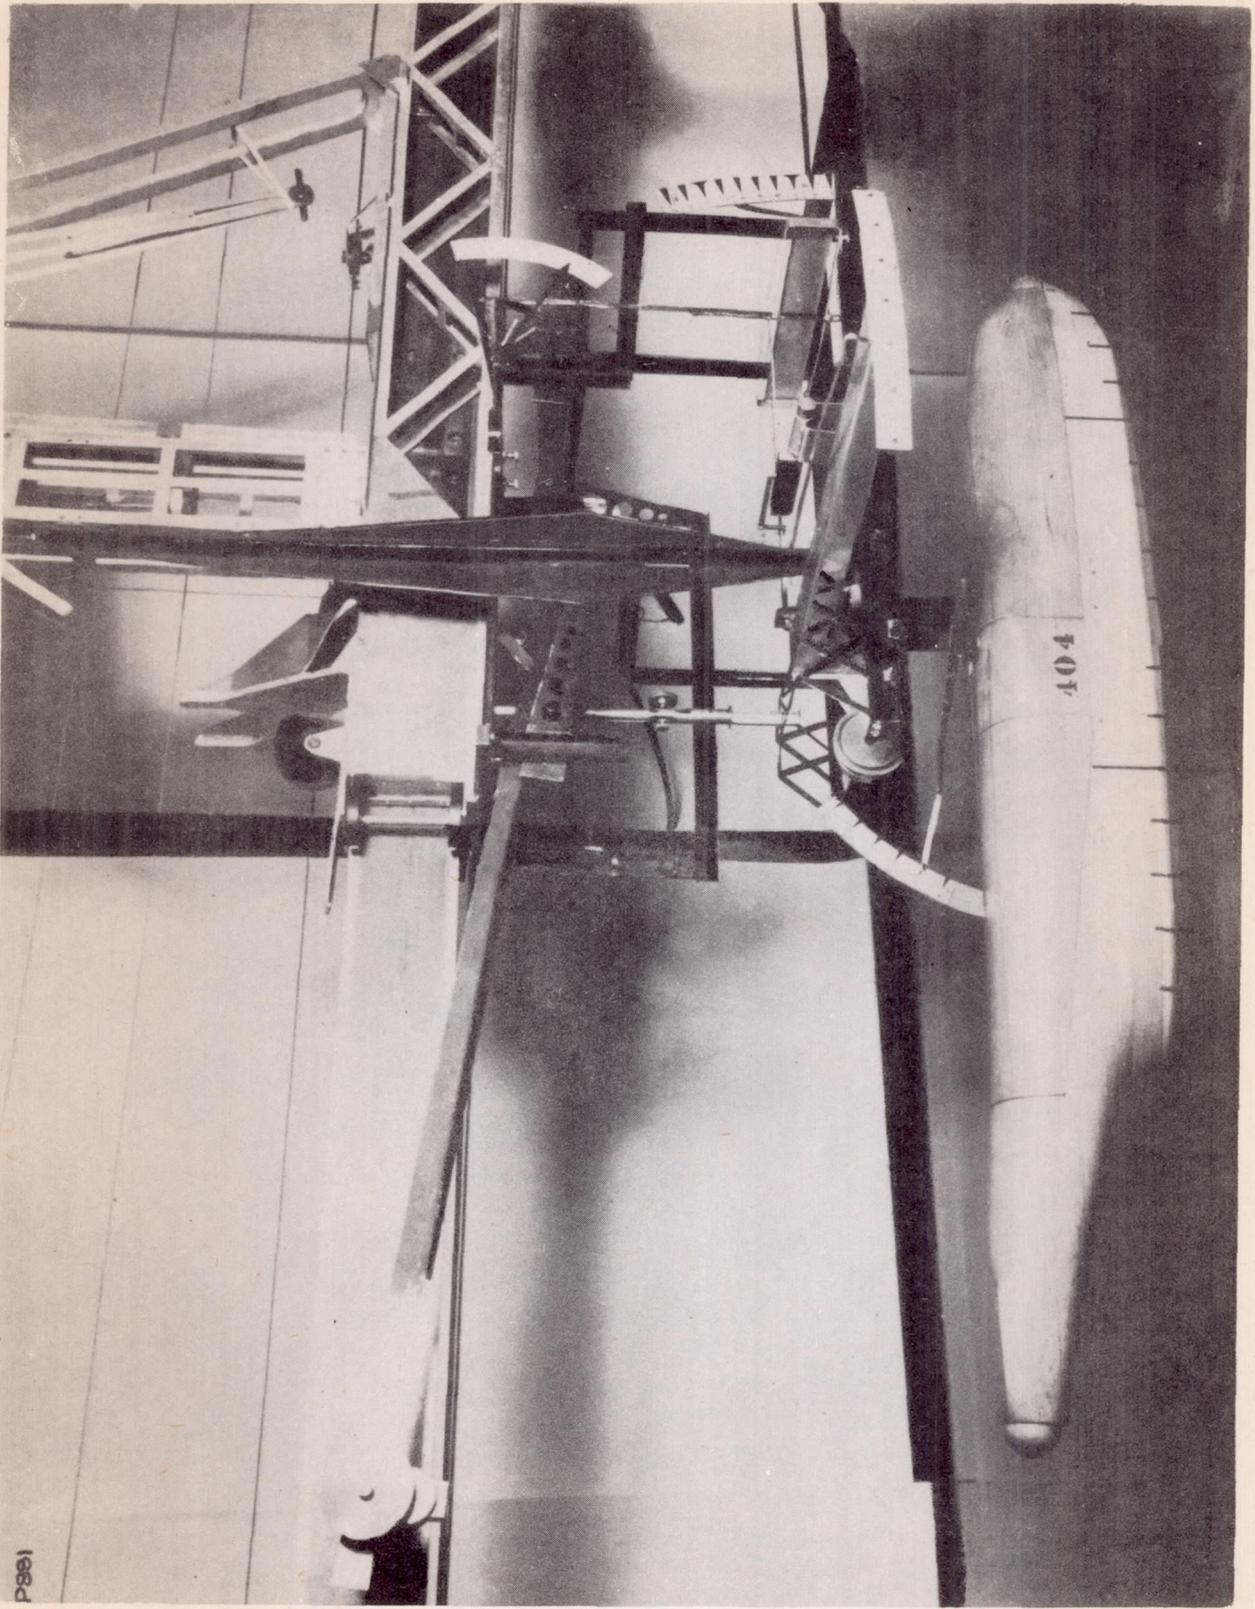
Figure 3.- Apparatus setup for yawing tests.

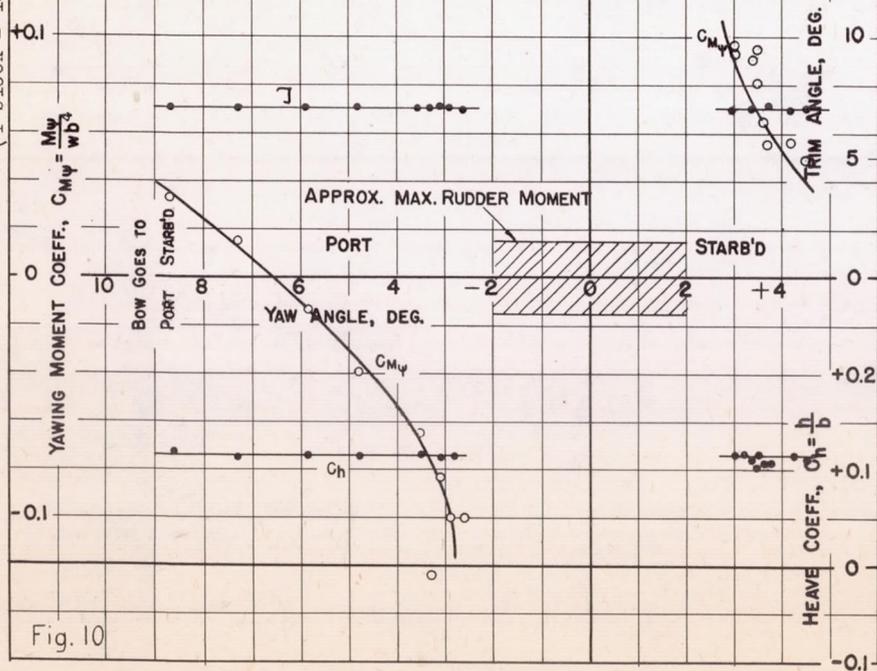
Fig. 10

STEVENS MODEL NO. 404-1

SP. NO. H₂ 9

FREE-TO-TRIM

$C_V = 2.33$

$C_{\Delta} = 0.79$
 $C_M = 0.00$
 $\Phi = 0.0^\circ$

"HOOKING" INSTABILITY

Some of the model test results are shown in detail in figures 4 to 17. The maximum available moments due to full rudder deflection, with balanced power, are marked on these charts. It will be seen that at low speeds the rudders are not nearly powerful enough to overcome the hydrodynamic yawing moments for anything more than a very small yaw. On the other hand, at high speeds, the available rudder moments are more than sufficient to control any deviation from the course. It appears, therefore, that any further work on directional stability may well be concentrated on the low- and hump-speed regions, and

Visual observations made during the tests indicated that the hooking instability in the vicinity of the hump was caused mainly by water which passed over the afterbody sides in the vicinity of the stern post and wetted the tail cone. Although sometimes noticeable under other conditions, this was especially noticeable where hooking instability occurred. In one or two of the tests with large yaw angles, at speeds in the vicinity of the hump, water washed right over the tail far enough forward to leave the rear gun turret out of water, and would probably have damaged the tail surfaces on the actual flying boat.

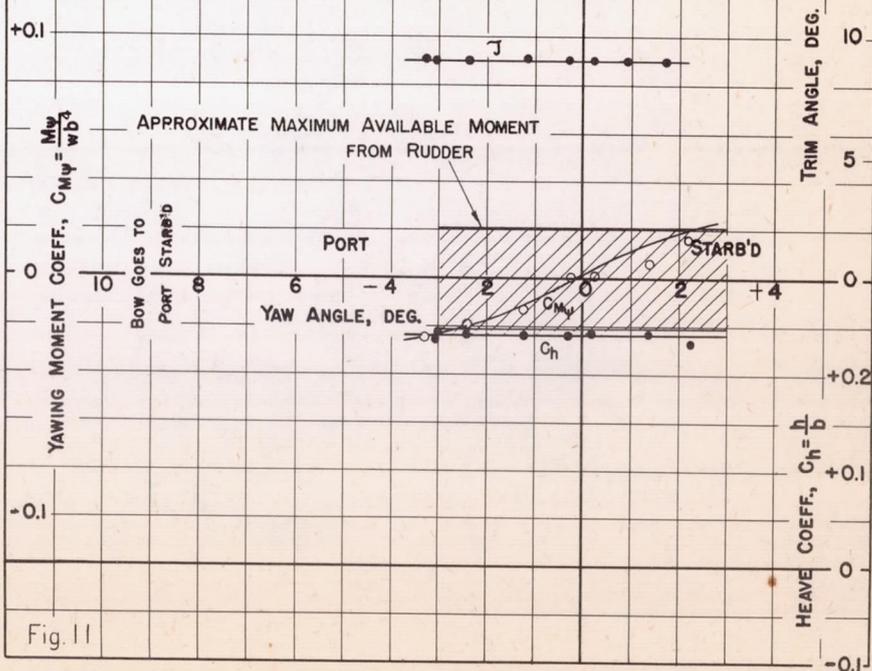
Fig. 11

STEVENS MODEL NO. 404-1

SP. NO. H₁ 23

FREE-TO-TRIM

$C_V = 2.74$

$C_{\Delta} = 0.74$
 $C_M = 0.00$
 $\Phi = 0.0^\circ$

NEUTRAL STABILITY

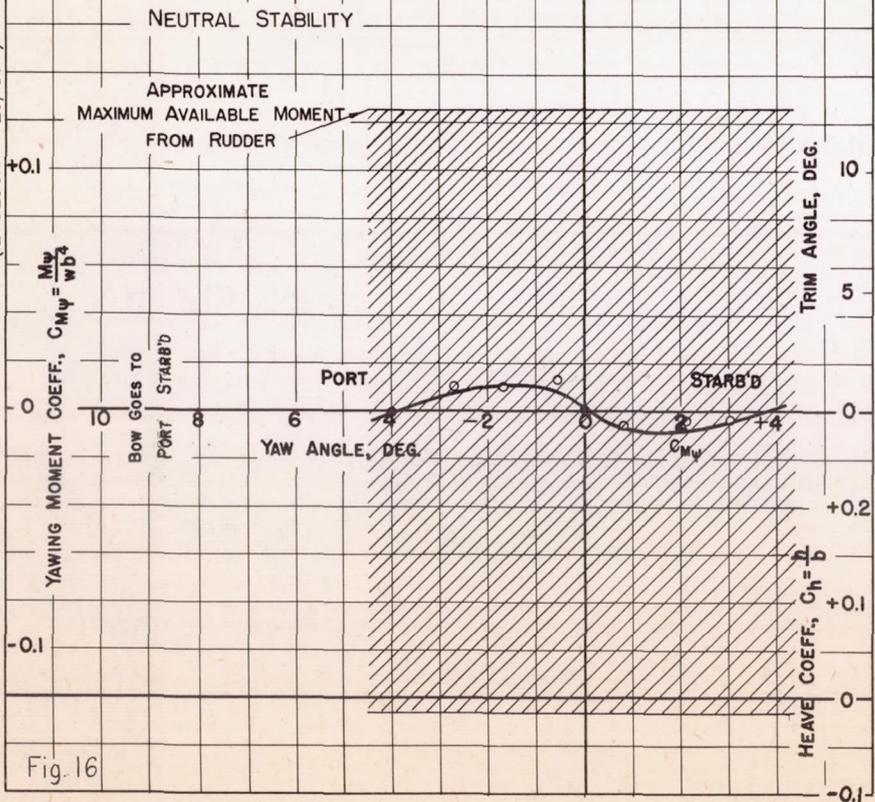
Fig. 16

STEVENS MODEL NO. 404-1

SP. NO. H₃30

FIXED TRIM

C_V = 6.75

$$C_{\Delta} = 0.31$$

$$C_M = \frac{C_{\Delta}}{\Phi} = \frac{0.31}{0.0^\circ}$$

$$\Phi = 0.0^\circ$$

$$\gamma = 0^\circ$$

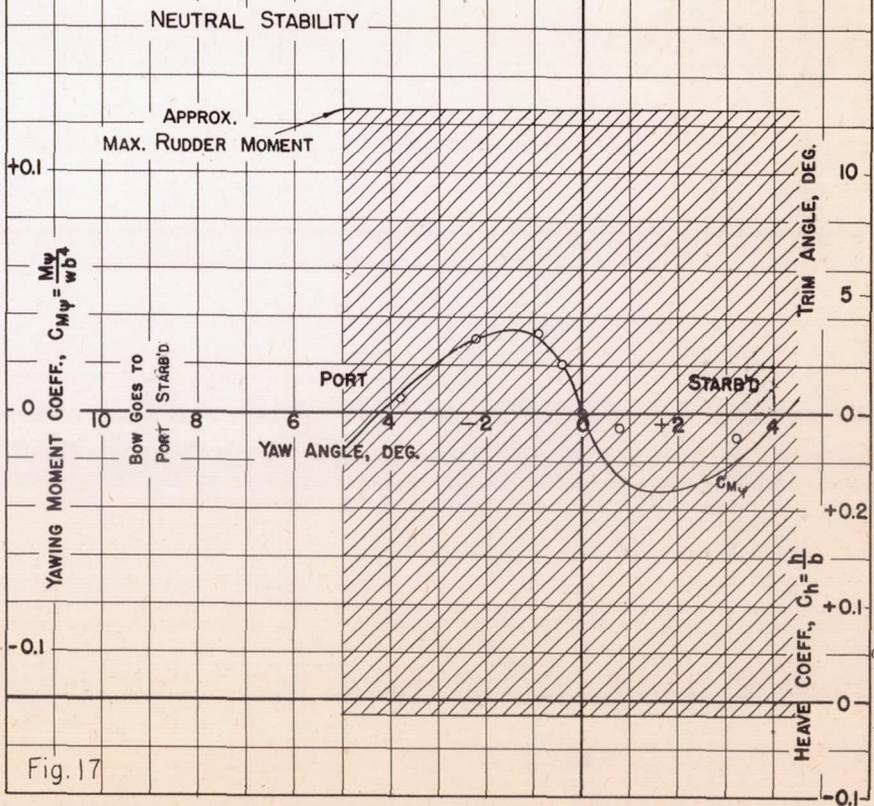
Fig. 17

STEVENS MODEL NO. 404-1

SP. NO. H₃30

FIXED TRIM

C_V = 6.75

$$C_{\Delta} = 0.08$$

$$C_M = \frac{C_{\Delta}}{\Phi} = \frac{0.08}{0.0^\circ}$$

$$\Phi = 0.0^\circ$$

$$\gamma = 4^\circ$$

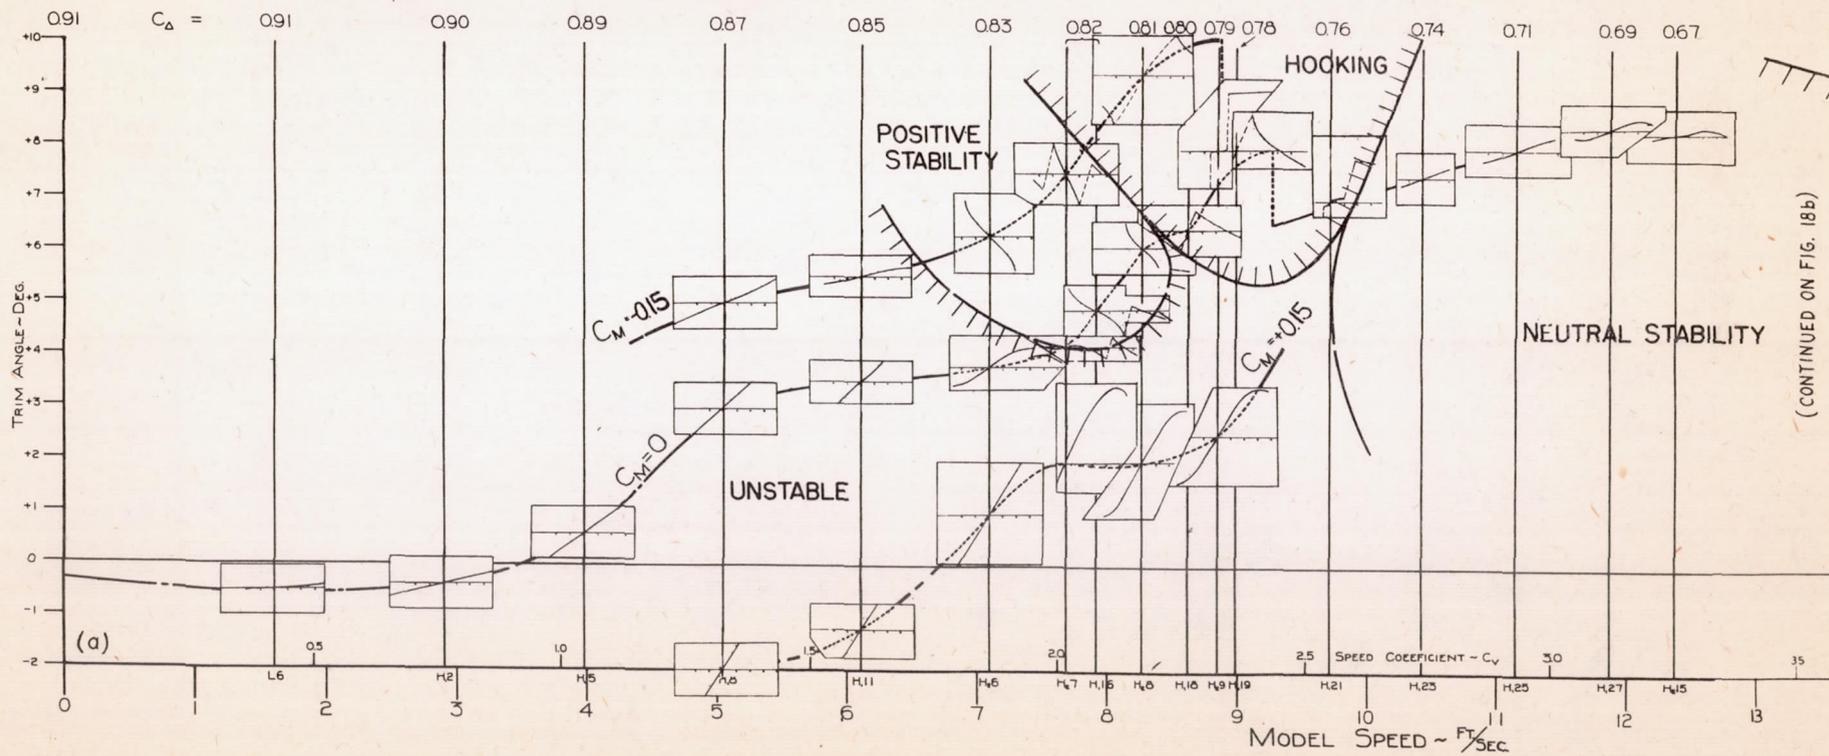
Fig. 18a

DIRECTIONAL CHARACTERISTICS
 MODEL No. 404-1
 XPB2M-1
 MODEL SCALE = $\frac{1}{30}$

CHART No. 1

$\Delta_s = 140,000$ LBS.
 700INS. FWD OF MAIN STEP
 C.G. 146.7INS. ABOVE B.L.

The large chart in figure 18 is considered an important presentation of the results; it provides a comprehensive view of all of the directional-stability characteristics under the given set of particulars. Each enclosed rectangle (or special shape where necessary) shows the curve of yawing moment against yaw angle for the speed and trim angle indicated by its center. Study shows that, in general, there are four types of curves. Taking the slope of the moment curve at zero yaw angle as a measure of the stability of the flying boat in yaw, the four types may be defined as follows:

It will be seen that the hull is directionally unstable up to about half the get-away speed, except for a very small region. This small region of positive stability is enclosed by a contour line. The cases of "hooking" instability occur within a small region, which is also enclosed by a contour line. It will be noted that the region of instability starts at zero speed and extends almost up to the hump. At speeds above the hump, the hull is stable at high trim angles, where the afterbody is normally wetted; and neutrally stable at low trim angles, where the afterbody is normally clear. It would be expected that, once this hull has passed the hump, no trouble from directional instability would be encountered.

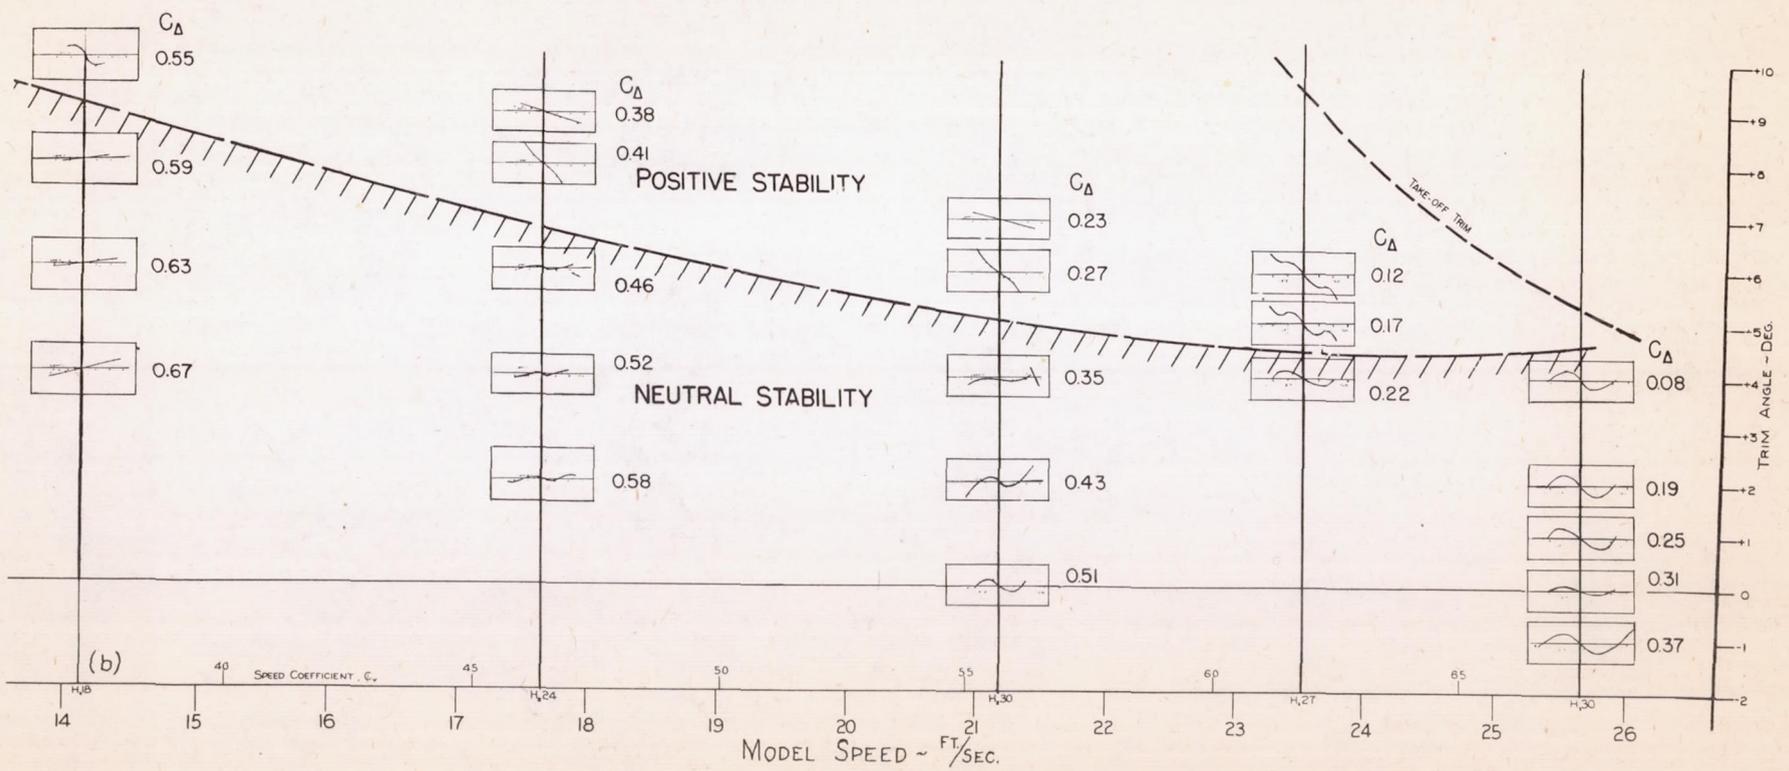
Fig. 18b

CHART No. 1 (CONTINUED)
