NASA Contractor Report 189687

**HIGH TEMPERATURE ELECTROMAGNETIC
CHARACTERIZATION OF THERMAL PROTECTION
SYSTEM TILE MATERIALS**

MCDONNELL DOUGLAS AEROSPACE
Saint Louis, Missouri

Contract NAS1-18763
September 1993

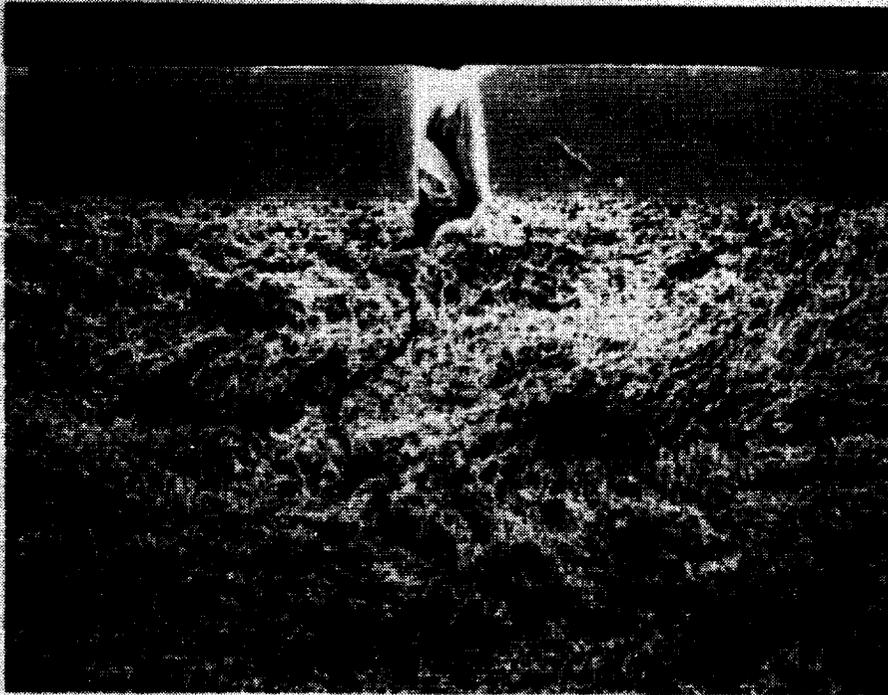
FILE 159849-003-1036

FIGURE 45 - 50X SEM MICROPHOTOGRAPH OF THE RCG
COATING/SUBSTRATE INTERFACE DISPLAYING A TYPICAL CRACK

4.3.1 Surface Cracking. Small surface cracks were noted on a number of the specimens after exposure to the 15kW laser. This cracking usually took the form of a circle slightly larger than the incident laser beam which is consistent with the large thermal gradients experienced around the perimeter. The cracks, when measured with the scanning electron microscope, averaged between .5 and 1 mil wide. Figure 43 is a microphotograph of the surface of a specimen displaying a typical cracking pattern. Figure 44 is a SEM microphotograph taken looking down at the RCG surface of a specimen and Figure 45 was taken looking at the cross section of the specimen. Note that these

microphotographs are to scale therefore accurate thickness and crack width measurements can be made. Note also that the chipping visible at the top of Figure 45 was a result of the preparation required for the SEM.

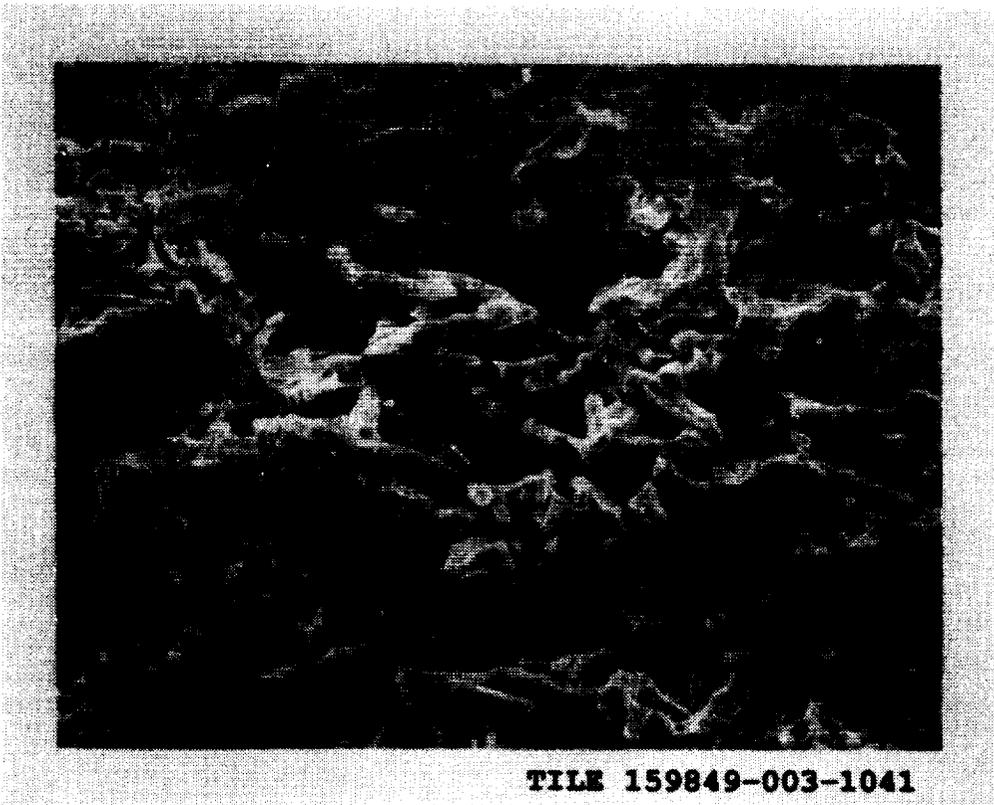
FIGURE 47 - 500X SEM MICROPHOTOGRAPH OF THE
SUBSTRATE MATERIAL DISPLAYING FIBER BREAKAGE
