NASA Contractor Report 191188

Insoluble Coatings for Stirling Engine Heat Pipe Condenser Surfaces

Peter M. Dussinger
Thermacore, Inc.
Lancaster, Pennsylvania

September 1993

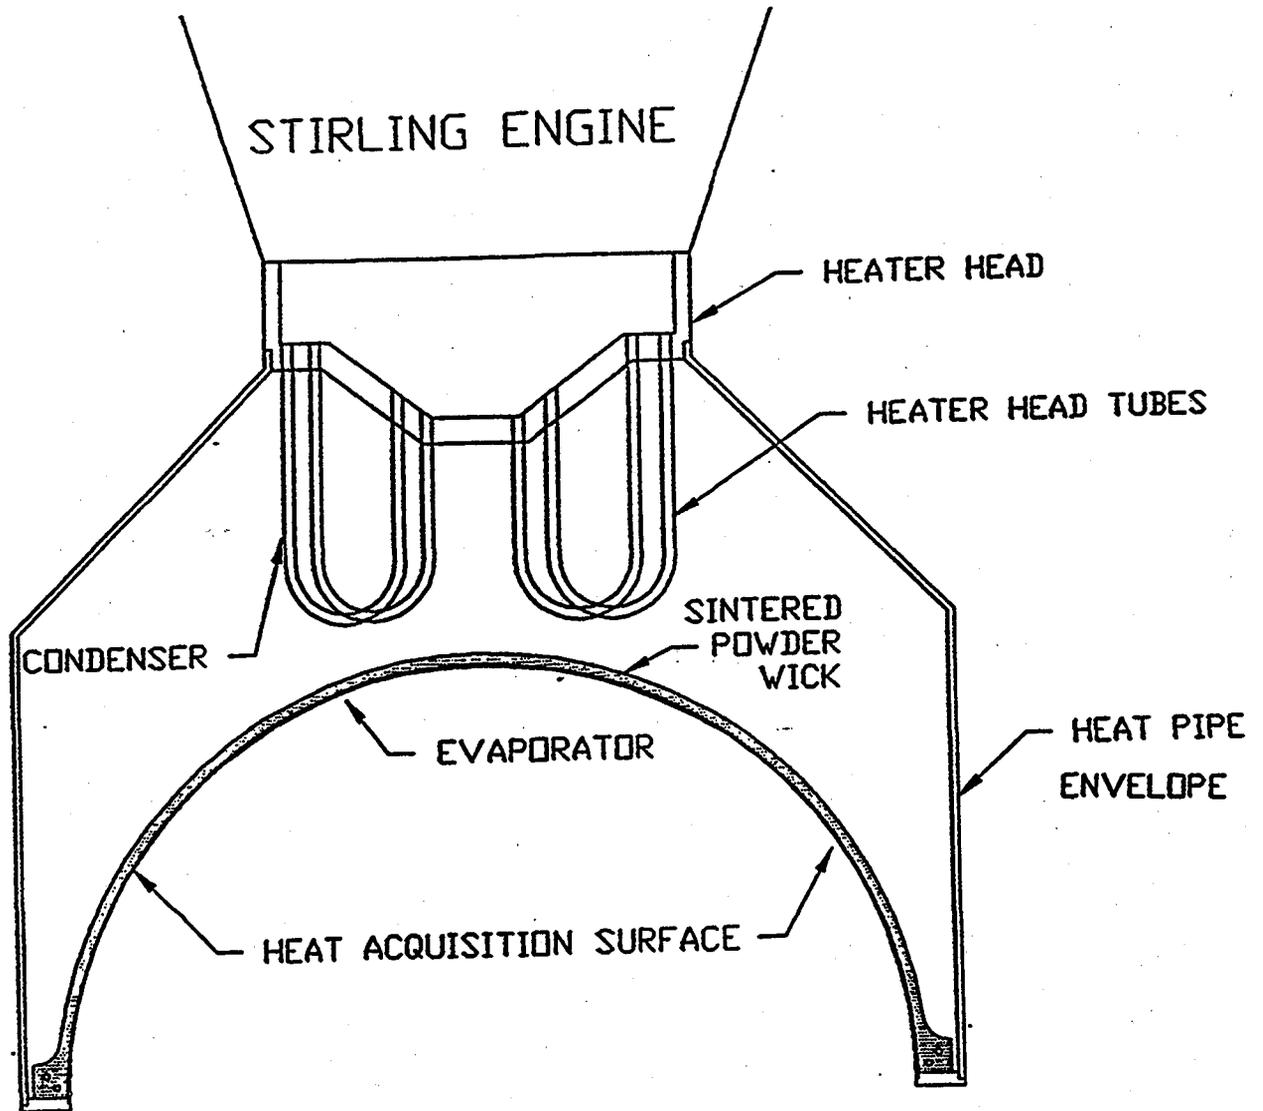
FIGURE 1. STIRLING ENGINE HEAT PIPE SOLAR RECEIVER

Dish Stirling systems are one of the most promising applications of the Stirling engine technology. Solar energy is concentrated by a parabolic reflector and is directed to the heat input section of the Stirling engine. The heat input section typically consists of a series of small diameter (5-8 mm) tubes that contain the engine working fluid, hydrogen or helium, as it shuttles between the expansion space and the cooler. It has been shown both analytically and by test, that the optimum engine efficiency results when the heat acquisition section is heated at a uniform temperature. The engine hot end typically operates at 550-800°C. Therefore, the optimum engine efficiency results when all of the heater head tubes are operating uniformly at 550-800°C. A liquid metal heat pipe receiver is typically utilized for this purpose. Figure 1 is a sketch of a typical heat pipe solar receiver for planetary use. A variation of this type of receiver can also be produced for use in space (zero gravity).

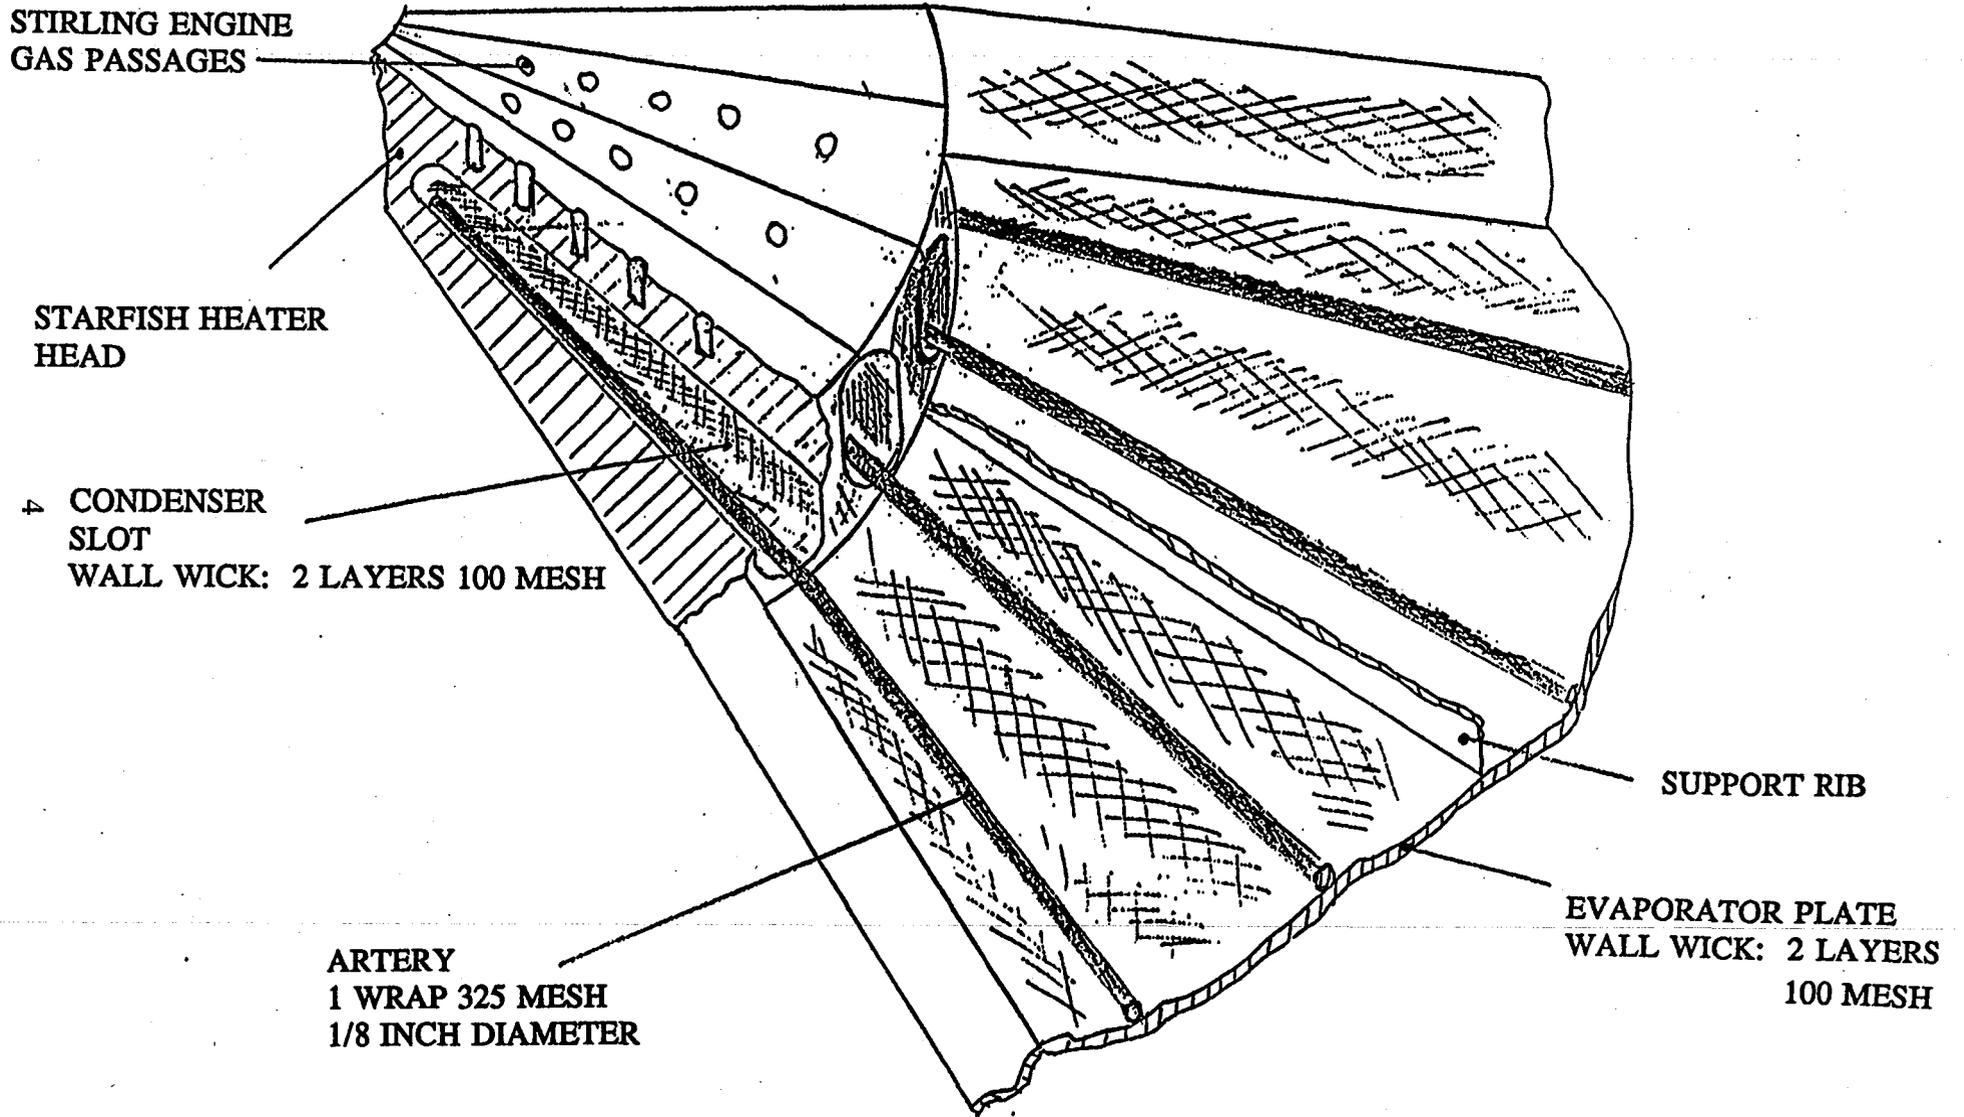
FIGURE 2. NUCLEAR REACTOR/STIRLING ENGINE HEAT PIPE RECEIVER

Nuclear Reactor/Stirling Engine Systems are also being developed for electrical power generation for use in space. In this application, the nuclear reactor is typically cooled with a liquid metal pumped loop. The pumped loop is thermally coupled to the Stirling engine by a heat pipe receiver. One example of this type of receiver is shown schematically in Figure 2. In this example, the heat acquisition section consists of solid metal fins with internal helium or hydrogen passageways. As mentioned previously, the optimum engine efficiency results when the heat input fins are heated at a uniform temperature of 550-800°C. Therefore, liquid metal heat pipes are used to transfer the heat from the reactor primary cooling loop at a uniform temperature to the heat input fins of the Stirling engine.

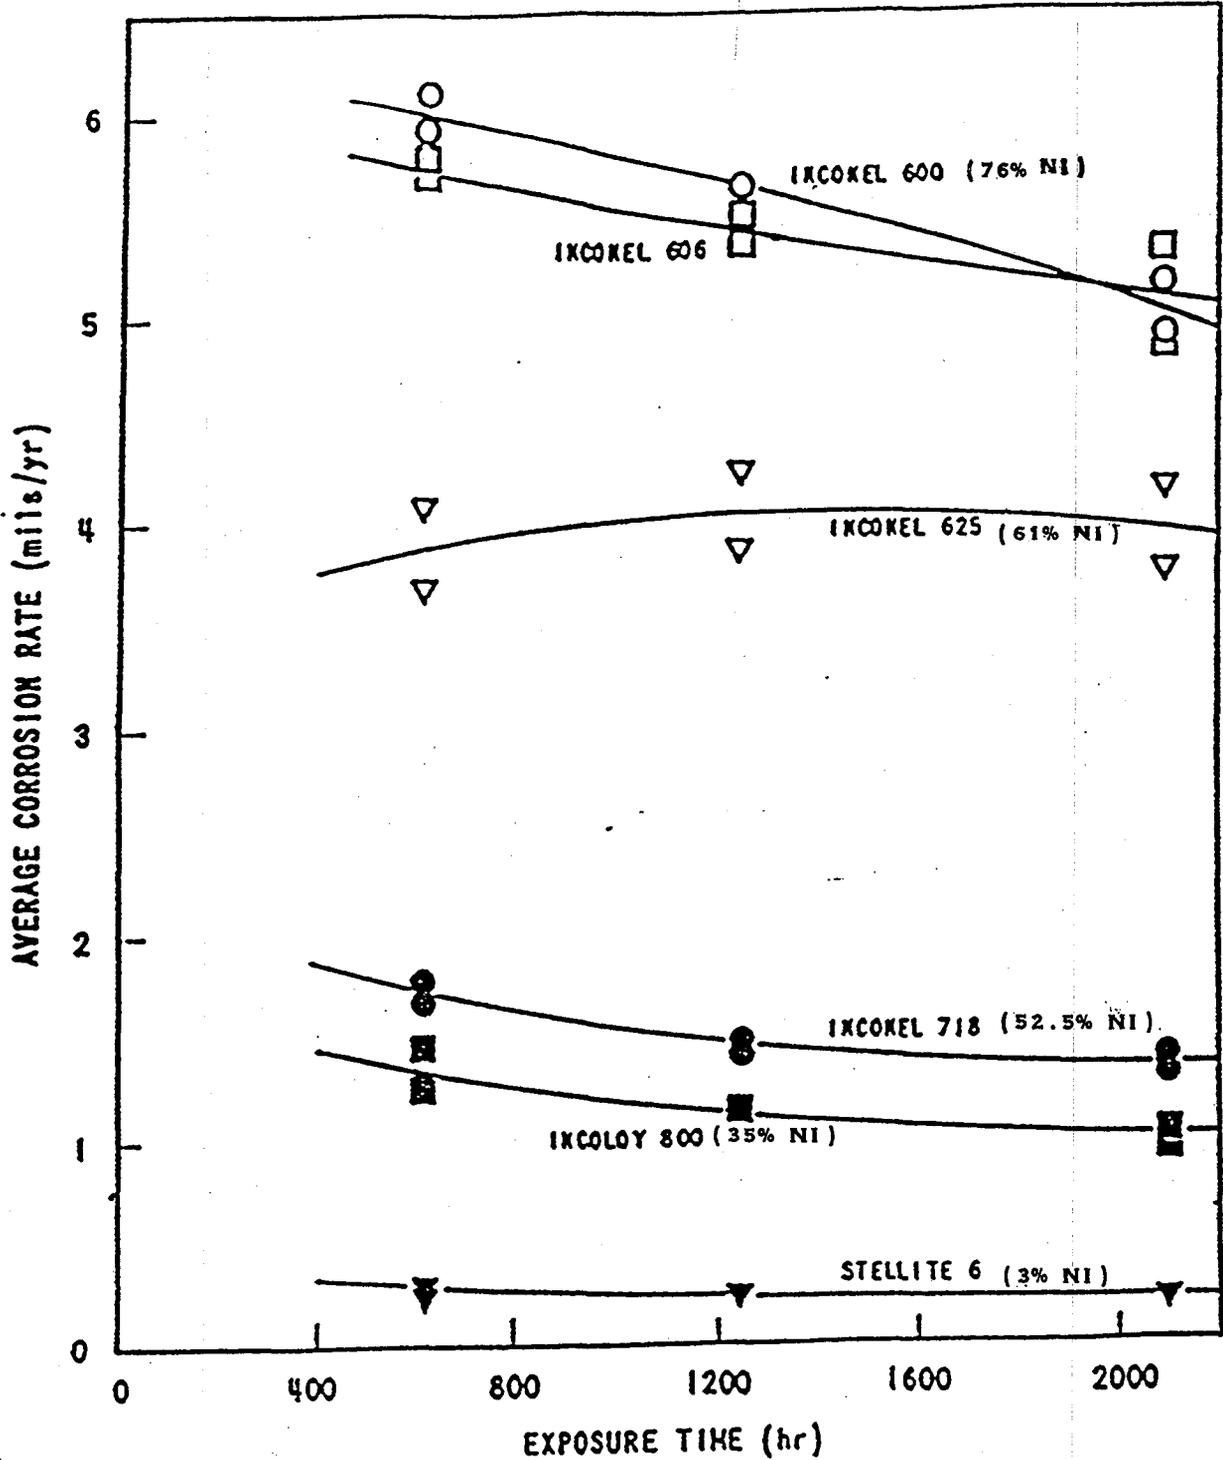
FIGURE 3. AVERAGE CORROSION RATE FOR NICKEL BASED ALLOYS IN PUMPED LOOPS

Solubility corrosion has the potential to be responsible for a number of premature failure mechanisms. Figure 3 is a plot of solubility corrosion rate versus time for a few nickel based superalloys subjected to flowing sodium at 720°C in a pumped loop. The corrosion rates

reported are 25-127 $\mu\text{m}/\text{year}$ (1-5 mils/year). Assuming a similar mechanism as that in a pumped loop, the wall thickness of a heater head tube or fin could be reduced by .25 - 1.27 mm (.010 - .050 inches) in ten years. In some cases this corrosion depth is greater than the starting wall thickness and in most cases the depth of corrosion is at least 50% of the starting wall thickness. Another potential failure mechanism is plugging of the heat pipe evaporator wick structure with the precipitated heater head material. Heat pipe wick structures typically have pore sizes of 1×10^{-5} m. Partial plugging can cause high liquid flow pressure drops that exceed the wick pumping capability which results in a dryout situation and potential melting of the receiver envelope.

A general trend for nickel based superalloys in pumped loop environments, which can be seen in Figure 3, is that higher nickel concentrations resulted in increased corrosion rates. This is only a trend and exceptions can be found. The other constituents, such as chromium, iron, molybdenum, columbium, aluminum, etc. are also soluble in sodium, potassium, and NaK. The literature suggests that iron is particularly susceptible to corrosion if the oxygen content of the liquid metal is high ($> 10\text{ppm}$). Precipitation hardenable alloys are particularly susceptible to selective corrosion of the grain boundary materials. If this condition occurs the material may crack along the grain boundaries and cause failure of the pressure boundary.

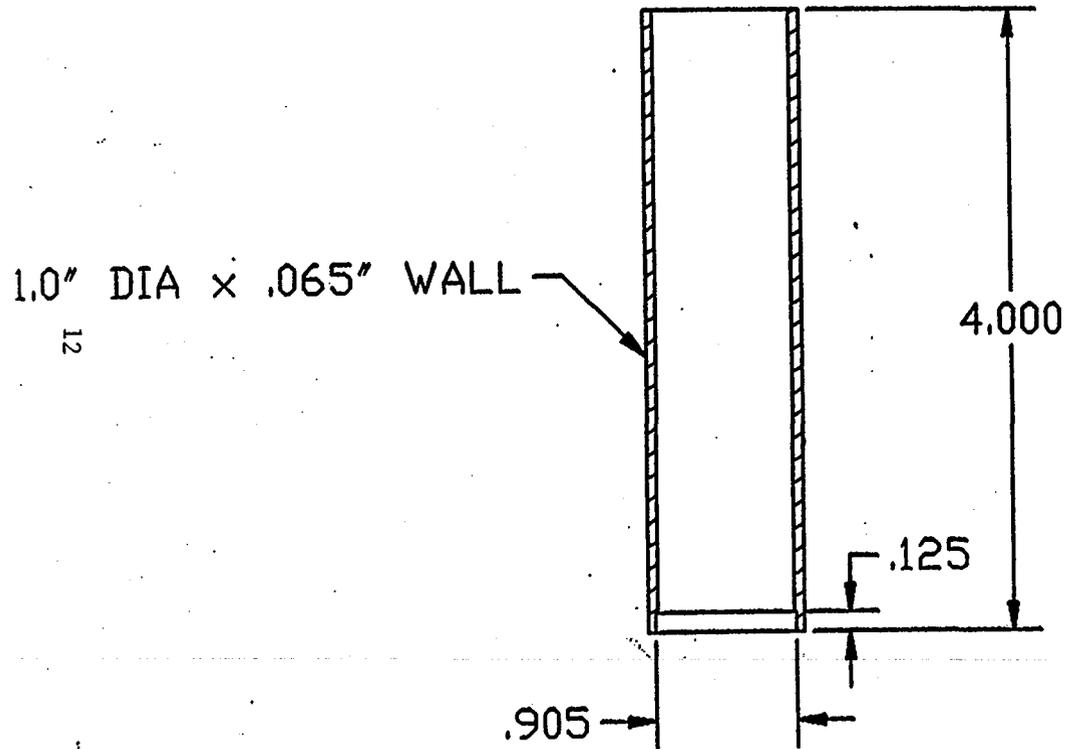
SAMPLE TUBE

As stated in Section 2.1 Requirements, it was determined jointly by Thermacore and NASA LeRC personnel that a total of six sample tubes would be prepared for solubility corrosion testing. Three tubes would be Nickel 200 and three would be Nickel 200 with a nickel aluminide coating. Based on the condensation heat flux and the typical dimensions of a Stirling engine heater head, the sample tubes were chosen to be 25.4 mm (1.0") diameter x 1.65 mm (.065") wall x 101.6 mm (4") long. The sample tube and endcap drawings are shown in Figure 4. The endcaps were gas tungsten arc welded (GTAW) into the tubes.

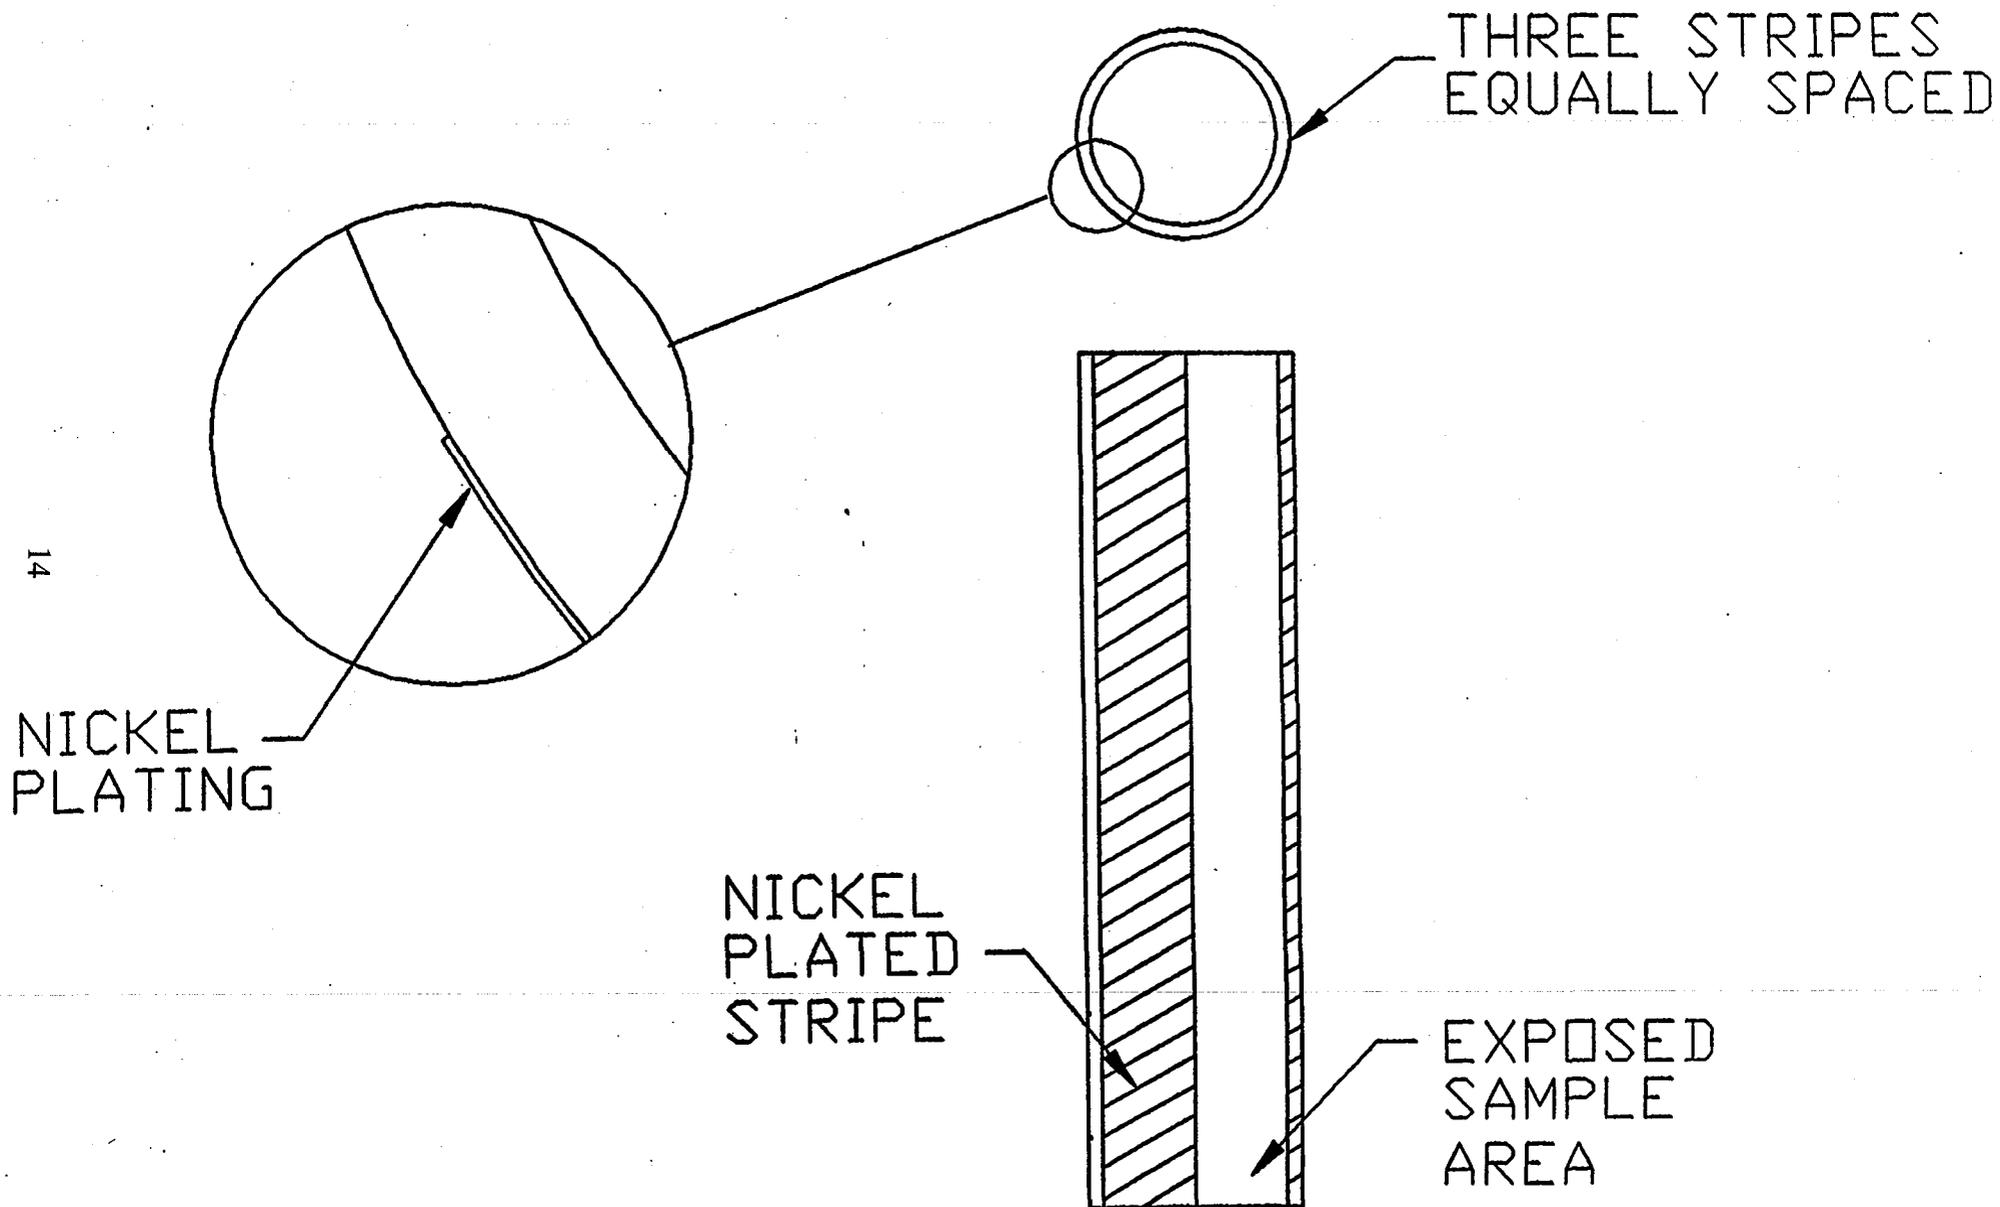
FIGURE 5. STRIPED NICKEL PLATING CONCEPT

Scaling from photomicrographs at high magnification, 50 to 400X, can be used to accurately determine the depth of corrosion. For example, at 200X magnification $2.5 \mu\text{m}$ (.0001") of corrosion is .5 mm (.020") which is easily measured with an accurate flat scale or dial calipers. In order to make the measurements, a base measurement location must be preserved. One technique that can be used to preserve the base measurement location is to nickel plate stripes onto the sample tubes. The nickel plating stripes are applied axially, in the direction of gravity draining and protect the underlying surface from solubility corrosion. The nickel plating thickness was selected to be $76.2 \mu\text{m}$ (.003"). The nickel plating stripe must be thick enough such that the plating will not be completely dissolved during the 1000 hour test. Figure 5 illustrates the striped nickel plating concept.

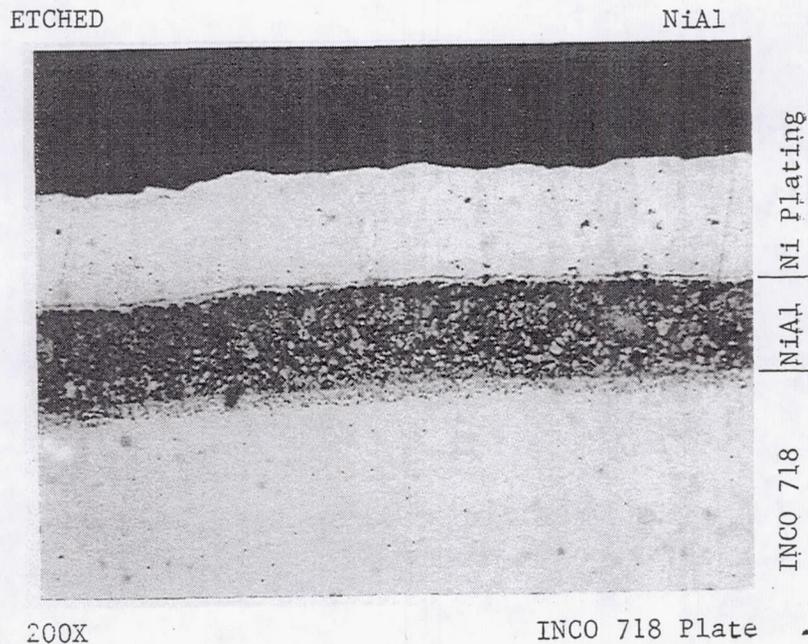
FIGURE 6. PHOTOMICROGRAPH NICKEL ALUMINIDE COATED INCO 718
PLATE WITH NICKEL PLATING STRIPES

**COATED BY CHROMALLOY RESEARCH
& TECHNOLOGY DIVISION FOR
MECHANICAL TECHNOLOGY, INC.
3 MILS**

**PLATED WITH 3 MILS, Ni-426 ELECTROLESS NICKEL
VACUUM FIRED AT 820°C, 4-6 HOURS**

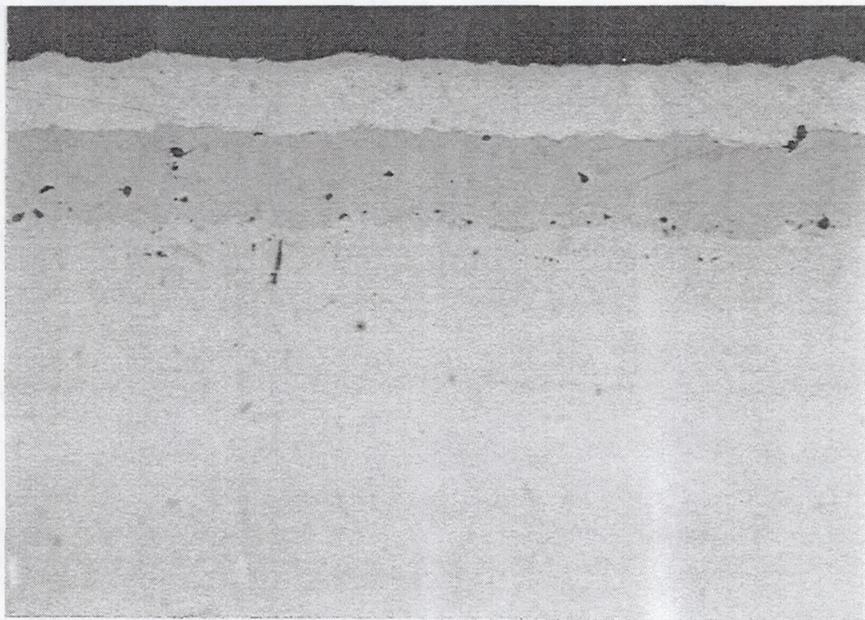
FIGURE 7. PHOTOMICROGRAPH OF NICKEL ALUMINIDE COATED NICKEL 200 TUBE, ONE STEP PROCESS, RT21

ALUMINIDE COATING
ON NICKEL ALLOY TUBES
EXTERNAL COAT ONLY

RT21 COATING, 1875 F
1.2 MILS, 27% Al

Chromalloy Research and Technology Division was contracted to coat several Nickel 200 sample tubes with nickel aluminide. Chromalloy typically uses one of two processes. The first, designated RT21, is a high temperature (1024°C) pack cementation diffusion coating process. This process is a one step process that is typically utilized for relatively thin coating thicknesses of $12.7\text{-}50.8 \mu\text{m}$ (.0005" - .002"). The second process, designated RT573, is a two step process. The first step is a low temperature (746°C) pack cementation process. During this step, an essentially pure layer of aluminum is applied to the sample tube. The second step is a high temperature (1038°C) diffusion heat treat. This process is typically used when coating thicknesses greater than $50.8 \mu\text{m}$ (.002") are required. Photomicrographs of each coating applied to a Nickel 200 sample tube are shown in Figures 7 and 8.

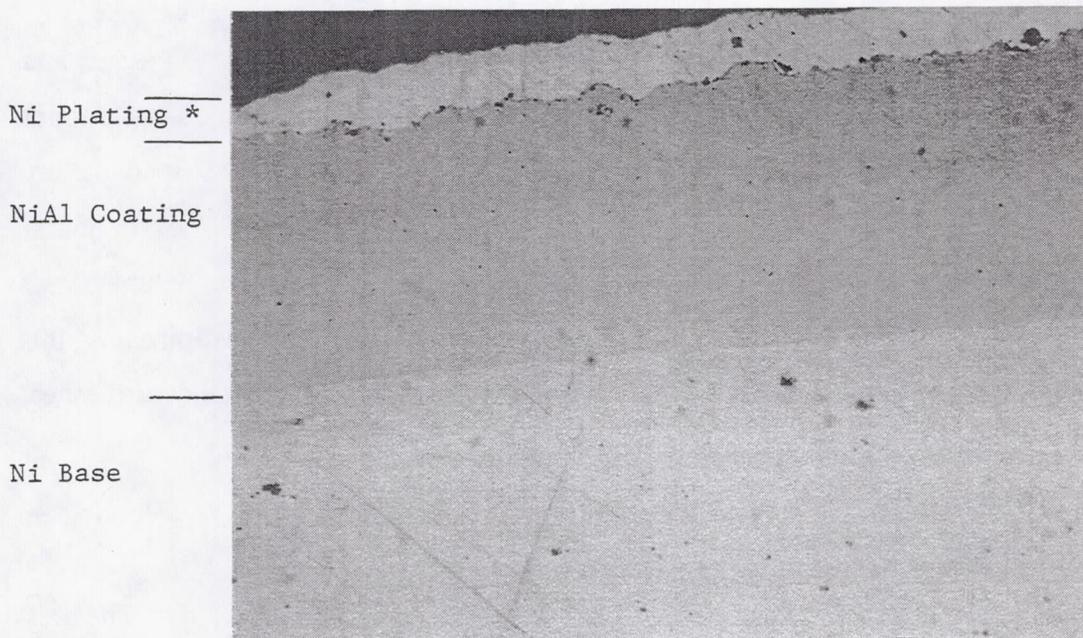
**ALUMINIDE COATING
ON NICKEL ALLOY TUBES
EXTERNAL COAT ONLY**

**RT573 COATING, 1875 F
9.6 MILS, 27% Al**

* Nickel plating used to preserve NiAl surface for photomicrograph.

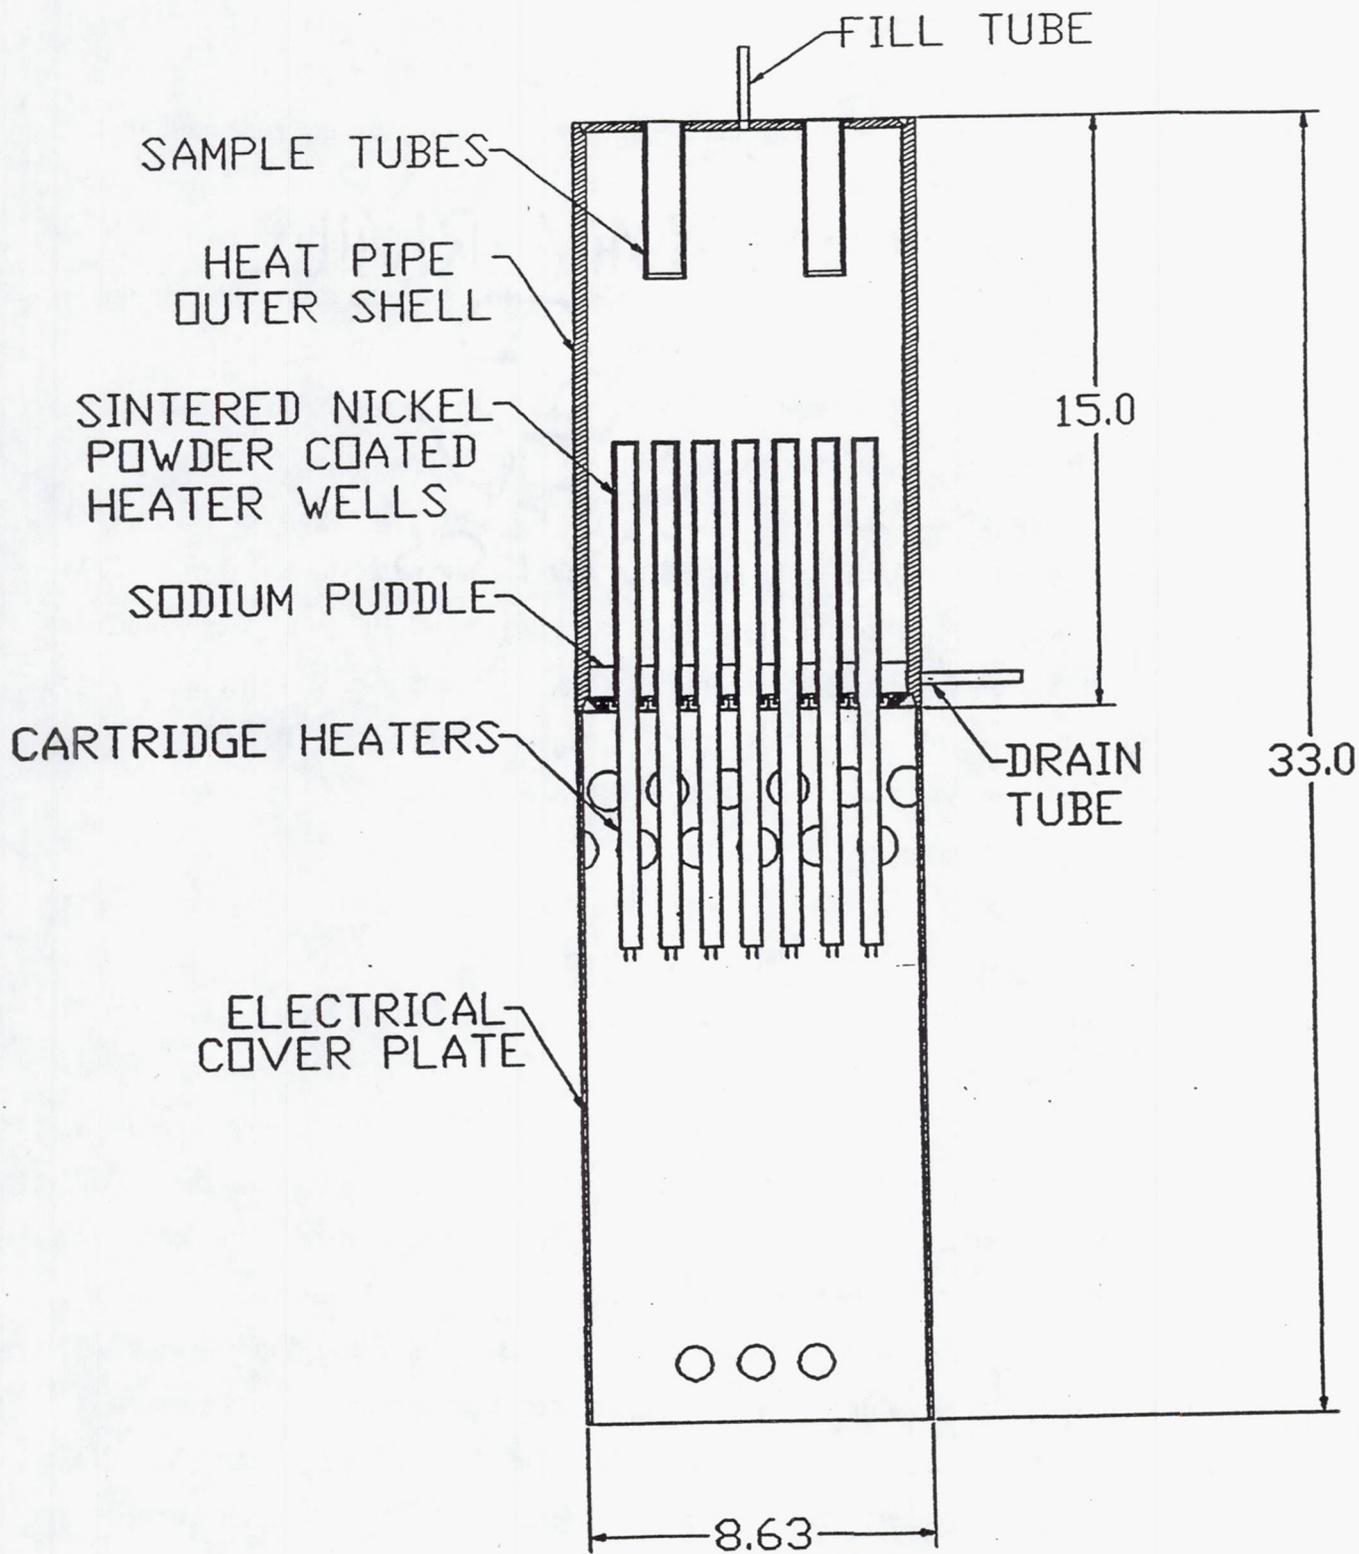
FIGURE 11. LAYOUT DRAWING OF THE SOLUBILITY CORROSION TEST HEAT PIPE (Dimensions in inches)

laboratory setting. A layout drawing of the selected design is shown in Figure 11. The evaporator section consists of 36, 1000 Watt cartridge heaters brazed into sintered nickel powder coated heater wells. The sodium fluid charge was selected to completely wet the sintered wick and to also cover the lower tube sheet to a depth of approximately 19 mm (.75"). The sodium working fluid is wicked up the length of the heater by capillary pressure generated in the sintered nickel wick structure. The sodium is evaporated from the heated surface and travels as a vapor to the condenser section consisting of the sample tubes welded into the heat pipe top endcap. Each of the sample tubes was fitted with a bayonet style gas gap calorimeter designed to extract the thermal power at the 25 W/cm² condensation heat flux.

The evaporator design is a variation of a number of heat pipes that Thermacore has supplied to Stirling engine manufacturers for laboratory testing of engines at full power conditions. The design of the nickel wick structure, 152.4 mm (6.0") long, 190.5 mm (.75") outer diameter, and 1.6 mm (.063") thickness was selected such that at full power (1000 Watts/heater), the safety factor for liquid pumping capability was 100% more than required. In other words, the wick structure was designed with a safety factor of 2 at the worst case operating conditions. In reality, the heaters are never operated at full power. In fact the heaters for this test vehicle were operated at only 40% of full power. Therefore, the effective wick design safety factor was approximately 5.

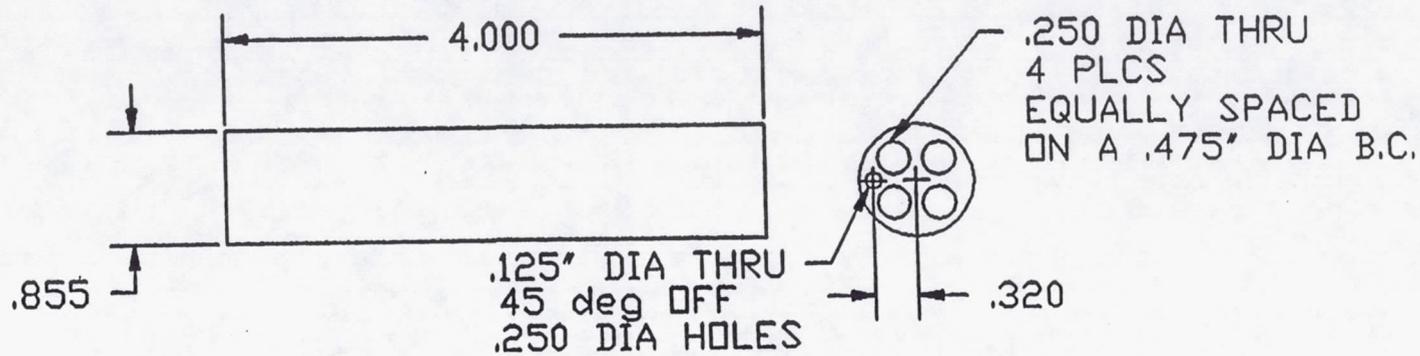
FIGURE 12. GAS GAP CALORIMETER FABRICATION DRAWING (Dimensions in inches)

In order to extract the thermal power and simulate the 25 W/cm² condensation heat flux, bayonet style gas gap calorimeters were designed. A gas gap calorimeter can be used to operate a heat pipe over a wide power range at a fixed operating temperature. The gas gap calorimeter

consists of two parts: the heat pipe condenser tube (in this application the sample tube) and the water calorimeter. In this application, the water calorimeter is placed inside the condenser tube with a known gap between the two parts.

The operation of a gas gap calorimeter is best understood by tracing the flow of thermal energy from the inside of the heat pipe to the water in the water calorimeter. The sodium vapor generated in the evaporator section condenses on the outer diameter of the sample tubes releasing its latent heat of vaporization. The thermal energy is transferred through the wall of the sample tube by conduction. Next, the energy is transferred across the gas gap by radiation and by conduction through the gas. By controlling the fraction of argon, a low thermal conductivity gas, and the fraction of helium, a high thermal conductivity gas, in the gas gap, the resistance to conduction across the gap can be modulated. The heat is then transferred through the wall of the water calorimeter by conduction and transferred by convection to the water flowing through the water calorimeter. The temperature rise of the water flowing through the calorimeter and the water flowrate are used to calculate the power extracted and the condensation heat flux.

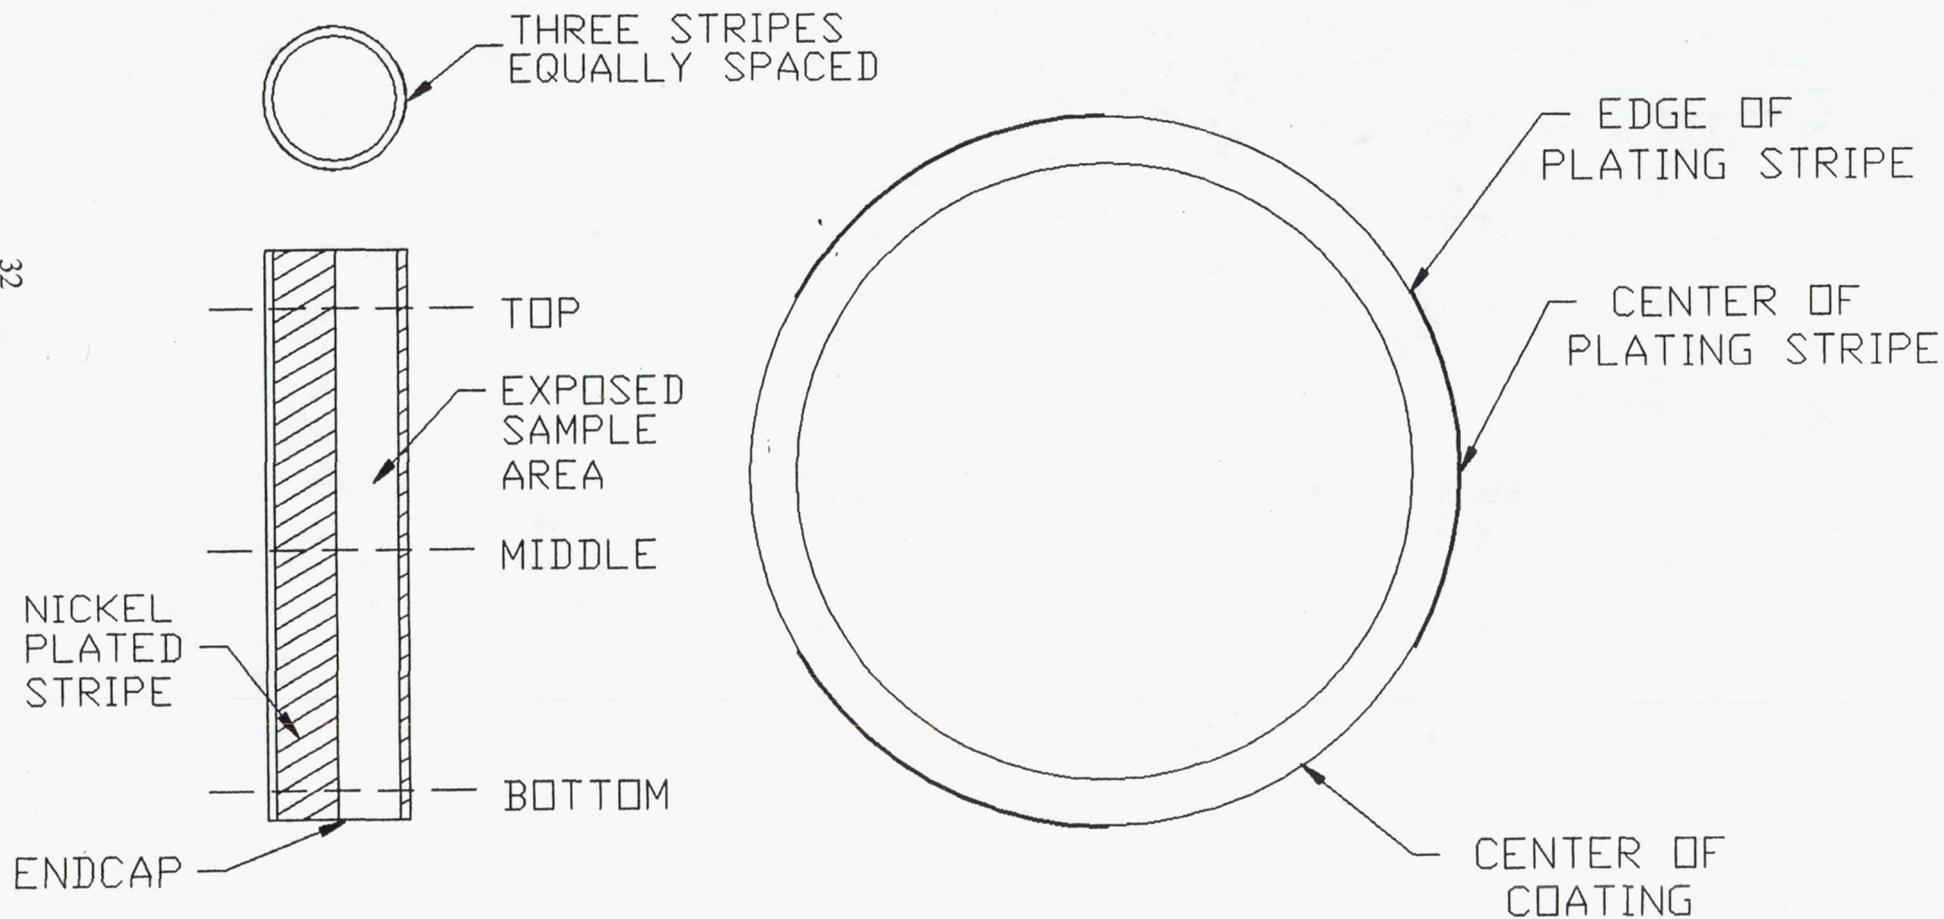
FIGURE 16. KEY FOR AXIAL AND CIRCUMFERENTIAL PHOTOMICROGRAPH LOCATIONS

photomicrographs was a three acid etch consisting of nitric acid, hydrochloric acid, and acetic acid. A small amount of cupric chloride was added to enhance the etchant's staining capability. Each of the above mentioned locations were photographed at three magnifications: 51, 100, and 200X. A complete set of photomicrographs is included as Appendix A. Figure 16 is a key of the axial and circumferential locations. Figure 19 presents the Appendix A photomicrograph labeling organization.

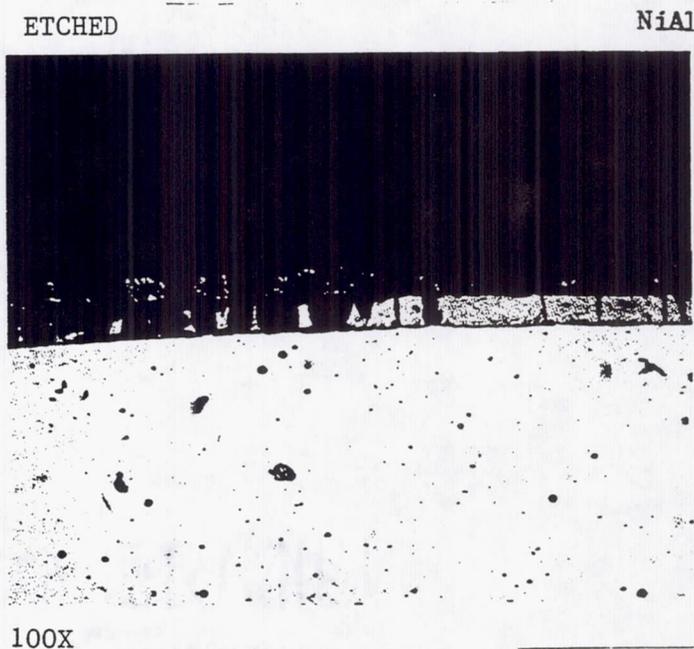
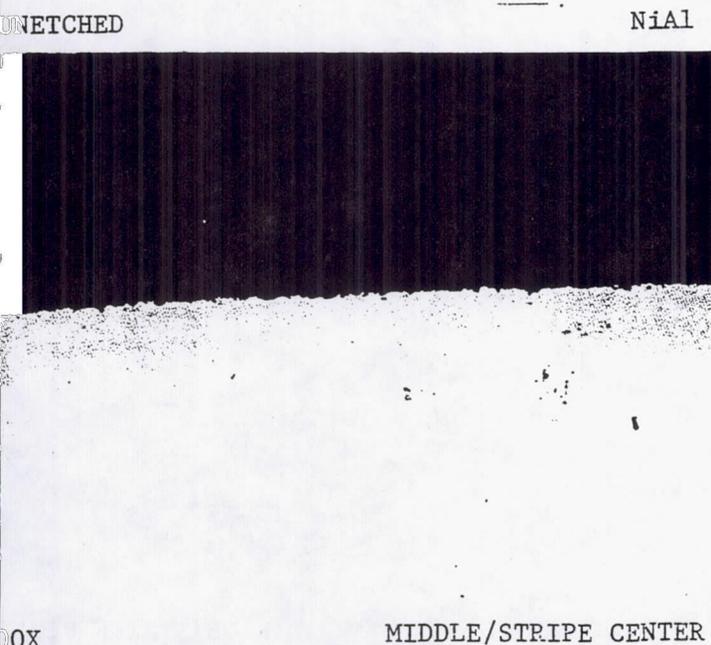
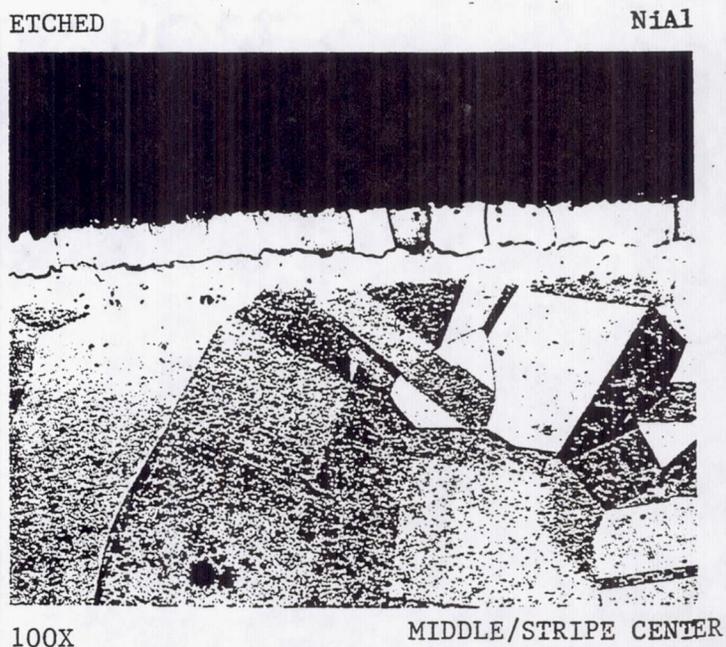
**FIGURE 17. PHOTOMICROGRAPH OF NICKEL ALUMINIDE COATED NICKEL 200
SAMPLE TUBE BEFORE AND AFTER 1000 HOUR TEST**

BEFORE 1000 HOUR CONDENSING SODIUM TEST

**AFTER 1000 HOUR AT 800°C SUBJECTED TO 25 W/cm²
CONDENSING HEAT FLUX WITH SODIUM**

2. Photomicrographs of the nickel aluminide coated Nickel 200 tubes showed less than .00254mm (.0001") corrosion from the 25 W/cm² condensing sodium flux at 800°C for 1000 hours. The resolution of the photomicrographs is better than .00254 mm (.0001").

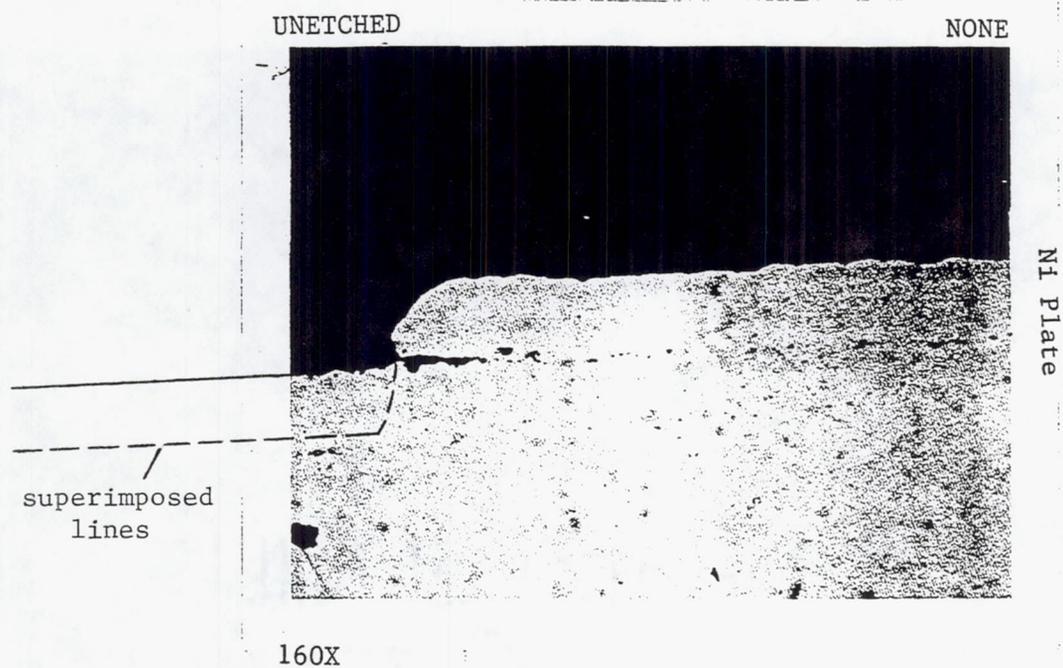
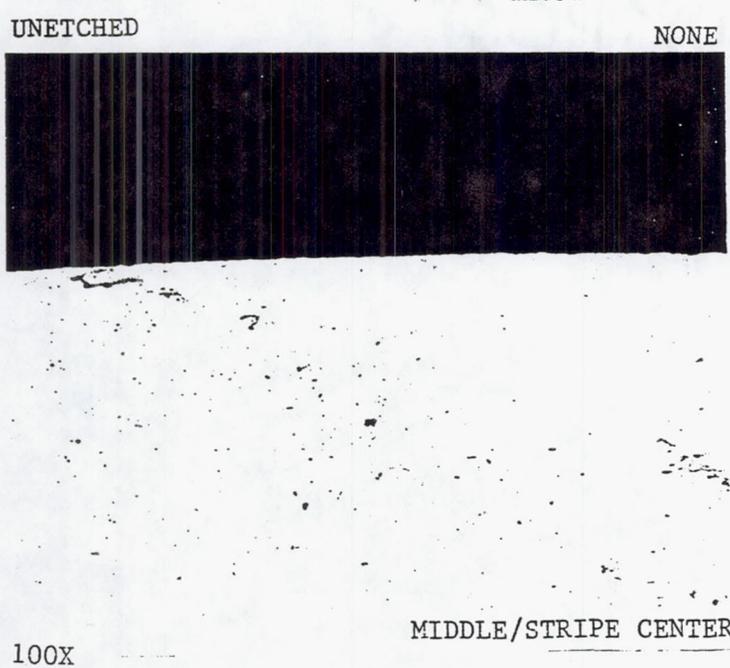
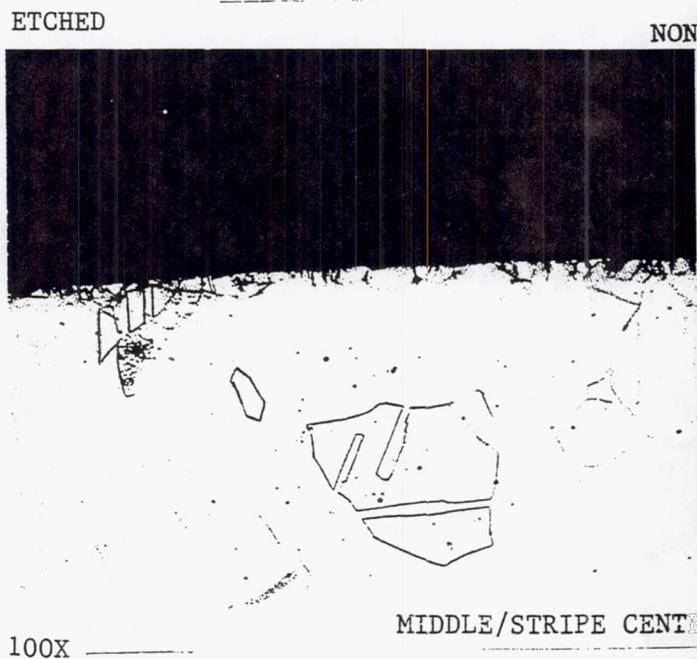
FIGURE 18. PHOTOMICROGRAPH OF NICKEL 200 SAMPLE TUBE BEFORE AND AFTER 1000 HOUR TEST

BEFORE 1000 HOUR CONDENSING SODIUM TEST

AFTER 1000 HOUR AT 800°C SUBJECTED TO A 25 W/cm² CONDENSING HEAT FLUX WITH SODIUM

3. Photomicrographs of the bare Nickel 200 tubes showed less than .00254 mm (.0001") corrosion from the 25 W/cm² condensing sodium flux at 800°C for 1000 hours. The resolution of the photomicrographs is better than .00254 mm (.0001").

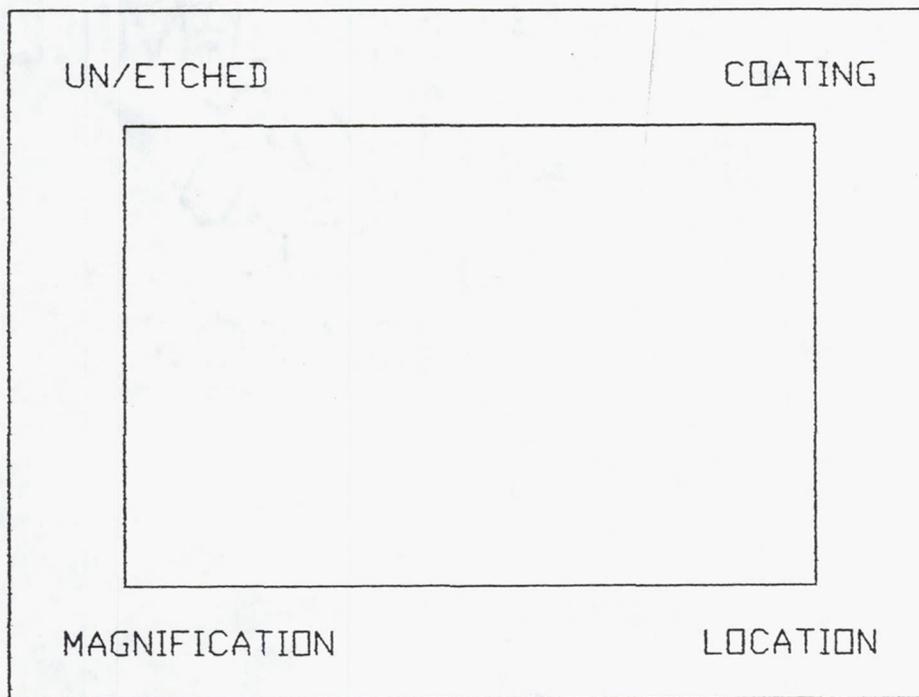
FIGURE 19. APPENDIX A PHOTOMICROGRAPH ORGANIZATION

UN/ETCHED = UNETCHED OR ETCHED SAMPLE PHOTOMICROGRAPHS

COATING = NONE OR NICKEL ALUMINIDE (NiAl)
