FINAL REPORT
HOT HYDROGEN TESTING OF METALLIC
TURBO PUMP MATERIALS

May 13, 1992 to May 12, 1993

Contract: NASA-39131 #11

Ralph Zee, Bryan Chin and Rohit Inamdar

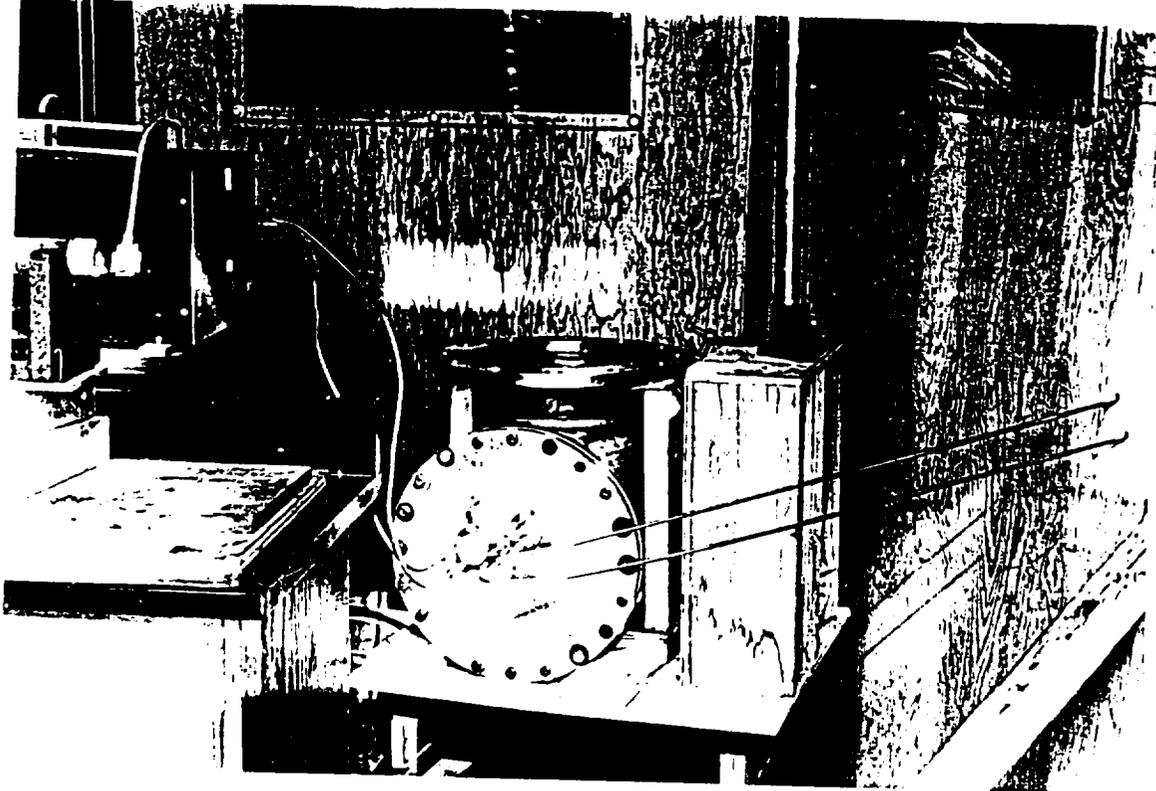
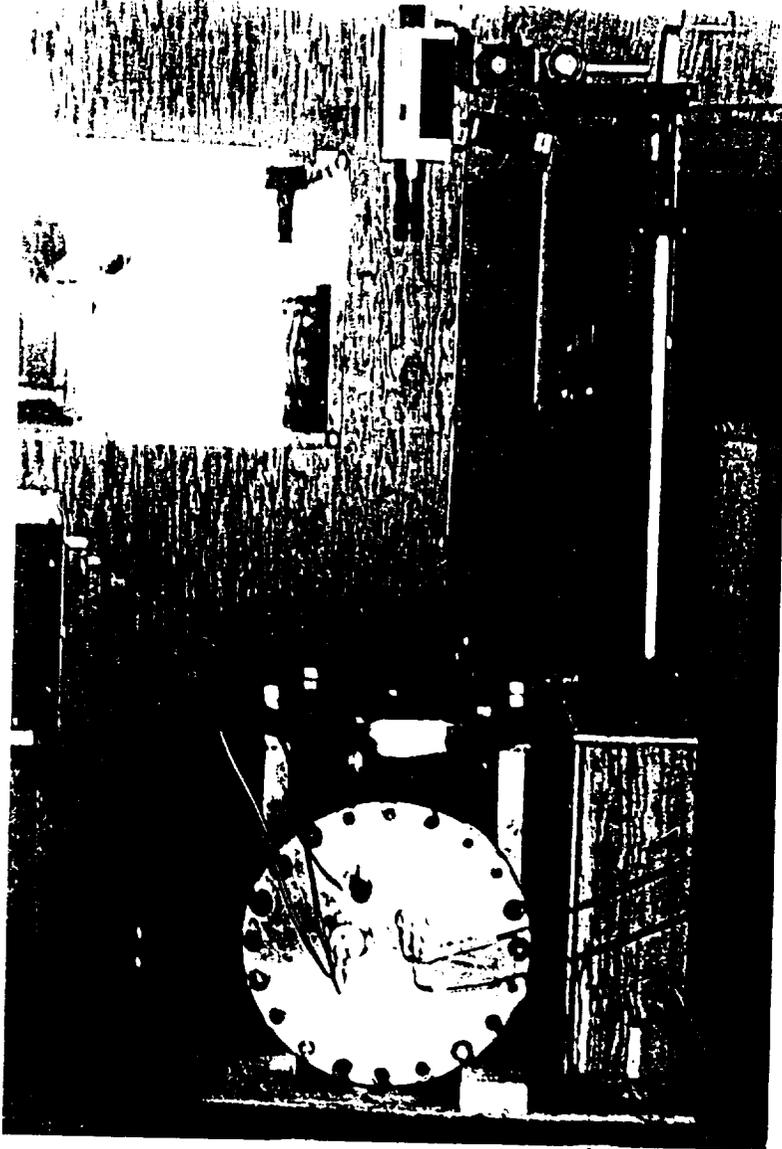
Figure 1.a. Experimental Setup.

Figure 1.b. Experimental setup.

A double wall vacuum chamber was used to carry out the experiments. Figures 1 and 2 respectively show a photograph and a schematic drawing of the system. The inner chamber was 3/4 inch diameter Nb-1Zr tube and was also used as the susceptor for the induction field. The tube was typically seven to eight inches long and was tungsten inert gas (TIG) welded at one end. The tube was replaced periodically because of degradation due to thermal and hydrogen embrittlement and oxidation. The use of TIG weld eliminated the necessity to produce a vacuum tight swage-lock at one end. The other end was connected to a stainless steel gas/exit line using a swage-lock connection. The inner chamber was enclosed in a

stainless steel containment vessel (outer chamber) which was significantly larger. Since hydrogen was only introduced into the inner chamber, this chamber was kept much smaller compared to the outer chamber due to safety considerations. The outer chamber was basically a large stainless steel "tee". On the outer chamber, three ports were designated back, front and top. Each port was 16 inches in diameter. The back port contained a vacuum line to the main pumping system. The front port contained the feedthrough for the induction coils, thermocouple, pressure sensor, hydrogen gas line and the venting to the chamber. The top port was removable and was used to place the samples inside the inner chamber. It also contained the viewport which was utilized by the pyrometer. The viewport also served as a safety device. The viewport was a flat circular piece of quartz that was slightly larger than the port hole in the top plate. The quartz was sealed against the face plate by vacuum inside the chamber and vacuum grease. This viewport served as a pressure relief device, if there was an undesirable pressure buildup in the outer chamber.

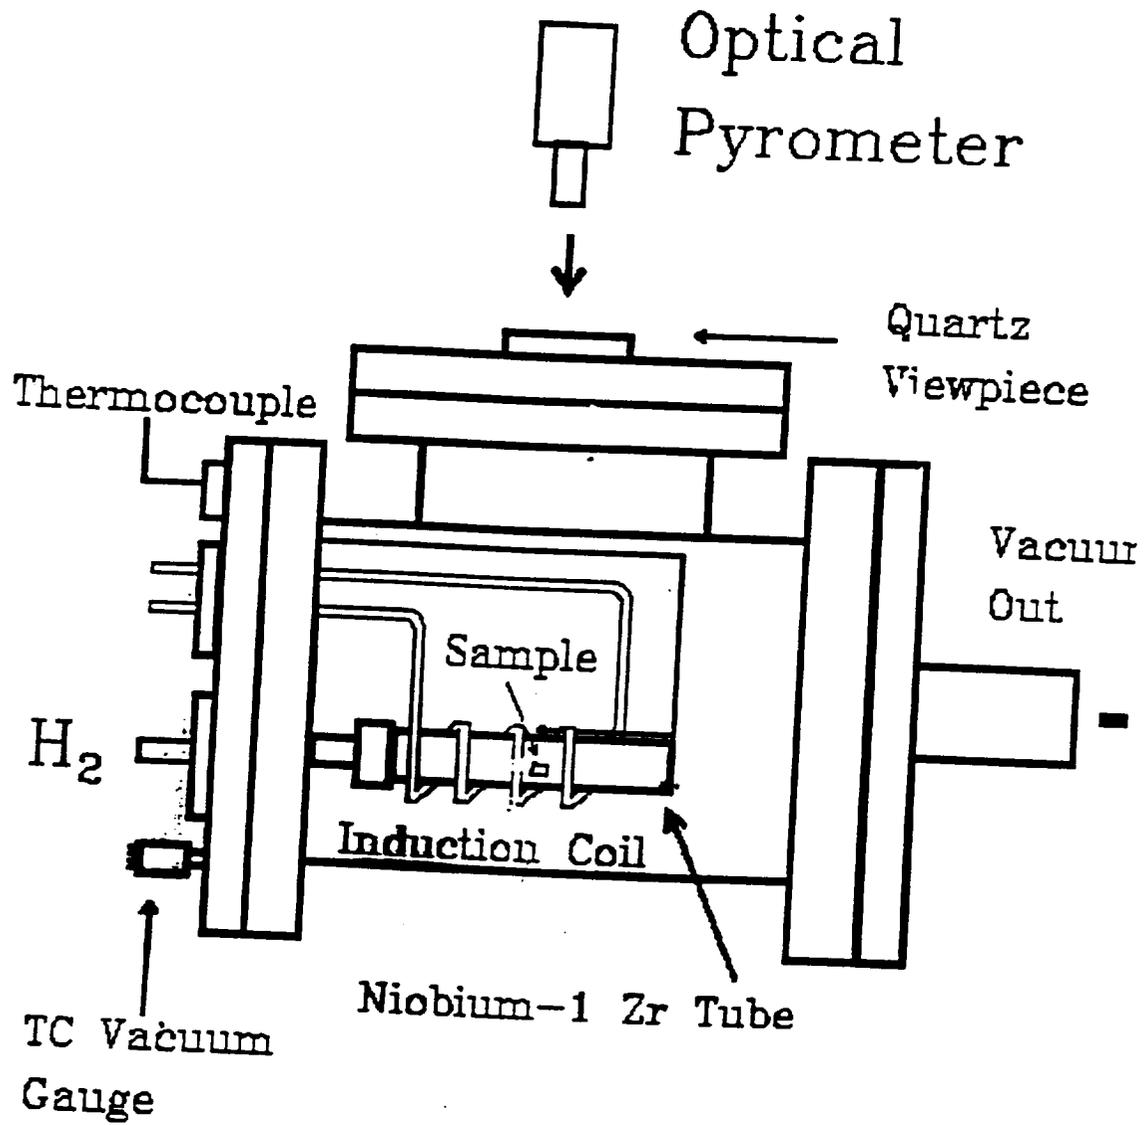
Figure 2. Schematic of Hydrogen Exposure Facility.

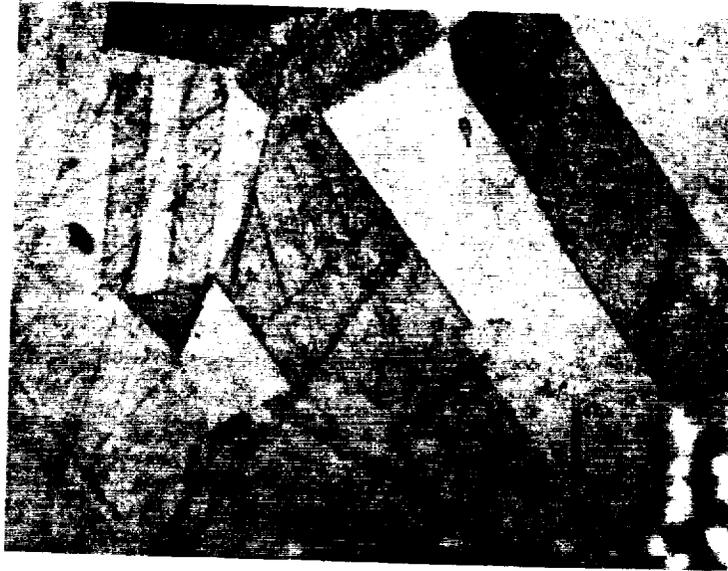
Inconel 718 Test #3; 500X

NASA-23 (C) Test #3; 200X

Figure 8. Optical Micrographs of Inconel 718 and NASA-23 (C) After Test #3.

Detailed microstructural and EDS analyses were then conducted. Optical microscopy of these processed samples supports the results obtained by XRD analysis. Figures 6 through 12 are the optical micrographs of these specimens. Grain growth can be easily observed in the microstructure of samples for which peak sharpening effect is evident in the XRD. No change could be observed in the microstructure of the processed samples from that of virgin sample apart from a change in the grain size which was a consequence of an annealing and not from hydrogen exposure.

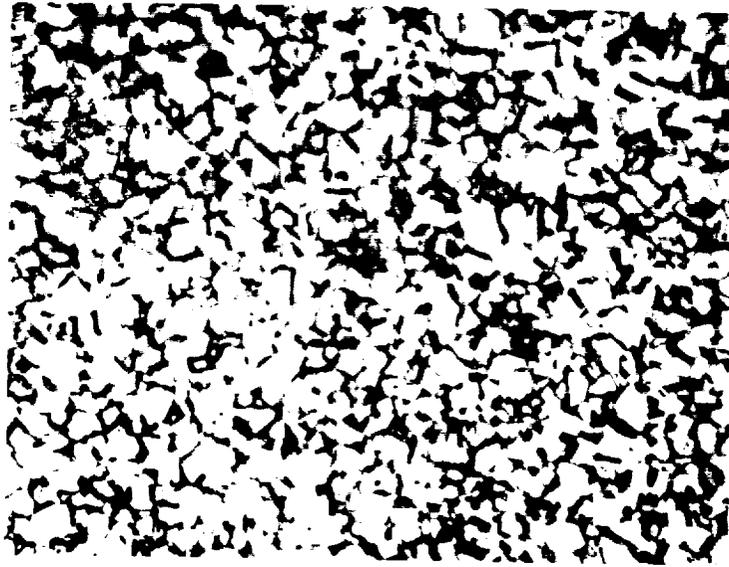
Inconel 718 Test #4; 500X

NASA-23 (C) Test #4; 200X

Figure 9. Optical Micrographs After Test #4.

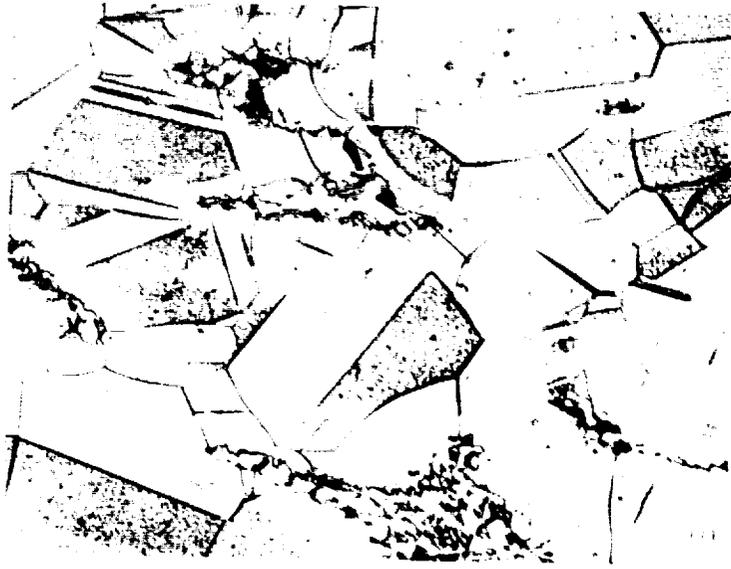
NASA-23 (W) Test #5; 500X

Inconel 718 Test #6; 500X

Figure 11. Optical Micrographs of NASA-23 (W) and Inconel 718.

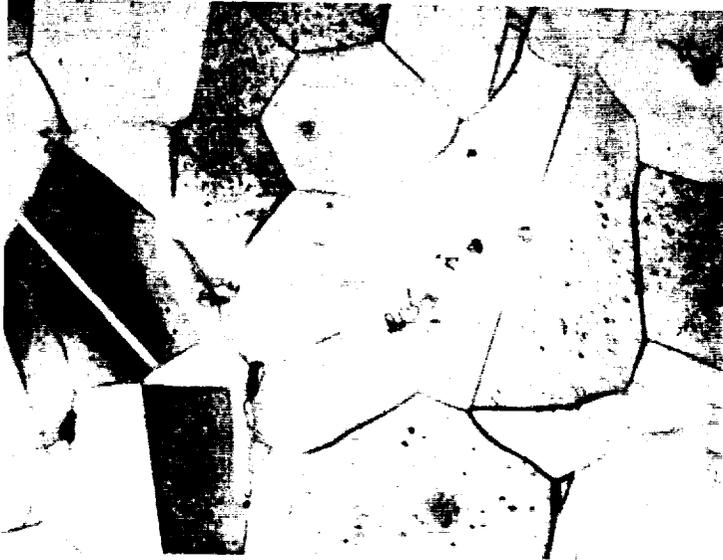
NASA-23 (W) Test #8; 500X

Inconel 718 Test #9; 500X

Figure 13. Optical Micrographs of NASA-23 (W) and Inconel 718.

X-ray diffraction pattern shows no additional peaks. Since no hydride peaks were obtained, in any of the x-ray spectra, it can be said that if at all any hydrides were formed during the hydrogen exposure, the amount was insignificant and below the detection limit of XRD. Similar to isochronal experiments, increase in the peak intensity was observed due to grain growth in some cases. The optical micrographs obtained from these experiments specimen are shown in figures 12 to 18.

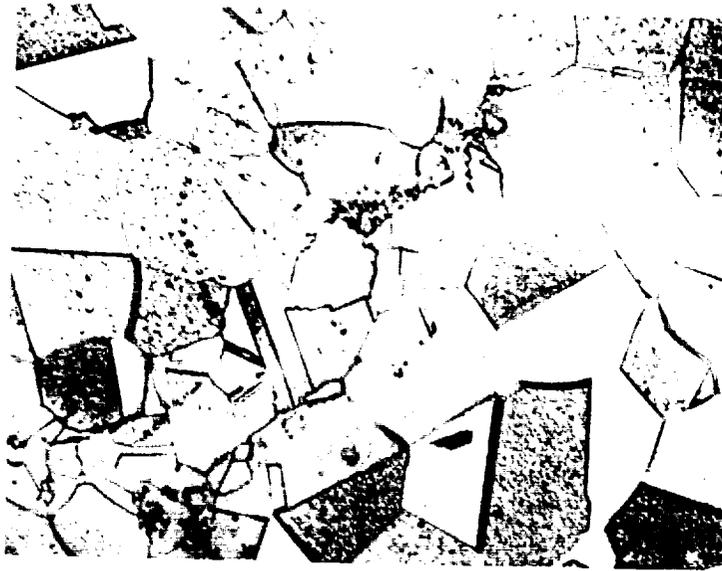
NASA-23 (W) Test #10; 500X

Inconel 718 test #11; 500X

Figure 16. Optical Micrographs Of NASA-23 (W) and Inconel 718.
