## LESSONS LEARNED FROM SELECTING AND TESTING SPACEFLIGHT POTENTIOMETERS

T. Iskenderian  
California Institute of Technology  
Jet Propulsion Laboratory  
Pasadena, California

## ABSTRACT

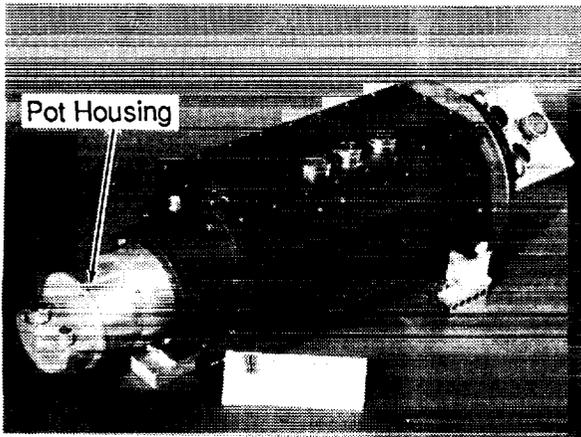
**Figure 1**

**TOPEX/POSEIDON SAD**

Problems with electrical noise and poor mechanical integrity of the pots began to show up as soon as environmental tests began. After four design cycles and three rounds of failure analysis, all problems except for electrical noise were completely corrected. Although the noise was reduced to a large extent, development problems halfway through the effort prompted the project management to seek risk reduction by asking for an additional means of position feedback. Thus an electronic motor-step counting circuit, named the SAD Incremental Counting Mode (SICM), was designed and built concurrently with the pot rework efforts. The final configuration of the SAD mechanism is shown in Figure 1. Figure 2 shows the general layout of the pot mounting and surrounding structure.

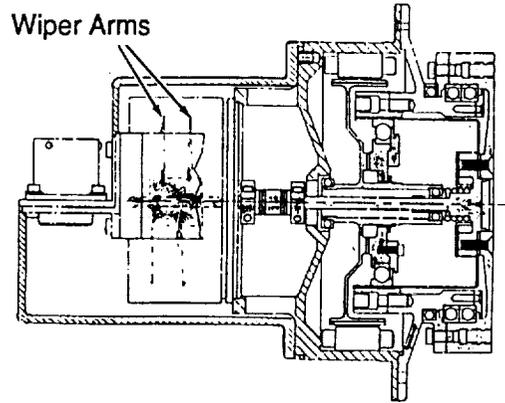
**Figure 2**

**Potentiometer/Actuator Module**

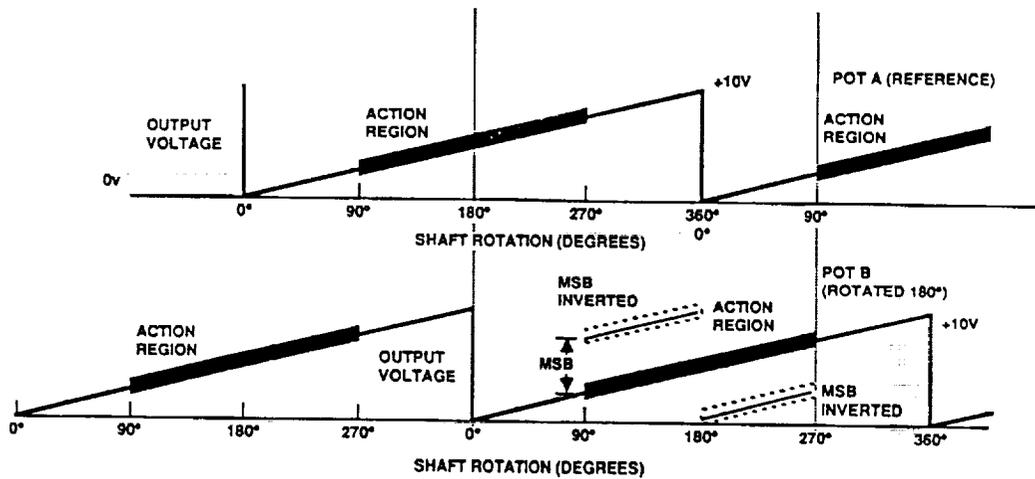
**Figure 3**

**ALGORITHM**

- (1) WHEN IN ACTIVE AREA OF POT A, USE DIGITIZED OUTPUT UNMODIFIED
- (2) WHEN IN ACTIVE AREA OF POT B, INVERT MSB OF DIGITIZED OUTPUT

**Digital Method of Selecting Active Potentiometer Element**

major design challenge for any of the options we studied. An electronic means of switching between potentiometer (pot) elements to maintain continuous function over 360° was proposed, which removed the reliability concern of mechanical switchover.

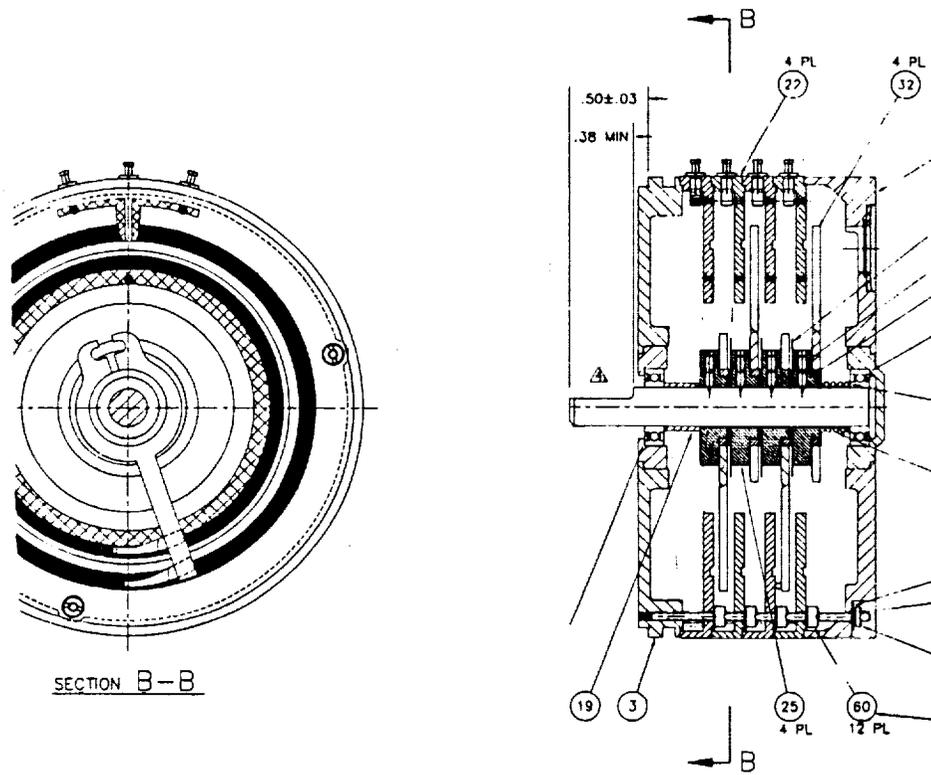
Figure 4

Potentiometer Cross Sections

A general cross section view of the pot is shown in Figure 4. The resistive and conductive tracks are two annular rings on each element, co-molded into the Diallyl Phthalate (DAP) disk substrate during fabrication. Each pot element is manually trimmed to specified linearity by grinding away small fractions of these co-molded resistive tracks by removing material from an annular channel that is cut adjacent to the track for this purpose. A thin electrical wiper contact, whose contact force is controlled to approximately 15 cN, sweeps over each track. As seen in Figure 5, two wipers per element, originally made of beryllium copper alloy, are resistance welded to their wiper arm. The wiper arm grips an insulating ring on its respective hub by friction generated through spring force when the arm is sprung open, much like a retaining ring, to install it on the hub.

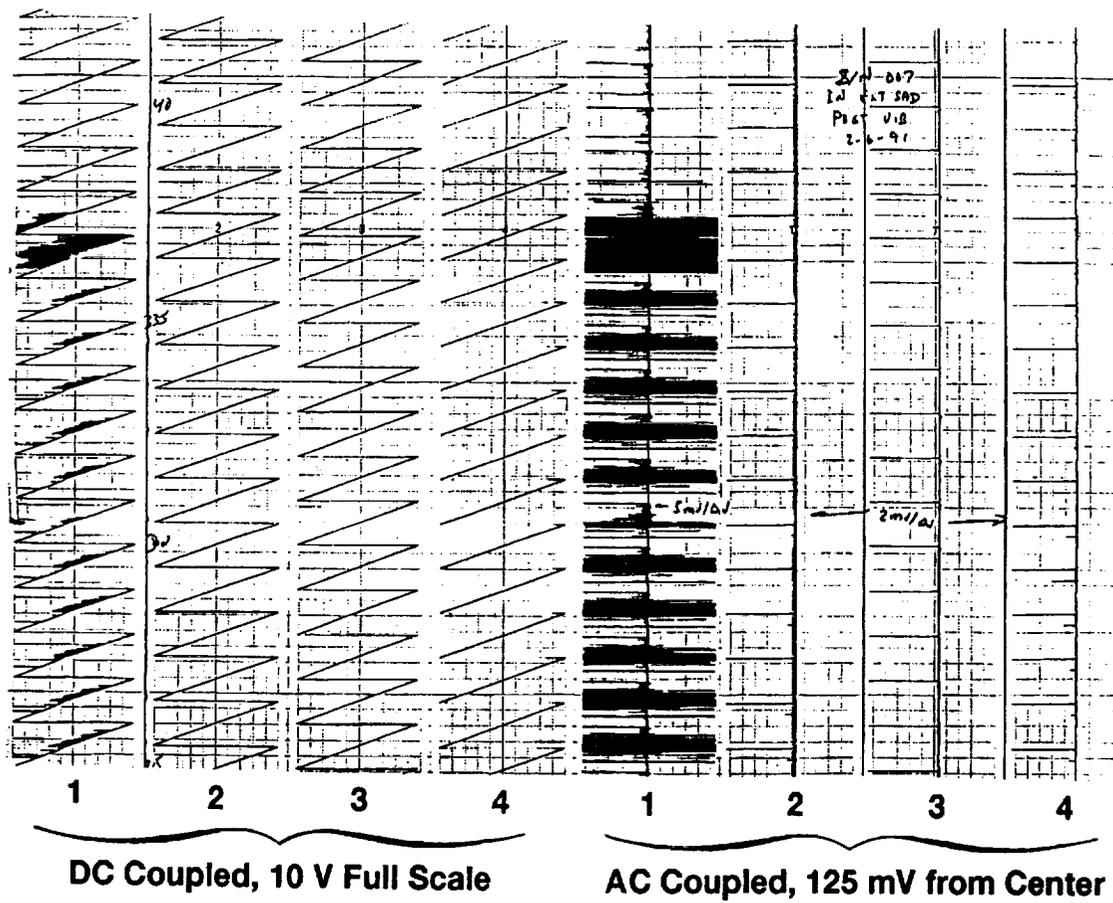
Figure 6

Chart Record of Noise on Pot SN 007 after Vibration, Elements 1 through 4.

Electrical signal noise was experienced on many occasions. The noise most often occurred after vibration tests, but would sometimes be manifest before exposure to any flight environment. It was often of a very dramatic nature, sometimes opening the pot circuit altogether. A sample chart record of pot noise is shown in Figure 6. The noise signature could vary

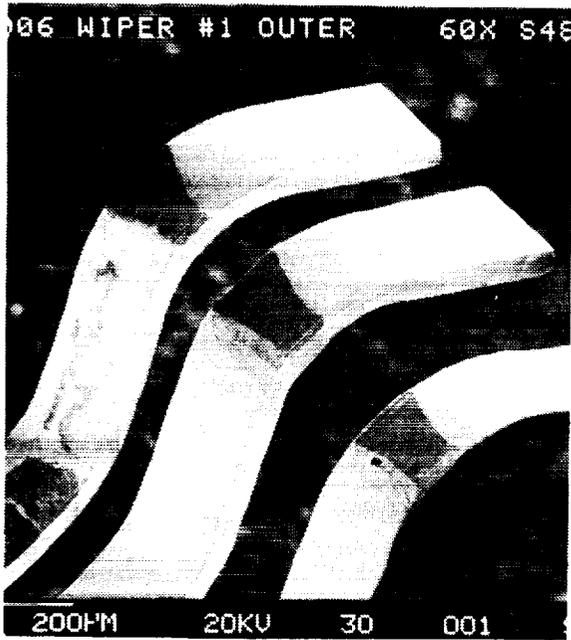
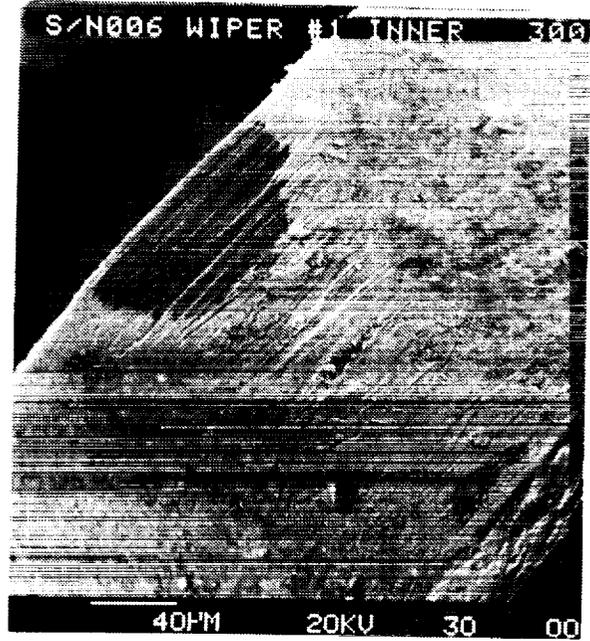
**Figure 9**

**SEM Photo of SN 006 Wiper Contact Wear**

Our findings, and the pot vendor's opinion, convinced us that the contact lubricant was not helpful, and could actually be trapping debris and exacerbating the noise problem. In fact, most of the wiper contacts displayed more wear in SEM photos, as shown in Figure 9, than did the unlubricated contacts with the same normal force.

Results from life testing were favorable. Element number three tended to have more noise than the others, but within acceptable bounds. By comparing the noise amplitude and location with the vibration level at that shaft dwell position, a clear correlation between vibration damage (Figure 9) and noise was observed. Noise behavior at rates ranging from 1x to 120x flight showed no significant rate dependence. A trend towards increased shaft friction torque was noted; average values at the start of the test were 0.0105 N•m, increasing to 0.0199 N•m at the end. Average error

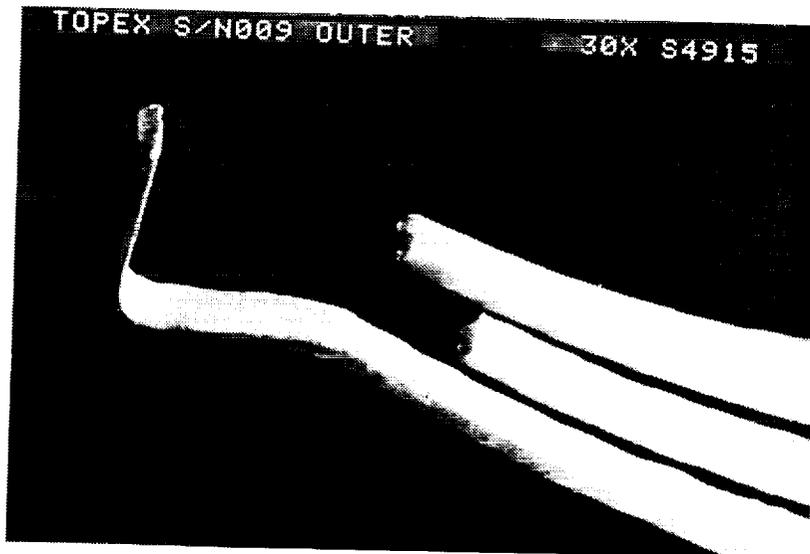
**Figure 10**

**SEM Photo of SN 009 Fractured Wiper**

The new lot of pots, numbers 008 - 012, entered vibration test with acceptable characteristics. Unfortunately, we found that the wipers had not been adequately re-engineered; the wipers fractured halfway through the random vibration test at regions of high stress. The fracture was observed as the pot signal was monitored in vibration; a sudden step change in the position signal occurred as a new contact point was established with the stub of the remaining wiper.

Metallurgical analysis of the failed wipers showed they had broken due to crack propagation from fatigue loading, followed by ductile failure. Failure analysis photos of a representative broken wiper are shown in Figures 10 and 11. It turned out that Be-Cu alloy No. 25, in the half hard condition and fully heat treated after forming, was among the least fatigue-resistant of Be-Cu alloys.

We turned to the J. M. Ney Company, a firm that specializes in the design, test, and manufacture of sliding electrical contacts, for a solution. Ney recommended its Paliney-7, a precious metal alloy primarily comprising palladium, silver, gold, copper, and platinum. This material was developed for use in sliding electrical contacts, and has been applied in other manufacturers' pot designs. The available fatigue property data for this alloy suggested that it would be fair to expect excellent performance in vibration. New wiper contacts of Paliney-7 were fabricated to a contact force specification of  $20 \pm 4$  cN, and assembled into the final lot, serial numbers 013 through 018.

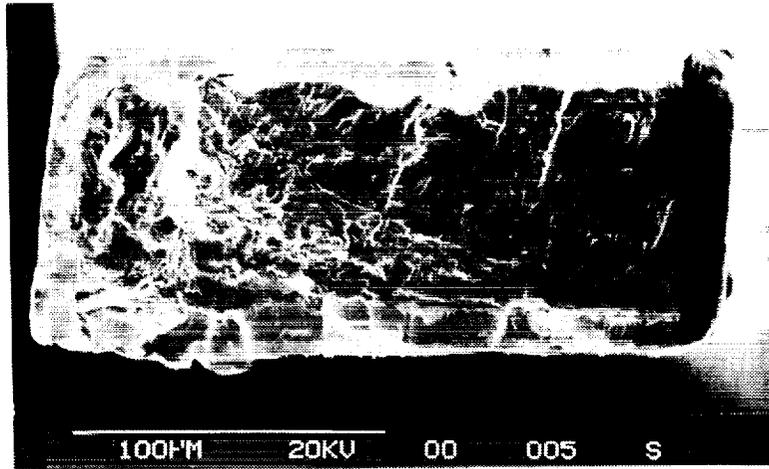
Figure 11

SEM Photo of Fracture Plane,  
Showing Gold Plated Outer Layer

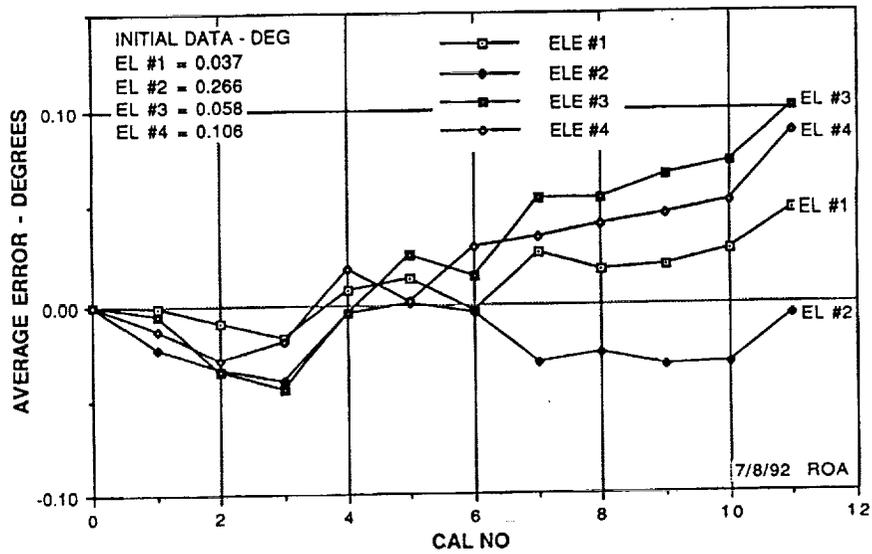
Figure 12

Life Test Calibration Trend for SN 016 Pot Elements

remained within specification for the duration of the test, although a worsening trend is clear (Fig. 12).
