NASA  
Technical Memorandum 106361

# Metallographic Analysis of Brush Bristle and Integrity Testing of Brush Seal in Shroud Ring of T-700 Engine

Prepared for the  
Fifth International Symposium on Transport Phenomena and  
Dynamics of Rotating Machinery  
sponsored by the Pacific Center of Thermal Fluids Engineering  
Kaanapali, Maui, Hawaii, May 8-11, 1994

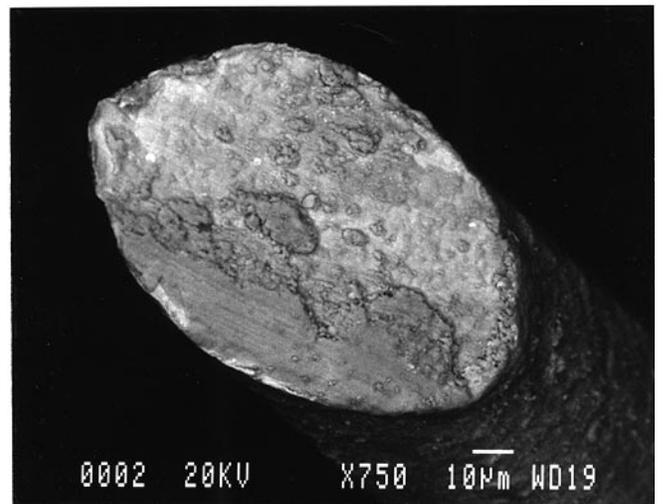
Figure 11.—Material transfer at bristle tip.

With significant material transfer to the rotor and oxide scale formation over the bristle surface indicated by Figs. 9 and 10, an examination of a bristle tip (Fig. 11) showed wear traces, pitting, and material transfer. Figure 12 illustrates that although the base material appears as Haynes 25, the distribution of tungsten differs as noted in the element spectra. Therefore, some form of resolidification must have occurred right at the bristle-rub runner interface.
