Materials Testing on the DC-X and DC-XA

Dane Smith, Carol Carroll, Jochen Marschall, and
Joan Pallix

January 1997

Summary

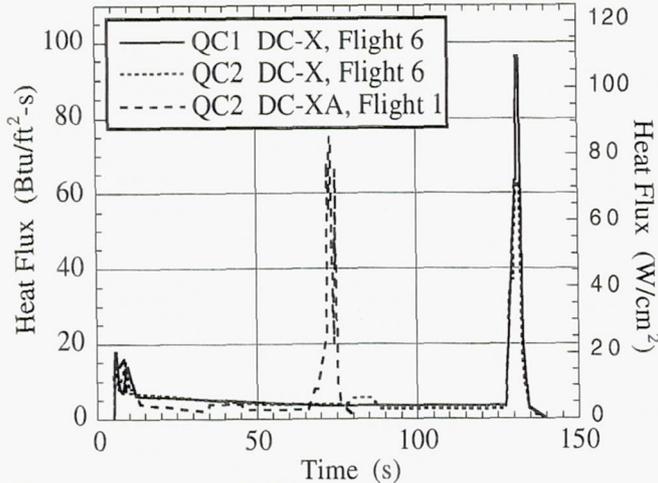
Figure 1(a). The approximations to the measured heat fluxes

TPS testing was carried out on DC-X flights 6, 7, and 8 (May 16, June 12, and July 7) in 1995. The most severe thermal environment occurred during vehicle landing. During landing the test panels were exposed to a short duration high temperature heat pulse (peak fluxes up to $\sim 100 \text{ W/cm}^2$) and in most cases were simultaneously impacted by debris from the concrete landing pad. Representative heat flux measurements from calorimeters located in the DC-X and DC-XA base heatshields are shown in figure 1(a). This data was transmitted by Mike Johnson of MDA (Huntington Beach). The heat fluxes measured by calorimeter QC2 are considered the best representation of the heating environment seen by the test panel; see figure 1(b). The initial rise in heat flux corresponds to vehicle lift-off (at about 5 seconds) and the large spikes to vehicle landing. The DC-X flight 6 heating conditions are typical for landings on concrete, which were the case for most of the Delta Clipper flights. The heating conditions for DC-XA flight 1 are for a vehicle landing on a metal grate.

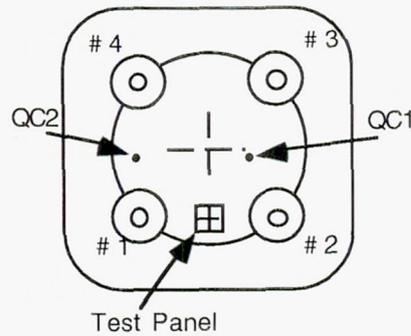
Figure 1(b). The locations of the two calorimeters relative to the test panel on the base of the DC-X and DC-XA.

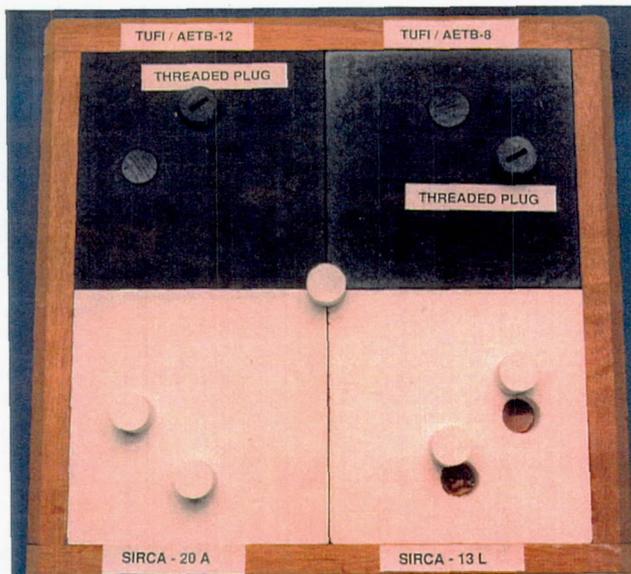
Figure 2(a). Pretest panel for DC-X flight 6. Contains different density TUFI/AETB tiles (black) and SIRCA tiles (white). Note the nine plugs prepared to cover the attachment screws. Two of the plugs were machined out of TUFI so that they could be screwed into place.

The TPS panel tested on flight 6 consisted of four 6 inch \times 6 inch \times 1 inch tiles of different densities. Two Toughened Unipiece Fibrous Insulation (TUFI) tiles were prepared from 8 lb/ft³ and 12 lb/ft³ Alumina Enhanced Thermal Barrier (AETB) ceramic substrates, and are shown in figure 2. TUFI tiles were developed specifically to be resistant to impacts. The white Silicone Impregnated Reusable Ceramic Ablator (SIRCA) tiles in the photo were prepared by silicone impregnation of 9 lb/ft³ and 18 lb/ft³ silica tile substrates.

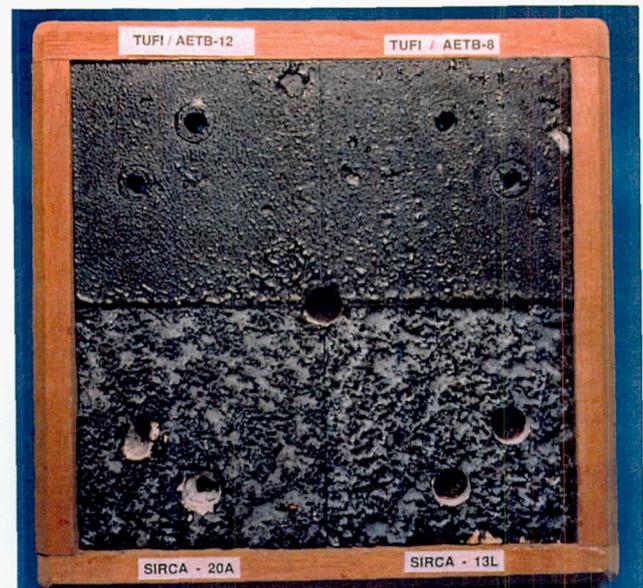
Figure 2(b). Posttest panel shows recession of SIRCA (about 1/4 inch). The plugs have been bored out to remove the panel from the vehicle. Note the textured glaze over the entire panel surface. This is presumably due to deposition of molten concrete. TUFI/AETB-12 sustained the least impact damage.

Figure 2(b) shows the posttest panel. Posttest examination of the panel indicated that the TUFI tiles were essentially unaffected by the high temperature experienced (primarily) during vehicle landing. Both TUFI tiles, however, were pitted due to impact by pieces of solid and molten concrete which spalled from the landing pad. The 12 lb/ft³ tile sustained much less damage than the 8 lb/ft³ tile and was patched and reused in the next flight. The SIRCA tiles showed considerable erosion, recession, and some evidence of melting, from the combined thermal and impact environment. Modified versions of SIRCA

were prepared for flight 7. A layer of glass was deposited in an irregular pattern on all of the TPS surfaces during vehicle landing. This was presumably due to deposition of molten concrete.

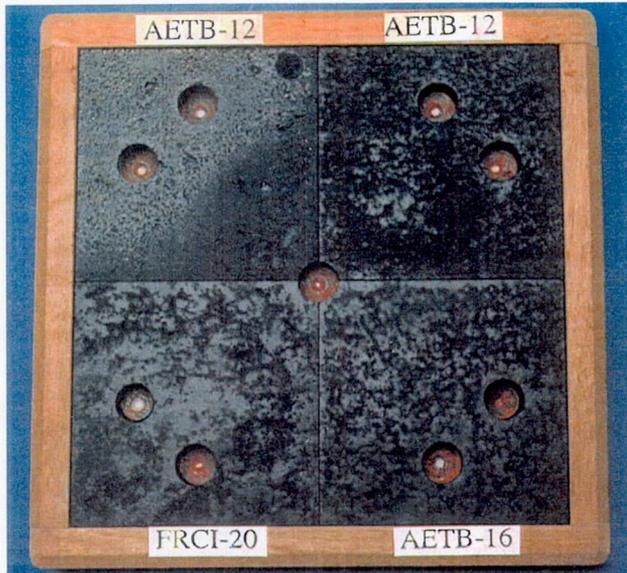
Figure 3(a). Pretest panel to be left on the vehicle for DC-X flights 7 and 8. Contains different densities of TUF/AETB tiles and an FRCI-20 tile. The AETB-12 tile in the upper left corner was already flown on flight 6. FRCI tends to be more durable than AETB but doesn't withstand as high a temperature (ref. 3).

The other three tiles were replaced with new TUF tiles including a second TUF/AETB-12, a TUF/AETB-16 (16 lb/ft³ tile) and a TUF/FRCI-20 tile (20 lb/ft³ tile; Fibrous Refractory Composite Insulation=FRCI). For this test, the performance of AETB and FRCI was compared. In general, AETB withstands a higher temperature than FRCI but FRCI is inherently stronger (ref. 3). This refurbished panel was left on the vehicle for flights 7 and 8. The pretest panel is shown in figure 3(a).

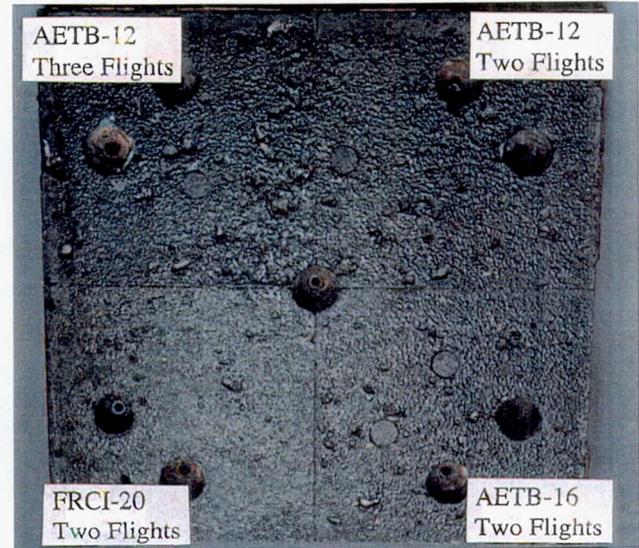
Figure 3(b). Posttest panel after flights 7 and 8. FRCI-20 shows the least impact damage as expected. Note the additional plugs that were installed between flights 7 and 8 in a quick on-vehicle repair.

The panel shown in figure 3(a) was flown again on flight 8 with minor modifications. A technician was sent from Ames to repair several areas on the lower density tiles which had sustained impact damage during flight 7 and to demonstrate an on-vehicle repair process. Four 1/2 inch diameter damaged areas were bored out and plugs were inserted for repair (see fig. 3(b)). The entire repair process took only 15 minutes.

Figure 3(b) shows the flight 8 posttest panel. Minimal additional impact damage was found on any of the TUFU tiles when compared with the previous flight. The actual landing of the DC-X took place much faster than in previous flights so the material exposure to extreme conditions was not as prolonged (i.e., on the order of 4 seconds as opposed to 7 seconds). Figure 3(b) clearly shows that the highest density tiles exhibit the least impact damage as one would expect.

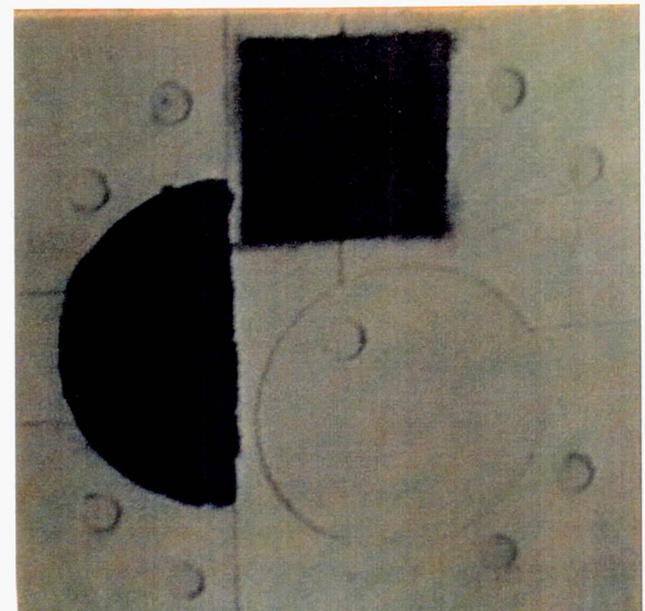
Figure 4(a). Second pretest panel for DC-X flight 7. Contains a variety of forms of SIRCA including a precharred sample (black half circle) which should have a more durable surface. A PCC coated CFBI blanket was also tested on this panel.

The panel shown in figure 4 was also flown on flight 7. This panel consisted of a 22 lb/ft³ SIRCA tile (round white section), a 16 lb/ft³ organic reusable coating application (ORCA) black semi-circle tile and a protective ceramic coating (PCC) coated SiC Composite Flexible Blanket Insulation (CFBI) black square. The SIRCA and ORCA performed well during this test. The surfaces became much more textured during the flight but there was no significant surface recession and no large

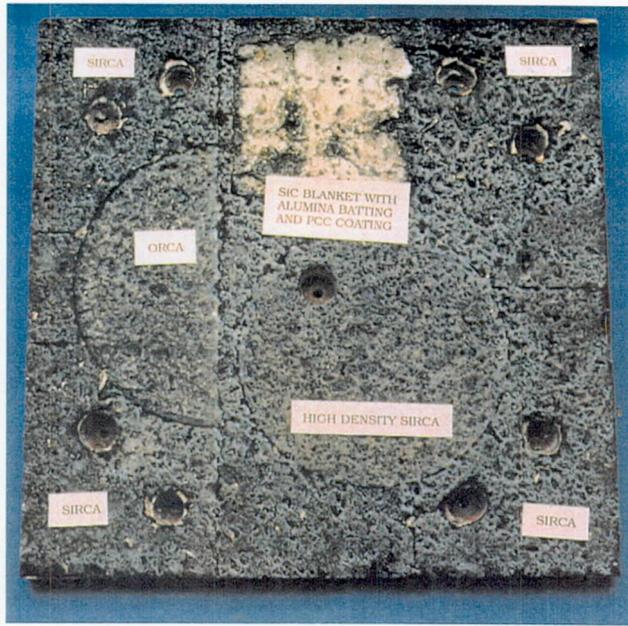
Figure 4(b). DC-X flight 7 posttest panel. The surface of the blanket is missing. The high density and precharred SIRCA performed the best. No surface recession was observed in any of the SIRCA samples but the surfaces became textured compared to the preflight specimens.

holes from molten concrete impact (see fig. 4(b)). The CFBI did not perform well and was so badly damaged that only the batting material remained. The mode of failure is not clear from this test. More work was done in 1996 to determine whether failure occurred due to heat flux, aerodynamic loads or impact damage (see discussion of DC-XA tests).

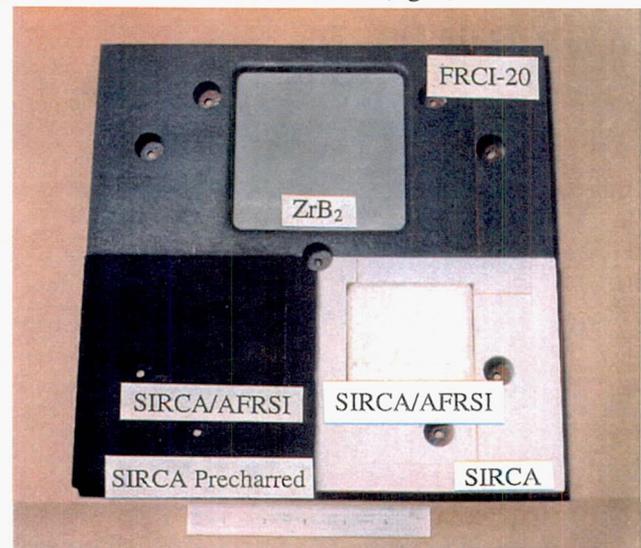
Figure 5(a). DC-XA flight 1 pretest panel. Contains TUFU/ FRCI-20, a ZrB_2 composite, SIRCA tile and silicone impregnated AFRSI blankets with and without precharring.

As mentioned previously, a similar blanket did not survive the more extreme conditions of the base heatshield on flight 7 of the DC-X. On the first flight of the DC-XA a more durable blanket was tested on the base heatshield but still did not survive (fig. 5). In this case two

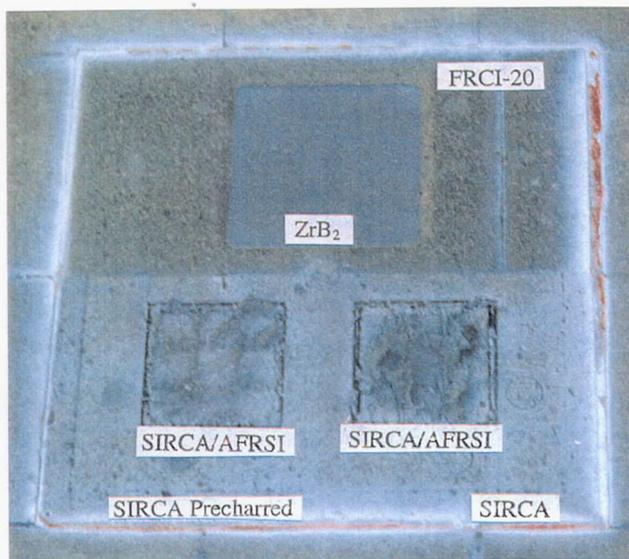
Figure 5(b). DC-XA flight 1 posttest panel. Note that no impact damage has occurred to any of the tiles yet the front fabric of the blankets is missing just as observed a flight 7 of the DC-X.

AFRSI blankets (4 inch \times 4 inch \times 1 inch) were impregnated with silicone which improves the strength of the surface fabric as well as the batting material. The surface of one of the blankets was precharred with a torch prior to testing. The precharring tends to harden the surface which would further improve its durability. It was expected that this material would survive the first DC-XA flight because the vehicle was landing on a metal grate instead of a concrete pad, which would reduce impact damage. Also, the total heat load for this flight was about 60% of that measured for previous landings on concrete. However, after the flight, the front fabric of the blanket was missing and the batting was exposed, just as observed previously for the PCC coated CFBI blanket flown on flight 7 of the DC-X. This was surprising because almost

no impact damage was observed on the materials surrounding the blankets (see fig. 5(b)). Apparently the combined thermal and aerodynamic load experienced by the heat shield is too harsh for AFRSI. If a blanket surface undergoes severe deformation due to aerodynamic loads, the threads used to attach the batting to the fabric will break and the fabric can also tear. It is also likely that the temperature of loose surface fabric will rise sharply, since it has little intrinsic thermal mass and can no longer dissipate heat effectively by conduction to the underlying batting. This may also contribute to blanket failure.

The other materials tested on flight 1 included SIRCA-20, TUFU/FRCI-20 and a ZrB_2 composite. As seen in figure 5(b), no significant damage occurred to any of these materials. However, there were tiny ($\sim 0.5 \times 0.5 \times 0.5$ mm)

pits uniformly distributed over the surface of the SIRCA and no difference was observed for precharred versus uncharred SIRCA. Also, a uniform film had been deposited over the entire panel. This is believed to be due to vaporization of the martite ablative coating that was applied to the landing grate.

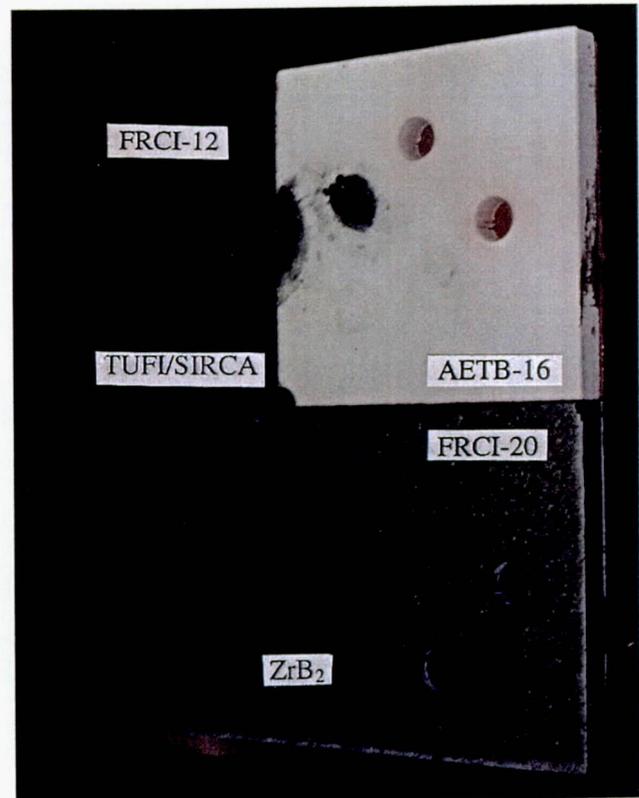
Figure 6(a). DC-XA flight 3 pretest panel. Bottom half of the panel is the one flown on flight 1. On top is a TUFU tile that was impregnated with silicone to add durability. This 4 inch \times 4 inch sample is surrounded by a TUFU/FRCI-12 tile. The upper right hand tile is an AETB-16 provided by MDTI. This tile was purposely damaged in the lab to test a quick repair method (see text).

On the top half of the panel shown in figure 6 there are three different materials including AETB-16 which was provided by MDTI, TUF coated FRCI-12, and TUF coated FRCI-20 that was impregnated with silicone. All three materials sustained some impact damage. The white areas around the attachment holes are damage resulting from the tools used to remove the panel after the flight. No photos are available prior to removal of the panel because there was no access to the vehicle during the accident investigation. However, it does appear that impact damage during landing was minimal on the higher density materials (AETB-16 and impregnated TUF/FRCI-20) and more severe on the TUF/FRCI-12.

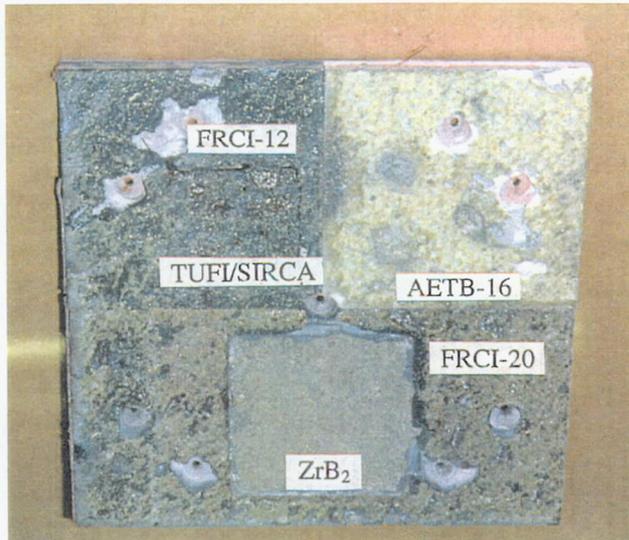
Figure 6(b). DC-XA flight 3 posttest panel. All materials survived and had a silica glaze deposited on the surface during landing on concrete. Note that the bright white areas are damaged due to panel removal from the vehicle and not due to flight damage.

The bottom half of the test panel contained the same TUF and ZrB₂ specimens that were flown on the first flight. This time, the vehicle landed on concrete and the TUF tile sustained moderate impact damage. The ZrB₂ composite, which is very dense (225 lb/ft³), was unaffected by the impact or thermal environment. This is the most resilient of the materials tested on any of the DC-X or DC-XA flights.

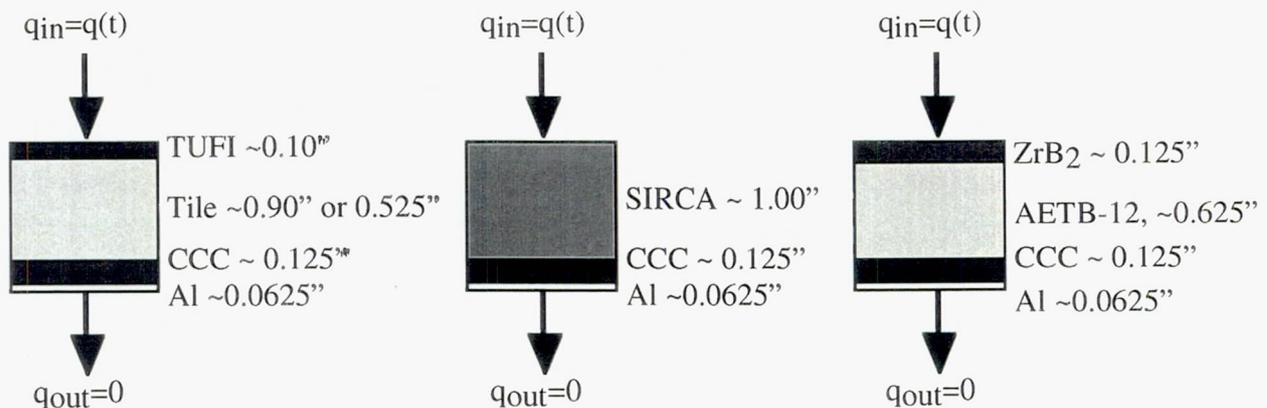
Figure 7. Schematics of the tile, SIRCA, and ZrB₂ panels analyzed.

Schematics of the material geometries analyzed are shown in figure 7. The materials involved are the reusable surface insulation (RSI) materials AETB-8, AETB-12,

and FRCI-20, the light weight ceramic ablators SIRCA-14 and SIRCA-18, and a diboride ceramic matrix composite. The tile panels consisted of 1 inch or 5/8 inch thick tiles bonded to a 1/8 inch thick carbon-carbon composite (CCC), which was mechanically attached to a 1/16 inch thick aluminum sheet. The AETB and FRCI tiles had a TUFU coating with a thickness was about 0.1 inch (out of the total tile thickness). In practice, an effective thickness was calculated from tile and TUFU densities such that the total added mass per unit area was equal to the manufacturing goal of 0.17 g/cm^2 ; i.e.,

The SIRCA panels all consisted of 1 inch thick SIRCA bonded to CCC and attached to an aluminum sheet. The ZrB_2 sample was 1/8 inch thick and was held on top of a 5/8 inch thick AETB-12 tile by a TUFU/FRCI-20 frame. This tile was bonded to CCC and attached to an aluminum sheet. The thermophysical properties of AETB-8, AETB-12, FRCI-20 and ZrB_2 were obtained from the TPSX data base (ref. 10). The properties of the TUFU coating on the different tiles were communicated by Dave Stewart (Ames). Those for SIRCA-14 and SIRCA-18 were estimated from data obtained by Energy Materials Testing Laboratory for a SIRCA-14 material under reduced pressures (0.05, 0.01, and 0.001 atm). Extrapolation of thermal conductivity data to atmospheric pressures was done using a logarithmic fit to the measured data. Values for SIRCA-18 were further

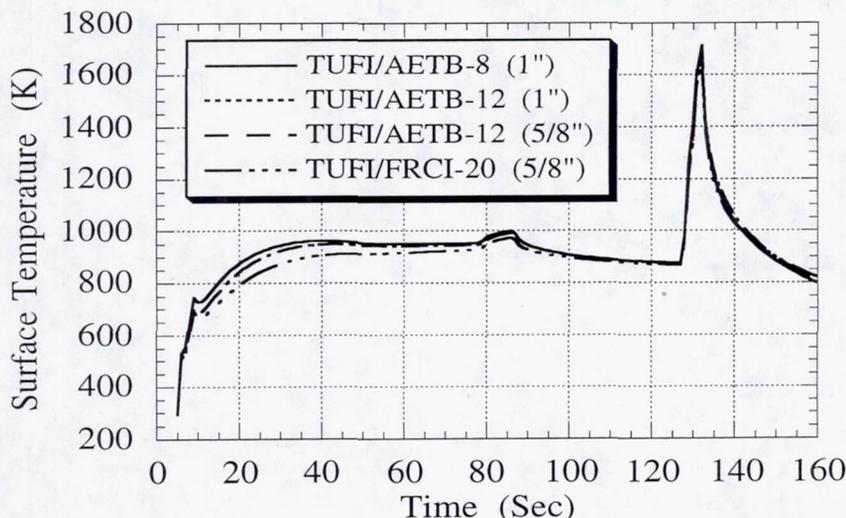
Figure 8. The temporal variation of the surface temperature for four RSI test panels exposed to the heat flux measured by calorimeter QC2 on DC-X flight 6.

The computed surface temperatures for the RSI tile test panels on flight 6 of the DC-X are shown in figure 8. The 1 inch and 5/8 inch thick tile specimens show the same surface temperature transients because both are sufficiently thick for very little heat to be drawn from the surface into the CCC and aluminum (over the time scale plotted). The maximum surface temperatures are reached during vehicle touchdown; about 1710 K for AETB-8 at 132 seconds. RSI materials are poor conductors of heat and their surface temperature response is driven by the need to reradiate most of the incoming heat flux. This response is modified in the present case by the thermal mass of the TUFU layer, which damps the rise in surface temperature somewhat. Generally, lower density tile

materials also have TUFU coatings which are of lower density and which extend further into the material. As a consequence the surface temperature response is fastest on the AETB-8 tile and slowest on the FRCI-20 tile.

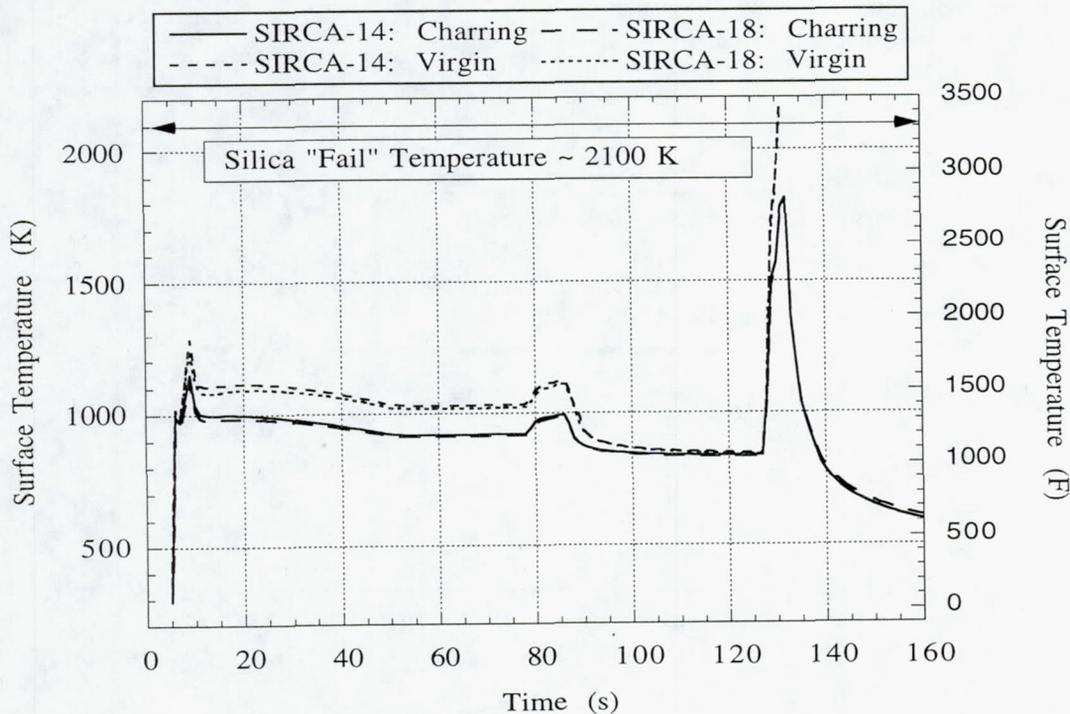
Figure 9. The temporal variation of the surface temperature for SIRCA-14 and SIRCA-18 test panels exposed to the heat flux measured by calorimeter QC2 on DC-X flight 6.

The calculated variation of surface temperature on the SIRCA test panels is plotted in figure 9. Again, because heat conduction away from the surface is minimal and surface temperatures are largely controlled by the reradiation of energy which depends on the surface emittance, the temperature variations for SIRCA-14 and SIRCA-18 are almost identical. The surface temperature response to changes in input heat flux is much quicker for SIRCA than for the RSI tile materials because the damping provided by the TUFU layer is not present. The temperature dependent emittance of virgin and fully charred SIRCA has been estimated in reference 5 from room temperature reflectance measurements. The emissivity of the charred material is relatively insensitive to temperature, with values of about 0.95. The emissivity of the virgin material varies greatly, dropping from a room temperature value of about 0.92 to about 0.58 at 1000 K and 0.33 at 2000 K. (These high temperature values for virgin SIRCA assume no char formation at elevated temperatures.) The silicone resin which impregnates SIRCA's silica tile substrate pyrolyzes over a

temperature range of about 500 K to 1000 K. In the present computations the virgin emissivity values were used up to 500 K and the char values were used once the surface temperature had exceeded 1000 K. As the surface temperature increased from 500 K to 1000 K, a linear combination of virgin and charred values was used. Because the surface composition of SIRCA depends upon the particular thermochemical reactions which take place upon heating, it is possible that the emissivity may be lower in some heating environments than in others. The limiting case would be that of negligible char formation, corresponding to the emissivity of a virgin surface. This case is also illustrated in figure 9. The approximate "fail" temperature of silica is 2100 K—around this temperature the material is sufficiently soft that it will flow under aerodynamic forces. The present computations suggest that a charring SIRCA material should survive the DC-X landing environment, reaching a maximum surface temperature of about 1820 K. A virgin surface, however, would not survive, as surface temperatures significantly exceed 2100 K during landing (computations were terminated at 2100 K). The SIRCA-14 and SIRCA-18 test panels which were flown on flight 6 of the DC-X had a charred appearance, yet also showed significant melting, while the neighboring TUFU/AETB-8 and TUFU/AETB-12 panels showed no evidence of melting. This may indicate

that the emissivity of the SIRCA samples pyrolyzing in the DC-X heating environment was lower than the ideal char values. Various possible scenarios can be constructed to support this possibility (e.g., the mechanical damage from debris during landing could have exposed virgin material during landing or perhaps the size of the heat pulse during landing was too large and sudden to allow time for char formation before the surface temperature increased past the silica fail temperature), however these are only speculative.

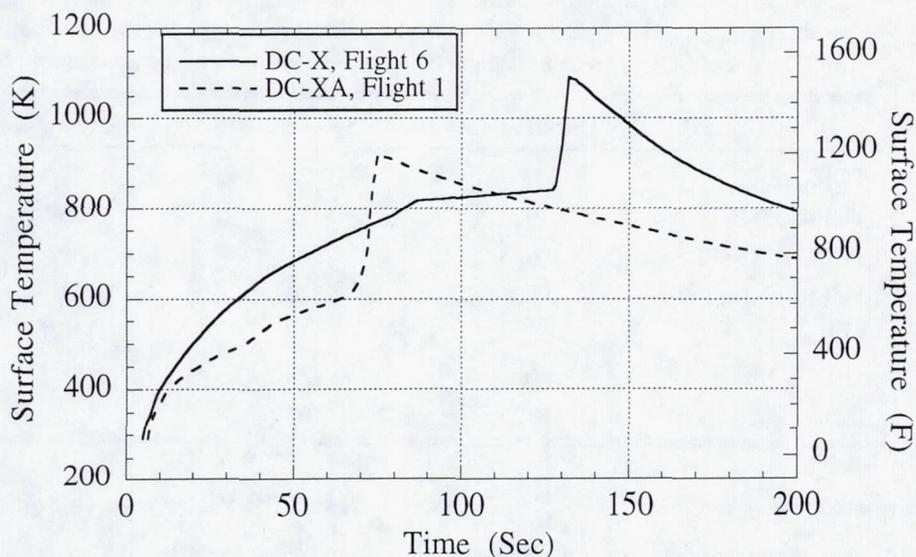
Figure 10. The computed surface temperature of the ZrB_2 specimen for the QC2 calorimeter heat fluxes measured on DC-X flight 6 and DC-XA flight 1.

Figure 10 shows surface temperature profiles computed for the ZrB_2 specimen using the heat fluxes measured by calorimeter QC2 on DC-XA flight 1 and DC-X flight 6. (This specimen was only flown on DC-XA flights 1 and 3, however DC-X flight 6 heat fluxes are typical of all landings on concrete and should be representative of conditions experienced on DC-XA flight 3.) The maximum surface temperature reached on the ZrB_2 specimen for the DC-X flight 6 heat flux is about 1100 K. This is hundreds of degrees lower than the temperatures reached by the tile and SIRCA specimens for the same conditions. It is also clear from figure 10 that the temperature response to heat flux variations is much slower than for the tile and the SIRCA samples. Both of

these effects are a direct result of the large thermal mass and relatively high conductivity of the ZrB_2 test specimen. This combination allows the specimen to absorb a large quantity of energy and heat up almost uniformly, with a resulting damped rise in surface temperature.

Flight 1 of the DC-XA was shorter than usual and ended with the vehicle landing on a metal grate to reduce impact damage from spalled concrete. The surface temperature still rises substantially upon landing but the maximum surface temperature reached by the ZrB_2 specimen is lower by almost 200 K. Similar computations for a 5/8 inch thick TUFIFRCCI-20 tile (not shown in fig. 10) also gave lower surface temperatures for DC-XA flight 1 than for DC-X flight 6, though in this case only by about 100 K. This lower surface temperature is due to the lower total heat load because of the shorter flight time and can not be attributed to landing on the grate. However, during flight 1 the engines apparently failed to shut down properly after landing and ran for an additional 2.5 seconds. Thus it is still likely that for identical engine performance and flight times, landing on the grate would contribute to reduced peak surface temperatures when compared to landing on the concrete pad.

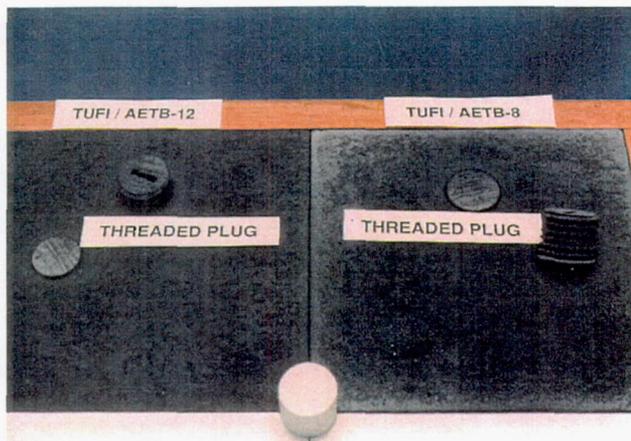
Figure 11. Screws machined from TUFU.

Plugs were fabricated to provide the required protection for the panel attachment screws shown in most of the photos. These were glued in after the composite plate was attached to the vehicle. After testing, the plugs were typically destroyed using a screwdriver to remove the attachment screws. For the first DC-X flight test panel, threaded plugs with a slotted surface (fig. 11) were fabricated for the TUFU panels to demonstrate the machineability of TUFU and to provide reusable plugs which would not require adhesive. During landing, a layer of glass was deposited in an irregular pattern on the TPS surface (fig. 2(b)). This thin glass coating sealed the threaded plugs so that it was necessary to bore them out to remove the panel. The threads inside the holes remained intact so that new threaded plugs could be inserted when necessary.

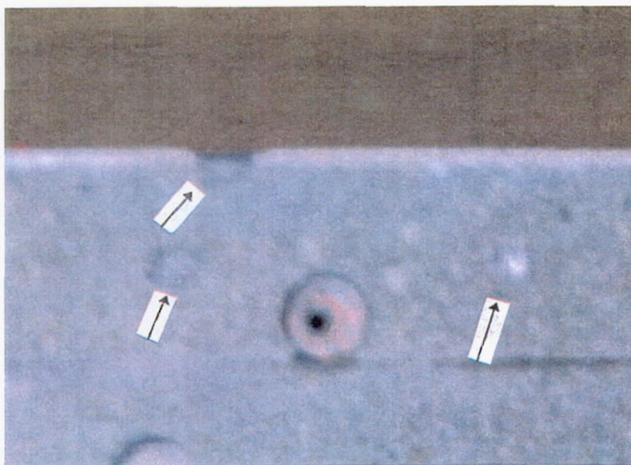
Figure 12(a). Ames fabricated FRCI-20 showing damage in three areas.

Figure 12 shows the FRCI-20 tile damaged, repaired preflight and repaired postflight. The damage to the FRCI-20 occurred during the first flight of the DC-XA. Damage consisted of two holes approximately 0.5 inches in diameter and 0.25 inches deep. There was also one chipped edge approximately 0.5 inches across and 0.25 inches deep (fig. 12(a)). The damage was repaired using a quickfix containing a high emissivity agent. The repaired tile damage (three black areas) is shown in figure 12(b). After applying the quickfix, a 24-hour drying period was allowed and the patch was as hard as the TUFU. Postflight inspection shows that the patched areas on the surface of

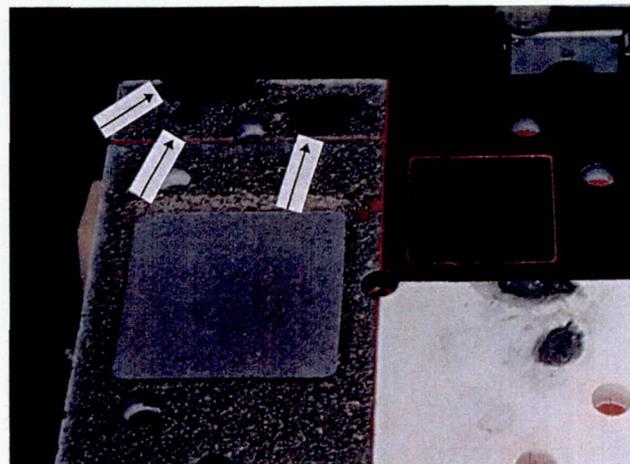
Figure 12(b). FRCI-20 showing repairs using quickfix putty.

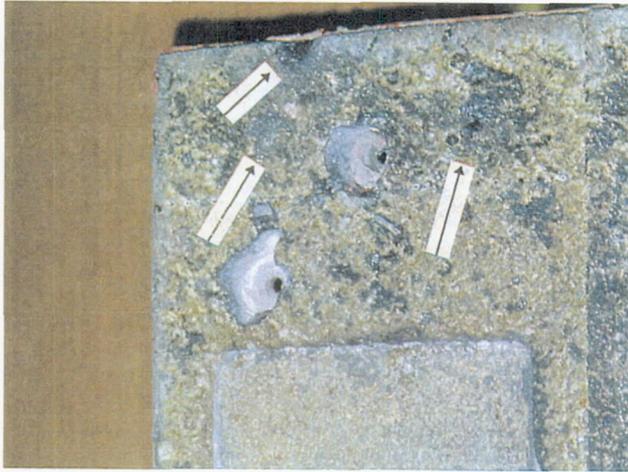
Figure 12(c). FRCI-20 posttest. Quickfix adheres well.

the FRCI-20 remained intact while the patch on the edge shows some shrinkage (fig. 12(c)).

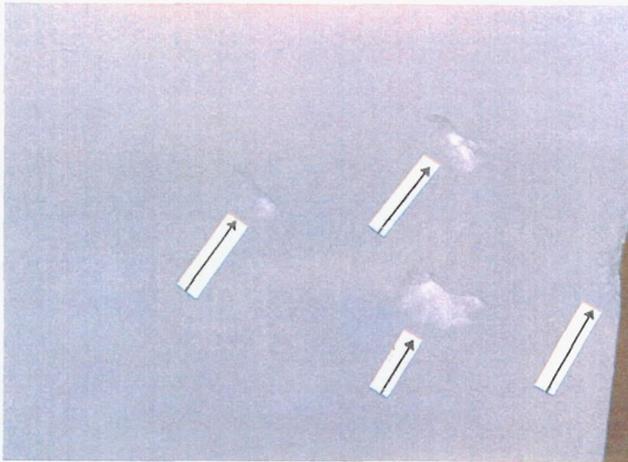
Figure 13(a). AETB-16 provided by MDTI showing damage created with a screwdriver.

The AETB-16 tile was supplied with a high density coating which raised the density to 38 lb/ft³. The damage areas shown in figure 13(a) were made with a screwdriver just to demonstrate the repair process. There are four damaged areas including two on the surface that are approximately 0.75 inches long and 0.5 inches across and 0.25 inches deep. Another larger area on the surface is about 1 inch in diameter and 0.5 inches deep. The fourth damaged area is along the edge of the tile and is the largest at about 2 inches long and 0.5 inches deep. Figure 13(b) shows that the damaged edge and the large hole were repaired using black quickfix and the two smaller holes were repaired using a white quickfix.

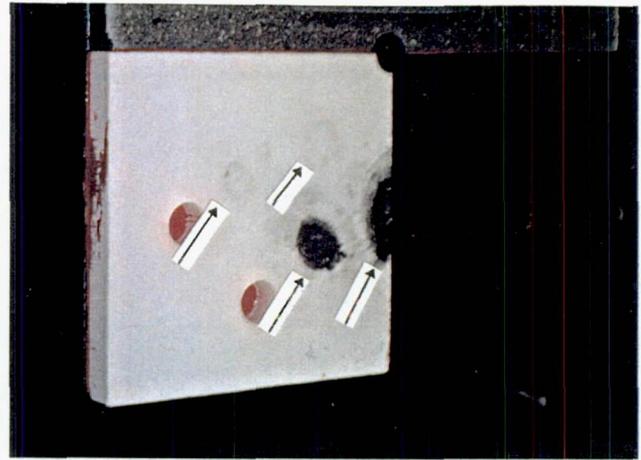
Figure 13(b). MDTI-AETB-16 showing preflight repair using quickfix with and without high emissivity agents.

On postflight inspection all of the repairs were in good condition with no shrinkage. The white quickfix had turned black and all repairs had provided good protection for the underlying areas. The impact damage in the

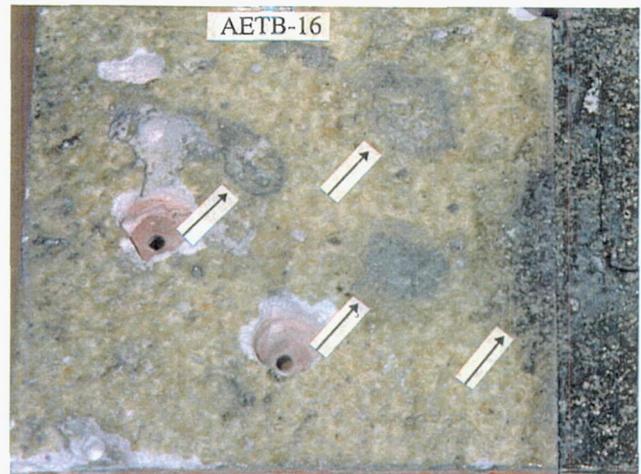
Figure 13(c). MDTI AETB-16 posttest. Shows excellent adherence of quickfix and no severe impact damage to repair areas compared to other areas of the tile.

repaired areas was no worse than on other areas of the tile. Note that the white damage areas seen in figure 13(c) occurred during removal of the tile from the vehicle.
