# 4<sup>th</sup> Conference on Aerospace Materials, Processes, and Environmental Technology

## Manufacturing Challenges Implementing Material Changes for the Super Light Weight External Tank

### A Welding Process Perspective

# Super Lightweight External Tank

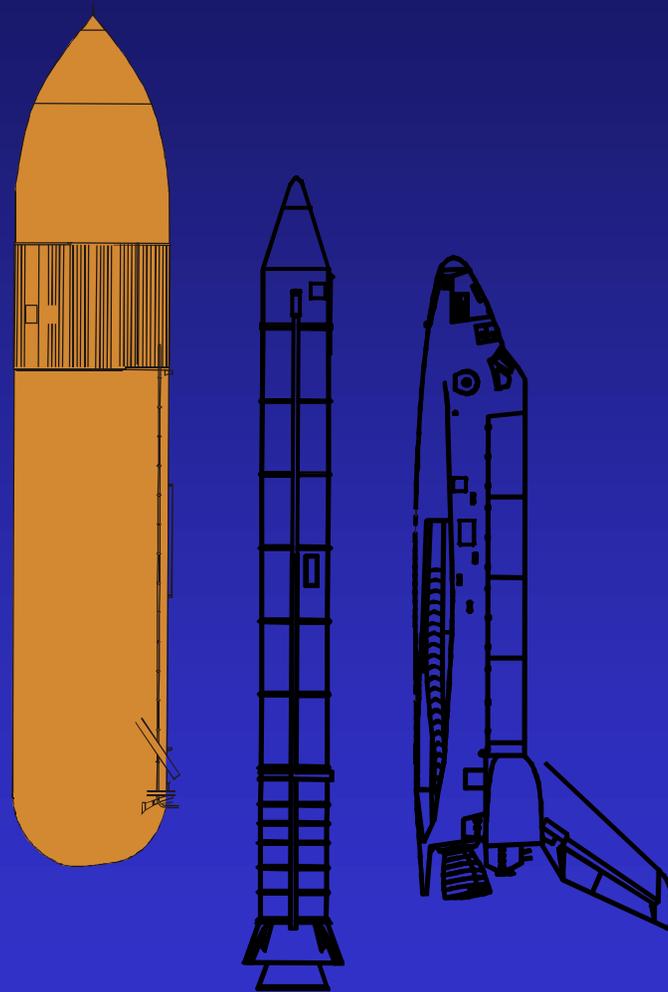
## Al-Li Weight Savings

1791 Oxygen Tank →

929 Intertank →

5283 Hydrogen Tank →

8003 Pounds Total

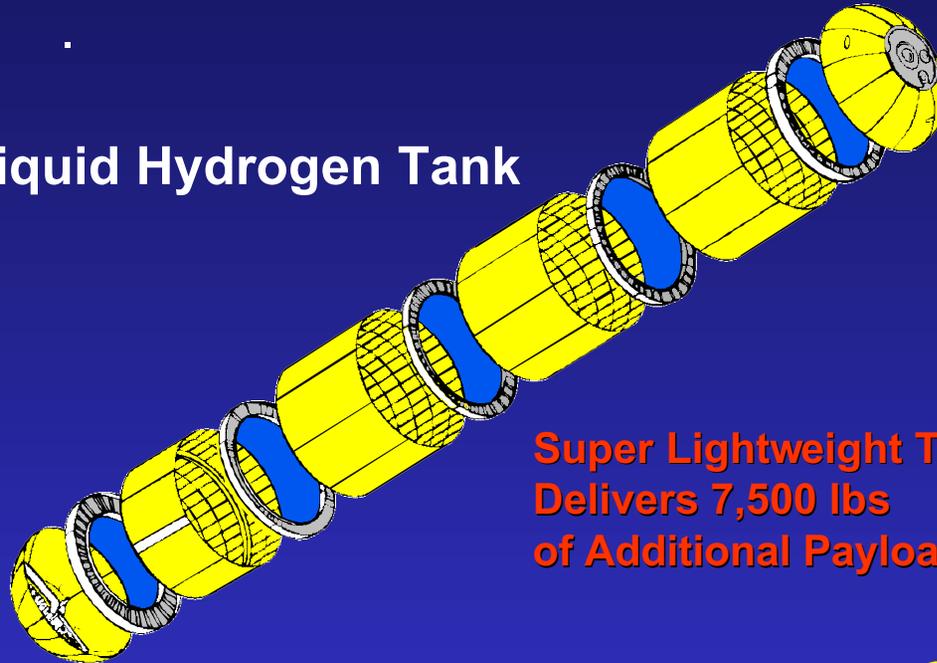
## Liquid Hydrogen Tank

- Substitute Al 2195 for Al 2219
- Redesign to Orthogrid Waffle
- Optimize TPS Application
- Weight Savings - 4,200 lbs

= Al Li 2090, 2195
-

= Other Redesigned Parts
-

= No Change

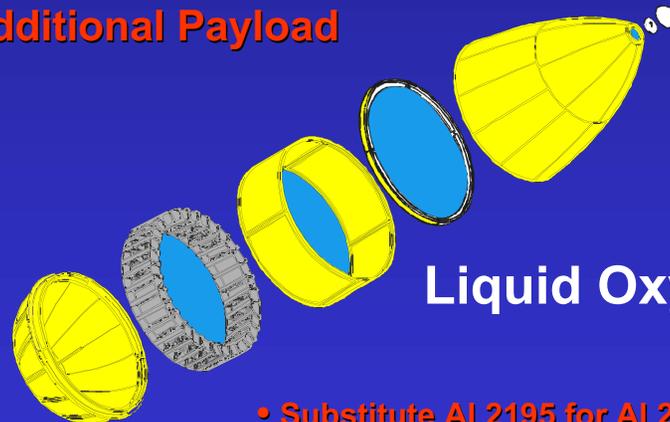
## Liquid Oxygen Tank

- Substitute Al 2195 for Al 2219
- Resize Panel Thickness
- Optimize TPS Application
- Weight Savings - 1,620 lbs

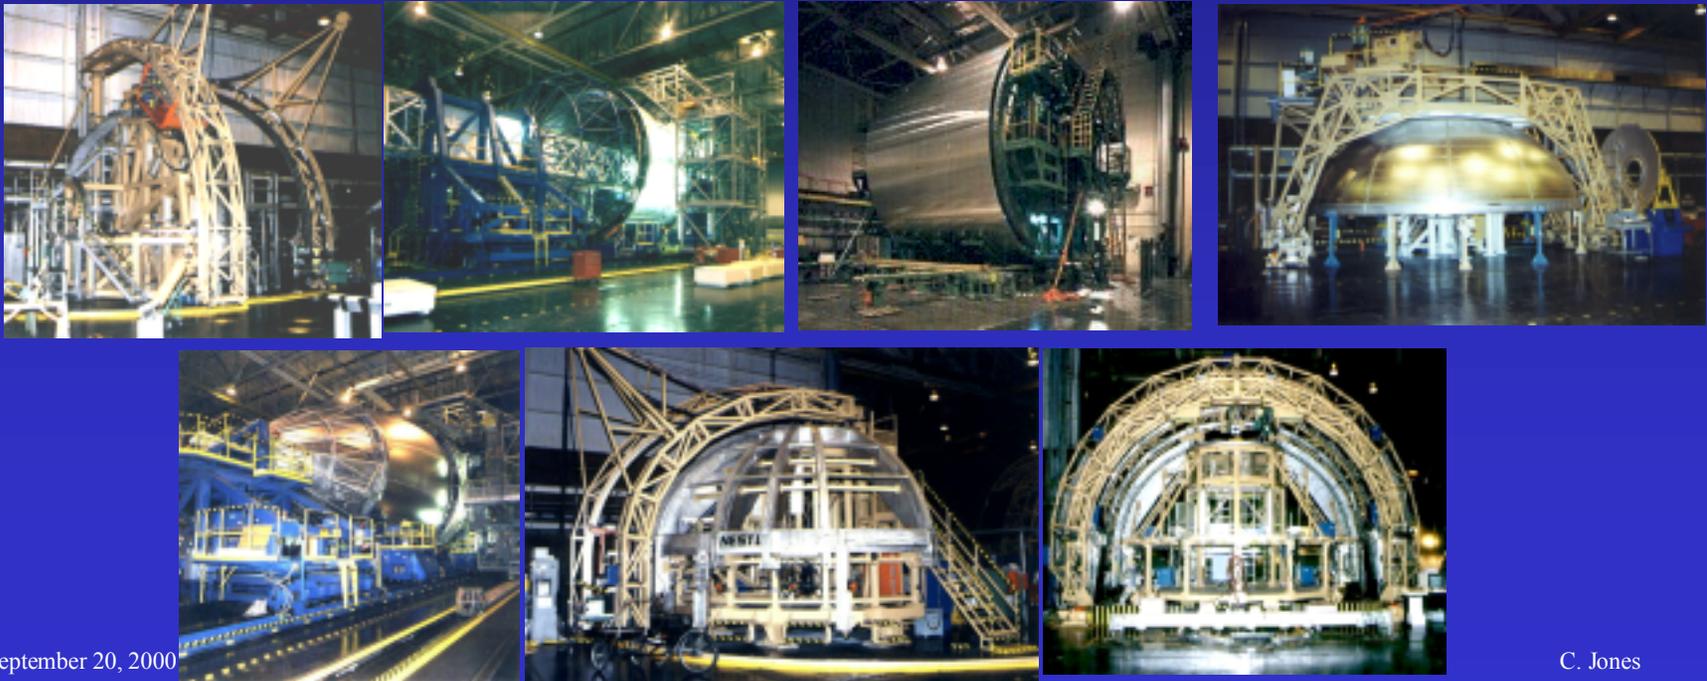
# Weld Purging Equipment

- Inert gas purge required on both sides of weld joint for 2195 alloy
  - Existing tooling retrofitted
  - Narrow tooling gaps provided major challenges
  - Circumferential weld tools required very complex devices
- Mixture of Helium and Argon purge gas required on root side shield
- Pre-weld test developed for gas coverage adequacy

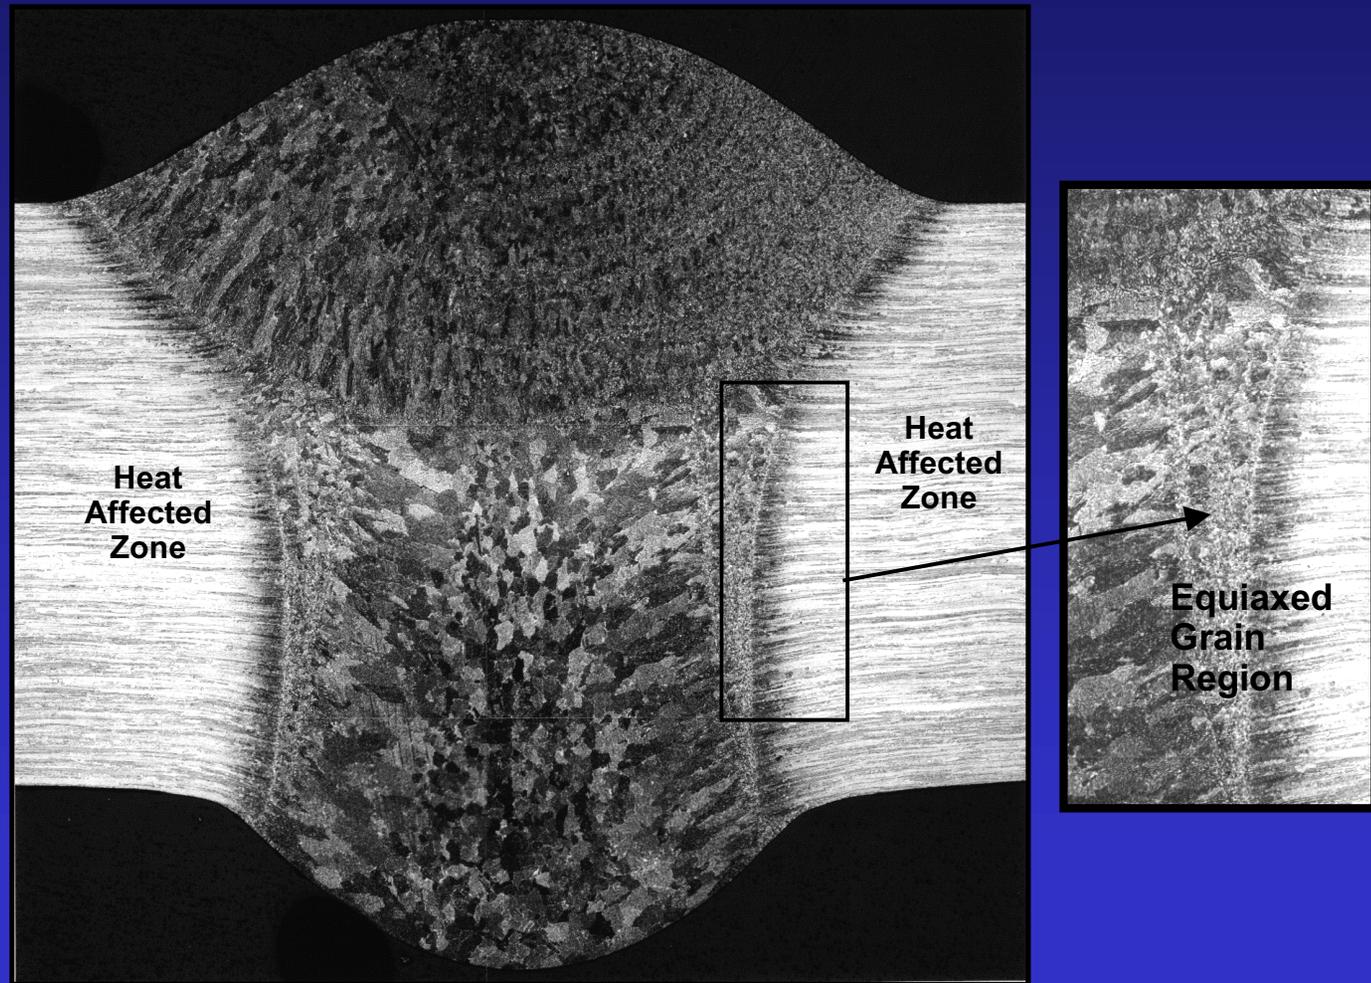
# Initial Weld Microstructure

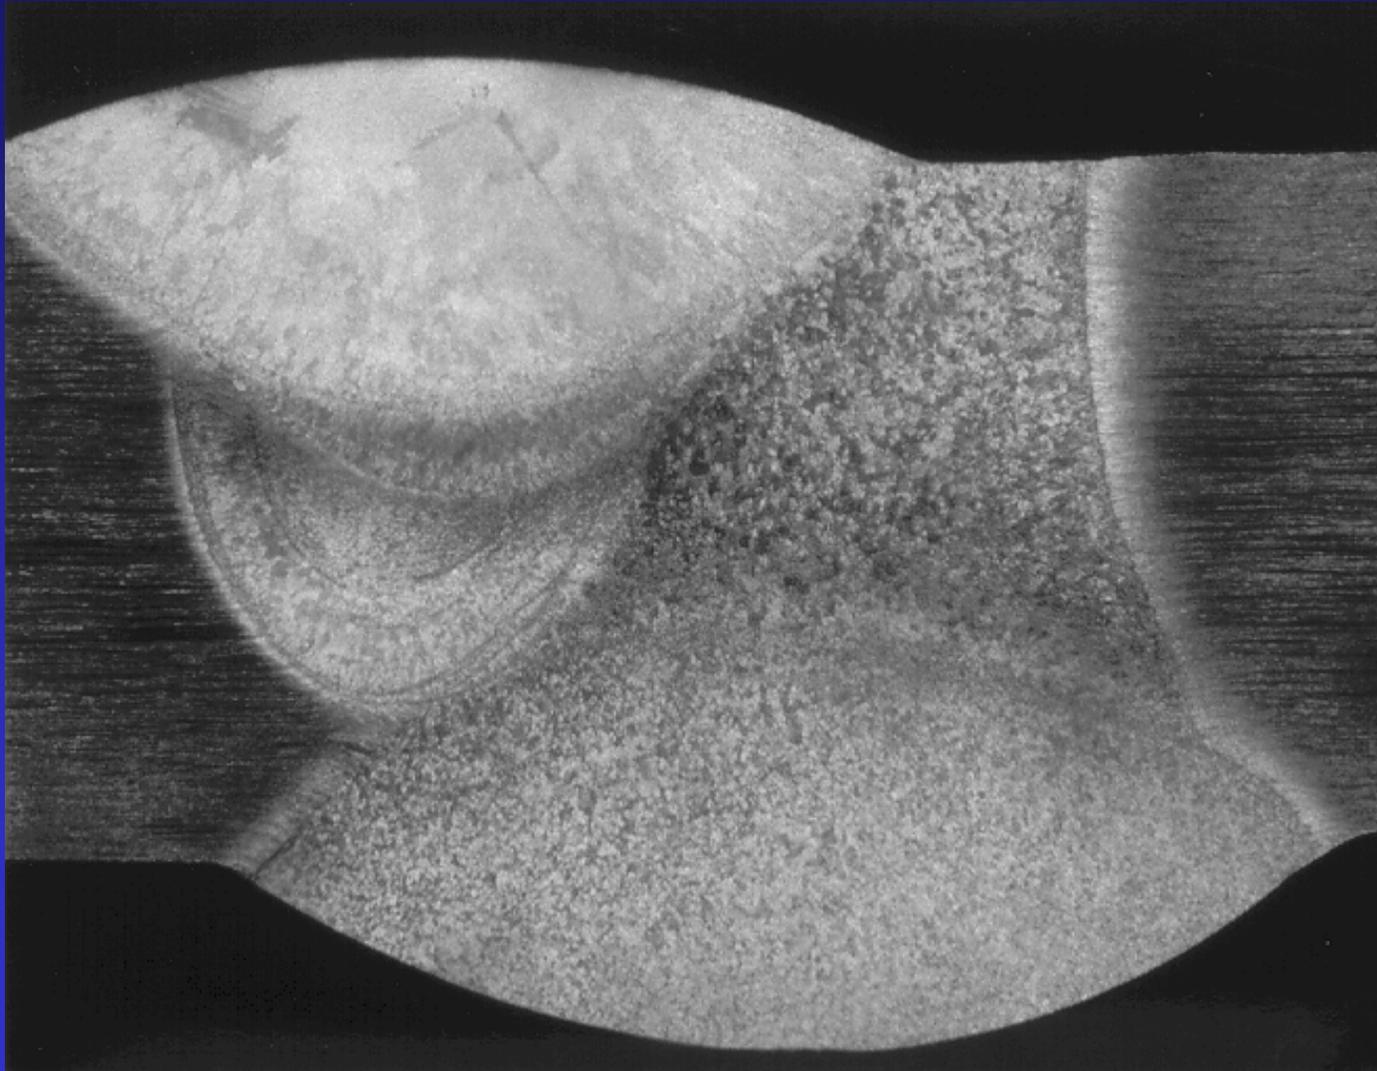
# Repair Weld Microstructure

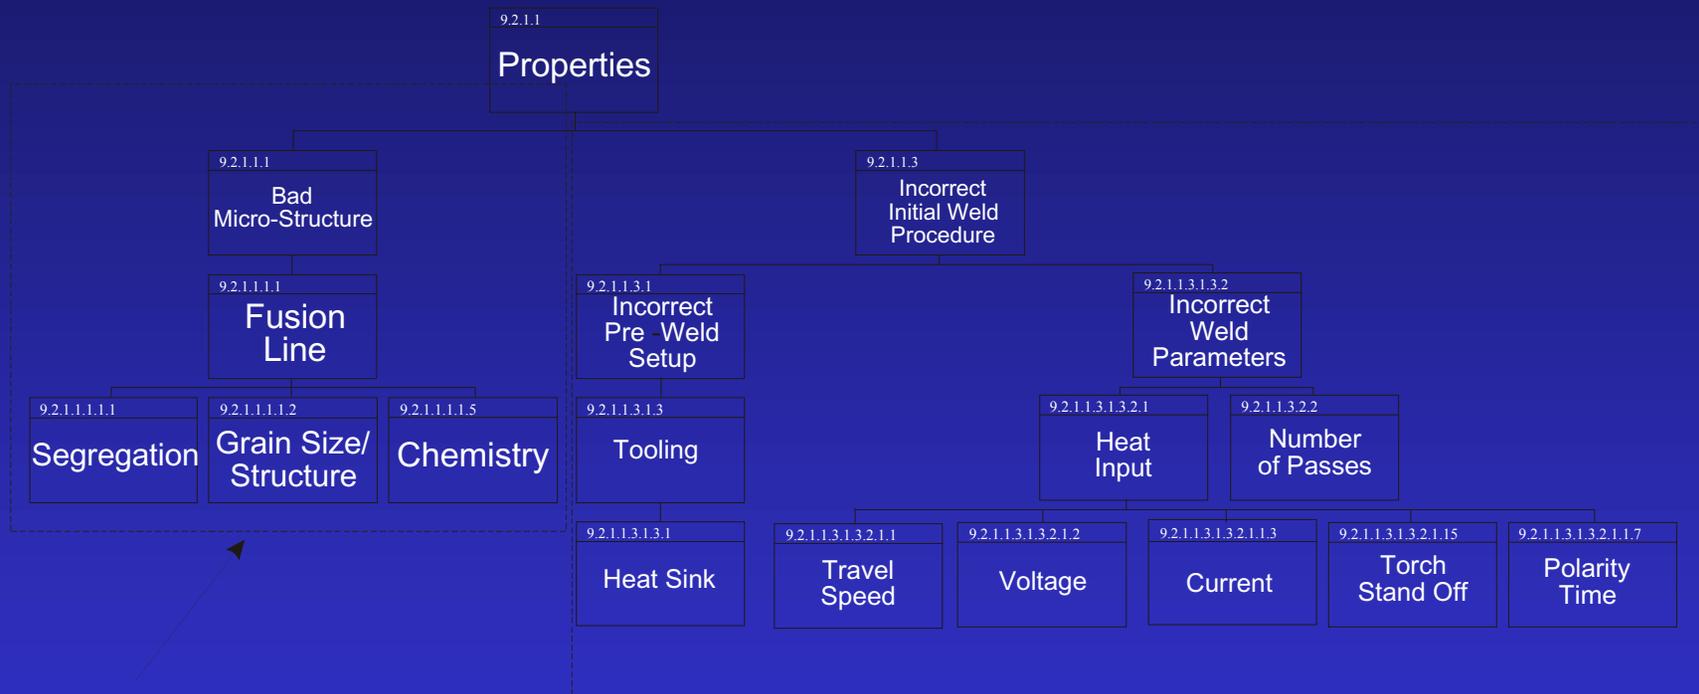
Initial Weld Fault Tree Entries with Contributor "Yes"

*The Initial Weld Fusion Line Microstructure was determined to be a major contributing factor for repair weld cracking.*

*The Initial Weld procedure and parameters were minor contributors as they affect "Time-at-Temperature" which contributes to the amount of segregation that occurs.*

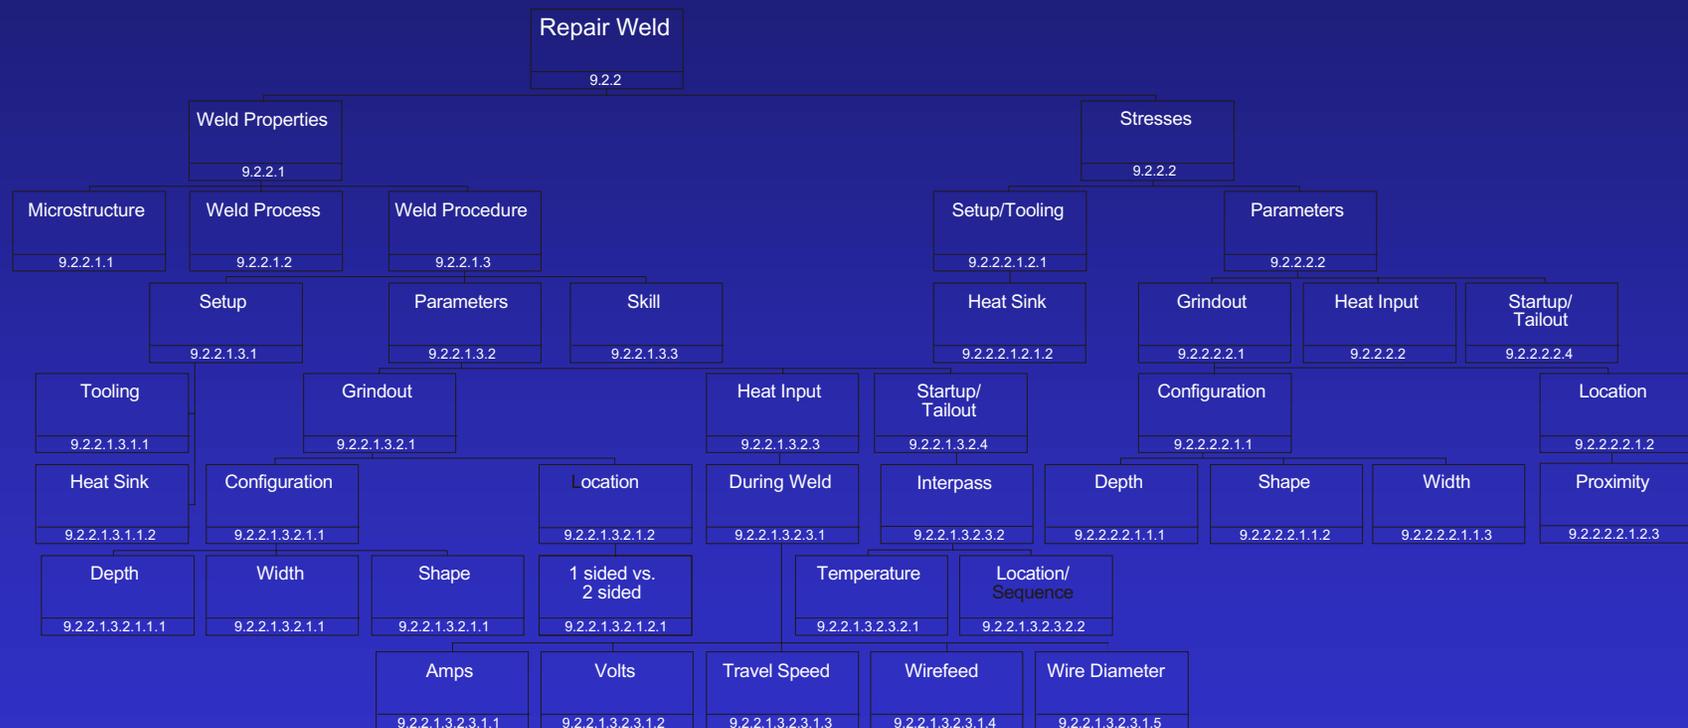
## Repair Weld Fault Tree "Yes" Contributors

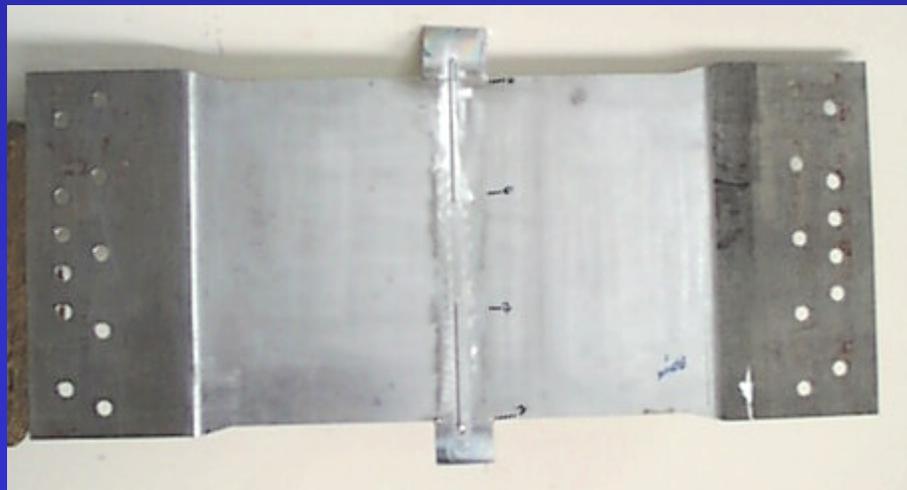
Wide Panel Tensile Specimen

- Small Structural Article developed to reveal stress distribution around repairs
- Instrumented with strain gauges and photoelastic material
- Results indicate residual stresses too high in repair for adequate load redistribution
- Some Wide Panel Tensile Testing data is now required for all 2195 weld repair development

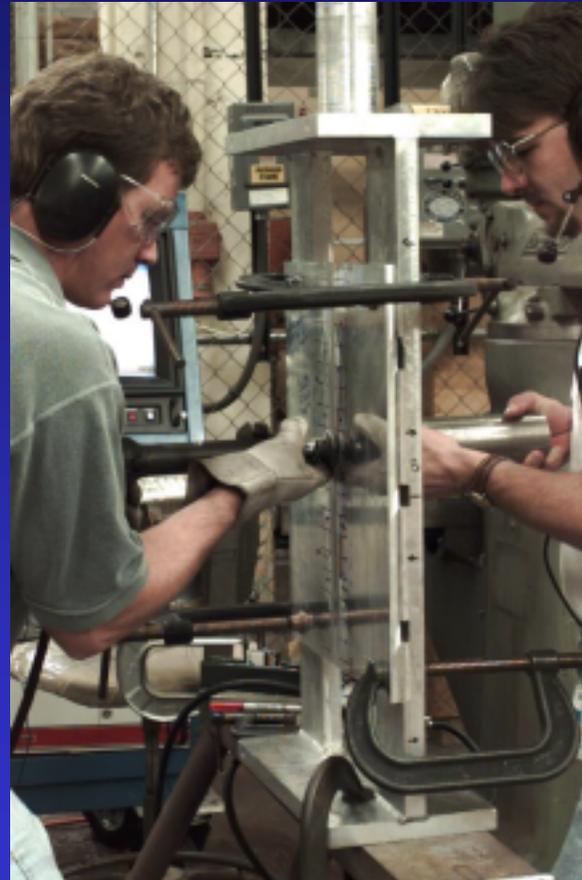
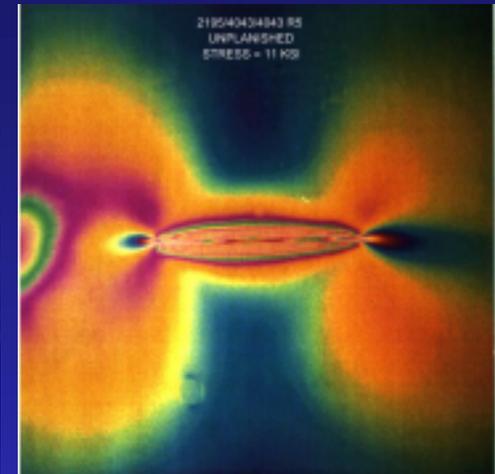
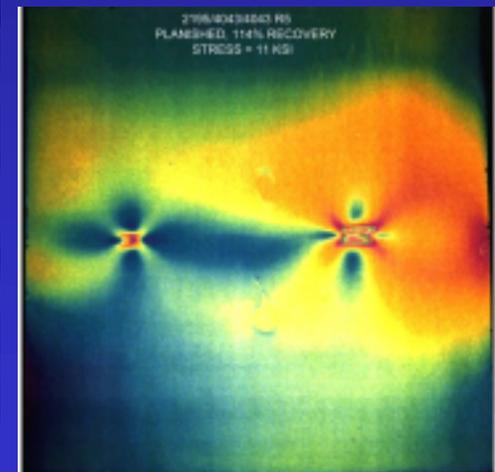
- Planishing Required for all 2195 weld repairs
- Relieves Tensile residual stresses
- Drives Compressive stresses into repair
- Allows for stress redistribution around repair

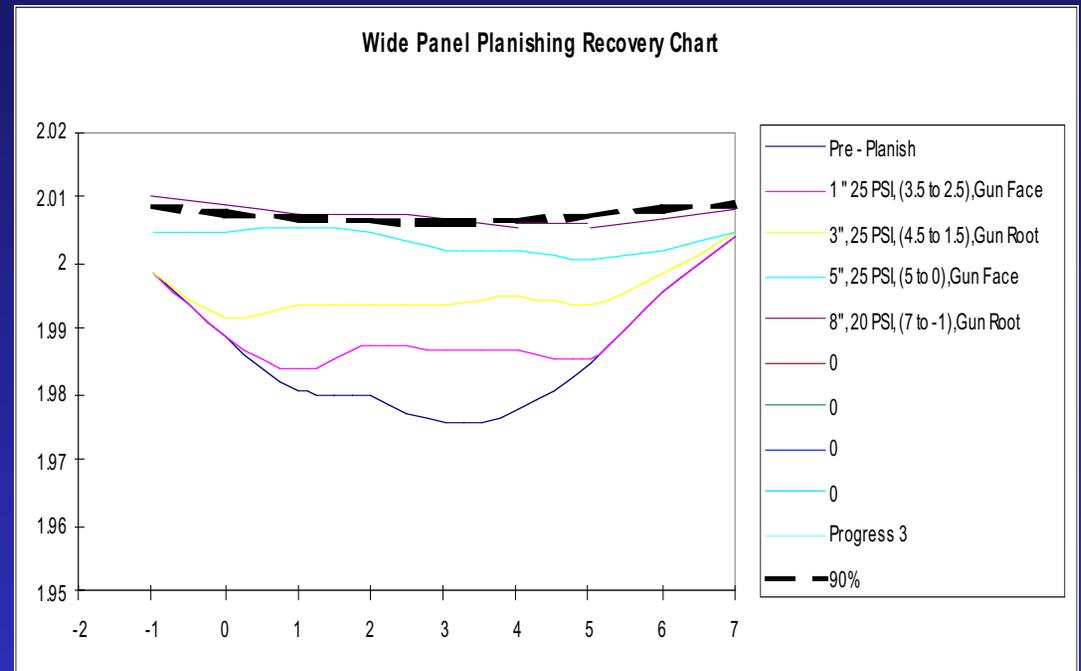
# New Metrics Developed for Planishing

- Planishing originally used on ET for distortion removal
- No metric existed other than removal of distortion
- Transverse Shrinkage Reduction Became new metric
- Adequate Strengths developed with 70% to 110% recovery

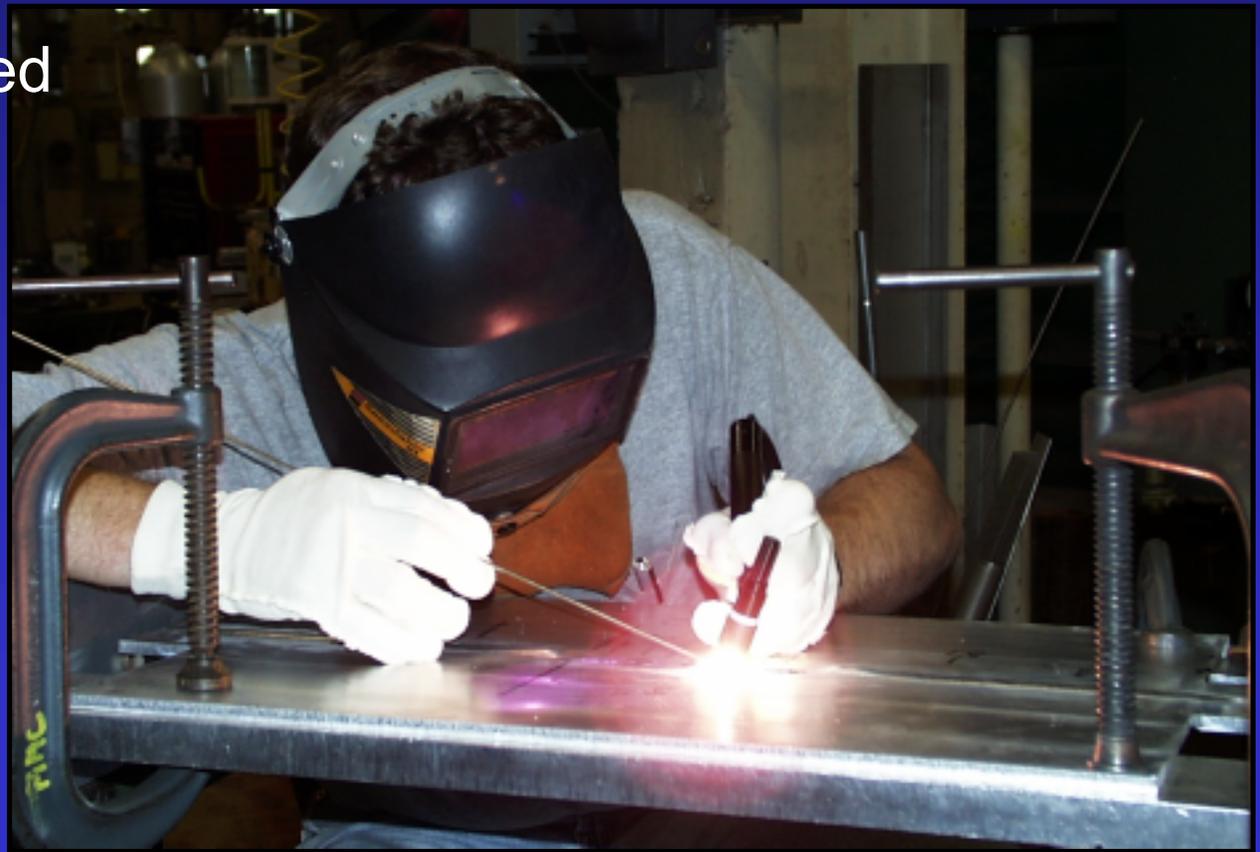
# Manual Welder Training

- Smaller Grinds
- “Fast Hand” Technique
- Continuous wire feed
- Special Start/Stop Technique

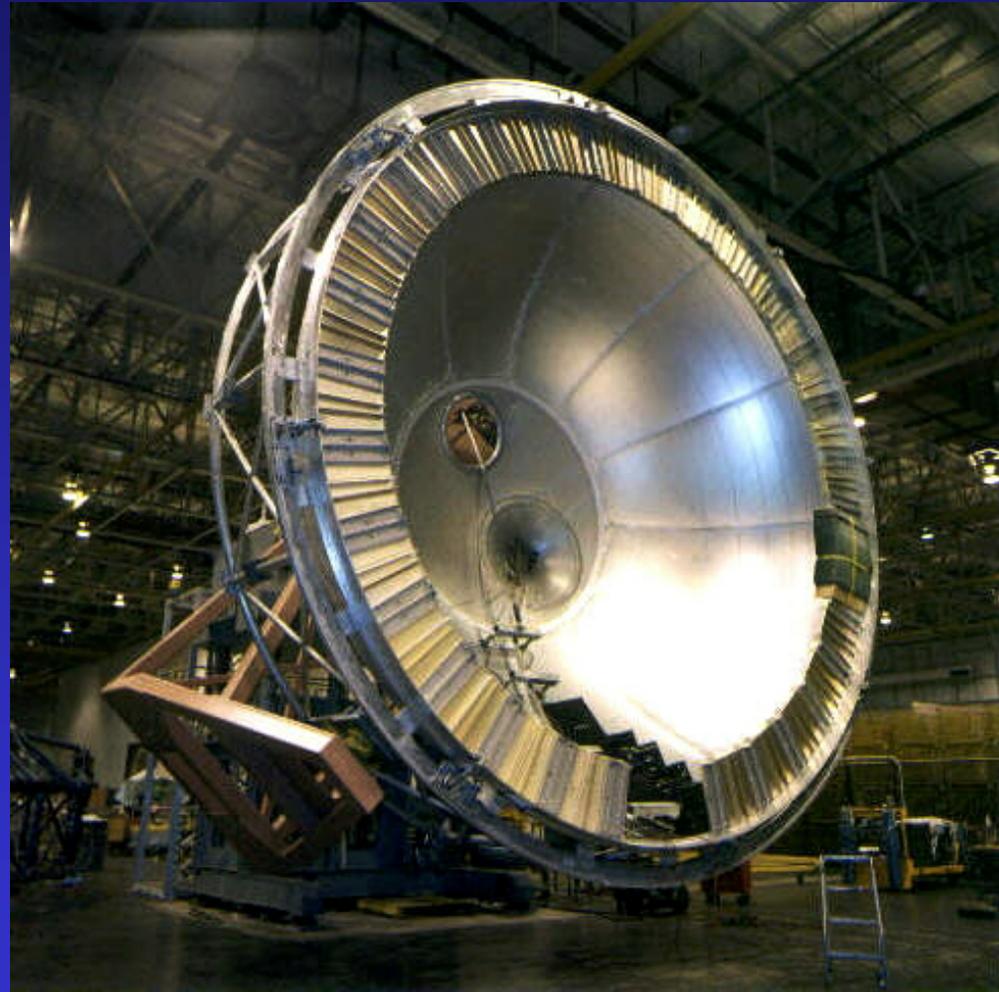
# Special Tooling for Weld Repairs

- Flat Position  
Determined Optimal  
Repair Position
- Vertical Position as a  
maximum case  
without defects

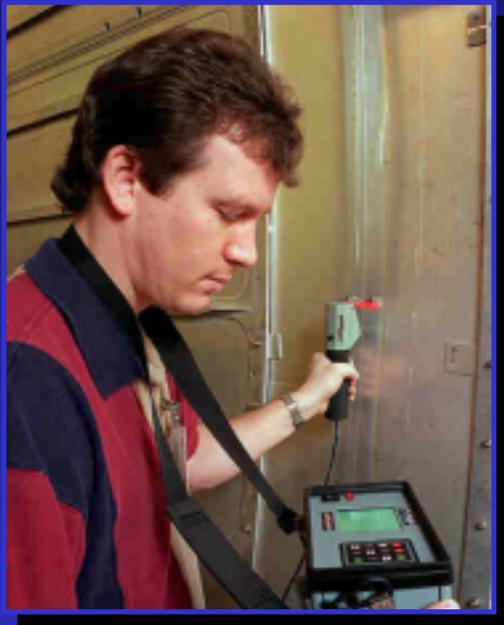
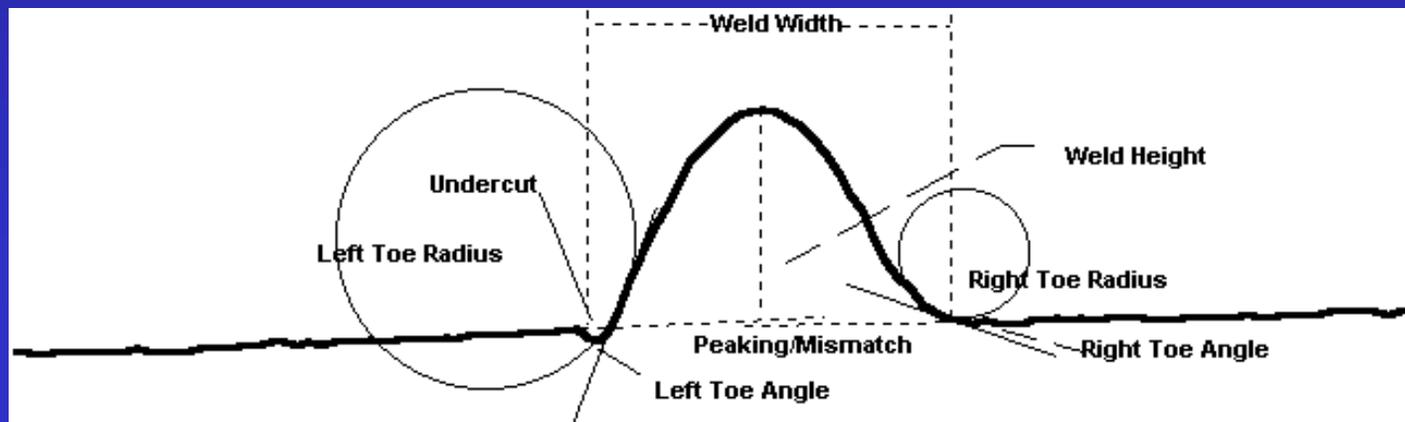
Optical/Laser based sensor system

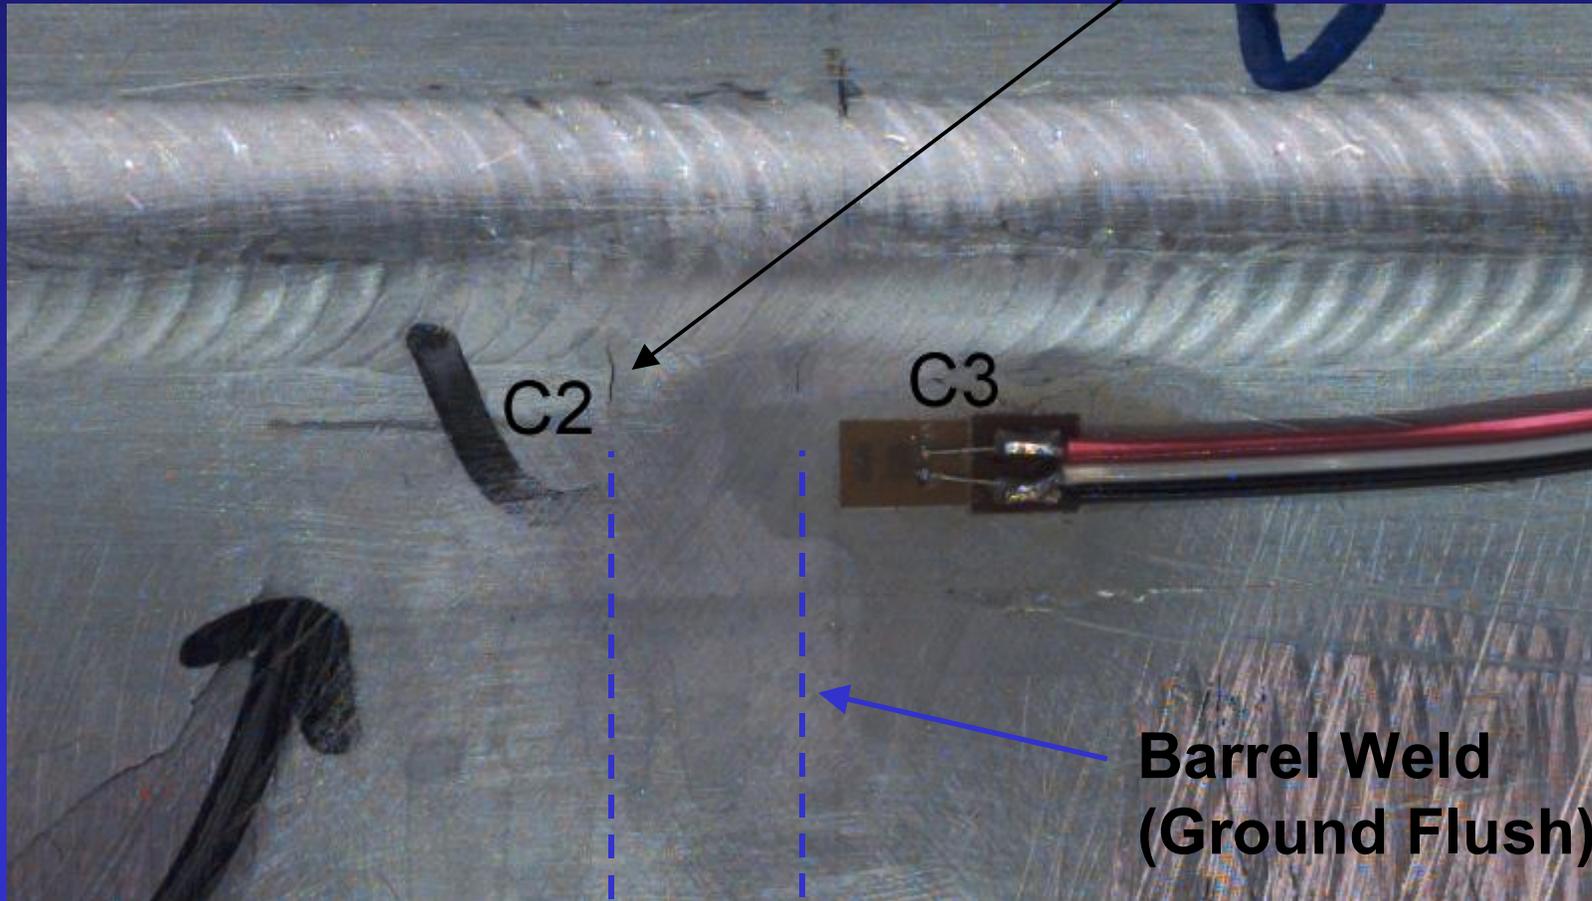
Crack Location

# Intersection Cracks

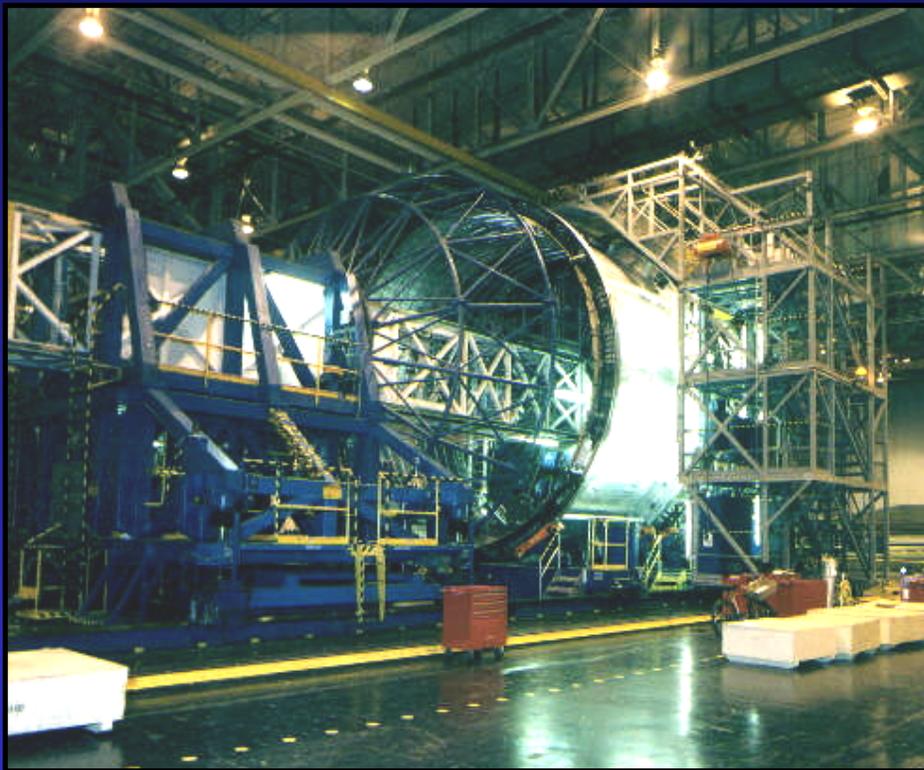
Hydrogen Tank Final Assembly Tool

# Intersection Crack Affected Tools

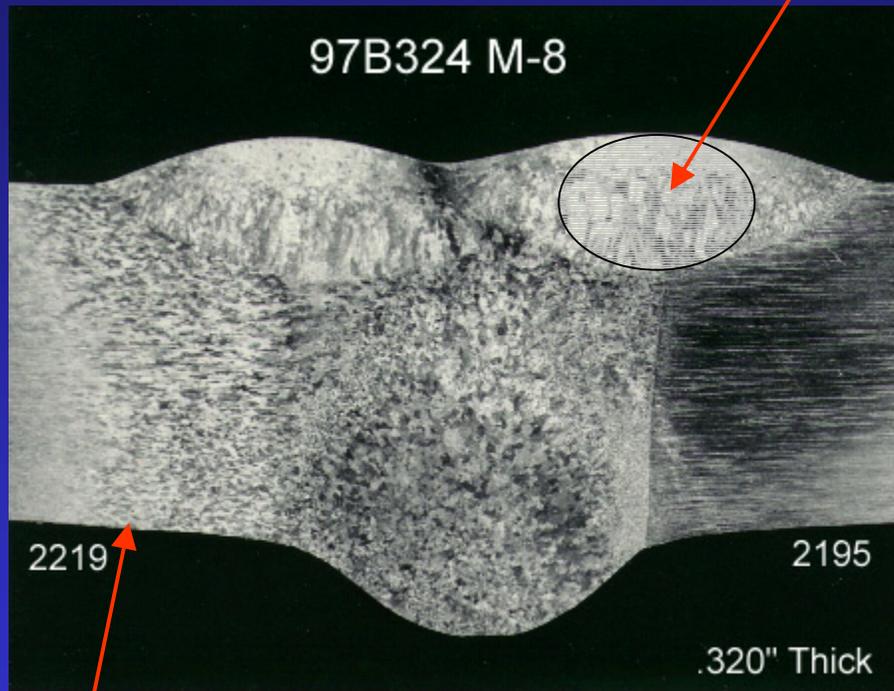
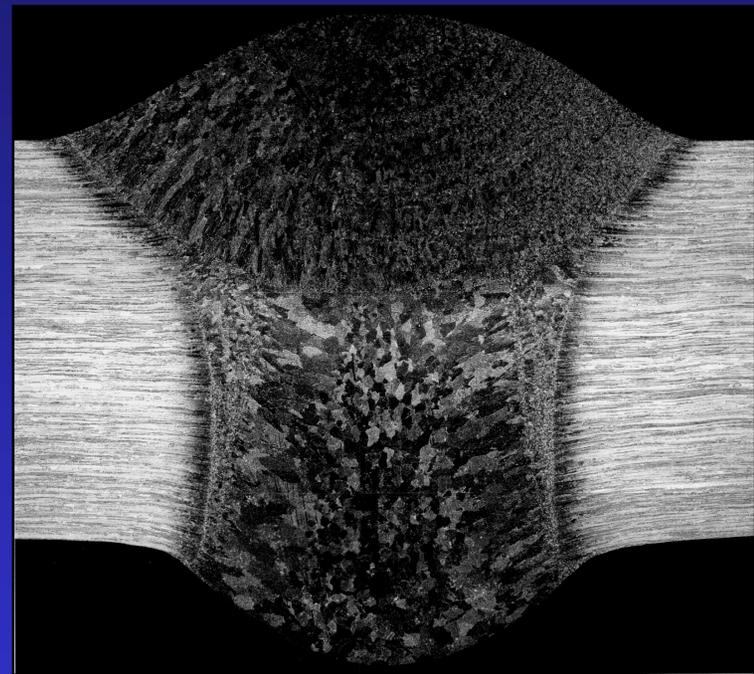
# Photomicrograph of Dual Cover Pass

Crack Susceptible Region Setup by Intersection

2219 Material  
No Problem on  
Frame side

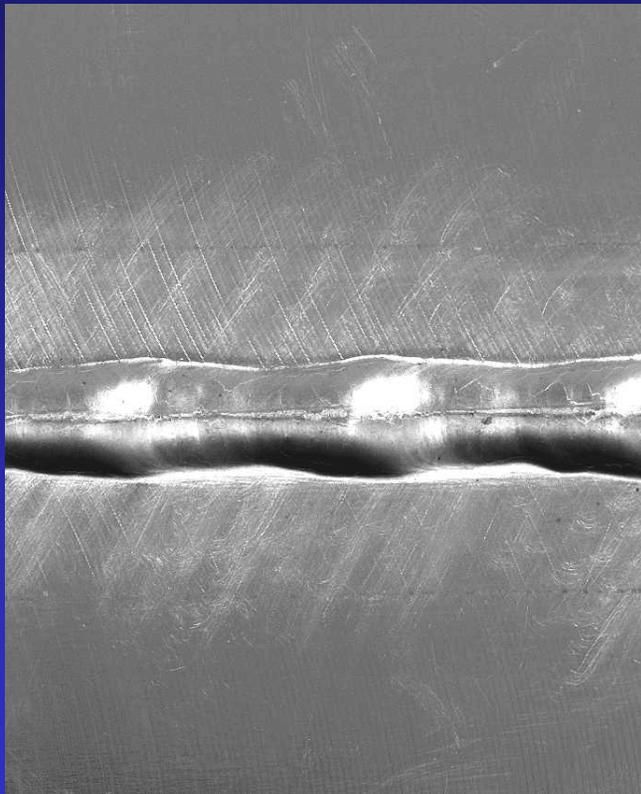
Weld Root

# Weld Lack of Penetration Issue

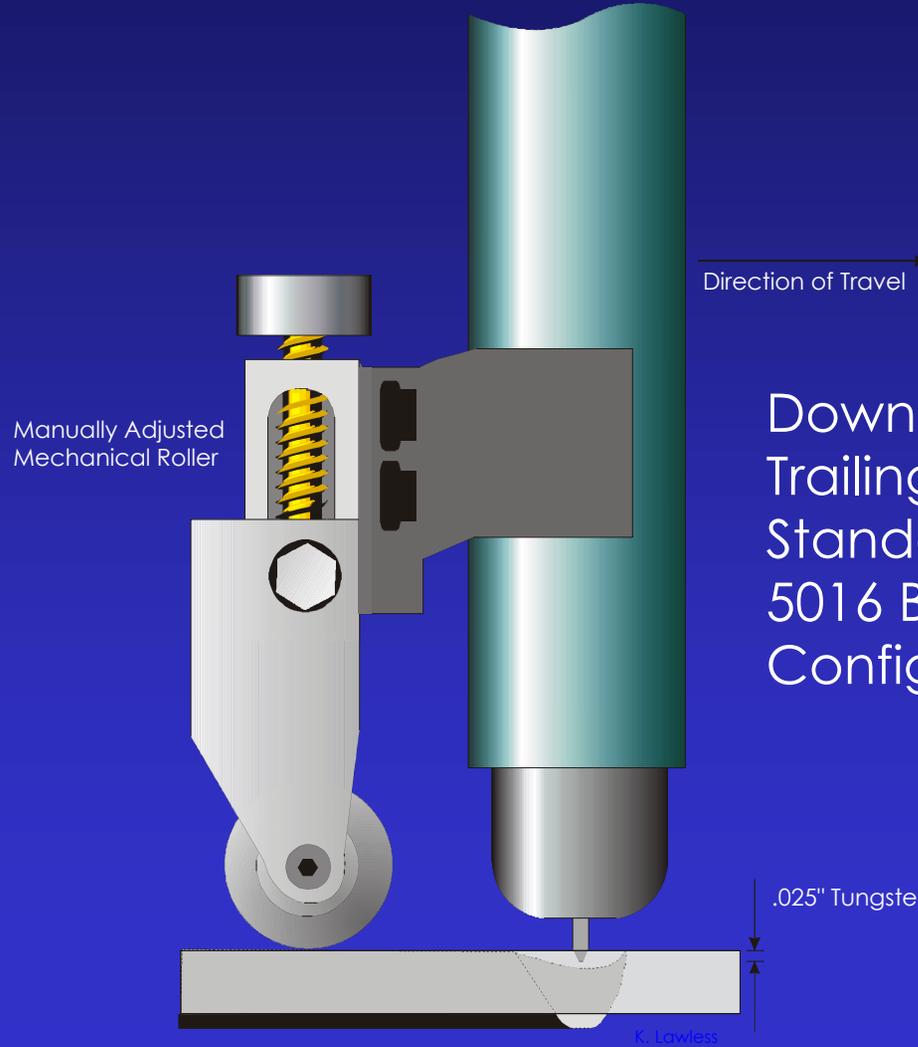
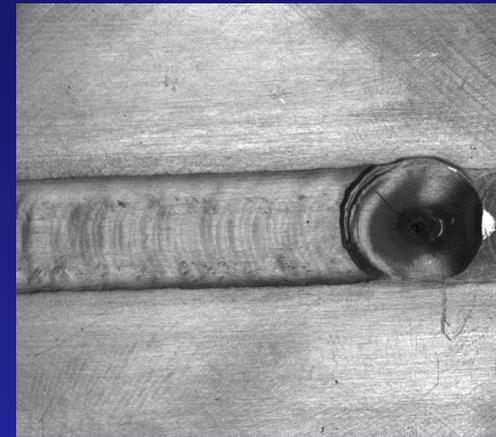
Spring Loaded VPPA Torch  
with SPAW Tungsten and Orifice Configuration

Downhand SPAW with  
Trailing Wheel Mechanical  
Standoff  
5016 Barrel Tool  
Configuration for SLWT

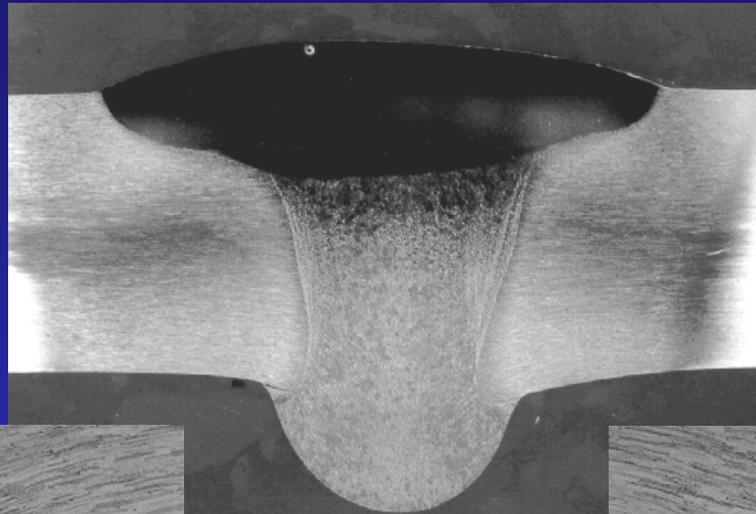
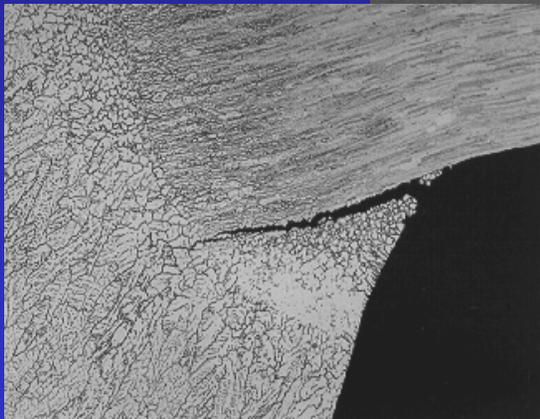
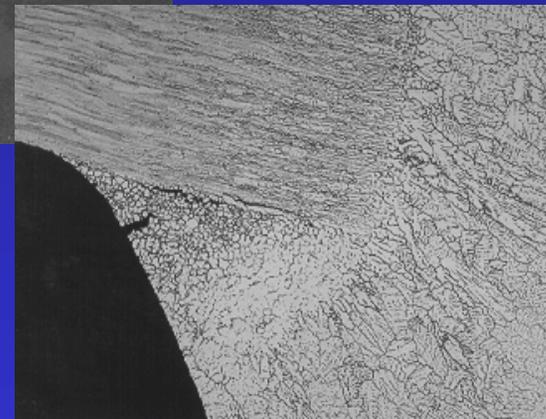
# Toe Cracks Investigation

ROOT TOE 50X ORIGINAL MAG.

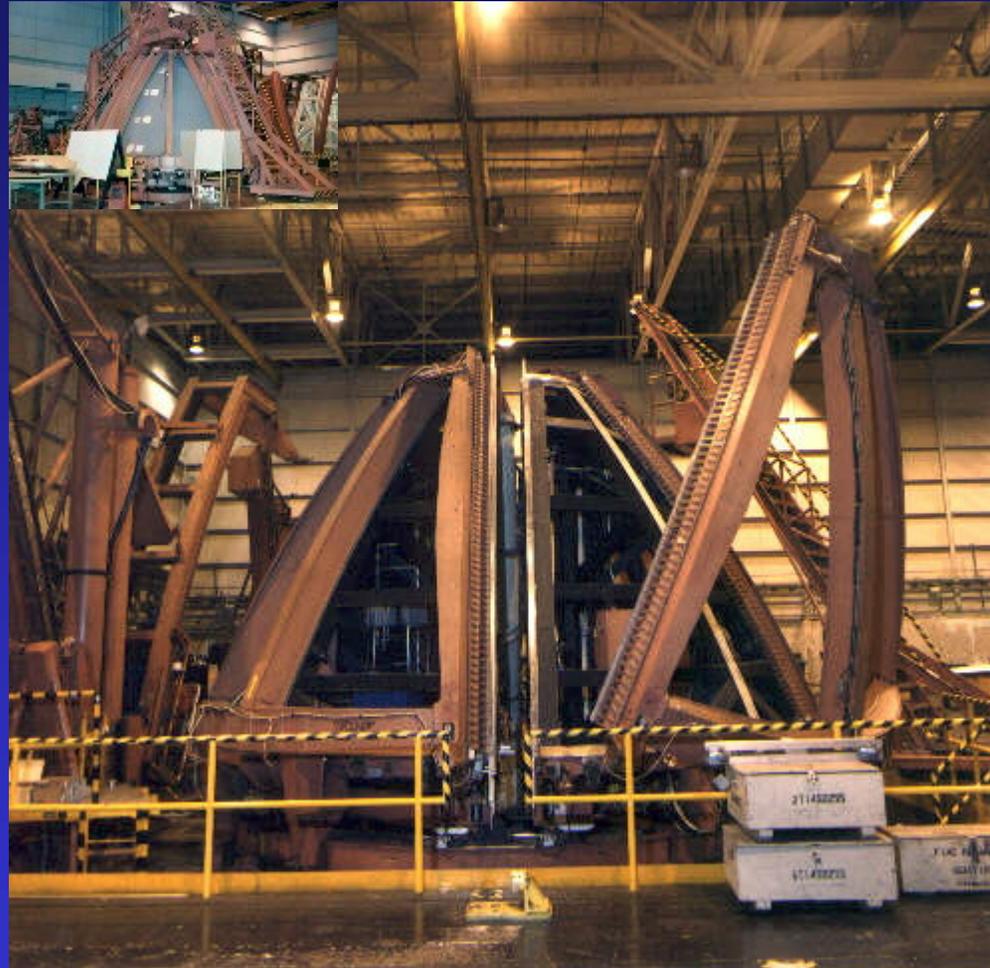
5012 Forward Ogive tool

0.190" –0.220" thick tapered welds

- VPPA power supply has inconsistent reverse current
- Repairs require even faster manual repair travel speeds and narrow grinds

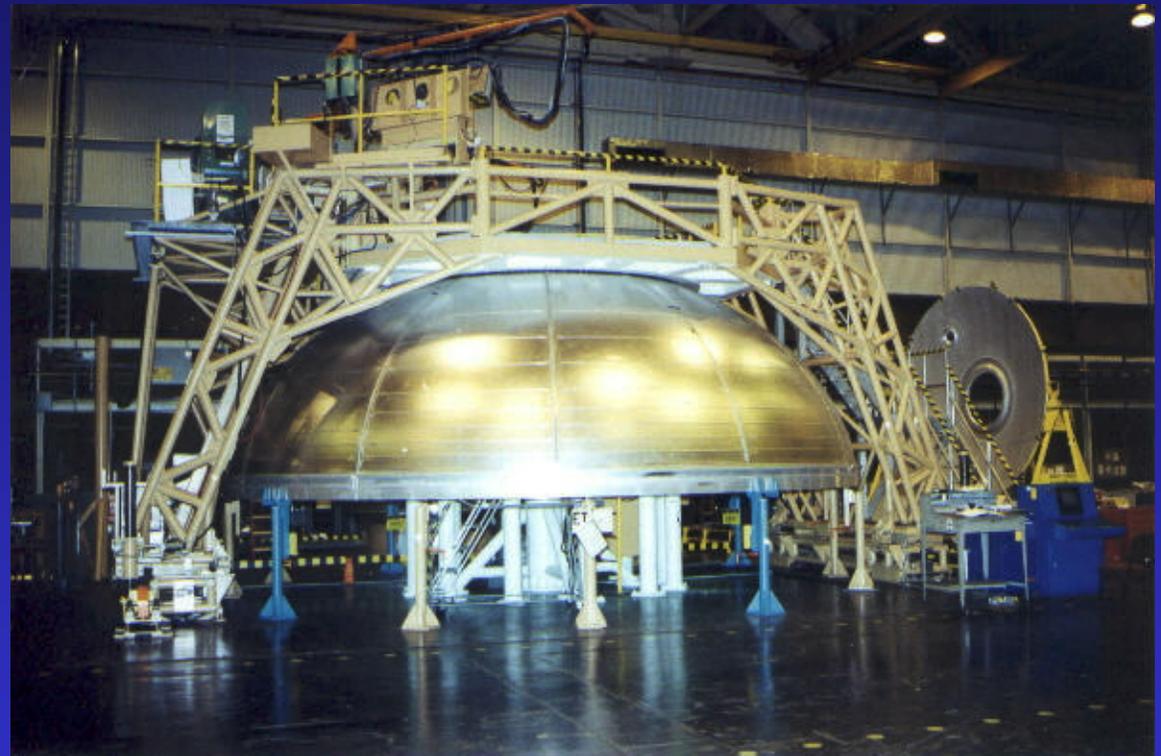
Dome Cap to Body Weld Tool

- Oxygen Tank Dome Cap most challenging weld
- Hydrogen Dome Cap a close second.
- Peaking at intersections creates welding challenge
