# **PERMEABILITY OF IMPACTED COATED COMPOSITE LAMINATES**

**Final Report**

*NASA Grant Number: NAG8-1819  
Ga Tech Project Number 1806675*

**Georgia Institute of Technology  
Atlanta, GA 30332-0245**

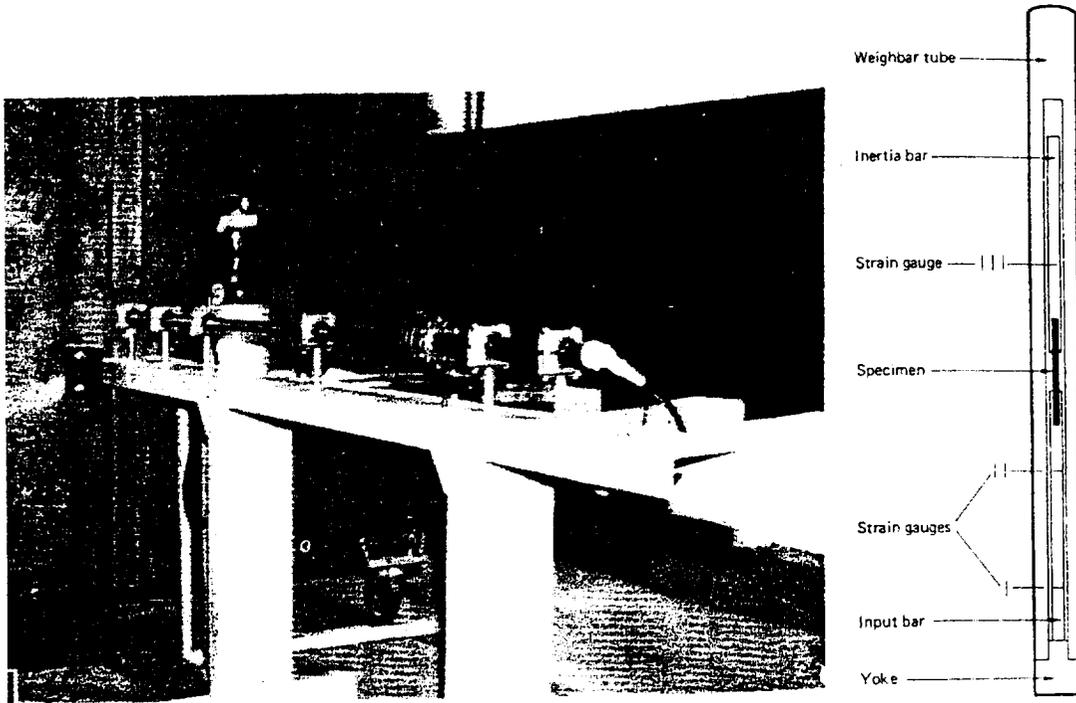
Figure 2.1. A Split-Hopkinson Bar set up for tension.<sup>6</sup>

The Split Hopkinson-Bar provides a dynamic high strain-rate impact test. In these tests a specimen is adhered between two bars. The input bar is then struck such that the impact of the bar can cause strain-rates as high as 1000/second. There are several different types of Split Hopkinson bar tests including punch loaded, compression bar, tensile bar, and the shear test.

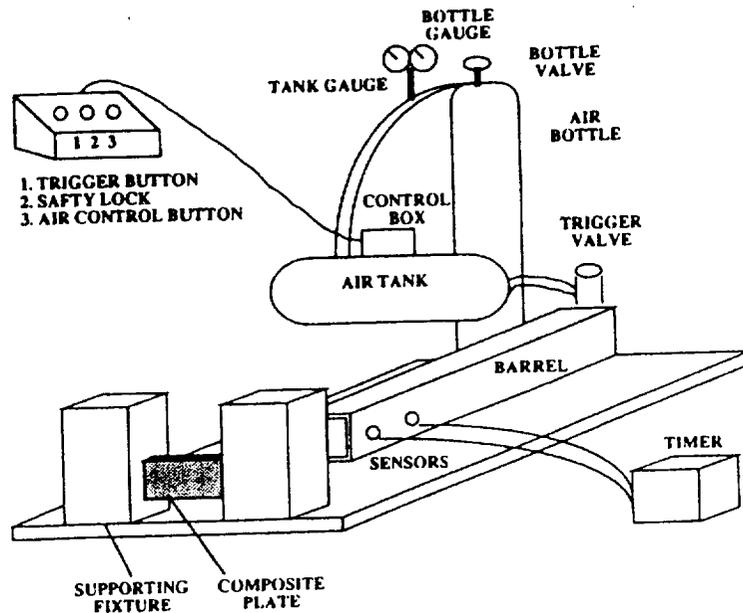
Figure 2.2. Gas gun impact test machine.<sup>7</sup>

Ballistic impacts and gas gun impacts are very similar. In both cases, a small projectile is shot at a specimen at high velocity. The main difference being the method in which the projectile is propelled. Figure 2.2 shows a schematic of a gas gun impactor.<sup>7</sup>

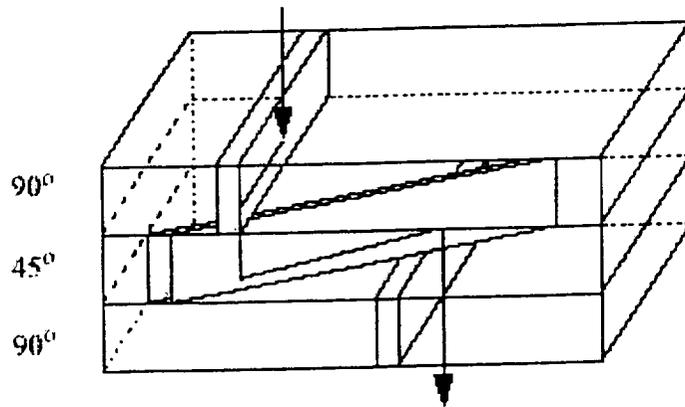
Figure 2.3. Cracks in a laminate such that leakage occurs.<sup>24</sup>

In work done by Kessler et al. it was found that carbon/epoxy composites are very vulnerable to microcracking caused by thermal cycling. At temperatures below 60K (-351 °F) cracking of the matrix material initiates, and after only a few cycles between 60K and 400K (261 °F) the maximum microcracking density is reached (generally on the order of 5 cycles).<sup>24</sup> Cracks that form due to thermal cycling grow parallel to the fibers because the matrix has a much greater coefficient of thermal expansion than the fibers. It was found that laminates with more variation in the orientation of the fibers had greater permeations than did those with fewer fiber orientations because the cracks had more overlap, and thus created more complete paths through the material. Figure 2.3 is a good example of how cracks in plies of different orientations create leak paths through composite materials.

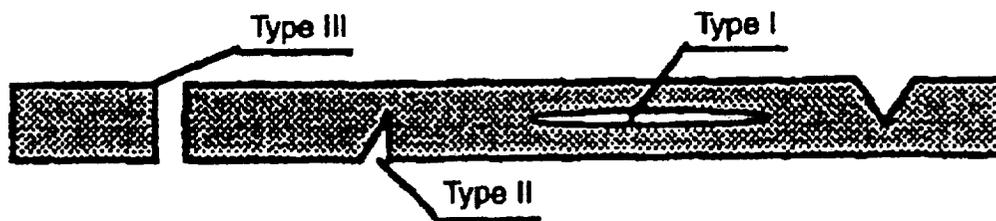
Figure 2.5. Types of damage that increase the permeability of a material.<sup>35</sup>

Firstly, there can be internal damage in the material such that two distinct phases of material exist (essentially the creation of voids) with each having reduced thickness. Secondly, there can be surface damage, which simply reduces the effective thickness of the material. Lastly, there can be through damage.<sup>35</sup> The three types of damage are illustrated in Figure 2.5.

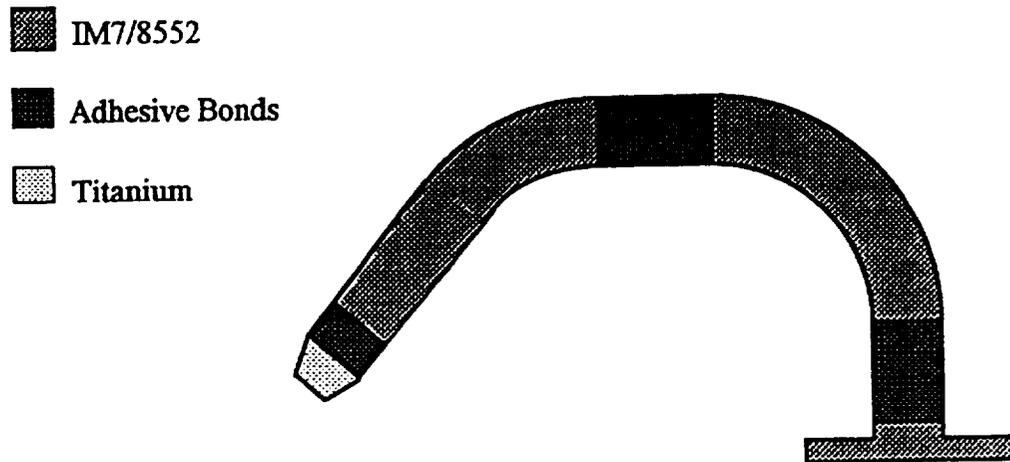
Figure 2.7. Sample LH<sub>2</sub> feedline.<sup>41</sup>

The feedlines tested by Nettles at NASA MSFC were made from materials very similar to the ones considered in this thesis. The feedlines were developed by McDonnell-Douglas and consisted of IM7/8552 eight harness weave preregs layed up in a [0/90/±45/±45/90/0] orientation. Some splice material was also necessary for the feedlines, and this was made of unidirectional tape layed-up as [60/-60/0]<sub>s</sub>. The final result is pictured below in Figure 2.7.

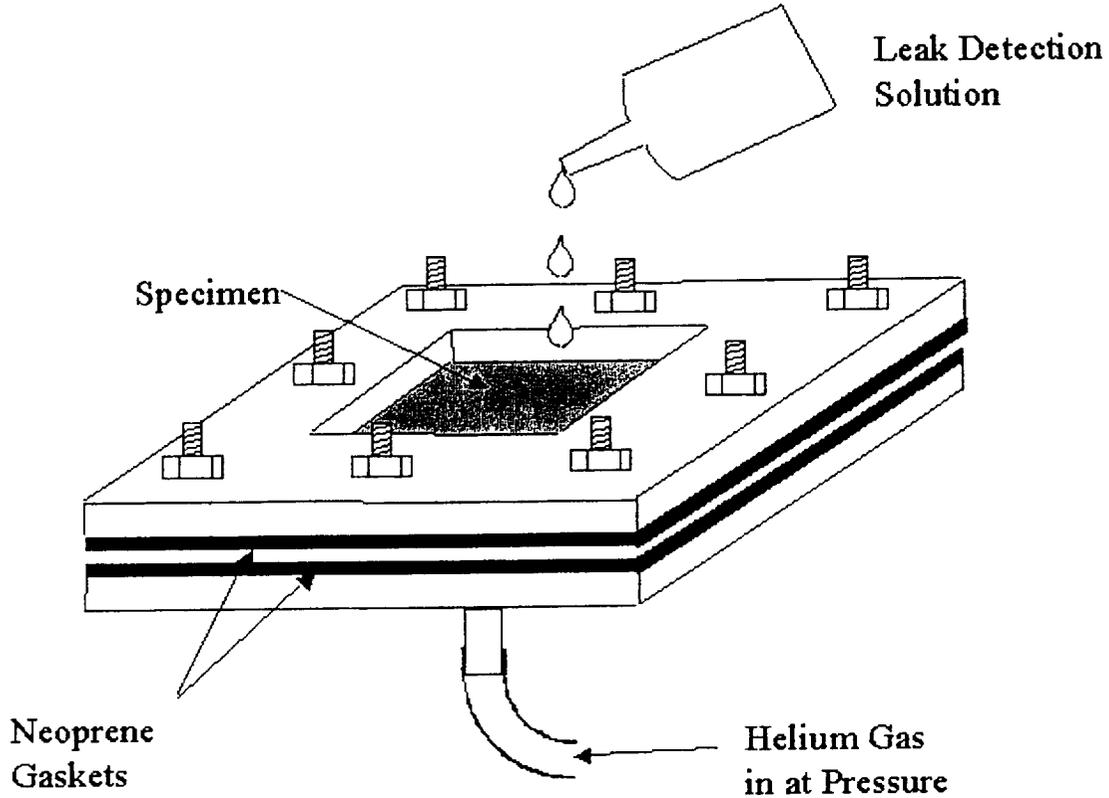
Figure 4.1. NASA MSFC leak detection apparatus.<sup>60</sup>

In order to accurately determine whether or not a specimen was leaking it was important to devise a method by which a gas could be applied at pressure to one side of a specimen such that the only escape route was through the composite. Then it is necessary to make any leaks that do exist clearly visible. The leak detection apparatus used at NASA MSFC accomplished these goals by creating a two-plate system. The bottom plate had a chamber created in it that could be connected to a gas line one side and would be flush with the specimen on the other. The top plate simply had a hole through its thickness in the exact size and shape of the chamber in the bottom plate. This hole in the top plate could then be filled with a liquid solution that would make any leaks visible as a stream of bubbles. Because it would be very difficult to obtain a seal against the composite using just the two aluminum plates, neoprene gaskets were designed to be sandwiched between the plates and the specimen. The plates were clamped against the specimen by tightening a series of eight bolts that were spaced evenly around the periphery of the plates. A diagram of the NASA MSFC leak detection apparatus can be seen in Figure 4.1.

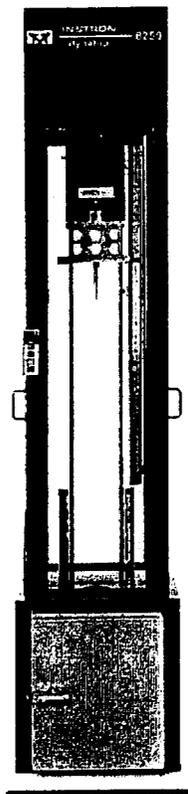
Figure 4.13. Dynatup 8250 drop weight impact test machine.

these types of impact. The impact machine used was a Dynatup 8250 as is shown in Figure 4.13.

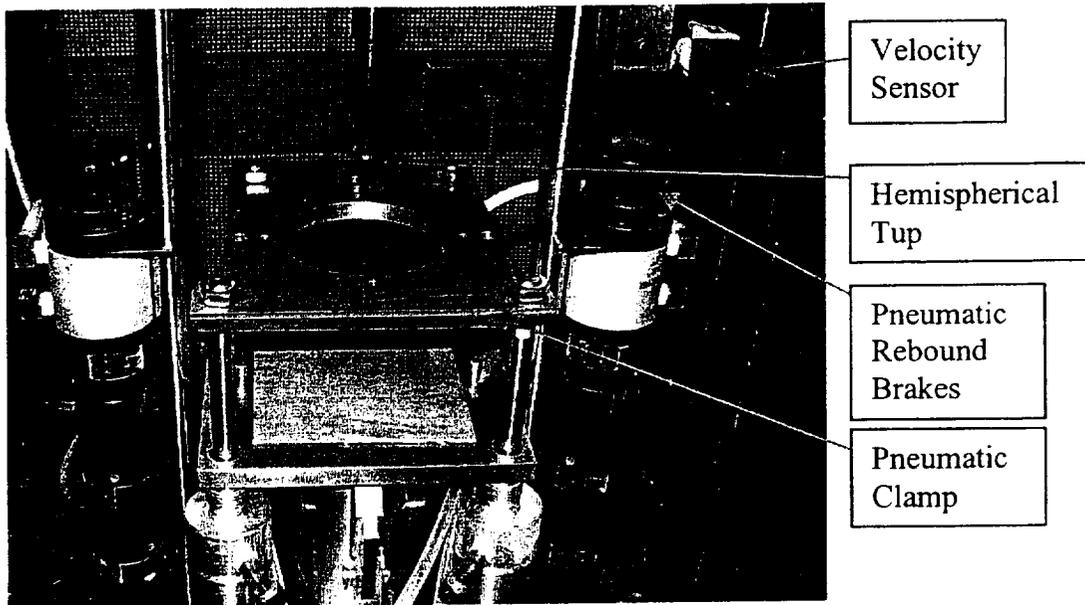
Figure 4.14. Pneumatic clamp and rebound breaks of the Dynatup 8250.

With the height sensor adjusted so that the impacts occur from the desired height, a specimen is then centered in the pneumatic clamp over the 3" (7.62 cm) diameter openings that allow for deflections caused by the impacts. Figure 4.14 shows both the pneumatic clamp and the rebound breaks in the 8250.

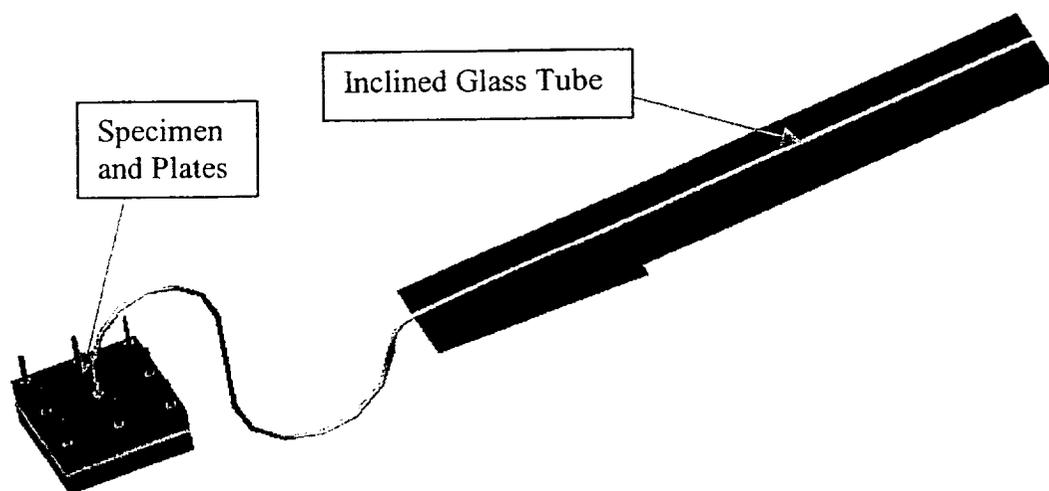
Figure 4.15. CAD rendering of the permeability test apparatus.

The equipment designed for this test incorporates the bottom plate from the leak detection apparatus already shown. The top plate in this case is identical to the bottom plate, but its hose connects to an inclined glass tube that is open to the air on the other side. Figure 4.15 shows a CAD rendering of the apparatus (minus the hose connecting the bottom plate to the helium cylinder).

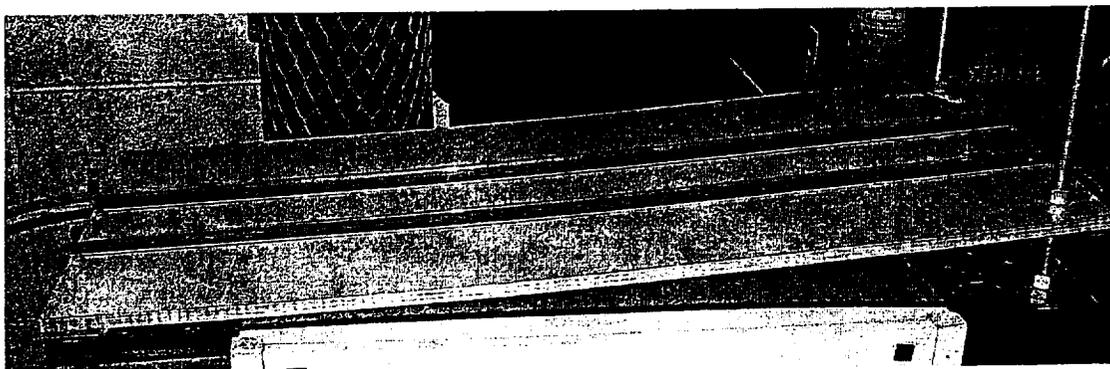
Figure 4.16. The glass tubes used to get volume measurements for the permeability tests.

To test a specimen for permeability is similar to the leak testing in that a specimen is placed between to 6" by 6" by 1" (15.25 x 16.25 x 2.54 cm) plates (with gaskets that have been smeared with vacuum grease on the side that bears on the composite). Again the bolts are tightened as much as can be done with a ratchet (around 100 in\*lb). Next a slug of isopropyl alcohol is introduced into the system through the glass tube that is attached to the hose connected to the top plate. The glass tube is inclined at five-degrees, this was found to be an optimal angle by NASA MSFC.<sup>60</sup> Next the gas is applied to the specimen. The pressure is slowly increased until the slug moves at a speed such that a reading can be taken. This is an approximate science, too much leakage makes it impossible to get a reading and if the leak is extremely slow the measurement can be very slow. A stopwatch is used to determine the length of the reading, and the distance the slug moves is read off of a ruler that is next to the glass tube. Figure 4.16 shows the inclined glass tube and ruler used for the permeability readings.

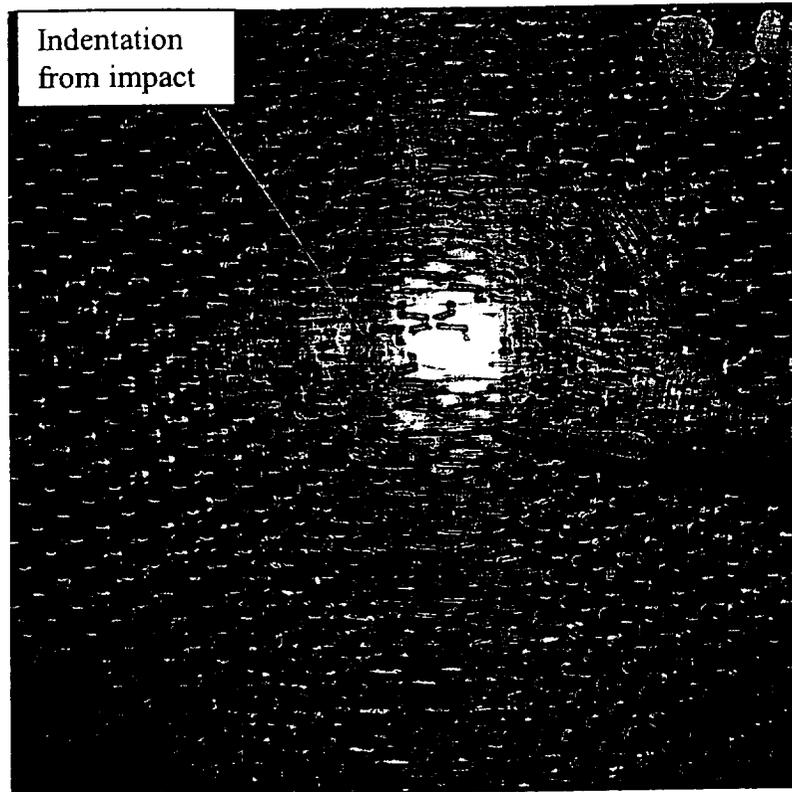
Figure 5.7. Uncoated specimen impacted at 3.87 ft\*lb (5.25 J), (a) back of specimen, (b) front of specimen, (c) close-up of damage on backside.

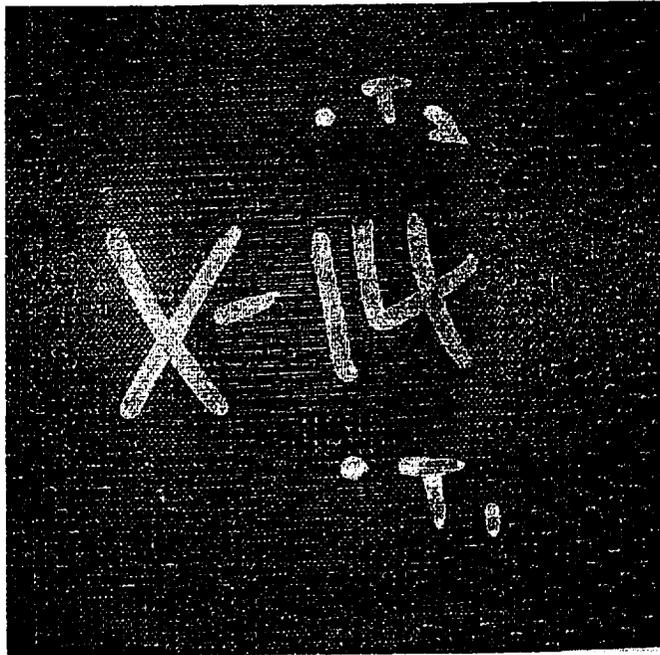
Figure 5.8. Thermaflex IIC specimen impacted at 2.30 ft\*lb (3.12 J), (a) back of specimen, (b) front of specimen (note there is no visible damage on this specimen).

As was mentioned in the caption for Figure 5.8, there is no visible damage on the back of the Thermaflex IIC coated specimen. This is even true of some of the specimens that were impacted with sufficient energy to cause leakage through the coating. In addition, when there was a leak path present in the composite substrate the Thermaflex IIC tended to delaminate around the location of damage until the coating finally failed, as shown in Figure 5.11.

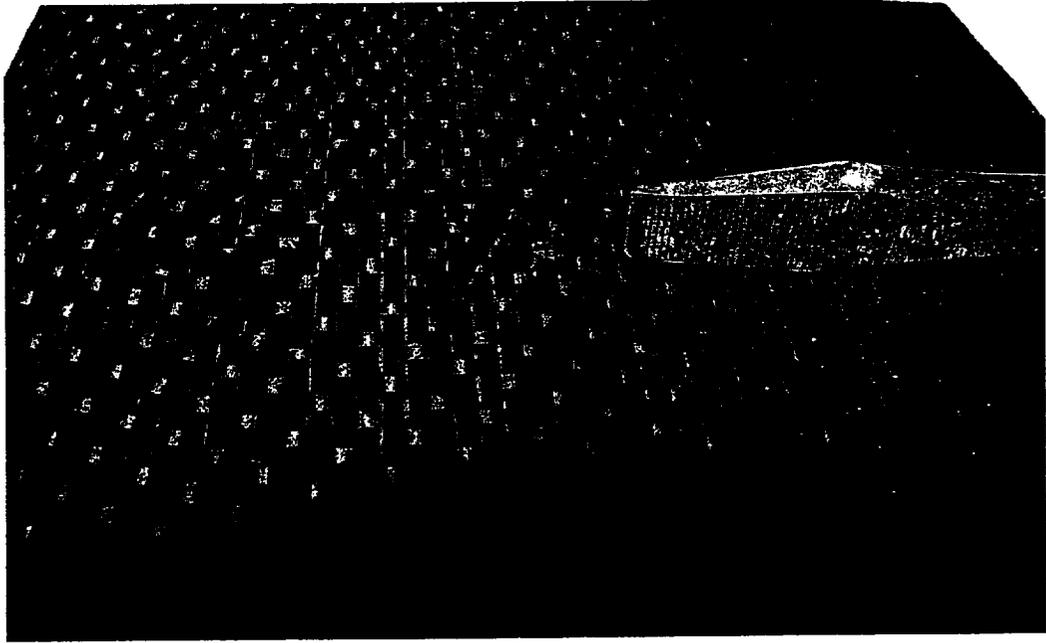
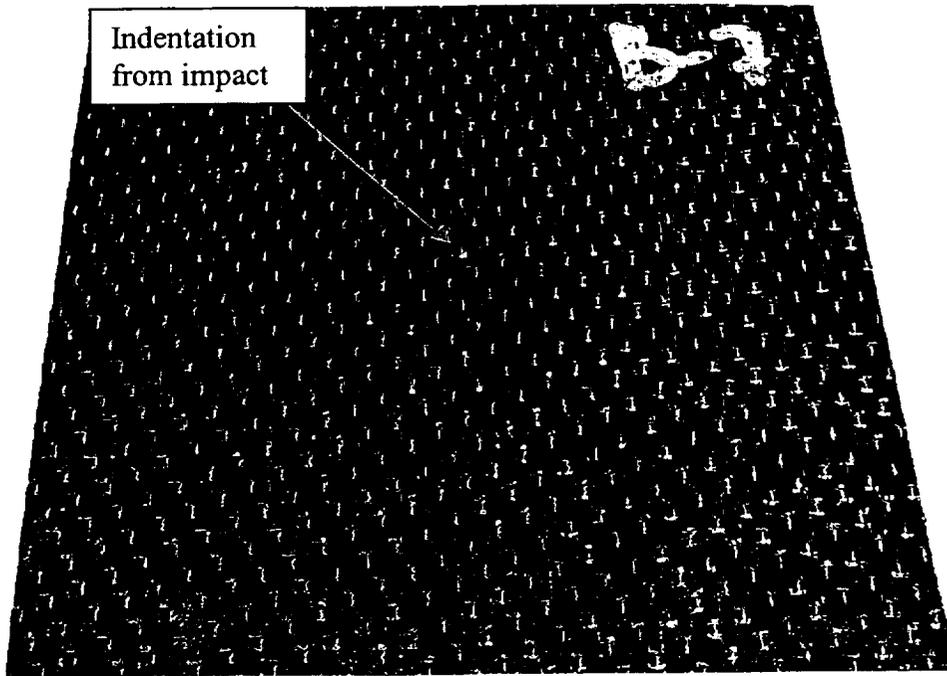
Figure 5.9. Uncoated specimen impacted at 2.30 ft\*lb (3.12 J), (a) back of specimen, (b) front of specimen, (c) close up of damage in back.

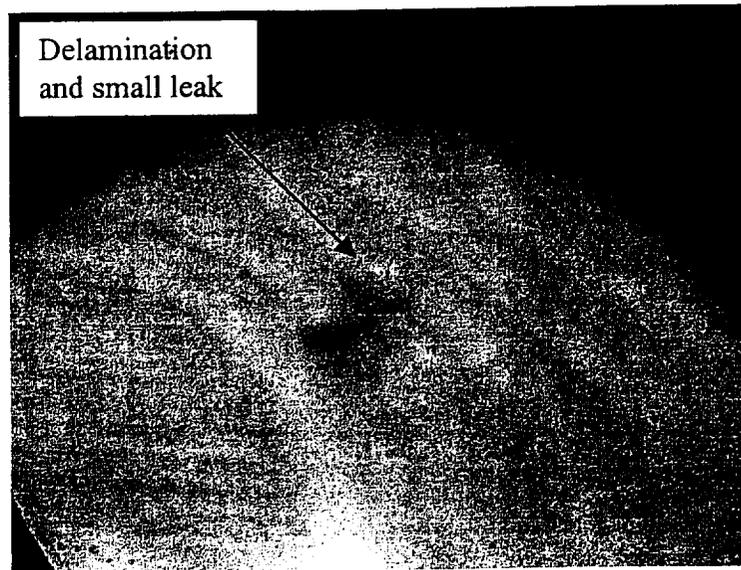
Figure 5.11. Thermaflex IIC specimen delaminating during leak test.

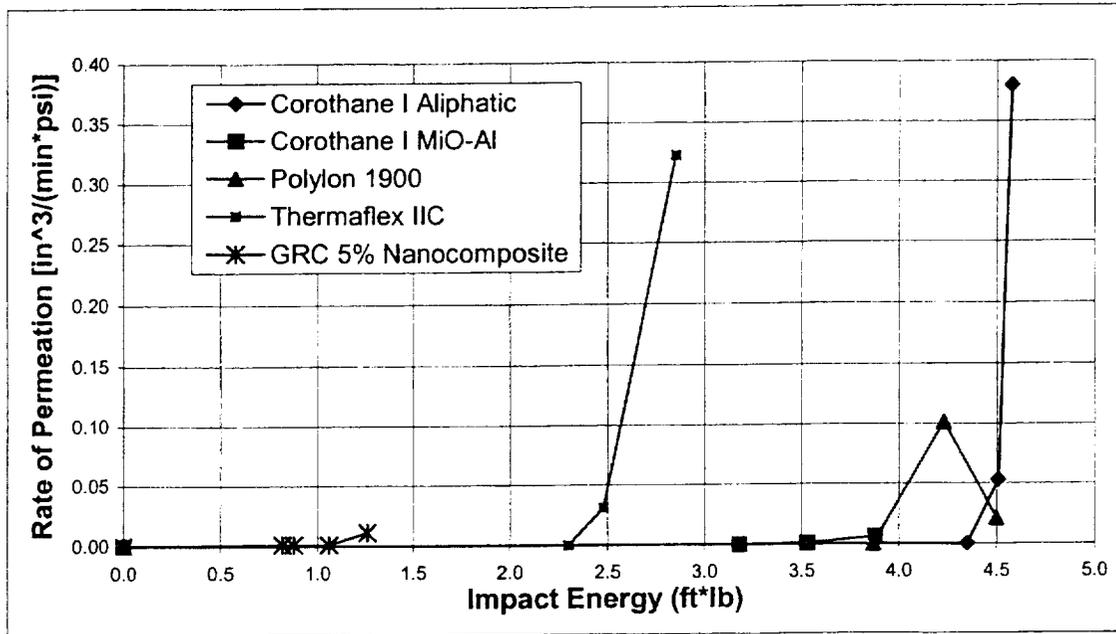
Figure 5.12. Impact energy vs. rate of permeation for coated specimens with 3 or more leaks.

The trend of rate of permeation versus impact energy is shown in Figure 5.12.

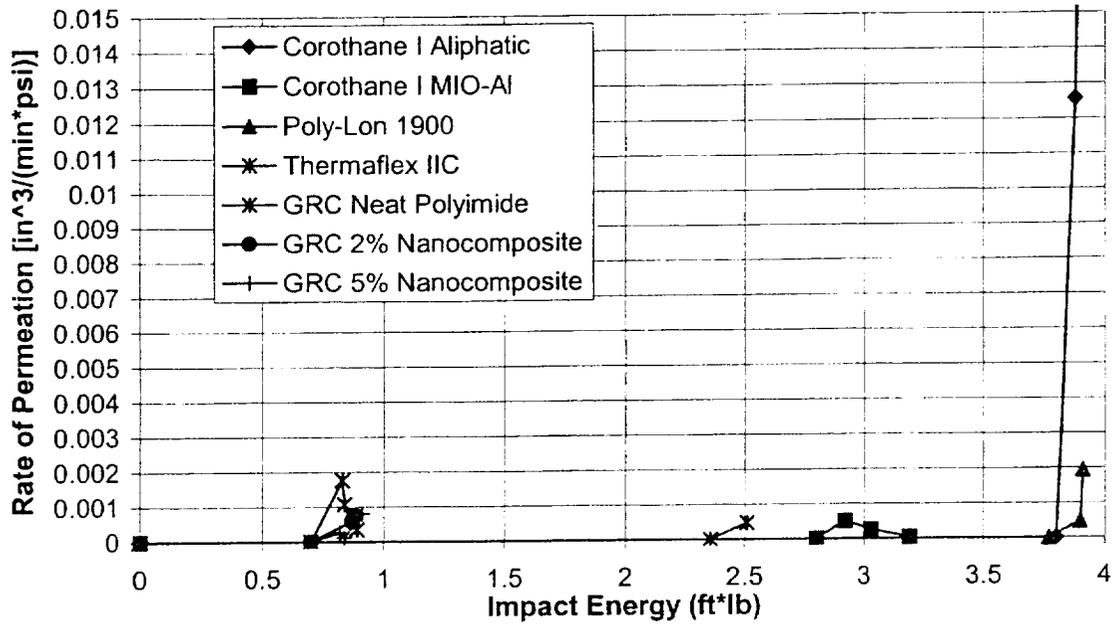
Figure 5.13. Impact energy vs. rate of permeation for coated initially impermeable specimens.
