Structural Analysis

*Stress
analysis
software
aided a
difficult
reconstruction
task*

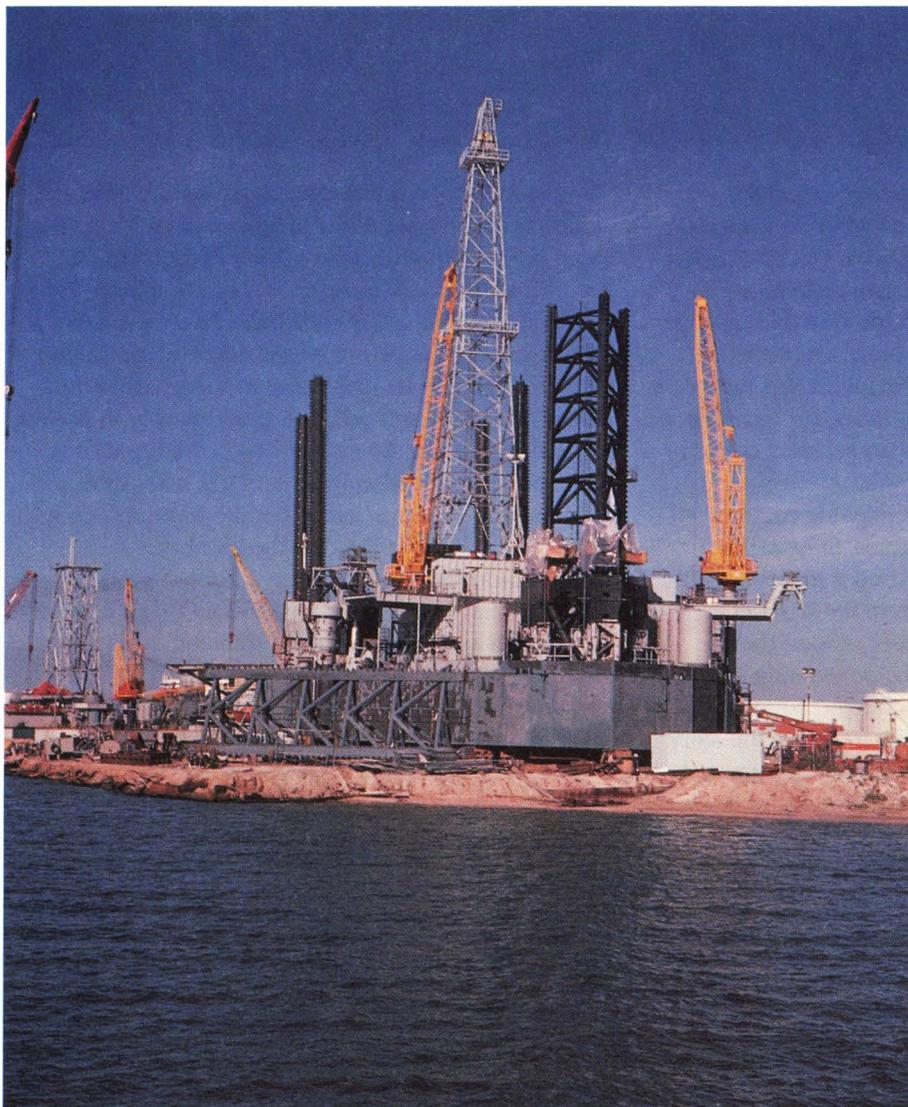
Below is an offshore platform under construction. Such large steel structures are used for discovery and subsequent recovery of oil or gas from deep wells beneath the ocean floor. Platforms like this one must be constructed to withstand extreme environmental hazards, such as North Sea winter storms or Gulf of Mexico hurricanes. The structure must also withstand damage from dropped objects, boat impacts and general use loads on the structure.
