NASA/TP—2002–210769

Composite Overwrapped Pressure Vessels

EXECUTIVE SUMMARY FOR DATABASE EXTENSION TASK 3.0 AND IMPACT DAMAGE EFFECTS CONTROL TASK 8.0

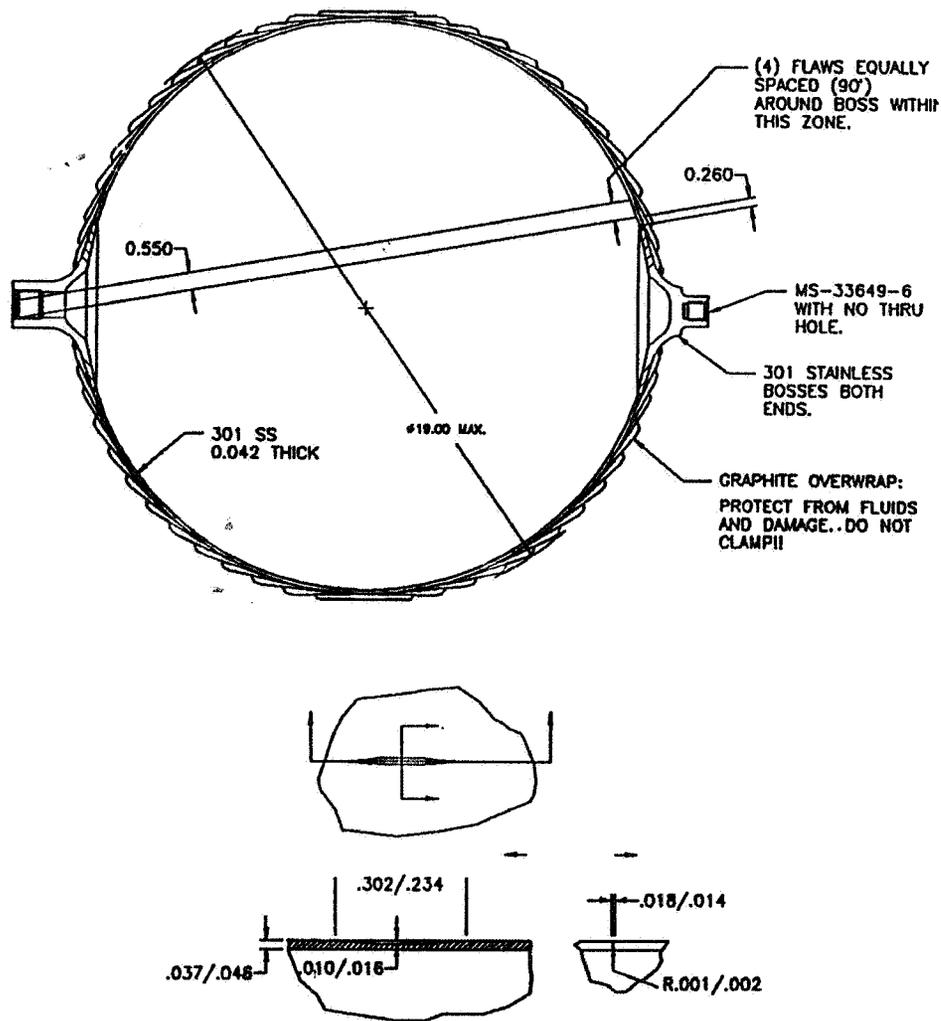
Figure 1-1. Manufacturer's sketch of flaw dimensions and placement for 19 in. dia spherical COPV.

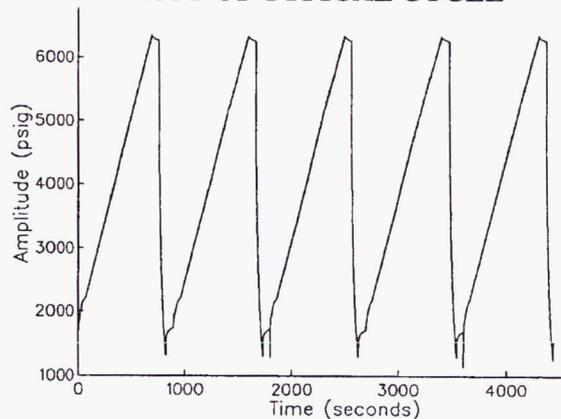
PLOT OF TYPICAL CYCLE

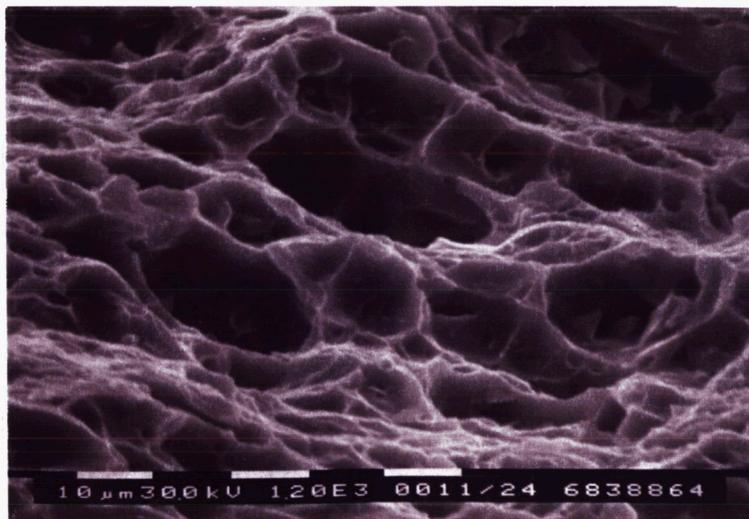
SEM PHOTOMICROGRAPH OF TYPICAL LINER FRACTURE FACE: (1200X MAGNIFICATION)

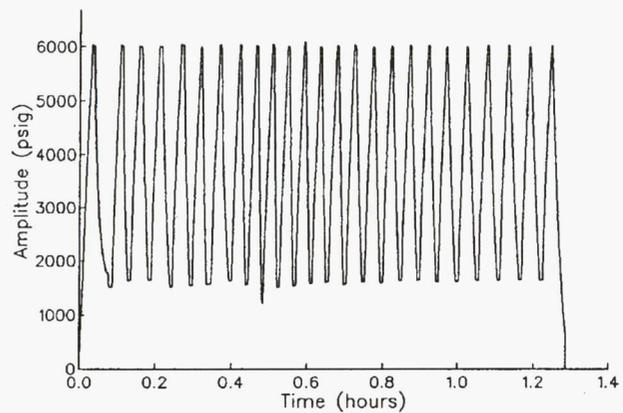
PLOT OF TYPICAL CYCLE

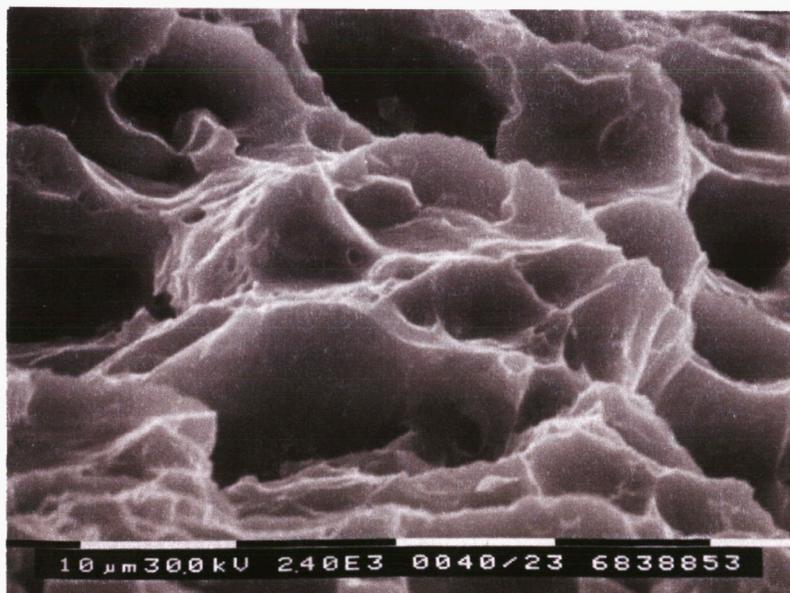
SEM PHOTOMICROGRAPH OF TYPICAL LINER FRACTURE FACE: (2400X MAGNIFICATION)

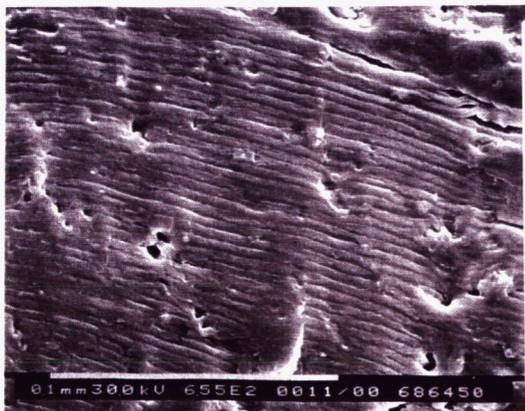
**FATIGUE STRIATIONS NEAR
FRACTURE INITIATION POINT (655X
MAGNIFICATION)**

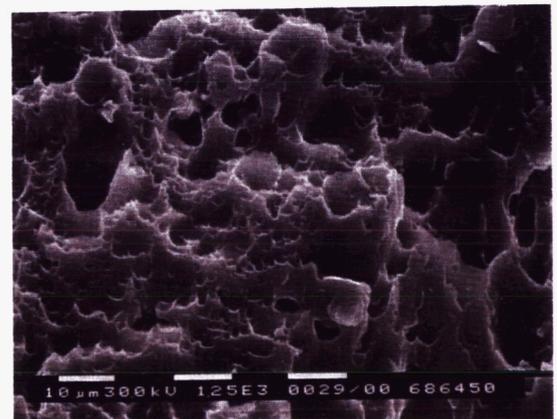
**DUCTILE MODE FRACTURE FACE
(1250X MAGNIFICATION)**

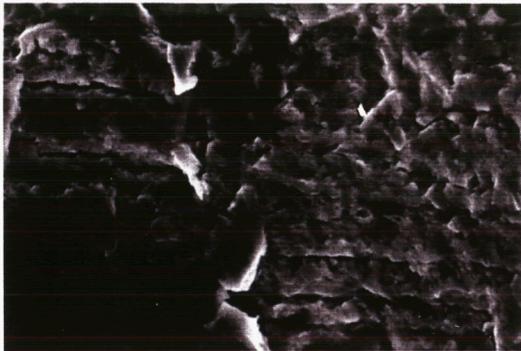
FATIGUE AREA FRACTURE FACE, SHOWING INCREMENTAL FRACTURE PATH (1930X MAGNIFICATION)

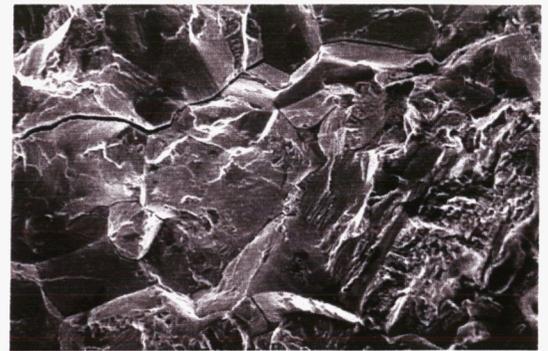
NON-FATIGUE FRACTURE FACE, SHOWING BRITTLE TYPE FRACTURE WITH INDICATIONS OF MICRO LEVEL DUCTILITY (287X MAGNIFICATION)

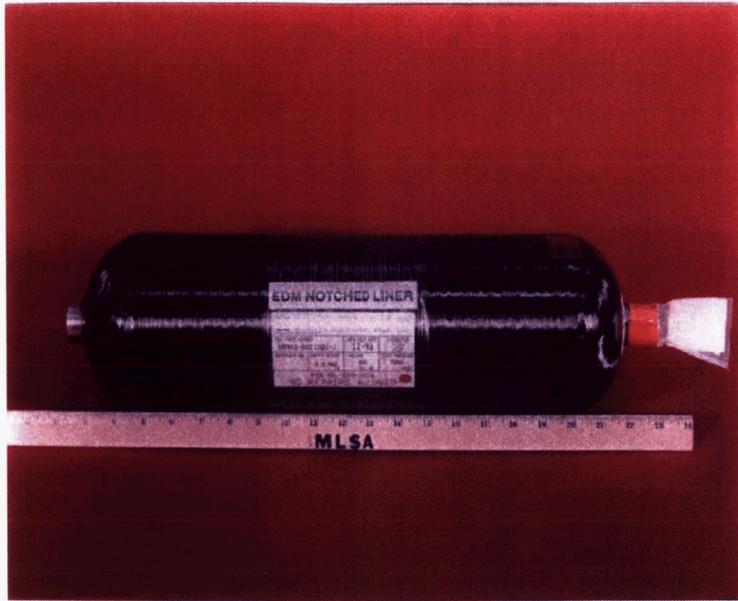
Figure 1B-1. Graphite composite overwrapped pressure vessel (GCOPV). Vessel was designed for inert pneumatic gas storage up to 7000 psi.

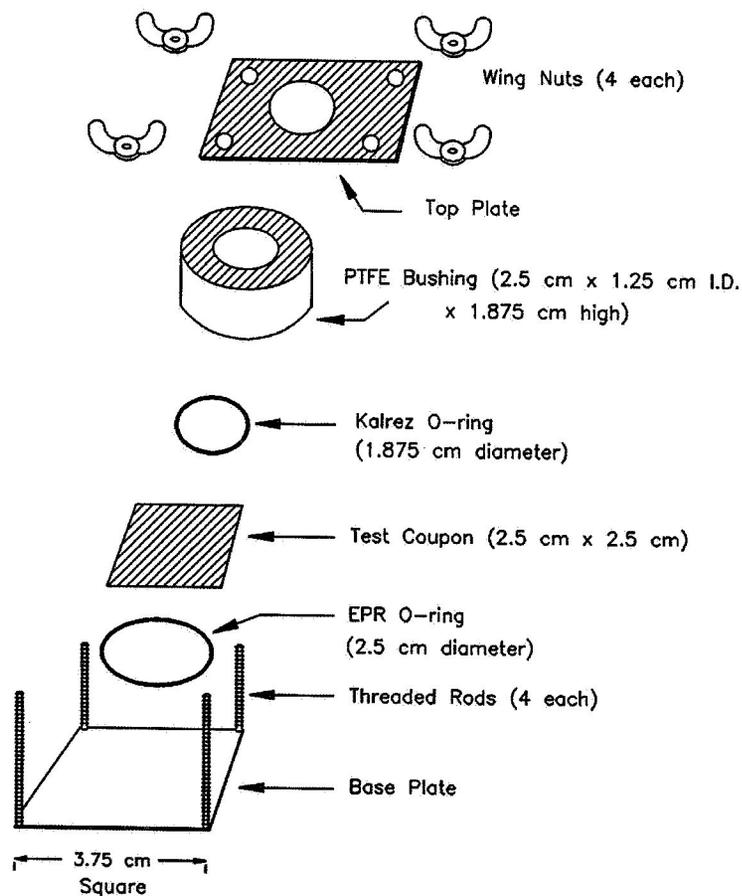
Figure 2-1. Test fixture for liquid exposure of composite coupons without edge exposure.

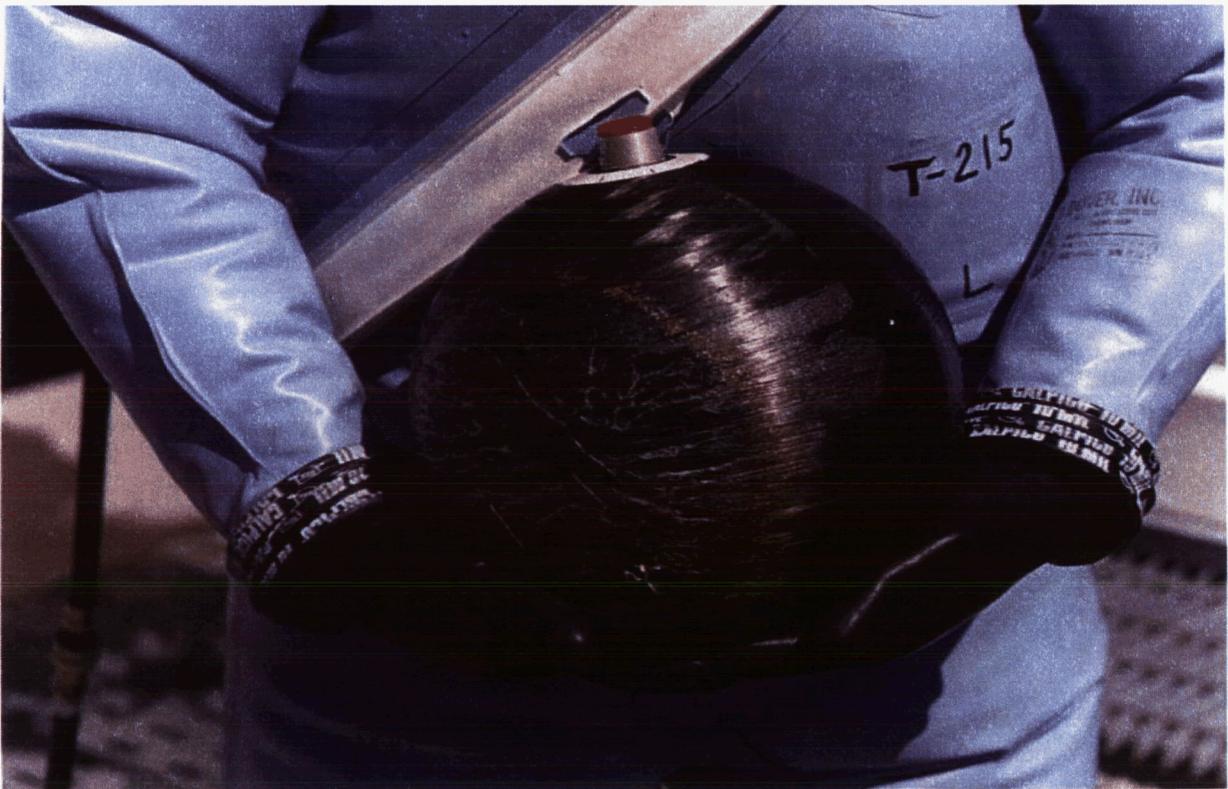
Figure 3-1. Typical post-exposure COPV.

We measured no significant effect on burst strength after exposing Lincoln Composites Model 220088-1 Gr/Ep COPVs to the space vehicle fluids N_2H_4 , N_2O_4 , or LOX under simulated launch pad leak scenarios.

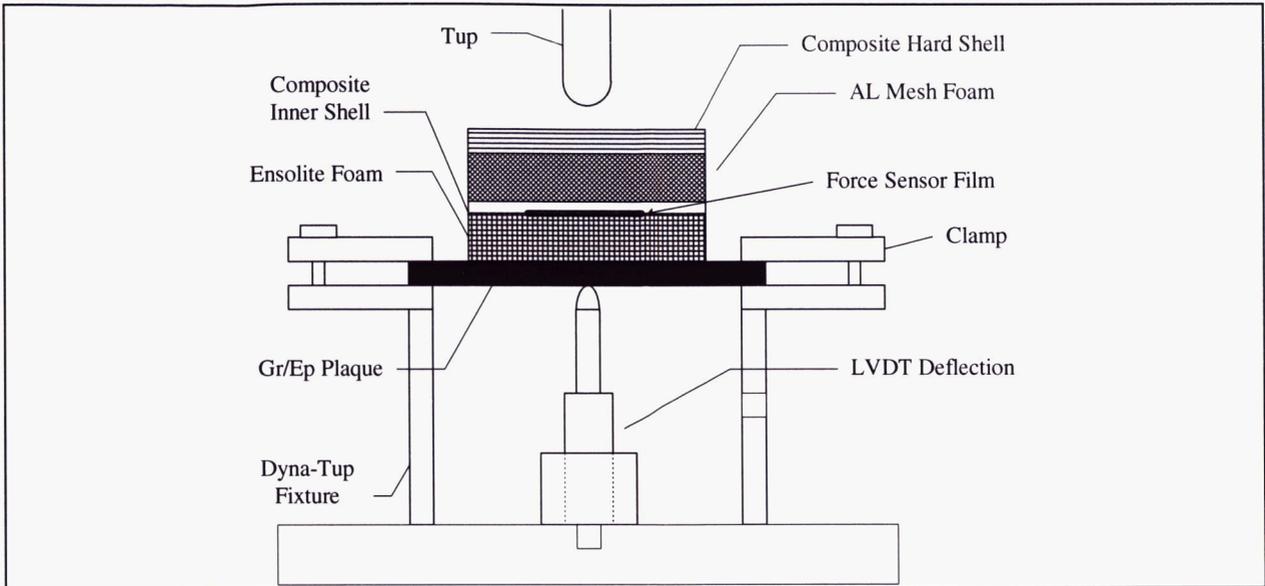
Figure 5-1. Impact fixture for testing the performance of impact protectors.

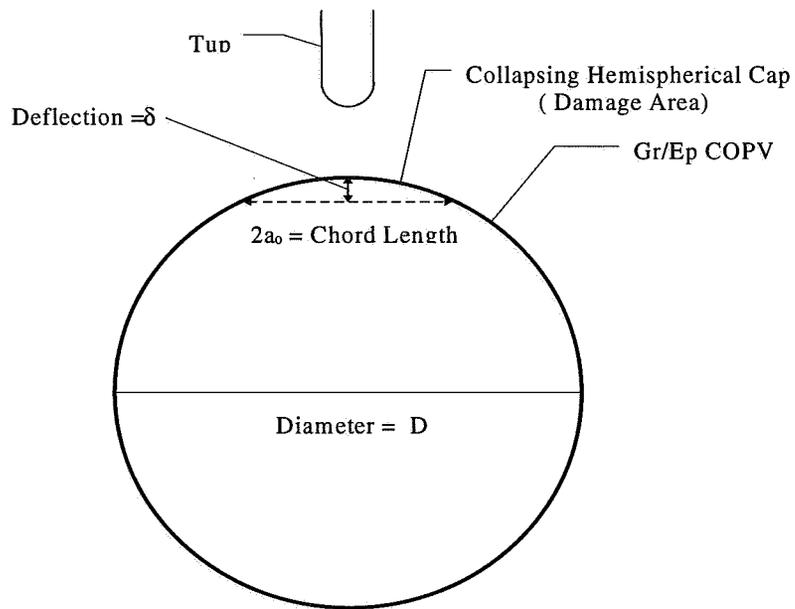
$$\text{Damage Area} = \pi a_0^2 \cong \pi D \delta$$

Figure 5-6. Deflection geometry of a collapsing spherical cap on a spherical COPV.

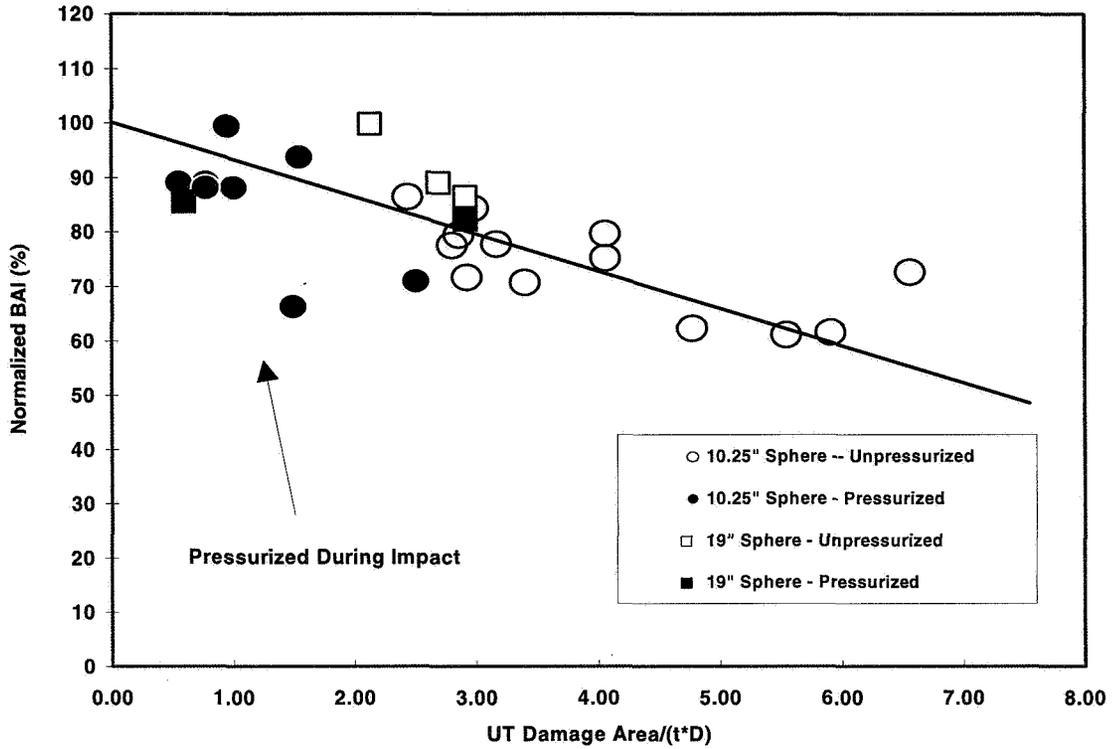
Figure 5-7. Correlation plot of normalized BAI to ultrasonic-NDE area (dimensionless) for spherical COPVs.

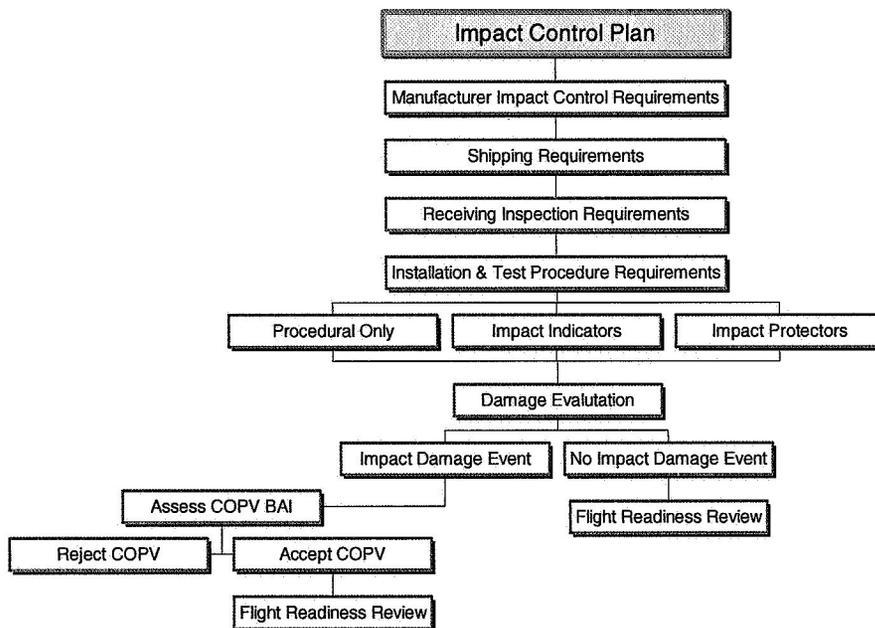
Chart 5B1. Impact Control Plan Overview

Chart 5B1 illustrates a general overview of ICP requirements. Implement the ICP at every stage throughout the life of the COPV, beginning at the manufacturing plant, through the various test and integration stages leading up to launch.

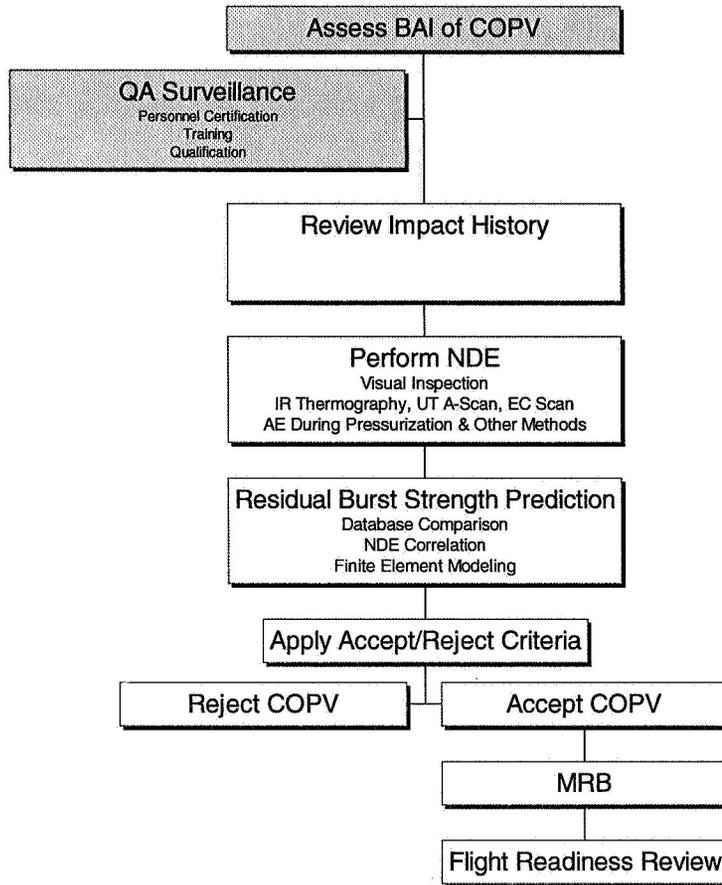
Chart 5B2. Assess BAI of COPV.

Chart 5B2 shows a chart for assessing the BAI of an impact-damaged COPV or suspect impact-damage condition. In general, the procedure involves reviewing the impact damage history, characterizing the extent of damage using visual and NDE methods, comparing the data with impact damage databases, and making a theoretical or empirical prediction of the BAI using three-dimensional nonlinear finite element analysis that includes progressive damage mechanisms. The BAI shall be predicted to within $\pm 5\%$ at the 95% confidence level to provide sufficiently accurate data to accept or reject a damaged COPV. Demonstrate the accuracy of the prediction with historical test data for the COPV design and configuration in question.

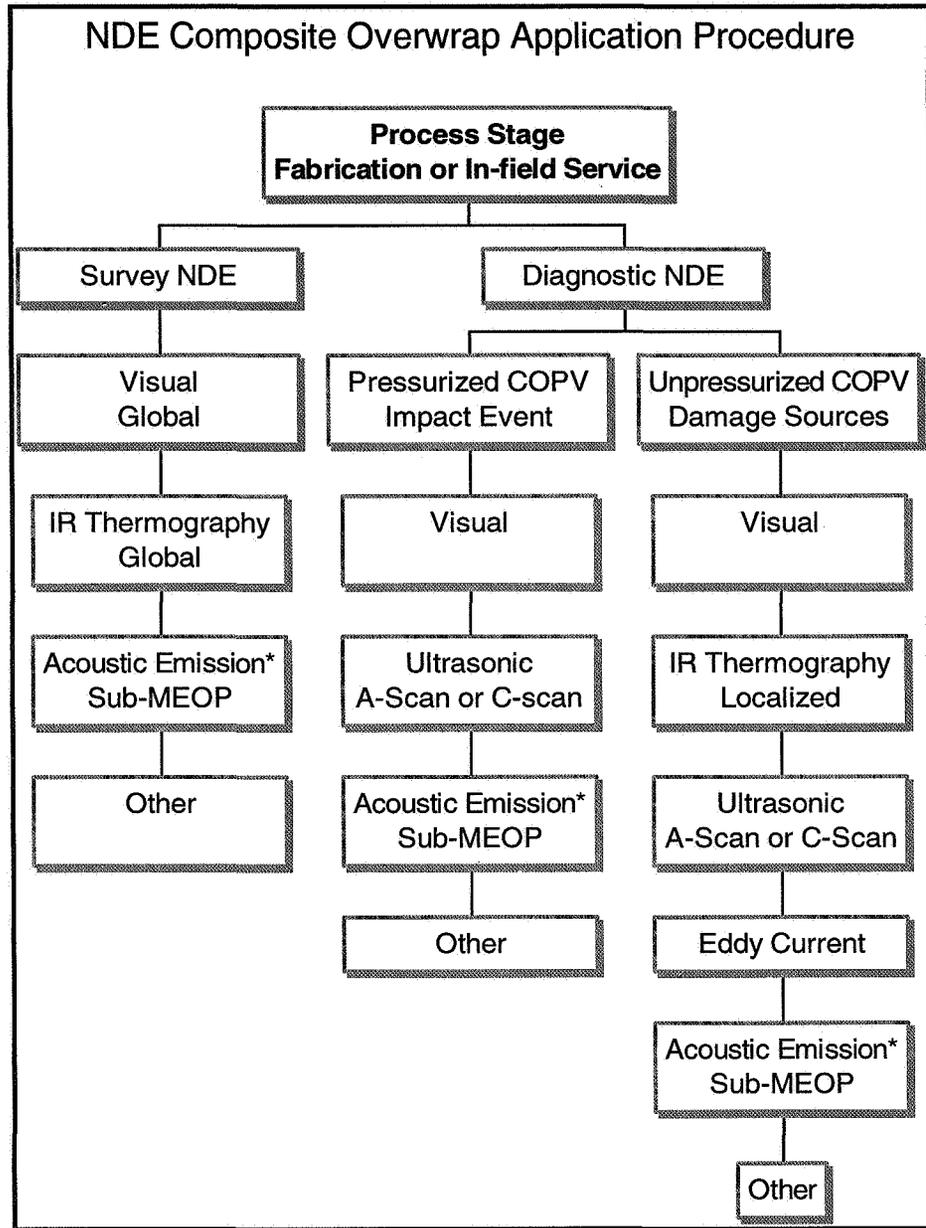
Chart 5B3. NDE methods and application procedures for COPV.

5B4.2.2.2 Other NDE Methods. Permit other optional NDE methods as required to enhance the survey or diagnostic inspection capability. Chart 5B3 illustrates the typical types of NDE methods that are applicable for overwrap inspections depending on whether a global survey is required or a diagnostic evaluation of a suspect region.

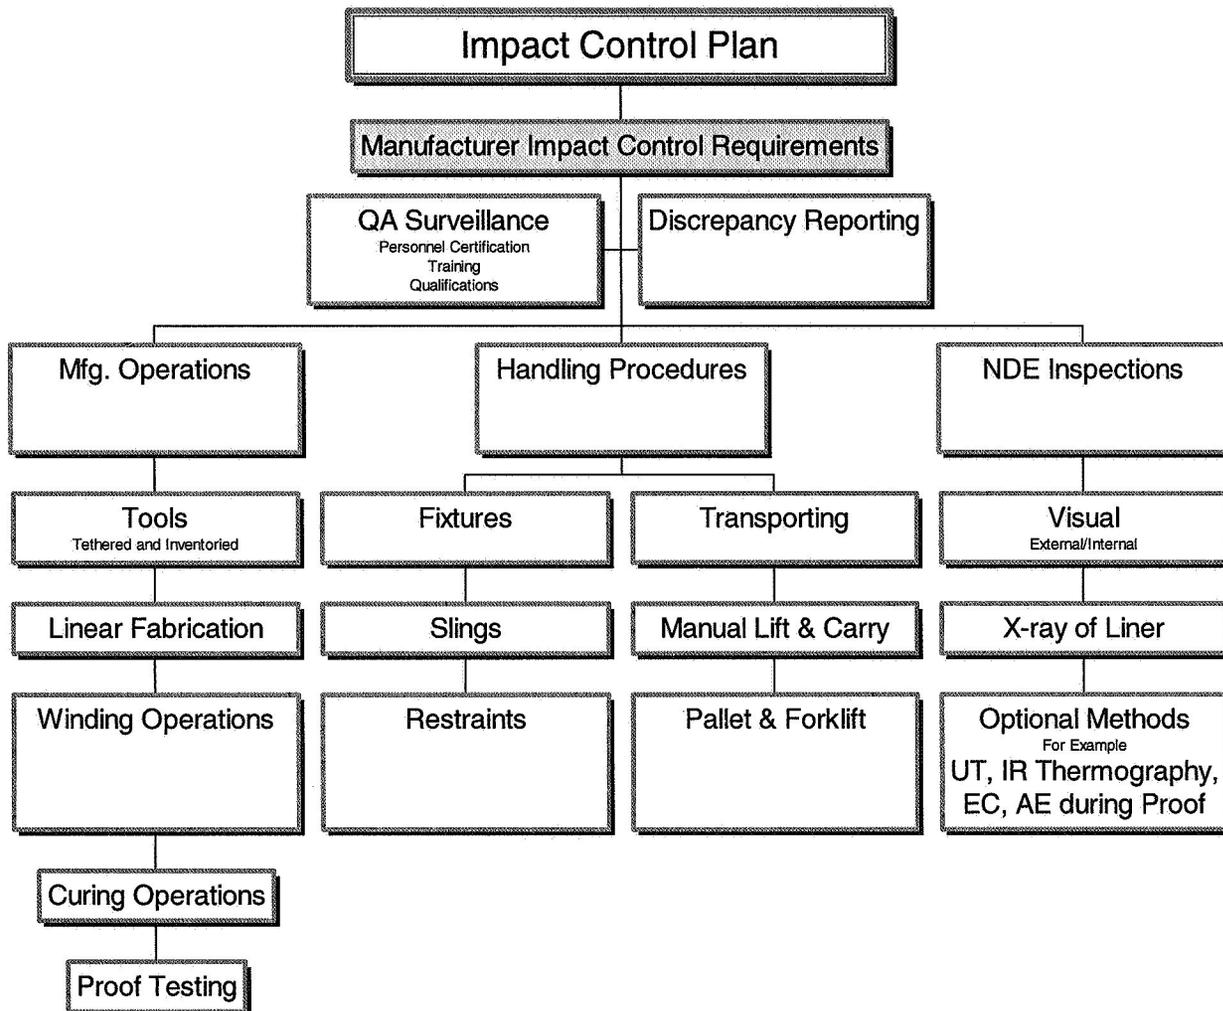
Chart 4B4. Manufacturer’s impact control requirements.

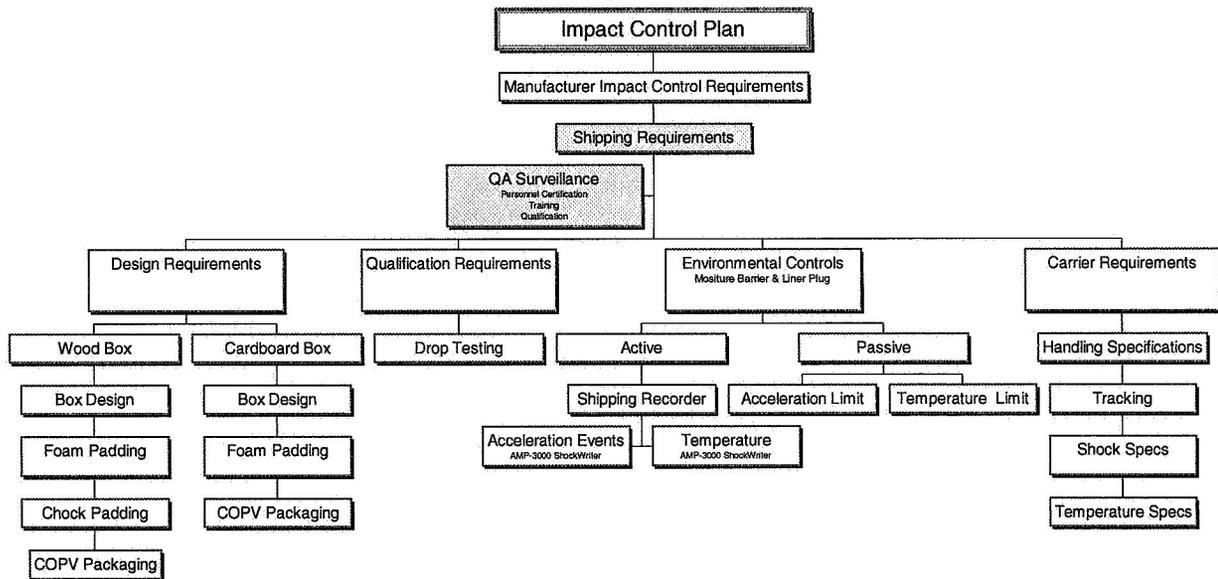
Chart 5B5. Shipping ICP requirements.

Chart 5B5 illustrates the ICP that shall be implemented with respect to COPV shipping requirements. Implement QA requirements per the requirements identified in Section 5B4.2. Handling procedures for shipping and receiving depend on the size of the COPV. For small COPV cylindrical or spherical vessels, perform handling under 100% surveillance using procedures that specify the use of gloves and foam pads to prevent scuffing of the composite overwrapped surface. Large COPVs require lifts and slings to be moved. Prevent COPV impact damage procedurally when using lifts and slings.

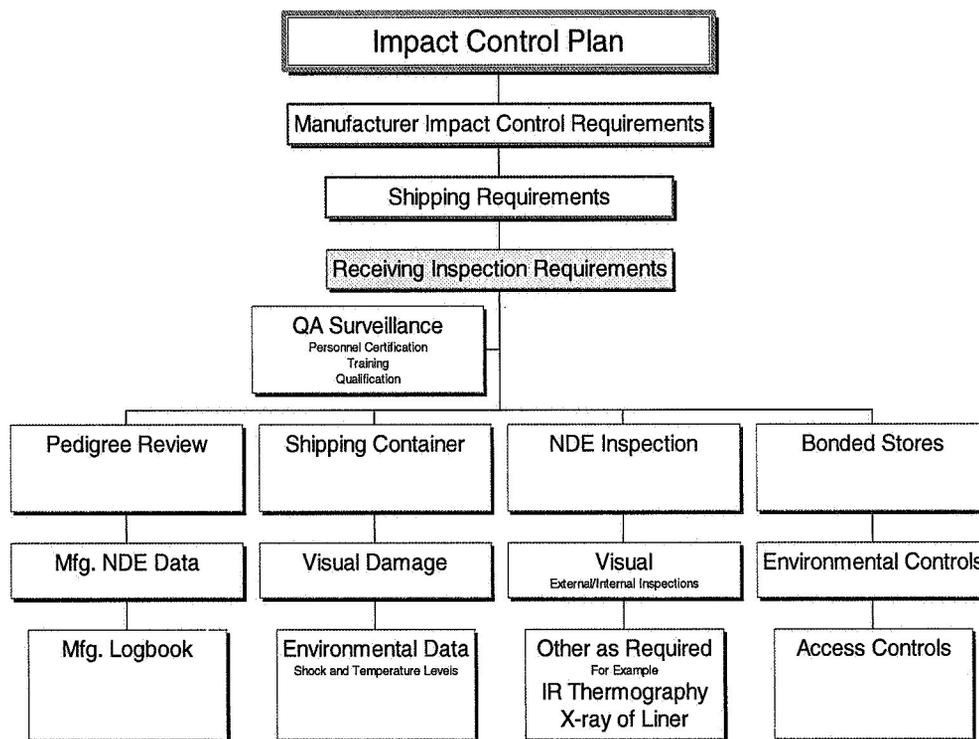
Chart 5B6. Receiving inspection ICP requirements.

Chart 5B6 illustrates the ICP that shall be implemented with respect to COPV receiving inspection requirements. Implement QA and NDE requirements per the requirements identified in Section 4.2. Handling procedures for receiving inspection depend on the size of the COPV. For small COPV cylindrical or spherical vessels, accomplish manual handling with 100% QA surveillance using procedures that specify the use of gloves and foam pads to prevent scuffing of the composite overwrapped surface. Large COPVs require lifts and slings to move the COPV. Prevent COPV impact damage procedurally with 100% QA surveillance when using lifts and slings.

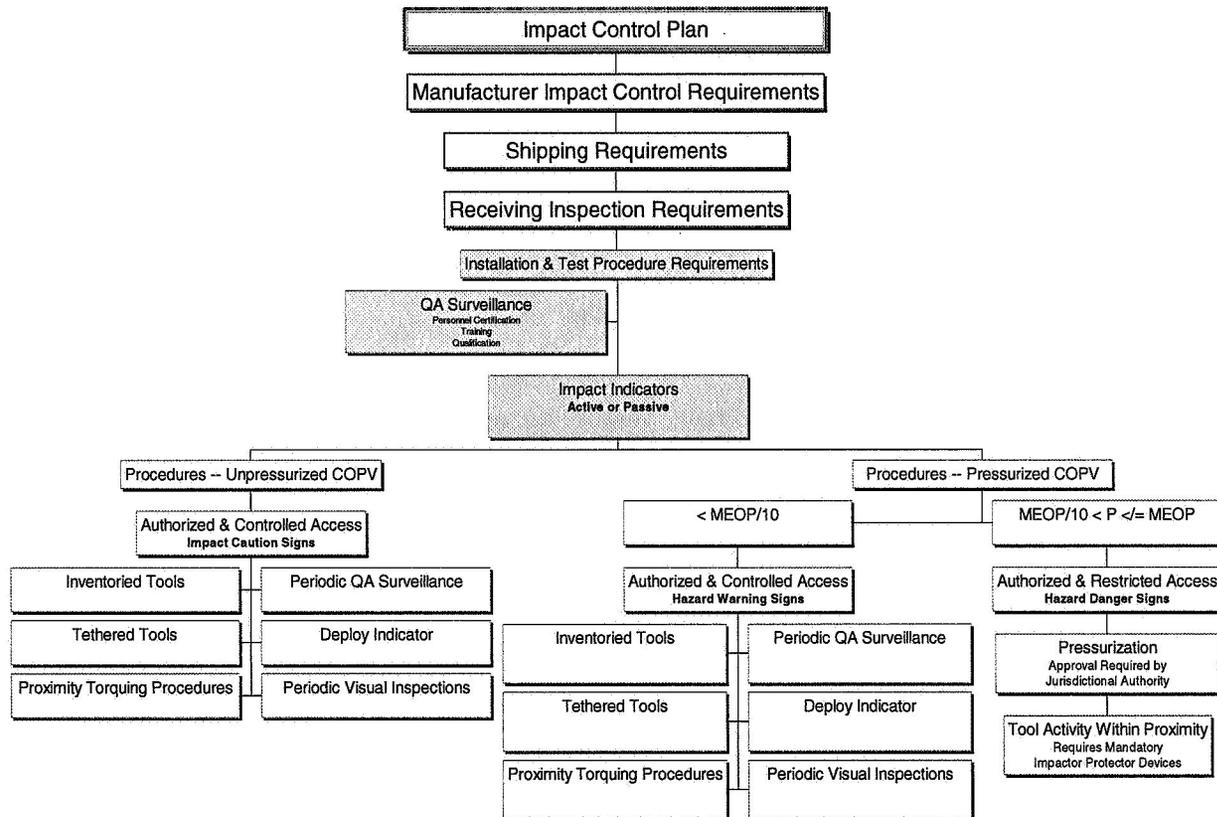
Chart 5B8. Installation and system-level procedure for using *Impact Indicators* ICP.

Chart 5B8 illustrates the *impact indicator* ICP option that, if selected, shall be implemented during the installation and test of the COPV mounted on the spacecraft hardware or the launch vehicle. Implement QA and NDE requirements per the requirements identified in Section 4.2. Handling procedures for installation depend on the size of the COPV. For small COPV cylindrical or spherical vessels, accomplish manual handling using procedures that specify the use of gloves and foam pads to prevent scuffing of the composite overwrapped surface. Large COPVs require lifts and slings to move the COPV. Prevent COPV impact damage procedurally when using lifts and slings.

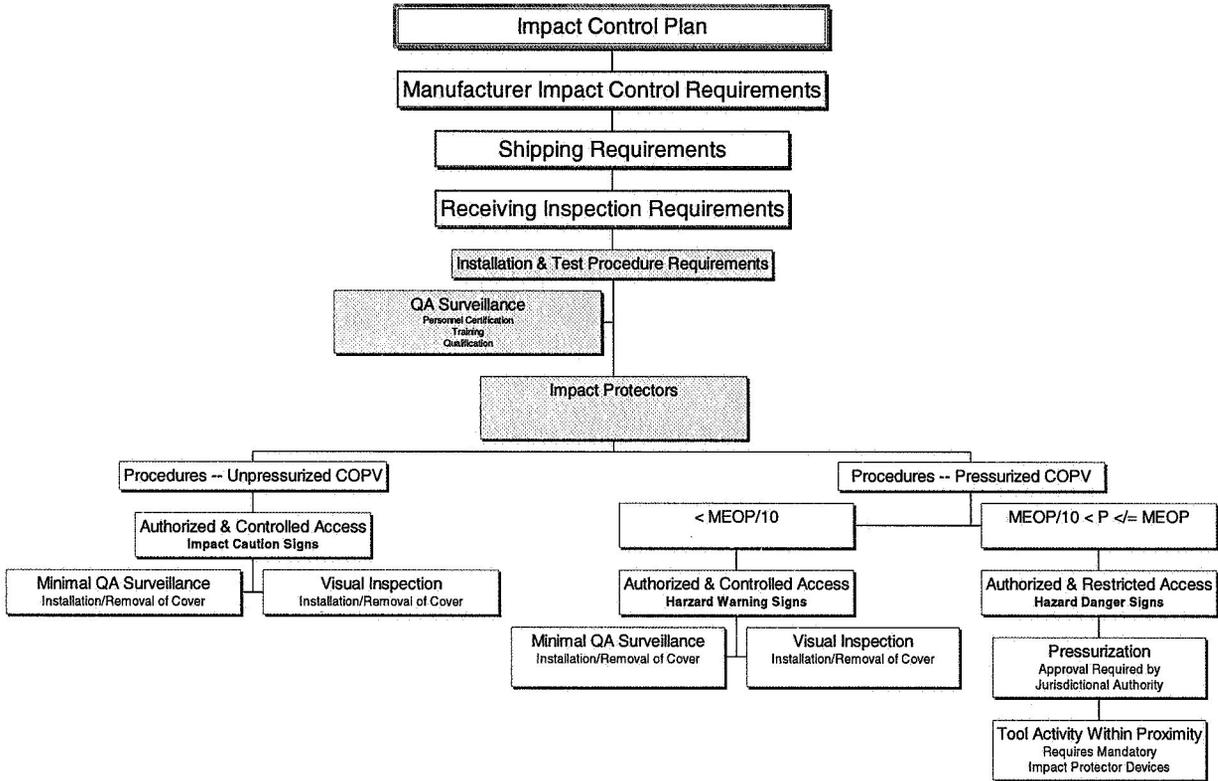
Chart 5B9. Installation and system-level procedures for using *Impact Protector* ICP.

Chart 5B9 illustrates the *impact protector* ICP option that, if selected, shall be implemented during the installation and system-level operations of the COPV mounted on the spacecraft hardware or the launch vehicle. Implement QA and NDE requirements per the requirements identified in Section 5B4.2. Handling procedures for installation depend on the size of the COPV. For small COPV cylindrical or spherical vessels, accomplish manual handling using procedures that specify the use of gloves and foam pads to prevent scuffing of the composite overwrapped surface. Large COPVs require lifts and slings to move the COPV. Prevent COPV impact damage procedurally when using lifts and slings.

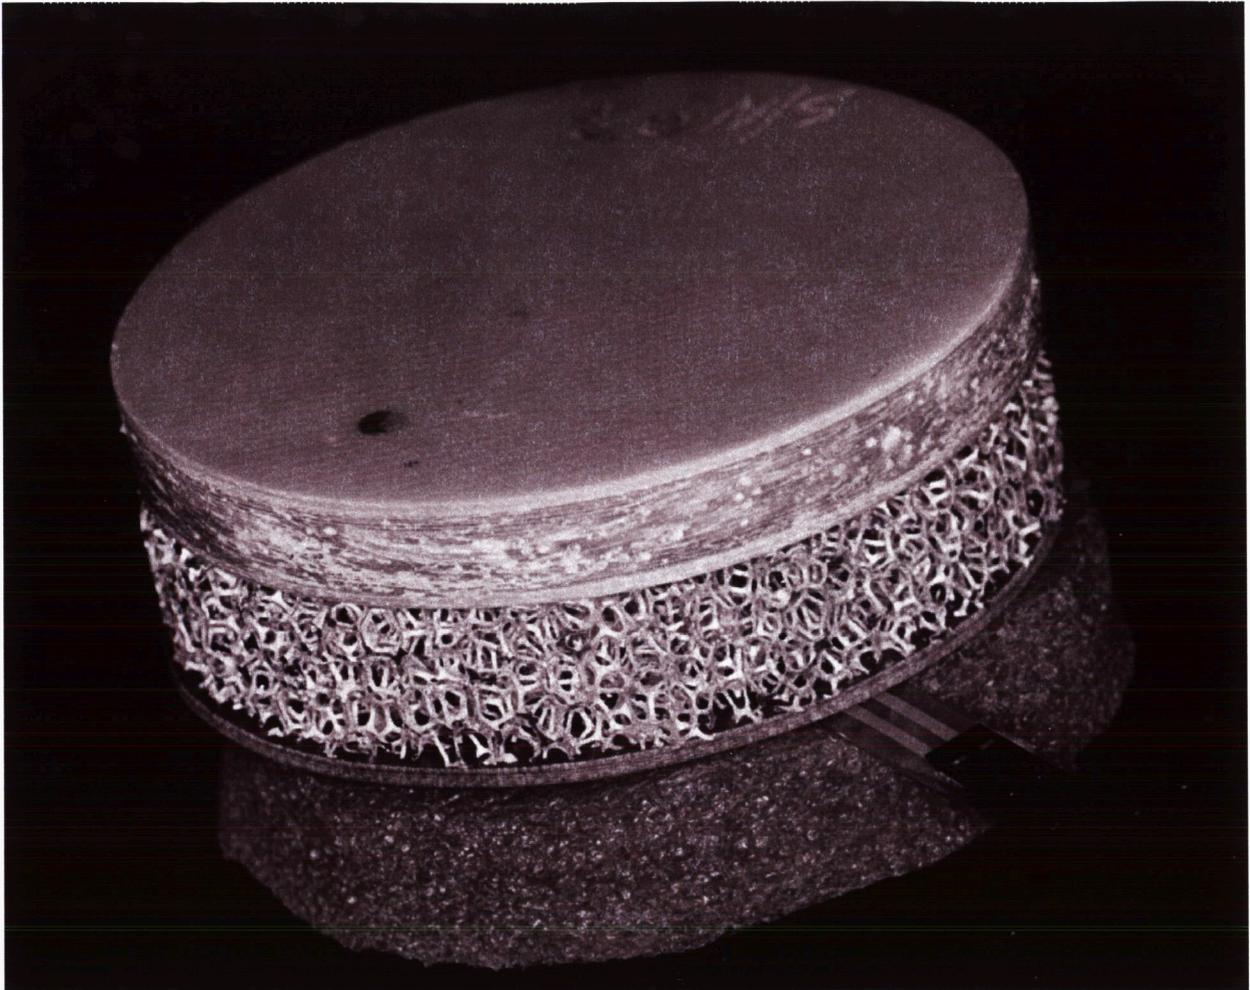
Figure 5B1. Cross-section of COPV impact protector.

Materials, Inc., is an example of energy-absorbing material that has been qualified for this application. Other materials with equivalent energy-absorbing properties can be qualified for this application. Finally, bond an impact indicator used in combination with the impact protector to a thin (0.15-cm [1/16-in.]-thick) layer of interface material (e.g., fiberglass epoxy composite or polymeric materials). Install the laminated impact protective cover over a layer of high-density Ensolite foam mounted directly on the COPV.

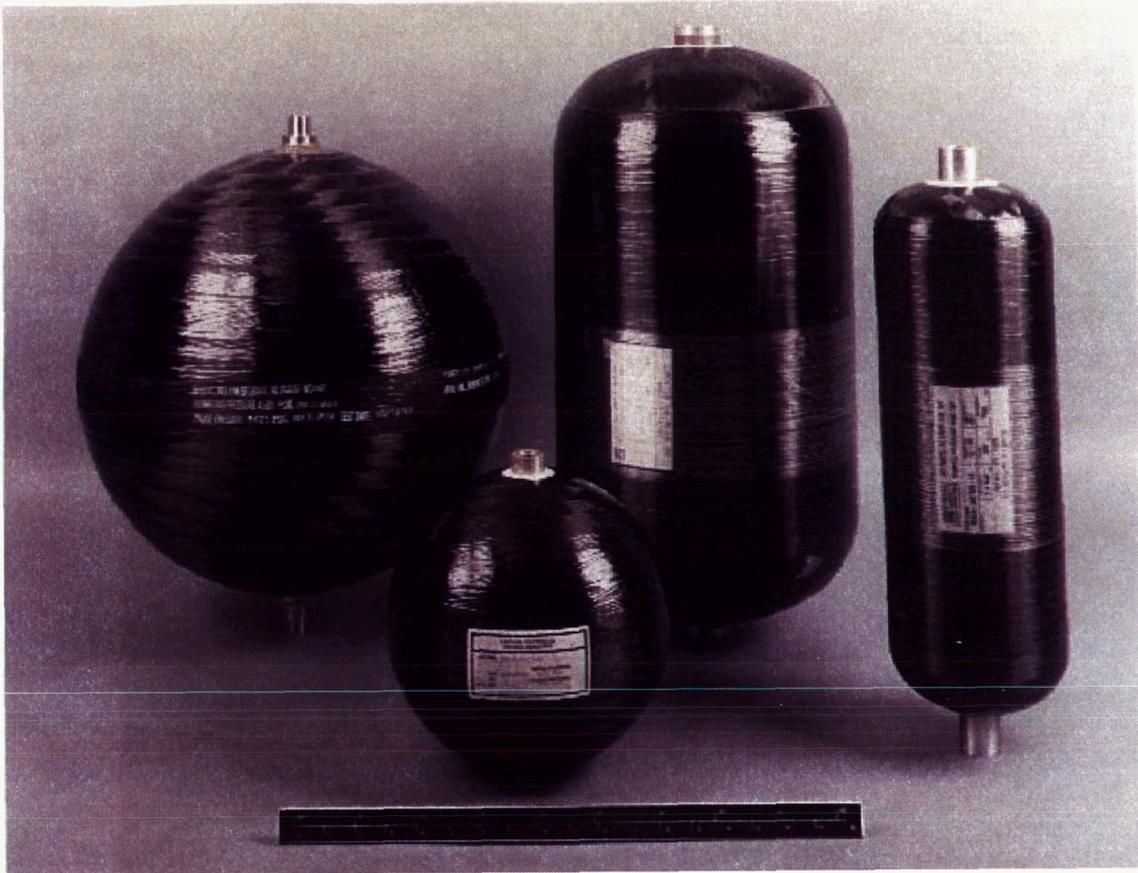
Figure 6-1. COPV types used for Subtask 3.4 testing.

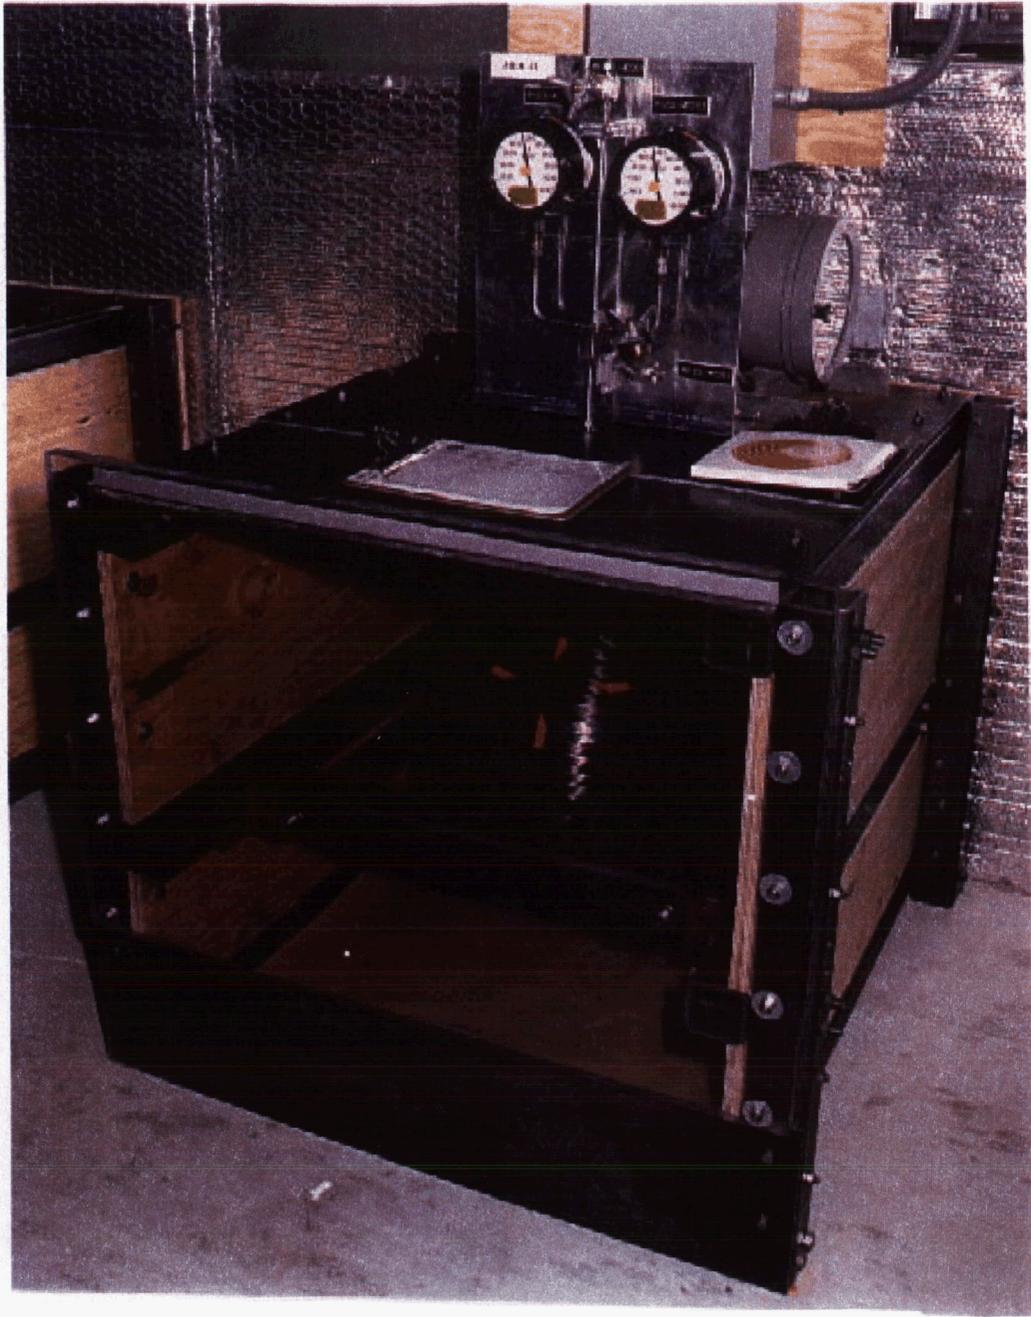
Figure 6-3 shows a general schematic of the pressurant supply system. We calibrated all gauges to NIST standards before test and verified calibration posttest for each gauge. We used Chevron Technical White Oil 500, a pure mineral oil, as pressurant to circumvent potential corrosion concerns and used a hand pump mounted on a mobile cart (Figure 6-3a) to provide it to the vessels. Note that, while only one hand pump cart with its associated plumbing exists, each vessel is plumbed as a separate, identical subsystem. The hand pump can be connected to an inlet manual valve of the dedicated vessel plumbing subsystem (Figure 6-3b) as necessary, operated until the desired pressure is attained, then disconnected. We thus accomplished incremental pressure adjustment for all test articles.

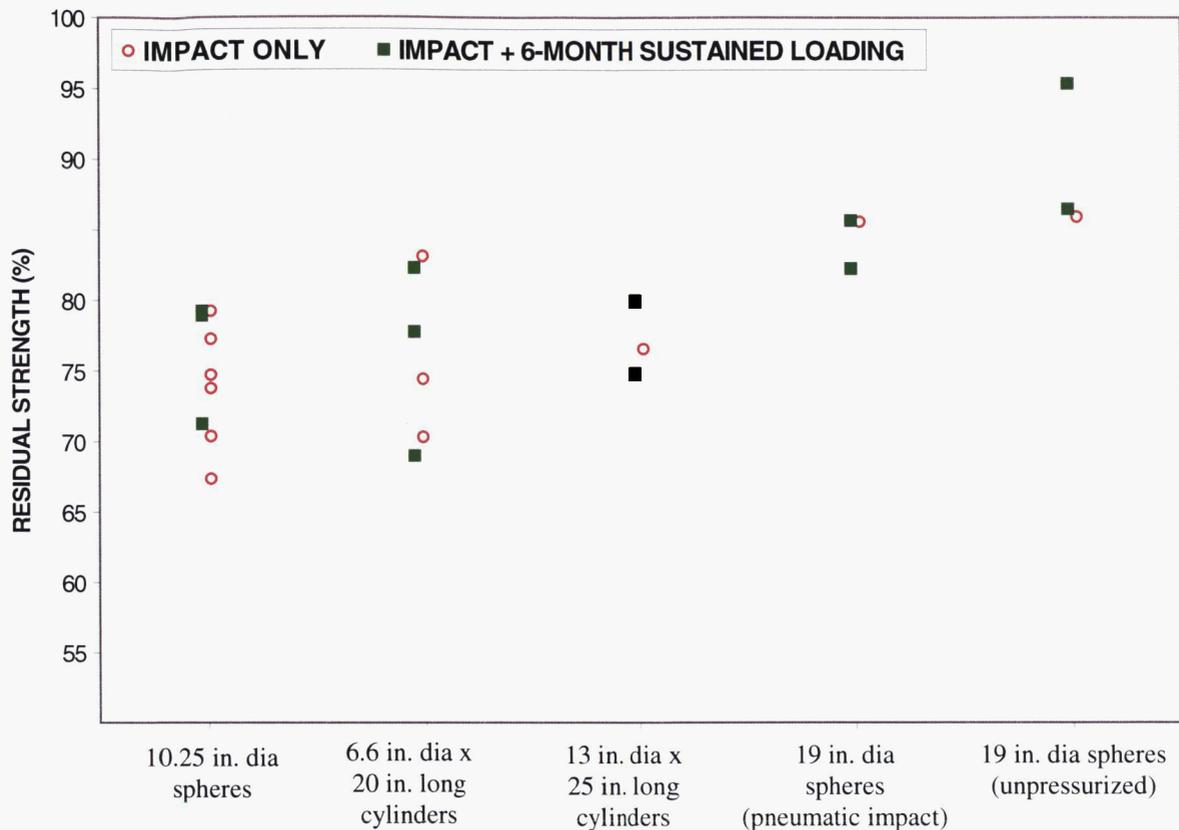
Figure 6-4. Effect of sustained loading on burst strength of impact-damaged COPVs.

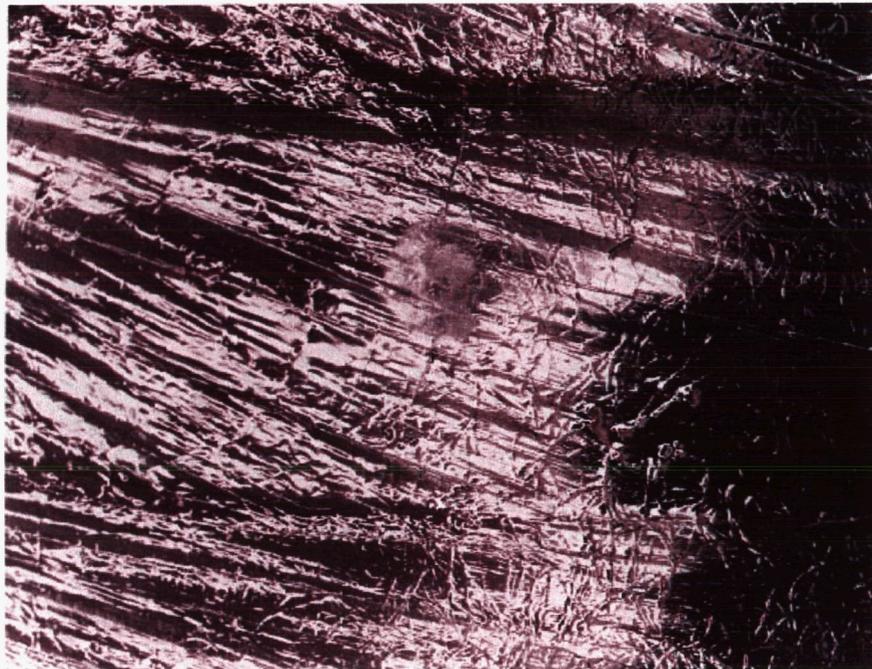
Figure 6-5. Impacted region of 19-in. spherical COPV (S/N 015), before sustained loading (approximately 3X magnification).

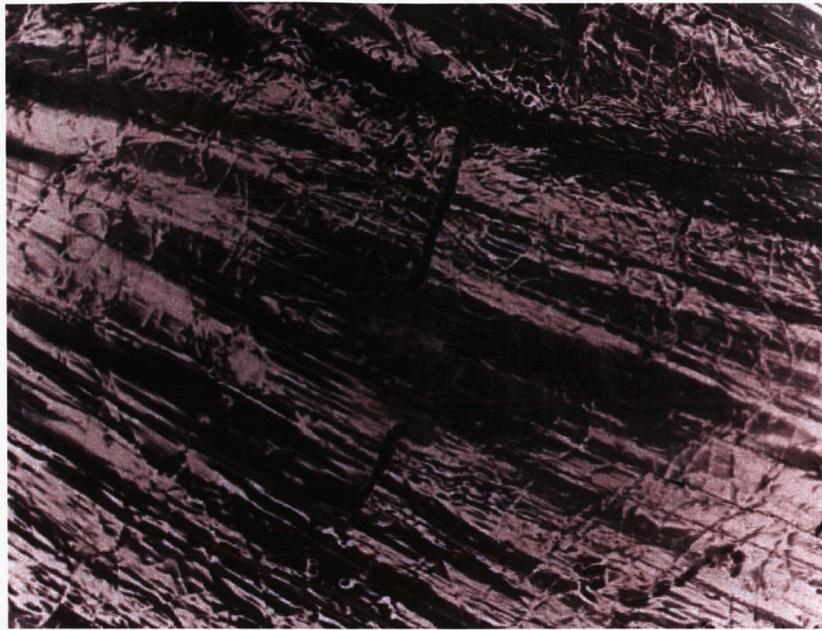
Figure 6-6. Impacted region of 19-in. spherical COPV (S/N 015), after sustained loading, showing crack growth (approximately 3X magnification).

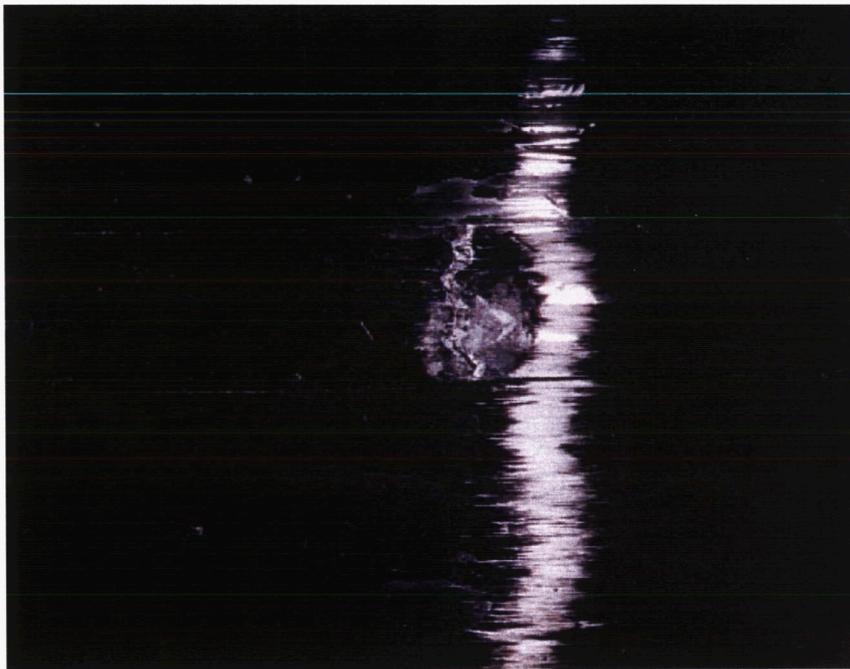
Figure 6-7. Impacted region of 6.6-in.-dia \times 20-in.-long cylindrical COPV (S/N 042), before sustained loading (approximately 3X magnification).

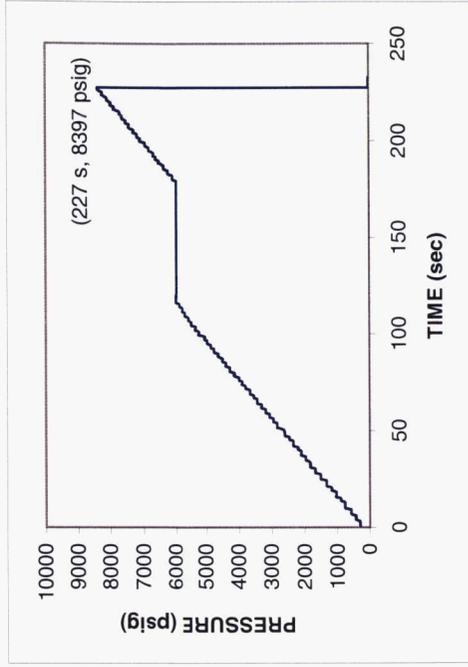
Burst pressure: 57.90 MPa (8,397 psi)
 Strength degradation from undamaged vessel average of 73.1 MPa (10,600 psi): 20.8%
 from impacted vessel average of 53.9 MPa (7,819 psi): none
