NASA/TP—2002–210769

Composite Overwrapped Pressure Vessels

EXECUTIVE SUMMARY FOR DATABASE EXTENSION TASK 3.0 AND IMPACT DAMAGE EFFECTS CONTROL TASK 8.0

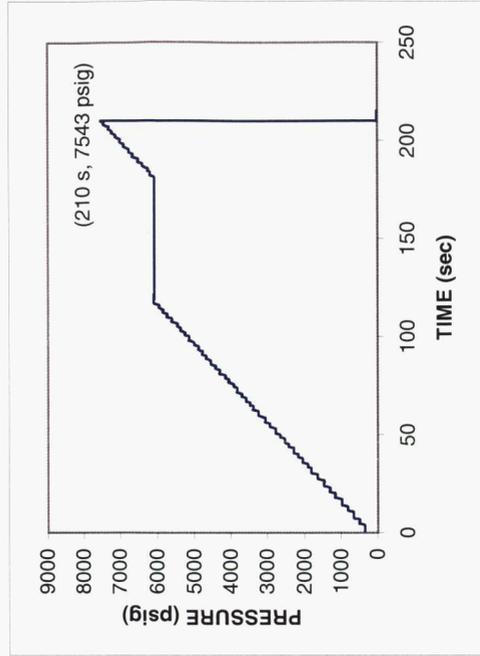
Burst pressure: 52.01 MPa (7,543 psi)
 Strength degradation from undamaged vessel average of 73.1 MPa (10,600 psi): 28.8%
 from impacted vessel average of 53.9 MPa (7,819 psi): 3.5%

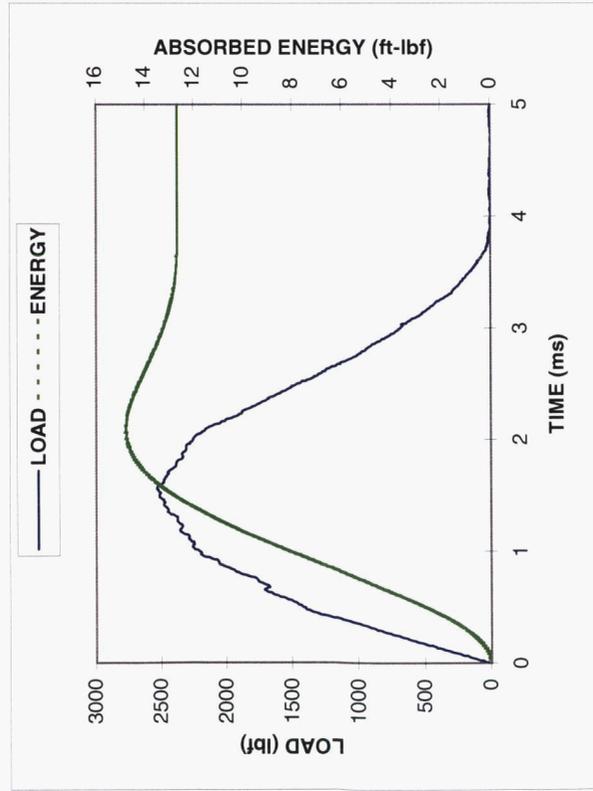
Impact energy: 19.81 J (14.61 ft-lbf)
 Impact velocity: 2.323 m/s (7.62 ft/s)
 Maximum load: 11.26 kN (2,532 lbf)
 Energy to maximum load: 17.88 J (13.19 ft-lbf)
 Time to maximum load: 1.56 ms
 Deflection at maximum load: 0.28 cm (0.11 in.)
 Velocity slowdown at maximum load: 67.32 %
 Total absorbed energy: 17.16 J (12.66 ft-lbf)

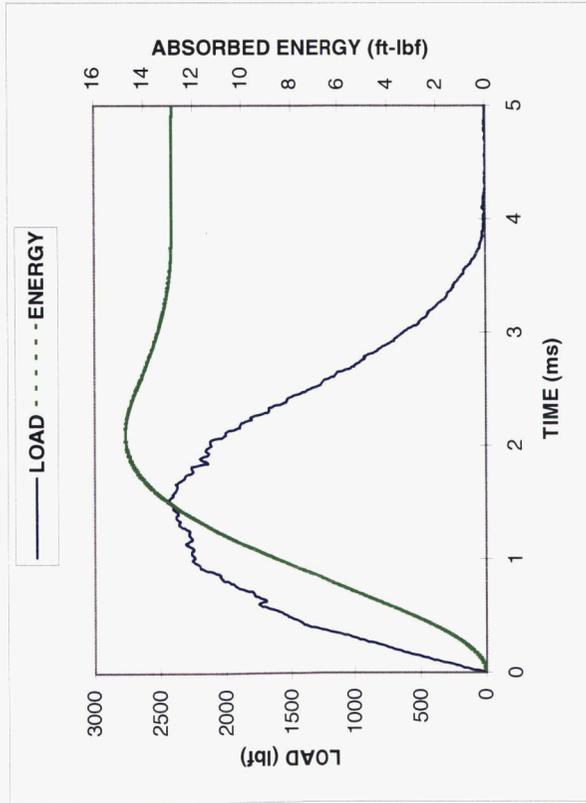
Impact energy: 19.78 J (14.59 ft-lbf)
 Impact velocity: 2.320 m/s (7.61 ft/s)
 Maximum load: 10.85 kN (2,440 lbf)
 Energy to maximum load: 17.75 J (13.09 ft-lbf)
 Time to maximum load: 1.52 ms
 Deflection at maximum load: 0.25 cm (0.10 in.)
 Velocity slowdown at maximum load: 66.40 %
 Total absorbed energy: 17.45 J (12.87 ft-lbf)

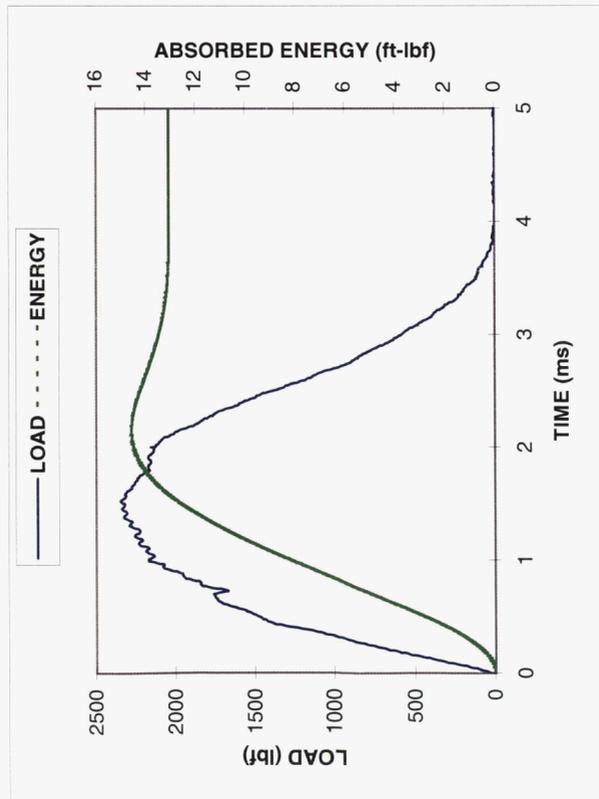
Impact energy: 19.52 J (14.40 ft-lbf)
 Impact velocity: 2.304 m/s (7.56 ft/s)
 Maximum load: 10.44 kN (2,348 lbf)
 Energy to maximum load: 17.22 J (12.70 ft-lbf)
 Time to maximum load: 1.52 ms
 Deflection at maximum load: 0.25 cm (0.10 in.)
 Velocity slowdown at maximum load: 64.25 %
 Total absorbed energy: 17.68 J (13.04 ft-lbf)

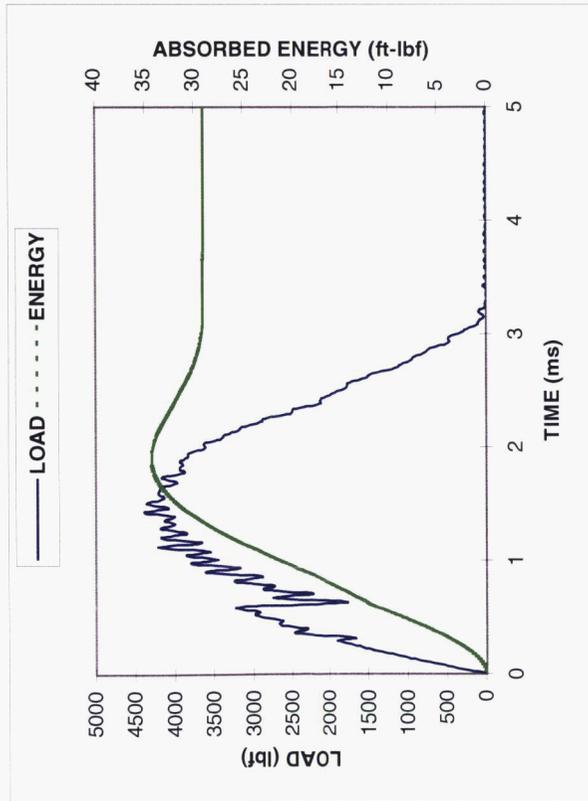
Impact energy: 46.25 J (34.11 ft-lbf)
 Impact velocity: 3.548 m/s (11.64 ft/s)
 Maximum load: 19.54 kN (4,393 lbf)
 Energy to maximum load: 41.47 J (30.59 ft-lbf)
 Time to maximum load: 1.43 ms
 Deflection at maximum load: 0.38 cm (0.15 in.)
 Velocity slowdown at maximum load: 67.00%
 Total absorbed energy: 39.41 J (29.07 ft-lbf)

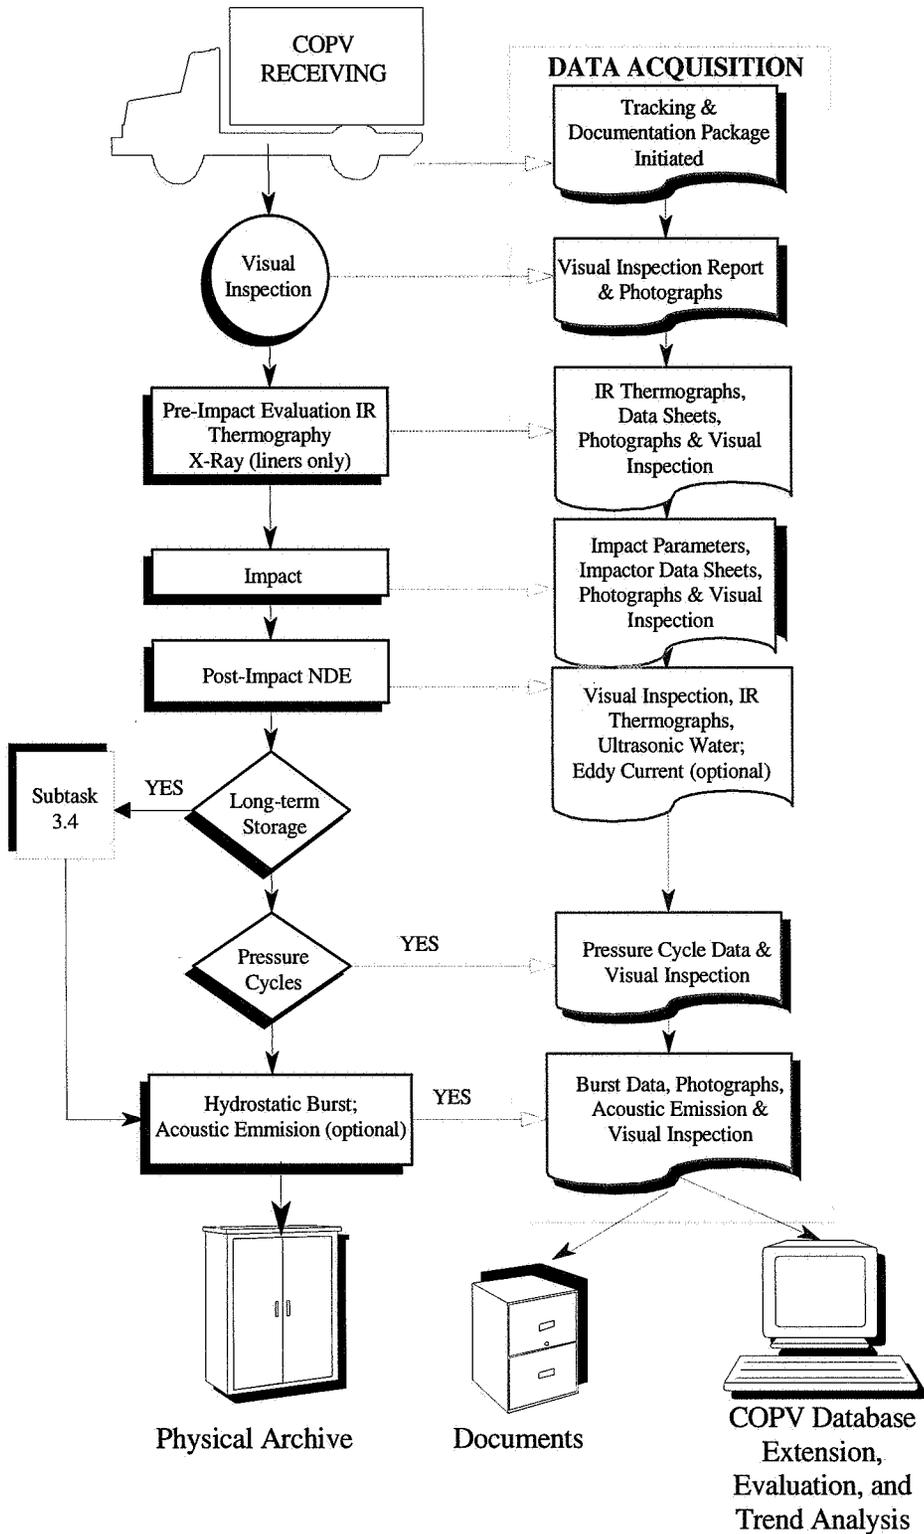
Figure 7-1. COPV testing: process flow and data acquisition path.

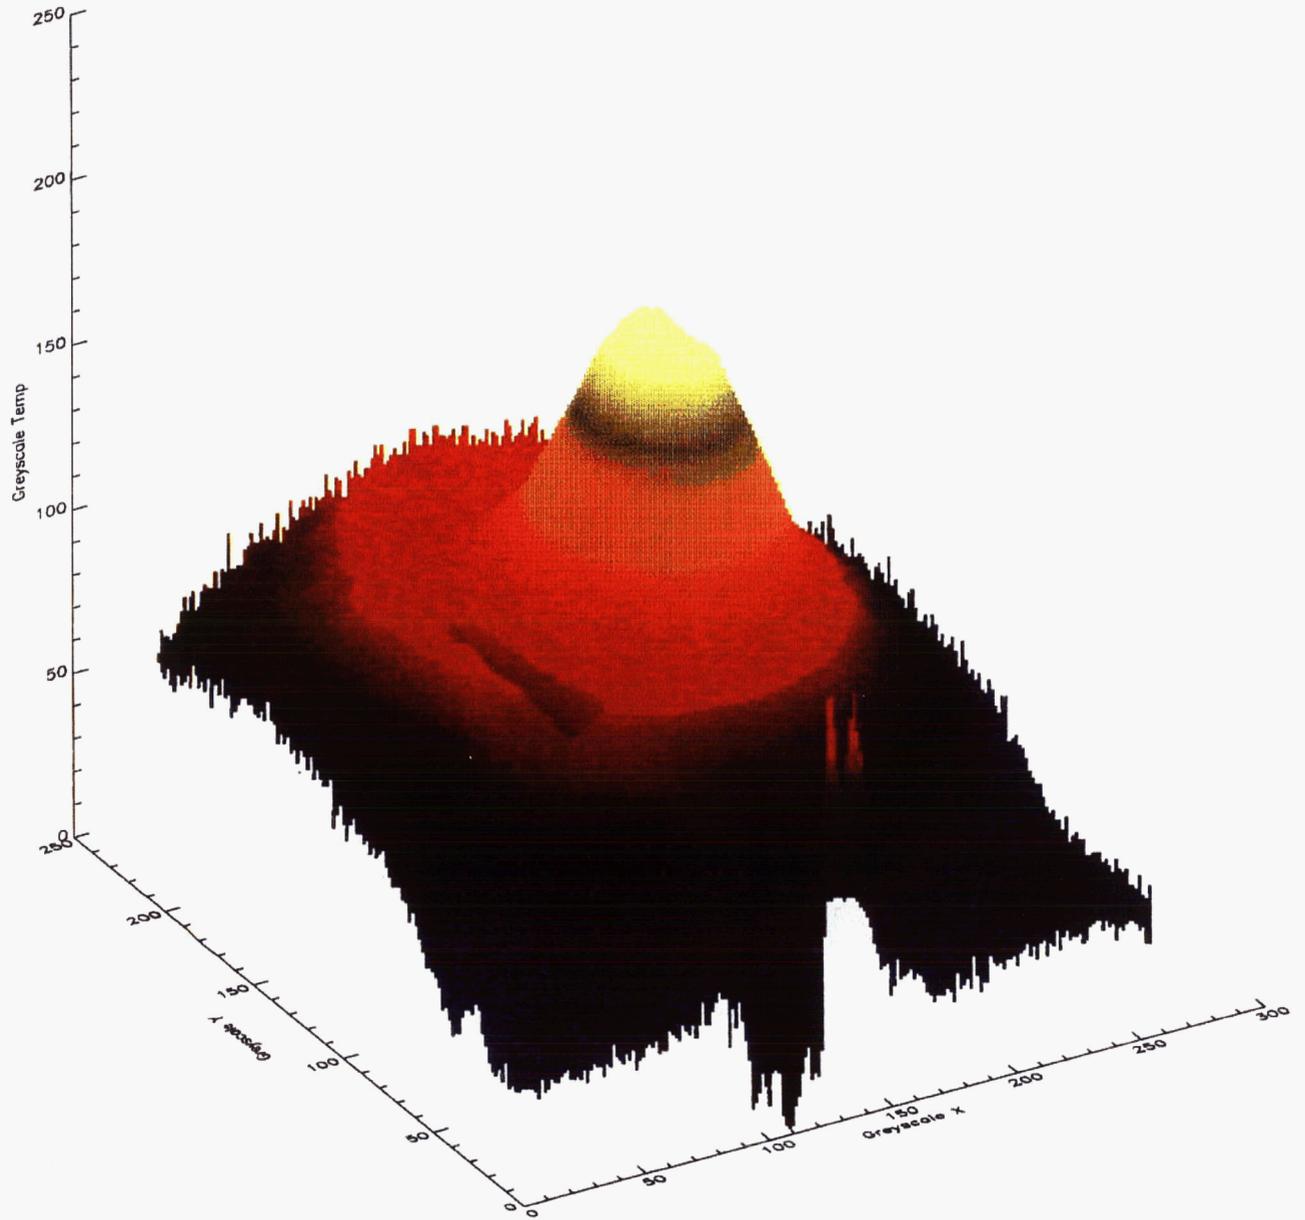
Figure 7-13. Three-dimensional temperature distribution map of COPV impact damage zone.

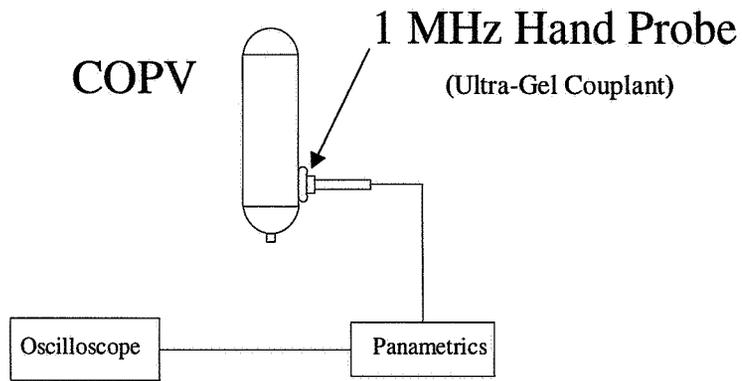
Figure 7-14. Ultrasonic A-scan NDE setup.

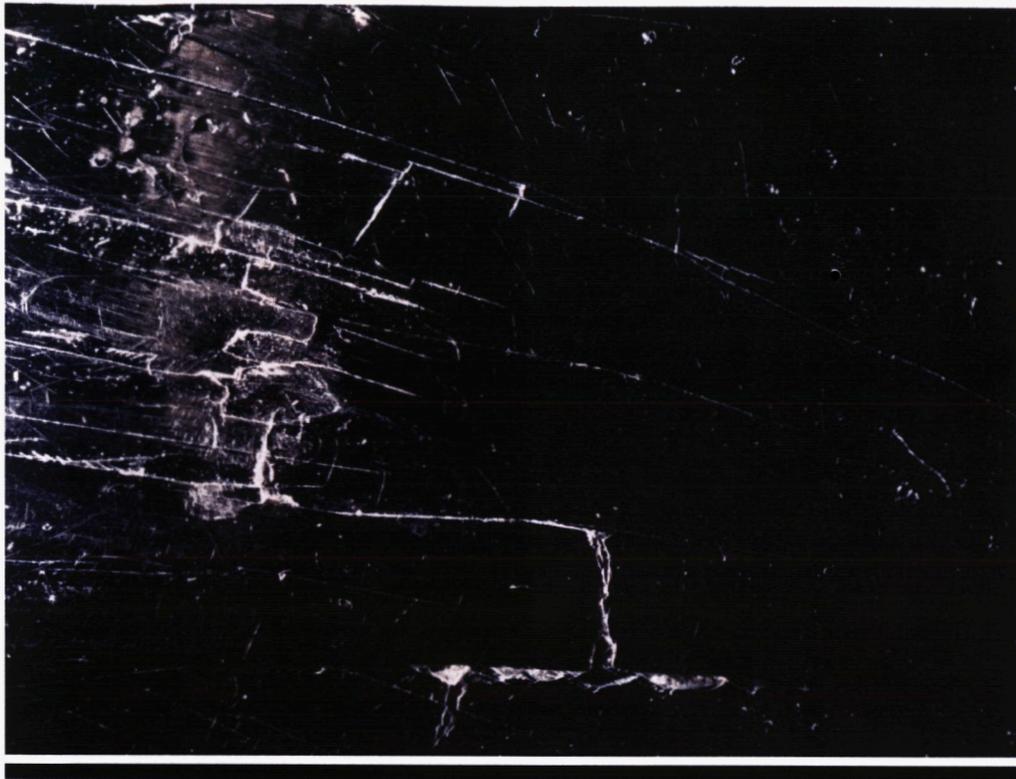
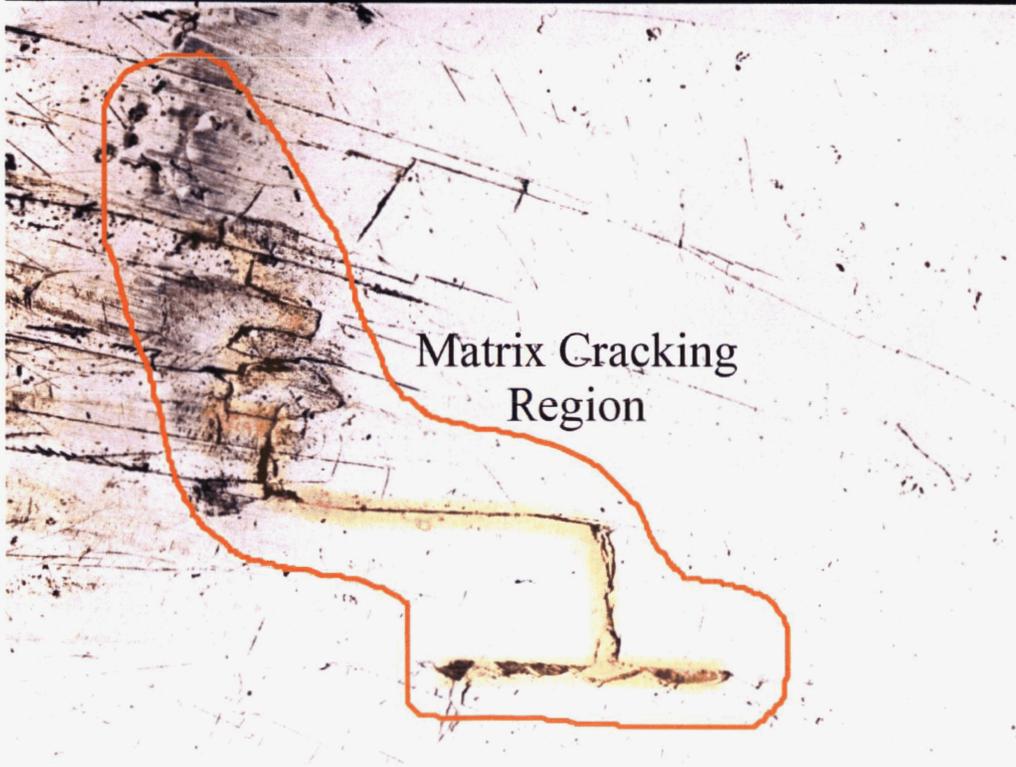
Figure 7-21. Typical matrix cracks.

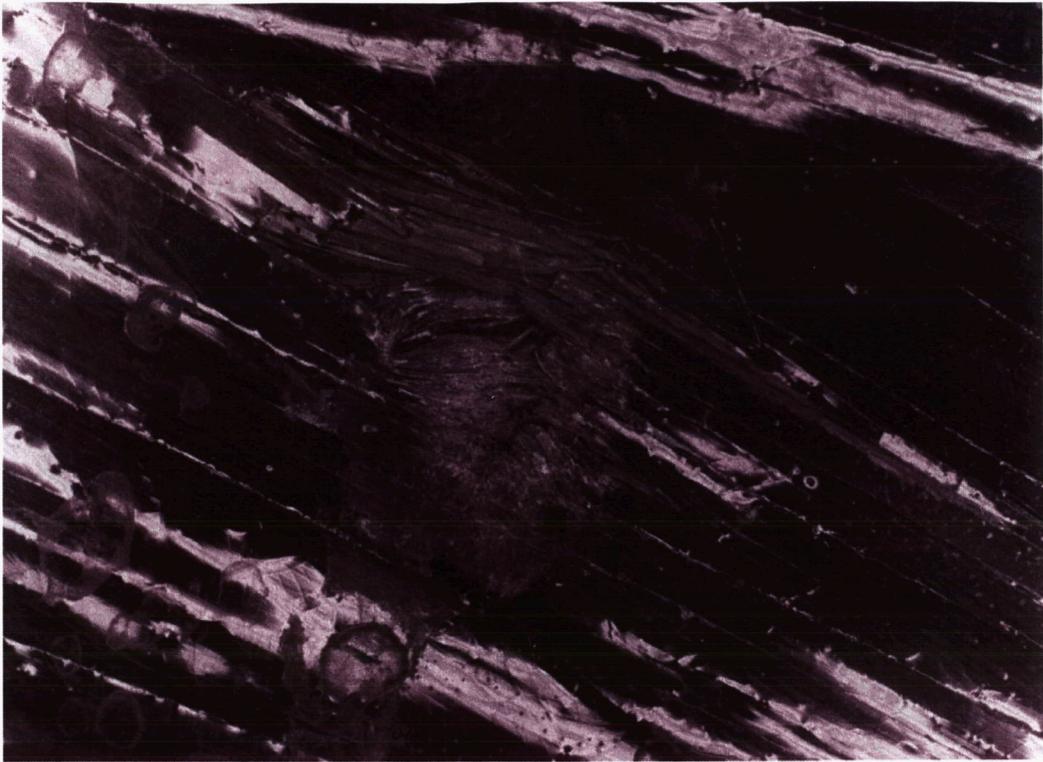
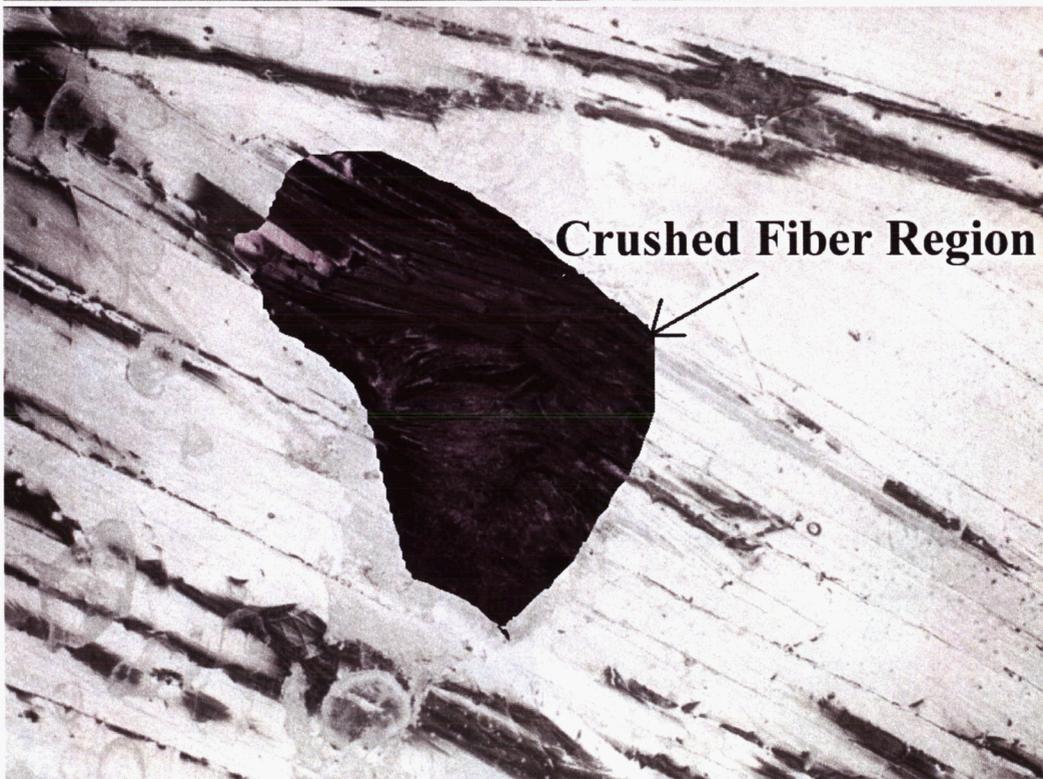
Figure 7-22. Typical crushed fibers.

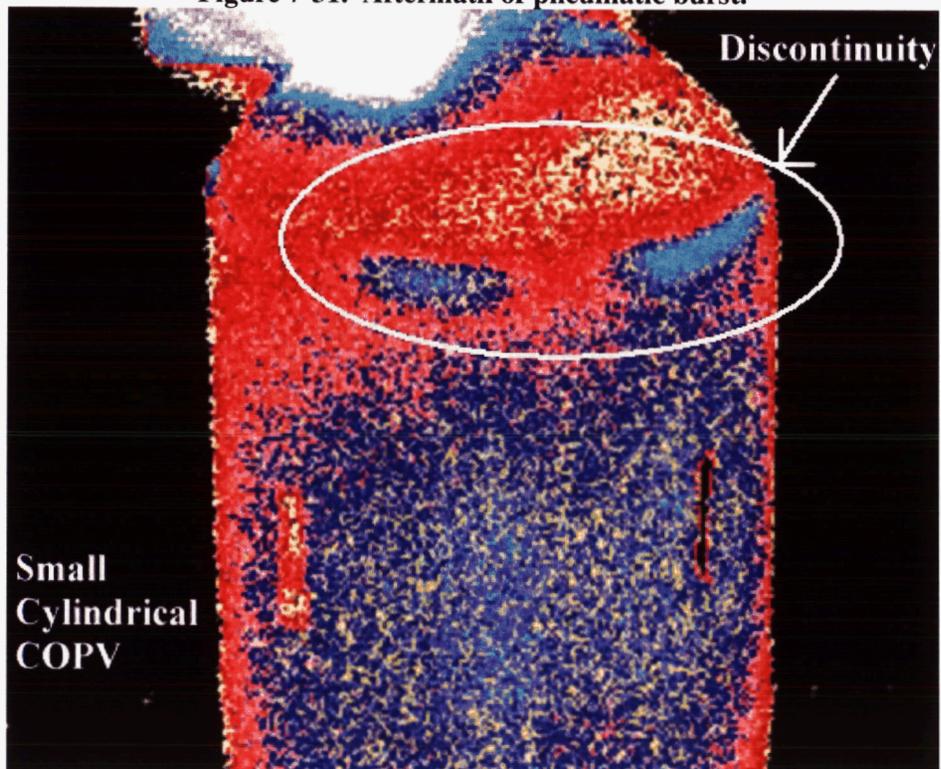
Figure 7-32. IR thermograph of nonvisible damage.

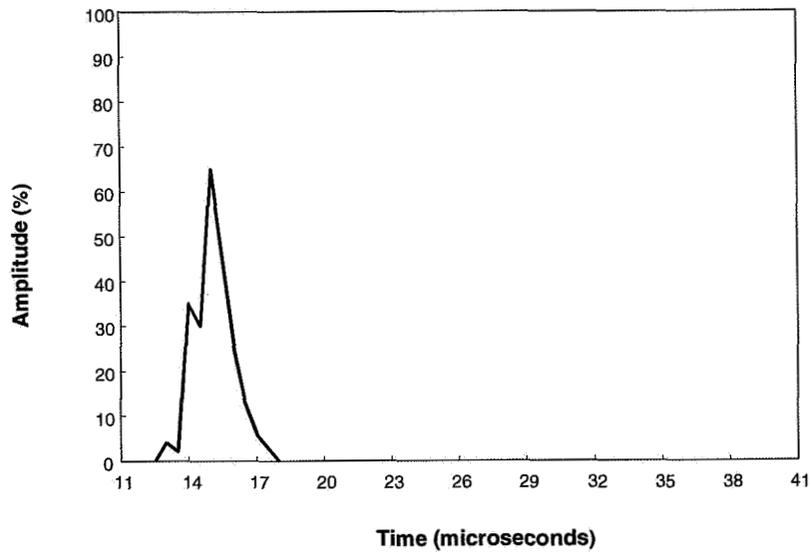
Figure 7-35. Ultrasonic A-scan of damaged COPV.

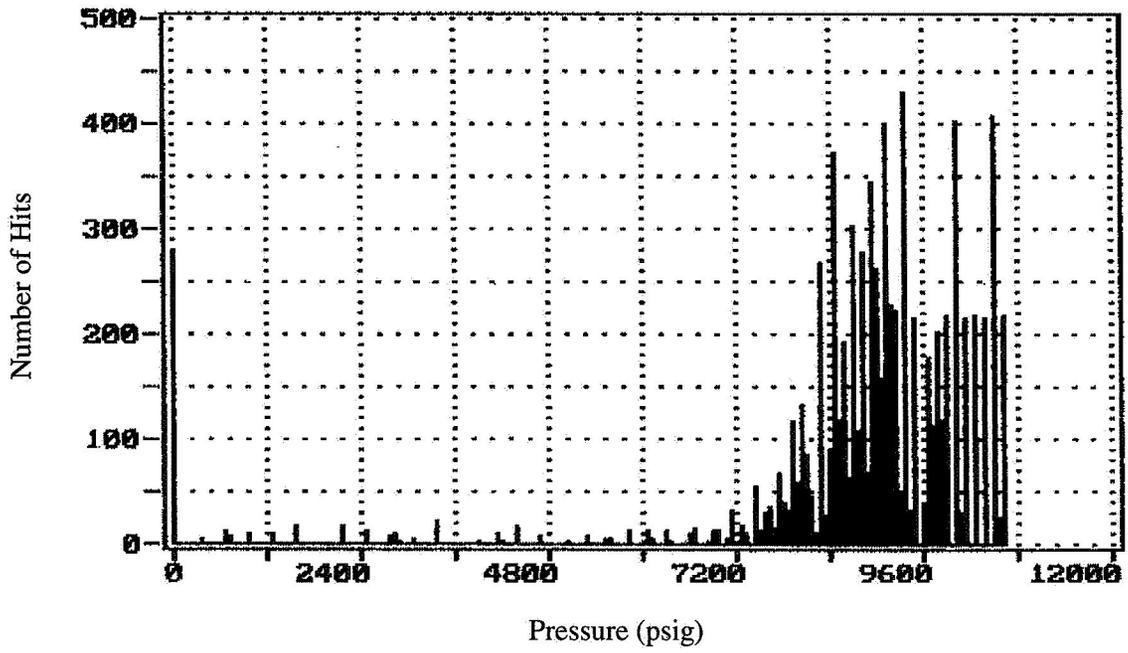
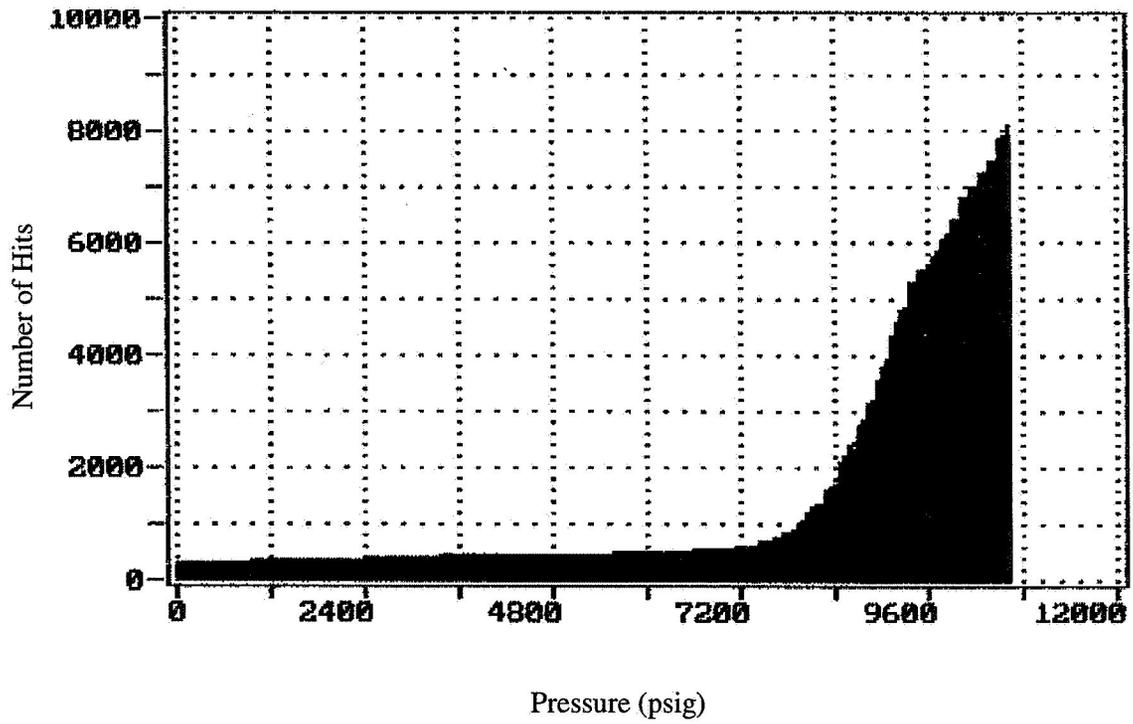
Figure 7-36. Acoustic emission spectra of an undamaged COPV.

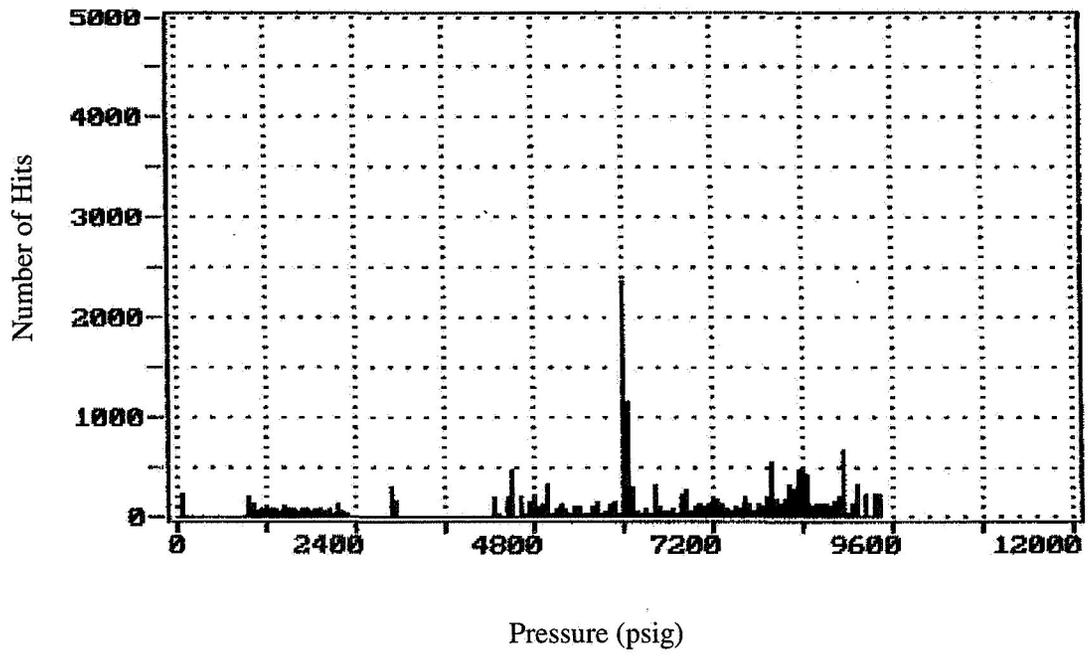
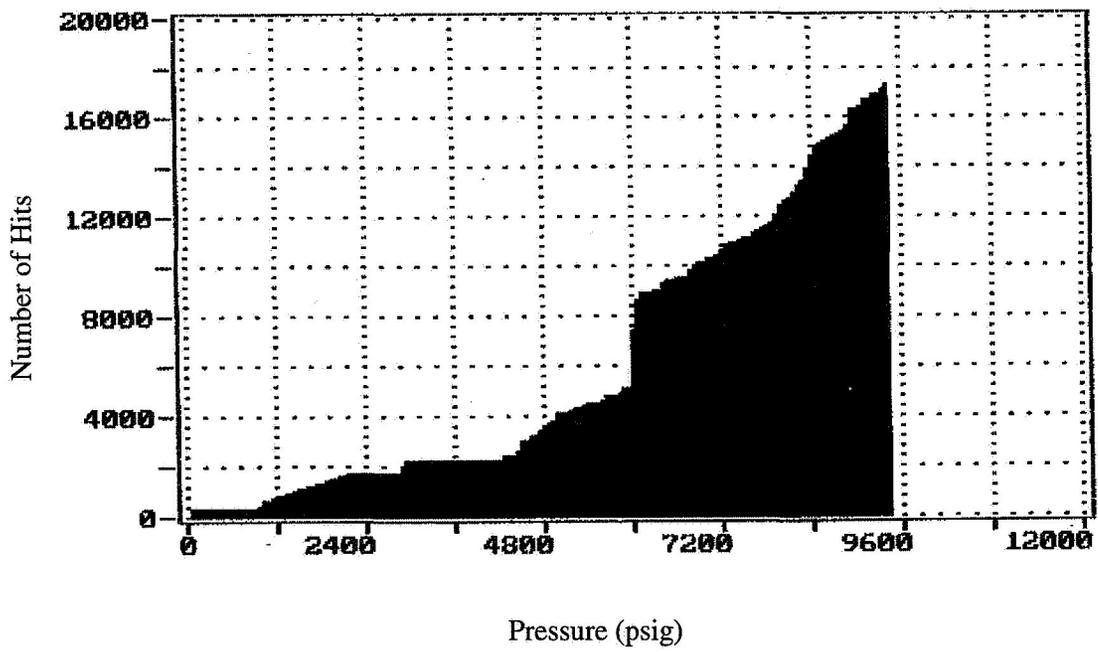
Figure 7-37. Acoustic emission spectra of an impact-damaged COPV.

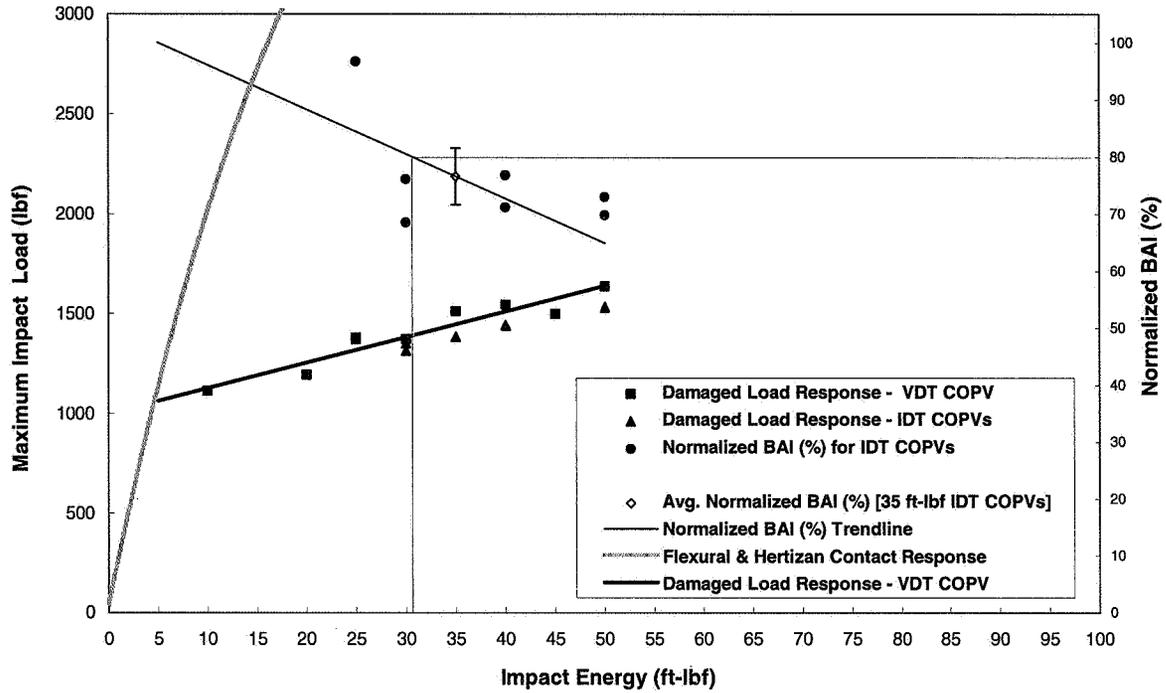
Figure 7-38. Critical impact energy and impact damage threshold for an unpressurized 10.25-in. spherical COPV.

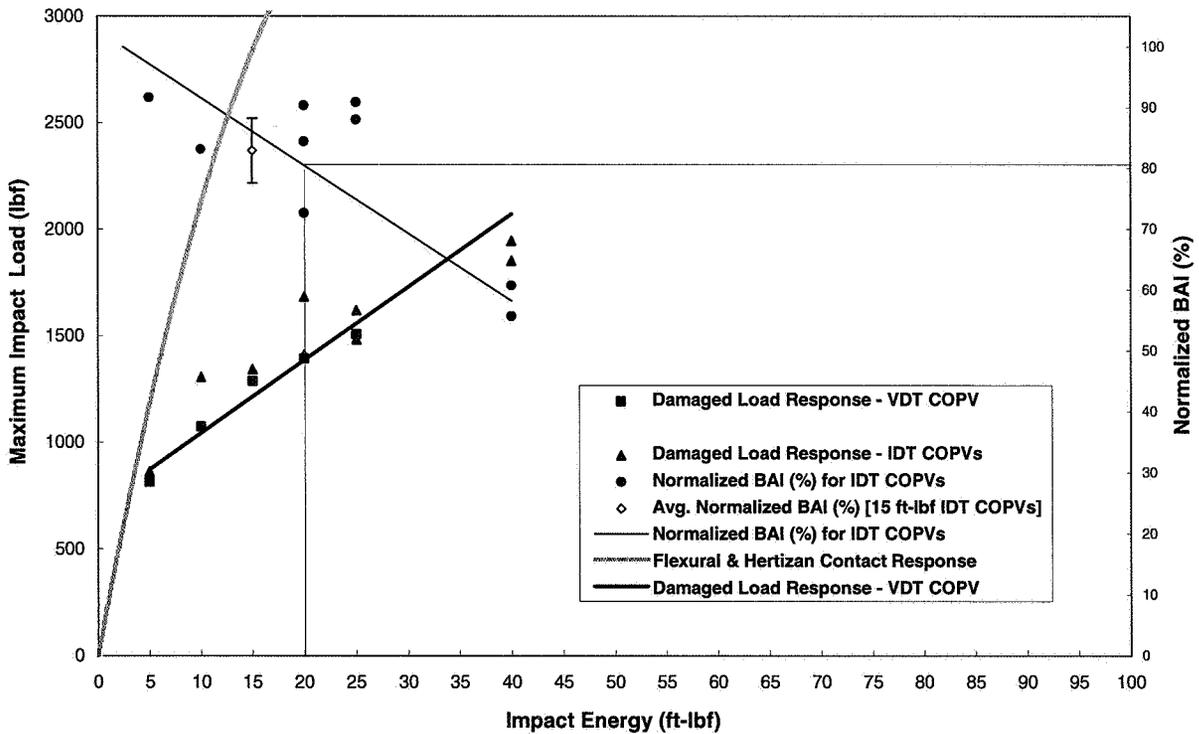
Figure 7-39. Critical impact energy and impact damage threshold for an unpressurized 6.6-in.-dia \times 20-in.-long cylindrical COPV.

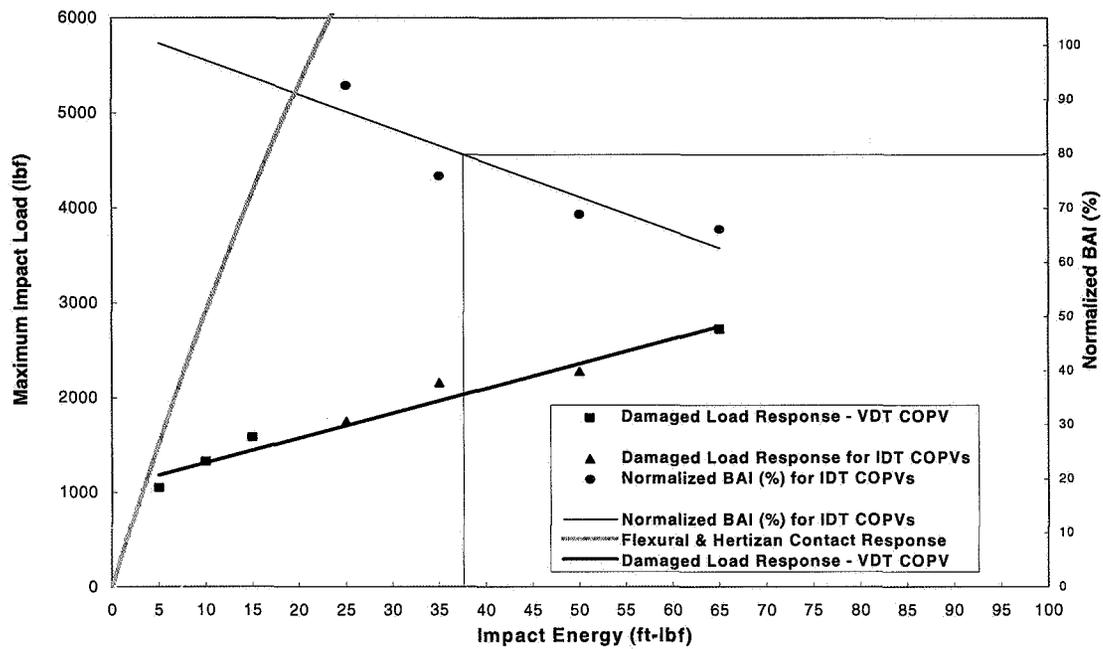
Figure 7-40. Critical impact energy and impact damage threshold for an unpressurized 13-in.-dia × 25-in.-long cylindrical COPV.

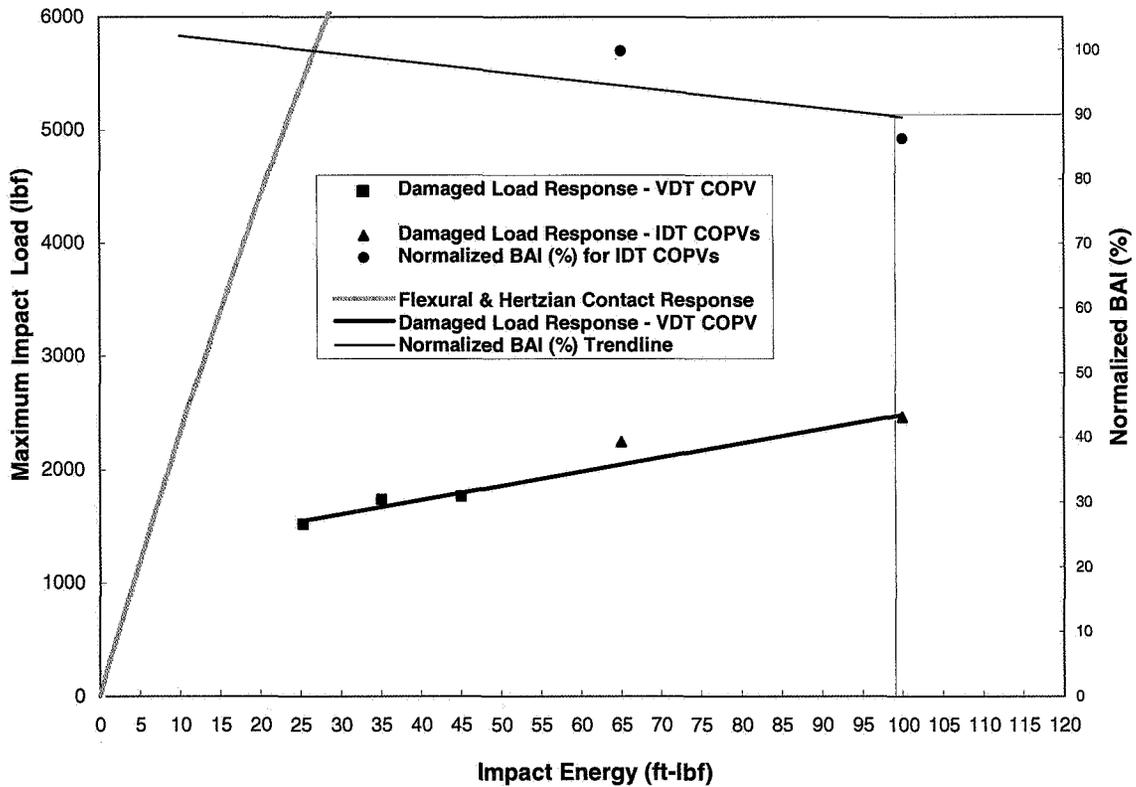
Figure 7-41. Critical impact energy and impact damage threshold for an unpressurized 19-in. spherical COPV.

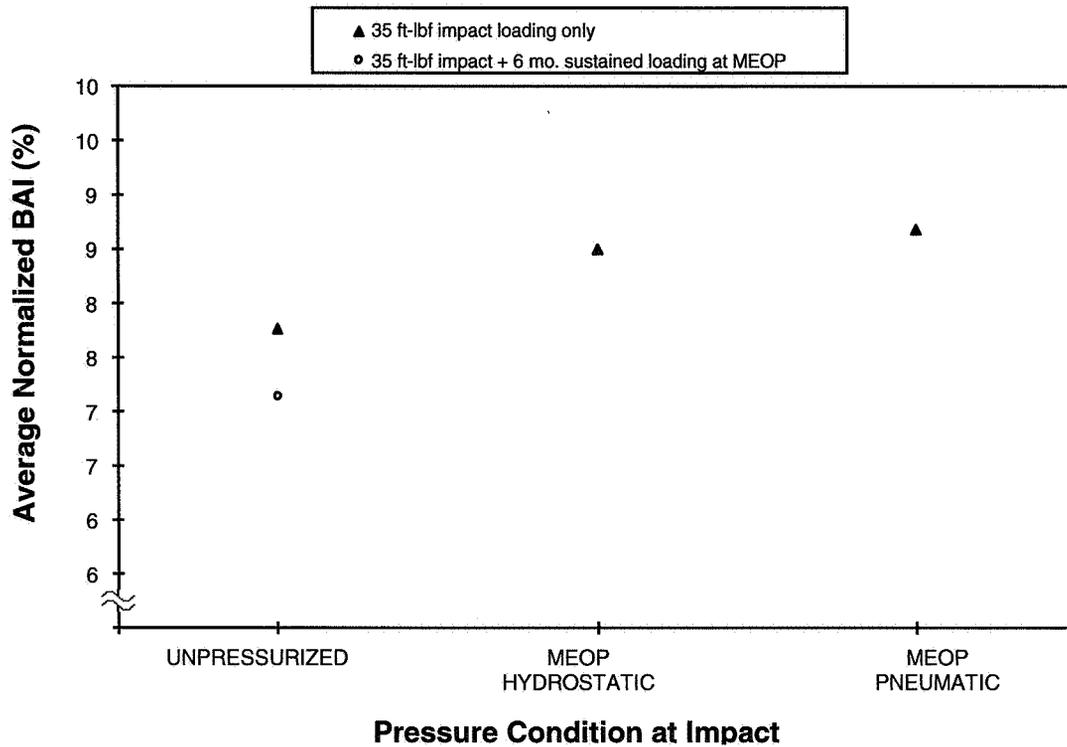
Figure 7-42. Data trend for 10.25-in. spherical COPVs.
