# Evaluation of Training Samples Manually Welded With the Universal Handtool in a Space Simulation Chamber

## TECHNICAL MEMORANDUM

## 1. INTRODUCTION

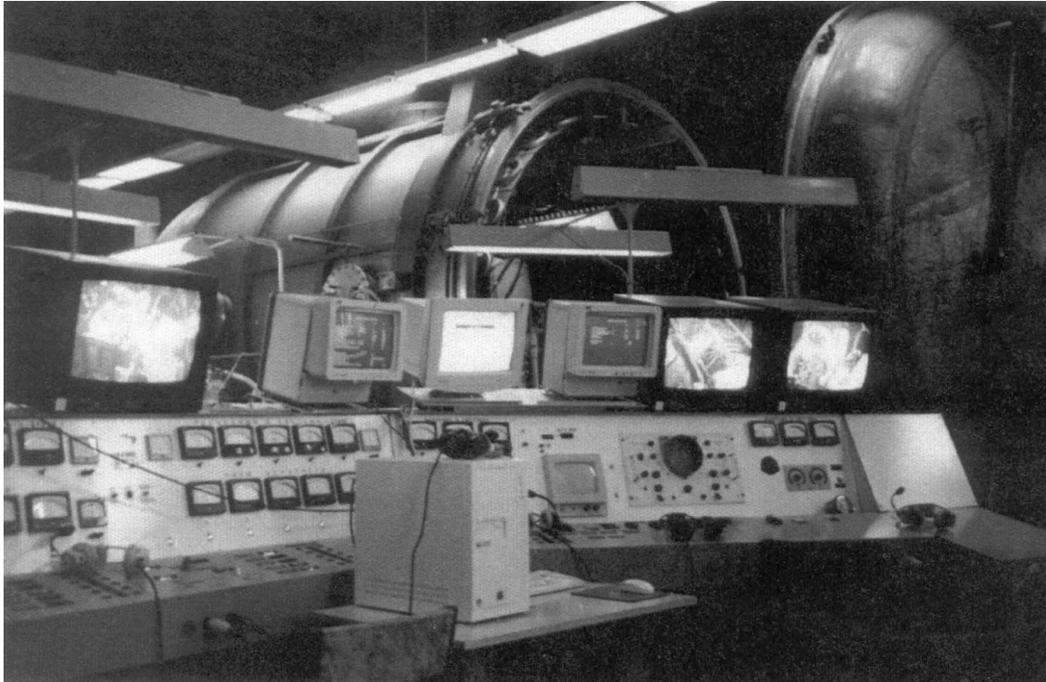
Figure 1. Space simulation chamber.

The TBK-50 chamber was also used to test weld sample layout, ambient lighting requirements, validity of established weld parameters, effectiveness of protective spacesuit covering, and medical effects of the working conditions imposed by this experiment setup.<sup>2</sup> The operators trained in an Orlan suit similar to those used in space. The suit and UHT were equipped with counterweights for simulated weightlessness (figs. 2 and 3).

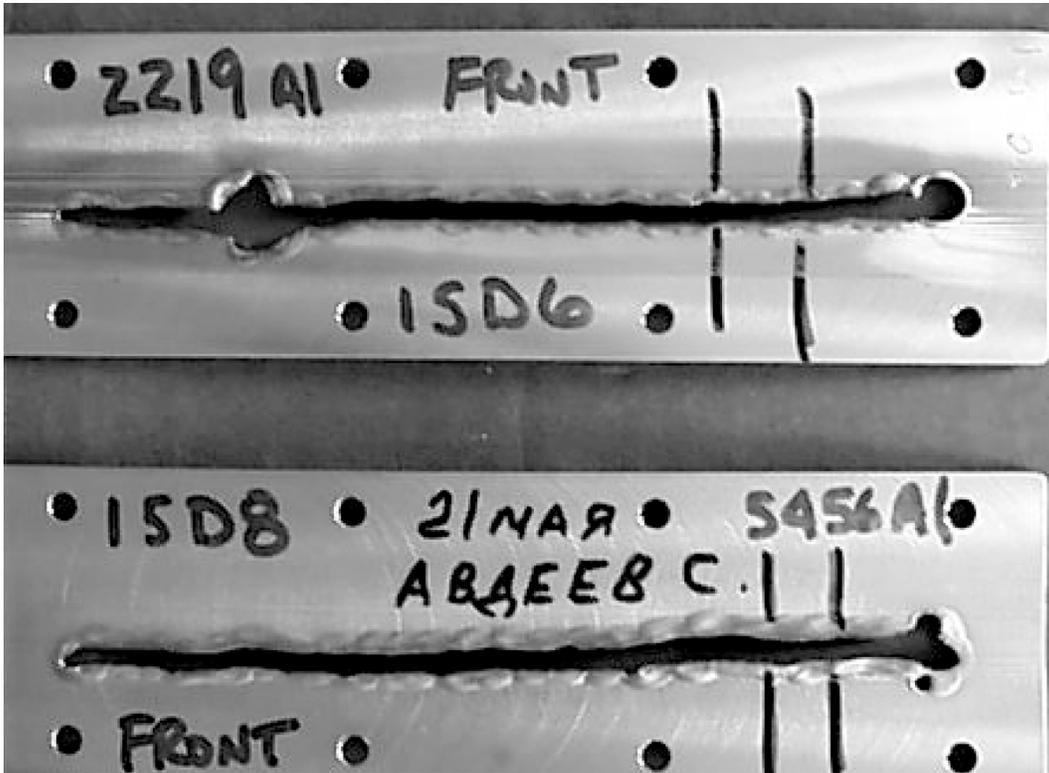
Figure 12. Al 2219 and 5456 cutting samples.

The final plate samples were used to demonstrate cutting with the UHT. The operators cut four plates, one of each material. The visual appearance showed consistent widths for the Al 2219 and 5456 cuts in 0.024-in-thick plate, with even melting evident along both edges of the cut (fig. 12). A different appearance was presented by the 304 SS and Ti-6Al-4V cuts in 0.032-in-thick plate (fig. 13). These widths were very inconsistent, with uneven melting evident along the cut edges. In fact, the large solidified blobs could represent a safety concern if they were to release from the plate while molten. The 304 SS cut sample also showed evidence of spatter on the backside of the plate, indicating that molten metal was released during the cutting operation (fig. 14).

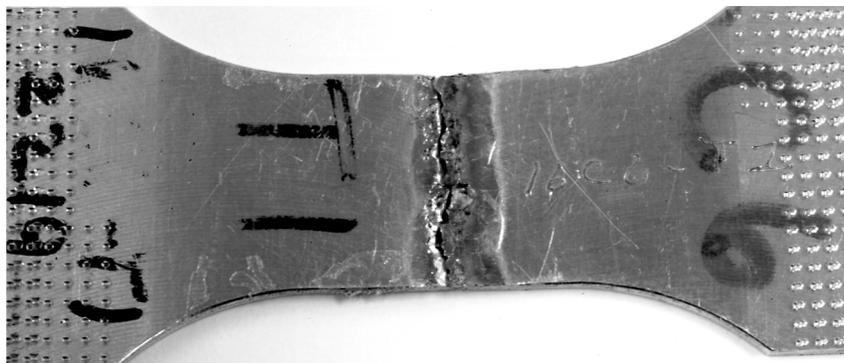
Figure 40. Al 2219 butt joint (test sample).

Figure 40 shows a butt weld joint on Al 2219. This fracture revealed many large pores and some lack of fusion with some good ductility on the fracture surface.

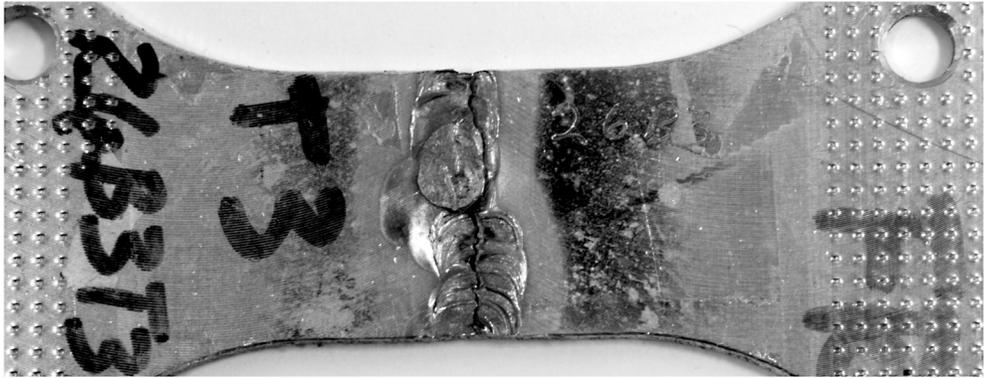
Figure 41. Al 5456 butt joint (test sample).

Figure 41 shows a butt weld joint on Al 5456, a configuration which included some of the most defective joints tested. This fracture revealed large voids, porosity, and lack of fusion.

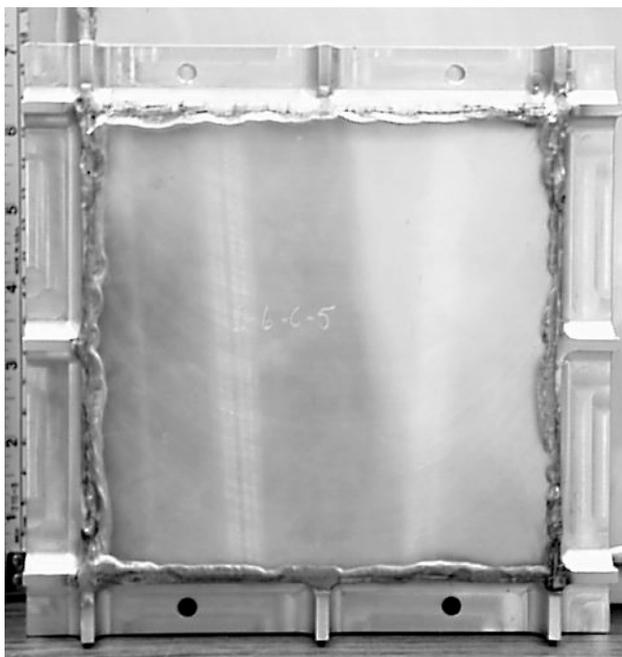
Figure 49. Russian module simulated patch (test sample).

Although the Al 5456 sample was supposed to be welded with the filler wire handtool, it was finally welded without filler wire, as the operators found it impossible to orient the handtool and filler wire in the correct manner around all four sides of the patch. The weld bead was very inconsistent, with convex surface contour in areas.

(5) Additional work is needed to develop an acceptable repair weld technique for the Russian module patch.
