# RESEARCH MEMORANDUM

DITCHING INVESTIGATION OF A  $\frac{1}{15}$  - SCALE MODEL  
OF THE CONVAIR-LINER AIRPLANE

By Lloyd J. Fisher and William C. Thompson

Langley Aeronautical Laboratory  
Langley Air Force Base, Va.

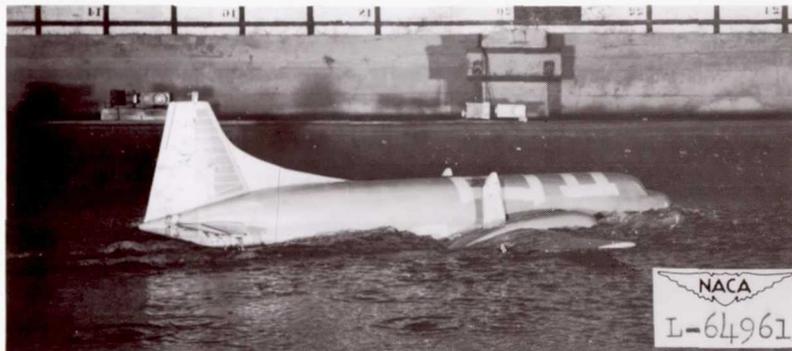
(a) Flaps down  $39^\circ$ , rotated toward neutral position when scale-strength flap connections failed.

Figure 6.- Sequence photographs of model ditchings with scale-strength fuselage bottoms installed; landing attitude,  $9^\circ$ . All values are full-scale.

With the flaps down and allowed to rotate toward the neutral position when the scale-strength flap connections failed, the model ran smoothly but deeply and nosed in at the end of the run. There was a relatively large amount of spray over the model throughout the run which is shown in the sequence photographs in figure 6(a). The total length of run was about 200 feet, and the maximum longitudinal deceleration was about 4g (fig. 4(b)). The bottom of the fuselage was usually damaged somewhat as shown in figure 5(b).
