DEVELOPMENT OF EDDY CURRENT TECHNIQUES FOR THE DETECTION OF STRESS CORROSION CRACKING IN SPACE SHUTTLE PRIMARY REACTION CONTROL THRUSTERS

ABSTRACT. A recent identification of stress corrosion cracking in the Space Shuttle Primary Reaction Control System (PRCS) thrusters triggered an extensive nondestructive evaluation effort to develop techniques capable of identifying such damage on installed shuttle hardware. As a part of this effort, specially designed eddy current probes inserted into the acoustic cavity were explored for the detection of such flaws and for evaluation of the remaining material between the crack tip and acoustic cavity. The technique utilizes two orthogonal eddy current probes which are scanned under stepper motor control in the acoustic cavity to identify cracks hidden with as much as 0.060" remaining wall thickness to the cavity. As crack growth rates in this area have been determined to be very slow, such an inspection provides a large safety margin for continued operation of the critical shuttle hardware. Testing has been performed on thruster components with both actual and fabricated defects. This paper will review the design and performance of the develo

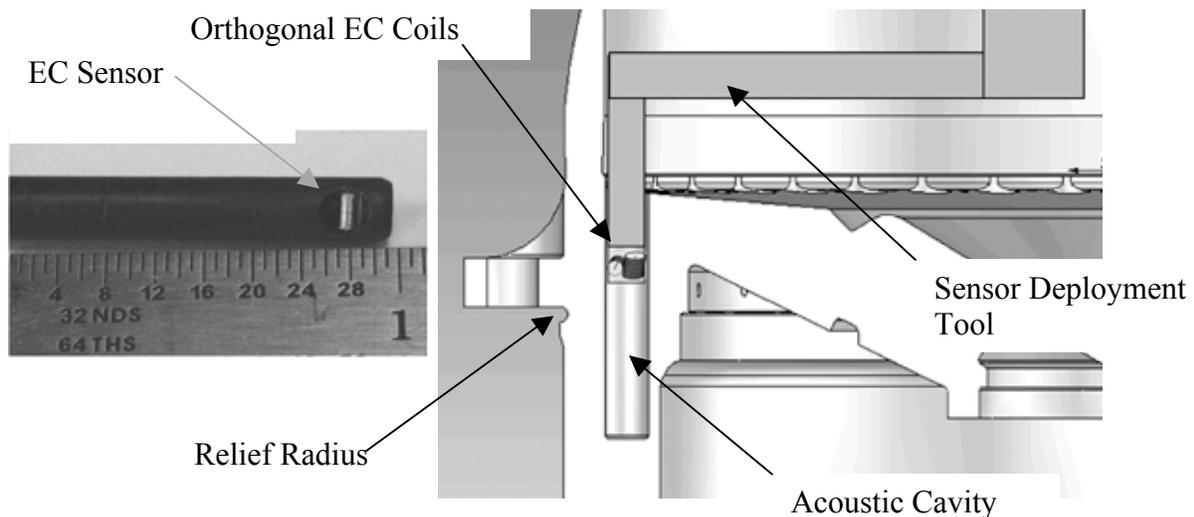
Figure 1 displays a photograph of the prototype eddy current (EC) sensor and a conceptual diagram of the eddy current inspection technique. Matched eddy current coils are arranged orthogonally to each other and scanned into the acoustic cavity of the thruster. In the conceptual diagram in Figure 1, the inspection coil on the left is arranged with its axis along the circumferential direction. This orientation enables a relatively deep field penetration with the small diameter coil required to fit into the acoustic cavity, and induces current in a direction that will have a strong interaction with cracking originating in the relief radius and growing towards the acoustic cavity. The second coil is arranged with its axis parallel with the axis of the acoustic cavity. This second coil is designed to provide a local reference for the inspection coil while minimally interacting with damage originating at the acoustic cavity.

Figure 1. Photograph of prototype eddy current sensor and schematic diagram of eddy current thruster inspection tool.

Initial testing performed with the sensor design shown in Figure 1 found a good sensitivity to nearly through-wall flaws, but damage that had not progressed to within approximately 0.020" – 0.040" of the acoustic cavity was difficult to detect due to the complex geometry of the part. The presence of varying material thickness, fuel passageways, and a potentially rough surface of the acoustic cavities was further complicated by the need to deploy the probe through the injector nozzle, past a narrow throat, and into the acoustic cavity for inspection. To minimize the combined effects of these attributes, a stepper motor controlled scanning system was incorporated into the inspection system. The stepper motor scanning system, designed in conjunction with NASA White Sands Test Facility, is deployed in the reaction chamber and rests on the face of the thruster. Once positioned, a pre-programmed scan of the sensor through the area of interest is performed. The use of the stepper motor scanning system significantly reduces lift-off effects associated with probe tilt and wobble, which are extremely difficult to control under hand scanning. In addition, the stepper motor scanner provides for indexed scanning such that eddy current response data can be plotted directly against location of the probe within the acoustic cavity. Probe responses associated with edge effects and varying wall thickness throughout the scan region can then be directly accounted for and filtered out, greatly enhancing the flaw detectability of the system.

Figure 2 shows a photograph of the eddy current sensor attached to the stepper motor scanner. The eddy current coil pictured in Figure 1 is now mounted in a probe housing that is attached to the stepper motor. In addition to the eddy current sensor, the probe housing holds a second, spare, scanning leg. Two other, fixed legs are attached to the scanning system to provide mechanical stability during scanning. When the scanner is positioned within a thruster, the four legs are spaced to fit into adjacent acoustic cavities. After receiving a trigger signal the stepper motor pulls the probe housing (along with the eddy current sensor and spare scanning leg) away from the thruster face, moving the eddy

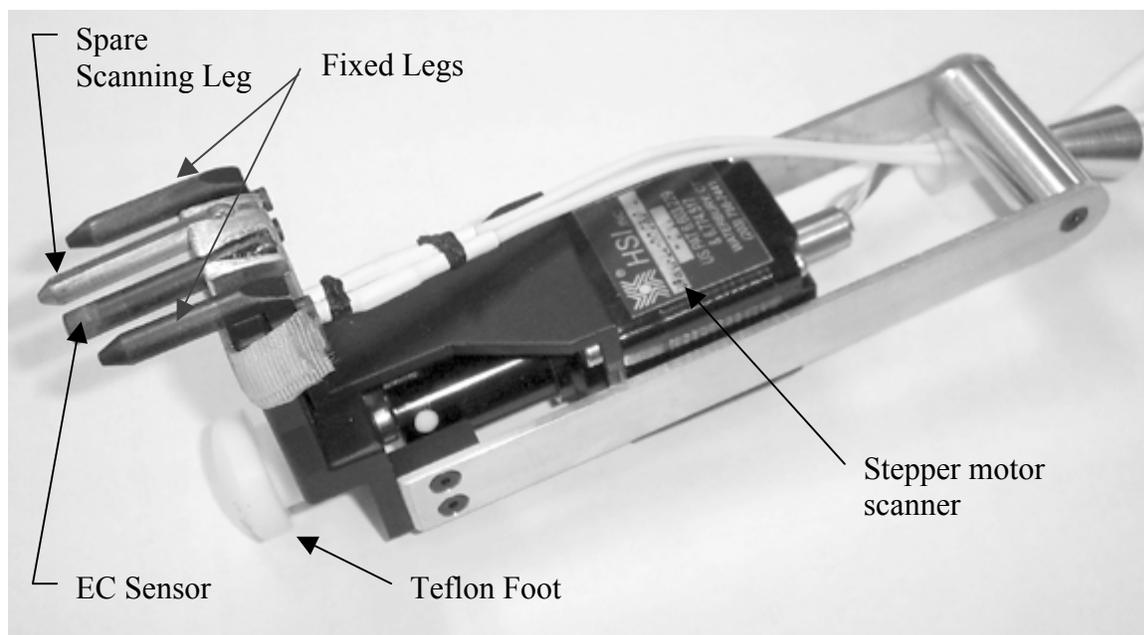
Figure 2. Stepper motor controlled eddy current PRCs thruster scanner.

current sensor through the region of interest. Immediately after withdrawing the probe the stepper motor reverses, moving the sensor once more through the region of interest and back to its start position.

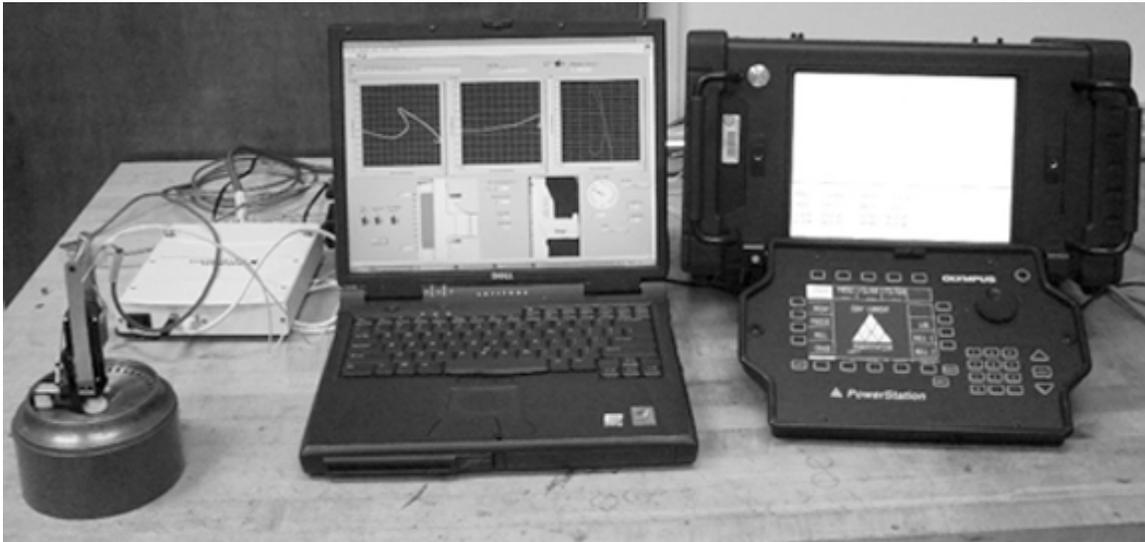
Figure 3. Complete eddy current PRCS thruster inspection system.

The complete eddy current PRCS thruster inspection system is pictured in Figure 3. Along with the eddy current sensor and scanner, the system consists of a dual frequency eddy current instrument, laptop computer, A/D converter, and custom software. The scanner is shown inserted into a thruster mock-up used for setup and calibration.

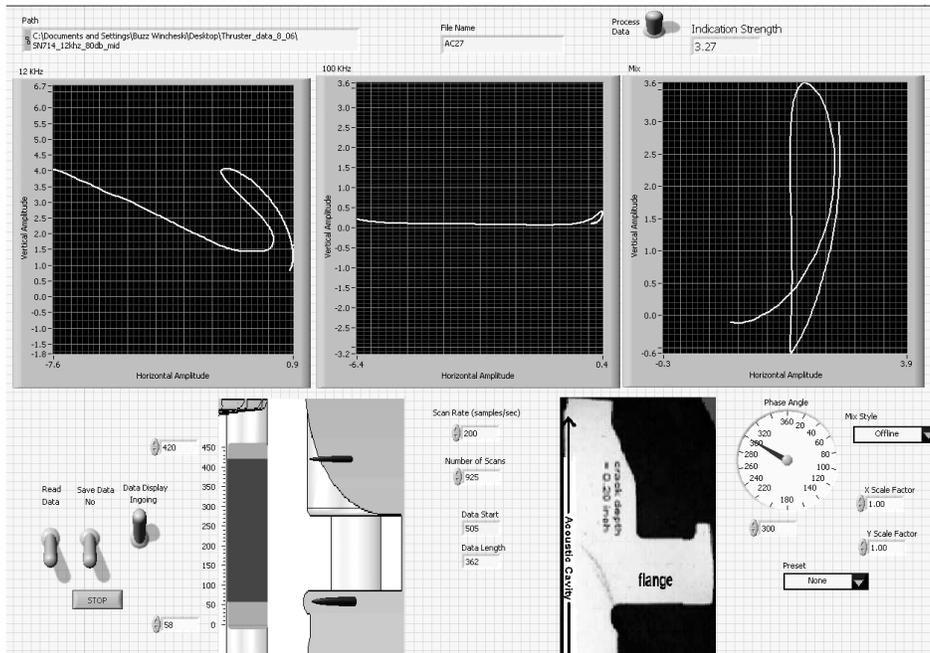
Figure 4. Front panel display of system control and data processing software.

software with data acquired during an inspection of a notched reference standard with 0.020” remaining wall thickness between the notch and the acoustic cavity. The three plots from left to right across the screen display the 12 kHz, 100 kHz, and frequency mix results, respectively. The nearly through-wall flaw is clearly detected in the low frequency and mix signals, with a slight indication of the flaw apparent even at 100 kHz. Toggle and slide switches are incorporated to enable the plotting of data over any region within the complete scan range, as well as of data acquired during the outgoing or ingoing scan of the probe. Controls are also present to adjust the mix signal parameters for data analysis on the selected portion of the scan data. The front panel also contains a micrograph of a stress corrosion-cracking site dissected from a PRCS thruster. The typical crack profile displayed in the micrograph is useful for interpreting the eddy current response in relationship to potential damage in the hardware.

A final feature to be noted on the front panel is the calculated “Indication Strength”, given in the upper right hand corner of the display. This value is calculated by fitting the eddy current response to the anticipated profile for the sensor scanned through an unflawed acoustic cavity region. Due to the edge effect as the probe nears the acoustic cavity opening, a sharp increase in the low frequency signal level is seen in this region. As the sensor moves into the cavity, a minimum in the low frequency vertical response is detected, most likely due to increasing wall thickness in this area. As the probe passes deeper into the cavity an increase followed by a final slight decrease in the probe output is detected. Subtracting the high frequency vertical component from low frequency vertical component helps to remove other artifacts, such that subsequent analysis is performed on this difference signal. Analysis of this signal profile has led to a signal processing technique employing curve fitting to a cosine modulated exponential function. The vertical component of the low frequency probe response minus that of the high frequency is fit to a curve of the form

The system control and data processing software initiates a scan sequence by sending a trigger signal to the stepper motor. Analog output data from the eddy current instrument are then acquired by the computer as the sensor scans partially out of and then back into the acoustic cavity. After the scan completes the acquired data at 12 kHz, 100 kHz, and frequency mix (calculated as the difference between the 12 kHz and 100 kHz responses) are displayed. Figure 4 shows a close up view of the front panel of the system

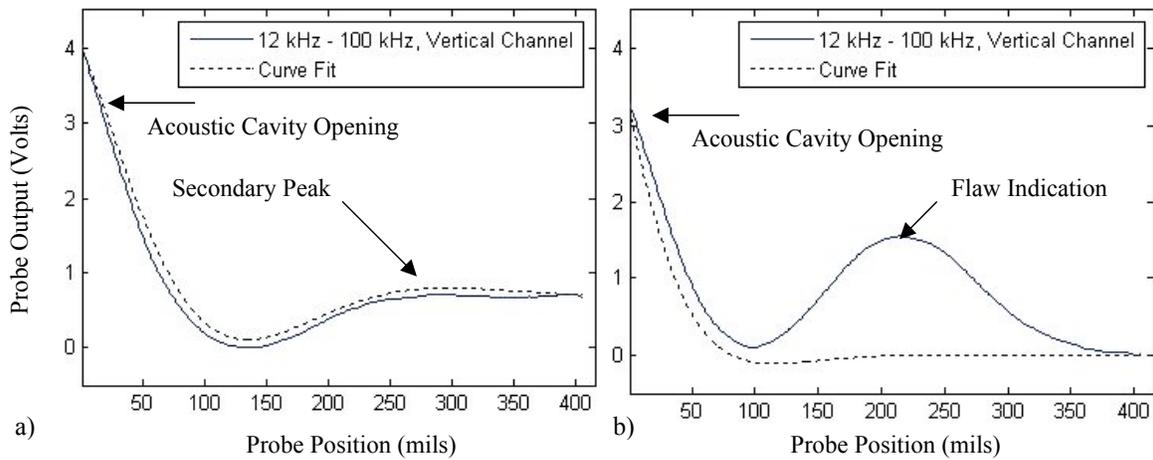
with L = the secondary peak location, x = scan position inside the cavity, and A = the curve fit parameter. The fit is also constrained to match the data at each end of the scan. Figure 5 displays the results of applying this curve fitting procedure to an unflawed acoustic cavity (left plot) as well as a region where a notch approaches an acoustic cavity to within 0.040” remaining wall thickness (right plot). The difference between the raw data and the curve fit highlights the flawed region in the plot on the right. This technique is particularly useful for flaws growing at a steep angle, projecting to an intersection of the acoustic cavity near the cavity opening. It has been found that a calculation of the peak amplitude in the plot of the difference between the curve fit and the raw data correlates well with remaining wall thickness between the acoustic cavity and damage originating in the relief radius area. This calculated peak amplitude is the “Indication Strength” displayed on the system software front panel.

Figure 5. Plot of curve fit results for (a) unflawed cavity and (b) cavity with notch approaching to within 0.040” of the acoustic cavity wall. Error between curve fit and raw data highlights flawed regions near the acoustic cavity.

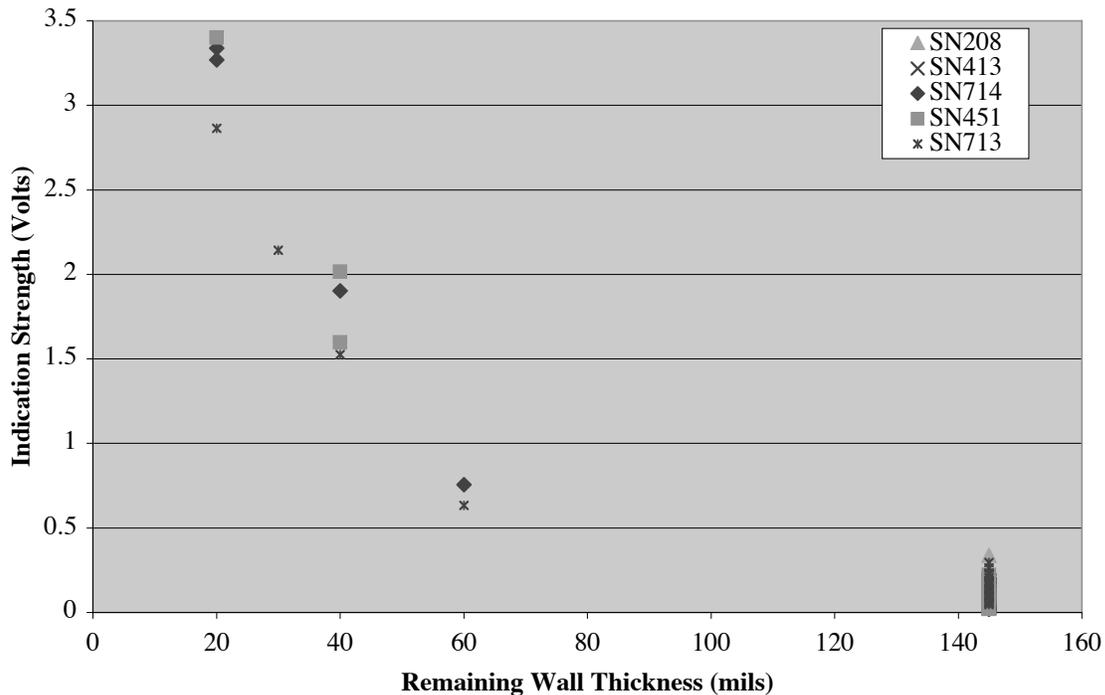
Figure 6 displays a plot of the calculated indication strength, as described above, versus remaining wall thickness between the acoustic cavity and relief radius. The data in Figure 6 was acquired on three thruster reference standards fabricated with electric discharge machine (EDM) notches and two non-flight (Class 3) thrusters. The EDM notch standards contained flaws at angles of 30, 45, and 60 degrees with remaining wall thicknesses of 0.020”, 0.030”, 0.040”, and 0.060”. There are no known flaws in the two Class 3 thrusters. The minimum distance between the relief radius and the acoustic cavity in an unflawed thruster is roughly 145 mils, such that the cluster of points at that value in Figure 6 represents all of the inspected unflawed cavities, 170 sites.

Figure 6. Calculated indication strength for all cavities with calibration notches originating across from the acoustic cavity as well as all unflawed cavities in PRCS thruster serial numbers 208, 413, 714, 451, and 713.

Based upon the data depicted in Figure 6, a clear threshold can be established between unflawed thruster regions and areas with notches approaching to within 0.060” of the acoustic cavity wall. It should be noted that the data shown in Figure 6 corresponds to notches originating directly across from the acoustic cavity. As the eddy current coil is aligned in this direction, the sensor has maximum sensitivity for flaws in this orientation. As a part of the reference standard development, flaws originating at an off angle have also been fabricated. Test results have shown that the signal response for flaws originating between cavities as opposed to directly across from a cavity does drop, although flaws up to 0.060” away from the acoustic cavity are still detectable.

Naturally occurring stress corrosion cracking in PRCS thrusters has also been studied. A limited number of stress corrosion cracking sites identified in the thruster inventory have been maintained for NDE development and system calibration. The indication levels from this naturally occurring damage have been found to be as high or higher than those for simulated damage using EDM notches. The likely cause for the increased signal levels on naturally occurring damage is the flaw profile. All naturally occurring damage sites identified to date have shown a very high aspect ratio of crack length to crack depth. The notch standards were all fabricated with a two to one aspect ratio, and therefore likely underestimate the crack length at a given remaining wall thickness. The natural crack profile with a long circumferential direction also makes the occurrence of deep cracking between cavities with little damage directly across from the cavity unlikely. It therefore is reasonable to anticipate flaw detection capabilities for naturally occurring stress corrosion cracking to be at least as reliable as those for the calibration data shown in Figure 6.
