Title: Recovery of Space Shuttle *Columbia* and Return to Flight of Space Shuttle  
Discovery

Recovery  
of  
Space Shuttle  
*Columbia*

Return to Flight  
of  
Space Shuttle  
*Discovery*

Michael U. Rudolph  
Engineering Director  
Marshall Space Flight Center

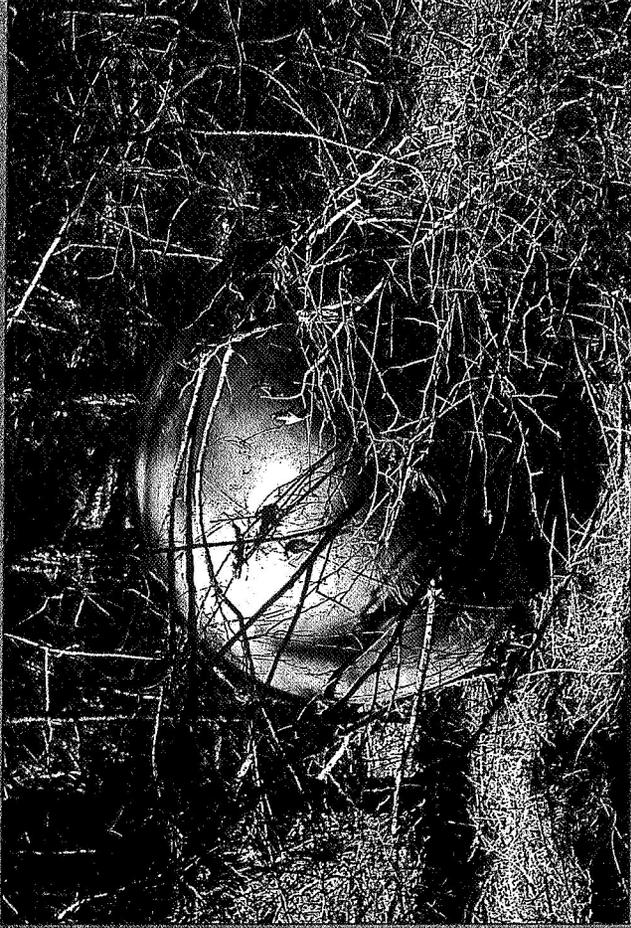
Monomethyl hydrazine  
spherical tank
