# **Results of on-orbit testing of an extra-vehicular infrared camera inspection System**

Patricia A. Howell and K. Elliott Cramer  
Nondestructive Evaluation Sciences Branch  
Mail Stop 231, 3B E. Taylor Rd  
NASA Langley Research Center  
Hampton, VA 23681-2199, USA  
757-864-4786  
757-864-4914 (fax)  
p.a.howell@nasa.gov

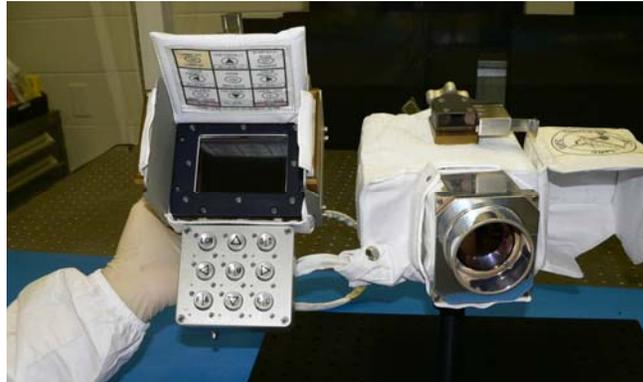
**Figure 1. Photograph of EVA IR Camera Flight Unit. The camera consists of two major components: the camera body with the germanium infrared detector, battery, memory, and flash drive, and the Remote Control Unit (RCU) containing the LCD screen and control buttons.**

The thermal NDE system used for ground inspections consists of a high resolution, high speed cooled detector. The significant limitations of available resources during space missions, such as weight and power, were defining parameters in the selection of the infrared camera. Further, budget and time considerations led to a decision to modify a COTS camera. This camera had to be capable of collecting and storing a series of images to provide the necessary data for NDE processing. Details of the camera modifications necessary to transition the COTS camera to space flight hardware are discussed in Gazarik, *et. al.* <sup>(3)</sup>. A photograph of the final camera system modified for on-orbit use is shown in Figure 1.

An uncooled microbolometer camera was chosen in order to minimize the system weight and required power. While cooled detector cameras provide significantly better signal-to-noise, the microbolometer provides sufficient signal-to-noise for detecting delaminations of the size and depth of interest, with lower weight and power consumption. The camera has a spectral range of 7.5 to 13 $\mu$ m with a 320 x 240 pixel focal plane array. The field of view is 24° x 18° with a minimum focus distance of 0.3m. It has a thermal sensitivity of 0.06°C at ambient and can collect and store up to

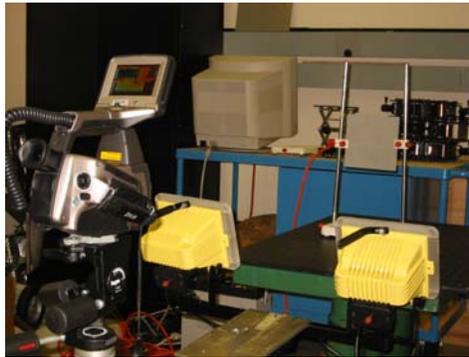
**Figure 2. Laboratory test setup simulating solar flux conditions on RCC.**

To save development time and costs as well as system weight and required energy, the feasibility of detecting sub-surface damage under on-orbit solar conditions was explored by imaging damaged RCC samples using quartz lamps to simulate the expected solar flux. The maximum expected absorbed solar flux on-orbit is approximately  $1100\text{W}/\text{m}^2$ . Two quartz lamps were used in a laboratory environment (ambient temperature and pressure) to simulate expected solar flux. By measuring the temperature profile in RCC and knowing the material properties of RCC (thermal conductivity), the lamp power settings were calibrated to solar flux levels. In addition, the measured temperature profiles were compared to a model simulation of RCC and found to be in good agreement. Figure 2 shows the laboratory test setup.

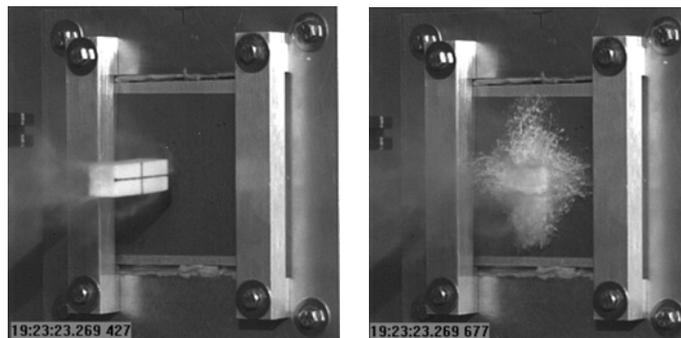
**Figure 3. Photographs of foam impact on RCC panels. Left-hand image shows block of foam just prior to impact. Right-hand side shows foam immediately after impact.**

Seven samples approximately 15 cm wide x 15 cm high of RCC material were impacted with SOFI foam as shown in Figure 3. All seven samples were cut from a previously-flown section of RCC to provide samples with surface emissivity variations as seen on flight panels. The samples were held in a metal frame around the edge to allow the RCC to flex upon impact. The edges of the samples were cushioned from the metal frame with pliable putty to allow further sample motion. The RCC was impacted with SOFI foam that measured 2.5 cm x 2.5 cm cross section and was 5 cm long with a weight of 2 grams. The panels were impacted at speeds of approximately 610 m/s. Multiple impact events were conducted to create samples with more significant damage.

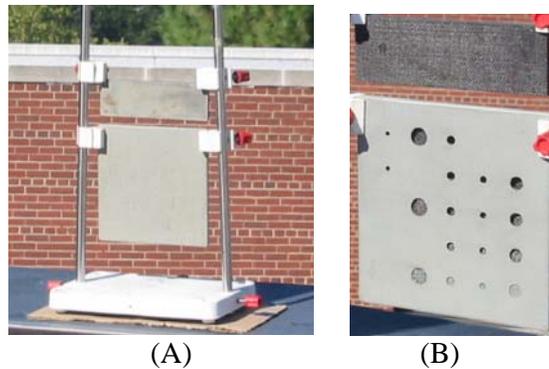
**Figure 4. Photograph of (A) front of samples and (B) back of RCC samples used for testing of thermal technique using solar heating.**

One of the requirements of transitioning the NDE technique to an orbital system is the adaptation of the input heat flux for in-space operations. For the thermal system used for ground RCC tests, a short flash of heat is delivered to the front surface of the sample via two 4800 J xenon flash lamps. The infrared data is acquired during the cool-down phase. Reliance on solar energy to provide the input heat flux results in a much slower application of heat. Quantitative data reduction techniques that are used for RCC inspection require a time-varying thermal contrast between a flawed and an unflawed material. On-orbit, this condition is best achieved by data acquisition at the onset of solar heating or at the end of solar heating phase. Rather than relying on the orbital cycle to set the timing of the solar heating cycle, blocking the sunlight controls the initiation and end of solar heat during data collection. Ground-based experiments showed the feasibility of this approach both from a crew operations perspective as well as a data analysis perspective. For this test, two RCC specimens with known defects were placed under solar heating conditions. The first sample measured approximately 5 cm x 15 cm and contained three full-width defects of various depths. The second sample was approximately 15 cm x 15 cm and contained numerous flat-bottom holes of various depths and diameters. A photograph of these samples is shown in

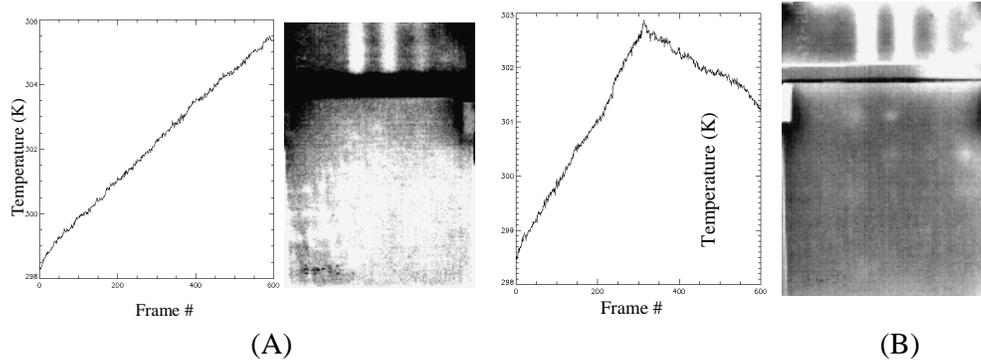
**Figure 5. (A) Processed thermal data on Shuttle RCC under solar conditions with no shading and (B) with shading**

Figure 4. NDE results of data collected under solar conditions on RCC both with and without shading are shown in Figure 5.

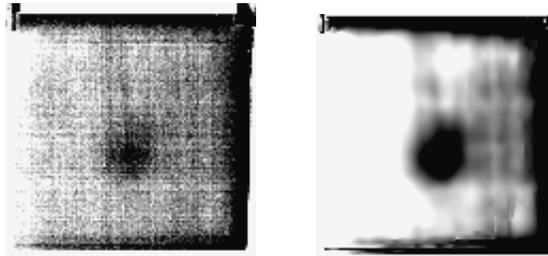
**Figure 6. Post-processed microbolometer data, solar heating (A) without anisotropic diffusion, and (B) with Anisotropic Diffusion algorithm applied.**

Anisotropic diffusion is a data processing technique that has been shown to enhance the contrast between damaged and undamaged regions in thermal images<sup>(8)</sup>. The technique has been shown to significantly reduce spatial image noise while maintaining defect contrast and preserving the important features of a flaw<sup>(9)</sup>. This is accomplished by a convolution of the data with a function containing a diffusion parameter. This parameter is high in regions of low gradients in image intensity and low in regions of high discontinuities in image intensity, as is the case near defect edges. For this data, the algorithm was applied to each frame of the data collected to remove spatial noise from the microbolometer data while maintaining any signal due to a delamination. Application of this algorithm resulted in a significant improvement in signal-to-noise of the final post-processed data, as seen qualitatively below in Figure 6.

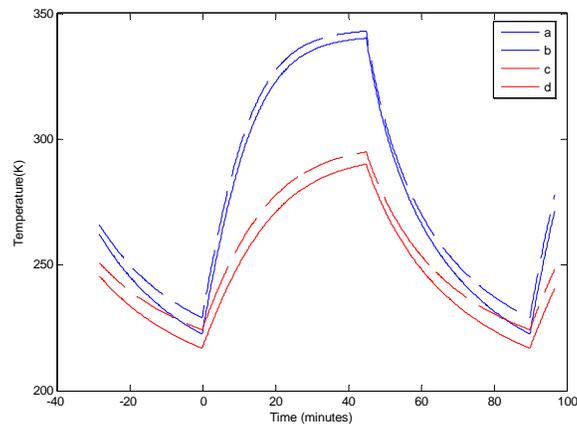
**Figure 7. Results of simulation of thermal response of specimen radiating into two different temperatures and with two different surface fluxes.**

The time history of the temperature at a point far from the delamination is shown in Figure 7. The time in the figure is set to be zero at the beginning of a cycle. The simulation indicates the temperature increases at the beginning of the cycle as the incident flux is applied. During the application of the incident flux, the temperature increases at a decreasing rate, asymptotically approaching a temperature that is determined by the point when the incident flux would be equal to the radiative heat transfer. This is seen in the figure where the case of radiative heat transfer into 170°K approaches a slightly higher temperature than for radiative heat transfer into 10°K.

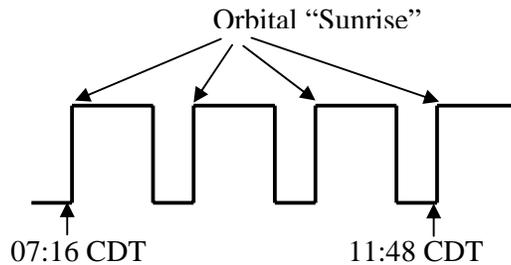
**Figure 8. Graphic illustrating the periodic thermal solar load on the RCC during orbit overlaid with the times data was taken on the Shuttle wing leading edge with the EVA IR Camera on STS-121.**

Two 20-second thermal movie segments of the starboard WLE were obtained on STS-121. One movie segment was taken just after egress from the airlock, and the other toward the end of the EVA. Constraints of EVA timeline planning were the primary driver to this schedule. Both of these thermal movie segments were taken at approximately the same relative point in the orbital day/night sequence – approximately 5 minutes prior to orbital sunrise as shown below in Figure 8.

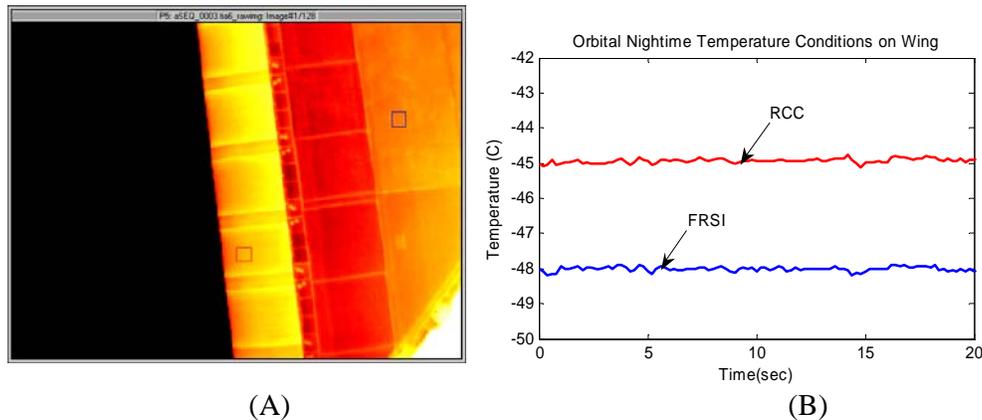
**Figure 9. (A) Infrared image from Shuttle wing leading edge taken at 07:16 CDT on July 15, 2006. Orbital sunrise will occur in approximately 5 minutes. (B) Temperature versus time plots for two regions of the infrared image.**

Figure 9 shows that for a region of interest over a representative RCC panel on the wing of the Shuttle and for a region over the white Felt Reusable Surface Insulation (FRSI) acreage region of the wing, the temperature has reached equilibrium in both regions during the nighttime cycle. The RCC is holding at a stable  $-44^{\circ}\text{C}$  and the FRSI is approximately  $4^{\circ}$  colder at  $-48^{\circ}\text{C}$ . Assuming the FRSI to be a thermal insulator, it is possible to approximate the background temperature for the radiative heat loss to space as  $-48^{\circ}\text{C}$ . The first infrared movie taken at 07:16 CDT July 15, 2006 was used in Figure 9. The second movie of the WLE taken 4.5 hours later, of the same section of the wing, had similar results, although the temperature of the FRSI was as much as  $5^{\circ}\text{C}$  colder than the previous movie sequence recorded. The difference in temperature is attributed to the change in the temperature of surround structures between measurements. Since this temperature difference does not significantly effect the radiation heat loss at the surface, it is does not appreciably impact the NDE technique, which depends on the thermal time history at a point.

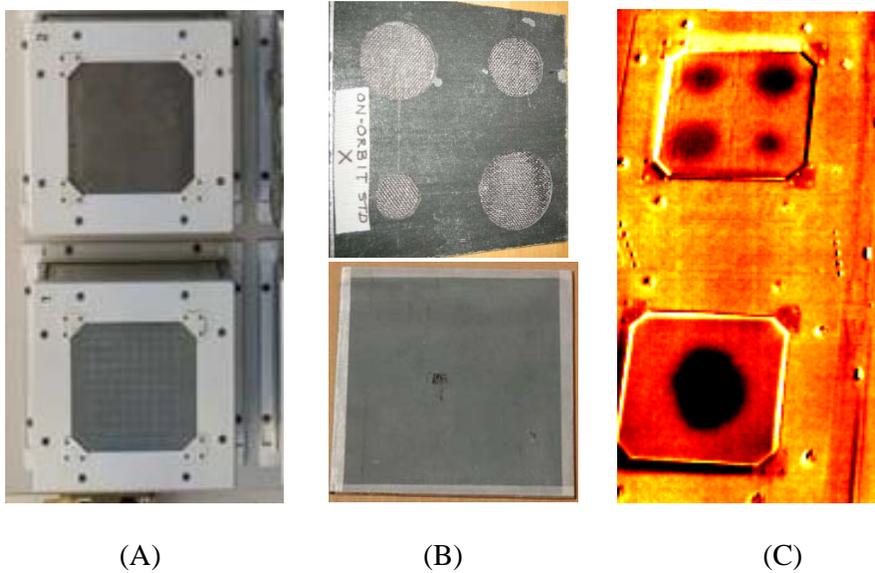
**Figure 10. (A) Photograph of the OML surface of the two RCC samples in the Shuttle cargo bay. No OML surface damage is visible on either sample. (B) Photographs of the IML surface of the same two samples. (C) Processed infrared NDE imagery from STS-121 flight test.**

For the samples flown on STS-121 (shown in Figure 10), the NDE standard included flat-bottom holes removing 50% thickness of the material in circular areas with diameters ranging from 2.5 cm. to 5 cm. Diameters of the flat-bottom holes were chosen to approximate delamination sizes of interest to the RCC damage assessment team at the time the samples were fabricated. The sample with impact damage flown on STS-121 had been extensively inspected by both thermography and x-ray CT prior to the flight. This sample was determined to have an approximately 6.3 cm. x 8.1 cm oblong delamination and included a small (1.3 cm long) region of Inner Mold Line (IML) coating loss. No front surface, or Outer Mold Line (OML), damage was present

in either sample. As can be seen in Figure 10c all delaminations and flat bottom holes are clearly visible

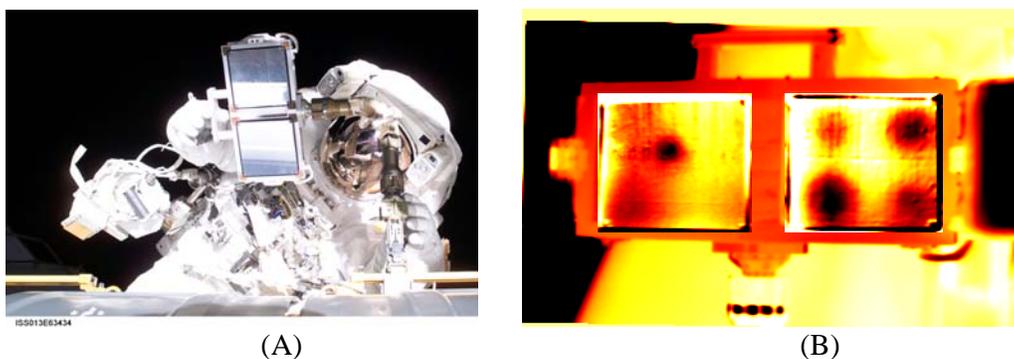
**Figure 11. (A) Astronaut Thomas Reiter prepares the Test Article Assembly for data acquisition. (B) Processed thermal images of acquired data.**

Results for camera tests conducted during the stage EVA on the ISS (Figure 11) resulted in detection of defects approximately 2.5 cm. in diameter created from panel impact and 4 flat-bottom-hole simulated damage regions ranging in size from 2.5 cm in diameter to 5 cm in diameter with 25% material loss from the back surface.
